# West Bradley House

## Existing Building Survey

Doc ref    *WBH-HYD-XX-ZZ-RP-S-0001*

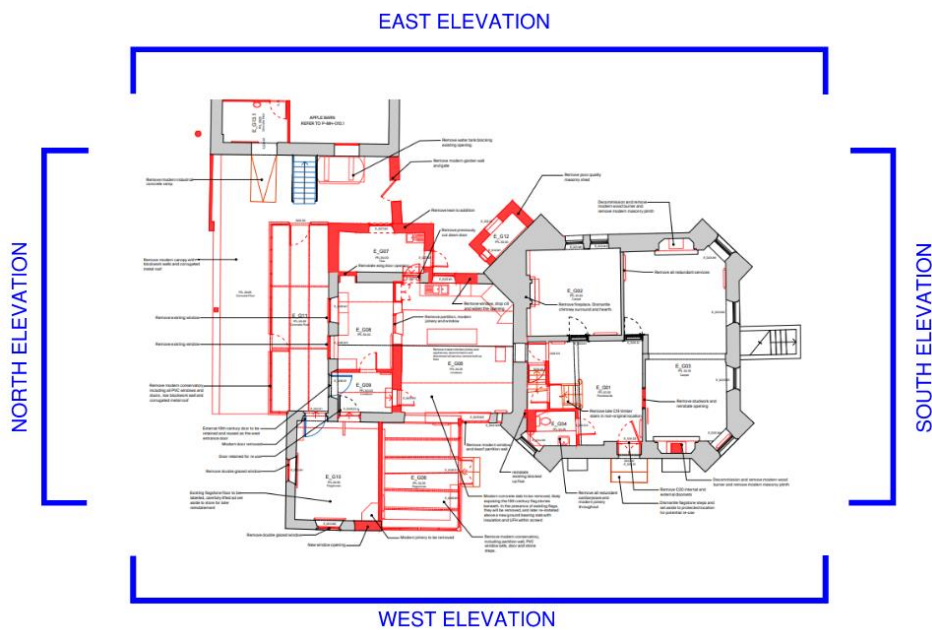
Figure 3: Main House. Plan indicating elevations

The pitched roof appears as a later ancillary addition to the original house. It is in keeping with the design of the Apple Barn and likely mimics this design, replacing a previous roof. Gable ends constructed of redbrick masonry have also been introduced.
