# Arboricultural Consultancy for Lloyds Bank

Insured		Address	4 Witley Lodge Close, Cheltenham , GL51 3LW		
Client	Subsidence Management Services	Contact	Brad Jenkins	Claim No.	IFS-LBG-SUB-22-0102485
ES Ref	SA-250762	Consultant	Simon Nash	Contact No.	
Report Date	27/10/2022

# GEOTECHNICAL

# SOIL ANALYSIS

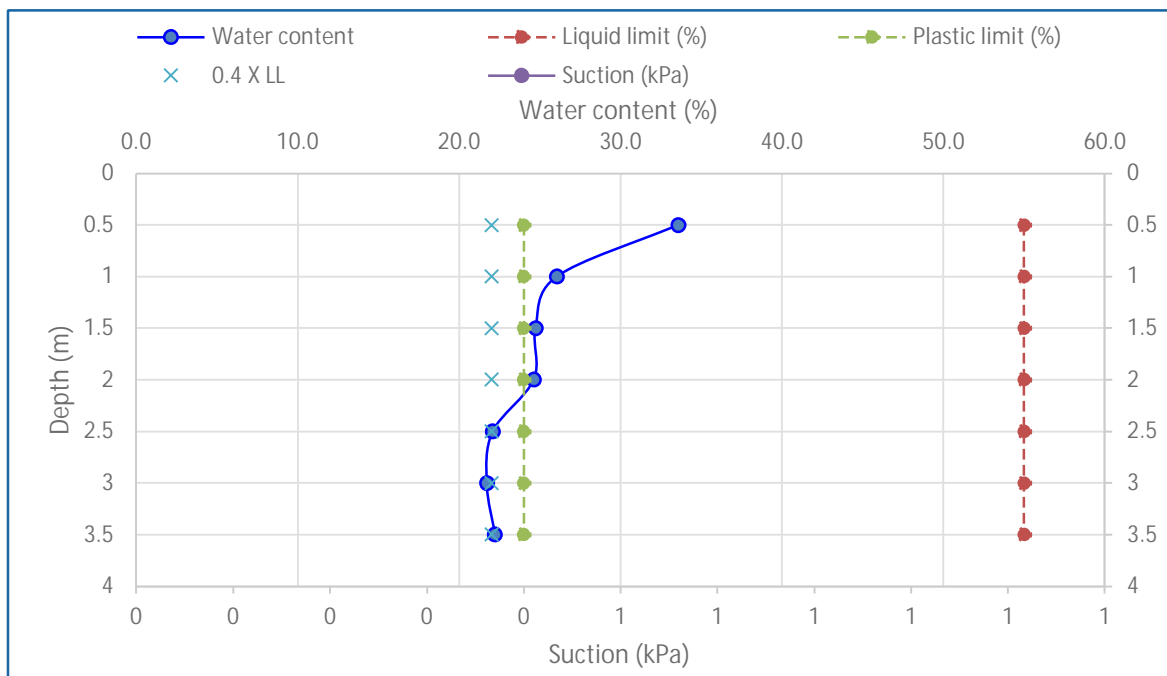
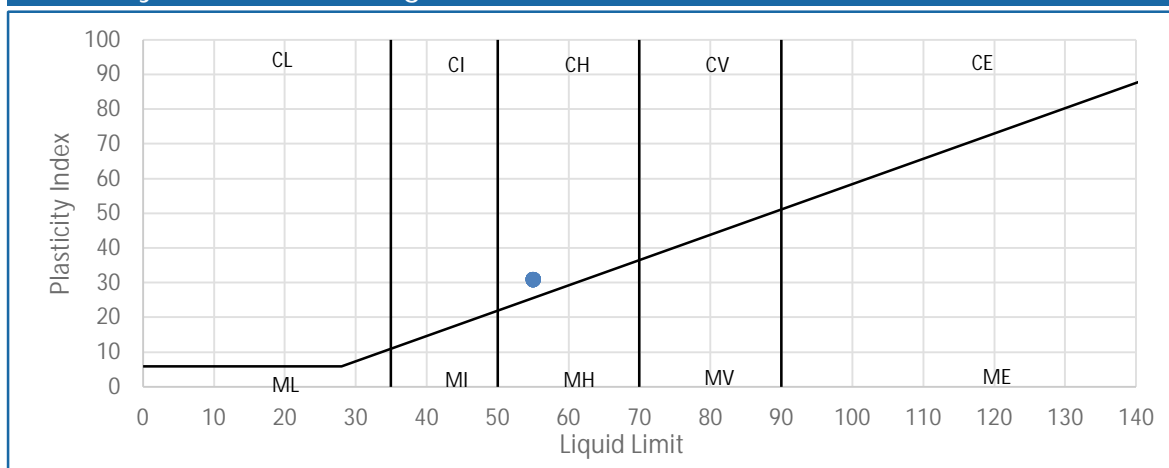
### Plasticity Chart for Casagrande Classification

Lab Ref	Depth (m)	WC (%)	LL (%)	PL (%)	PI (%)	.425 mm(%)	mod. PI (%)	Av. Suc. (kPa)	Description
1	0.5	33.6	55	24	31	99	31		Firm grey-brown/grey/dark grey mottled silty CLAY with rare gravel and organic material. Gravel is fine and medium.
2	1	26.0	55	24	31	99	31		Firm grey-brown/grey/dark grey mottled silty CLAY with rare gravel and gypsum. Gravel is fine and medium.
3	1.5	24.7	55	24	31	99	31		Firm grey/dark grey mottled silty CLAY
4	2	24.6	55	24	31	99	31		Firm grey/dark grey mottled silty CLAY
5	2.5	22.1	55	24	31	99	31		Firm grey/dark grey mottled silty CLAY
6	3	21.7	55	24	31	99	31		Firm dark grey silty CLAY
7	3.5	22.2	55	24	31	99	31		Firm dark grey silty CLAY

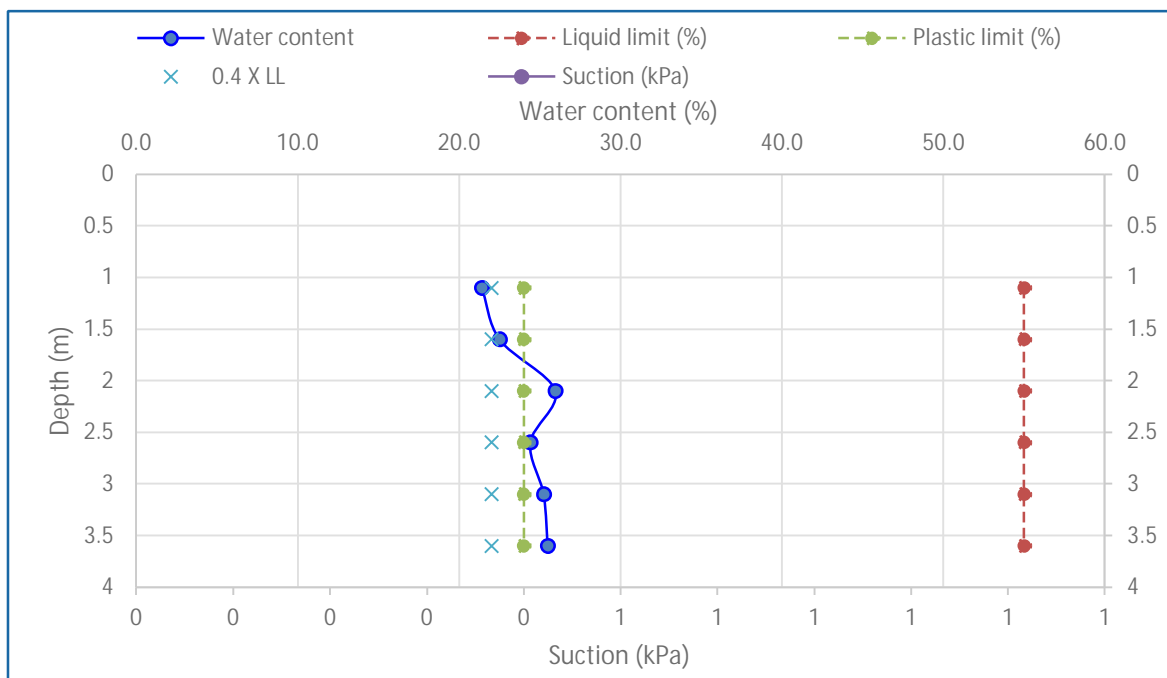
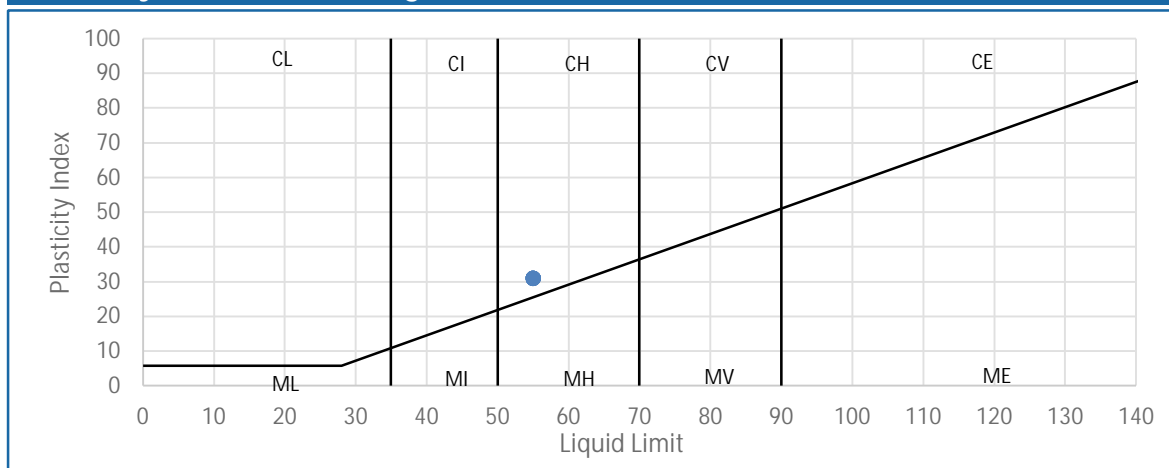
### Plasticity Chart for Casagrande Classification

Lab Ref	Depth (m)	WC (%)	LL (%)	PL (%)	PI (%)	.425 mm(%)	mod. PI (%)	Av. Suc. (kPa)	Description
8	1.1	21.4	55	24	31	99	31		Firm grey-brown/grey/dark grey mottled silty CLAY with rare gravel. Gravel is fine
9	1.6	22.5	55	24	31	99	31		Firm grey-brown/grey/dark grey mottled silty CLAY
10	2.1	26.0	55	24	31	99	31		Firm grey/dark grey mottled silty CLAY
11	2.6	24.4	55	24	31	99	31		Firm dark grey mottled silty CLAY
12	3.1	25.2	55	24	31	99	31		Firm dark grey mottled silty CLAY
13	3.6	25.5	55	24	31	99	31		Firm dark grey mottled silty CLAY
