# Sash Window Surveys Edinburgh

## Condition Survey Report

**DATE:**  
20/03/2024

**Address:**  
19 Heriot Row  
Edinburgh  
EH3 6HP

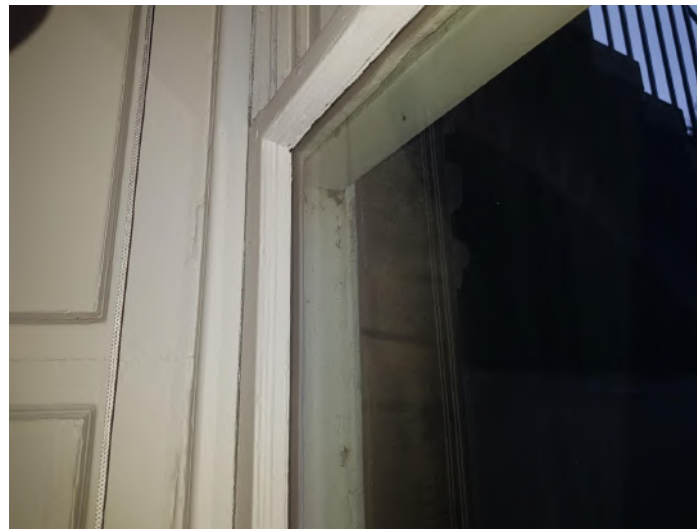
- Moisture permeation of the horizontal rails and extending to the lower stiles
- Condensation damage internally on horizontal rails.
- Loss of moulding detail around the sash perimeters due to previous filling/sanding
- Condensation damage to horizontal rails
- Previous patch repairs visible under paintwork
- Cracking of paint along the joins is indicative of shrinkage/swelling and a weakening of the structure.
- Currently has Slimline IGUs

Like-for-like replacement custom-fitted with Slimline IGUs

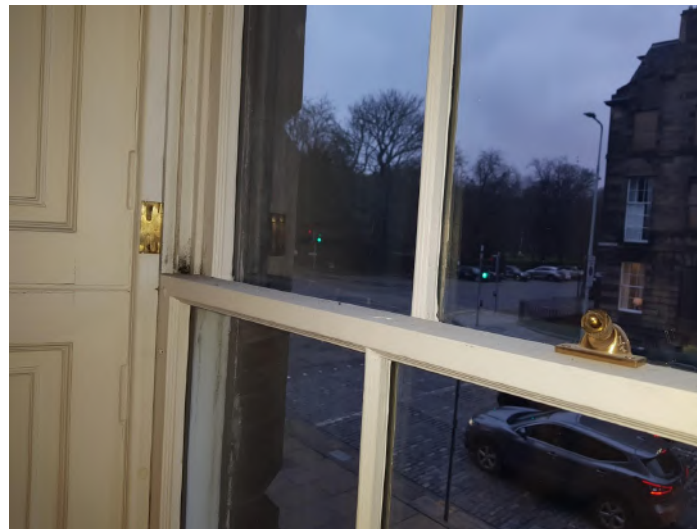
- Moisture permeation of the horizontal rails and extending to the lower stiles
- Cracking of paint along the joins is indicative of shrinkage/swelling and a weakening of the structure.
- Loss of moulding detail in place due to over-sanding/filling and overpainting.
- Currently has Slimline IGUs

Like-for-like replacement custom-fitted with Slimline IGUs
