The Guildhall Lyme Regis Dorset  
Statement of Significance and Heritage.

This Statement of Significance and Heritage Statement has been prepared to inform applications for planning permission and listed building consent for the replacement of the oriel window in the principal elevation of The Guildhall with a new gabled dormer window. The Guildhall is a Grade II\* listed building that was first listed on the 23rd April 1952, and it forms part of an important group of listed buildings within this part of the historic core of the Lyme Regis Conservation Area. Lyme Regis lies within the Dorset AONB, and its coastline forms part of the Jurassic Coast World Heritage Site. The purposes of this statement are firstly to provide an assessment of the significance of the Grade II\* listed building and its setting within the Conservation Area; and secondly to assess the impact of the proposed development on these designated heritage assets and their settings.

# The Guildhall, Lyme Regis Dorset.

## Statement of significance and heritage.

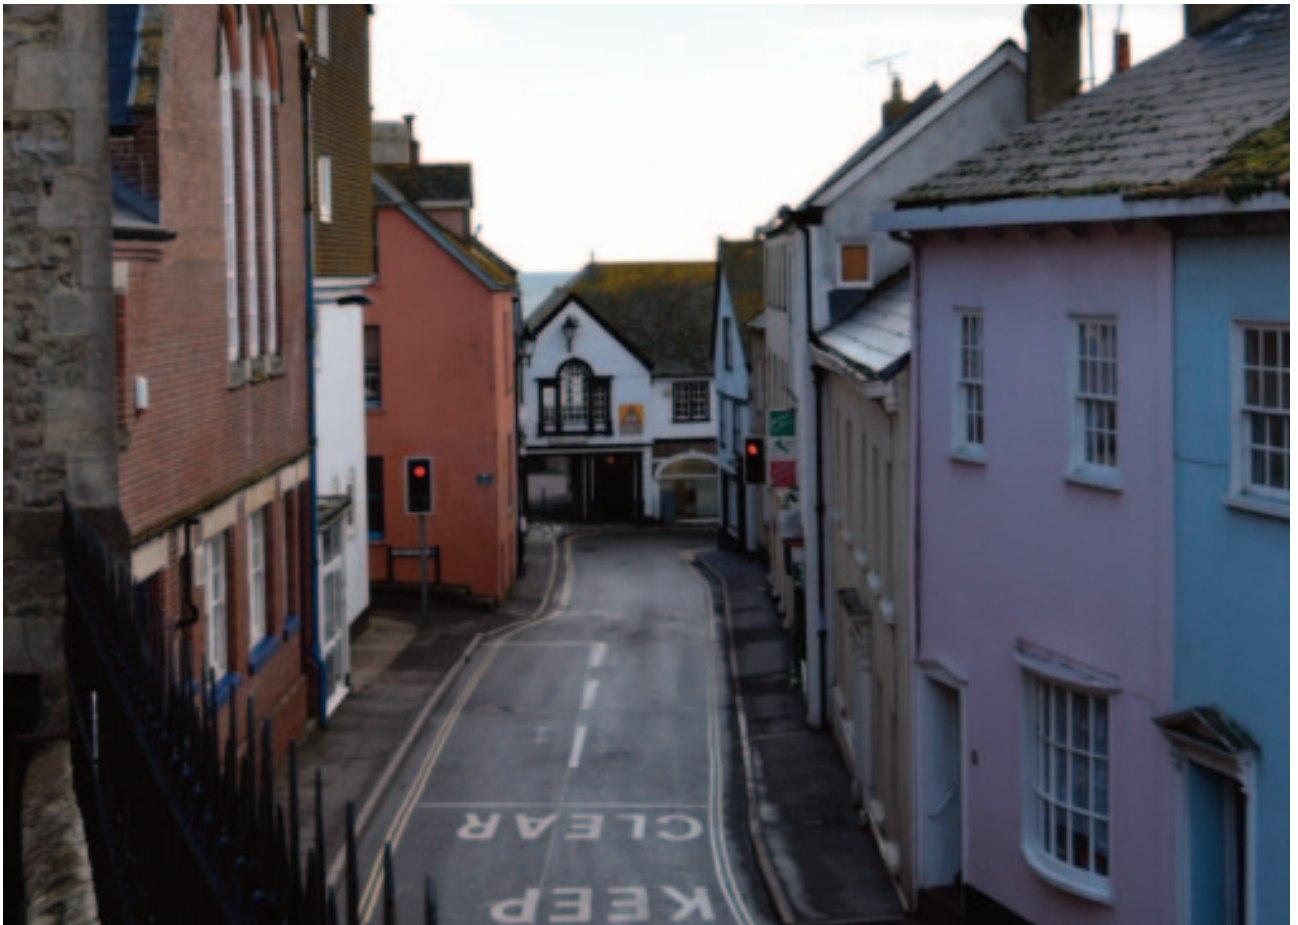
Fig 1. The north elevation of The Guildhall seen from Church Street with Lyme Bay behind. Many of the buildings lining the streets within the historic core of the town were re-fronted in the 18th and 19th centuries.

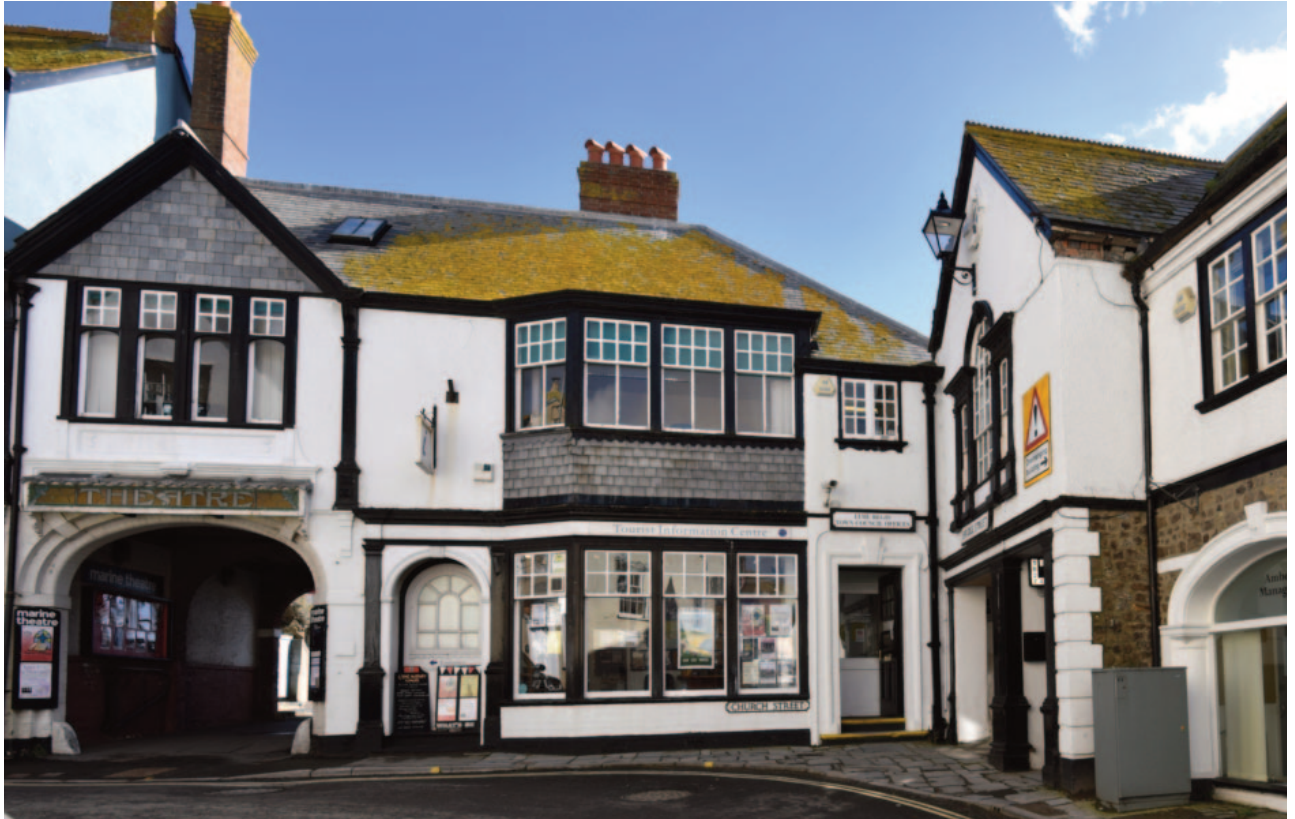
Fig 4. No 62 Church Street, (Guildhall Cottage), now the Town Council offices, and probably also remodelled by Vials when the Guildhall was rebuilt as it shares similar detailing.

The Guildhall is sited on the south side of Bridge Street, on the corner with Church Street; and forms a right angle with No 62 Church Street (Guildhall Cottage). No 62, now the Town Council offices is of two storeys with a slated roof which is hipped at its south end. The building is predominantly finished in white painted render over rubblestone. The front (west) elevation has a gabled bay to the left with moulded bargeboards and slate hanging to the apex. It is articulated by black painted pilasters at first floor level, supported on stone corbels on either side of a wide four-centred arched opening.

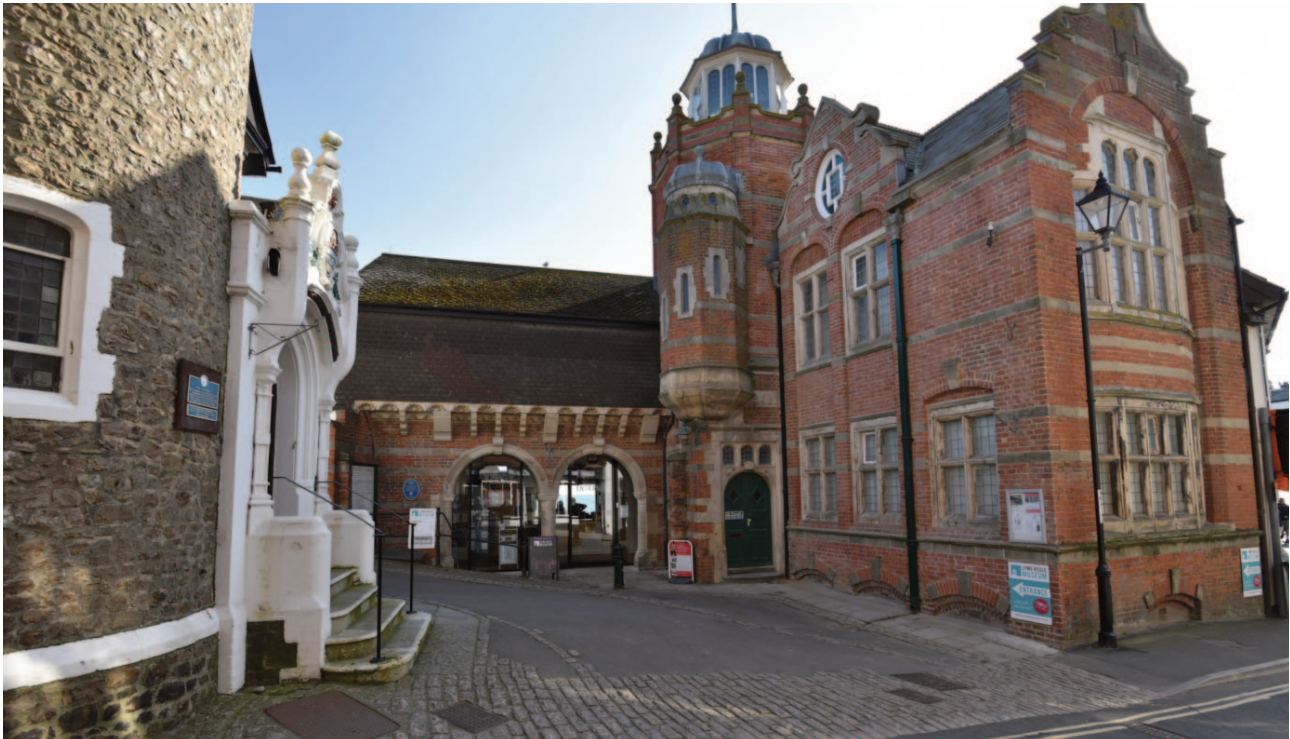
Fig 6. The small square (Cockmoile Square on historic maps) separates the Guildhall from the Museum (both designed by Vials). Until the mid 20th century the Square was enclosed by cottages that extended to the east of the museum and south of The Guildhall, and the arched openings provided access to the sea. The principal range of The Guildhall is of two storeys and is five bays long; it is rough-cast rendered at first floor, with rubblestone and dressed stone detailing at ground floor level, under a hipped slated roof, detailed with decorative ridge tiles, finials, and bargeboards to the verges. Attached to the west

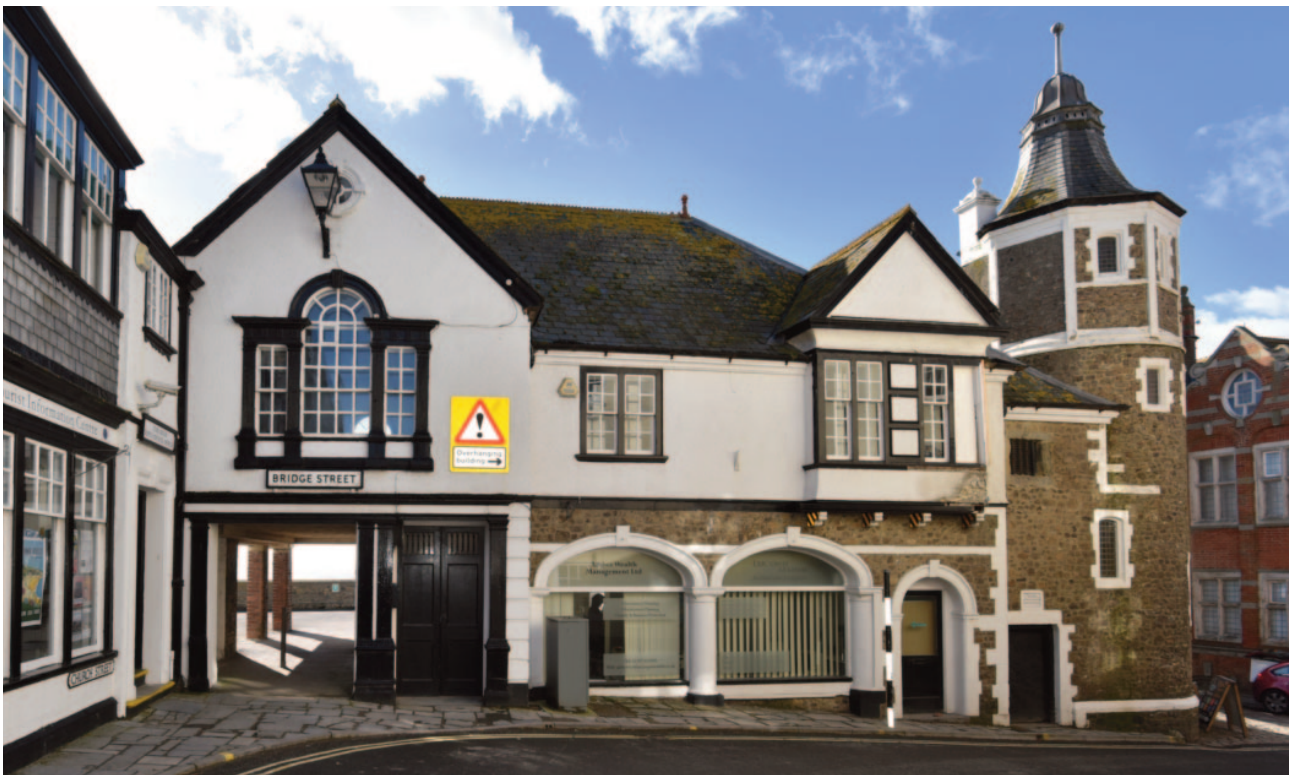
Fig 7. The front (north elevation of The Guildhall with its wide projecting gable to the left and the oriel window to the right. The two open ground floor bays to the left have been further opened up by removal of the east wall in the mid 20th century. Set back slightly on the right is the former jail and remodelled stair tower incorporating the main entrance porch. The left hand projecting bay may have survived the 1890 road widening.

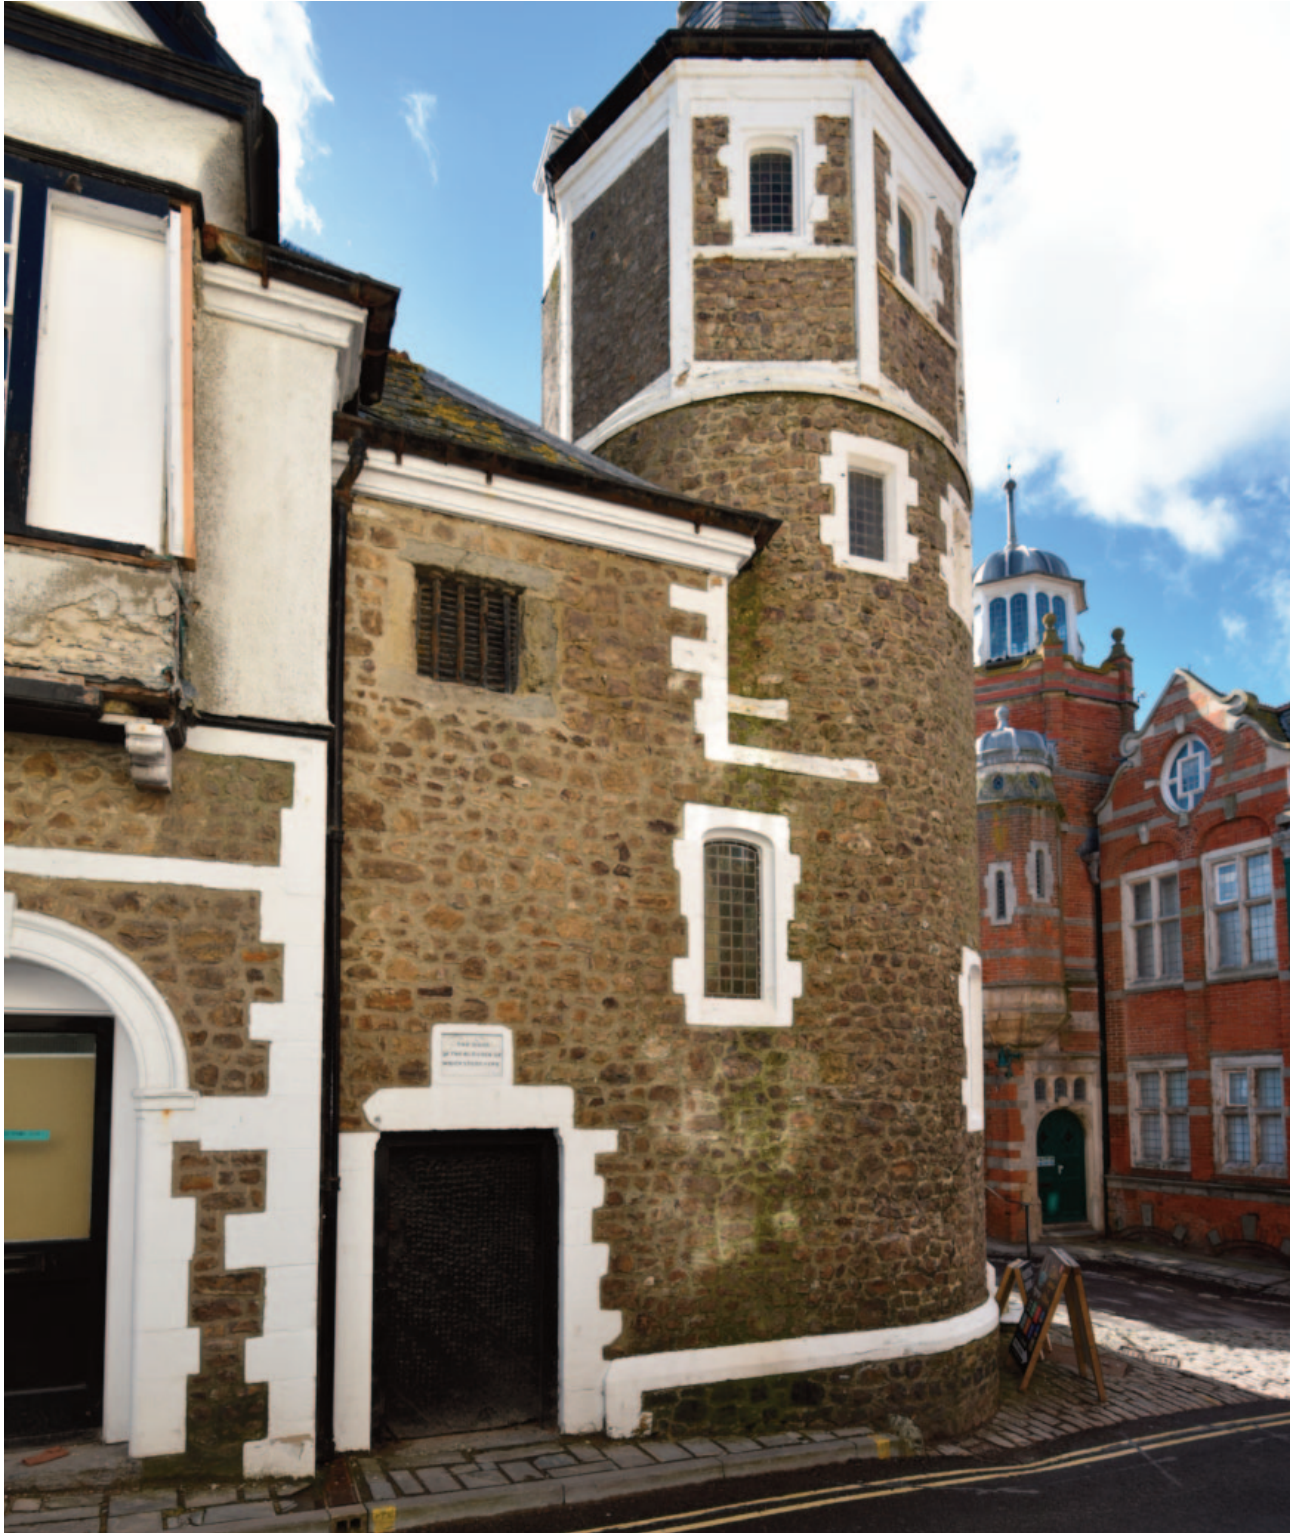
Fig. 9. The reformed north elevation of the former jail and guildhall, which was rebuilt behind its historic line to allow the road to be widened c.1890. It is unclear how much of the stair tower is historic.

This report found the building to be structurally dangerous; and the Corporation therefore instructed it to be partially rebuilt, and took the opportunity to relocate the north wall at the west end of the building in order to allow the road to be widened and to allow the entrance to be relocated to the west end. The new circular tower which formed part of these works was added to commemorate Queen Victoria's Diamond Jubilee.

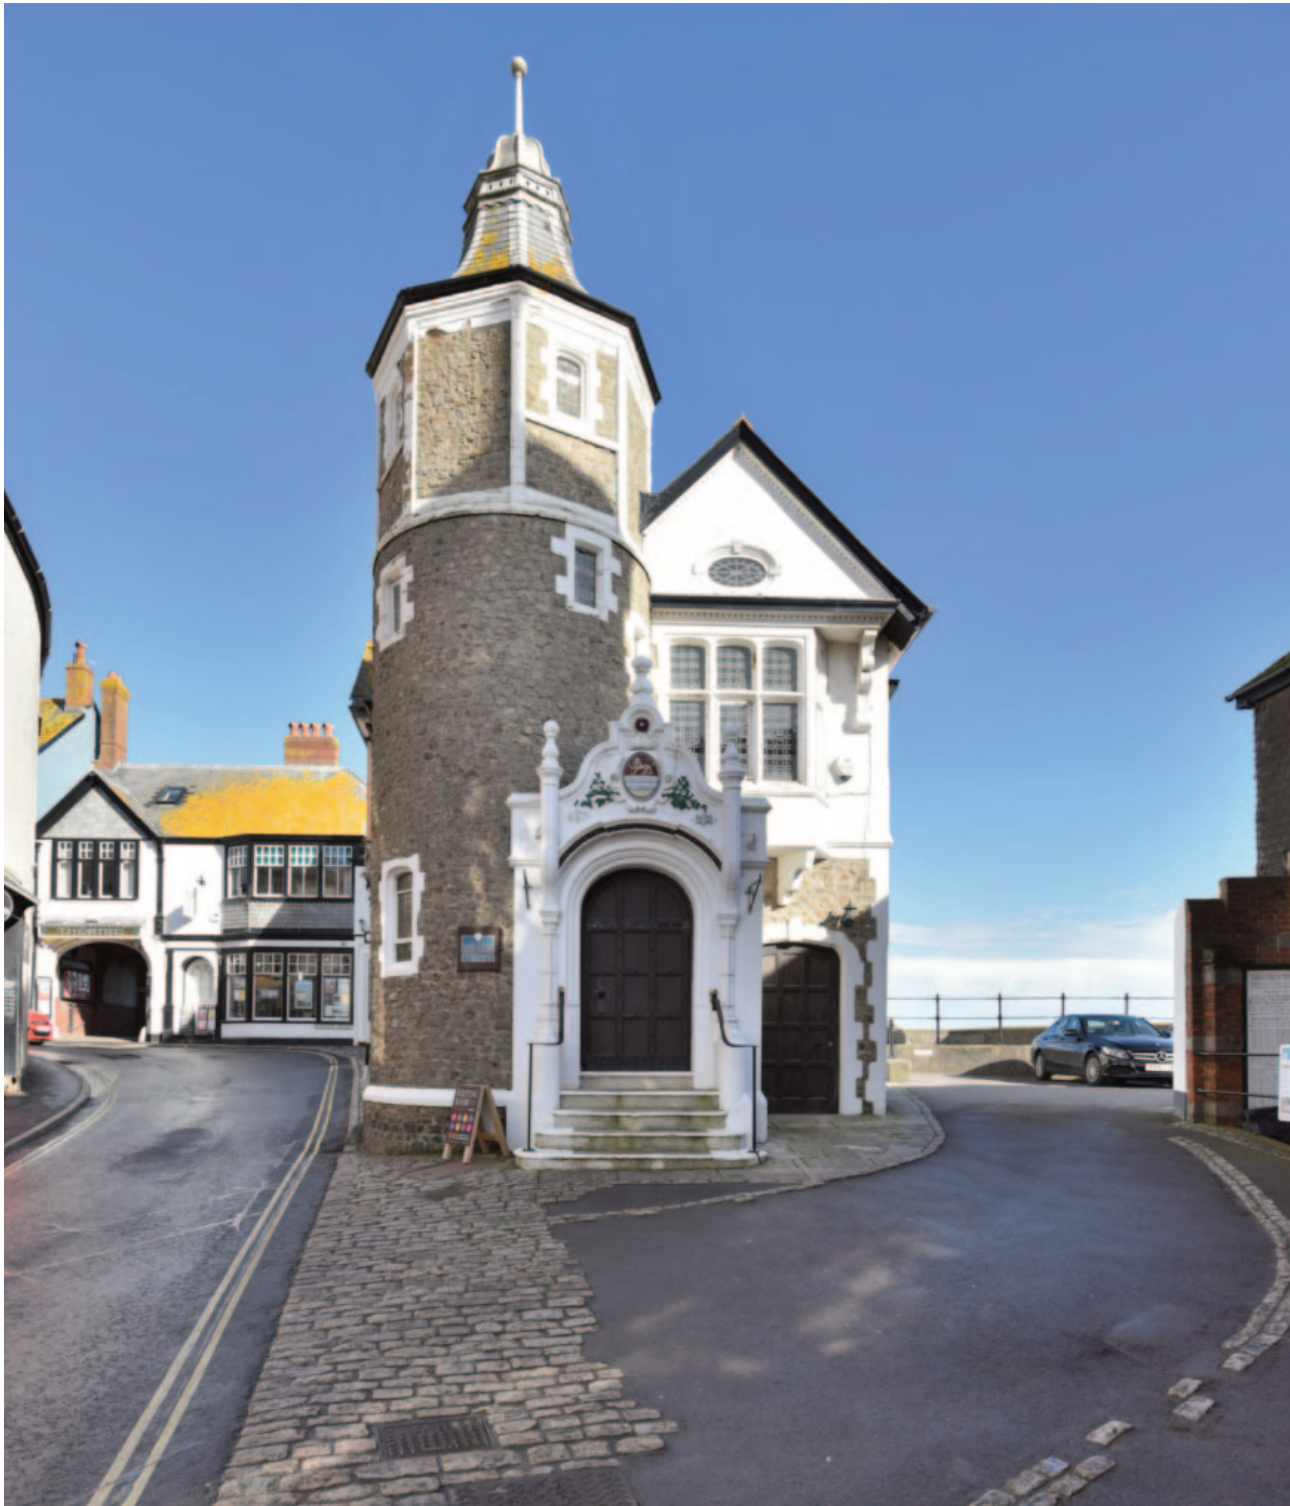
Fig.8. The west elevation with the ornate entrance porch containing the steps up to the first floor Guildhall and on the right the arched door to the ground floor rooms within the former market hall. Until the mid-20th century a row of cottages infilled the space between the Guildhall and the museum building on the right.

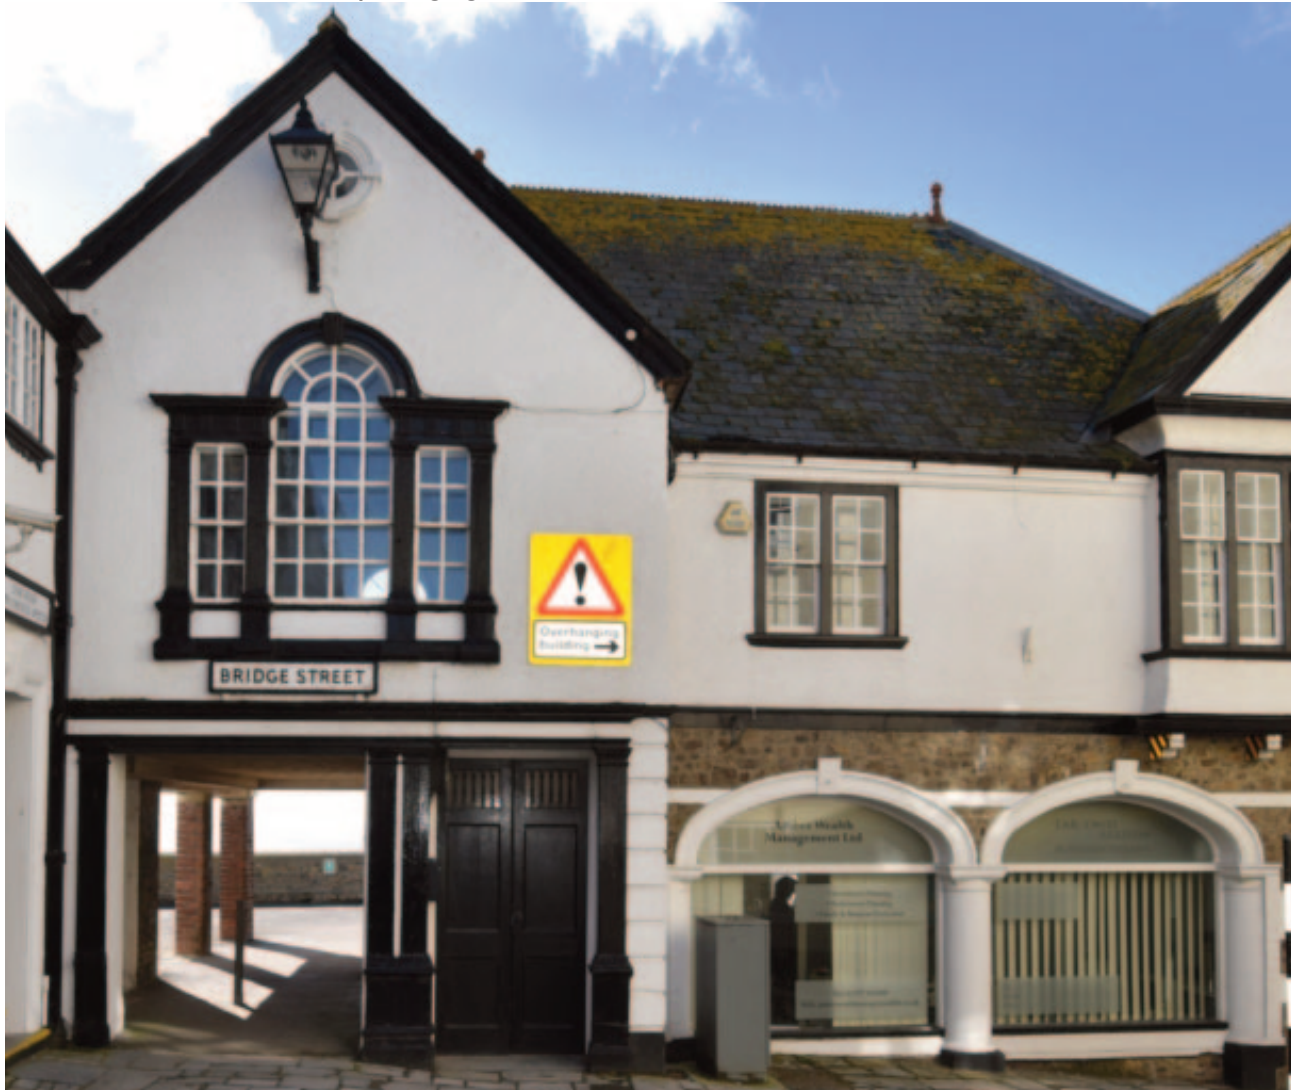
Fig. 11. The north elevation showing the possibly original left hand projecting bay with the refronted and set back central range with the former gaol and stair tower to the right.

On the principal north elevation, the two left hand (east) bays break forward under a gabled roof with an *oculus* within the apex of the gable. Set within the gable at first floor level is a centrally positioned Venetian window which has a formally-detailed dark painted surround with a keystone to the arched opening to the taller central window, and entablatures to each side window which are detailed with *metopes* and supported on fluted pilasters. These pilasters extend below cill level to rest on a deep moulded lower rail, which forms a plinth to the whole window. Within this moulded surround, the windows are sub-divided to form small paned sashes, with a curved head in the upper sash to the central window. A thicker surround to one pane within this upper sash reflects the later insertion of a small metal opening light.

At ground floor level within this projecting gabled bay there is a full width opening defined by a moulded timber “entablature” supported on four timber pilasters that separates the ground and first floor levels of this north facing elevation. The right hand third of the opening is enclosed to form a small room, accessed through a pair of six panelled doors with the upper panels replaced by turned spindles now with glazing behind but originally providing ventilation. A double pilaster separates this doorway from the open passageway occupying the rest of the ground floor within this bay. The pilaster to the right of the double doors is attached to a rusticated stone corner. The open passageway to the left opens onto what is now an open yard to the rear of the building, beyond which are views of the stone sea wall and the sea beyond.

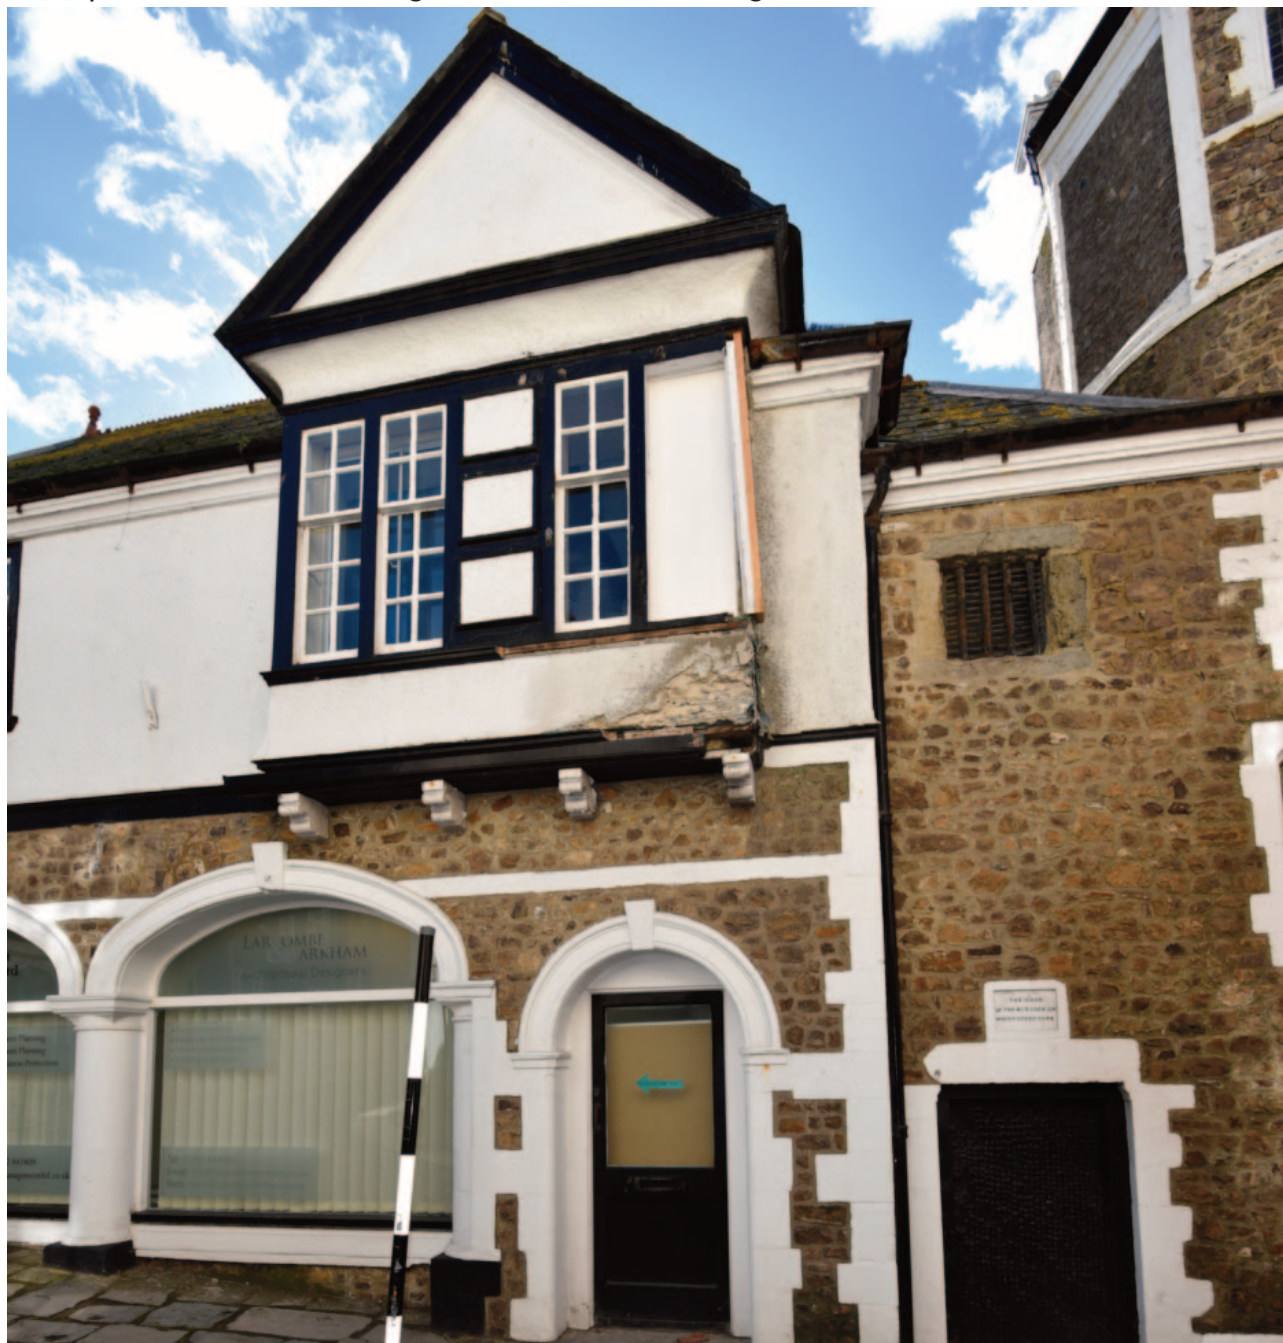
Fig 14. The oriel window showing recent vehicular impact damage. The rendered panels and much of the lower framework is of modern construction following repeated vehicle damage.

The oriel window is detailed with two pairs of four over six paned sash windows (the right sash currently boarded up externally), separated by a central timber panel detailed with a vertical row of three raised roughcast rendered panels. Above the window is a coved moulded plaster head supporting a wide pedimented gabled roof.

The oriel window projects on that part of the building which is closest to the road and at this point the front wall is only separated from the carriageway by a narrow strip of paving. Generally, the impact damage to the window is to the plasterwork beneath the window and the right hand corner of the window above. Whilst this option involves some loss of historic fabric, the loss is kept to the minimum and it also affects part of the window which has already been the subject of numerous repairs.

A close examination of the window shows that, with the exception of the corbels, all the fabric to this oriel window has previously been replaced; and indeed it is understood that extensive repairs were undertaken in the mid-1990's following a particularly bad collision. Consequently the only loss of historic fabric is the cut-back ends to the corbels. It is considered that this scheme has minimised the harm to the significance of this feature, and also the harm to the significance of this listed building and this part of the Conservation Area.

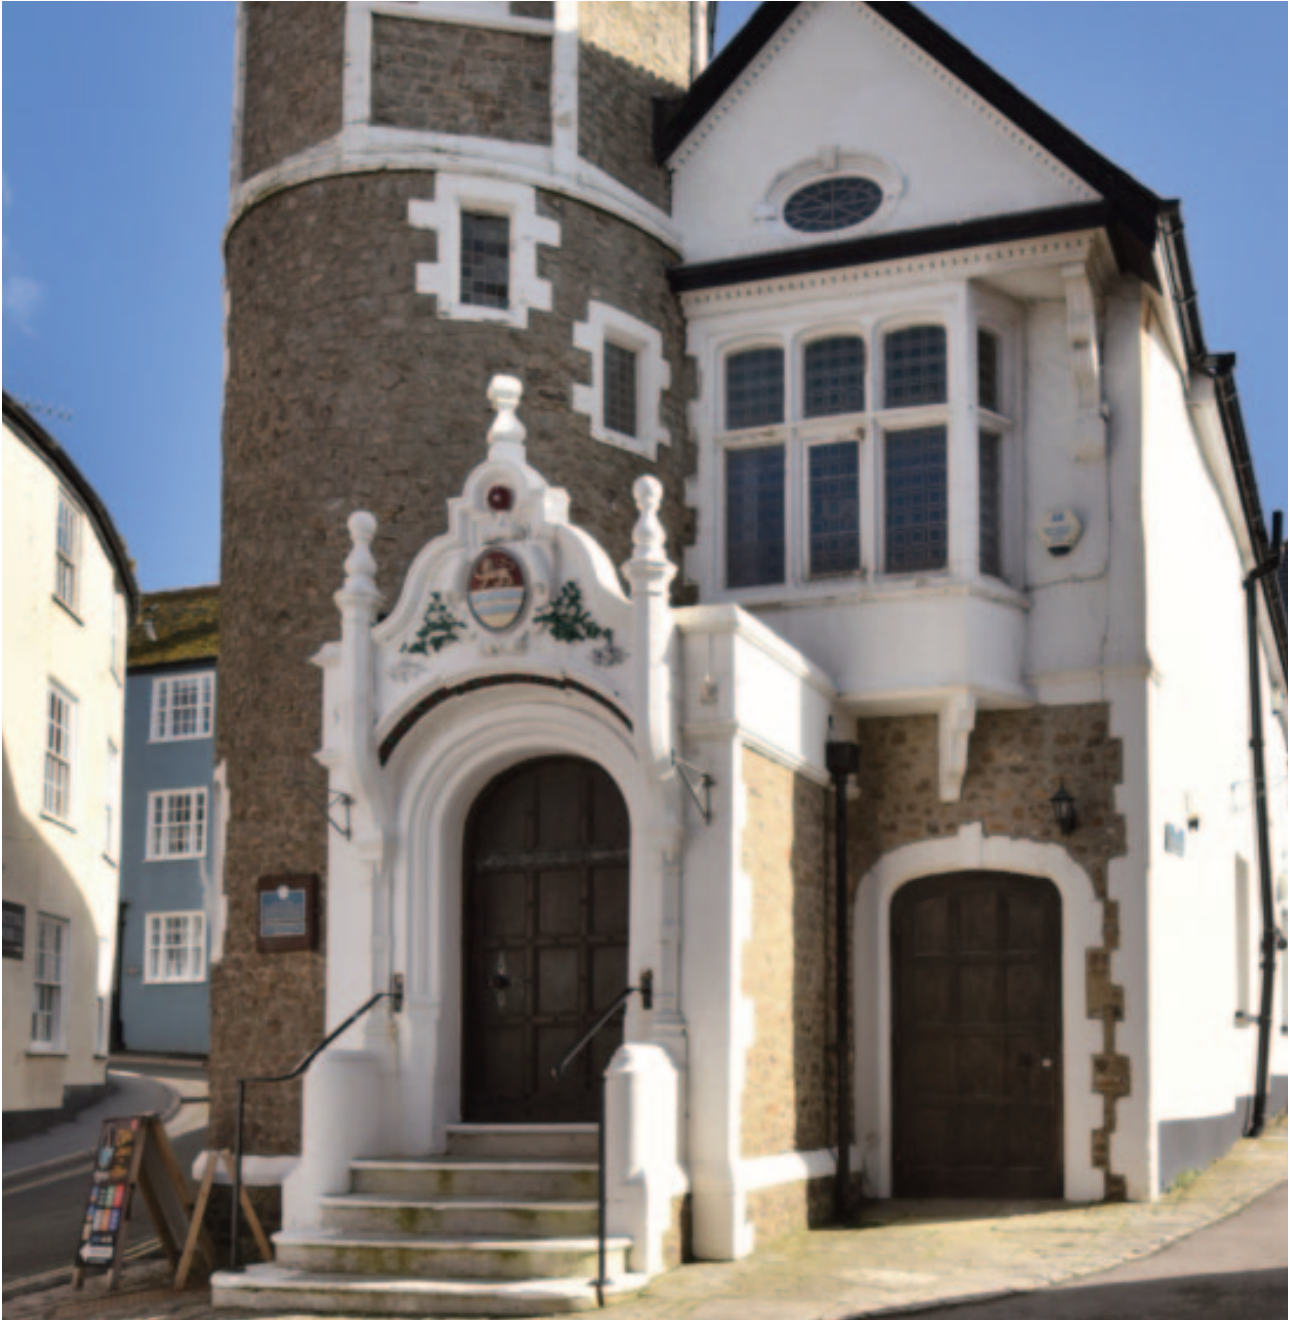
Fig. 16. The simply detailed raised front porch to the west elevation with the adjacent ground floor door to the right into what is now a separate office.

On the west side of this tower, is the principal entrance into the guildhall set within a parapeted stone porch and reached by flight of stone steps that is incorporated into a dressed stone doorcase with a curved arched surround surmounted by the town coat of arms, set within an ornate corbelled pediment. The timber entrance door is detailed with raised moulded rails and small panels with decorative steel strap hinges and door handle. A less ornate but similarly detailed timber door to the right of the porch provides access into the west gable of the attached rear range. This door is set within a shallow four centred arched surround.

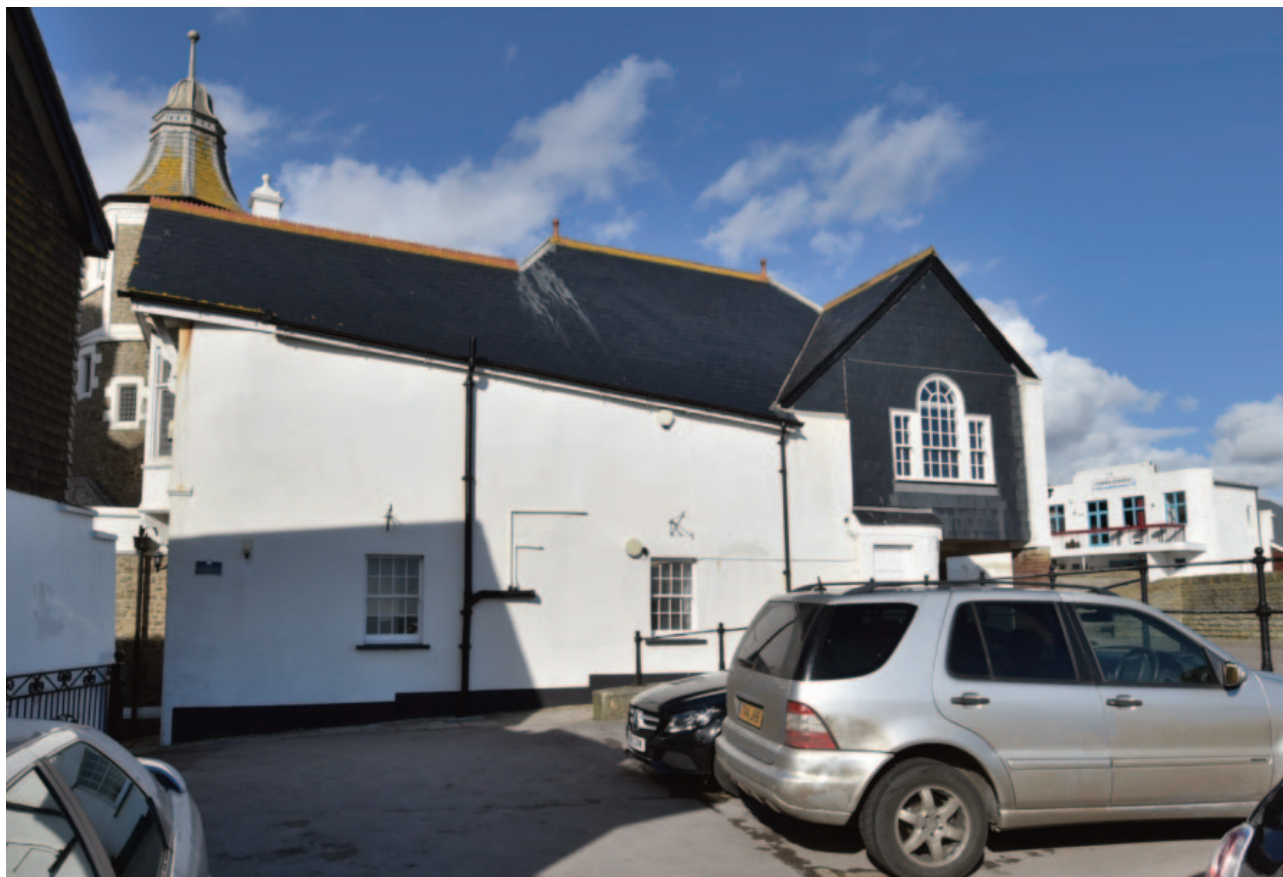
Fig. 18. The more simply detailed south elevation with its angled eave and plain rendered facade was originally attached to historic cottages which were set on the lower ground in front of the railings.

The two end (east) bays reflect the detailing of the north elevation, in that they have a centrally positioned Venetian window with a gabled roof above the two bays; however this window has a more simply moulded outer frame, and the whole elevation is flush with slate hanging to part of this gable at first floor level. There is a modern small lean-to addition tucked below the oriel window serving the offices on the ground floor.

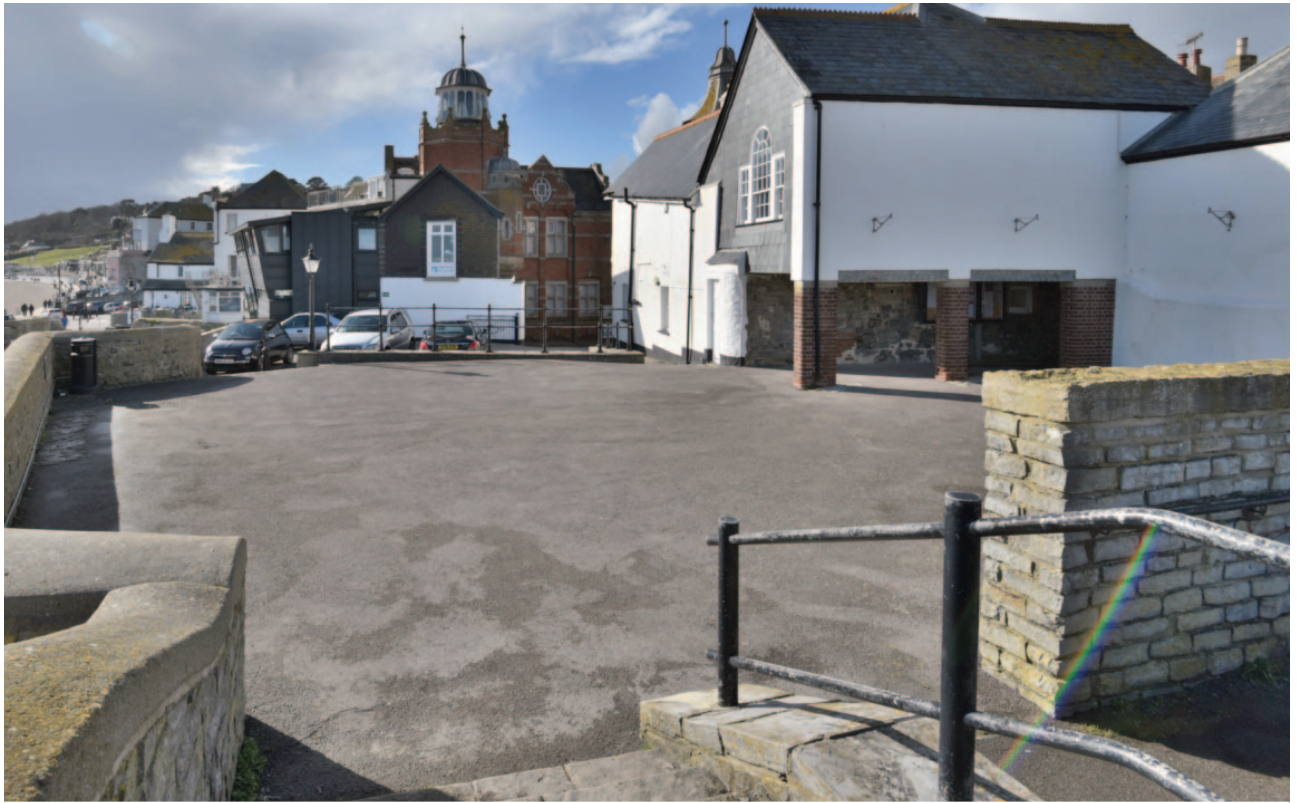
Fig. 19. The south elevation of The Guildhall with its angled eave and plain rendered facade where the adjacent cottages set on the lower ground beyond the railing were demolished.

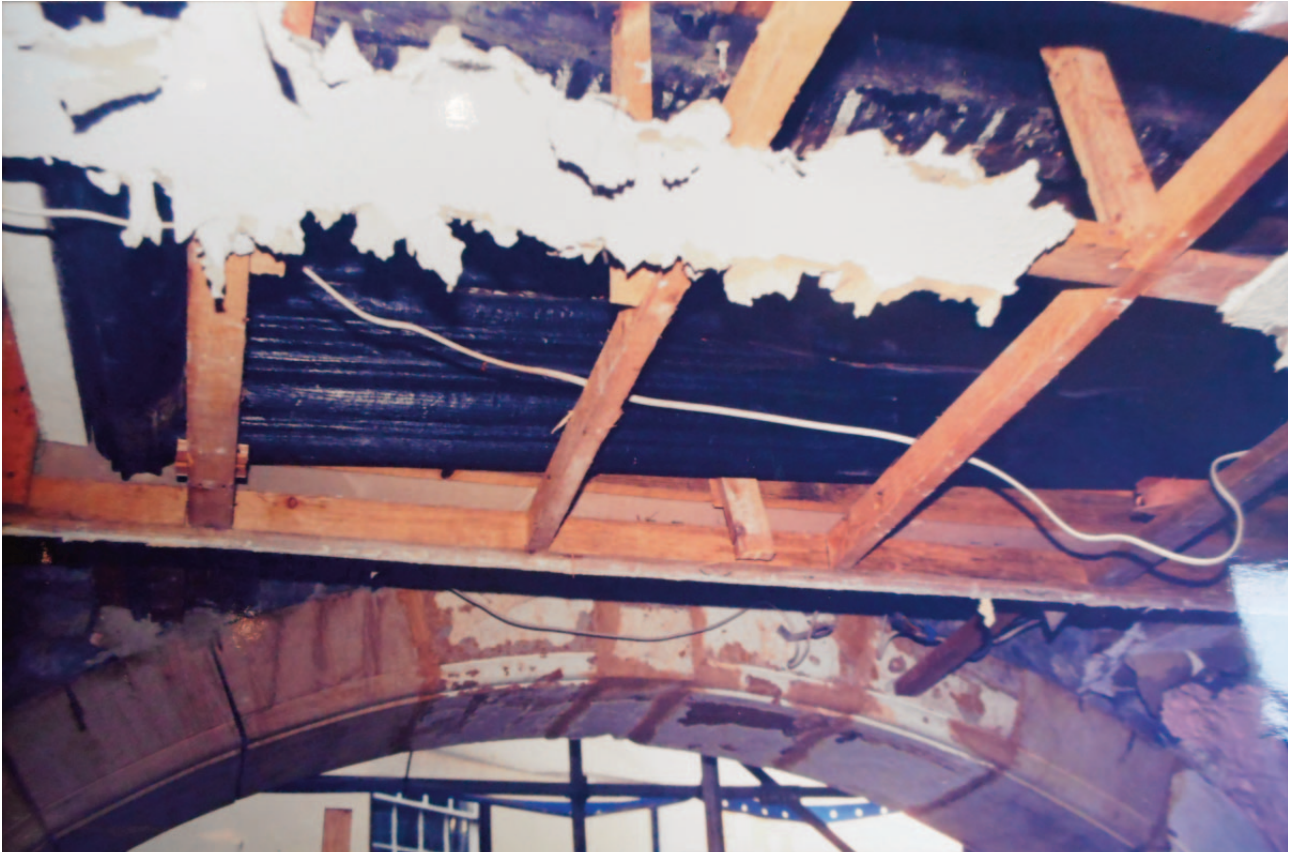
Fig. 21. The 16th century moulded ceiling beam surviving above the plaster ceiling in the ground floor of the guildhall. Exposed following vehicle damage in 1991 it shows charring from fire damage in the 19th century.

The former shop is now in office use and has not been inspected internally, although looking through the window, all the internal finishes are of late 20th century date. A 1991 photograph provided by the Museum shows that its existing plasterboard ceiling conceals apparently *in-situ* deeply moulded ceiling beams, of 16th century appearance. There are remnants of a lath and plaster ceiling to the south side of this beam, which are fixed to joists which appear to have horizontal proportions (also indicating a 16th century date), suggesting part of this ceiling remains *in-situ*.

Although these plans suggest that extensive demolition was undertaken, in practice the survival of the historic ceiling beams indicates that much of the historic fabric within the east bay remained untouched and indeed this bay was not shortened as part of the road widening. Within the central range, only the north part of the 18th century floor structure appears to have been cut back, and then only sufficient to allow for the repositioned north wall. The roof over this central and western end of the building was entirely replaced to respond to its narrower form. Because the first floor structure is concealed by modern finishes it is unclear how much of this floor was damaged during a fire recorded within one of the ground floor shops in the early 19th century.

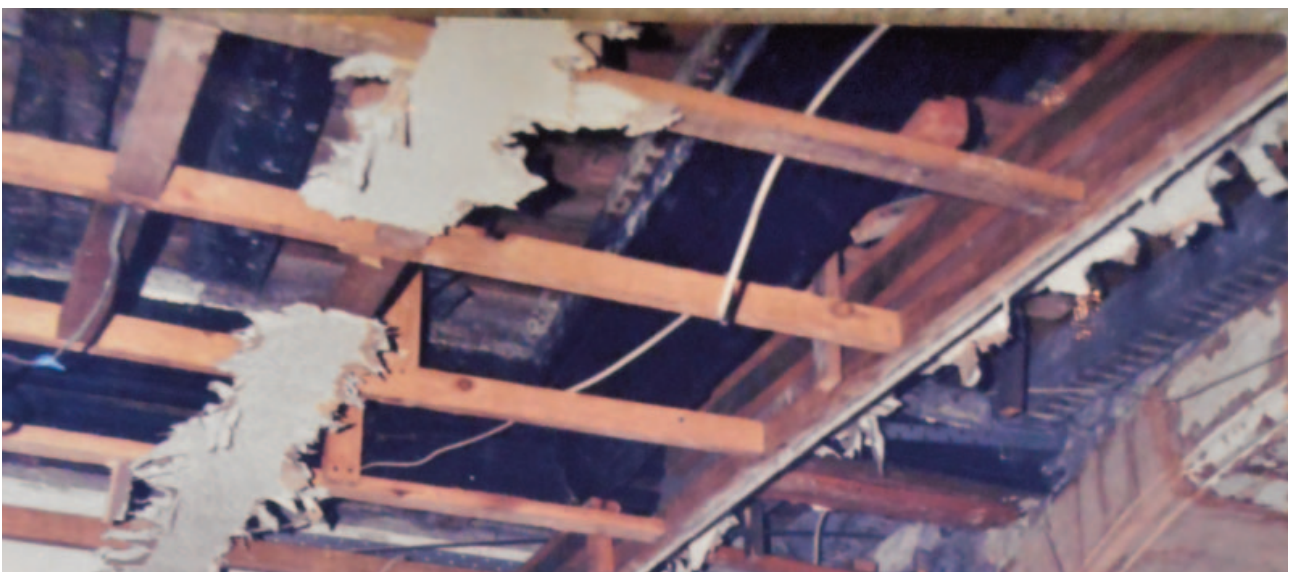
Fig. 22. A second view shows the ceiling beam attached to a cross beam both of which are *in-situ* but cut back when the building was refronted and narrowed by Vials. *In situ* floor joists can be seen on the left.

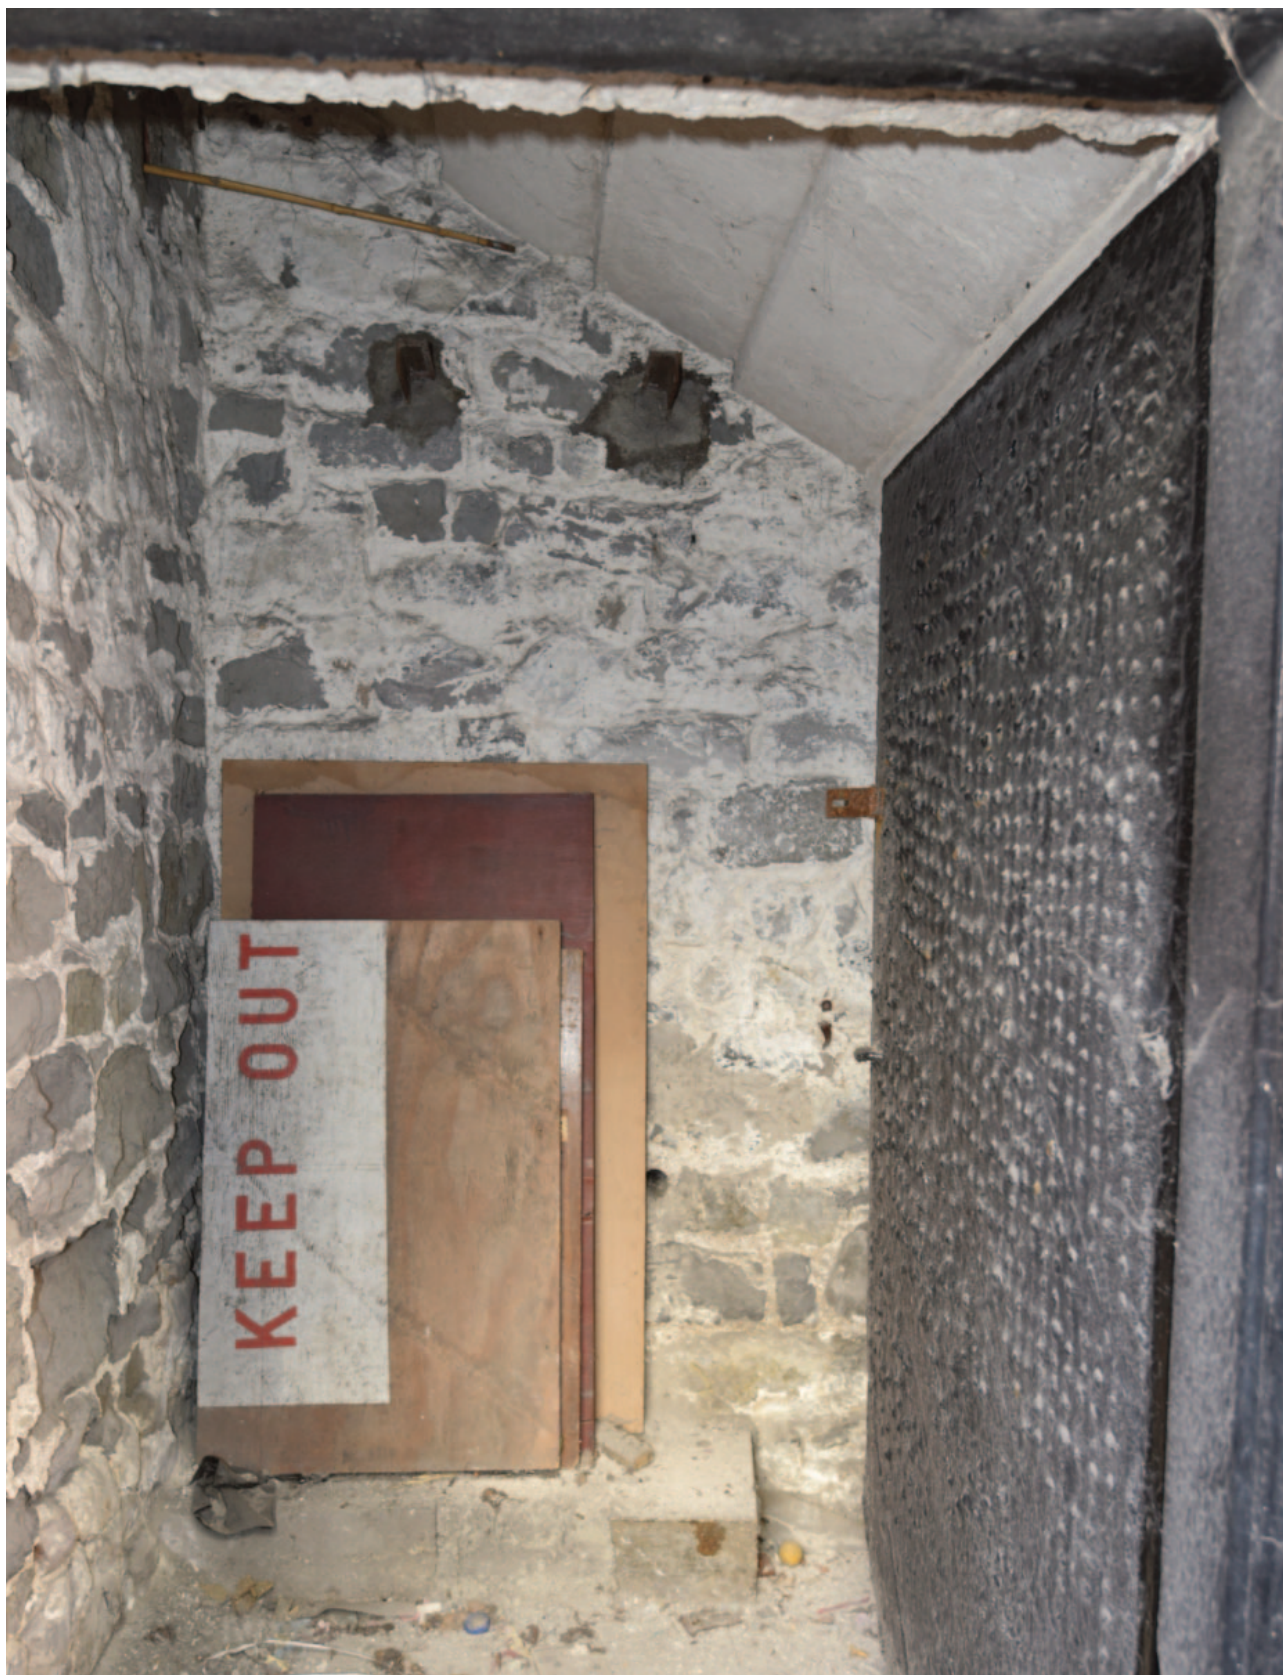
Fig. 23. The remnant of the former town gaol survives in truncated form with the historic entrance door reset in the repositioned front wall. The stairs to the Council chamber cut through its original roof.

Within the former gaol, the internal walls are all natural stone, with the exposed underside of the steps up to the first floor Guildhall forming its ceiling.
