The Guildhall Lyme Regis Dorset  
Statement of Significance and Heritage.

This Statement of Significance and Heritage Statement has been prepared to inform applications for planning permission and listed building consent for the replacement of the oriel window in the principal elevation of The Guildhall with a new gabled dormer window. The Guildhall is a Grade II\* listed building that was first listed on the 23rd April 1952, and it forms part of an important group of listed buildings within this part of the historic core of the Lyme Regis Conservation Area. Lyme Regis lies within the Dorset AONB, and its coastline forms part of the Jurassic Coast World Heritage Site. The purposes of this statement are firstly to provide an assessment of the significance of the Grade II\* listed building and its setting within the Conservation Area; and secondly to assess the impact of the proposed development on these designated heritage assets and their settings.

# The Guildhall, Lyme Regis Dorset.

## Statement of significance and heritage.

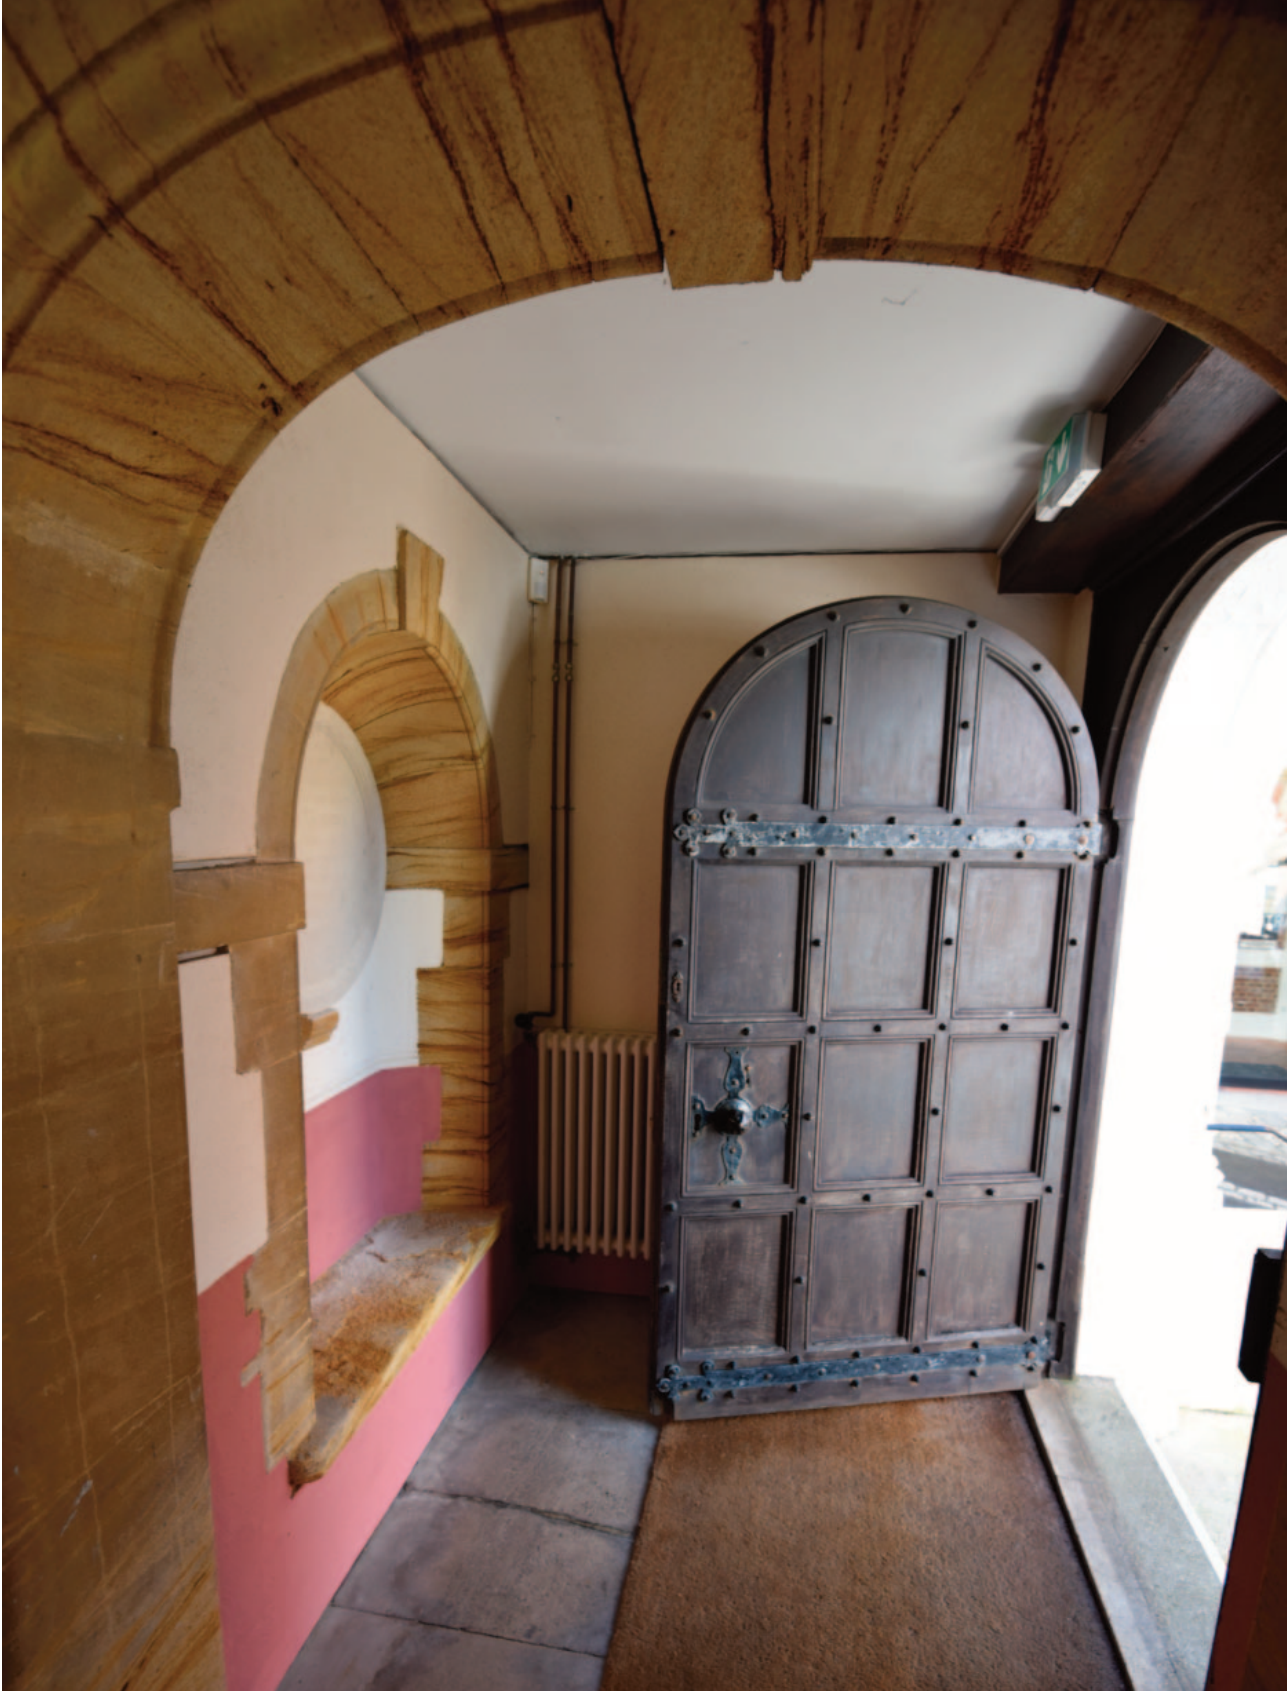
Fig. 24. The good quality Victorian entrance door opens into the small entrance lobby with its decorative stone detailing and commemorative plaque within the arched alcove.

The entrance lobby within the tower is well detailed with dressed stone arches with raised keystones to the opening onto the staircase and to the commemorative alcove. The staircase rises above the

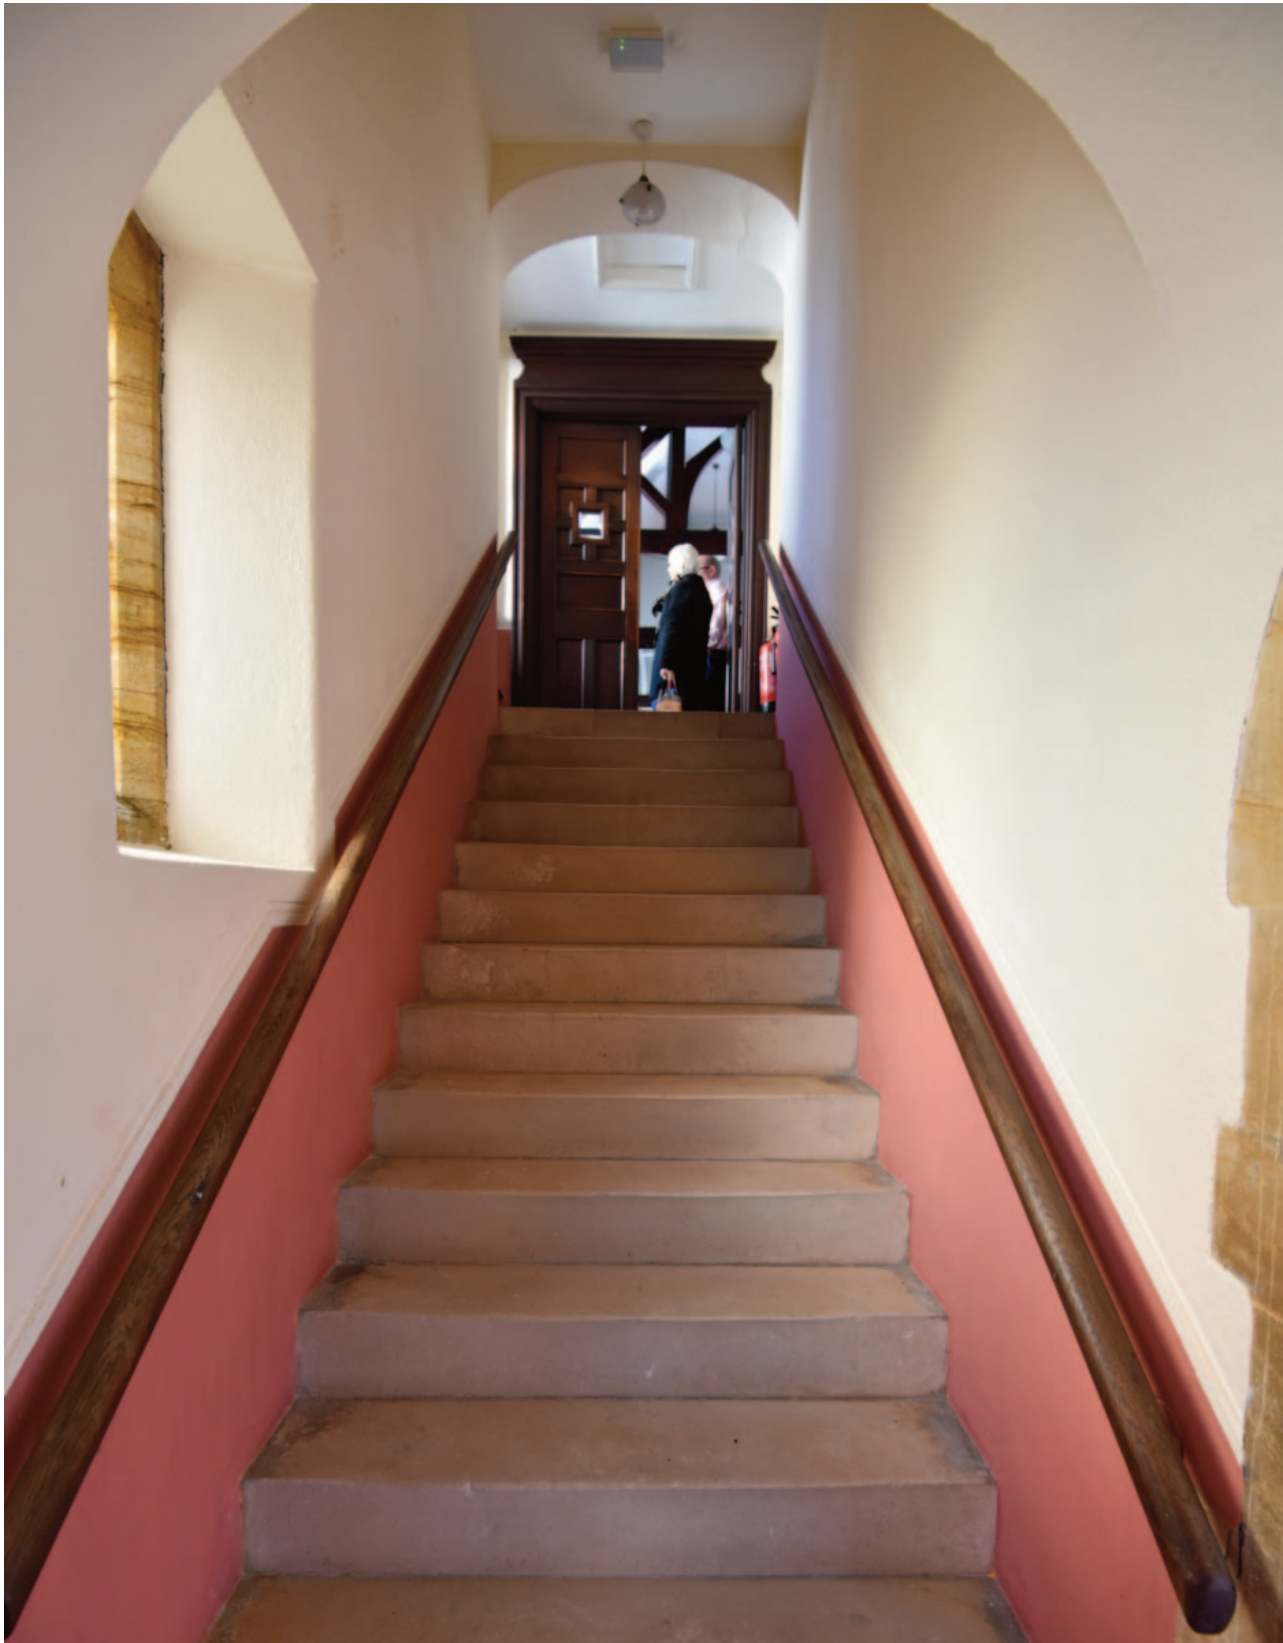
Fig. 25. The staircase added in the Vials remodelling rises to a small landing with the Council Chamber beyond.

cut back remnant of the former gaol, to a small landing at the entrance to the Council Chamber. The landing is lit by the west lights of the oriel window, and a partition aligned with the central blind window to the oriel separates the two spaces.

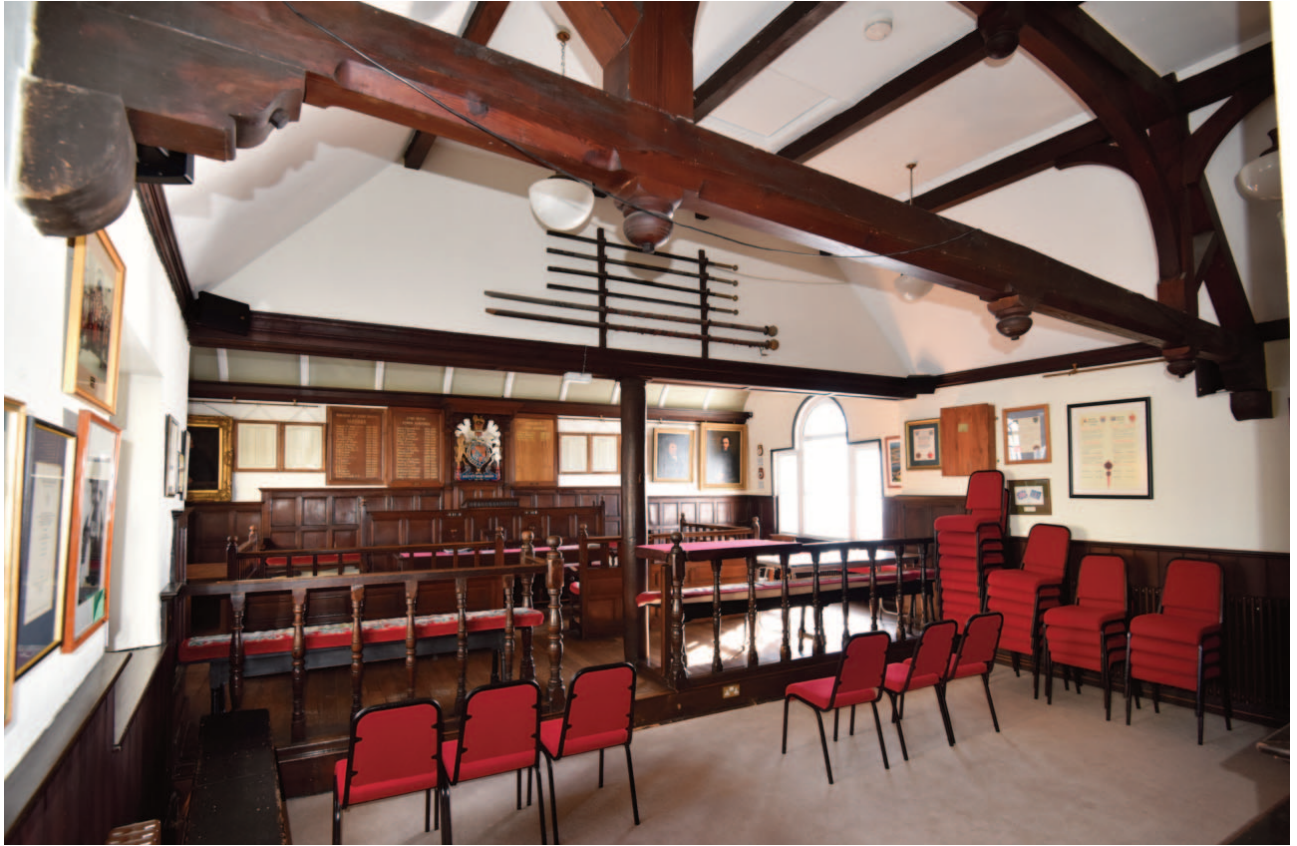
Fig. 26. The first floor meeting room, with the late 19th century truss in the foreground. The circular post supporting the downstand is historic; and the structure beyond this forms part of the earlier building. .

The central roof truss is supported on timber corbels and the collar is decorated with chamfers separated by decorative pendants. It has queen posts detailed with struts to the principal rafters and a curved braces rising to the collar; and more simple curved braces between the queen posts and purlins; and there are exposed ceiling beams above the collar.

A moulded timber beam (panelled on its underside) supports a plastered downstand which separates this bay from the wider east bay. This beam and downstand is supported on a reused (probably 17th century) round timber post with moulded capital; and this rests on a raised timber dais which extends across the entire bay and projects slightly into the central bay and terminates at a reused late 16th or early 17th century timber balustrade that separates off this bay from the rest of the Council Chamber.

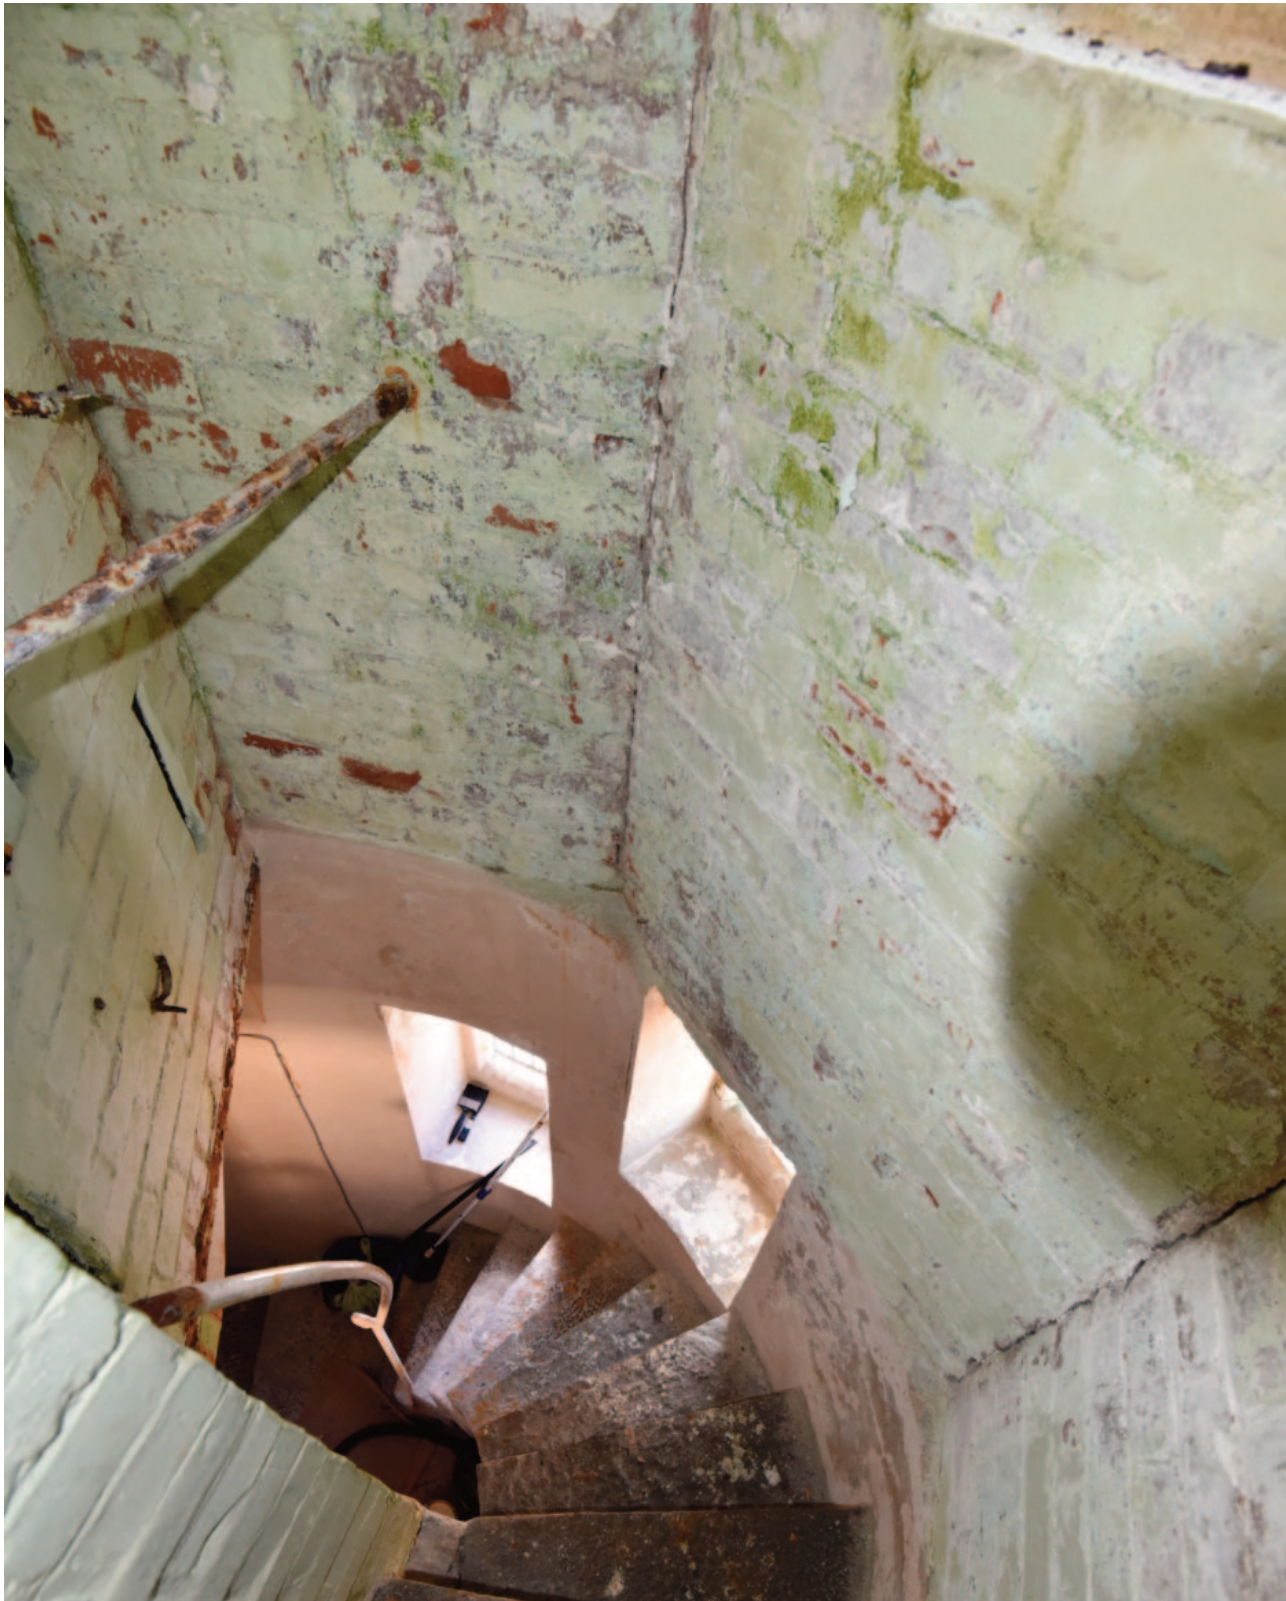
Fig. 27. The tower stairs seen from the upper room. The inner face of the walls are lined with brick with steel reinforcing to the stair opening and the tower roof.

At the rear (west) of the Council Chamber a door opens into the Mayor's Parlour, which is also pan-elled and the decoration includes other 17th century fittings. From the Mayors Parlour, a door leads to a winding stone stair rising within the tower to a simply detailed small store room in the tower and on up to the roof.

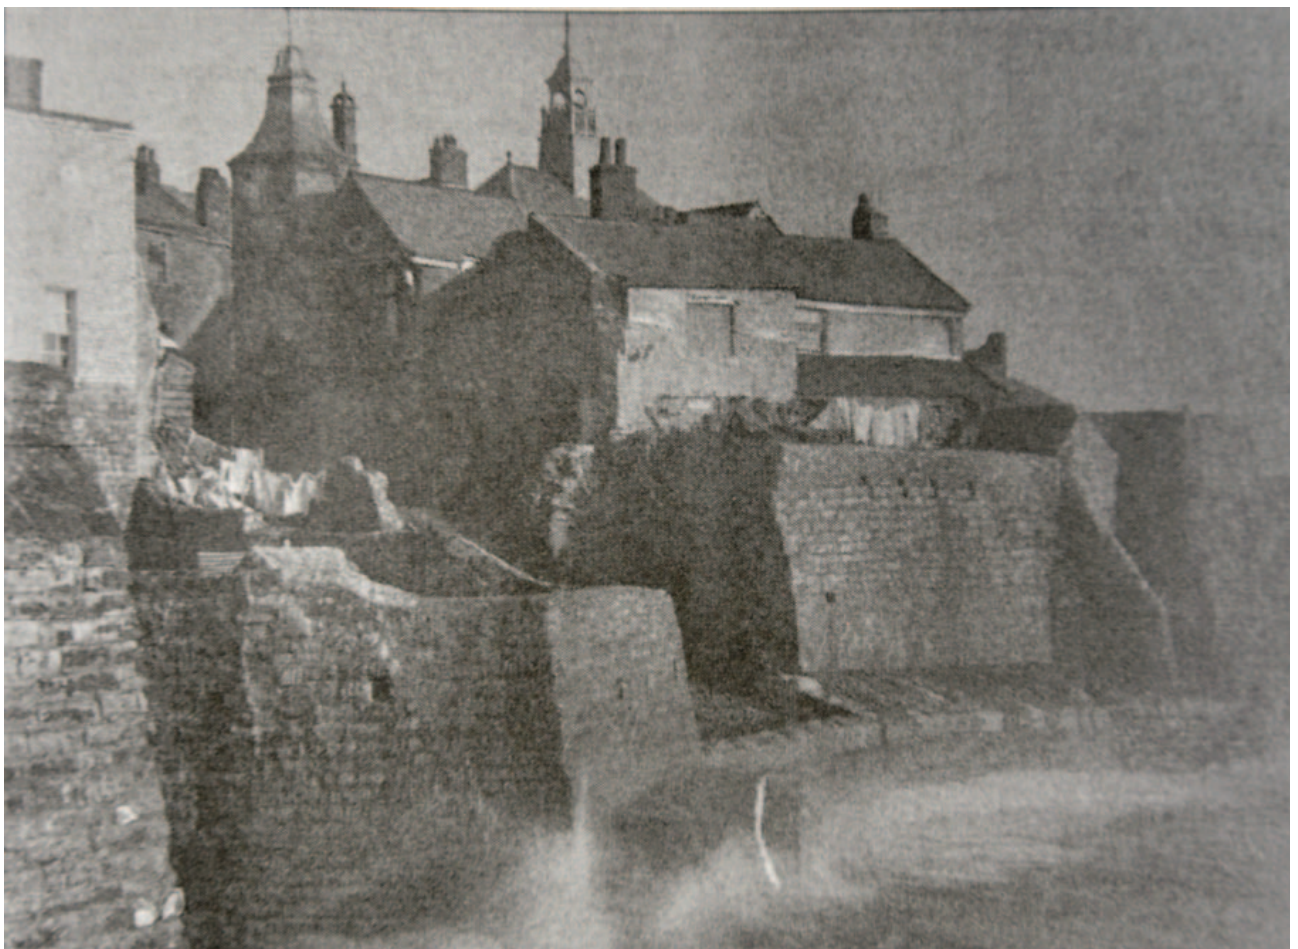
Fig. 28. The late 1890's photograph showing cottages built against the south side of the Guildhall, which still has its central lantern tower. The museum has not yet been built and other cottages occupy the site.

These 19th century photographs show the north elevation of the Guildhall, and the gabled elevation to the east bay, with its first floor Venetian windows that indicate an 18th century phase of alteration, to this bay, that escaped the rebuilding of the rest of the north front. A slightly earlier photograph shows the north elevation and projecting oriel window with a roughcast render. At ground floor level the east bay incorporates a covered walkway leading to Gun Cliff, with the entrance to the covered market to the right. The wide arches to the central market bays were closed by railings

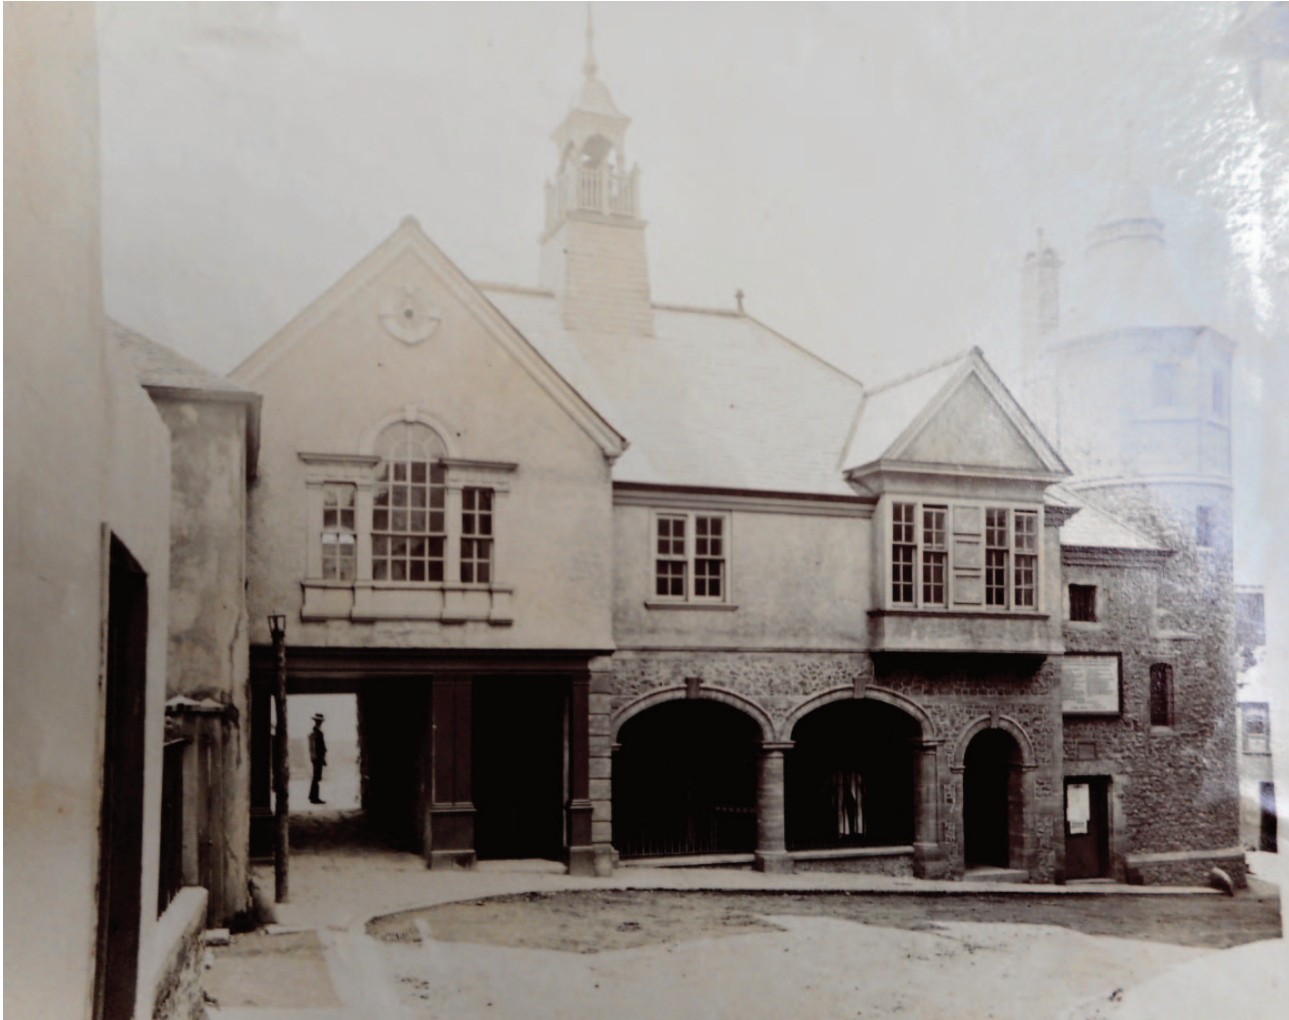
Fig. 29. The guildhall following the Vialls work in the late 19th century. The open walkway to Gun Cliff and the adjacent entrance to the open market area below the guildhall can be seen on the left, with the open arches to the market on the right. The adjacent door is on the site of the former entrance door to the guildhall stairs but following the rebuilding it opens into the open market area .

At first floor level there are small-paned late 18th or early 19th century sashes in the central range and in the jetty. The photograph of the west elevation, shows a large blocked ground floor opening in the side of the gaol with a grille above and parallel rear range, to which a further rear range can just be seen.

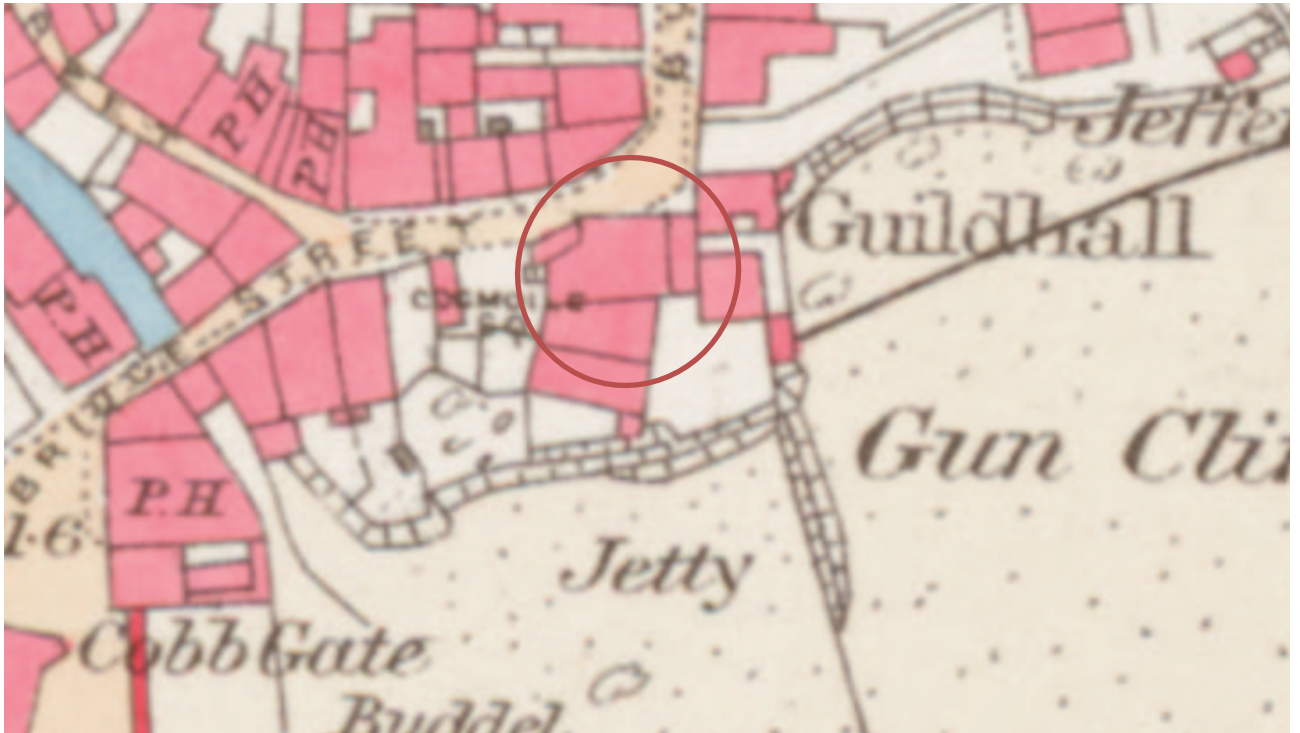
Fig. 30. The 1st edition O.S. map of 1887 showing the footprint of the earlier building on the site, with additional buildings attached to its south elevation facing onto Cockmoile Square; and to its southeast corner.

The historic form of the earlier Guildhall is recorded on the 1st edition Ordnance Survey County maps surveyed in 1887 (Devon) and 1888 (Dorset); and the map also shows that by this date the dwellings around the south and west sides of the Cockmoile Square had been demolished.

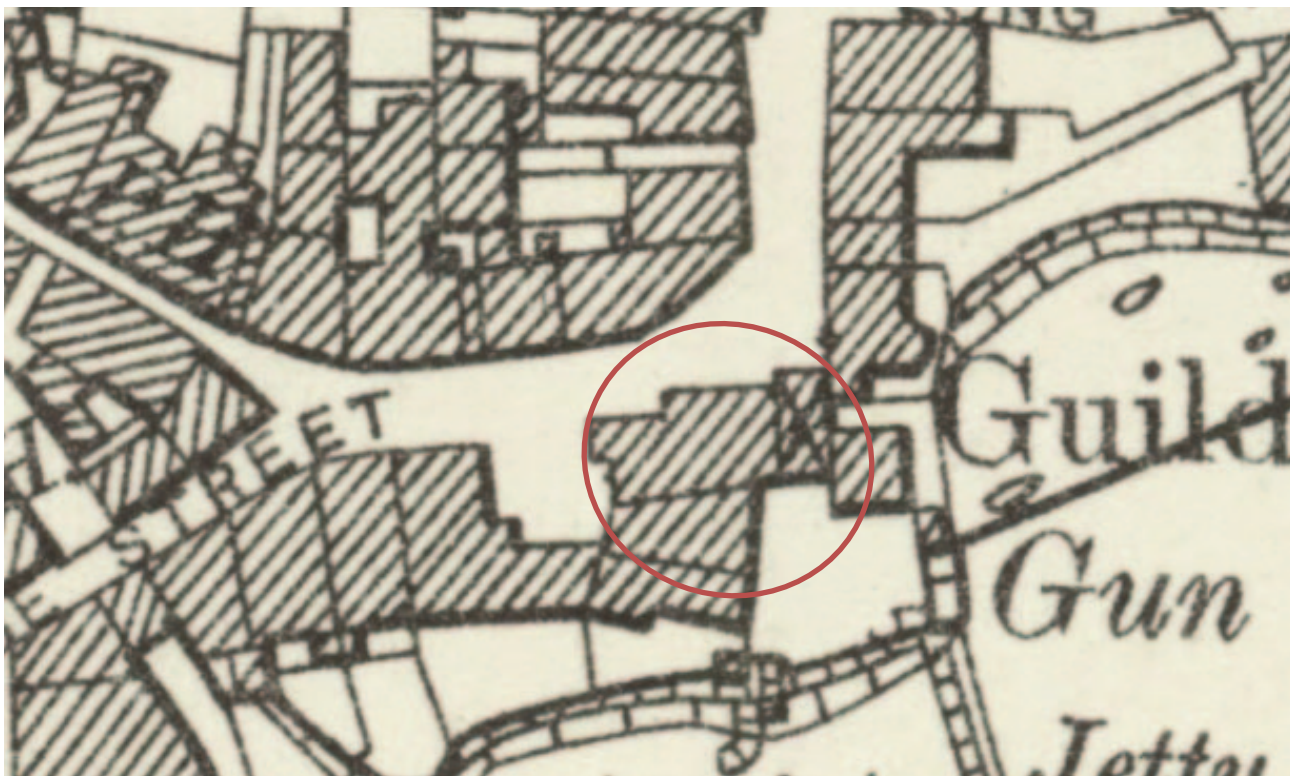
Fig. 31. The 2nd edition O.S. map of 1900 showing the footprint of the new building set back from the road behind the east bay; the buildings attached to the south elevation and south east corner remain in place.

Comparison with the 2nd edition map of 1900 confirms that the eastern projecting gabled wing retained its historic plan form, as did the rear (south) wall. The maps also show a ground floor passageway through this bay providing access to the sea wall behind, suggesting that this access was a historic one. More importantly, whilst the archaeological report notes that the dwellings to the south and west sides of Cockmoile Square were demolished in the latter half of the 19th century; those to the rear (south) of the Guildhall remained in place.

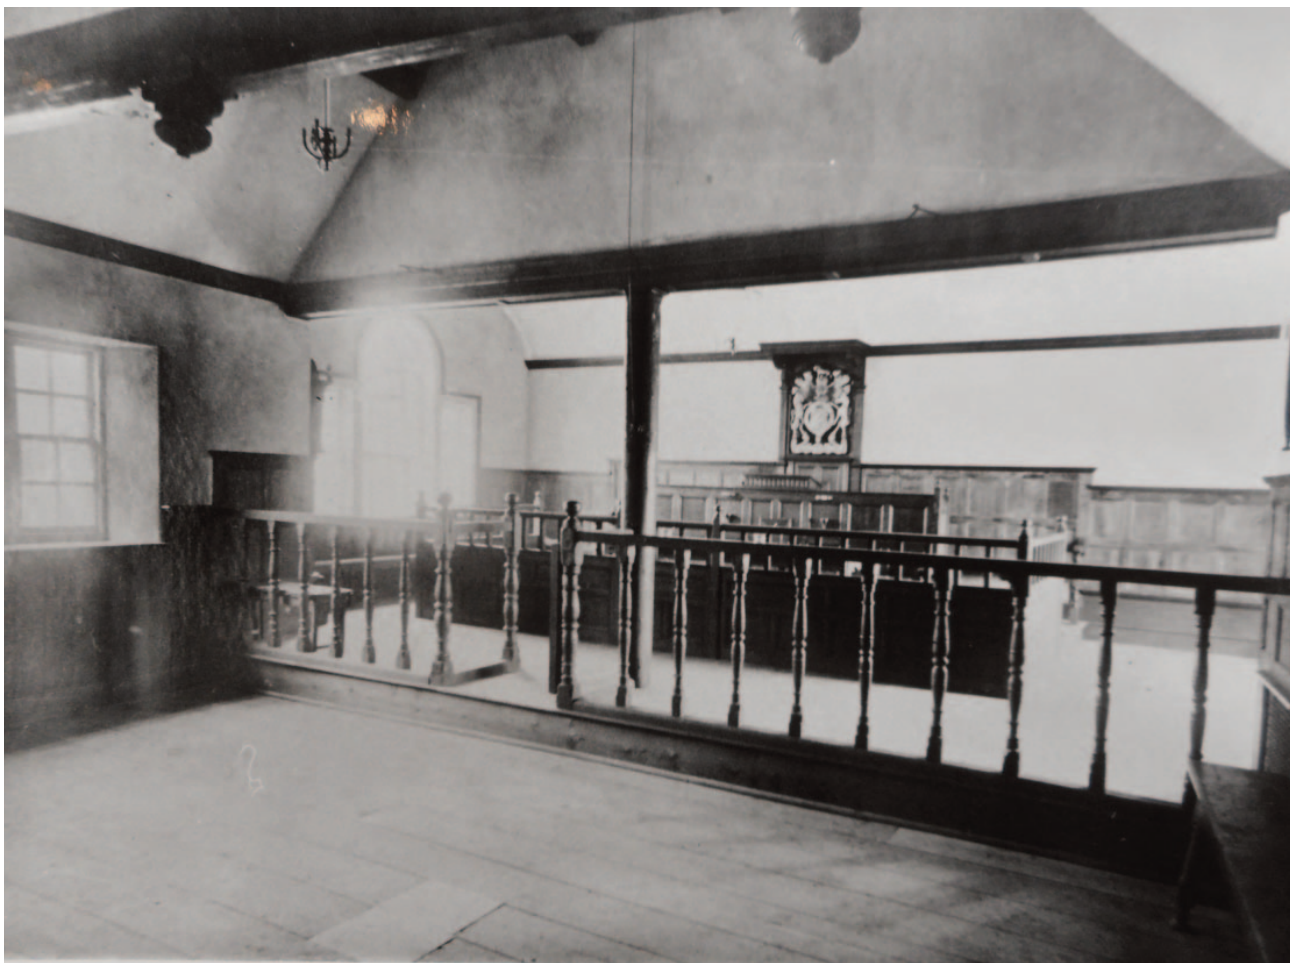
Fig. 34. The first floor of the guildhall after the works were completed. The plans show that the post supporting the ceiling beam was retained in-situ as was the step up to the court within this east bay.
