Heritage Assessment

Background to Application

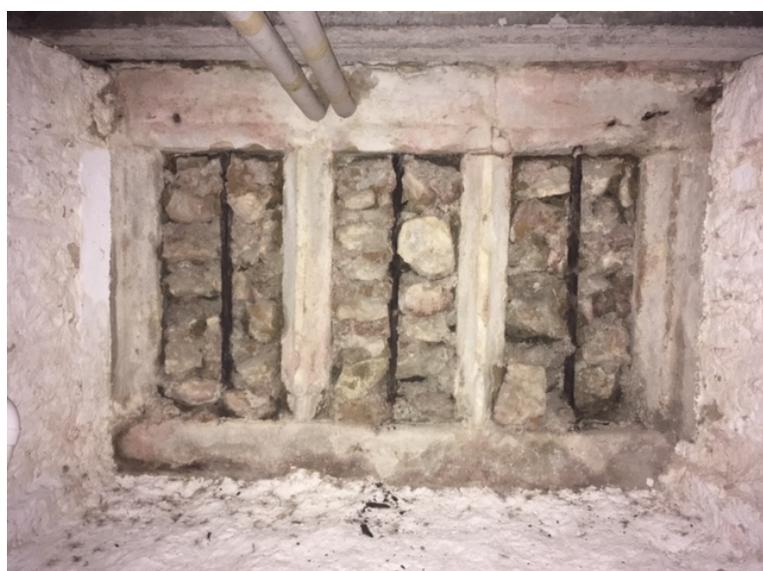
- The age and form of the original house is unknown, but certainly pre-dates the front facade and interiors, and the rear stair case tower.
- Its original form was a simple box of walls of around 600mm thickness, increasing to 900-1500mm for the complex double walls and chimney flues at either end. The scale of the chimney breasts suggests fireplaces of a much larger scale, and the (concealed) mantel stone on the ground floor eastern fireplace may be part of an earlier larger fire surround.
- The original building was probably of two floors plus basement, with a large roof void. A surviving stone mullioned window (below), once in the basement rear wall, but now embedded underground by the later kitchen extension suggests 17thC origins.

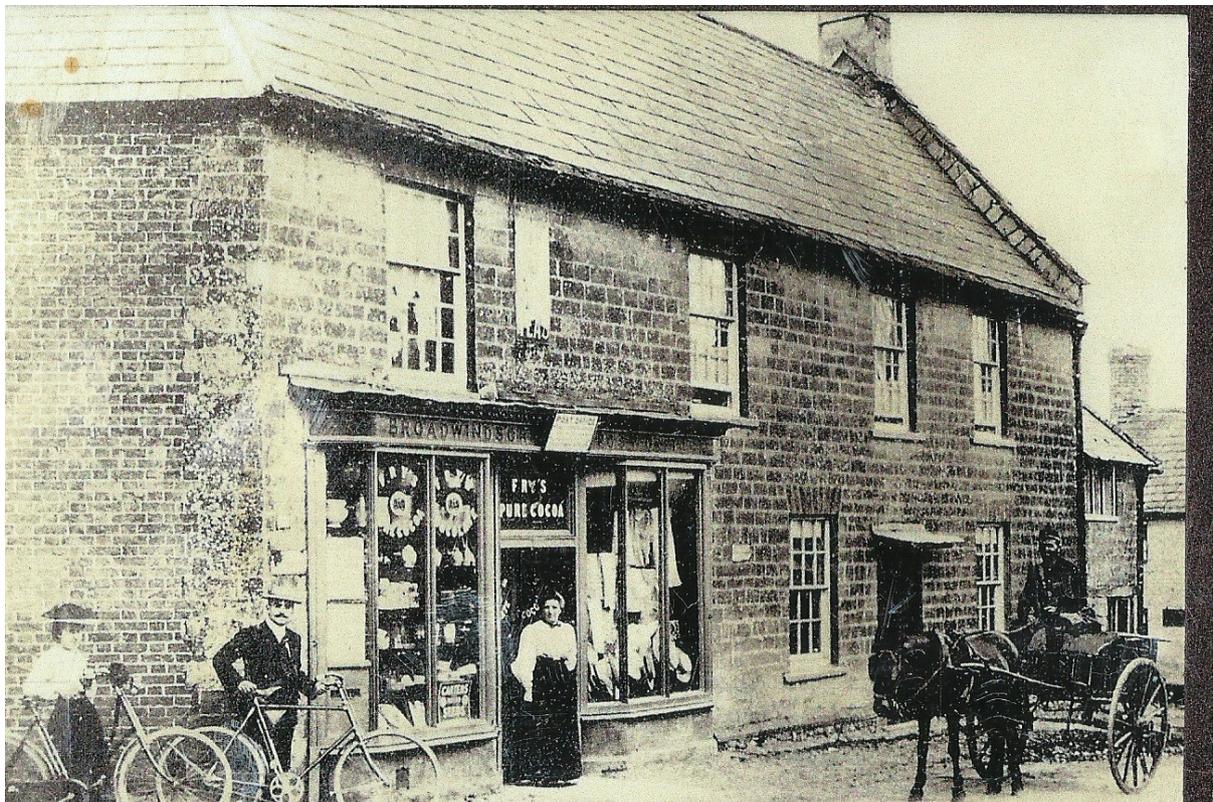
- From The Square, London House and Broadwindsor Stores appear as a “L shaped” single building. The roof coverings echo this singularity. It may not always have been the case however.

- The symmetry of London House and its two huge chimneys, taken with the abrupt change of geometry suggests that the Broadwindsor Stores element was either an addition or an adjoining dwelling later incorporated into one building.

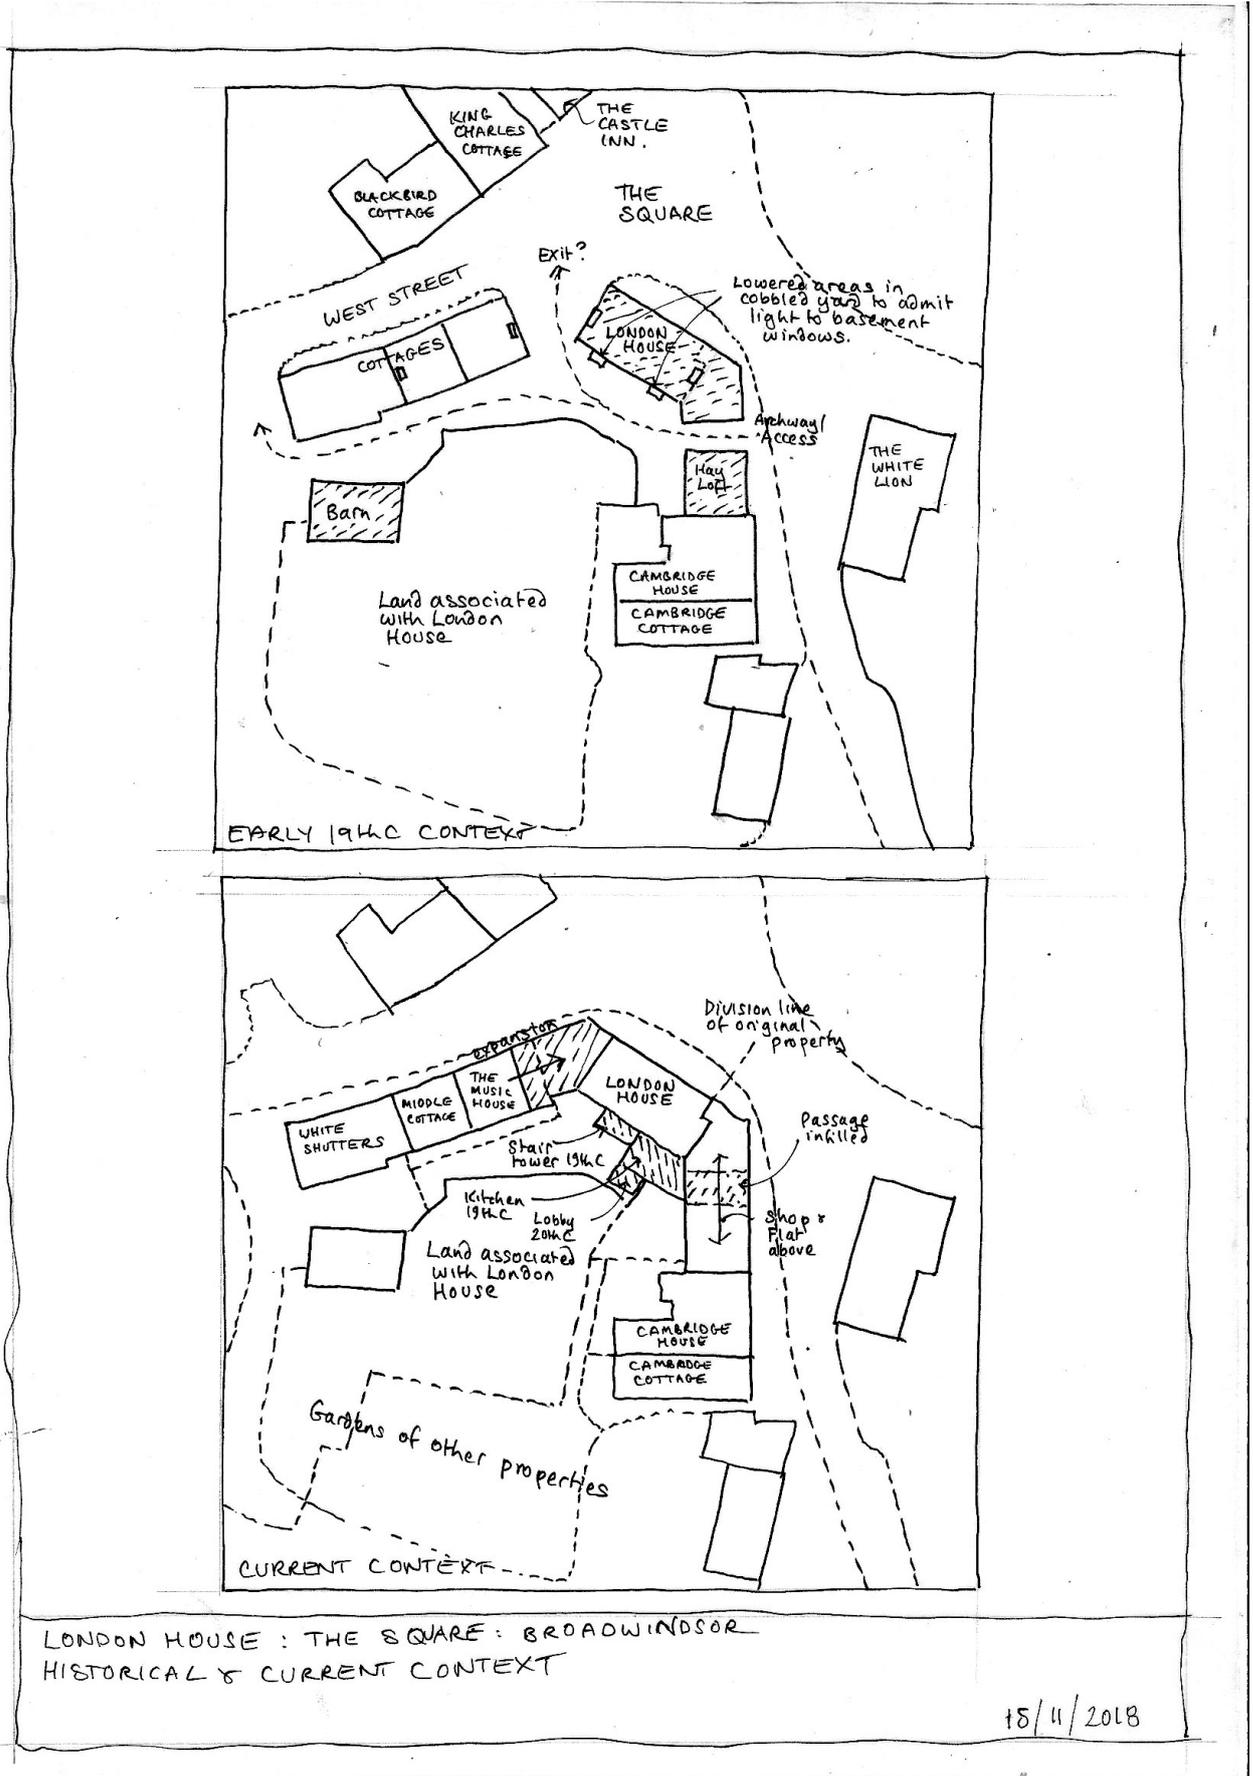
- The existence of a contiguous stone retaining wall holding back the higher ground to the south, and the evidence of a much extended form for the Music House from its original build (defined by its eastern chimney), suggests there may have been continuous access for coaches and horses around the cobbled rear yard of London House in the period in which it was an inn. This is shown conjecturally on the sketch plan following.

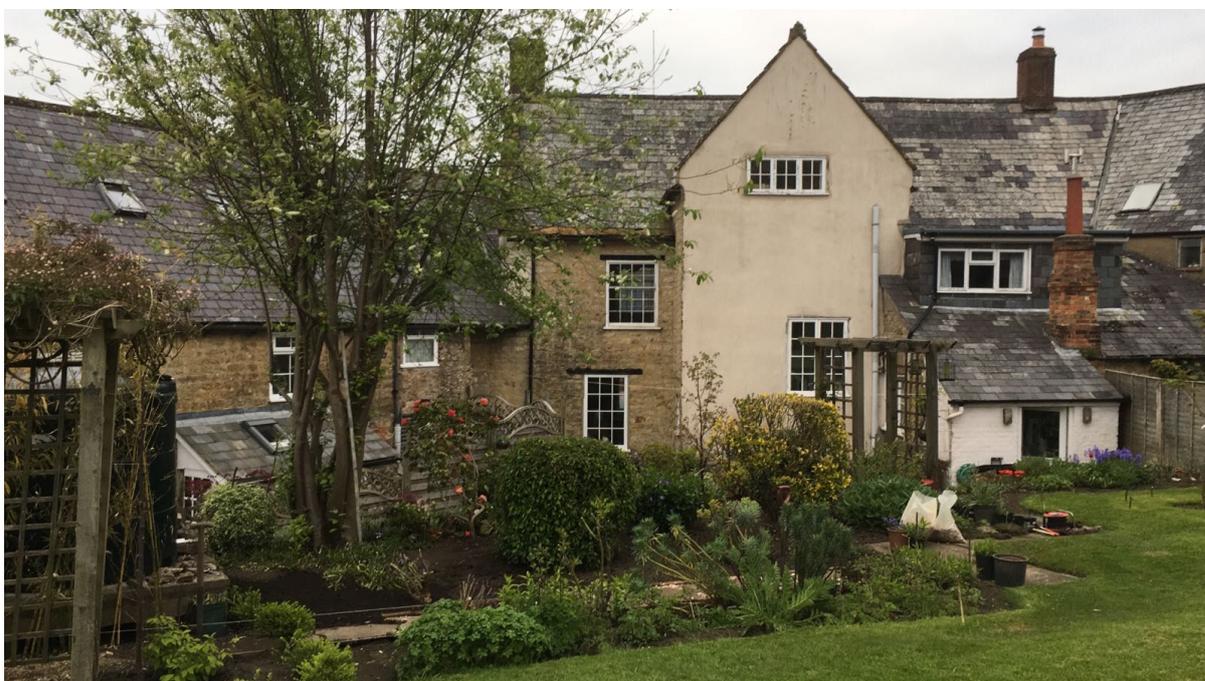
- The setting of London House from the rear, although not part of the public domain, is also important as (the blemishes noted above notwithstanding) it is a confident composition, which sits at the centre of the attached lower cottages to the west and south, together with ancillary curtilage listed smaller structures. All

- of these properties look into the (now reduced) garden of London House for which they provide a backdrop.
