BELLWAY HOMES LIMITED (NORTH WEST)

Lathom Pastures (Phase 2)

Geo-Environmental Assessment Report

TM/C4380/9070 Rev A

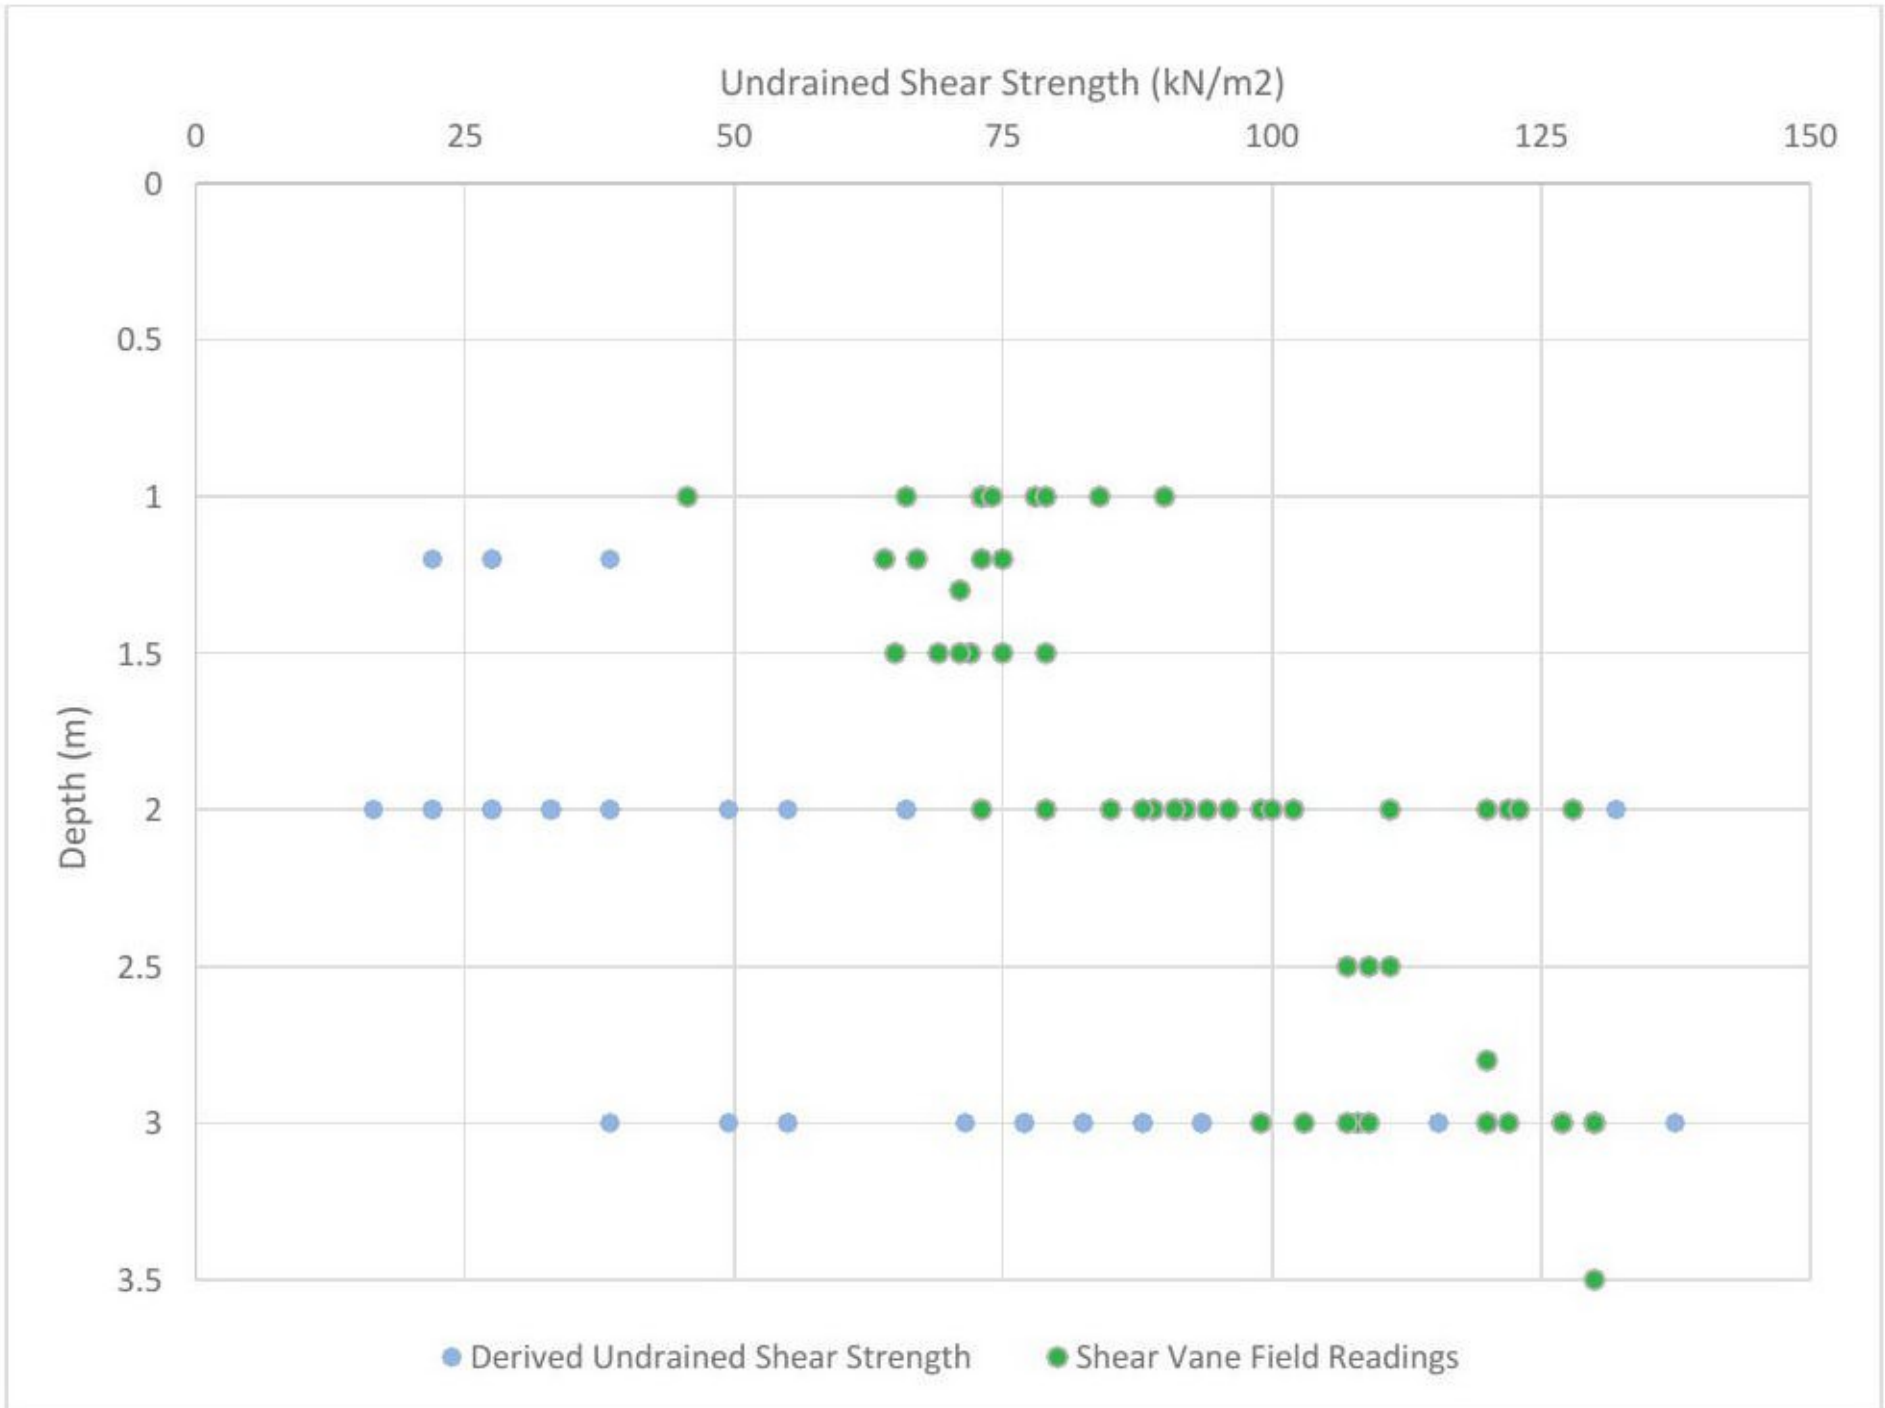
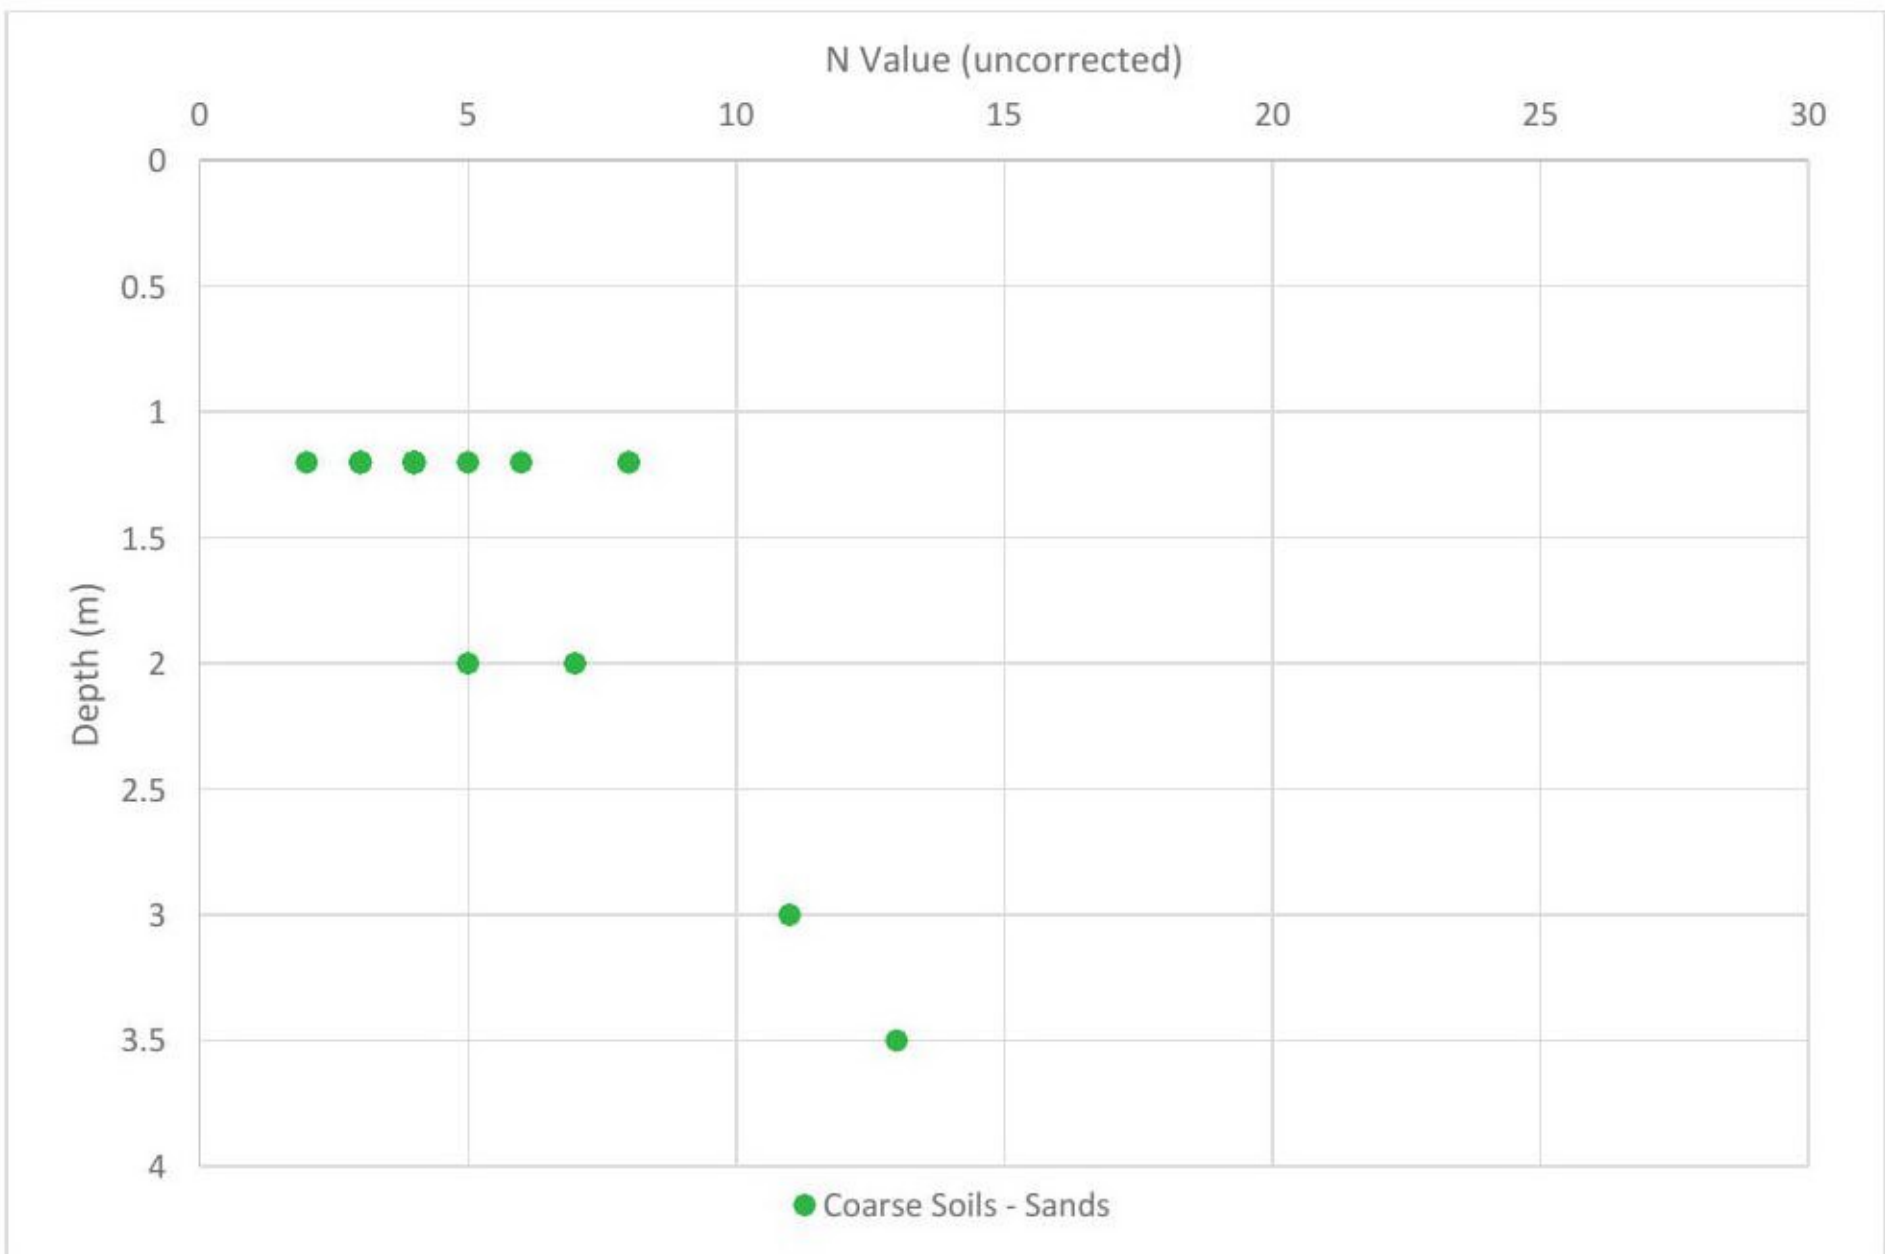
The test results have been evaluated to derive geotechnical soil parameters for the site. Due to the presence of both cohesive and granular soils at shallow depths in different areas of the site, graphs depicting depth vs Cu (for cohesive soils) and depth vs SPT N value (for granular soils) are provided below to provide a profile of the ground conditions underlying the site.

Cu values presented include both those from shear vane readings taken on clay soils in the trial pits and trenches and those derived from SPT N values within clay strata using the correlation of Stroud (1975), adopting an f1 value of 5.5 based on the low volume change potential of the clays.

Characterisation of the geotechnical parameters above has been undertaken to obtain a characteristic value, which is a cautious estimate of the value affecting the occurrence of the limit state.

There is broad correlation between the derived undrained shear strengths and the field shear vane readings, however the shear vane readings are preferred in this assessment given this is a direct measurement and does not rely on empirical correlations. Based on the field shear vane readings, the characteristic value for undrained shear strength in clays at 1.00m is interpreted to be 60kN/m², increasing to 75kN/m² at 2.00m.
