**3-4 Main Street, Shalstone**  
Listed Building Application No 2  
Design and Access Statement

Issue 1 – 19<sup>th</sup> January 2021

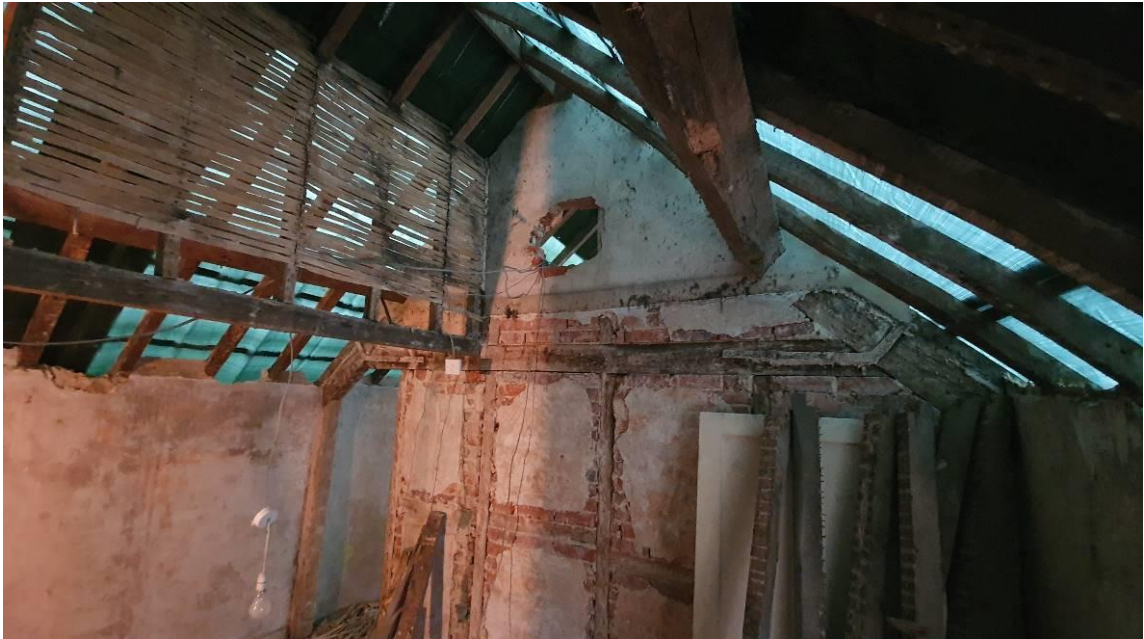
Following investigation during the strip-out stage and removal of damaged sections of existing lath and plaster ceilings, it was evident that originally, at first floor level, the bedroom ceilings were open to the ridge. This is evident both from the existing lime plaster on the gable walls continuing some way above the existing ceiling line, and also as one of the existing partitions between the new bathroom location and the landing was found to extend full height as the photo below, implying that there was no ceiling originally to these areas. The removal of these ceilings offers rooms with better proportions and aid to expose the large oak purlins and oak 'A' frame trusses. The philosophy of the removal of these ceilings was discussed with the Heritage Officer on site and deemed to be acceptable in principle.

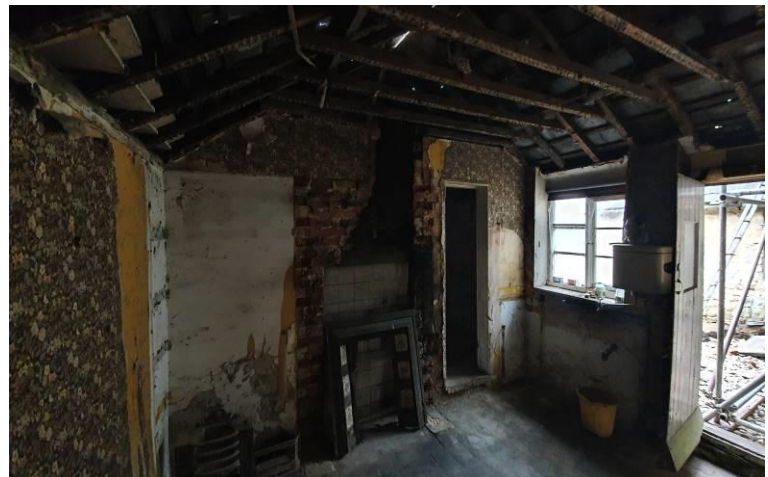
In addition to the removal of the ceiling joists to the first floor, this application requests the removal of the ceiling joists to the rear extension of No 3, as was approved under the first application for the rear extension of No 4. Note, as a result of this change the wood fibre insulation will be

used in lieu of the previous sheeps wool loose lay insulation.

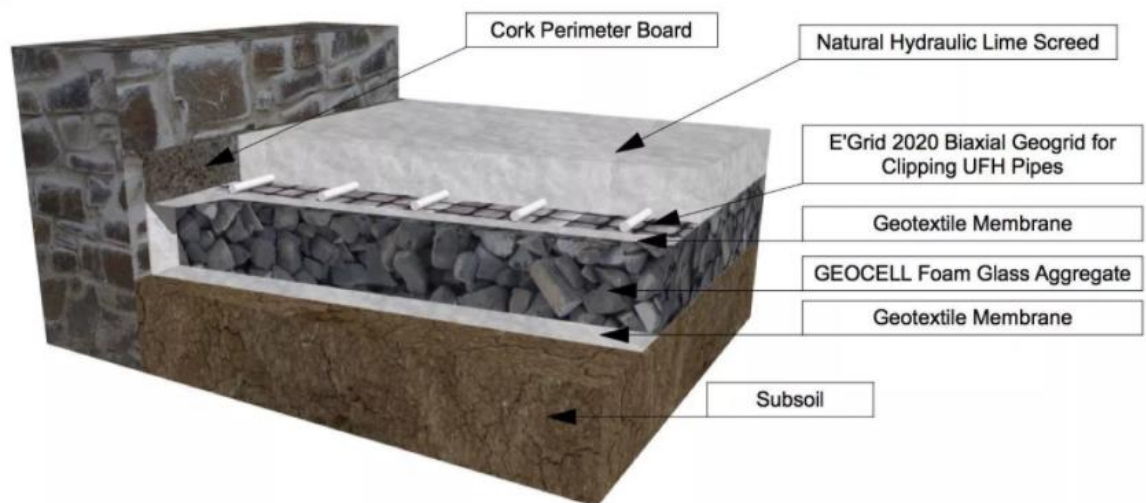
The proposals in this application include the removal of the existing floor finishes throughout and the provision of a 170mm breathable glasscrete insulation, with a limecrete slab above, with integral underfloor heating pipework. As per the below details courtesy of Mike Wye.

In addition to this it is proposed to install three radon sumps. These sumps are excavations approximately 1ft square with 110mm plastic sub floor ventilation which run through to outside. The location of these are as shown in the proposed plans. The ventilation pipework will terminate away from the building in the hedge adjacent to the Reading Room.

Note, after discussion with Public Health England and the Heritage Officer it is proposed that a radon barrier **will not** be installed as this would make the floor non breathable and could harm the transfer of moisture through the slab.
