Design and Access Statement

Proposed replacement of the existing conservatory and external boiler house with a oak framed garden room and replacement of the back door and porch in the south east elevation of the service wing into the kitchen with a pair of leaded light oak doors and a solar panel array in the back paddock

Brundish Manor, The Street, Brundish, Suffolk IP13 8BL

Rob Pearce Architects

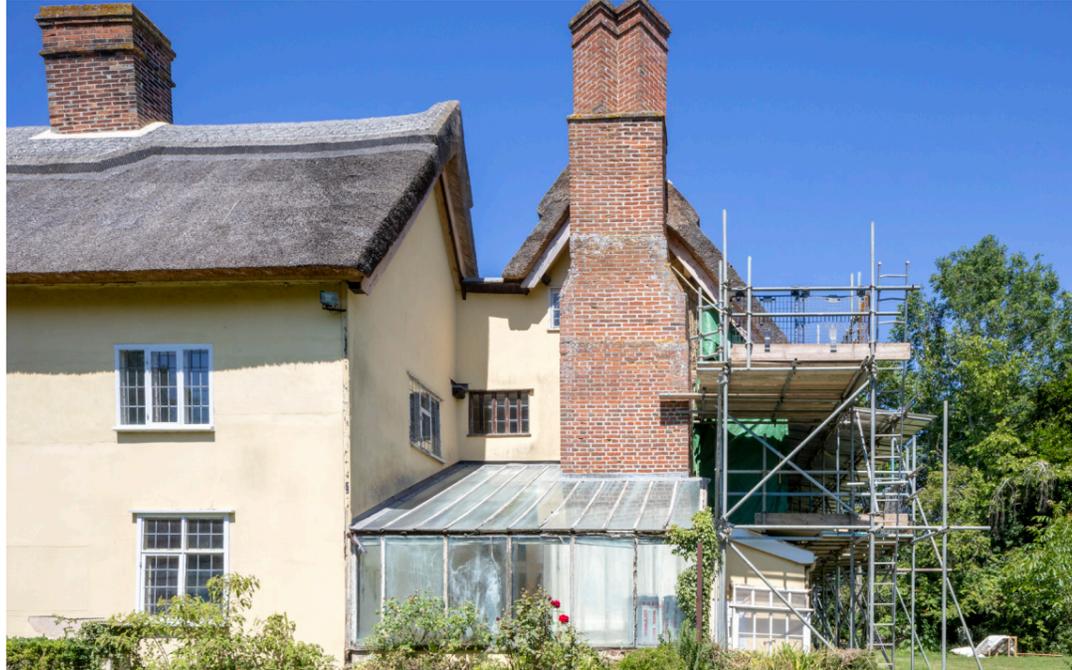
View of existing conservatory

Linus and Elaine Wright, the owners of Brundish Manor, hope to enhance the appearance of the Manor by taking down the lean too conservatory and brick boiler house. These structures wrap around the external brick chimney on the southeast gable wall to the principle wing. The softwood timber glazing bars to the conservatory are rotten and the conservatory does need to be replaced, before the glass panes slip form the roof. The

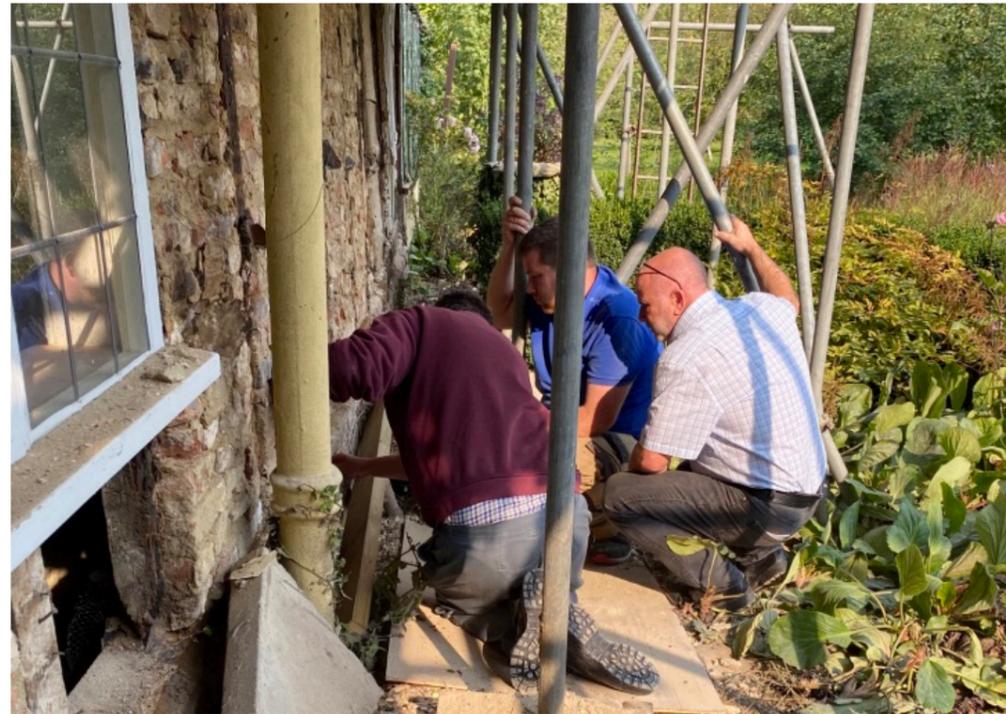
Timber frame repairs to South-east elevation

The timber frame to the Manor was in very poor condition, prior to the repair works undertaken by R & J Hogg Limited. The hard external cement render finish, unfortunately trapped moisture within the timber frame, particularly the sole plate, which sat directly on top of a porous soft red brick plinth. In the current phase of work the timber frame has been comprehensively repaired. Very fortunately most of the decayed and damaged timber to the framing is on the external face, closest to the cement render. It has therefore been possible to repair the frame, from the outer face. When covered with larch lath and a chalk lime render finish so these repairs are invisible and the interior is significantly unaltered.

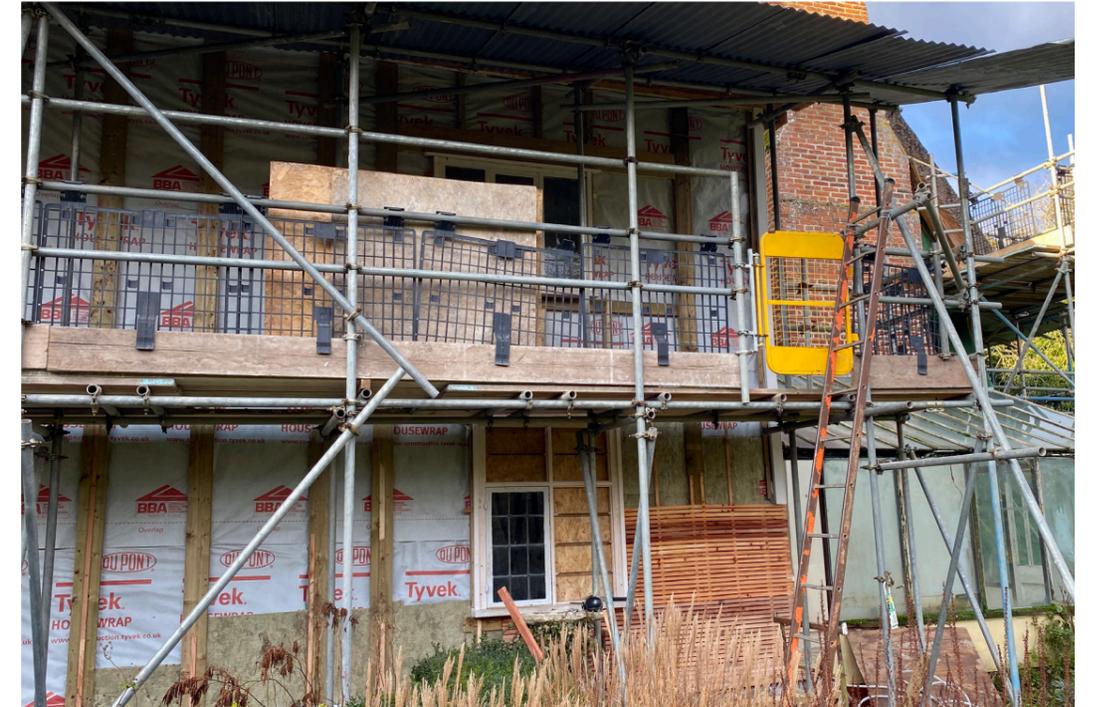
Scaffold on South-east elevation, Summer 2020

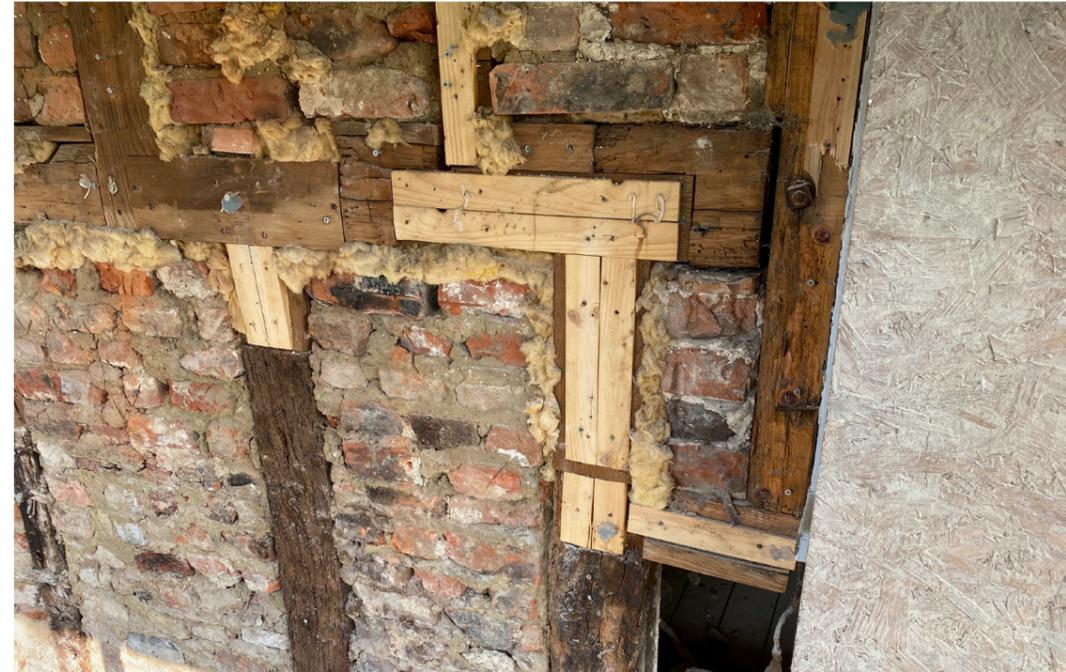
Previous face repairs to the original medieval eaves level plate

The timber framed repairs and removal of the hard external cement render have exposed details of the timber frame including the original 16th Century edge halved and bridled scarf joint to the eaves level plate immediately above the cavetto moulded mullion window on the north west elevation of the Service Wing. Even the eaves level plate in this position has evidence of fire damage.

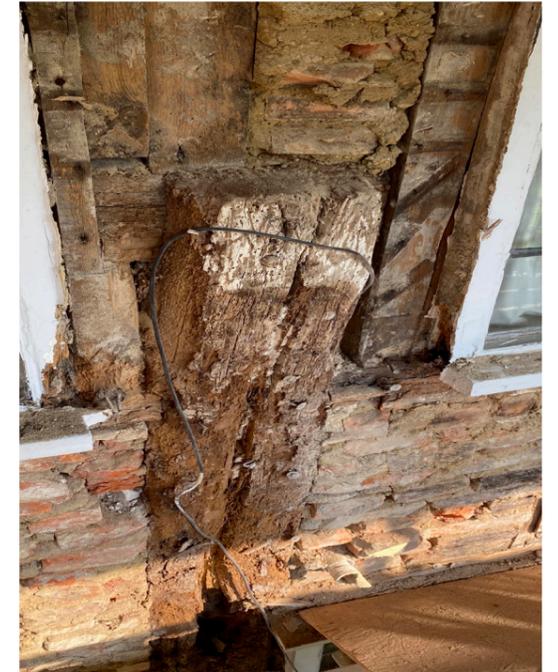
Detail of the original timber frame principal post, which forms the left hand jamb to window GW12

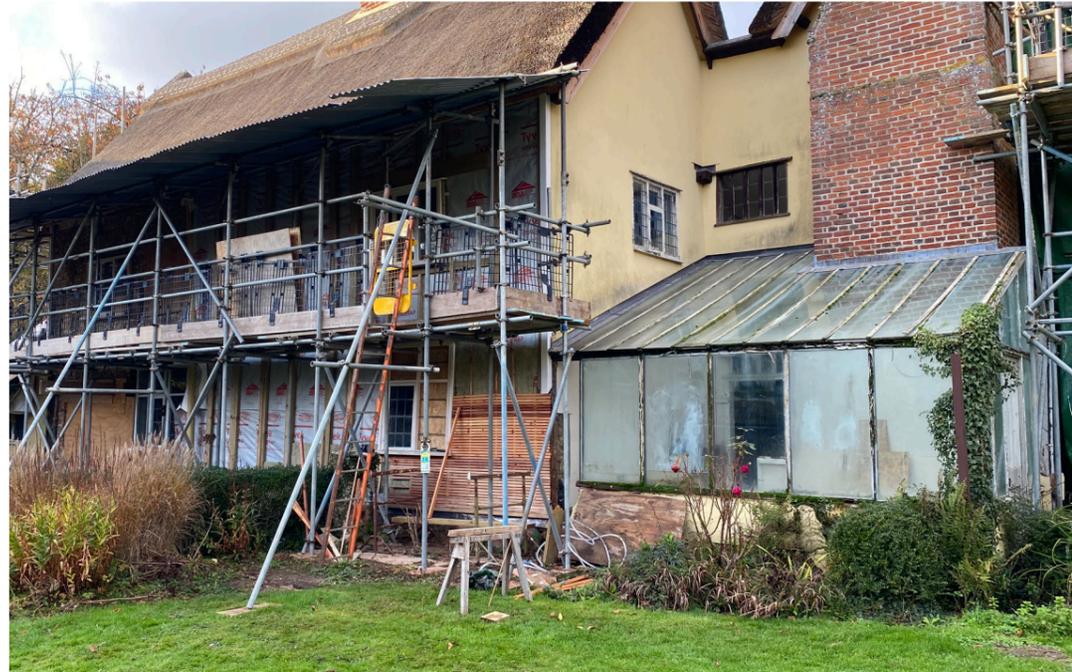
Existing conservatory

The existing conservatory allows light through the glazed timber mullion door into the ground floor entrance Hall to the Principle Wing. This natural soft light is extremely important and the discrete roof light is an essential to maintain the natural light levels in the Hall.

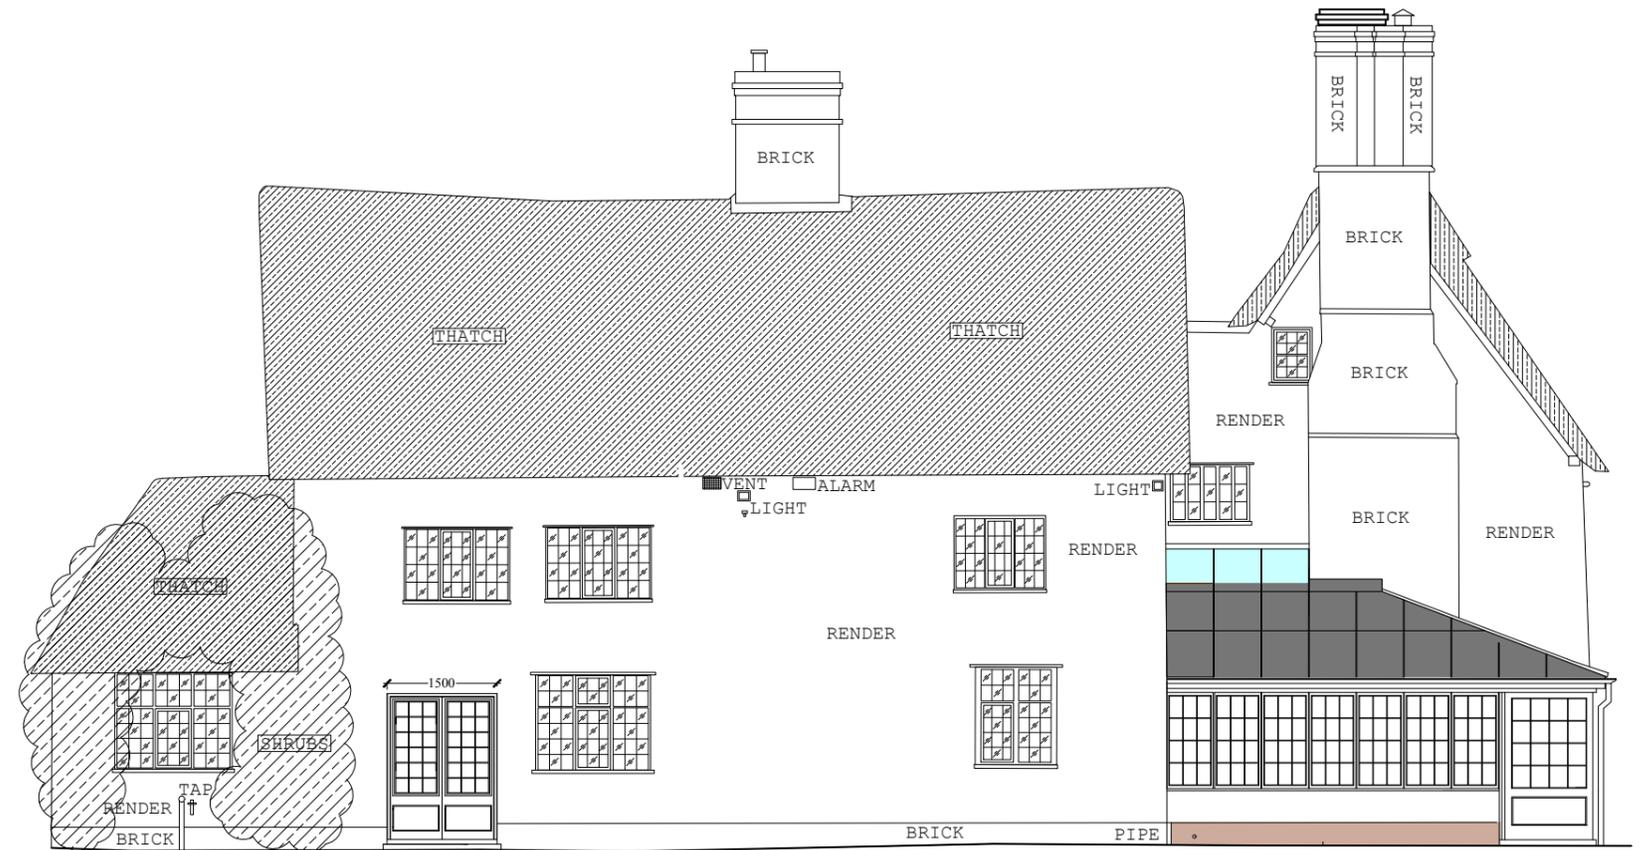
Proposed South-east elevation with new door to conservatory

We therefore propose replacing these two structures with a pair of doors, glazed with leaded lights and secured into a oak framed and paneled door to match the existing detailing to the leaded and timber framed casement windows to the Manor. This will enhance the appearance of the southeast elevation and increase the natural light into the kitchen. In the summer months the

The red brick plinth to the garden room will be rendered to match the existing chalk lime render finishes to the Manor. Leaded lights supported in natural English oak framing, sourced locally in Suffolk, will wrap around the oak frame and a pair of corner doors will open onto the garden with unimpeded views across the rectangular pond. The leaded lights in the conservatory will match the leaded lights and oak framed and paneled doors to the northeast elevation and the proposed doors in the southeast elevation into the kitchen, if permission is granted for these in the current application.

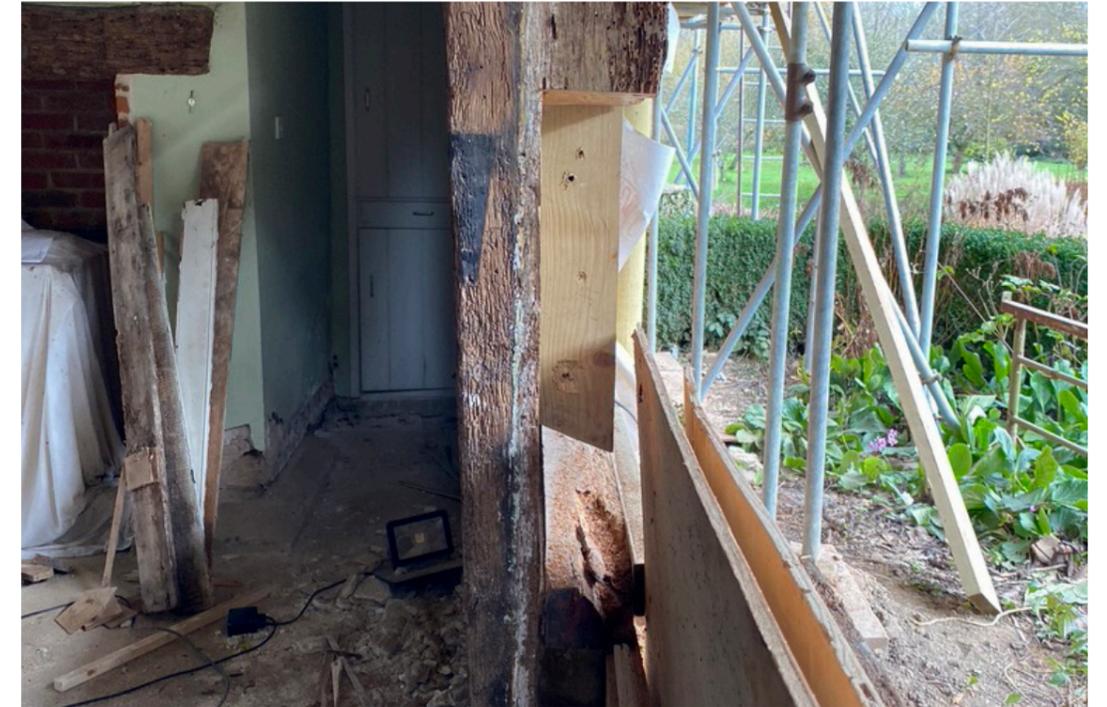
Door opening on South-east elevation

The repair works to the Southeast elevation have confirmed that a significant part of the historic timber frame was destroyed by fire. The painted softwood ledge and braced back door and cedar shingle roofed porch had to be removed to allow the frame repairs to the south-east elevation and only the principle post turned through 180 degrees is part of the original framing. The remaining softwood posts and sole plate are of much thinner timber sections than the original framing and appear to be contemporary with the roof and first floor softwood timber structures to the Service Wing. The back door and porch could also date from the late 19th or early 20th centuries.

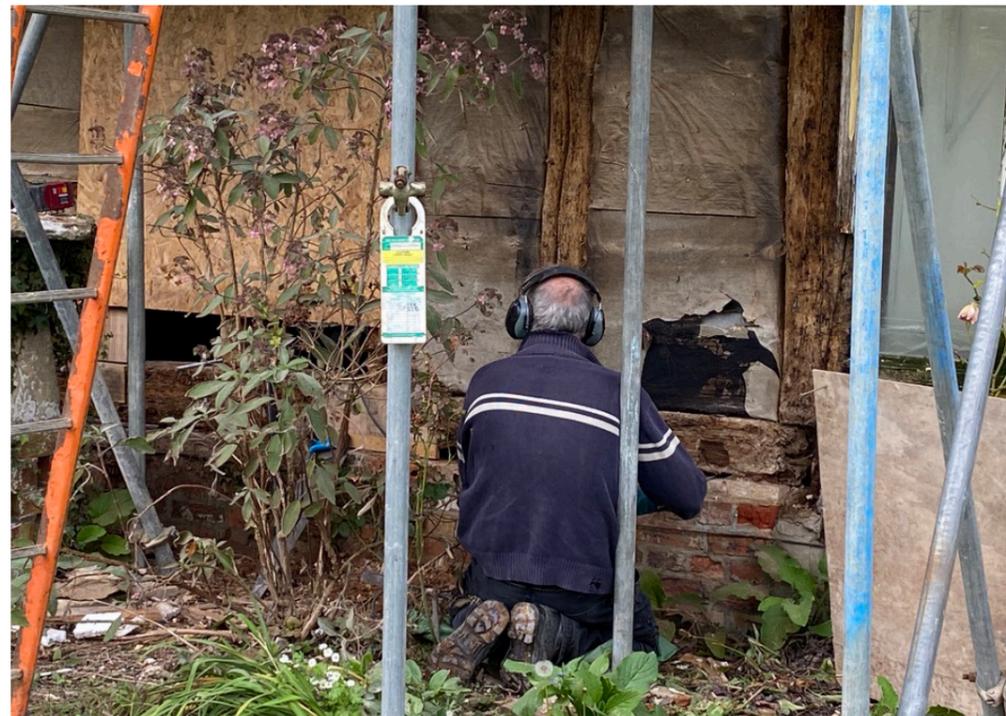
Timber frame repairs to South-east elevation
