Northumberland Line

Preliminary Sources Study Report - Ashington Station Appendix 06

Northumberland County Council

Project number: 60601435 60601435-ACM-07-ZZ-REP-EGE-000001

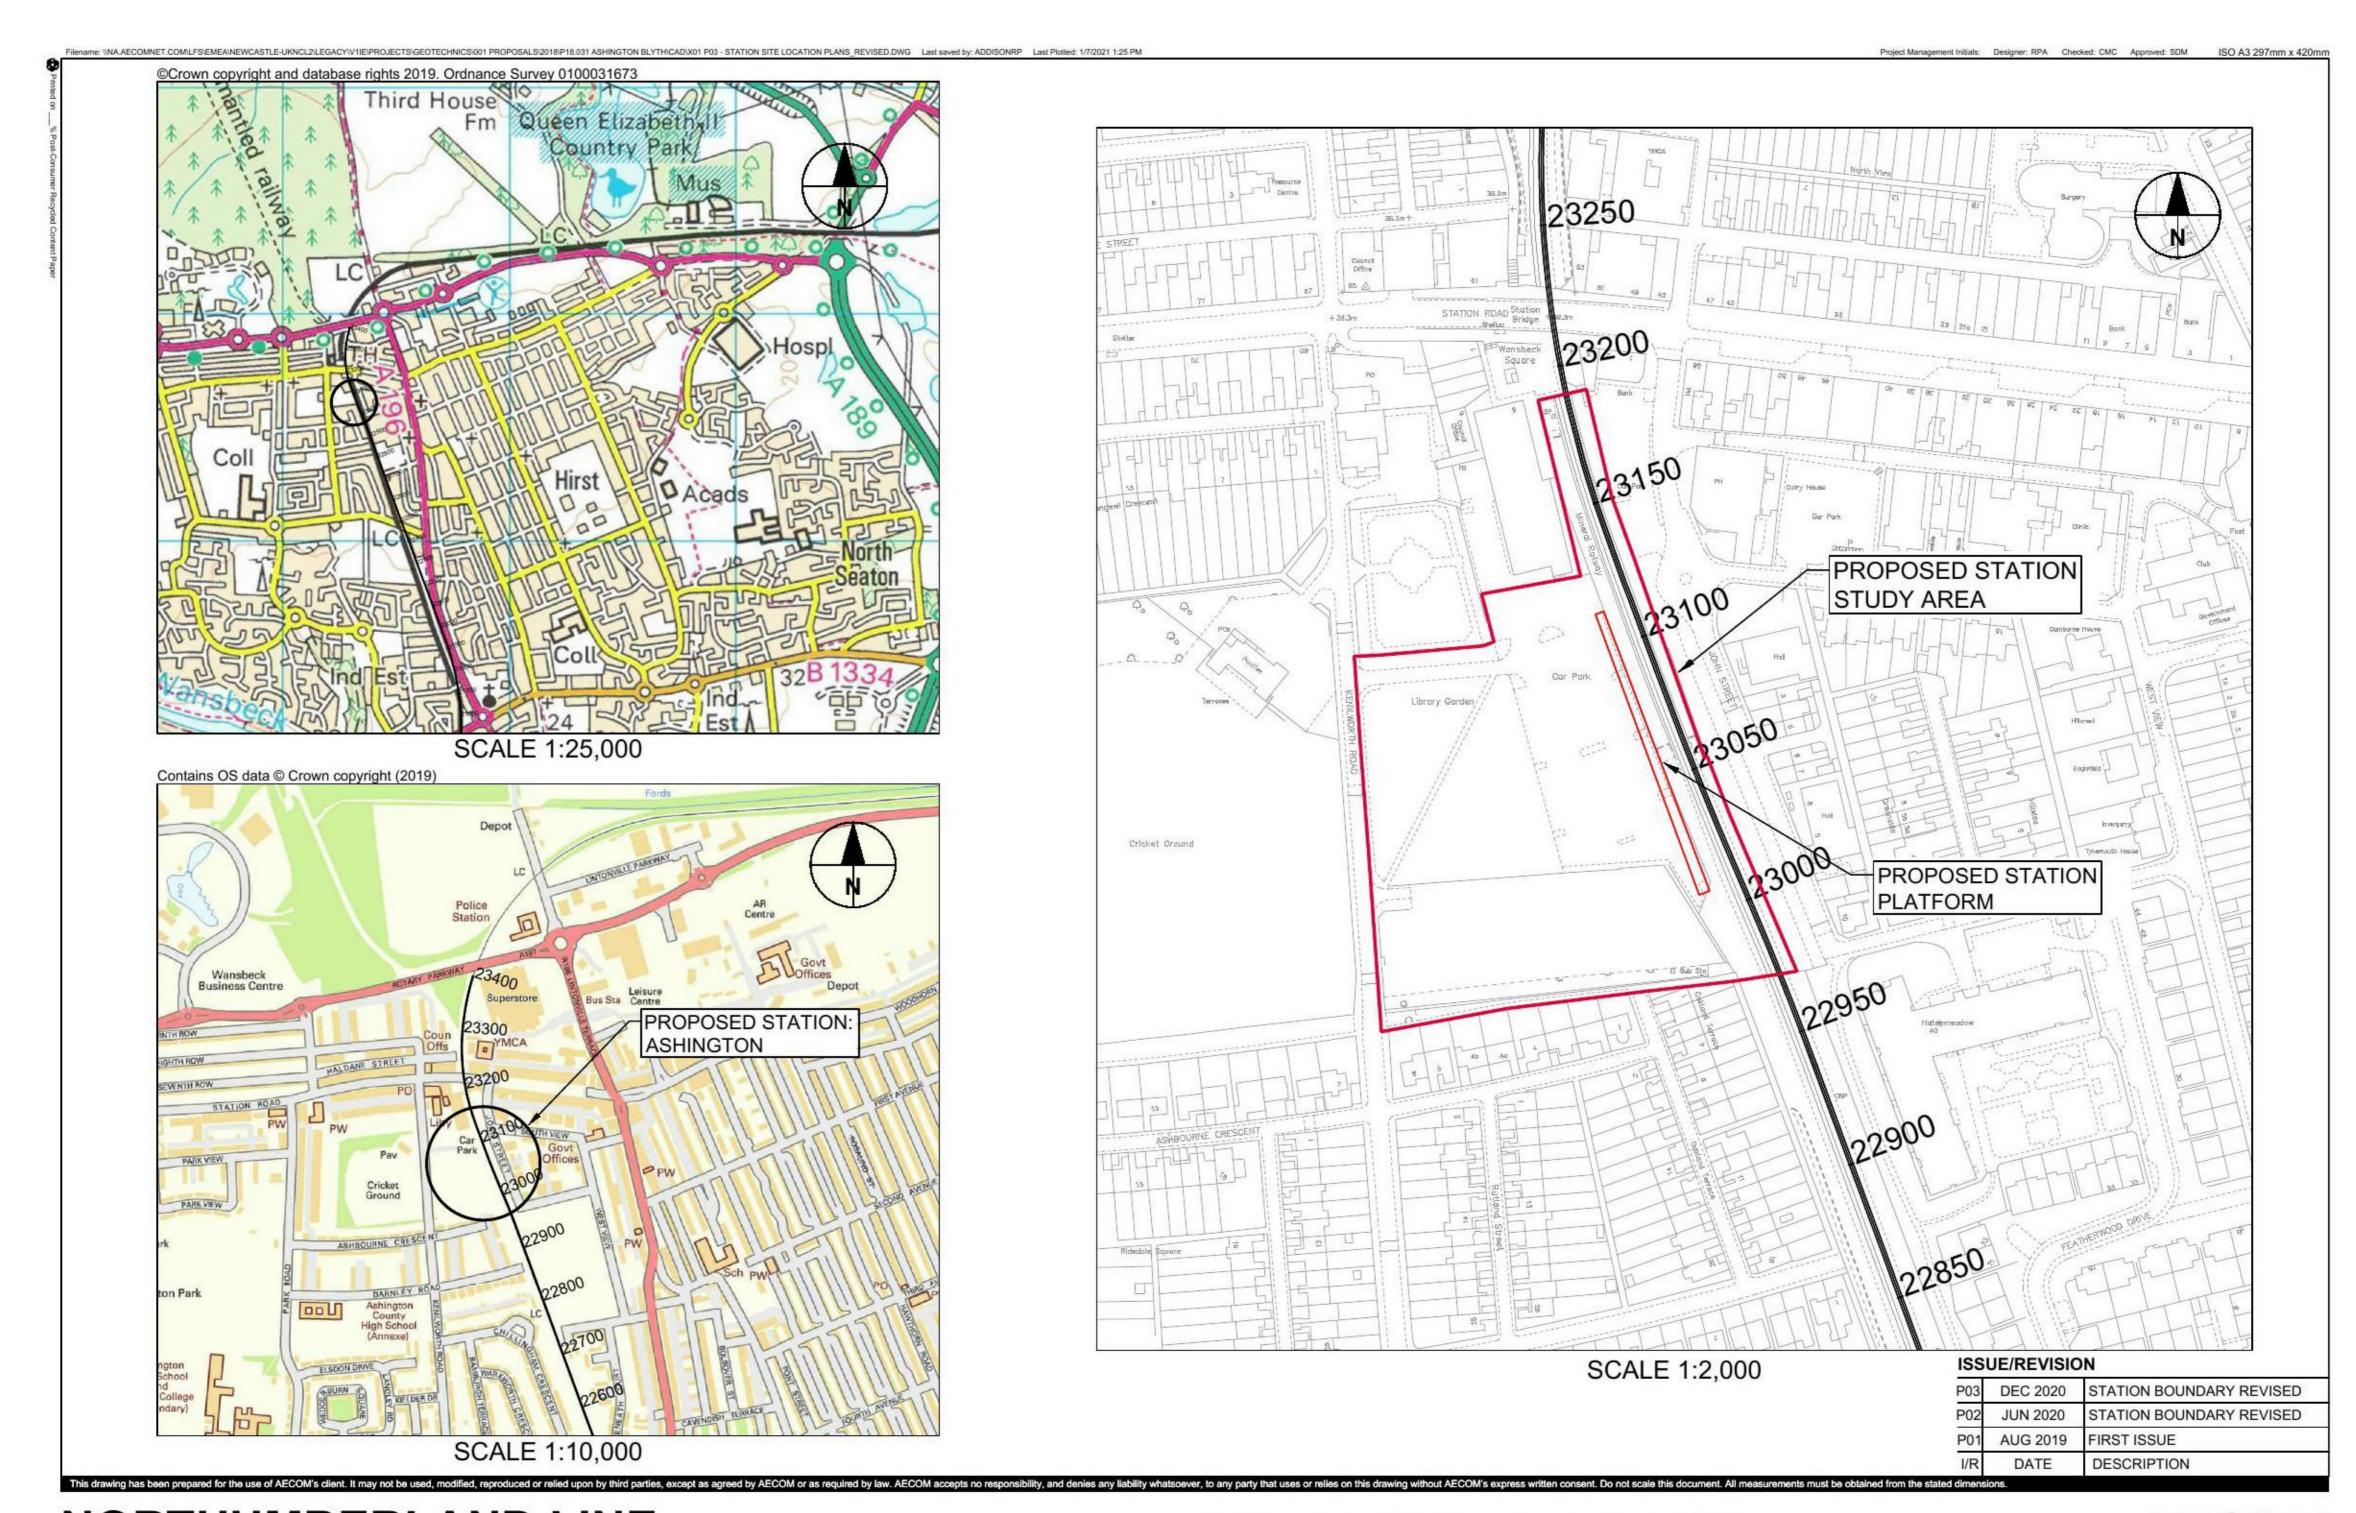
Ashington Station Location Plan

NORTHUMBERLAND LINE Northumberland County Council
