# **Haresfield Farms**

# Land to the East of Existing Caravan Store at Pool Farm, Haresfield, Stonehouse, GL10 3EJ

Flood Risk Assessment and Drainage Strategy

# 16<sup>th</sup> February 2021 V2

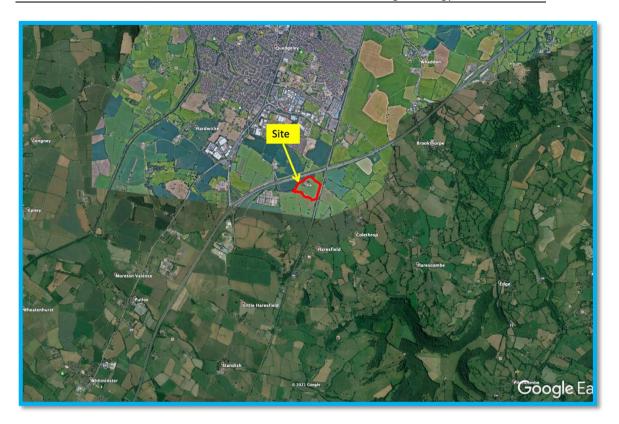
Fig 2 Satellite view of site and surrounding area (Google Earth).

- Immediately north of the site is Colethrop Lane, beyond which is a field and the M5.
   Ditches run along both sides of Colethrop Lane, starting just west of the Pool Farm buildings. Northeast of the site is Shorn Brook.
- The eastern edge of the site is bound by the railway line, beyond which is farmland.
   A watercourse runs along the southern half of the eastern boundary. This continues along the southern boundary of the site leading westwards.
- The watercourse flows east to west along the southern boundary of the site into the
  ditch along Colethrop Lane to the west of the site and then under the M5 in the
  vicinity of Junction 12. The predominant land use south and west of the site is
  farmland.
- 2.1.4 The site can therefore be described as being situated in a rural area on land falling to the west.

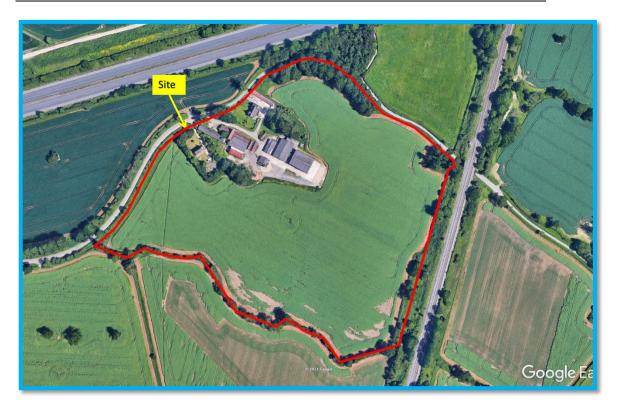
- Fig 3 Satellite view of farm site (Google Earth).
- 3.1.4 The land generally drains into the watercourse south of the site. The buildings and hardstanding area drain into a 300mm diameter underground pipe which flows unattenuated into the watercourse. The existing caravan store drains into a pond north of the buildings which discharges into a roadside pipe and along Colethrop Lane via roadside pipes and open roadside ditches, which has been diverted through the site into the watercourse south of the site.
- 3.1.5 The watercourse size has been given as approximately 1.5m deep, 1m wide at the base and 2m wide at the top of the bank.
- 3.1.6 The watercourse dimensions have been given as generally 1.5m deep, 1m wide at the base and 2m wide at the top of the bank.

- 3.1.1 The farm area of search is irregular in shape and is approximately 400m north-south and 410m east-west with a total approximate area of 11.23ha. The caravan store is in the northeast of the site.
- 3.1.2 The land is shown to have a generally uniform fall of about 1 in 90 from northeast to southwest according to the Ordnance Survey map and Google maps.
- 3.1.3 In the northwest of the site are existing farm buildings used for storage and an office for managing the farm. The northern area of the farm, and south of an area of woodland, is used for caravan storage (which post-dates the Google image).

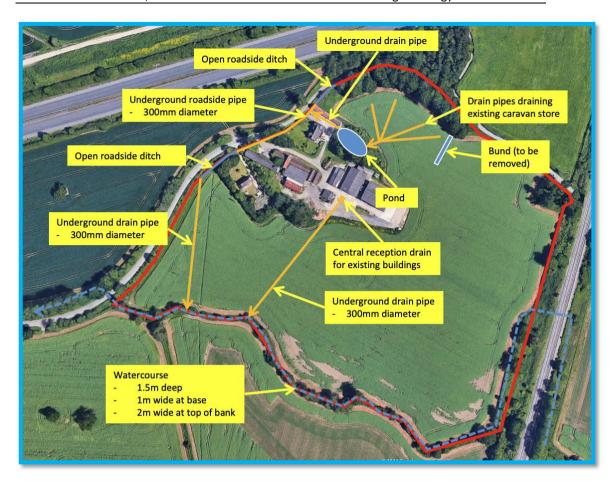
- Fig 4 Existing farm area drainage annotated on Google Earth satellite image.
- 3.1.7 The British Geology Survey shows the geology to be mudstone bedrock. The Cranfield Soilscape Viewer shows the soils to be clayey and some loamy with slightly impeded drainage. The land is low lying, drained by frequent ditches and not suitable for conventional soakways, but appropriate for managing rainfall from permeable surfaces, replicating the natural characteristics.

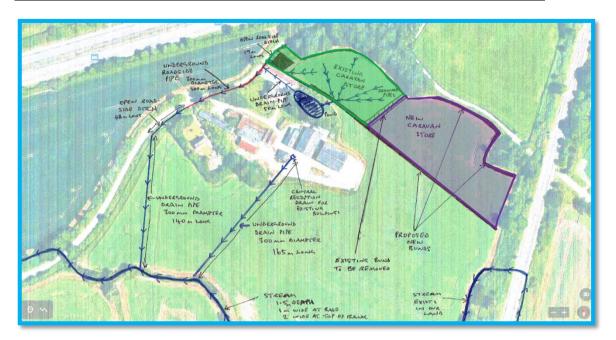
Fig 5 Proposed site plan showing new caravan store in northeast of farm site in context of existing infrastructure.

4.1.1 The work involves the extension of existing outside storage of unoccupied caravans and motor homes including partial removal of existing landscape bund, the construction of permeable hard-standing and associated drainage and landscaping is proposed to extend the open caravan store to provide further caravan storage spaces to the northeast of Pool Farm.

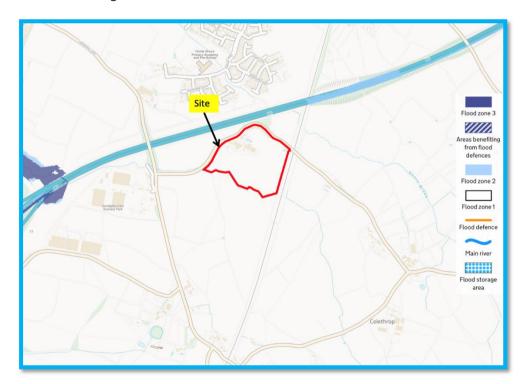
Fig 6 EA Flood Map for Planning showing site in Flood Zone 1, at low risk of flooding.

5.1.1 The EA Flood Map for Planning shows the site to be in Flood Zone 1 at low risk of flooding (land having less than 0.1% annual exceedance probability of river or sea flooding.

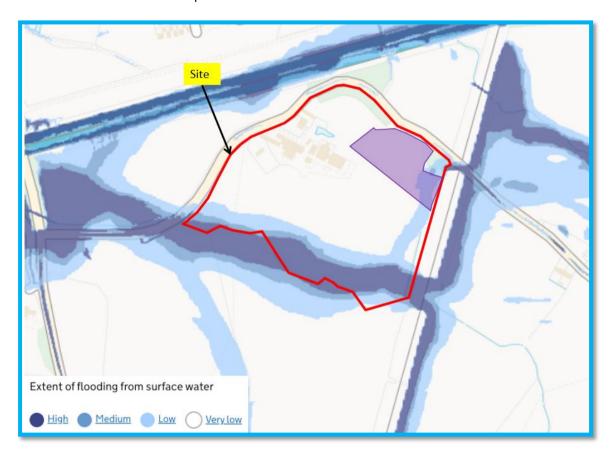
- Fig 7 EA Surface Water Flooding Map showing eastern part of caravan store at low risk of shallow flooding (ie less than 300mm deep according to the low risk scenario flood map).
- 5.2.3 The Medium Risk Scenario (1 in 100 year event) shows a localised ponded area predicted to be less than 300mm deep, but this is not evidence in the farmland. This area will be inspected on site and the level adjusted as necessary with the permeable material.

- 5.2.1 The EA Surface Water Flooding Map shows the majority of the farm site to be at very low risk of flooding with a small area along the eastern boundary at low risk of shallow flooding and the southern area along the watercourse to be at low to high risk of surface water flooding. The area of proposed development is at very low risk.
- 5.2.2 The eastern part of the caravan store site is shown to be at low risk of shallow flooding less than 300mm deep.

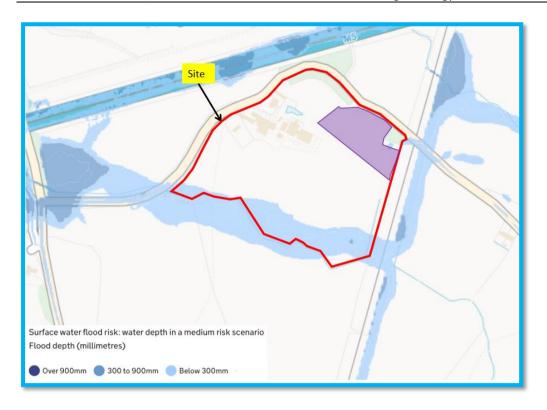
Fig 8 EA Surface Water Flooding Map – Medium Risk Scenario (1 in 100 year event).

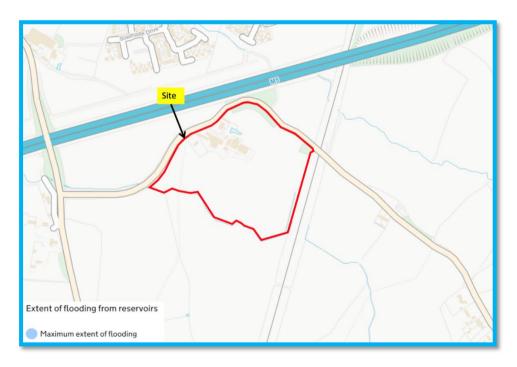
Fig 9 EA Reservoir Flooding Map.

5.3.1 The EA Reservoir Flooding Map shows the site to not be at risk of flooding from reservoirs.

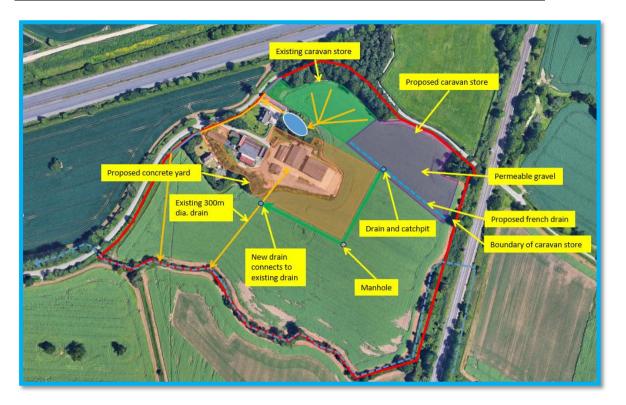
- Fig 10 Proposed drainage in the context of the railway and wider site drainage.
- 7.1.6 A manhole will be installed at the change of direction and on the existing pipe at the connection point to allow for inspection and for clearing debris.

- 7.1.5 As a precautionary measure, it is proposed to provide a french drain along the south site of the store, with a catchpit and drain discharging to the existing drain south of the farm buildings which leads to the watercourse, mimicking the natural characteristics.

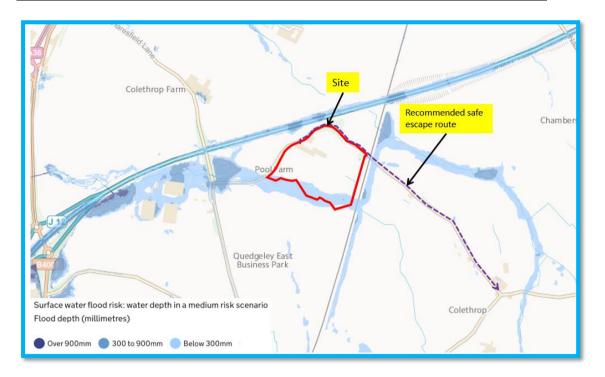
Fig 11 Safe escape annotated on EA Surface Water Flooding Map – Medium Risk Scenario (1 in 100 year event).

- 8.1.1 Site access and egress is not inhibited by fluvial or tidal flooding.
- 8.1.2 Colethrop Lane east of the site is shown to experience a short area of shallow flooding, less than 300mm deep, in the Medium Risk Scenario, adjacent the railway. This provides a safe route to and from the site during times of local heavy rainfall.
- 8.1.3 It is unlikely that caravans will be delivered or collected from storage if heavy storms are forecast.
