SECTION CC AND NORTH INTERNAL ELEVATION OF PORTICO (PORCH)- AS PROPOSED

SECTION DD AND SOUTH INTERNAL ELEVATION OF PORTICO (PORCH)- AS PROPOSED

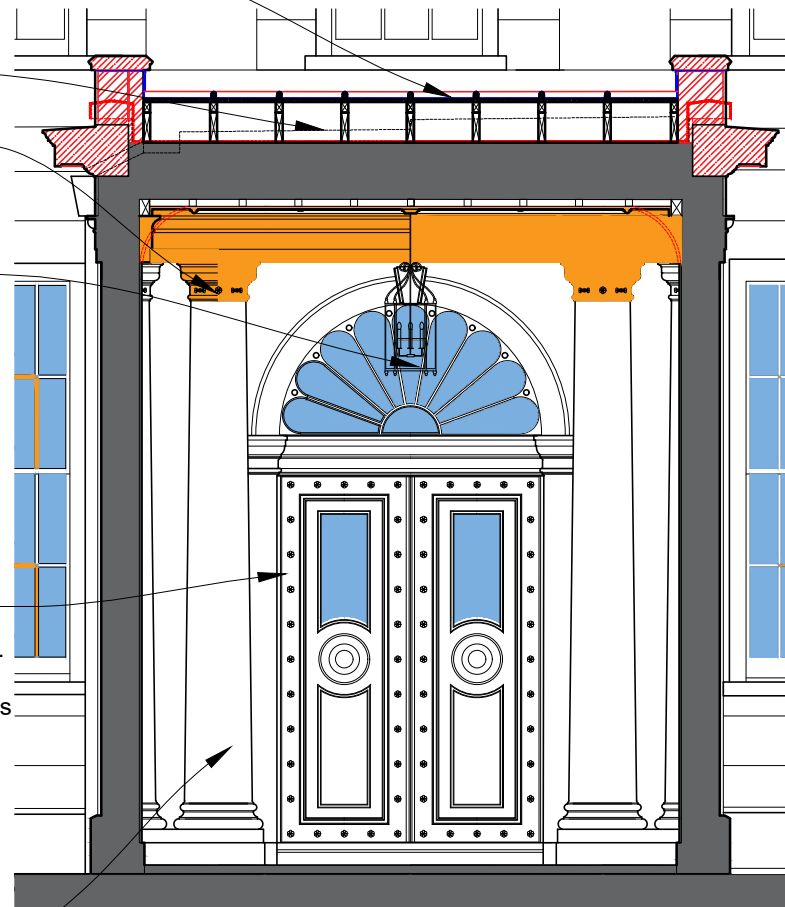
New code 6 lead flat roof on 18mm Airtrax board on new treated softwood substrait all to LSA recommendations. Code 8 lead gutter to back with one step, sump and overflow at west end. Refer to PPP10 for details.

Line of gutter dashed behind

Reinstate 2 no. missing capitals to pilasters including flower and wheat sheaf enrichments

Provisionally allow for replacing existing non-original pendant with new purpose made external cast iron and glass lantern, wired and switched from with the building.

Carry out minor repairs to joinery of existing door and fanlight and reglaze missing panes of fanlight in reproduction crown glass. Door panels to be reglazed in clear safety glass.

Rub down, prepare and paint doors.

Allow for overhauling existing hinges and lock / latch, fit client supplied drop handle midrail.

Brush down surface of stucco pilasters and fluted columns and remove all flaking limewash. Carry out repairs to stucco and re-limewash.

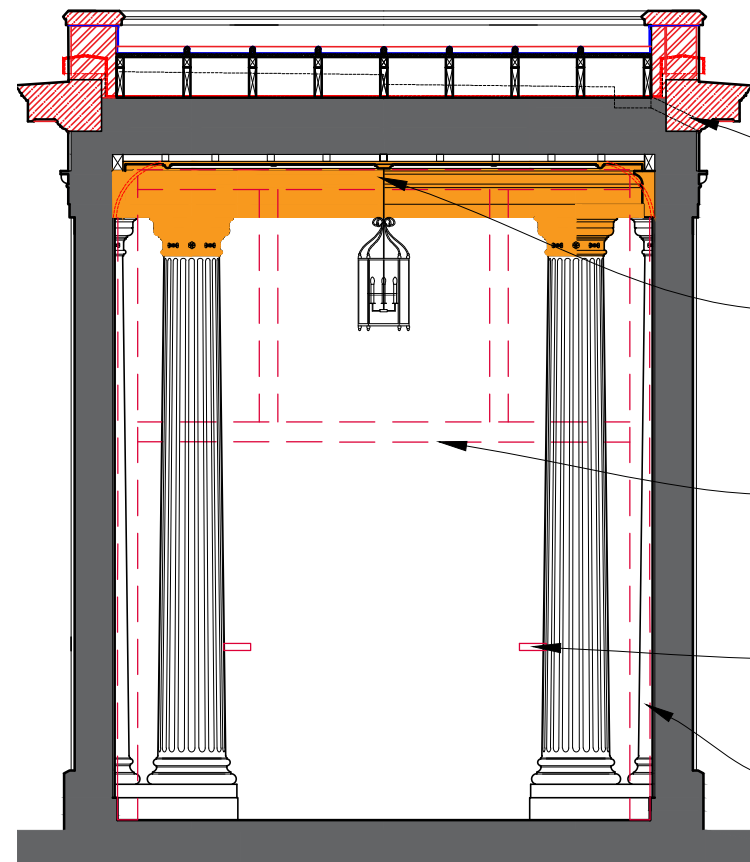
Take down existing non-original brick parapet and stone cope. Fit new limestone cornice and raised brick parapet complete with profiled limestone cope. For details refer to drawing PPP10

Allow for removal of ASBESTOS ceiling by certified contractor and allow for inspection by Conservation Architect. Form new flat lime plaster ceiling on split chestnut laths with feature moulding and run lime plaster cornice to match profile of external architrave. For details refer to drawing PPP10.

Allow for removal existing timber and glass screen. Allow for inspection behind by conservation architect.

Carefully remove remains of iron gate hinge pins and hand over to PHT. Allow for locally patch repairing stucco.
