Reserved Matters Submission & Condition Compliance Statement

Condition 7

Land at
Haresfield
Badgers Road
Badgers Mount
Sevenoaks
TN14 7AY

Prepared by:
The Mayhew Consultancy Ltd

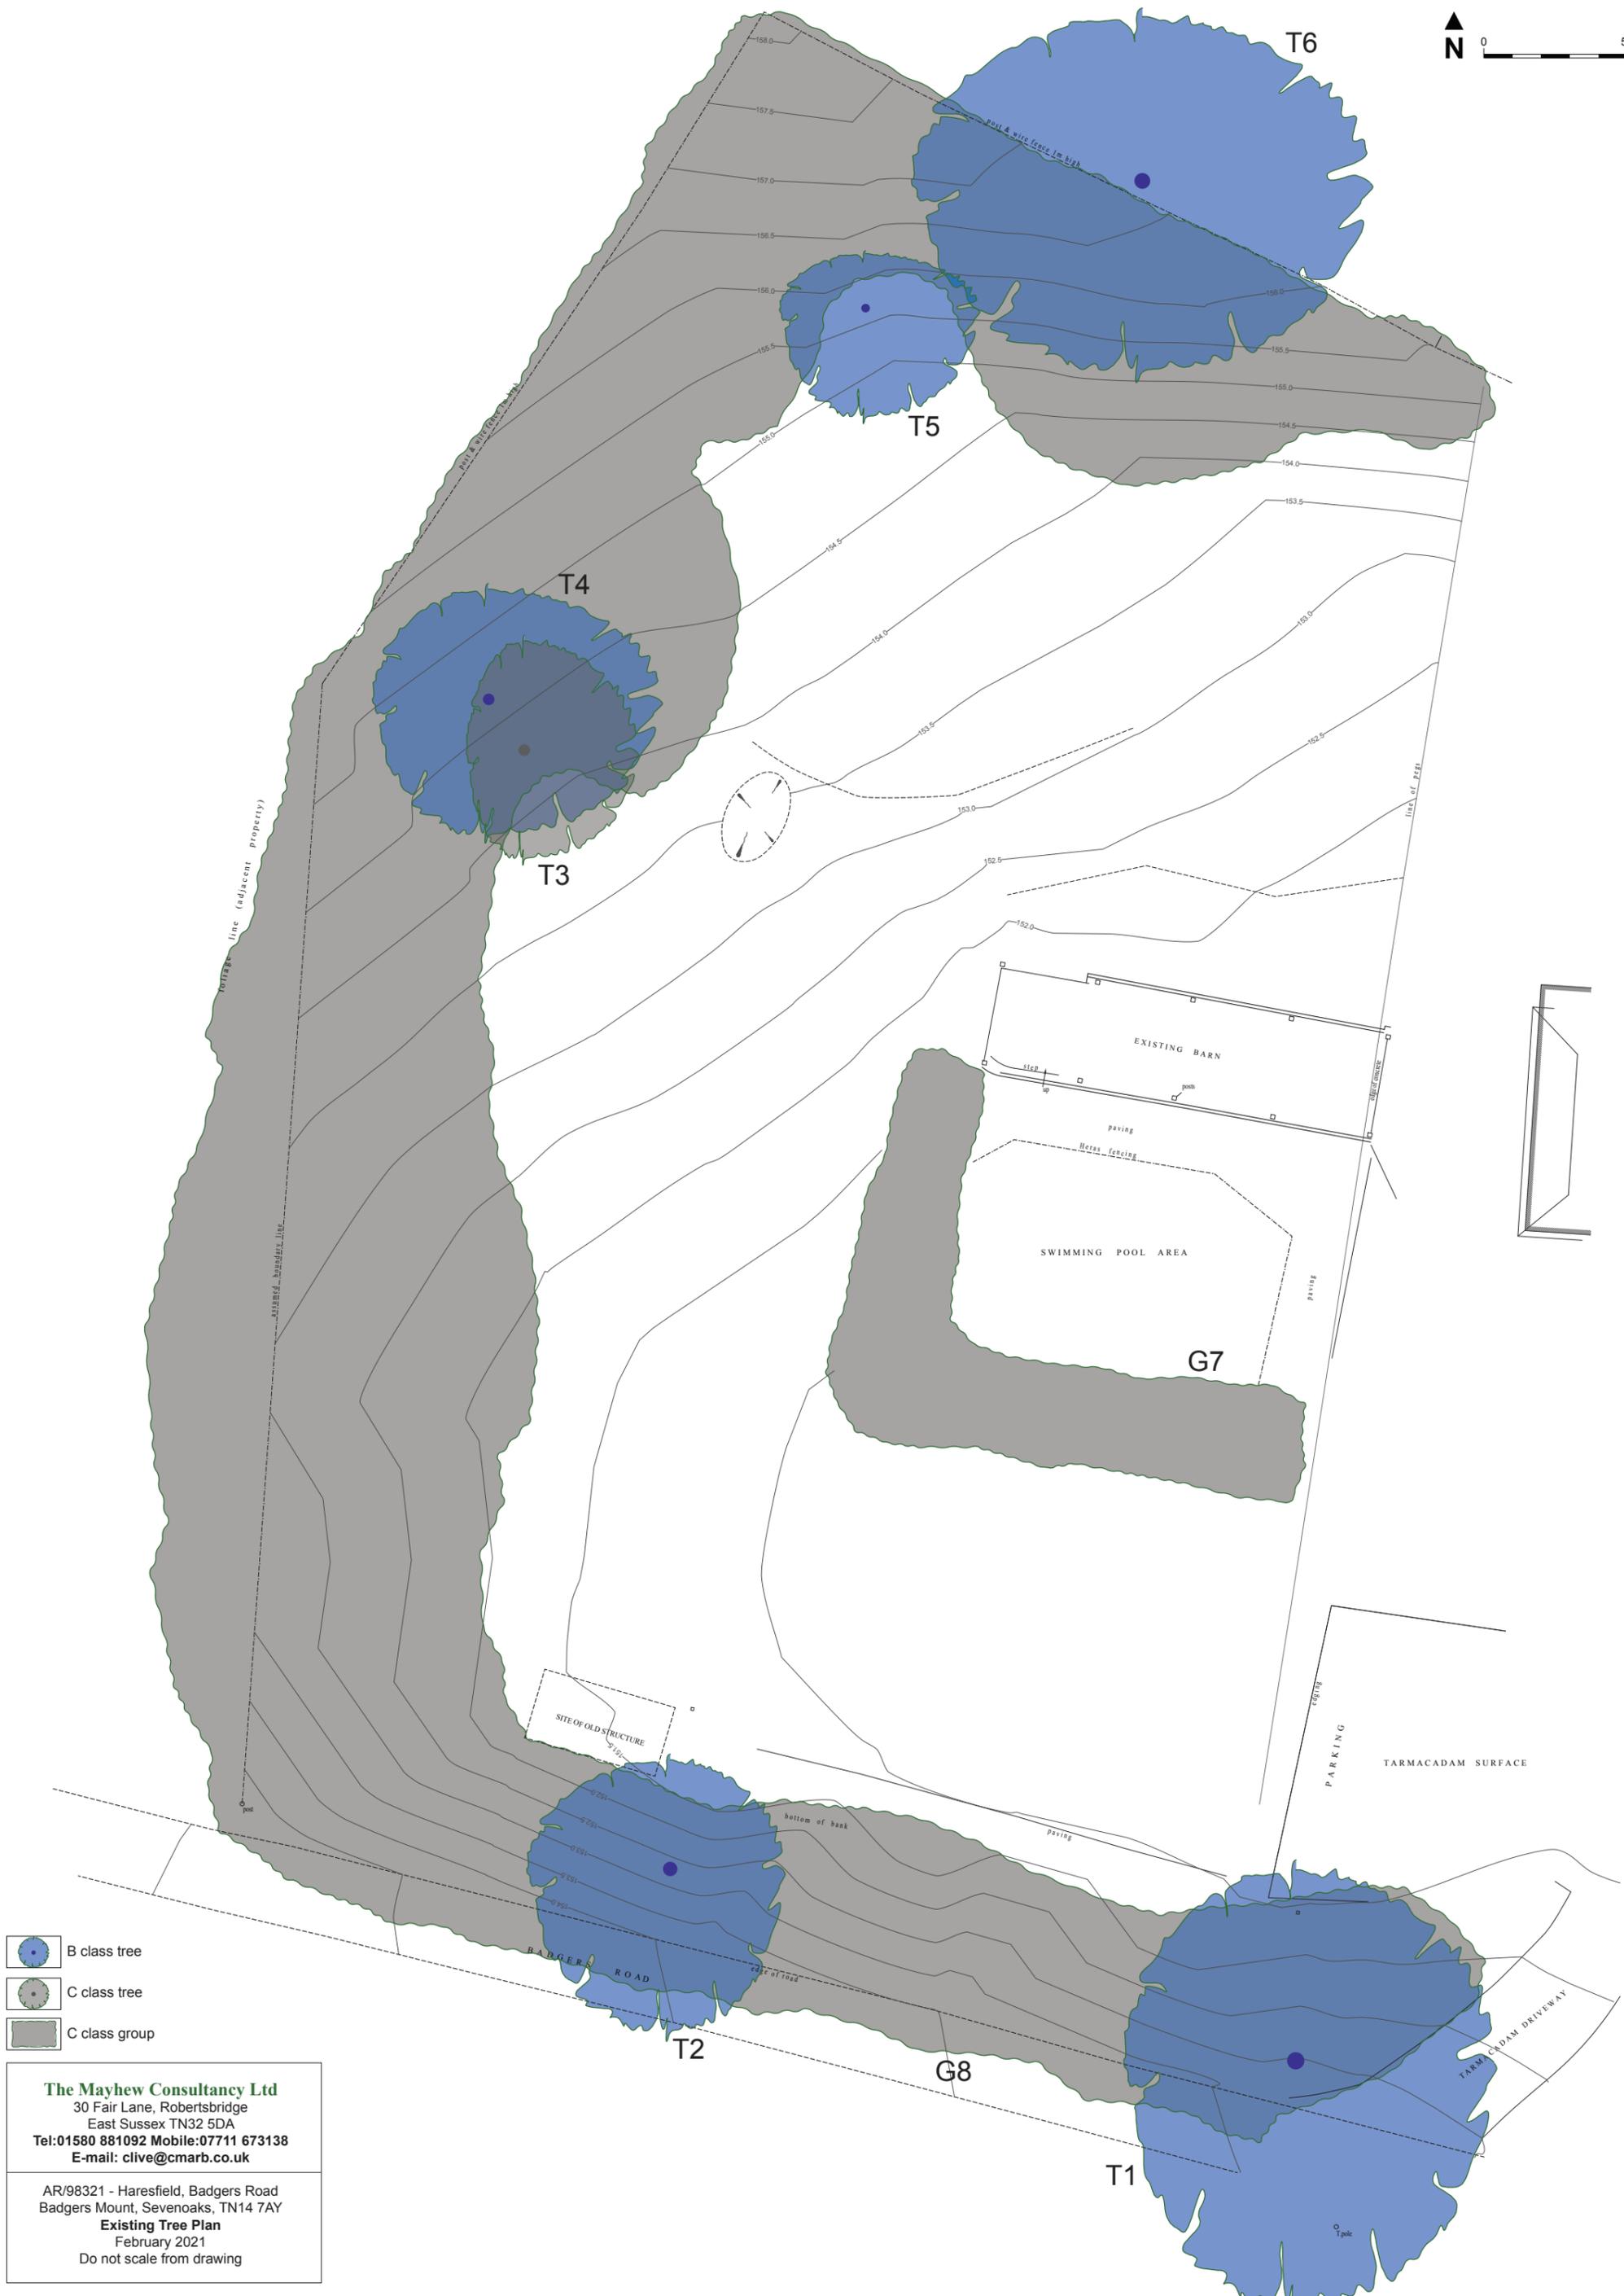
AR/98321 - Haresfield, Badgers Road
 Badgers Mount, Sevenoaks, TN14 7AY
Existing Tree Plan
 February 2021
 Do not scale from drawing

-

B class tree
-

C class tree
-

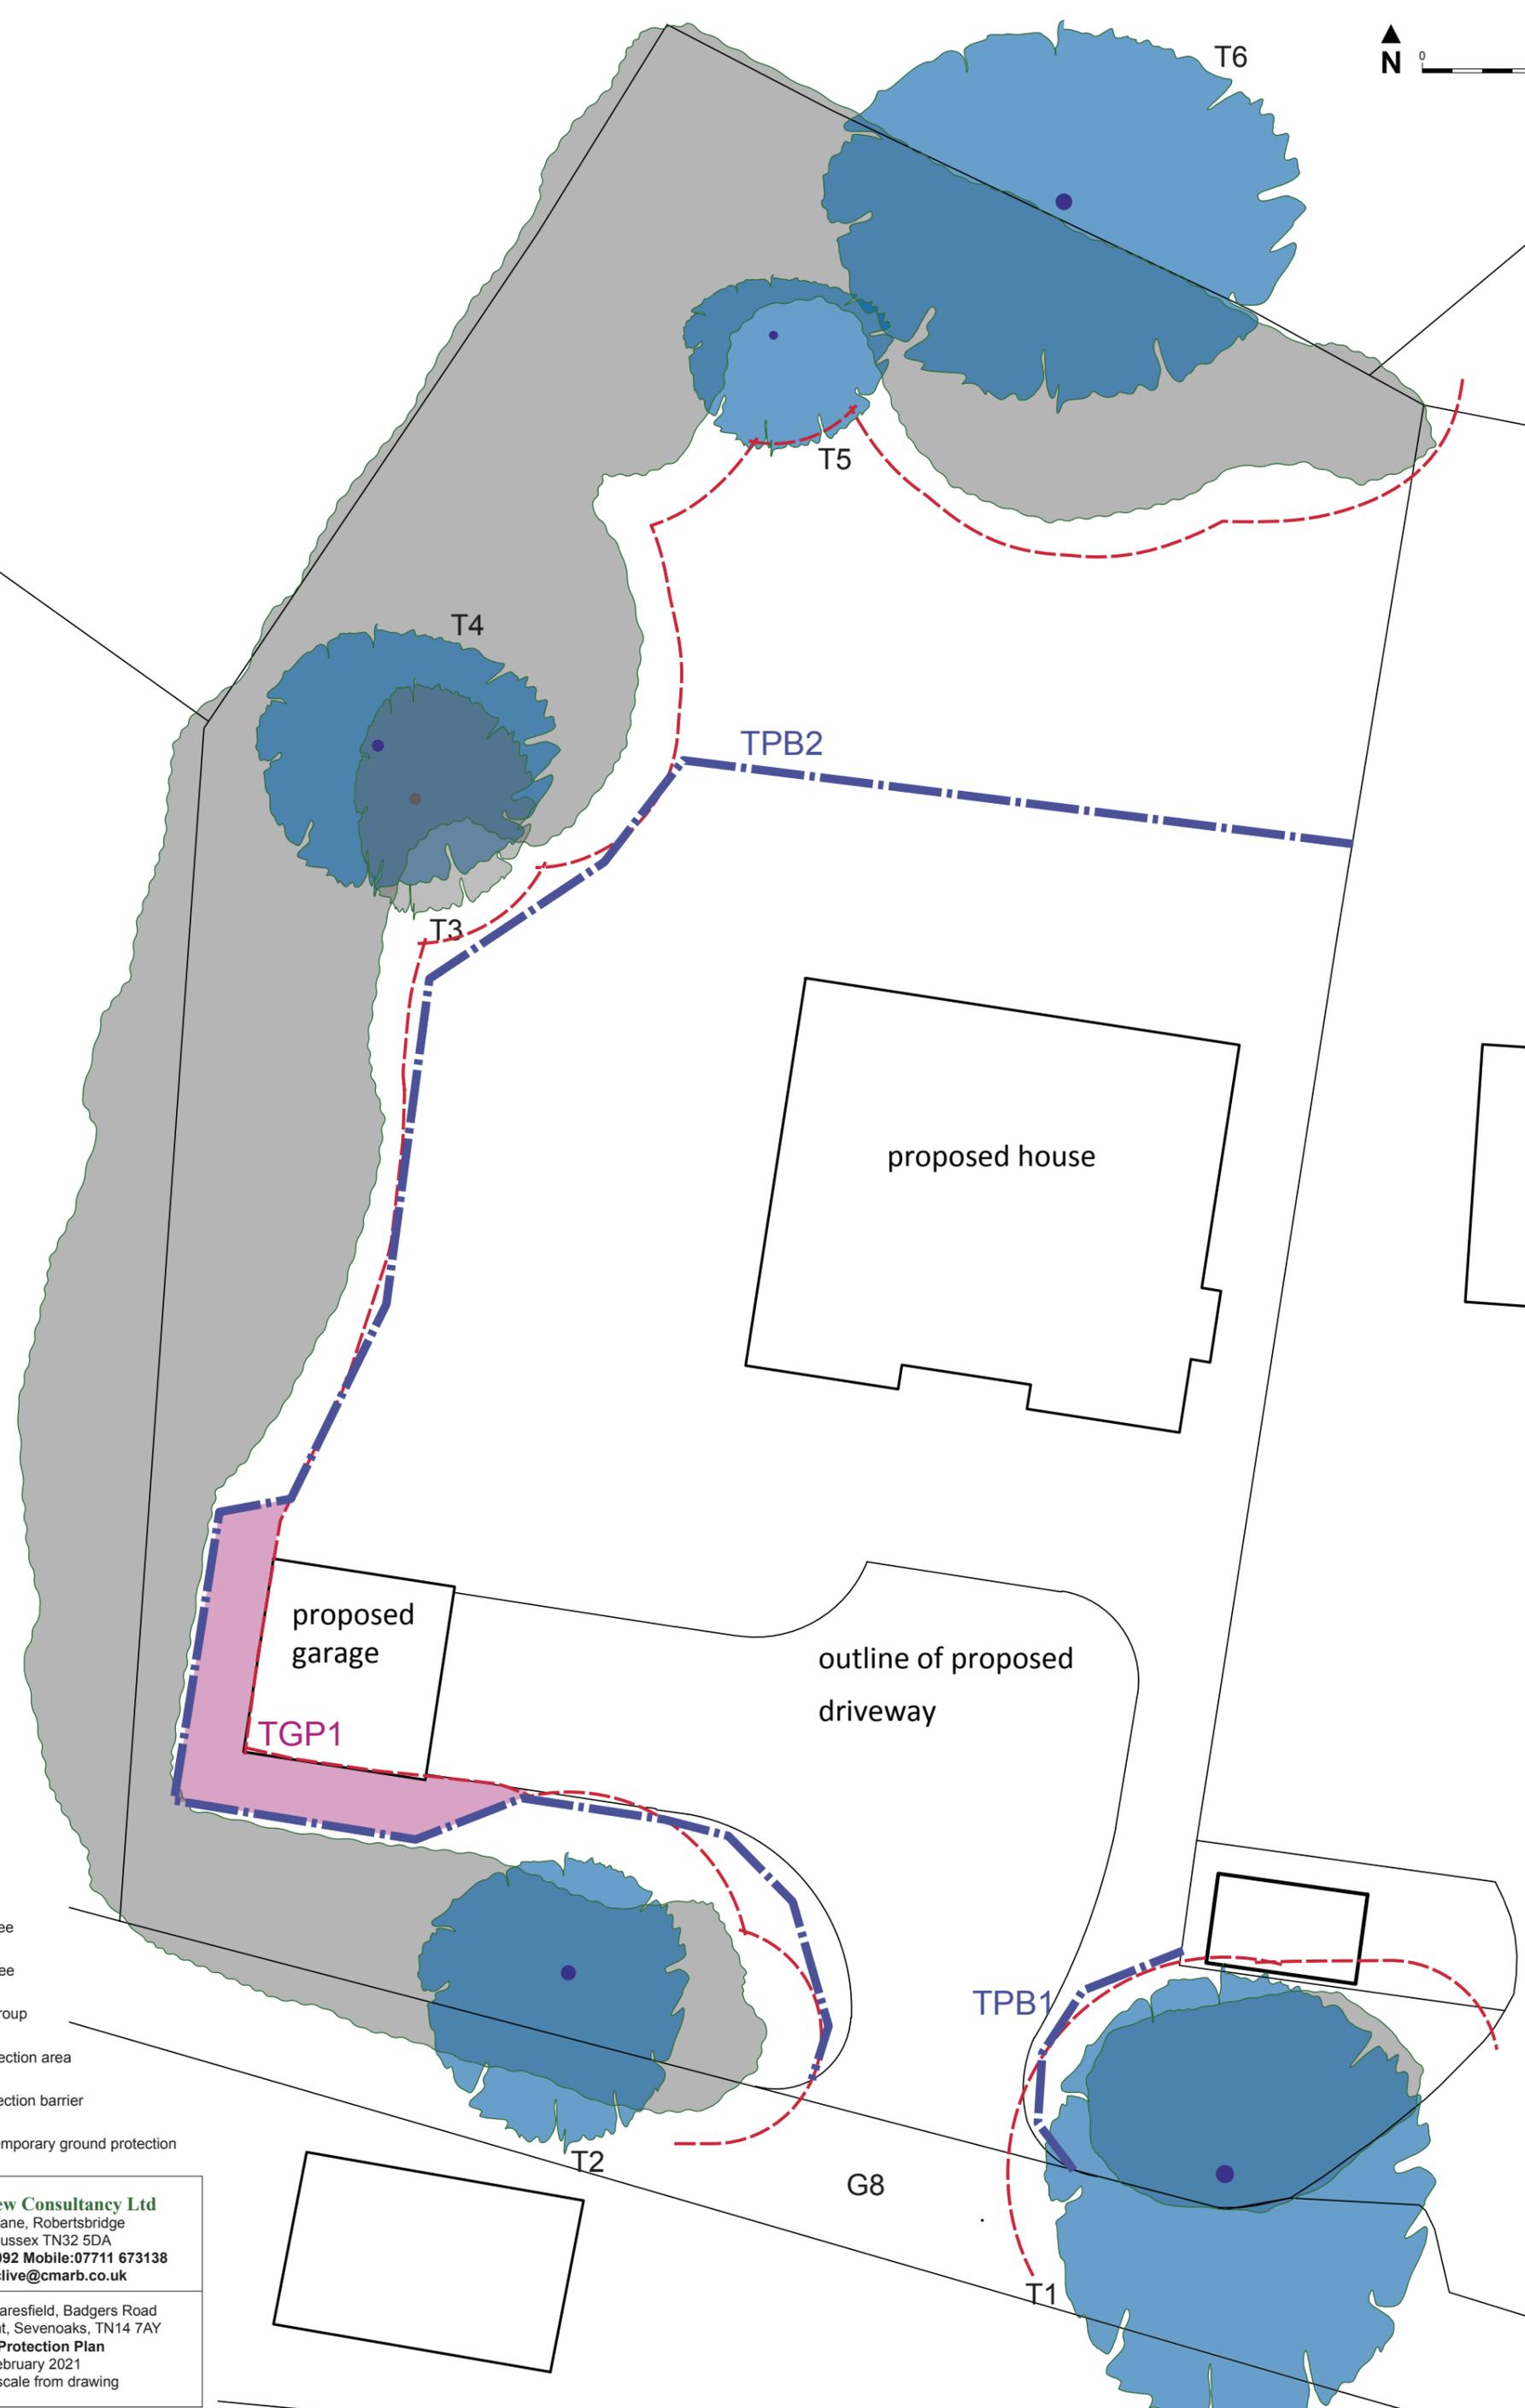
- B class tree
- C class tree
- C class group
- Root protection area
- Tree protection barrier
- Area of temporary ground protection

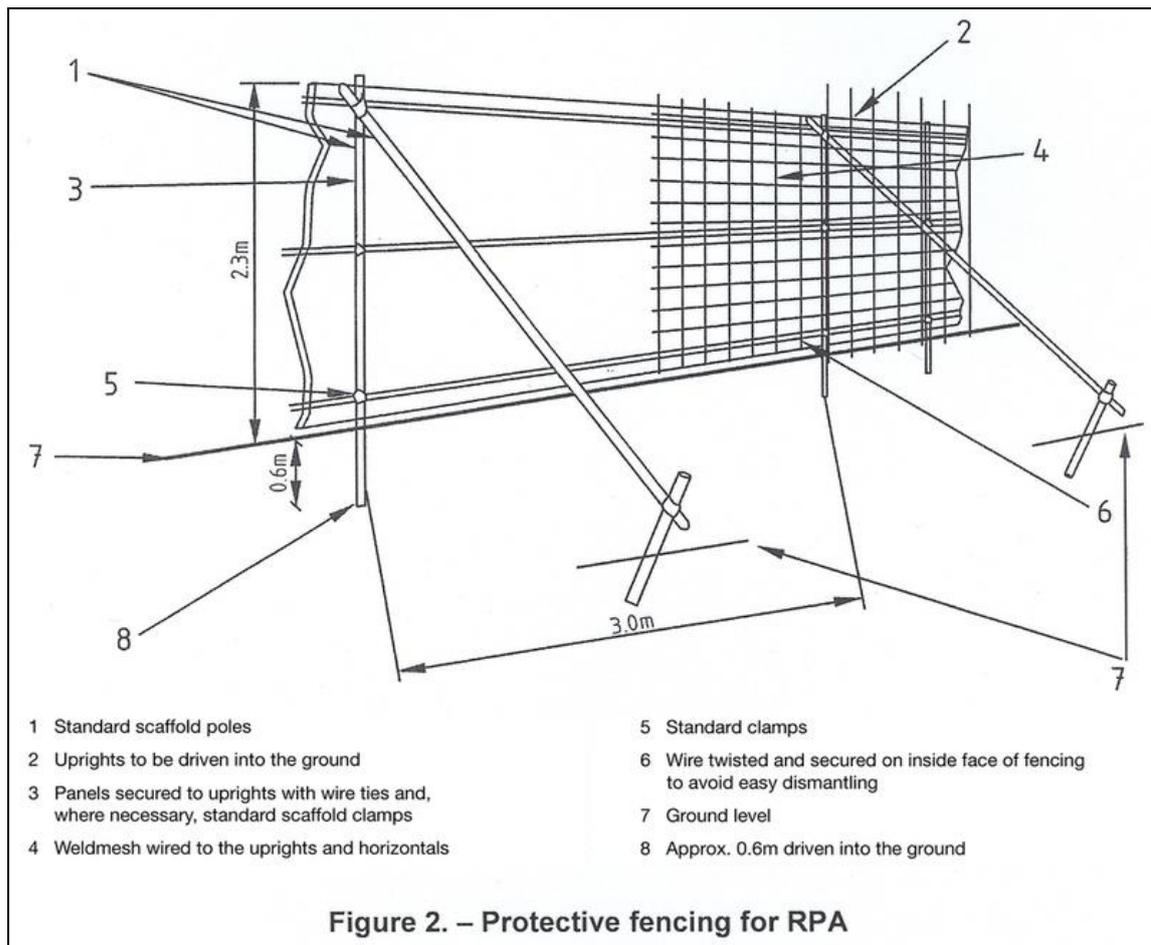
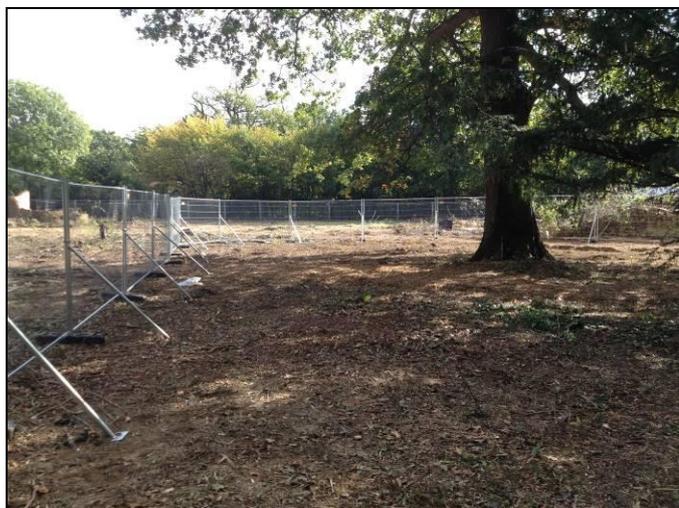
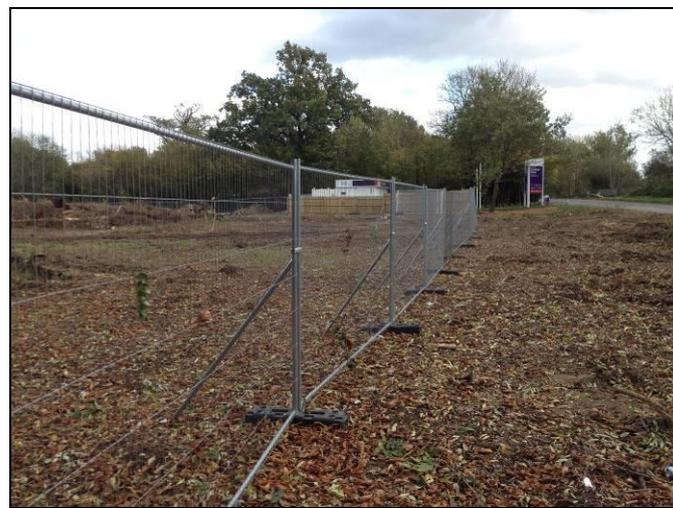
BS 5837:2012 - Tree protection fencing

On site examples of appropriate tree protection fencing installed as recommended within BS5837
