# Former Lombard Service Station, Bristol

Interpretive Report on Ground Investigation

Project No: 733272

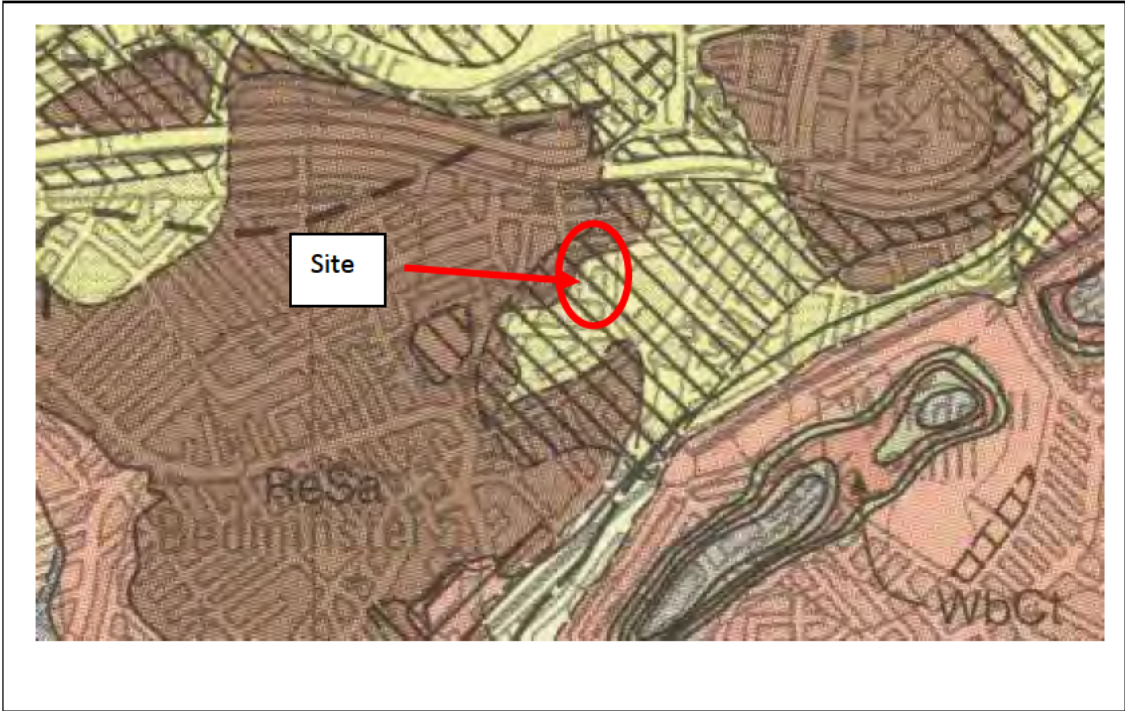
The BGS online maps portal provides access to scans of almost all maps produced by the BGS since 1932. An extract of the most recent available scanned map for the site is included below:

The mapped Alluvium below the site is associated with an embayment at the mouth of the channel of the Malago river where it would have joined the former tidal channel of the Avon between the high grounds of Southville/Bedminster and Redcliffe.
