## Design and Access Statement

Replacement of mechanical plant and building work measures, including replacement windows and insulating roof, to reduce heat loose and energy use at **Wolfson College Post Graduate College Oxford.**

January 2020

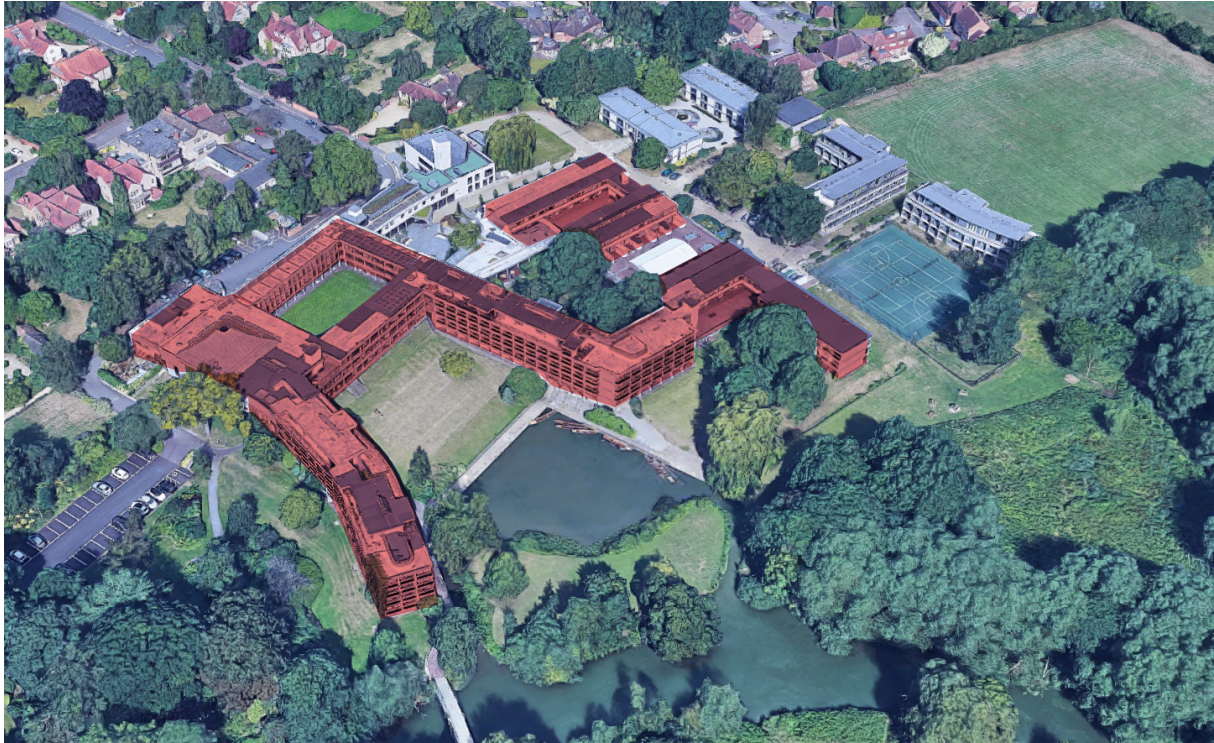
*Fig 1. Original buildings and proposed work areas shaded in red.*

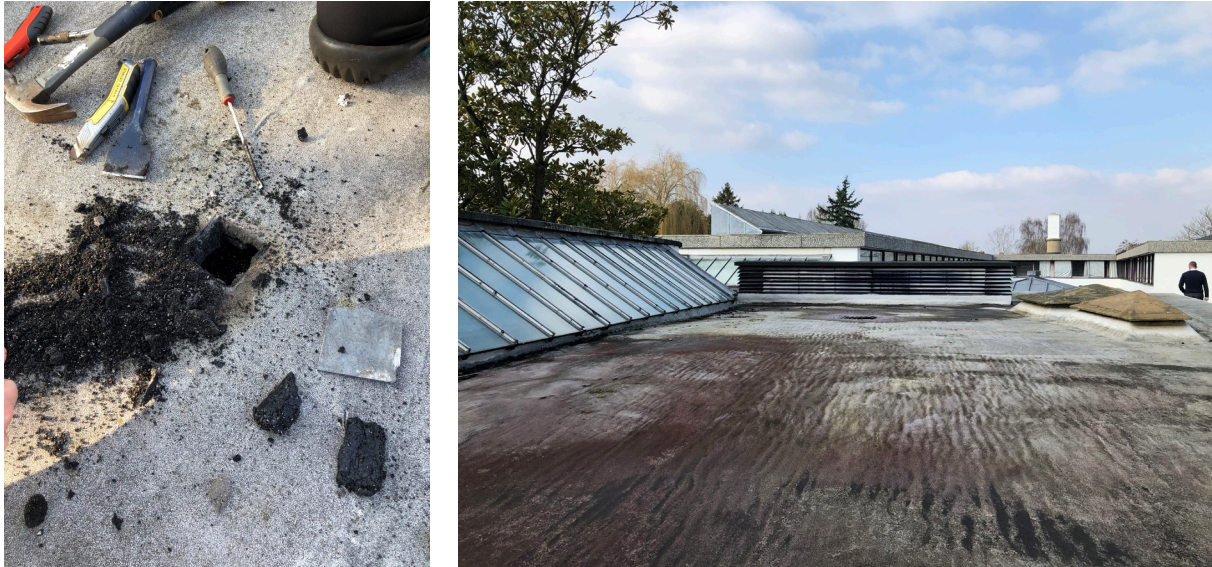
Fig 4 - Photographs of roofs and investigation hole prior to Block D re-roofing works
