Reuben College – Works Methodologies

Task Sheet MS06 – Jackson Wing, Sample Wall and Ceiling Plaster removal as part of Asbestos Abatement Works. February 2021.

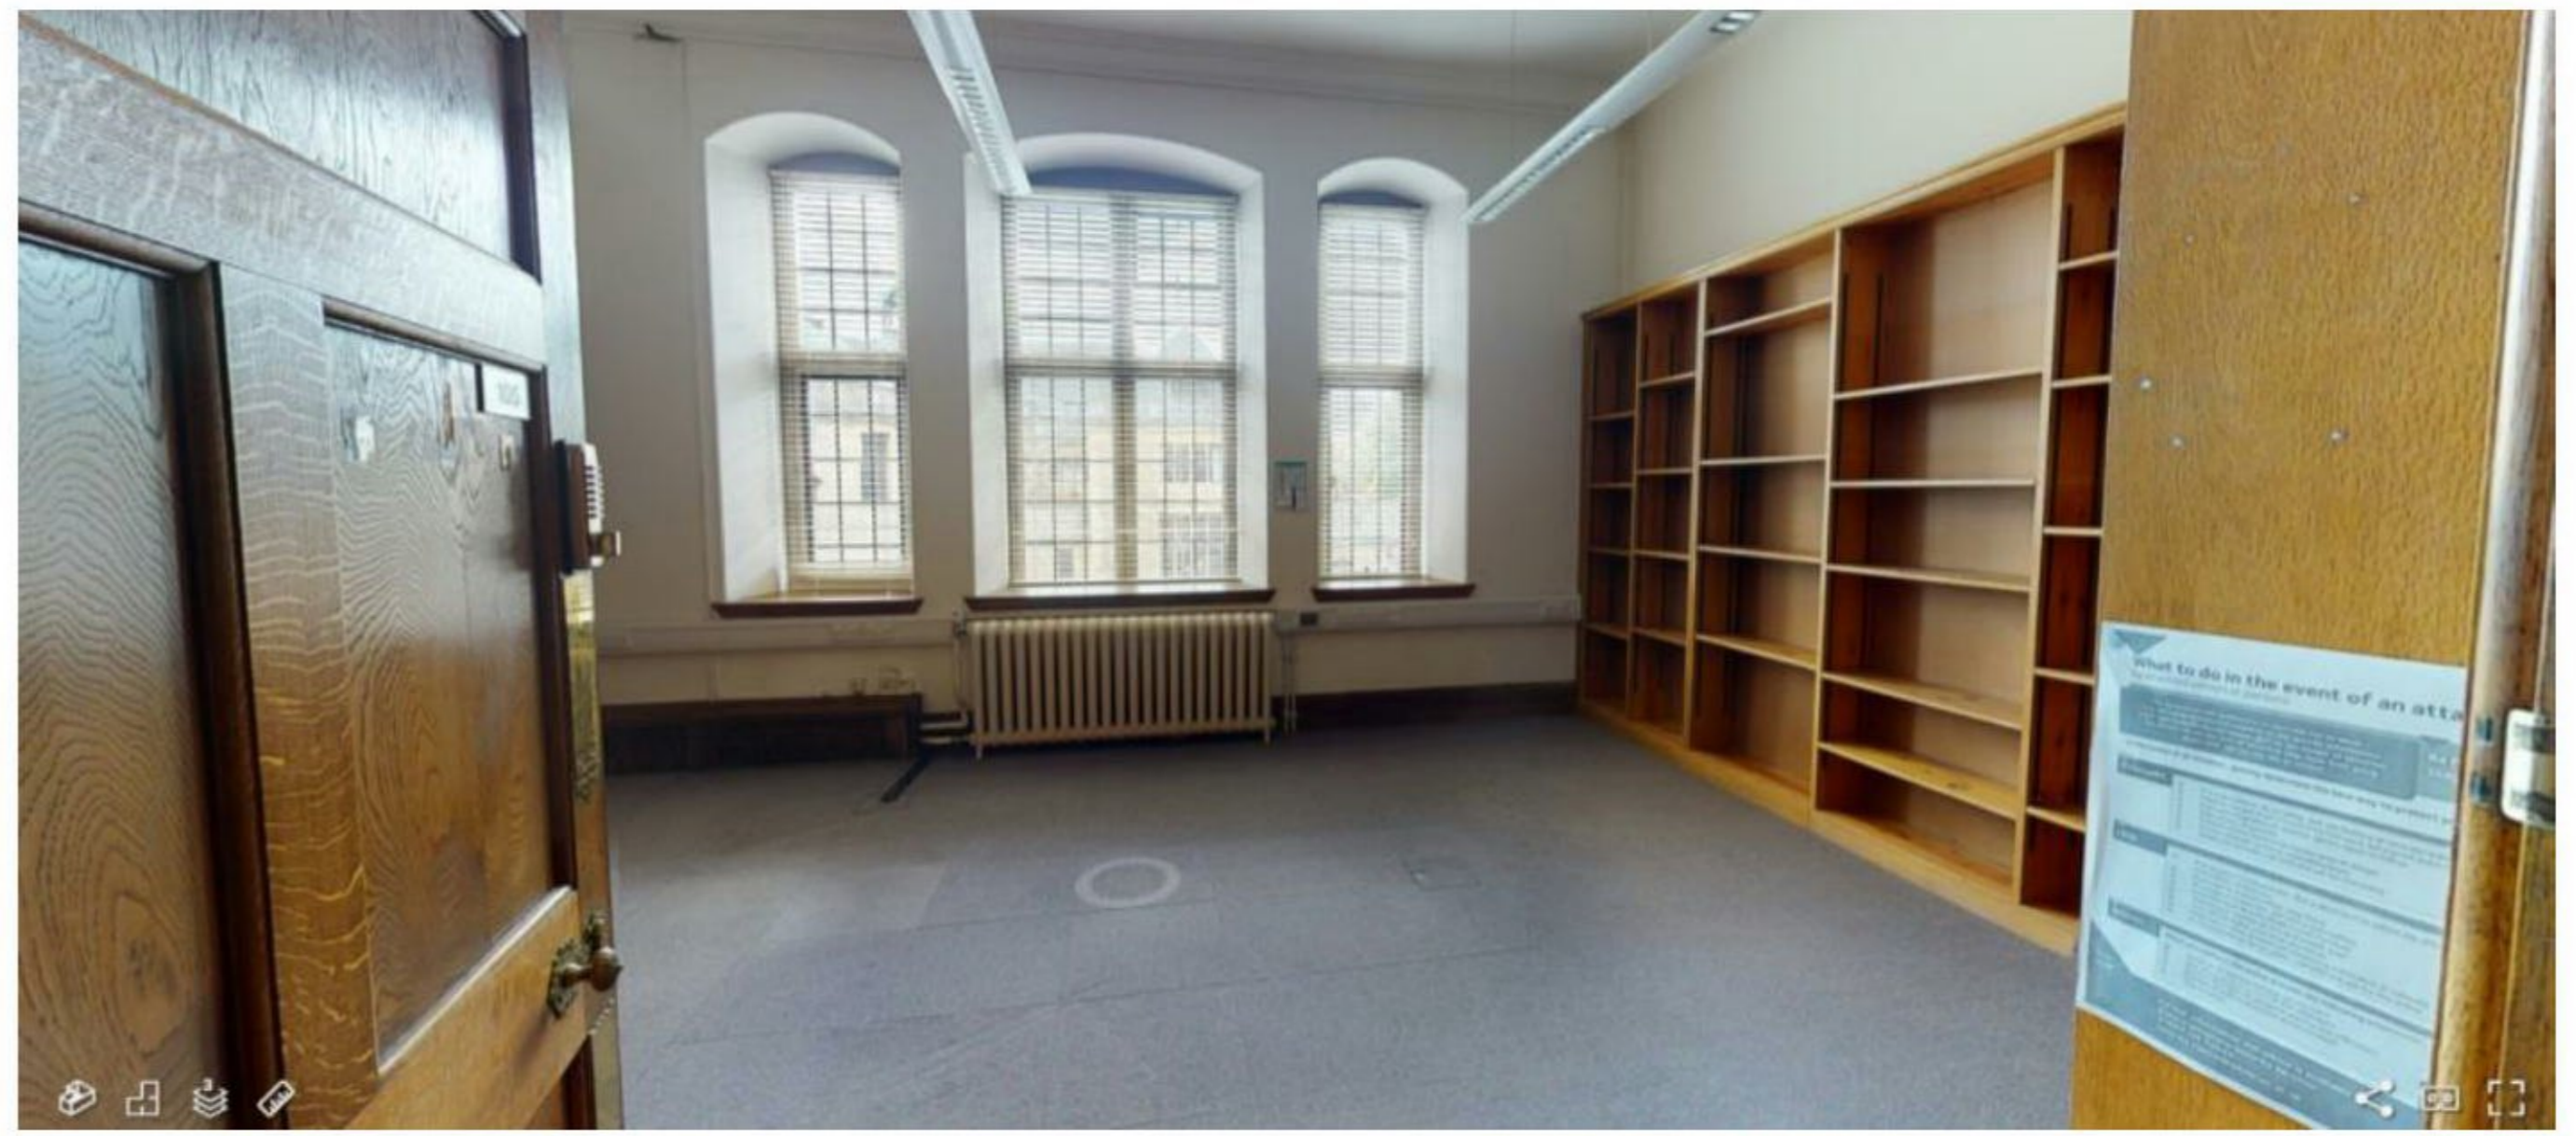
Area 1

Room JF-09 is situated on the first floor of the Jackson Wing.

It is approx. 26.5m² in plan area.

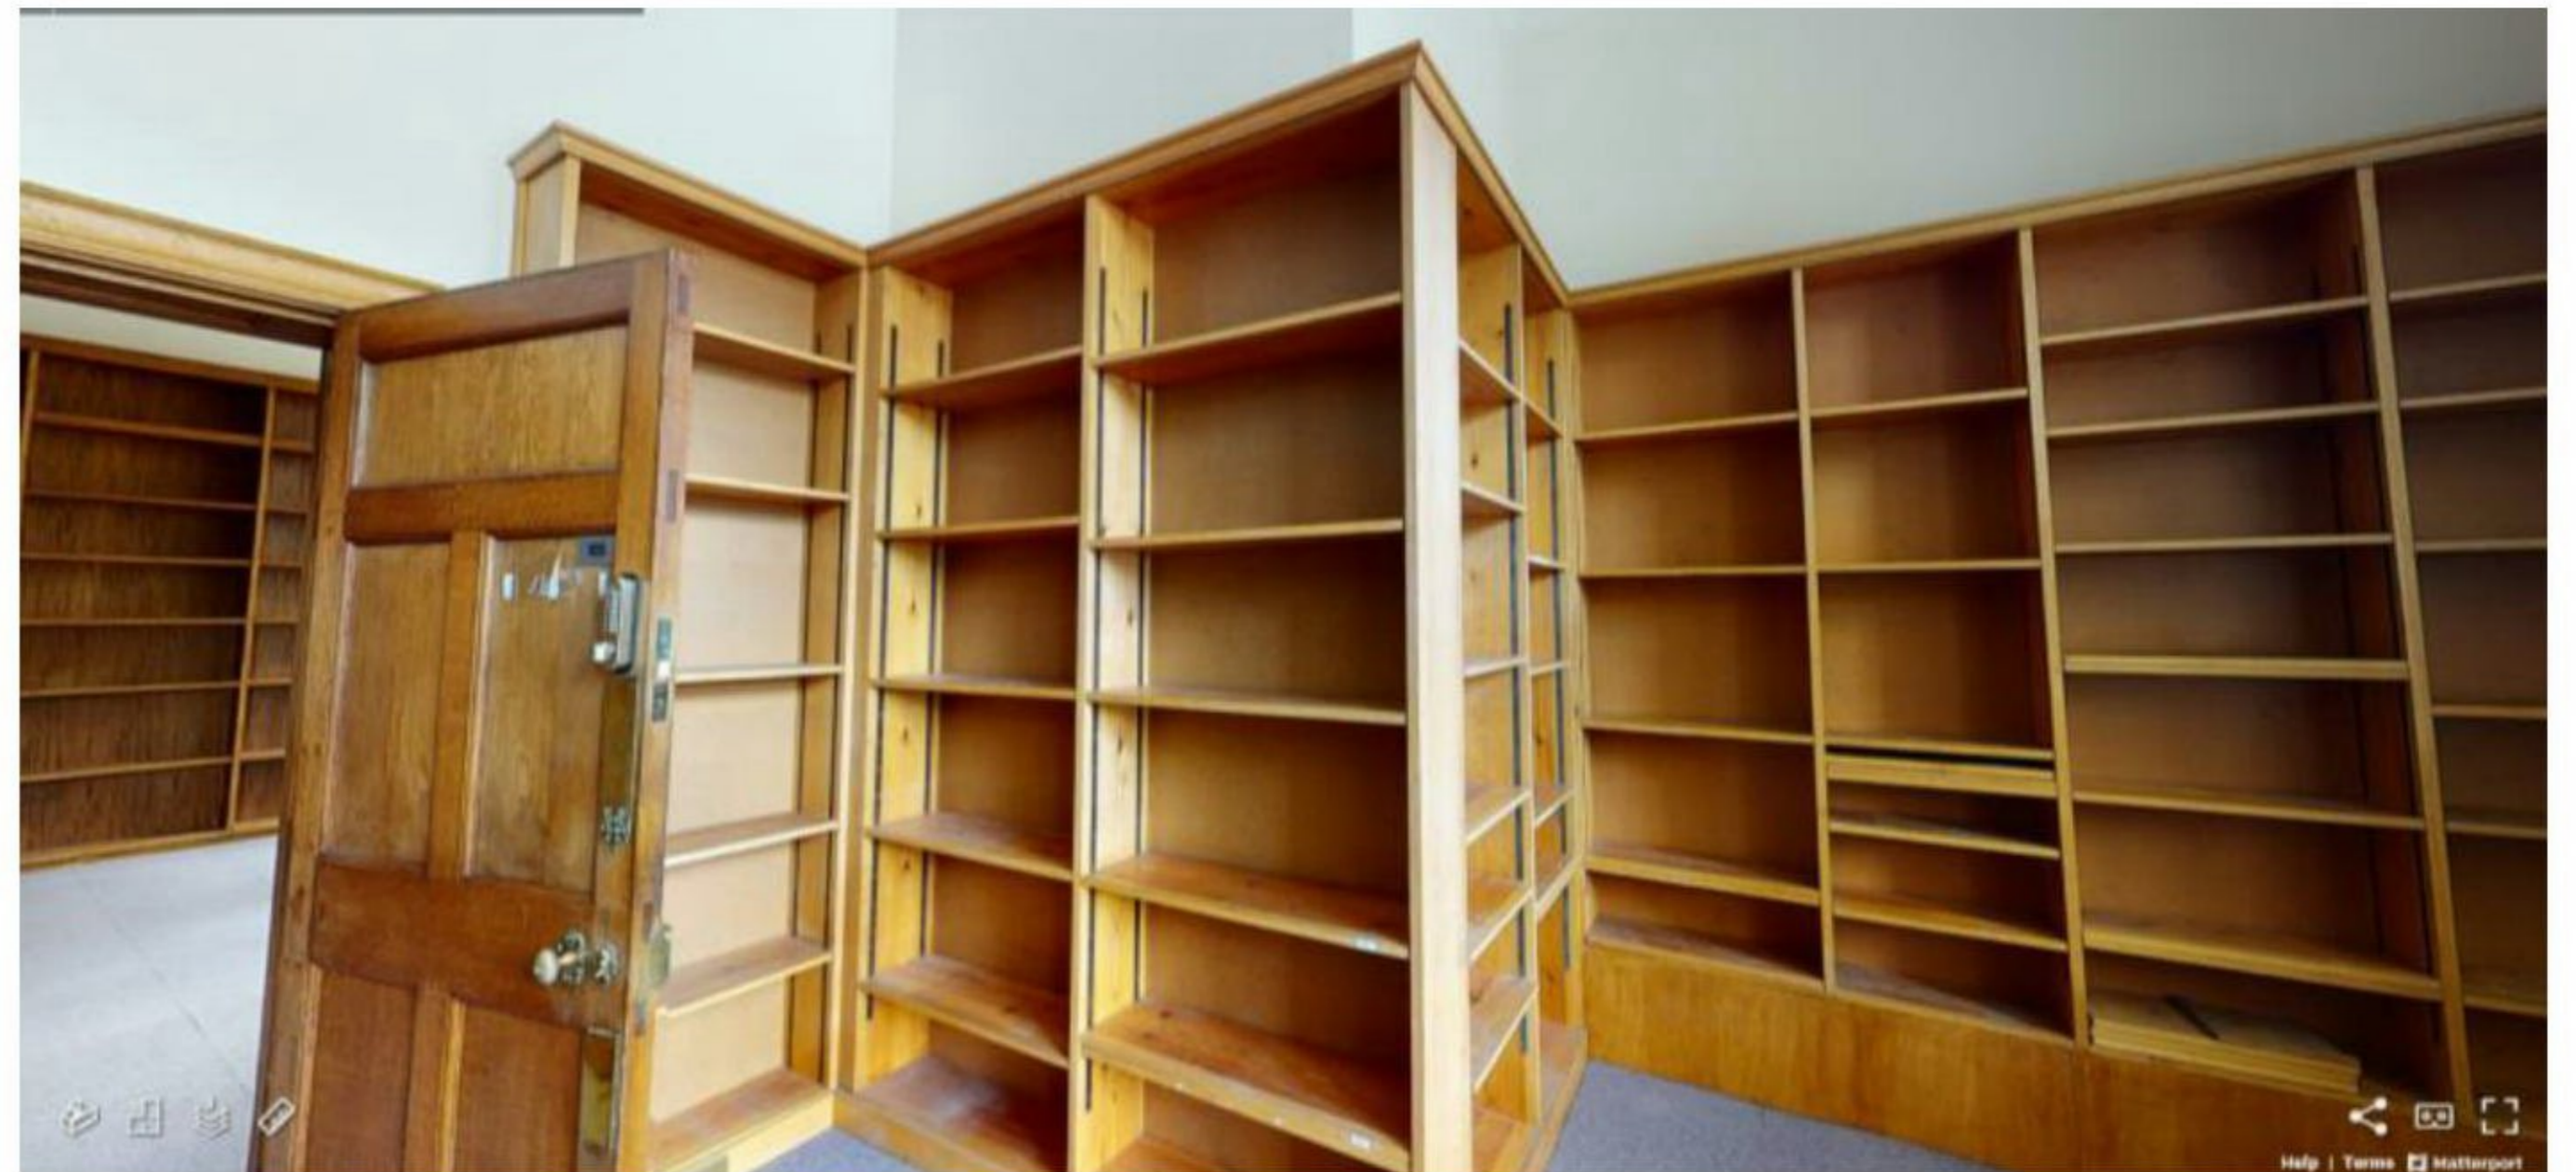
Many of the wall areas are covered by bookcases which are not original or of historic value.

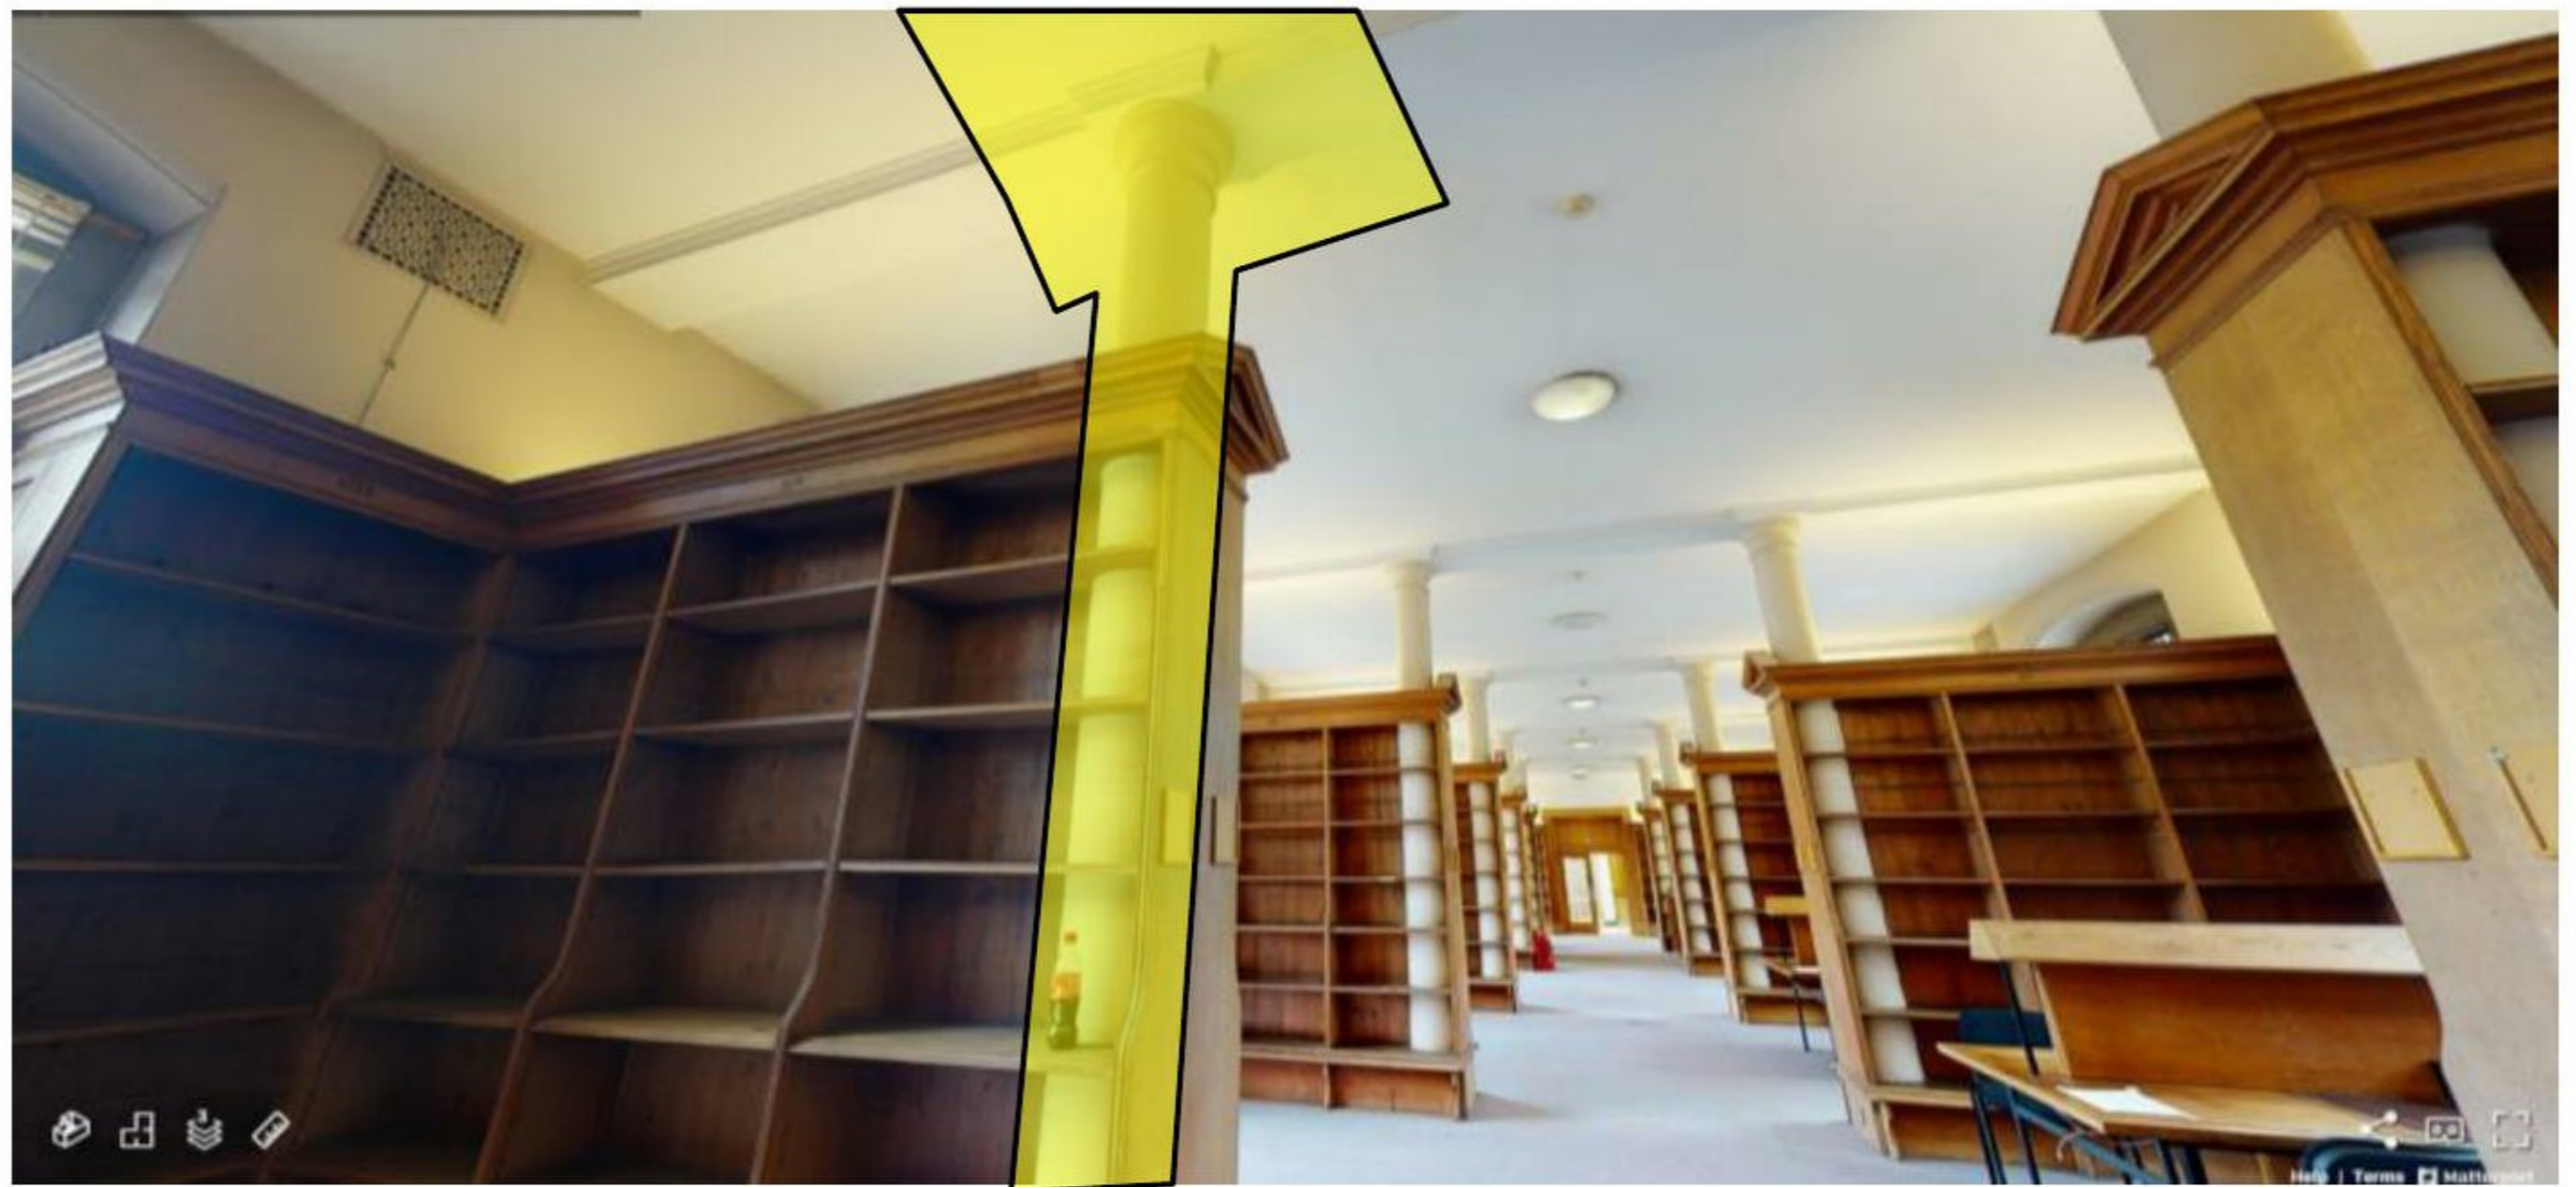
Area 2

The works within JF-08 are limited to those around the circular column and down stand beam above.

See the area as noted.

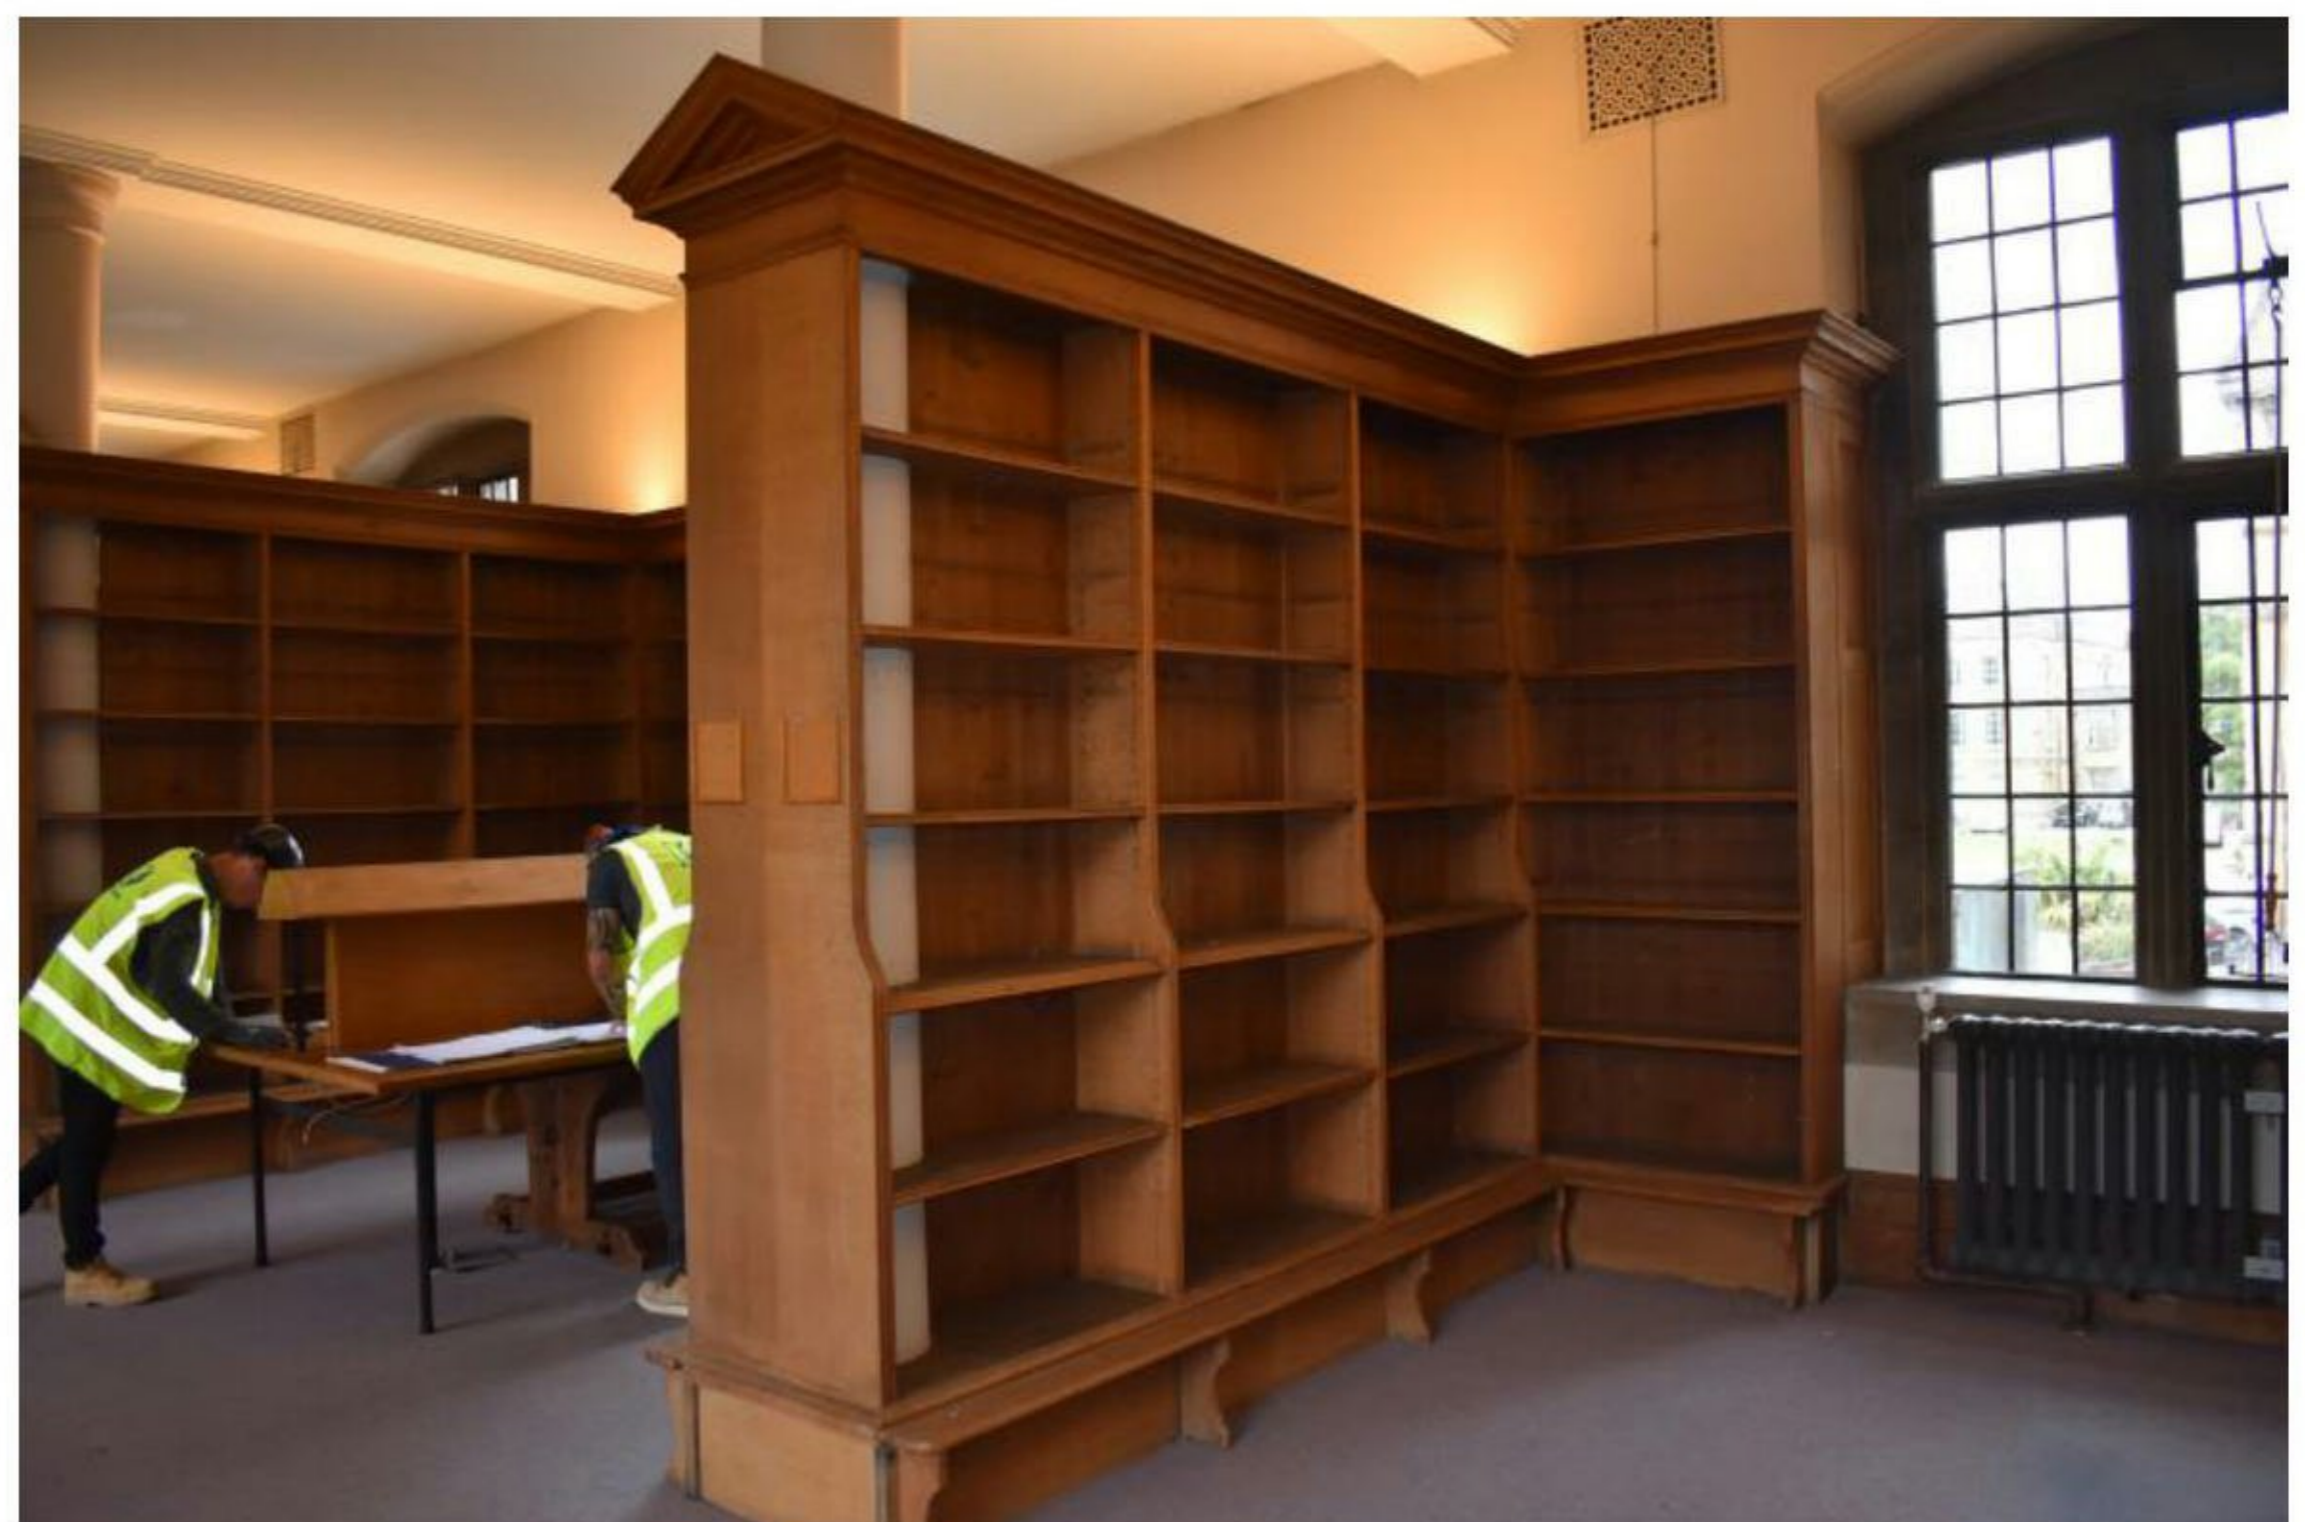
The bookcases are of oak construction and formed as a projecting back to back unit which spans between the wall mounted bookcase elements and the structural support column to the floor above.

Although believed to have originated from the former museum library the bookcases have been remodelled well to fit within the existing Jackson wing.

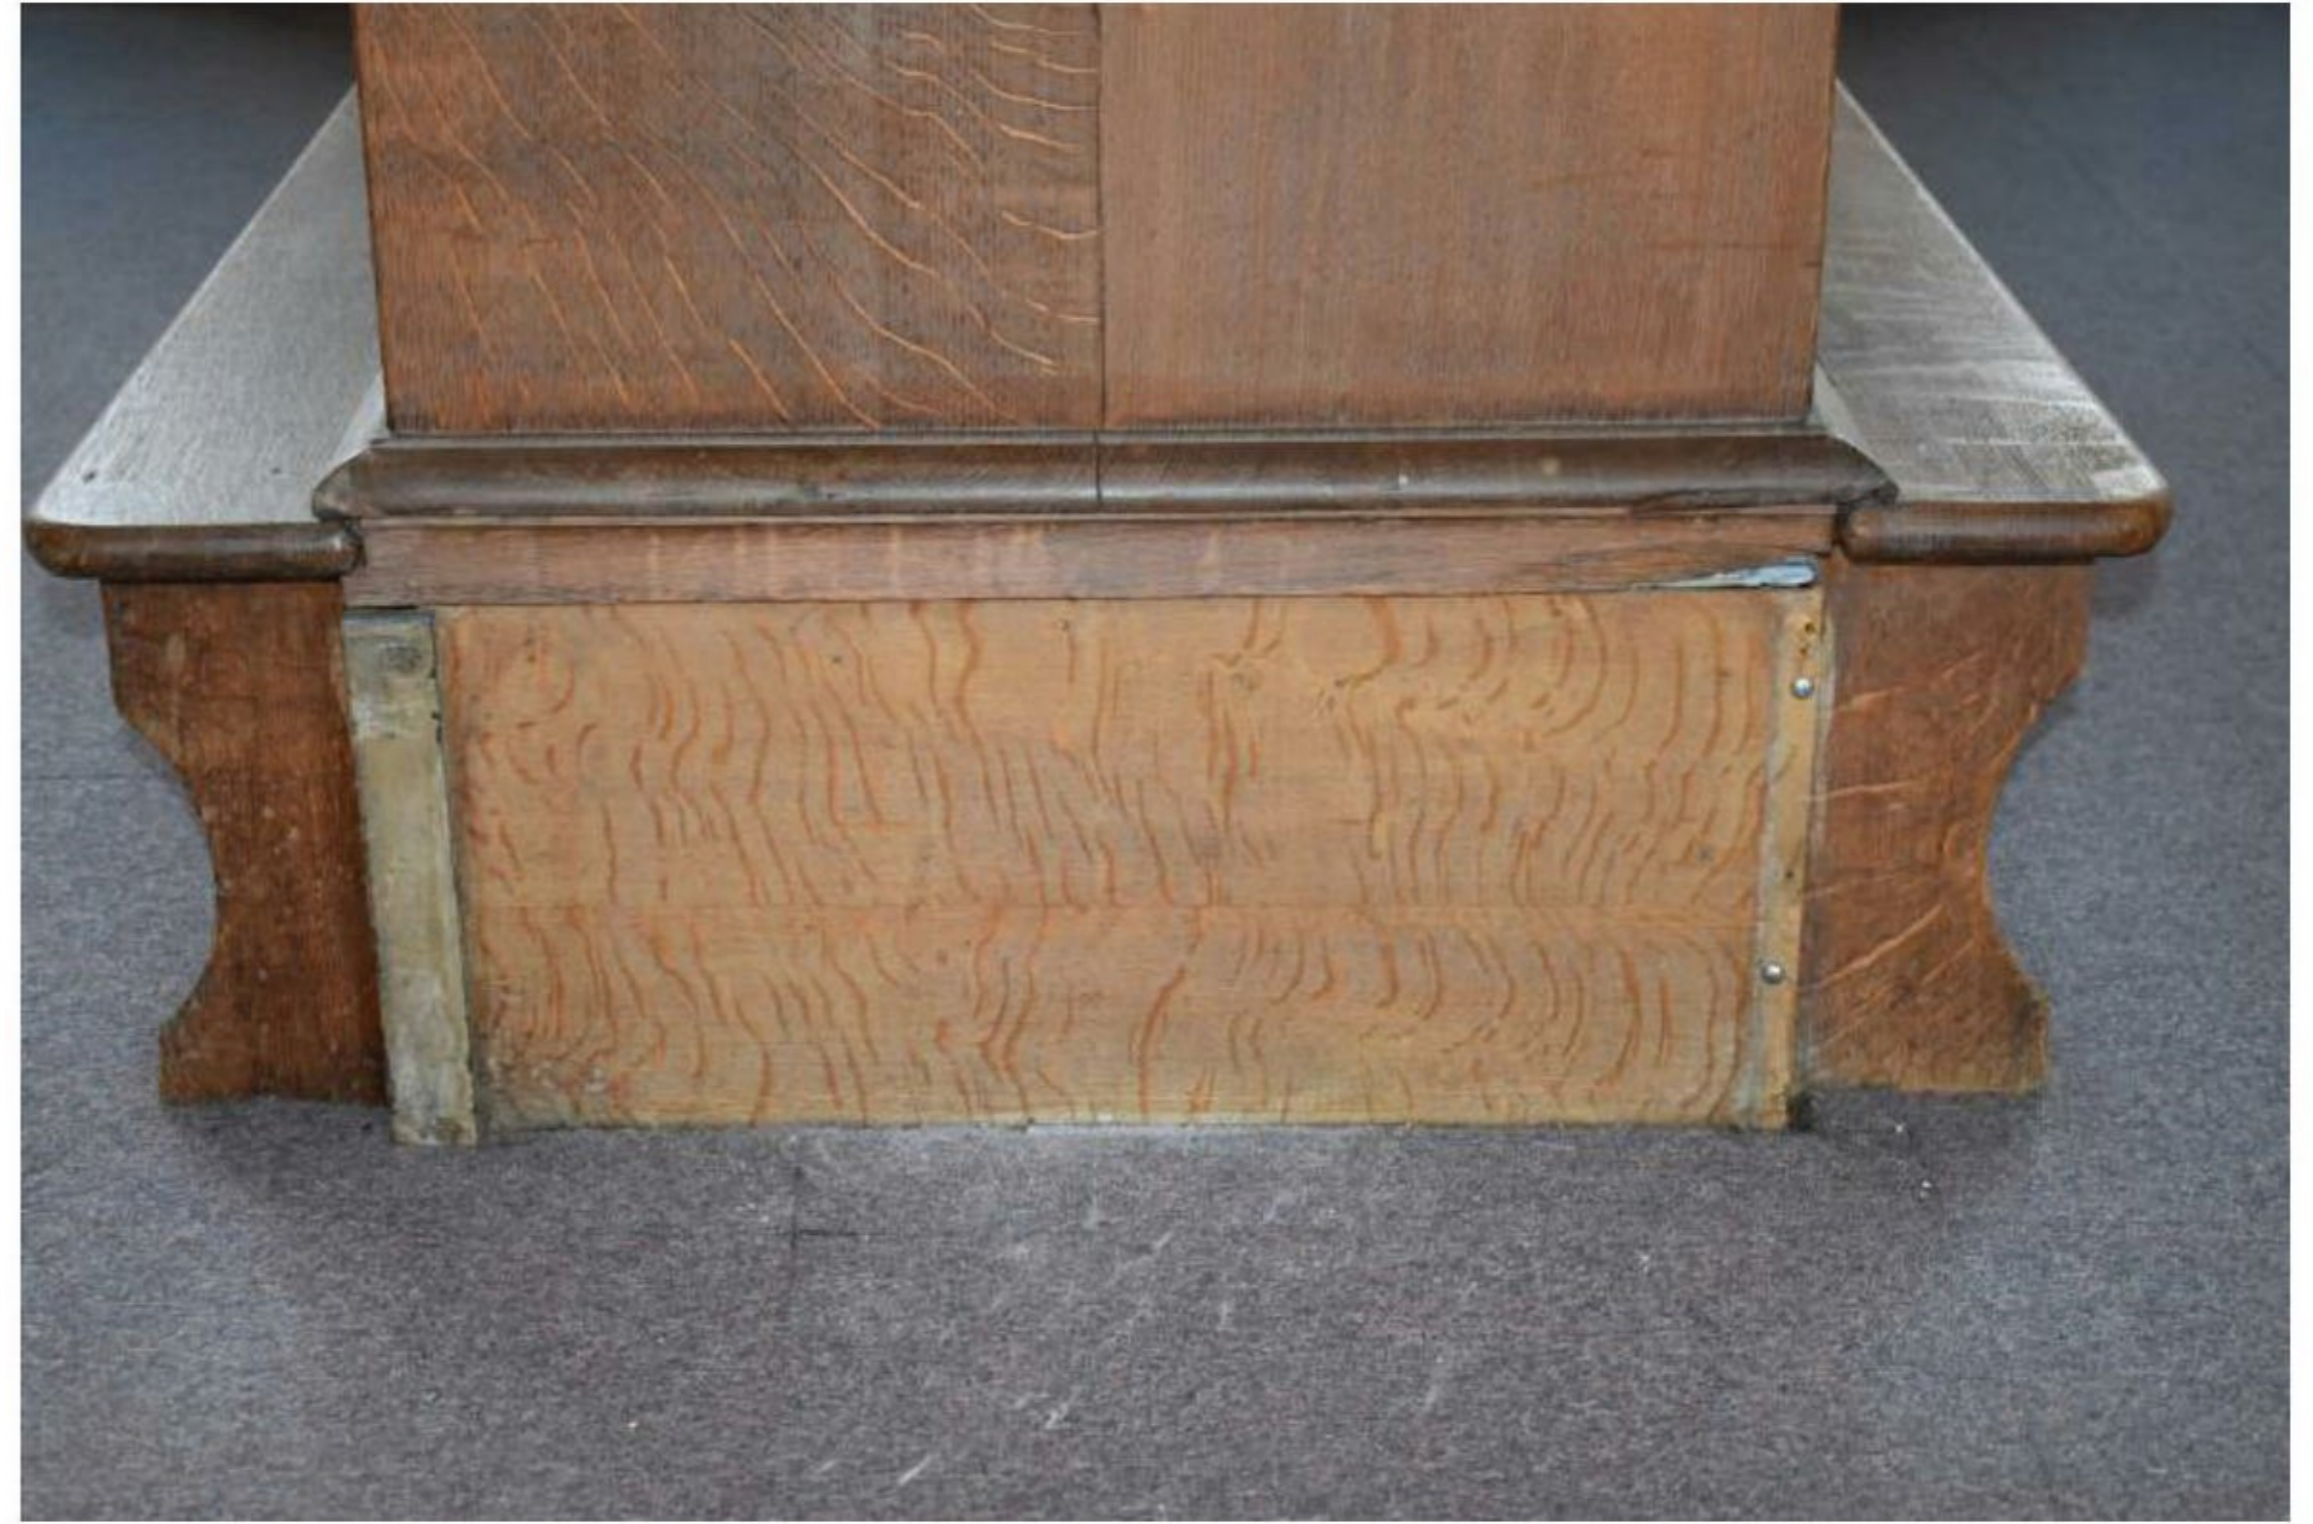
Plinth Detail

The ends of the plinth are removed by removing the angles protection brackets fitted to the corners of the plinth and then releasing the oak faced plywood panel to the base. (This fits in a rebate under the timber moulded edge at the base of the bookcase).

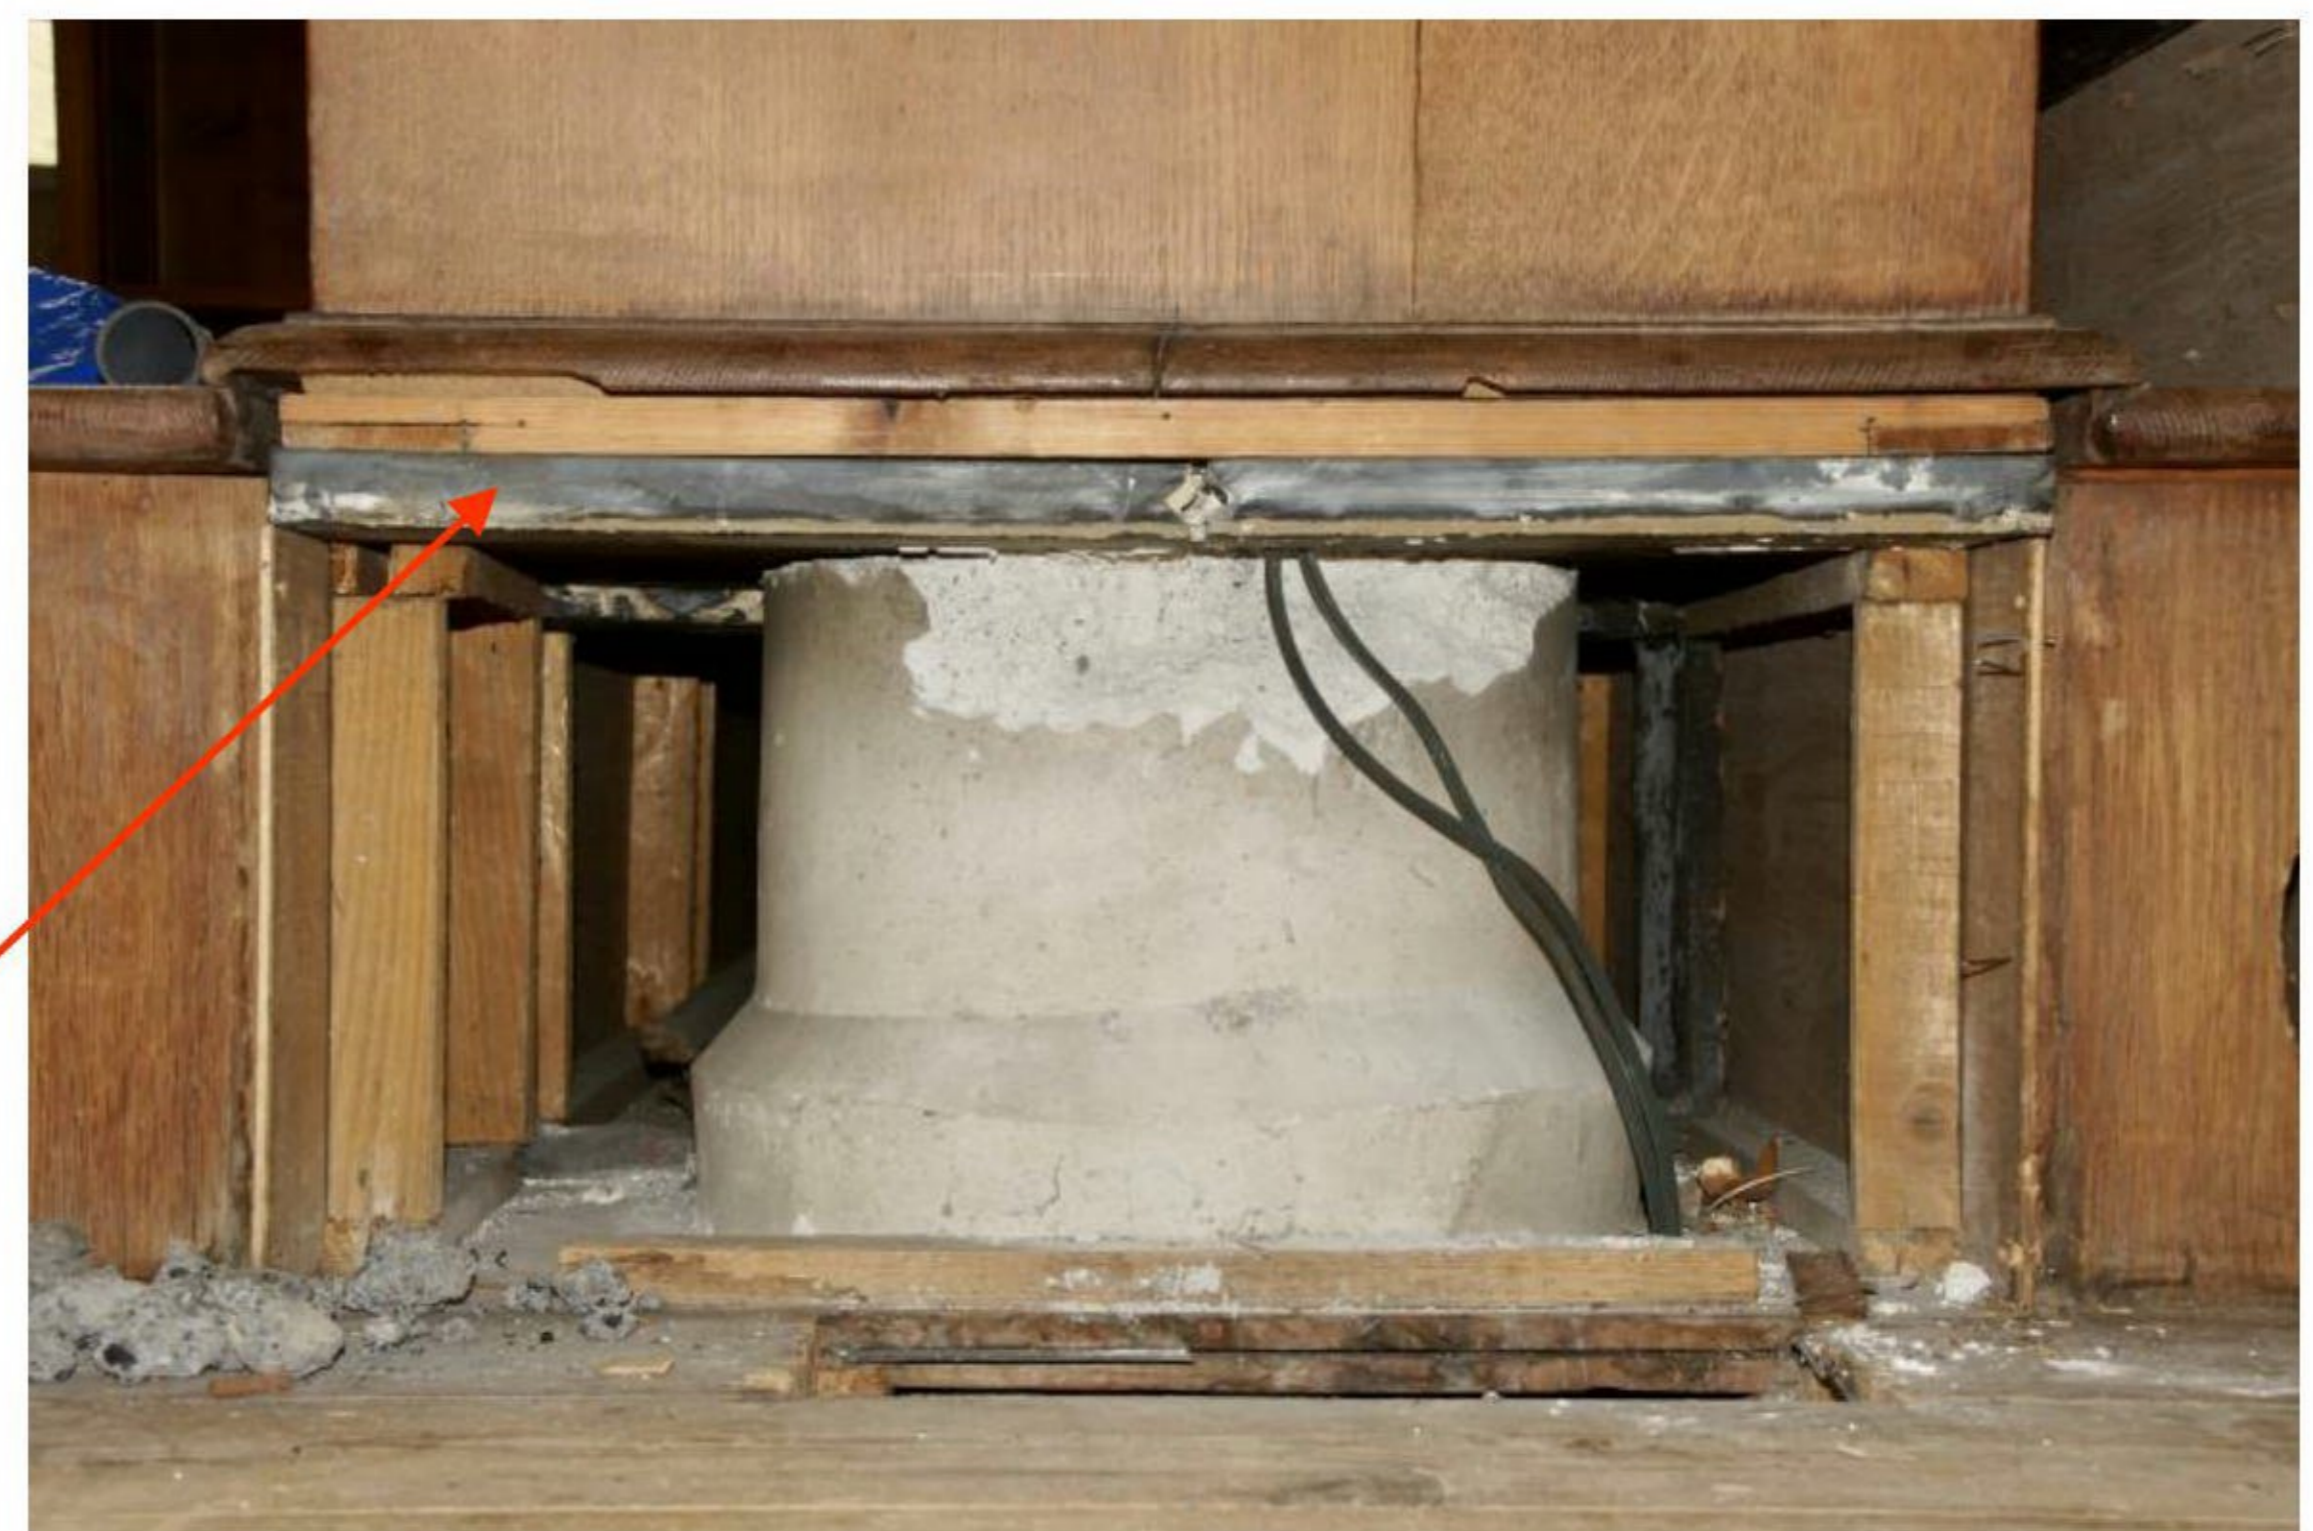
With the panel removed you have access to the void space under the bookcase. Note plaster column penetrates through the base of the bookcase and floor. Plaster casing which contains ACM's has been damaged to allow installation of lighting to the top of each bookcase.
