Reuben College – Works Methodologies

Task Sheet MS06 – Jackson Wing, Sample Wall and Ceiling Plaster removal as part of Asbestos Abatement Works. February 2021.

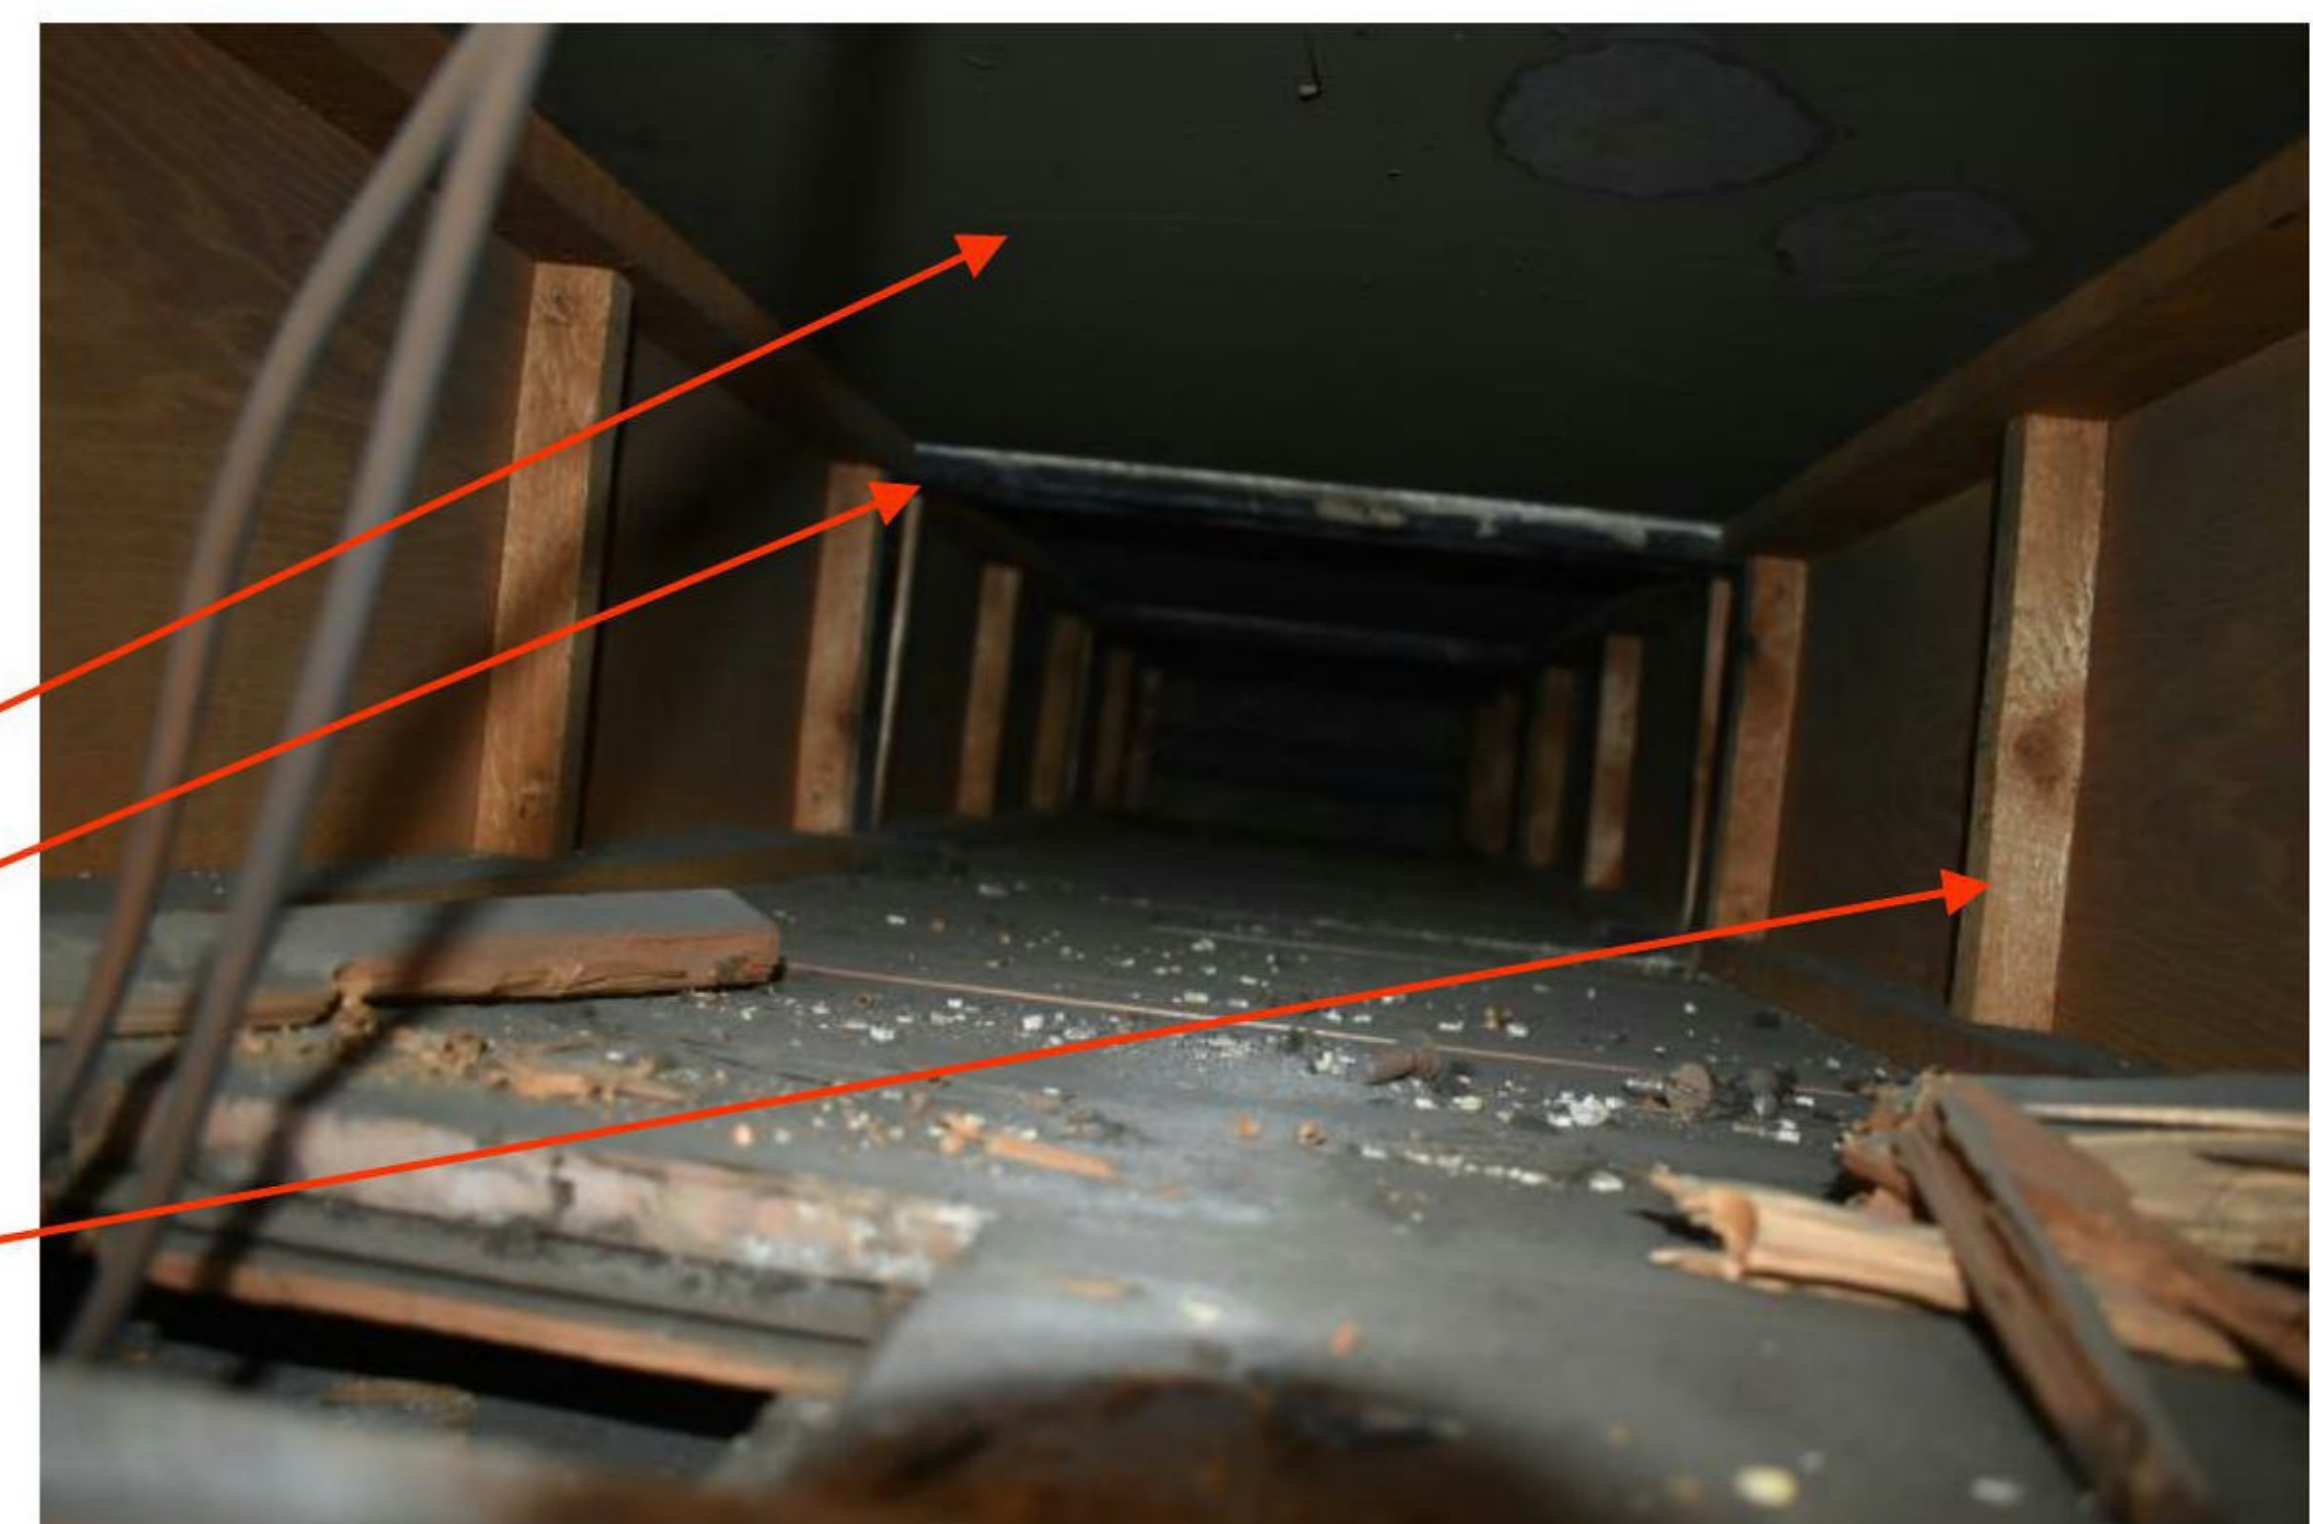
Slate bed to bookcase

Void space under bookcases (photo of level 8 shown for clarity however level 6 similar with column which obscures view).

Iron support straps

Framing for plinth / step.

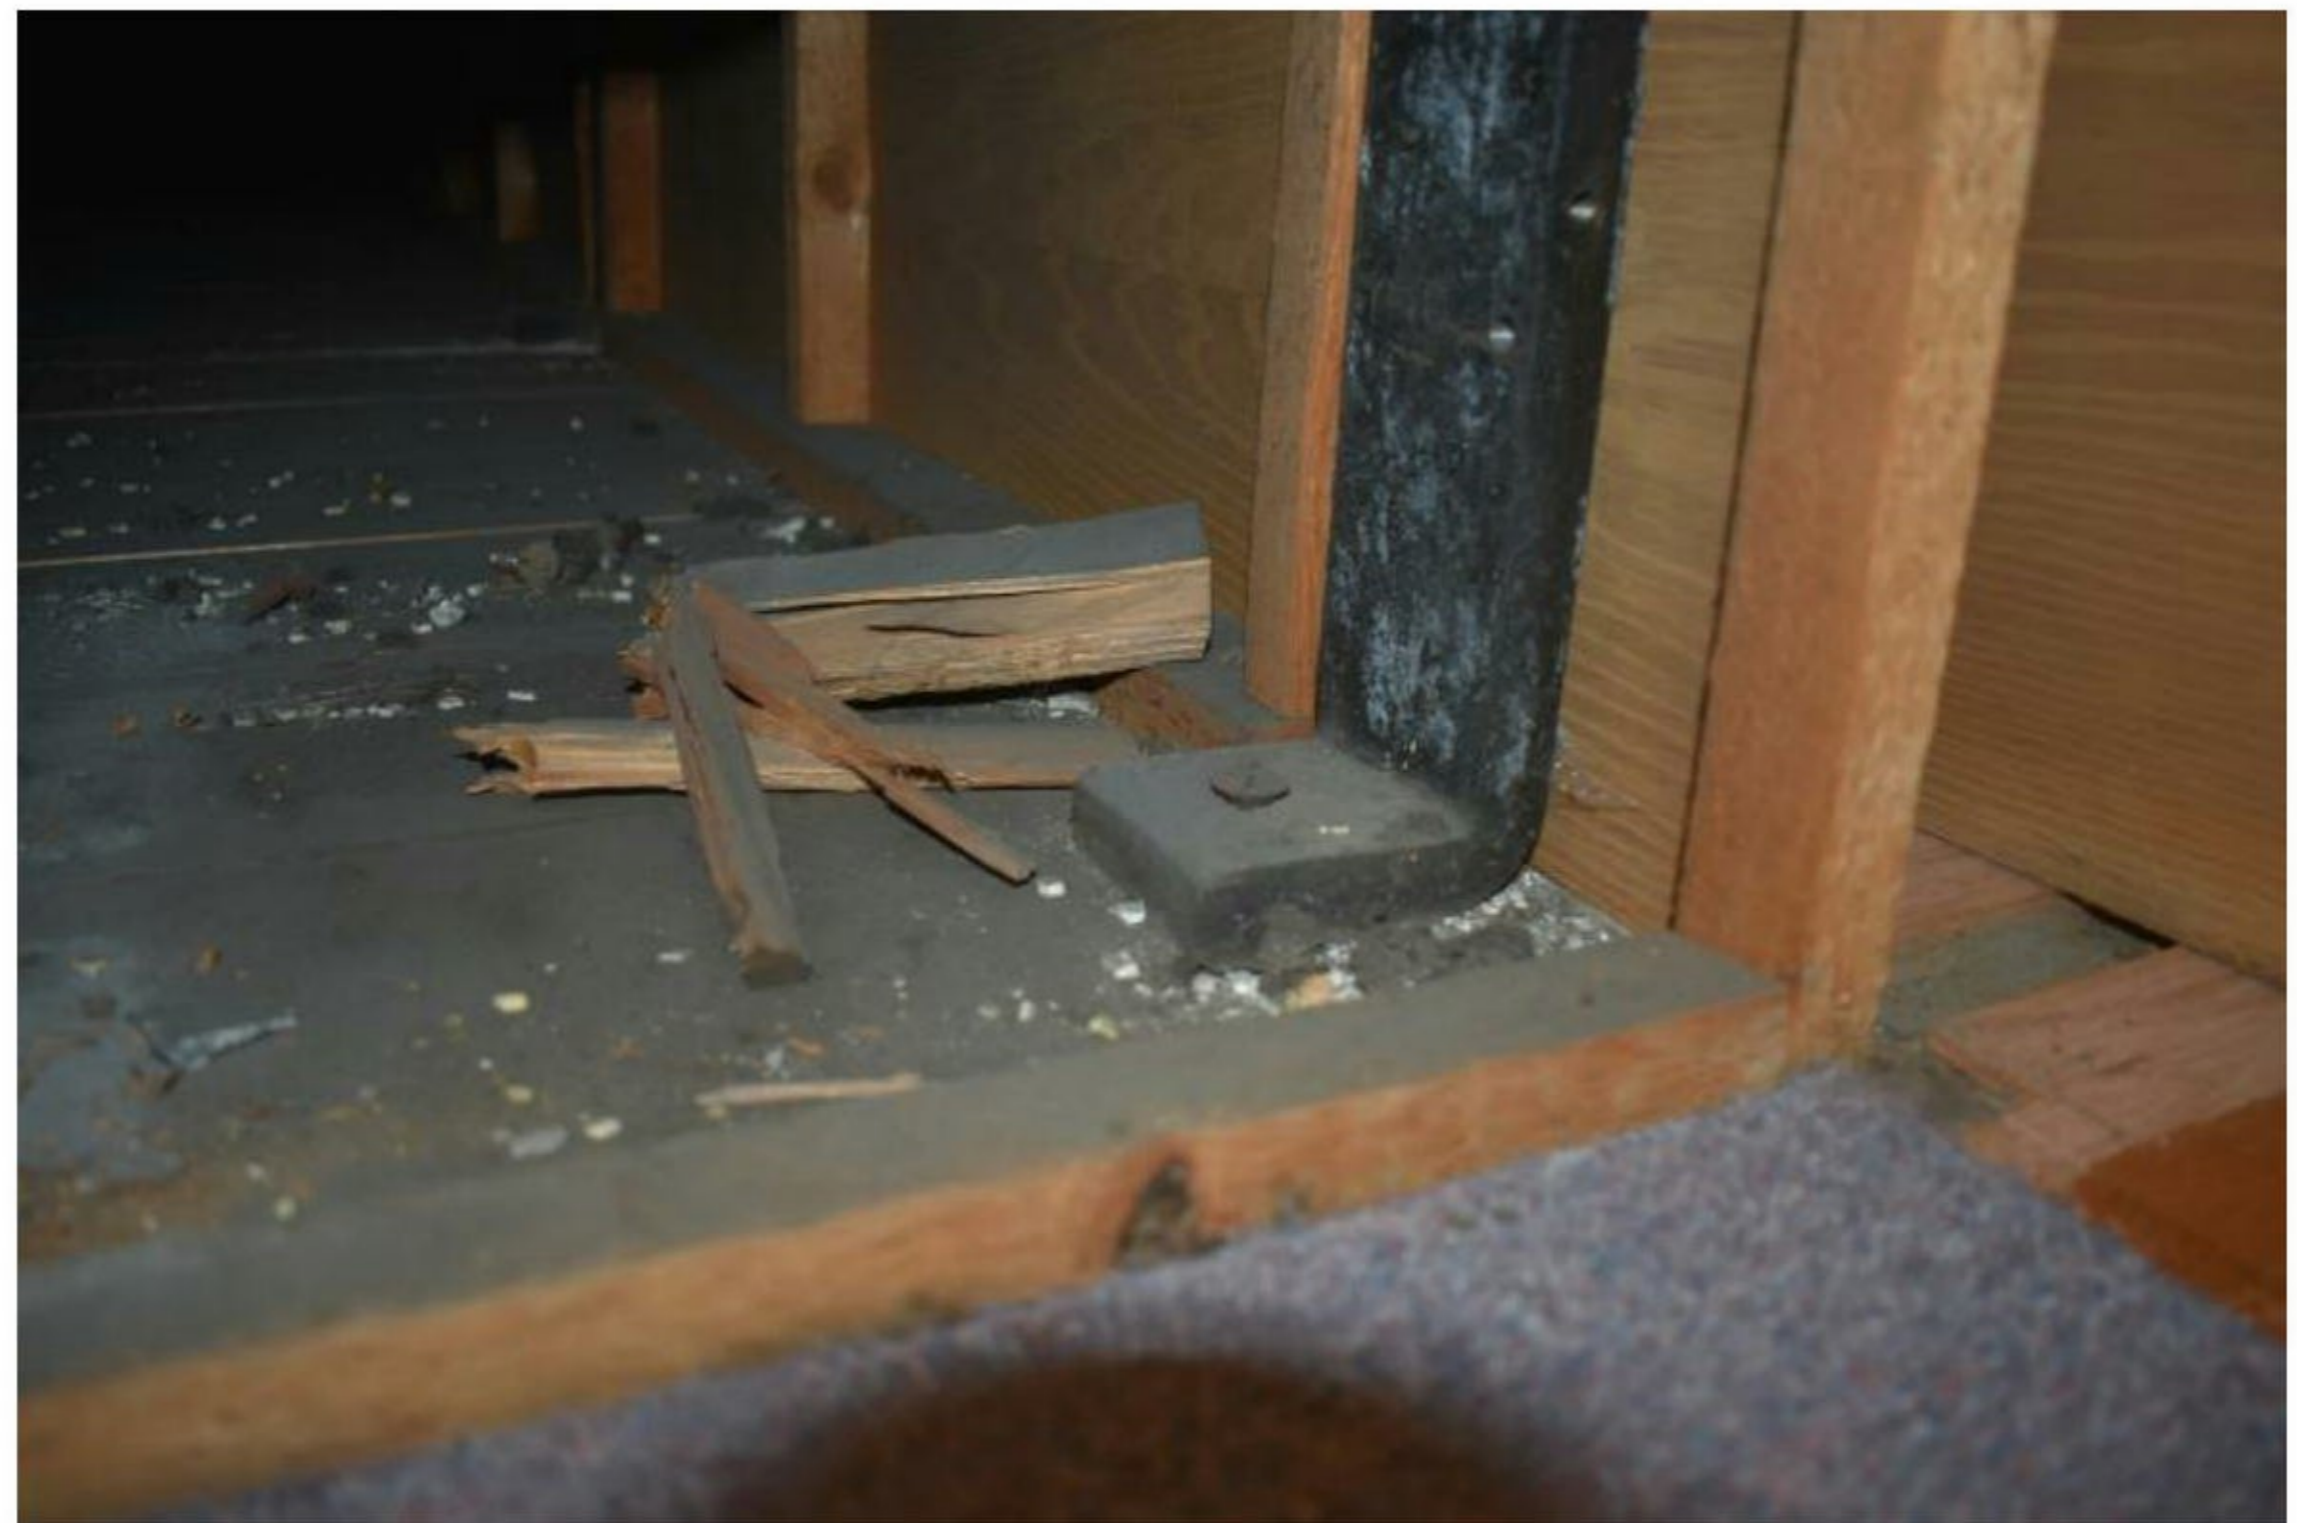
Foot of ironwork support strap – these are screw fixed to the floor boards.

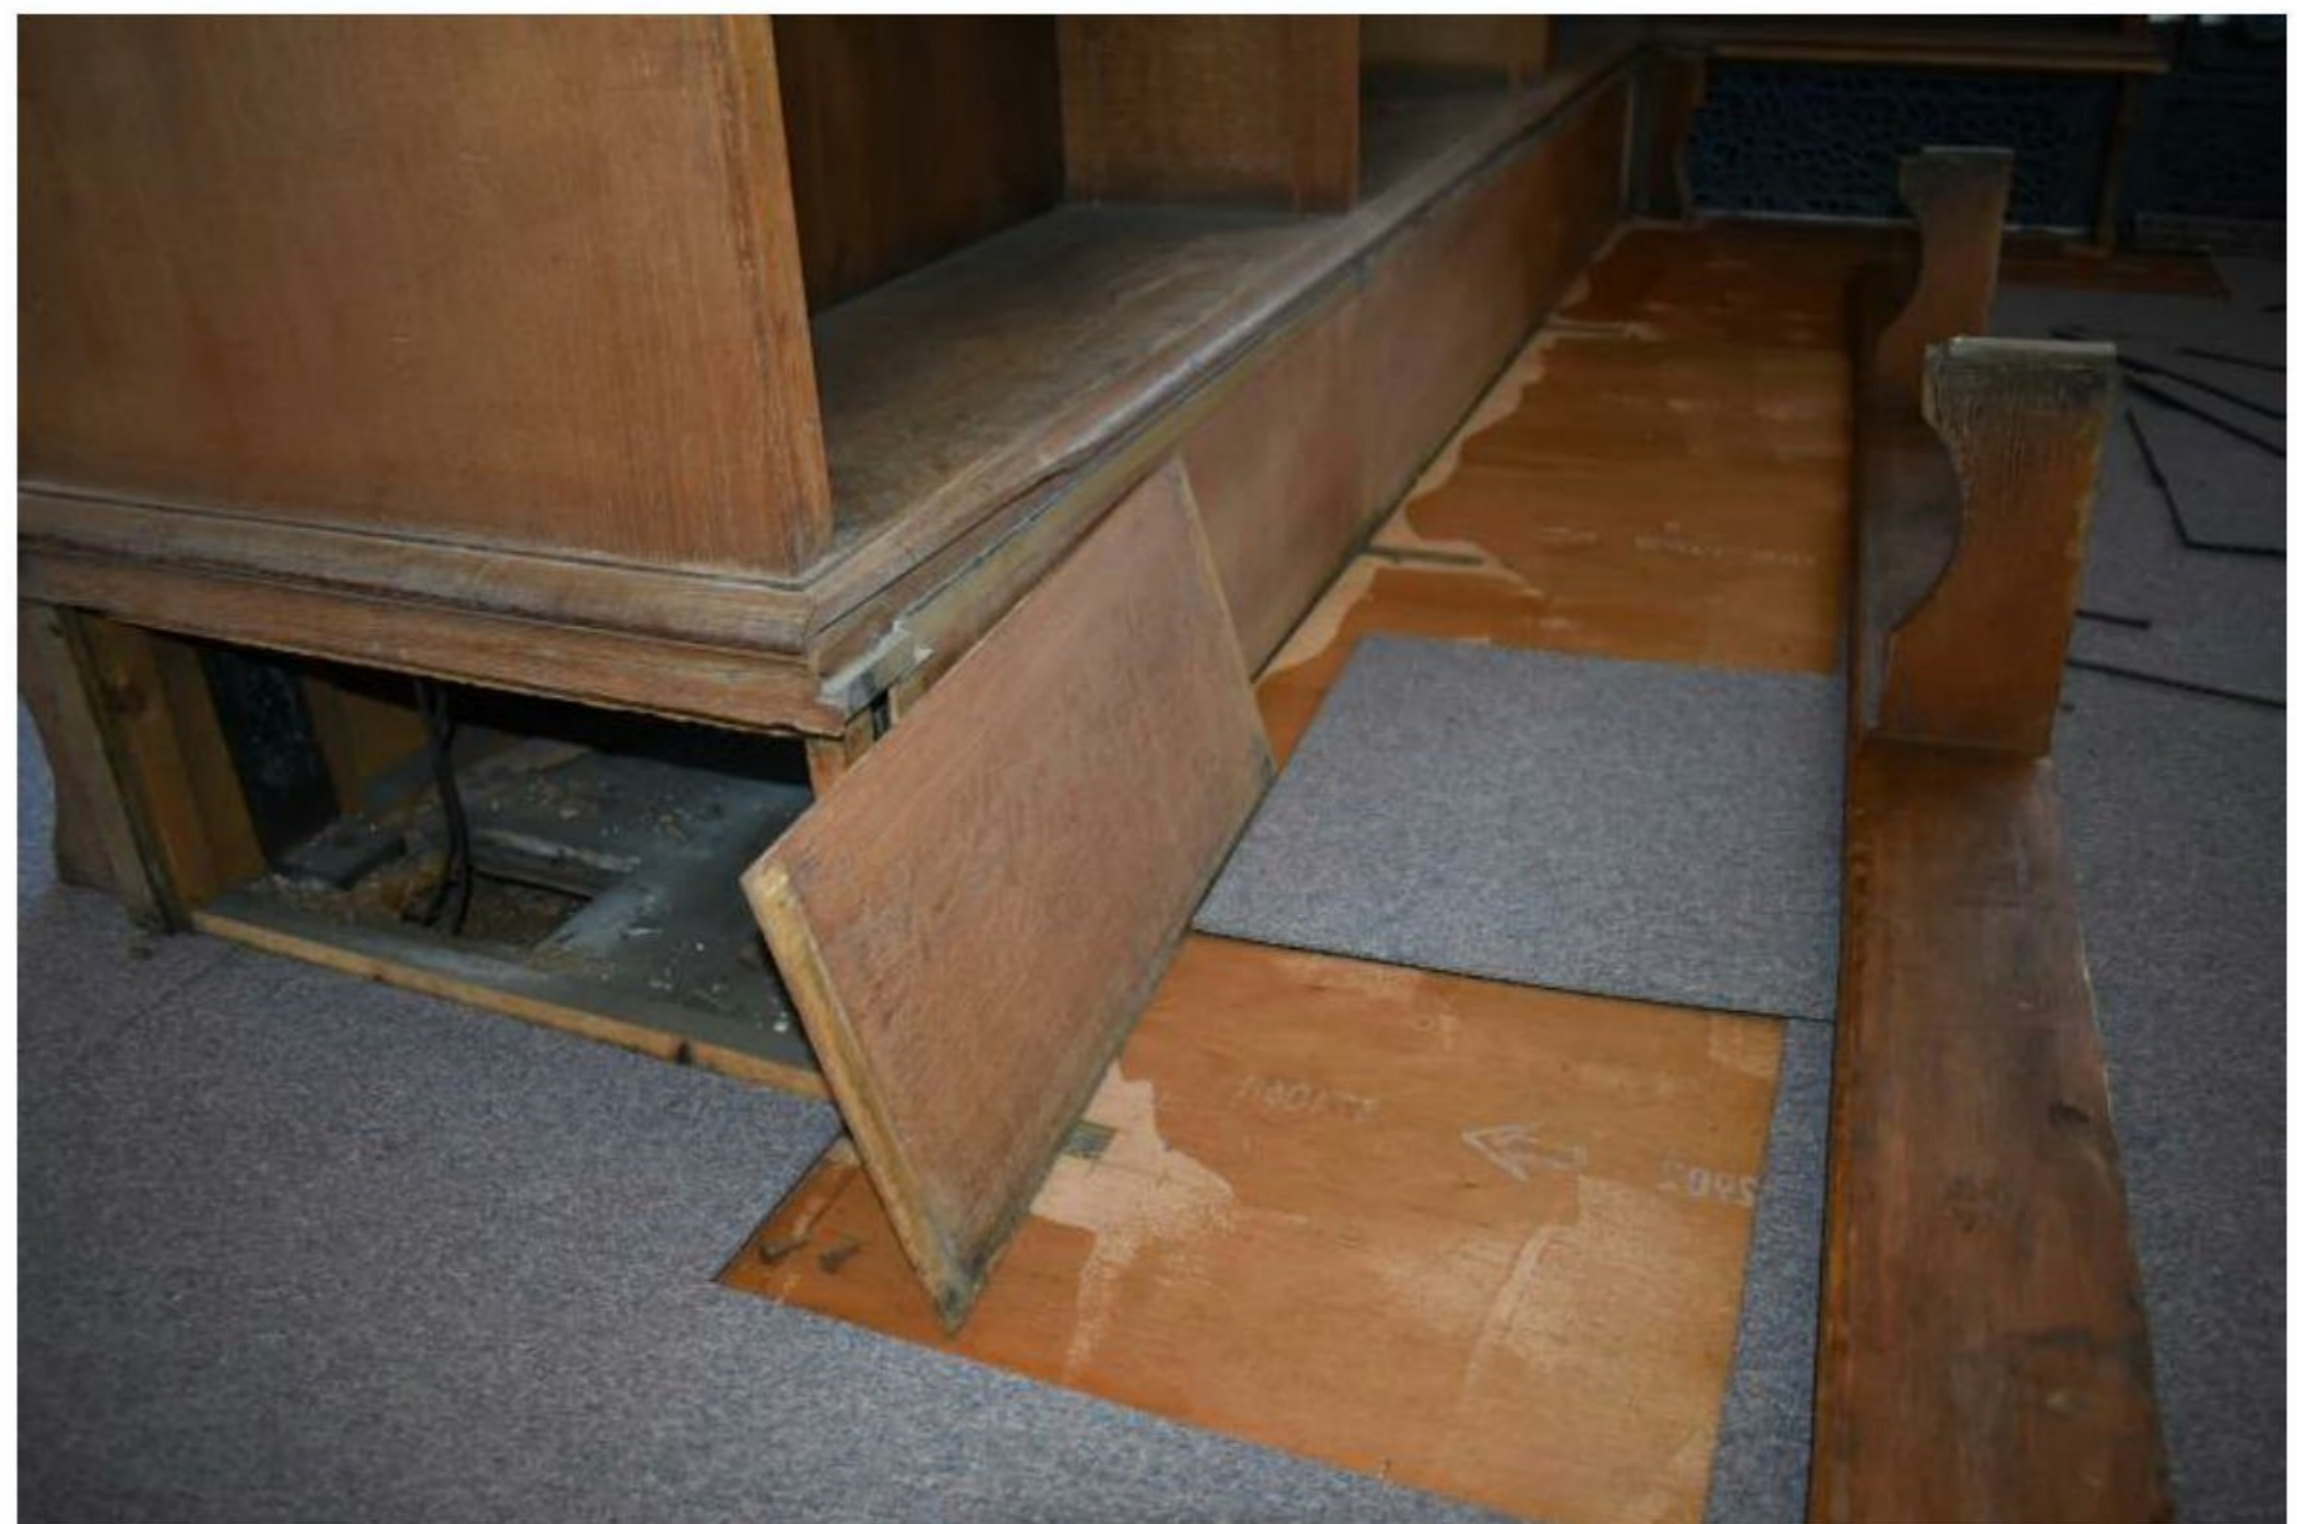
Plinth step is pinned to the plinth panel and can be removed by easing away from the bookcase as a single item. Each of the support legs is also pinned to the step itself. With the step removed it is possible to remove the remainder of the plinth panels which are pinned to the support framework. (Note these panels are faced plywood 4mm thick and require care to remove without damage.).

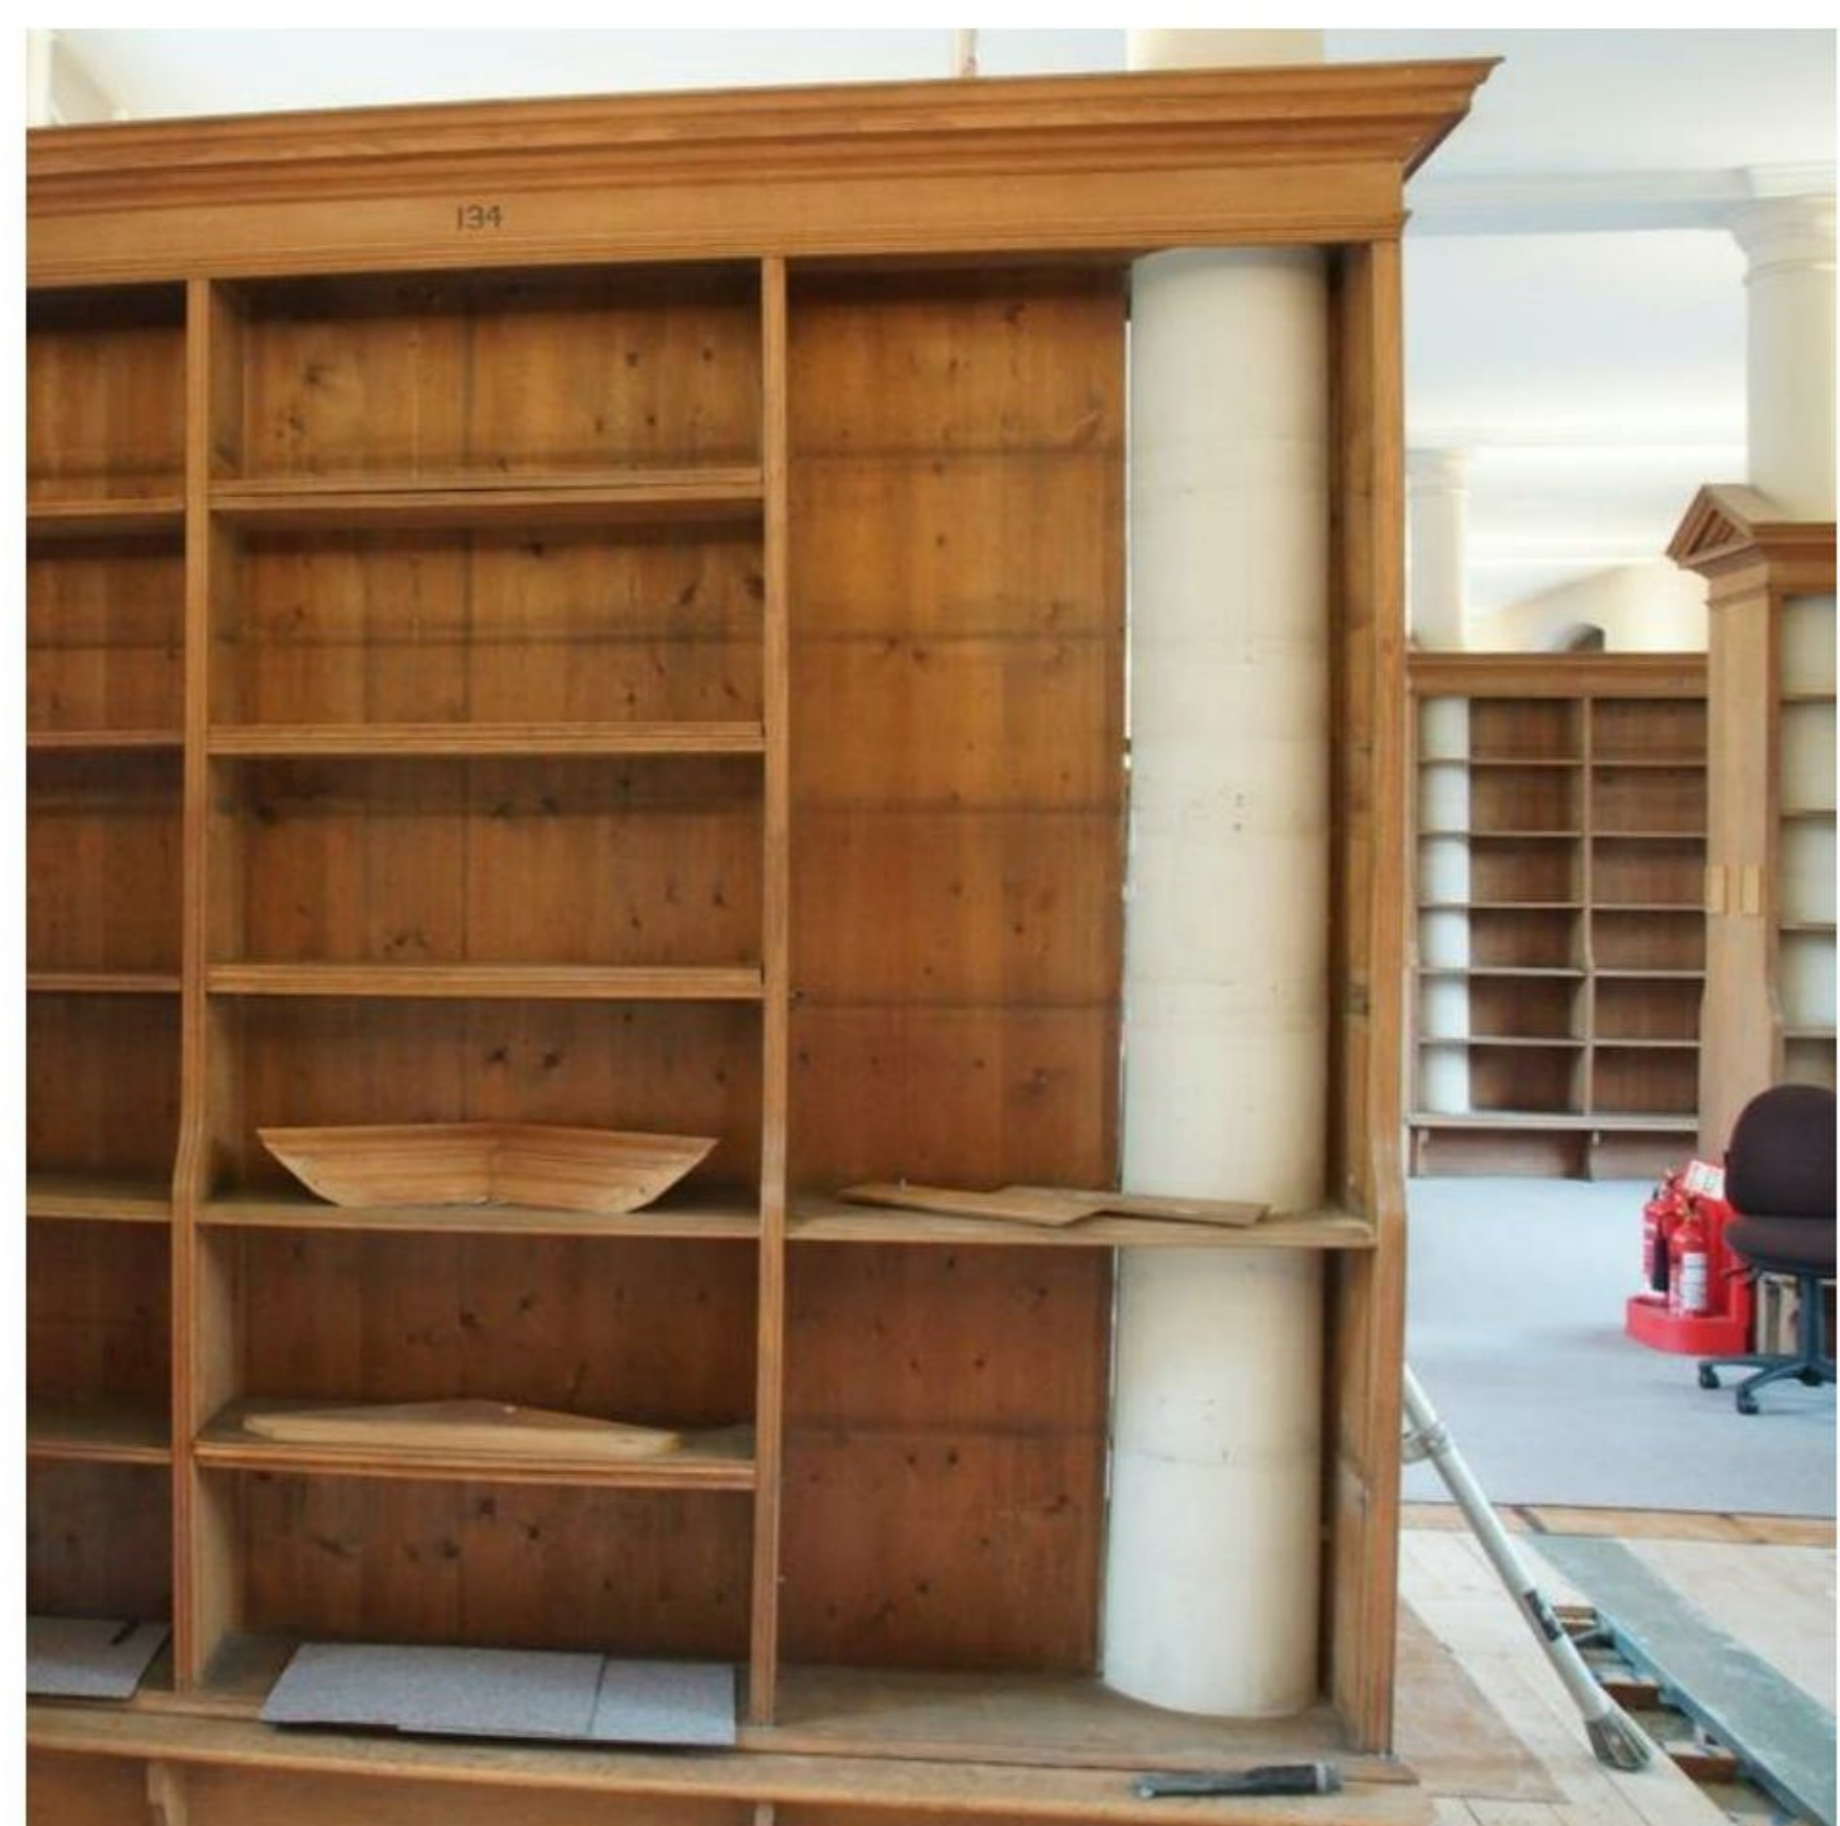
End Pediment Details

This is formed of 4 no. Oak components all jointed together with wood screws. The top covers are first removed from each side to give access to the 4 no. wood screws that secure the cornice to the top of the bookcase.

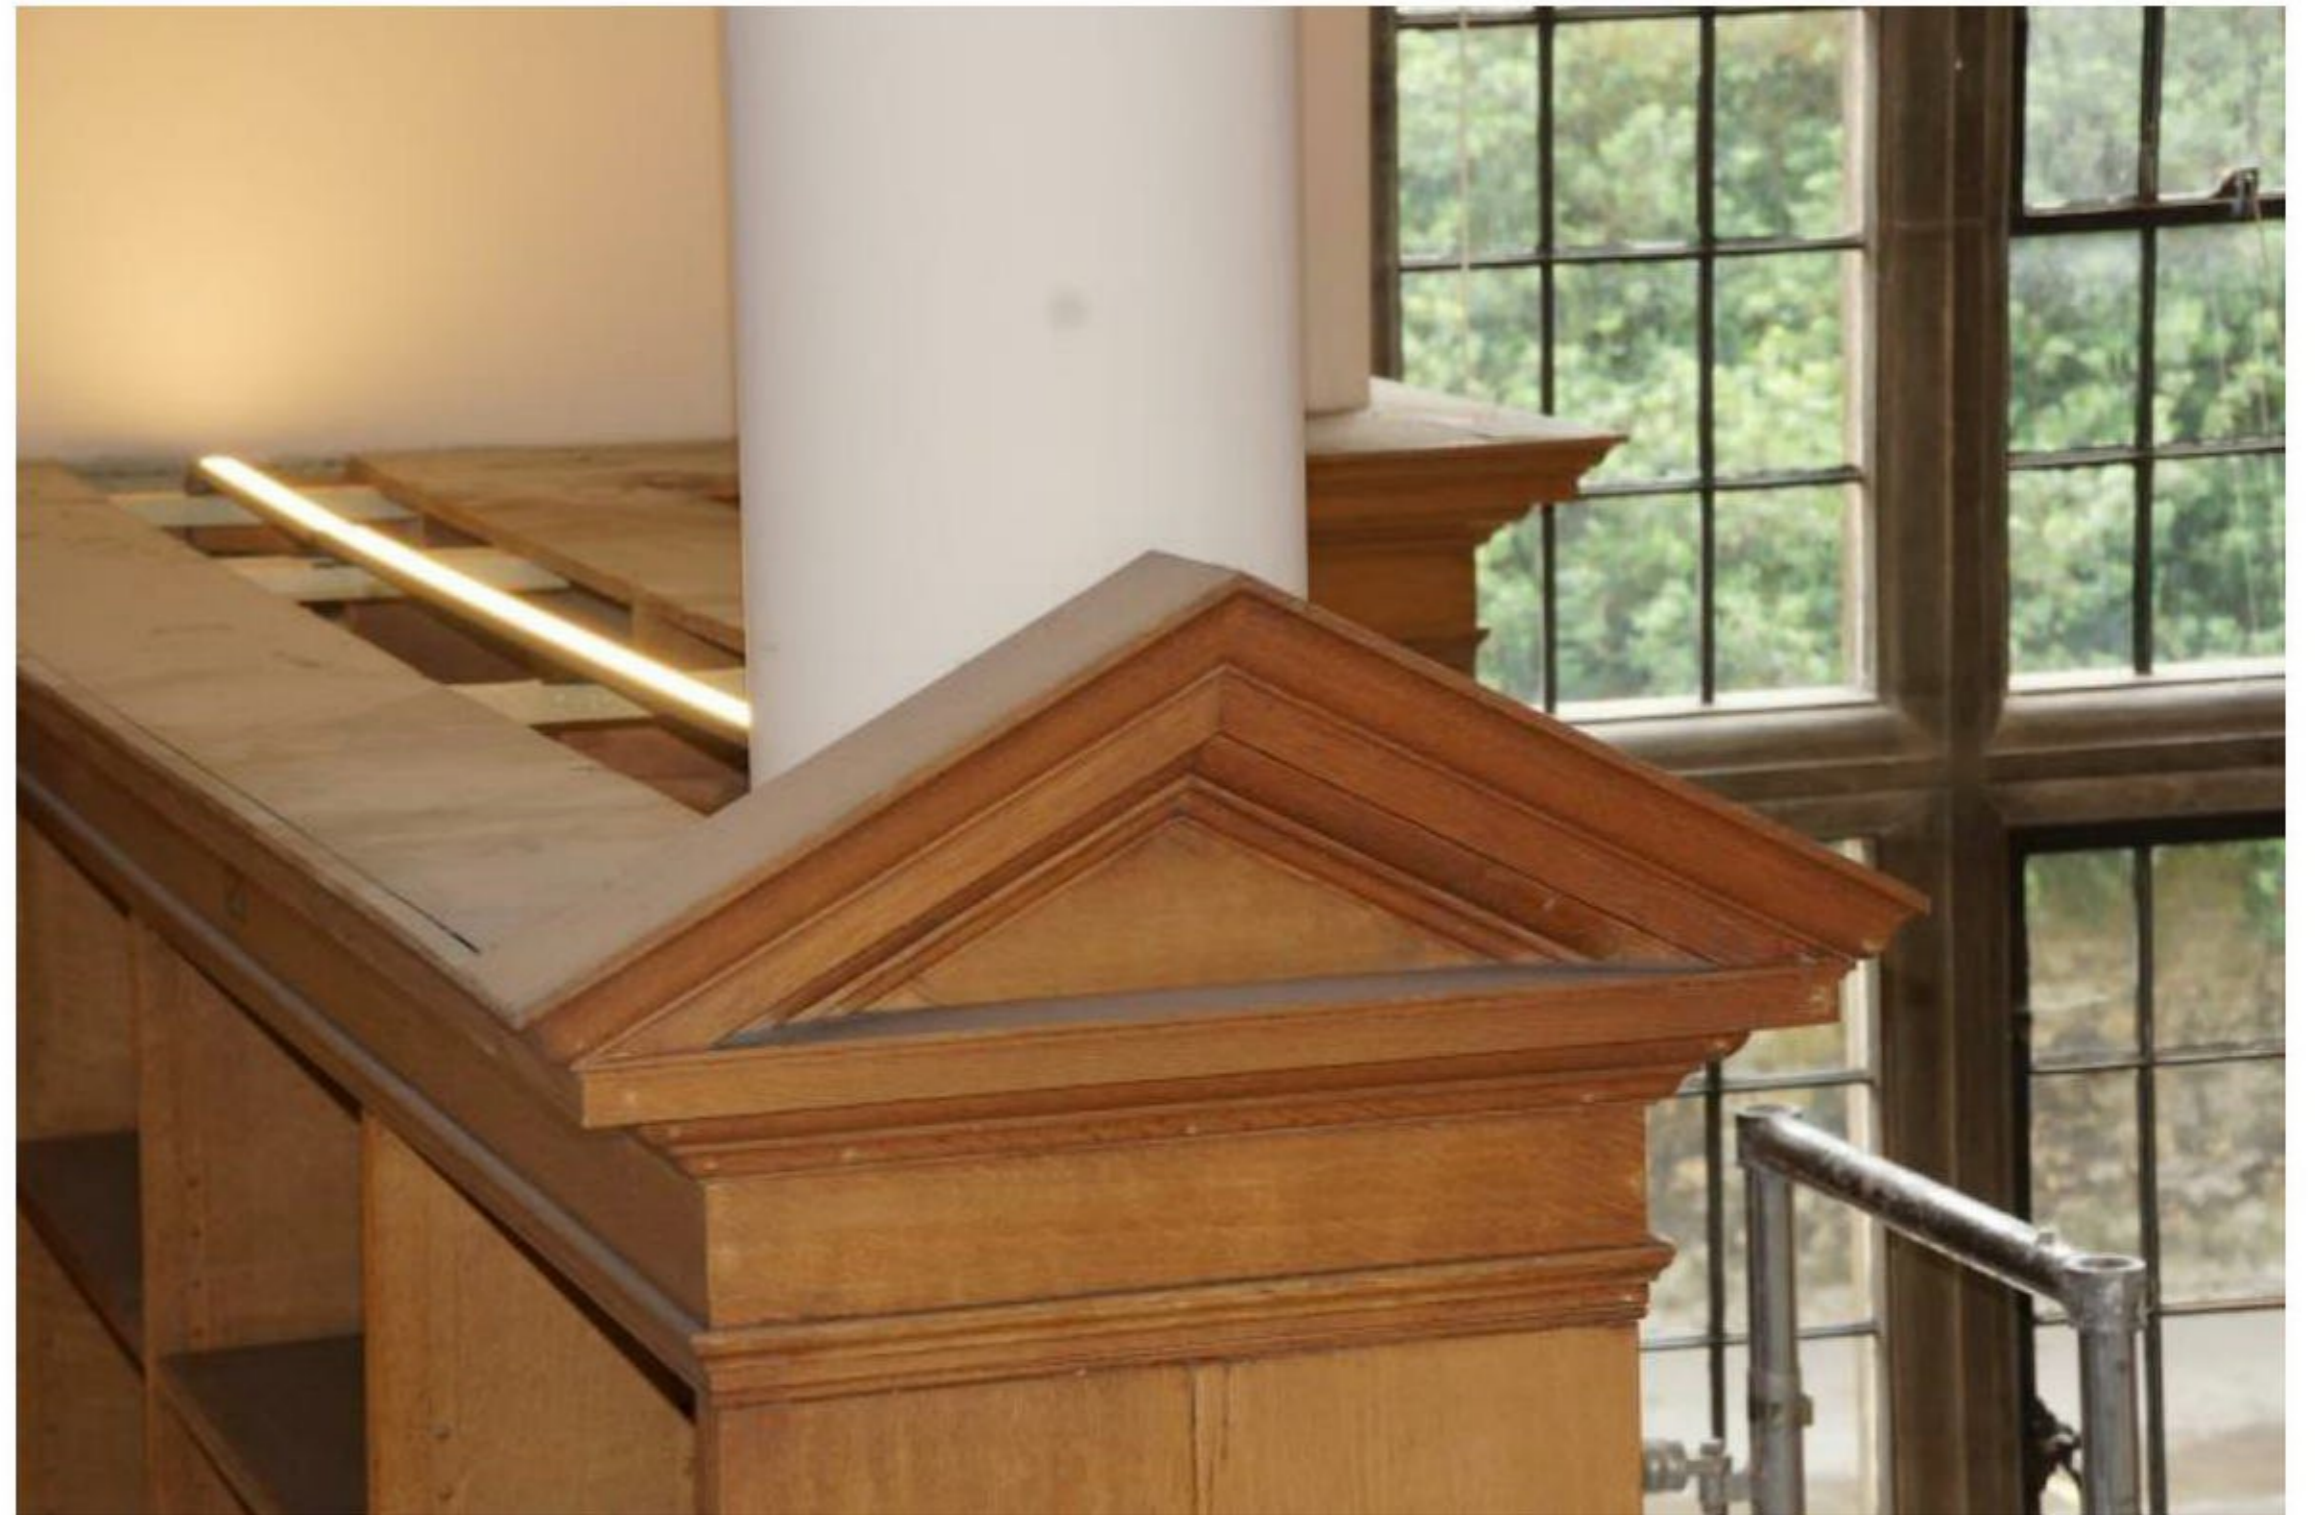
Lighting fitted to the top of each bookcase. A section of the top covers have been removed and lighting supported on timber battens.

The covers require removal the coving support framework beneath.

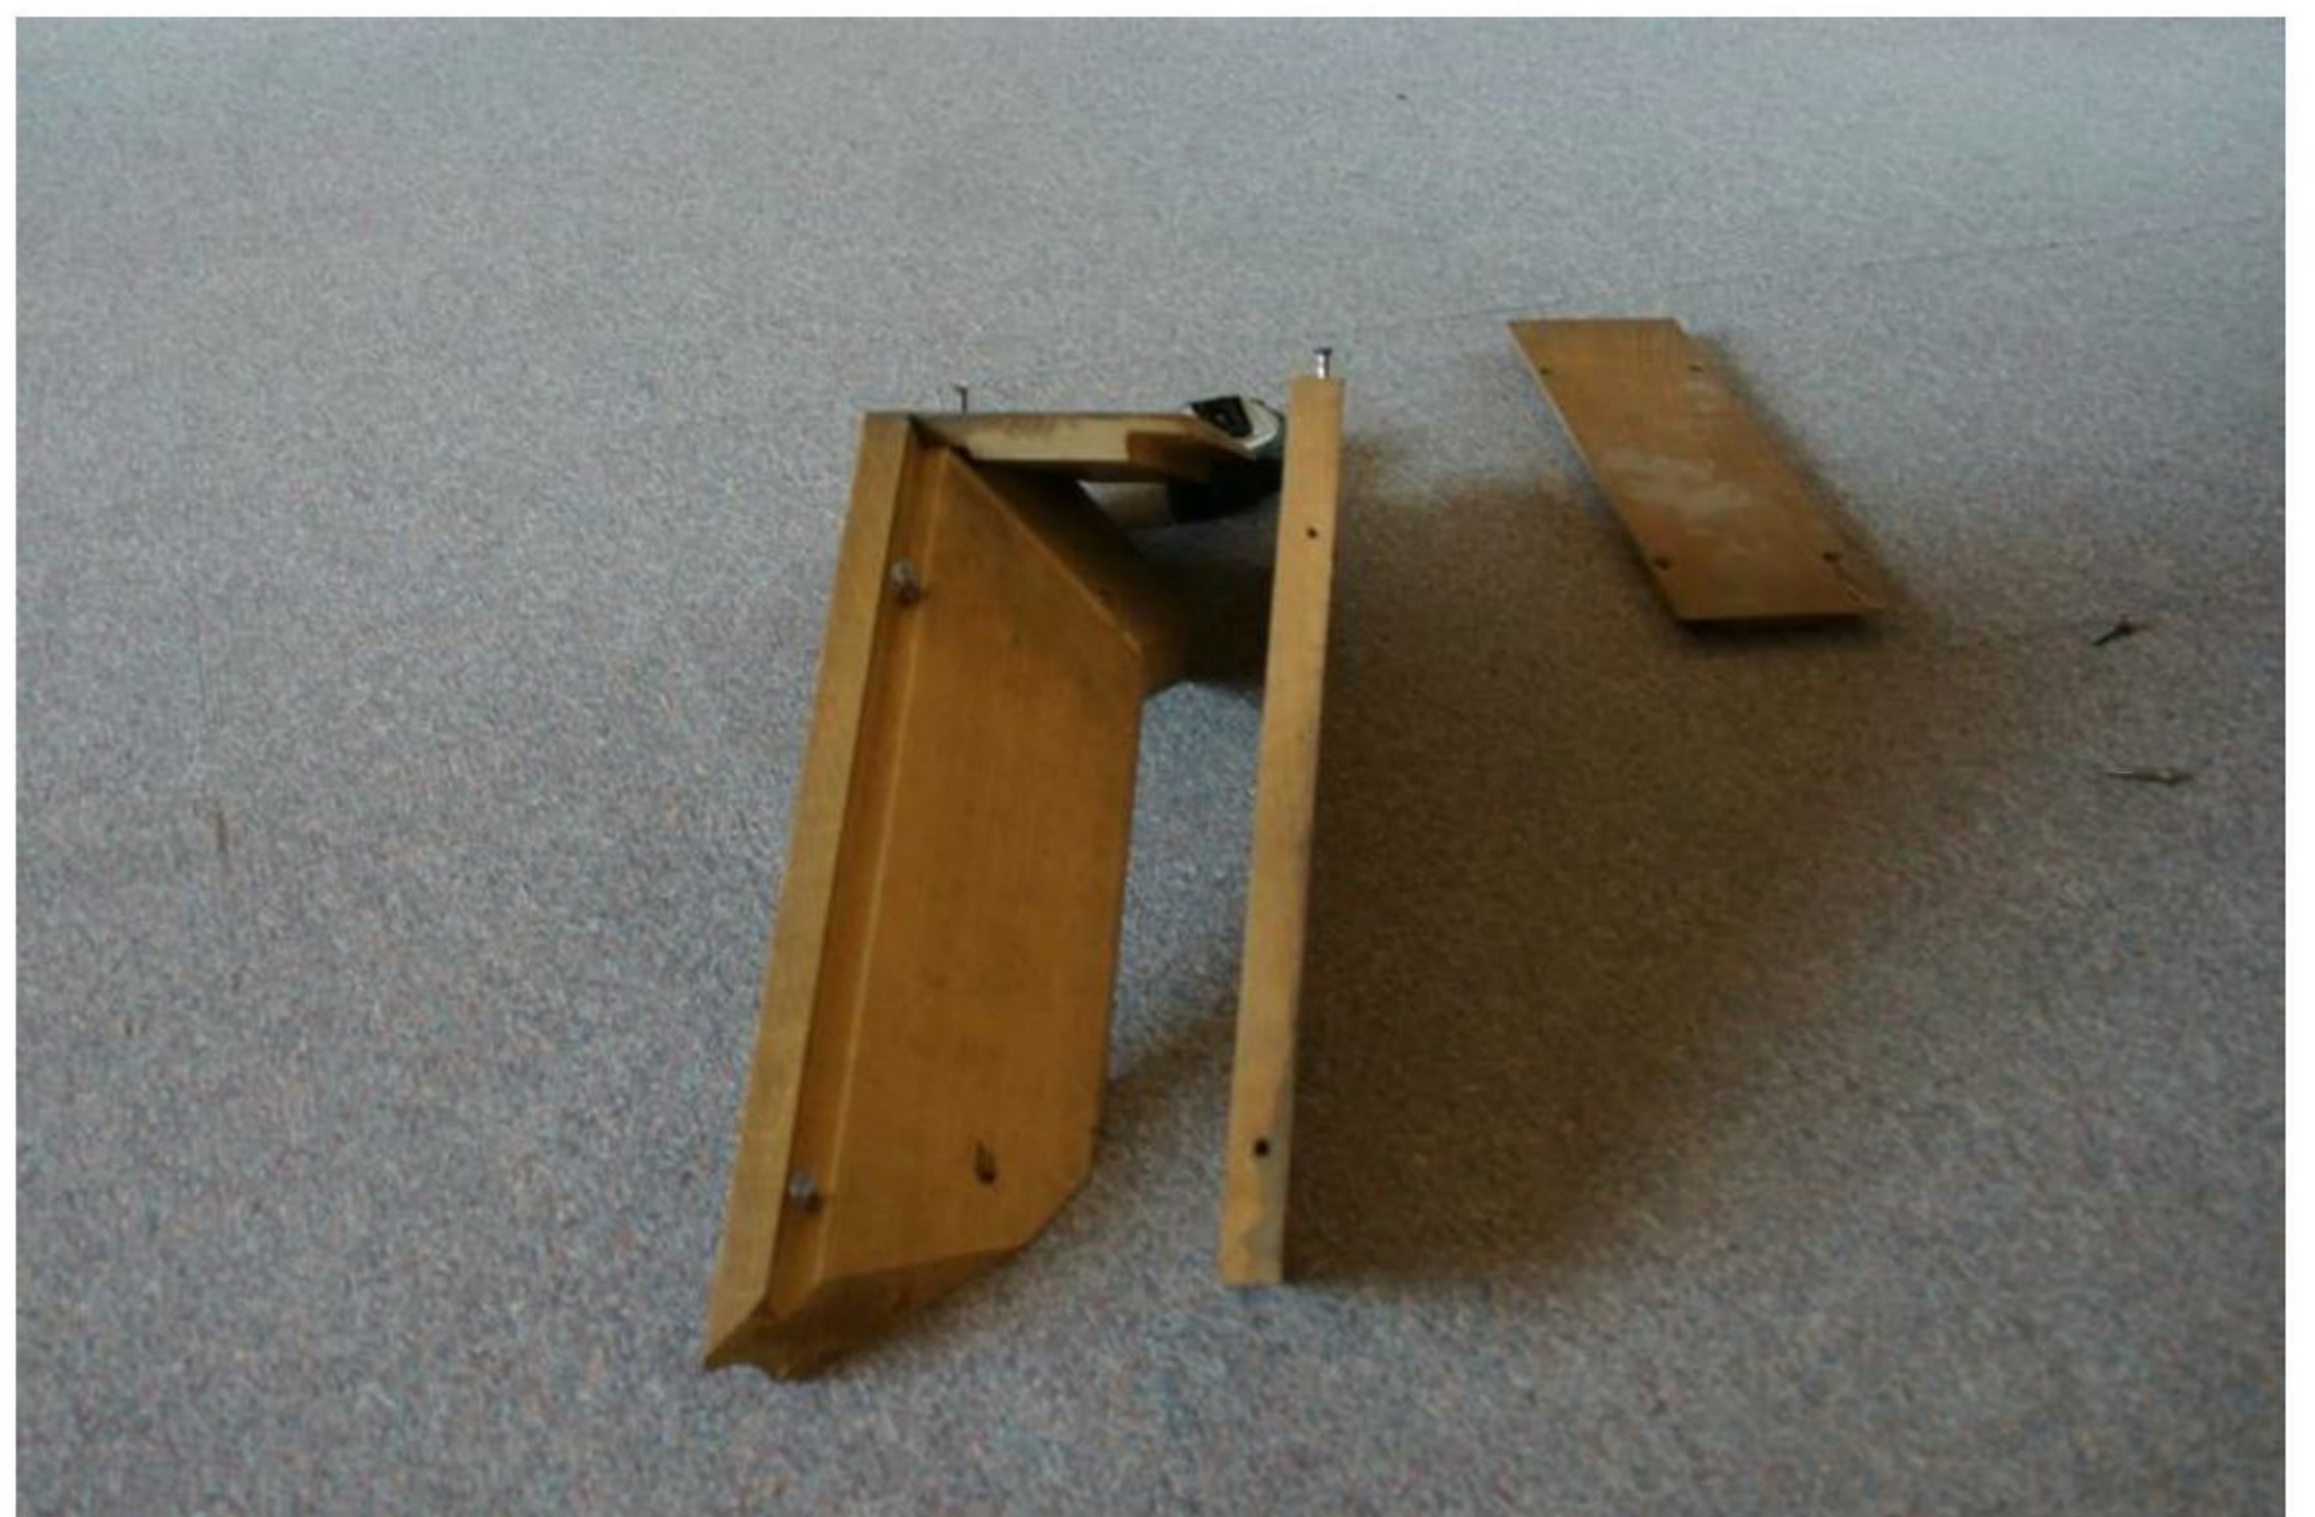
With the covers removed it is possible to the wooden coving to the pediment end and sides of the bookcase. The bottom edge of these slot into a groove in the bookcase top moulding piece. It is both nailed and glued in place.
