Reuben College – Works Methodologies

Task Sheet MS06 – Jackson Wing, Sample Wall and Ceiling Plaster removal as part of Asbestos Abatement Works. February 2021.

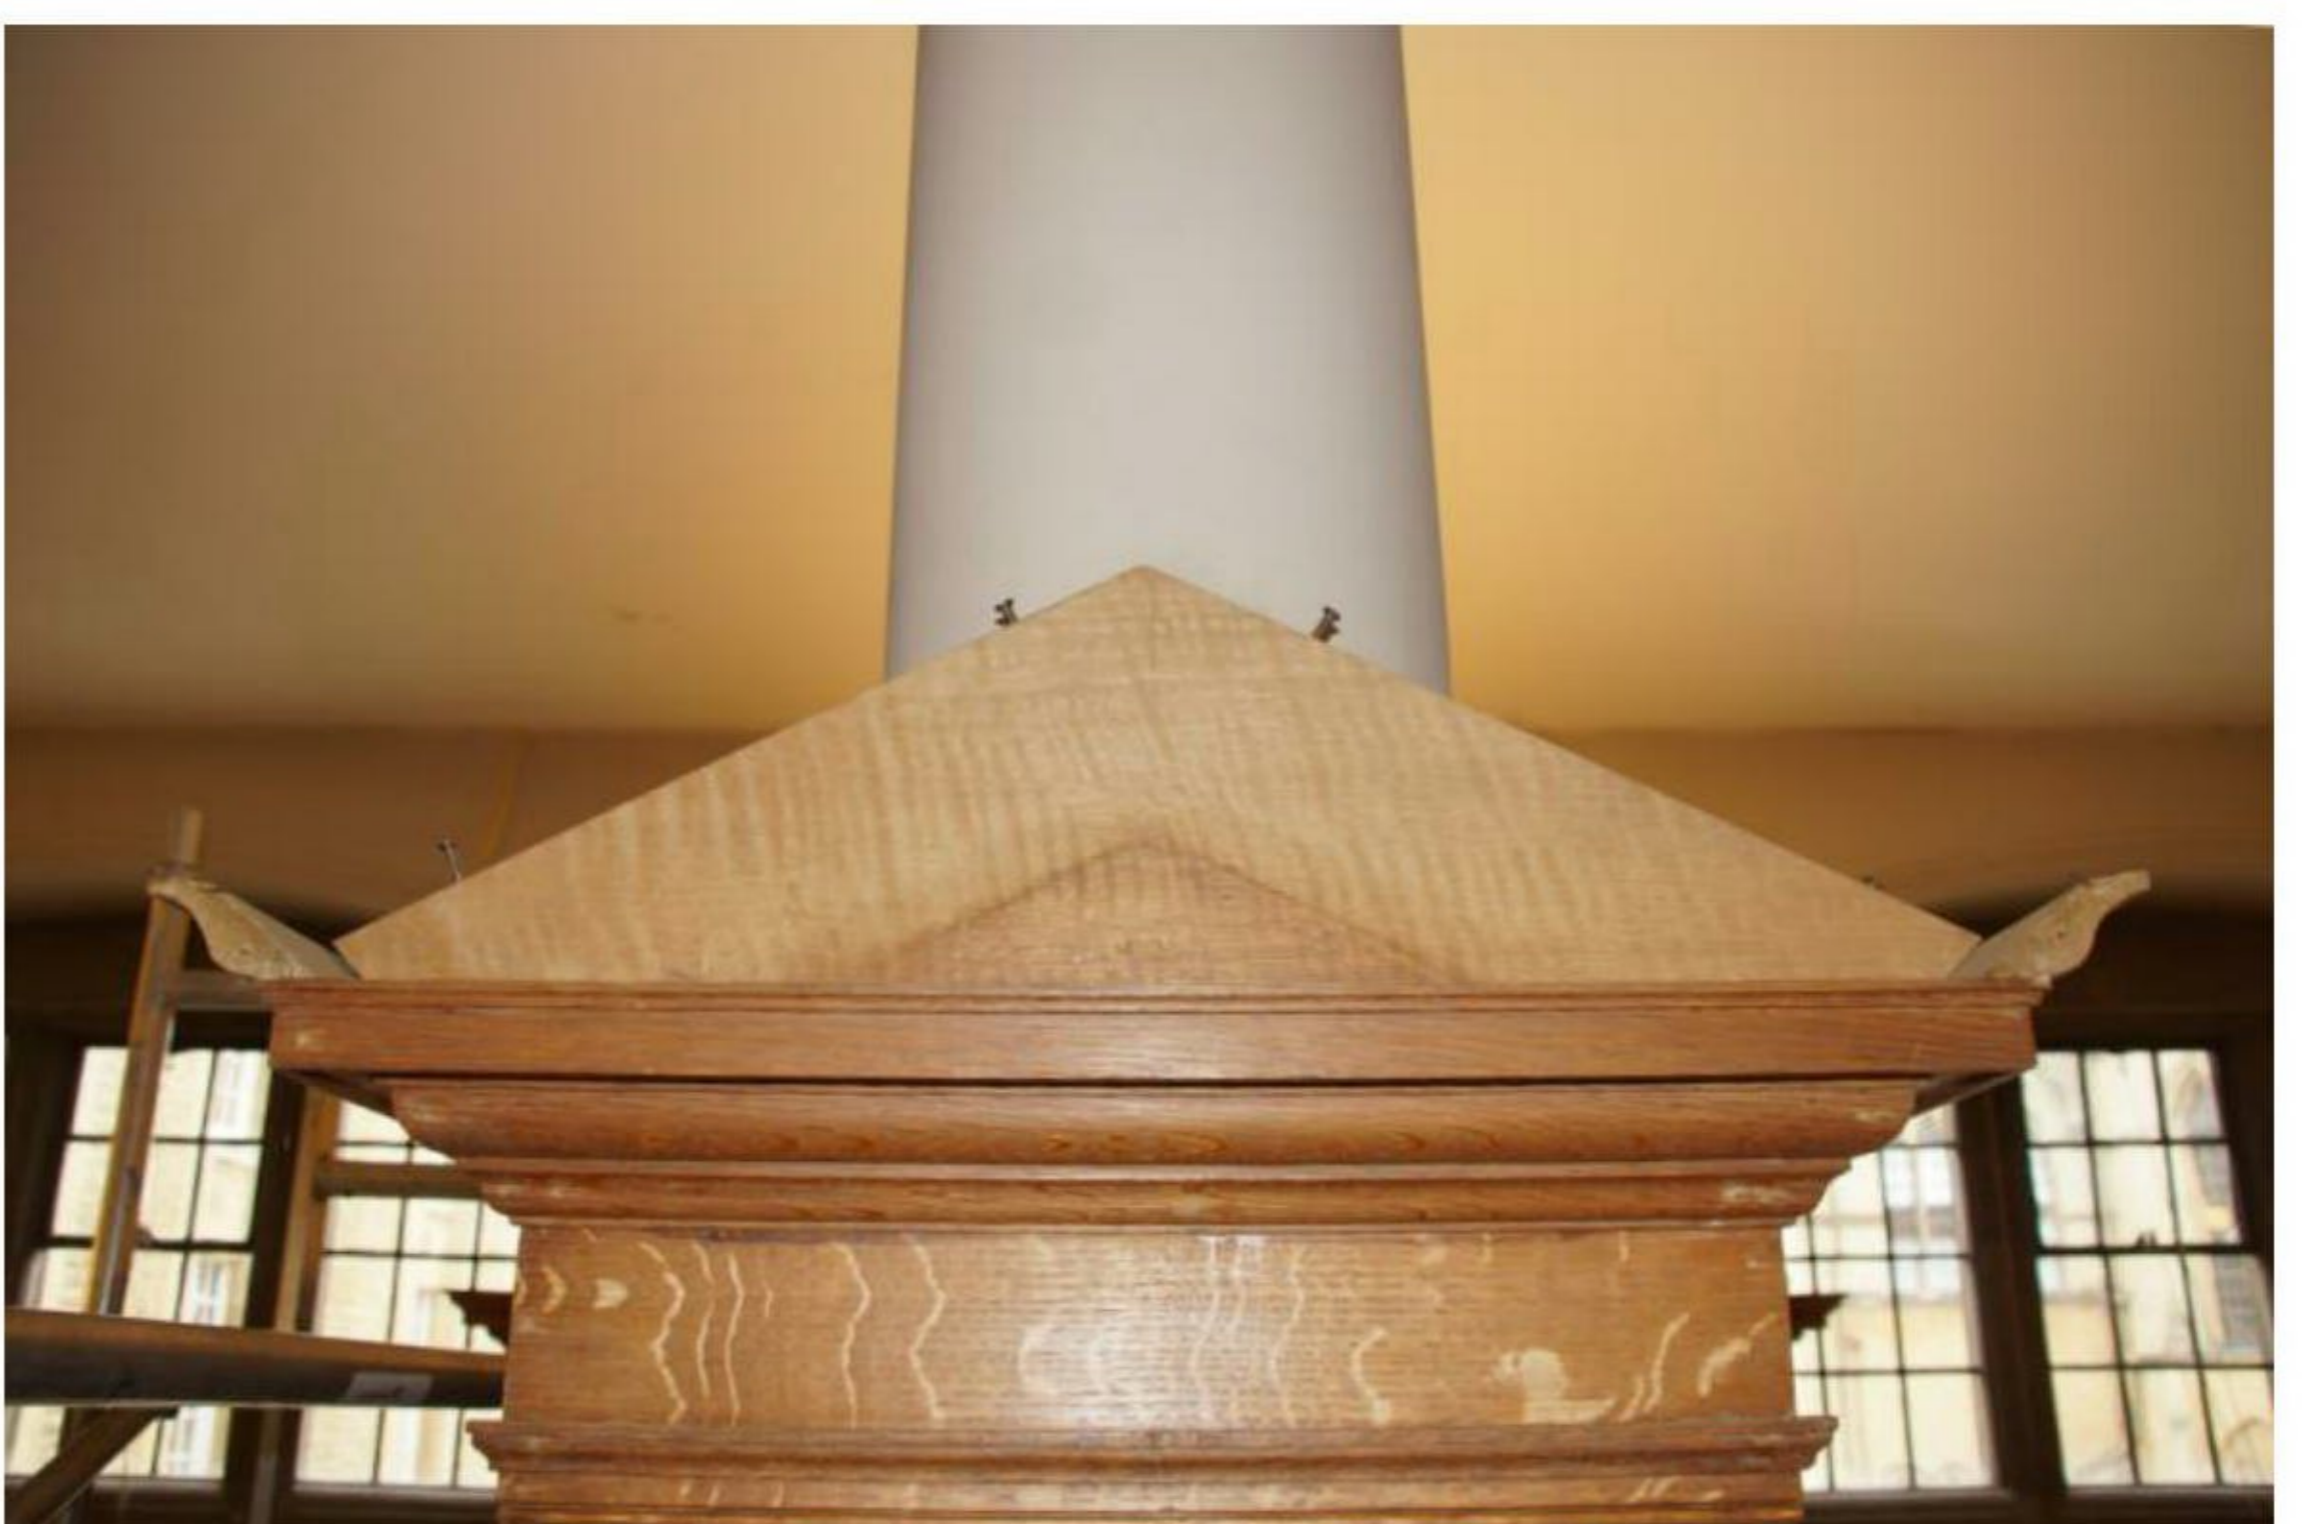
Cove elements removed from the pediment.

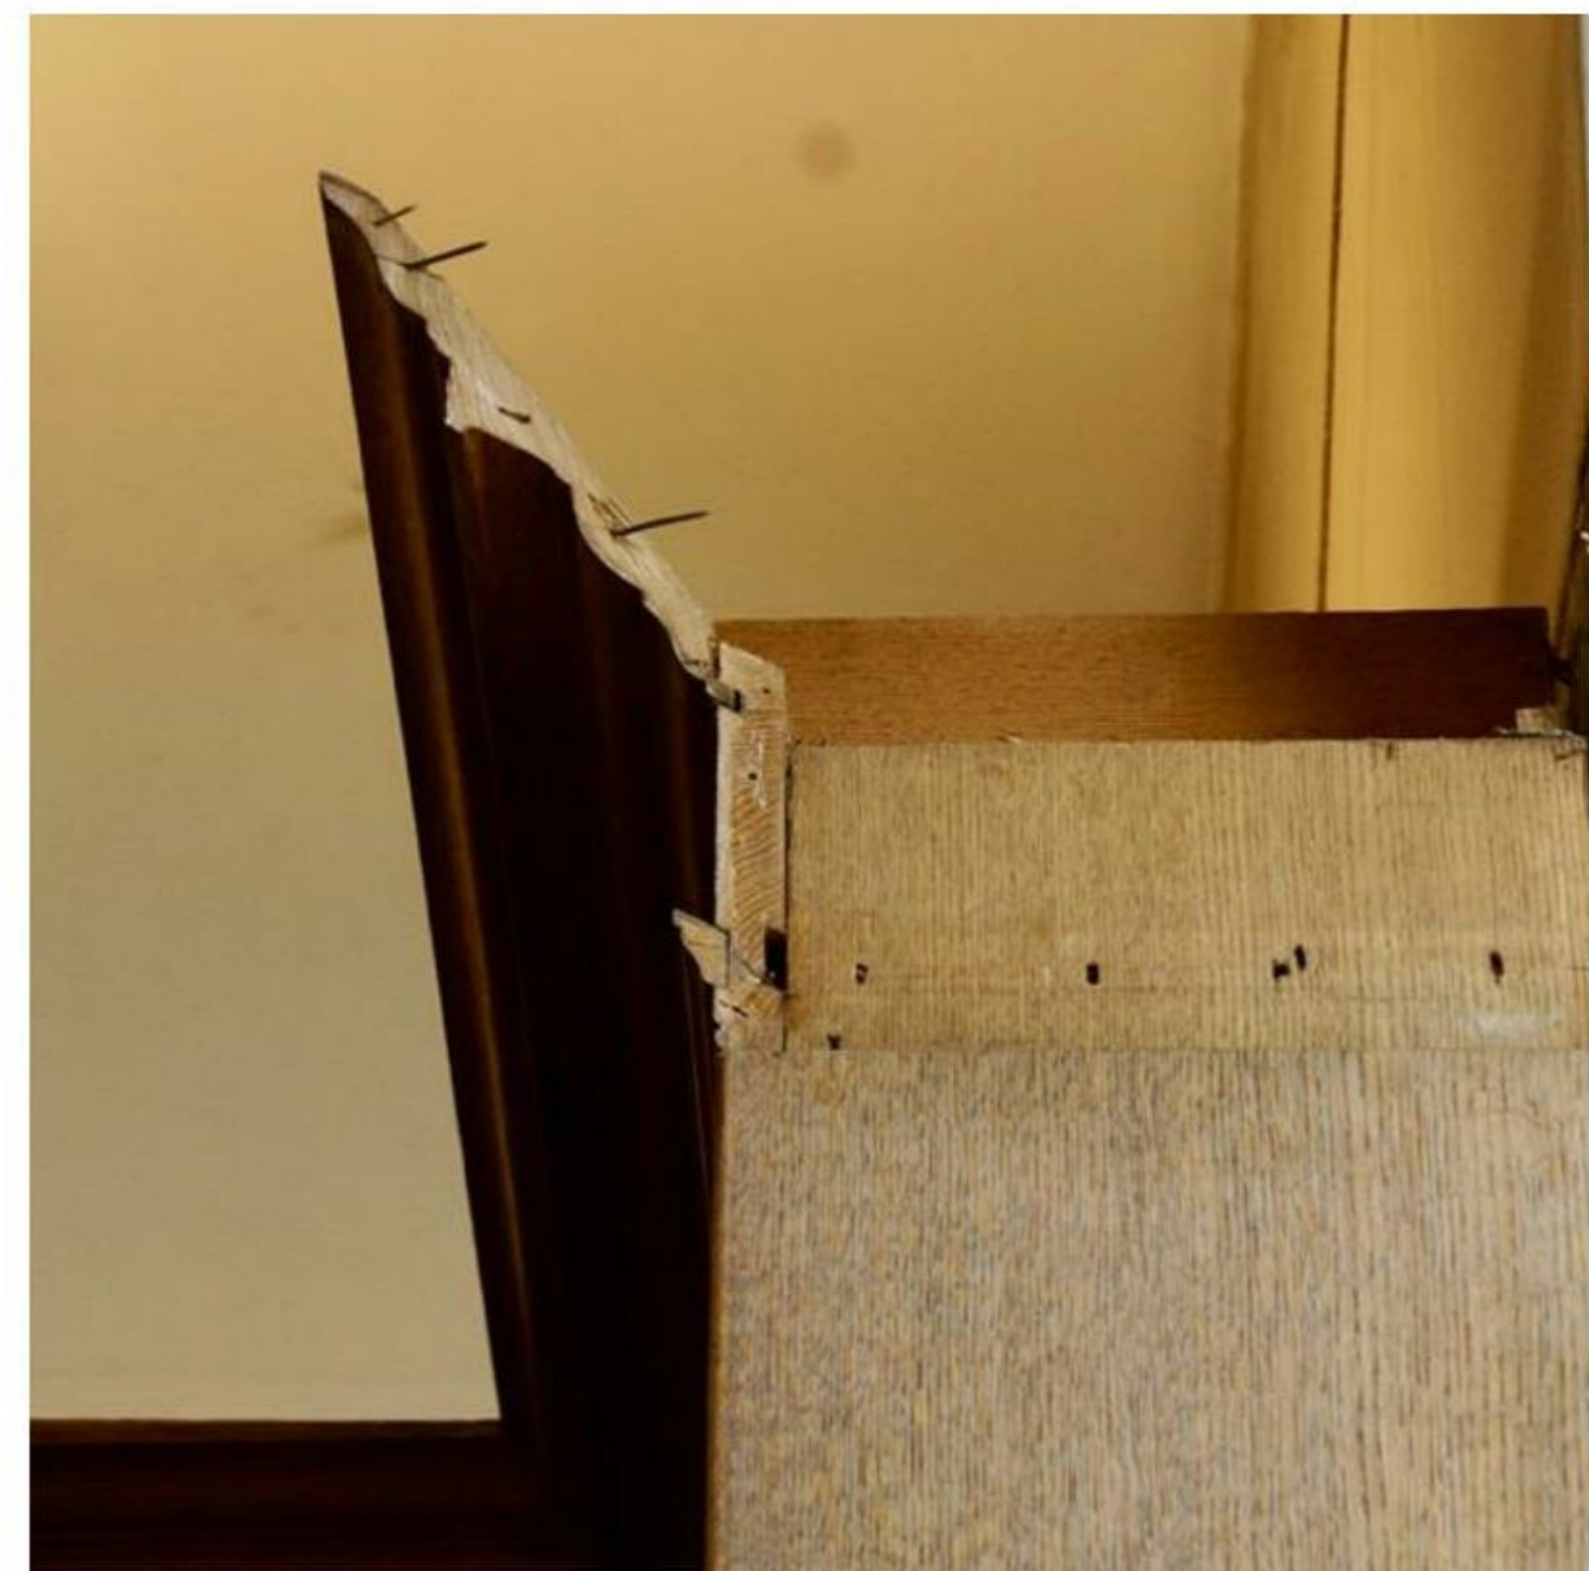
Once the coving has been removed the top moulding can be removed. This is secured by nails into the bookcase end and partition edges.

The end of the bookcase can then be removed. The top panel slots into the inner edge of the end panel and is nailed through from the outer side. The bottom edge of the end panel slots into the bookcase base panel and is pinned into place.

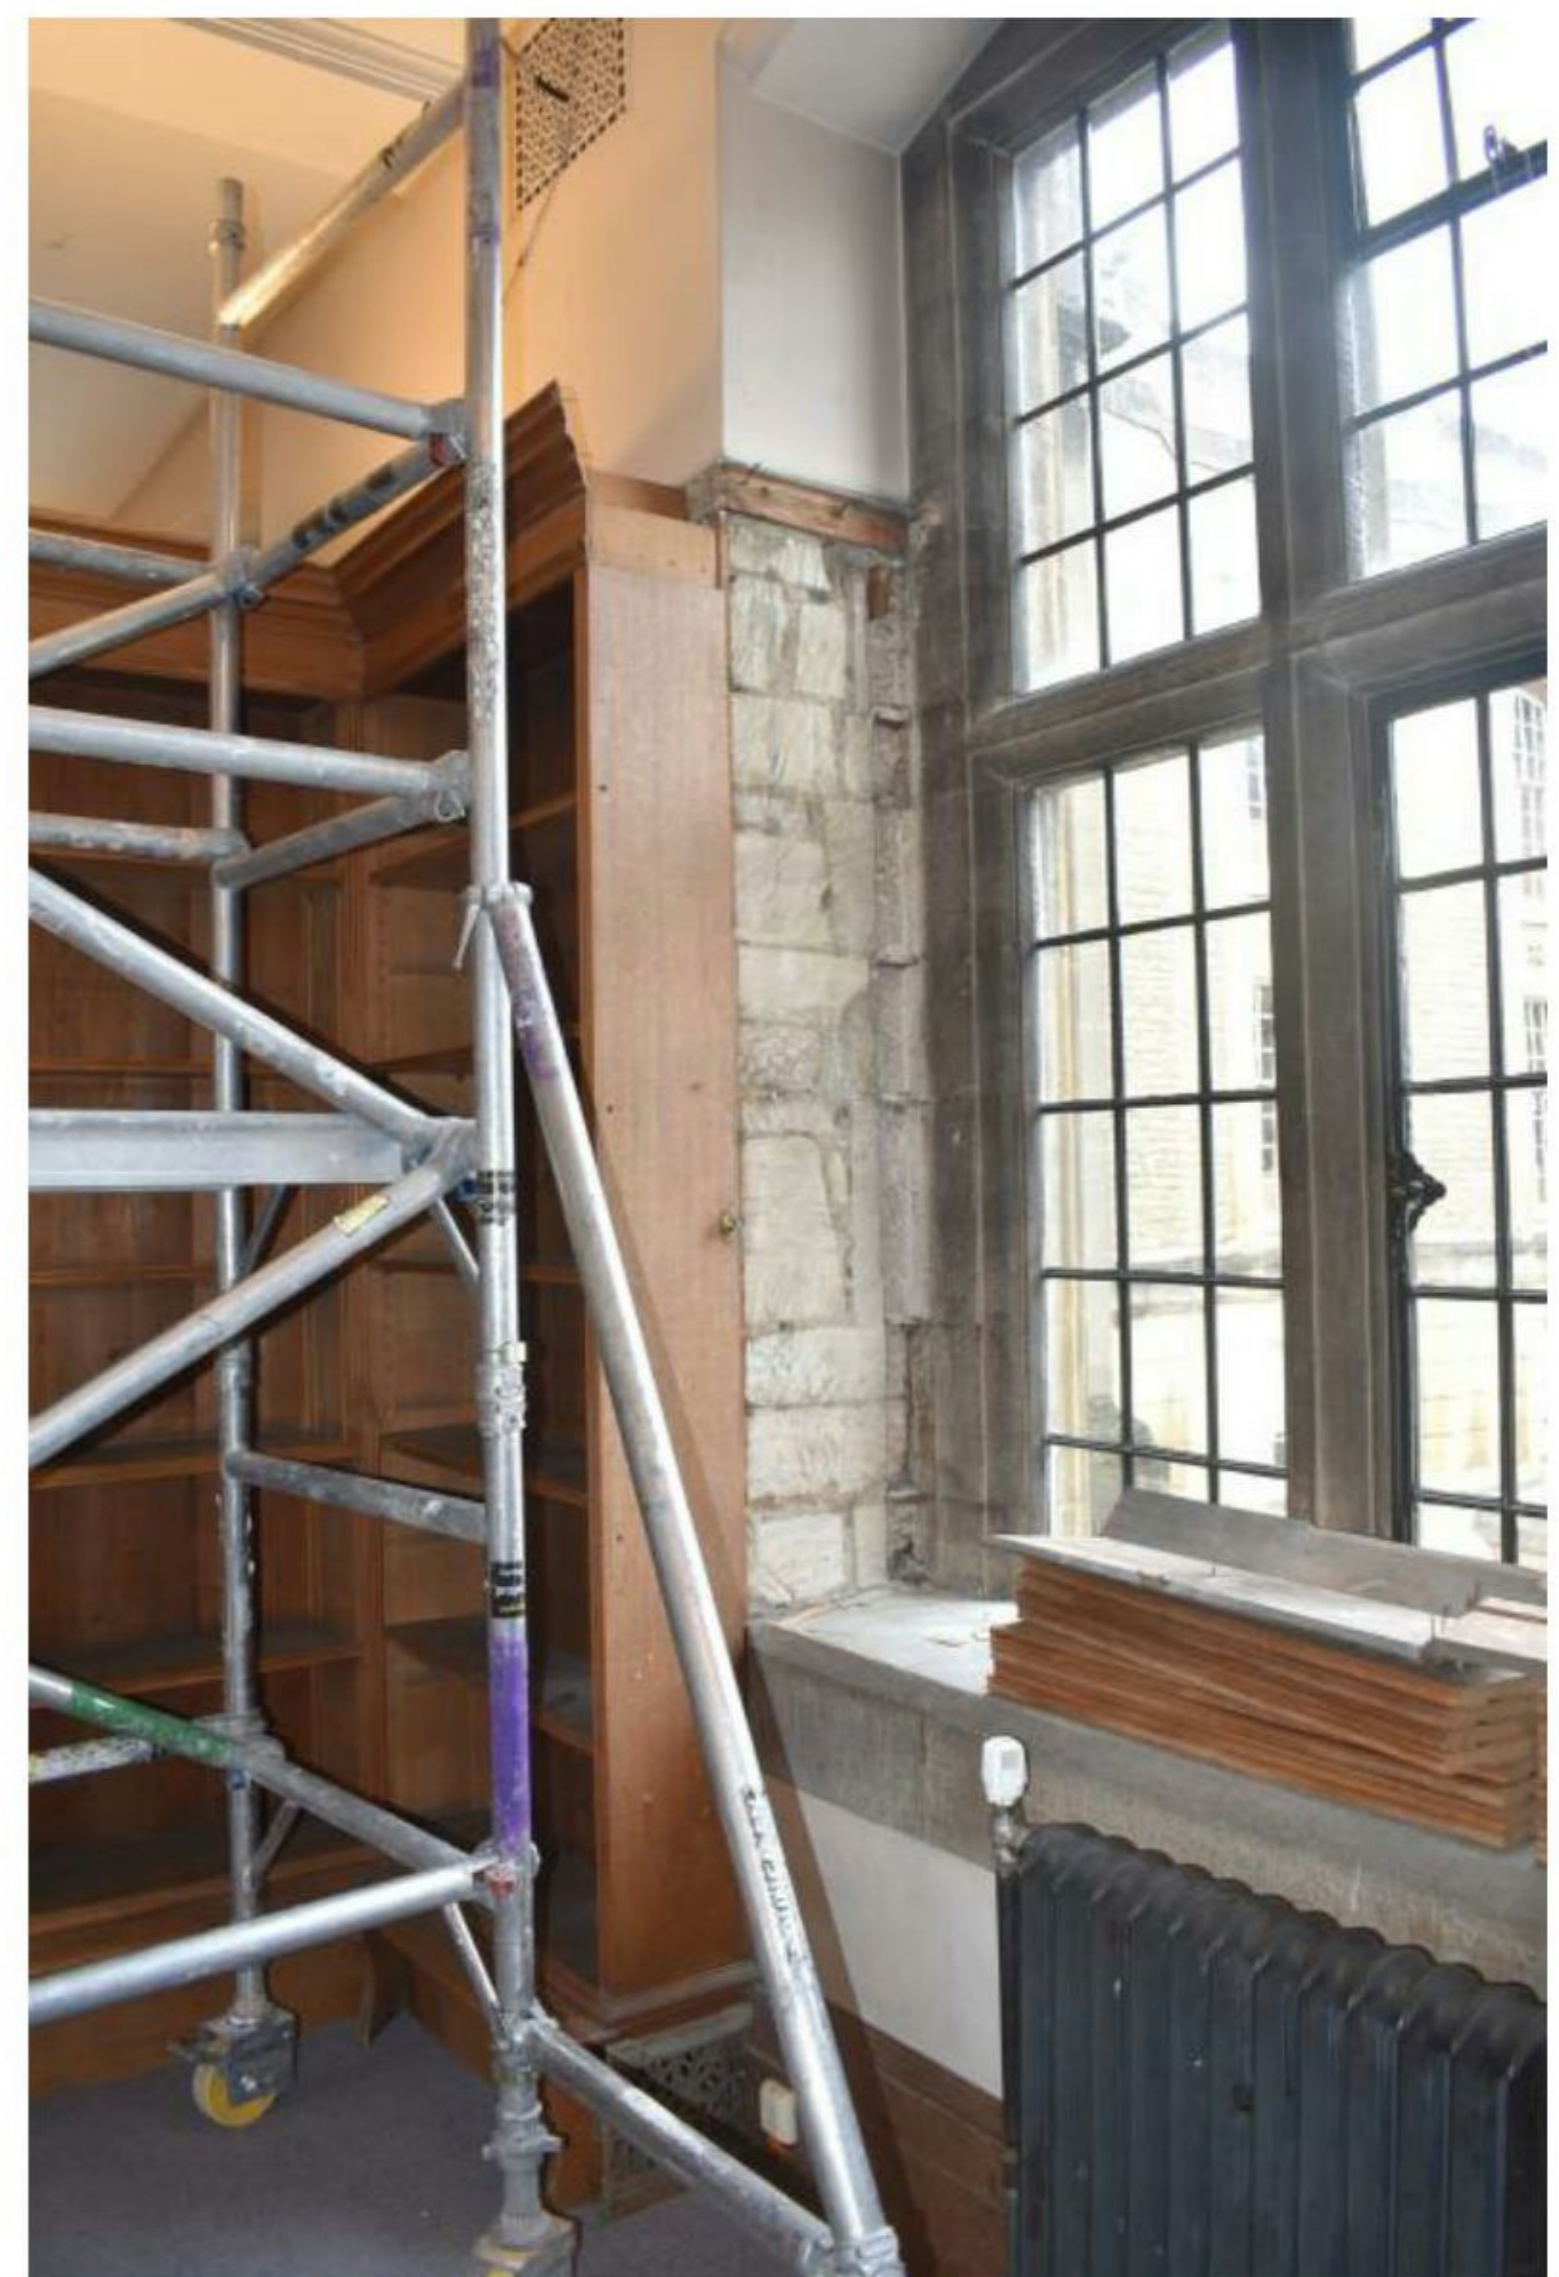
Window Reveal Panel

Reveal panel removed for investigation. Panel is rebated into the rear of the bookcases and pinned to wooden blocks which are built into the masonry.

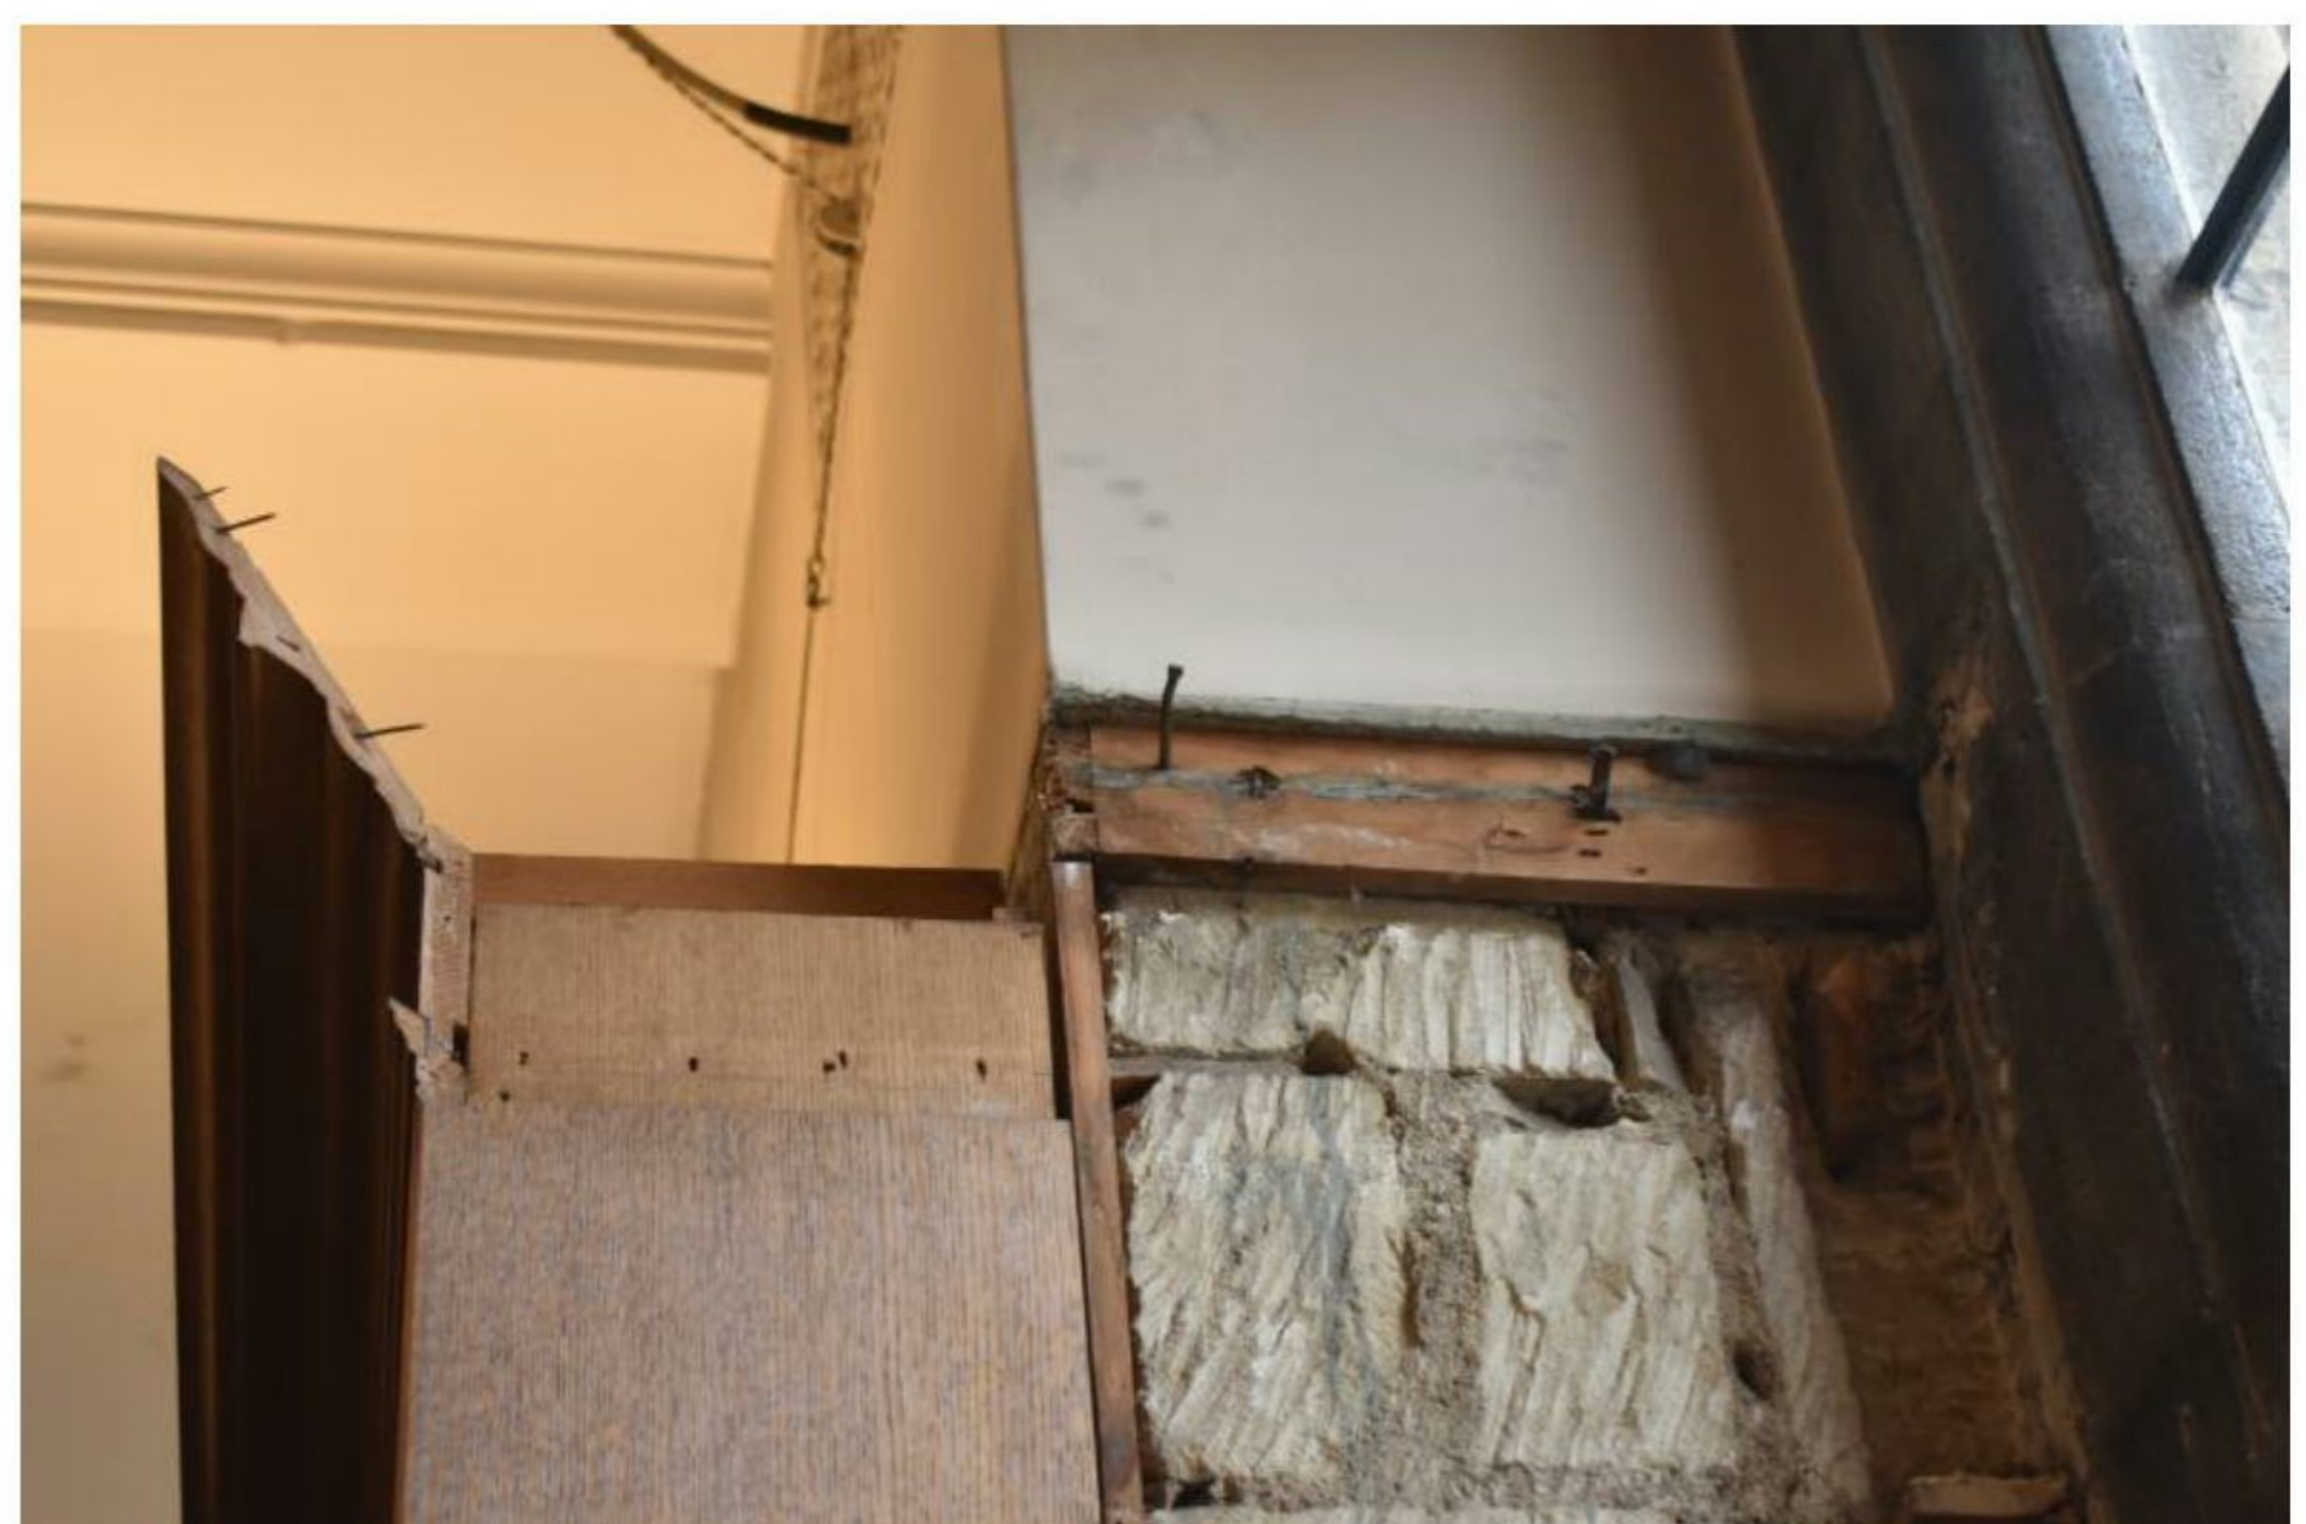
Coving removed from window to external corner of bookcase (pinned and glued at mitre) which allows release of the reveal panel from the grounds and rotated from the bookcase rebate.

Note: plaster does not extend behind the bookcases.
Grounds fitted as plaster guide and fixing method for joinery.

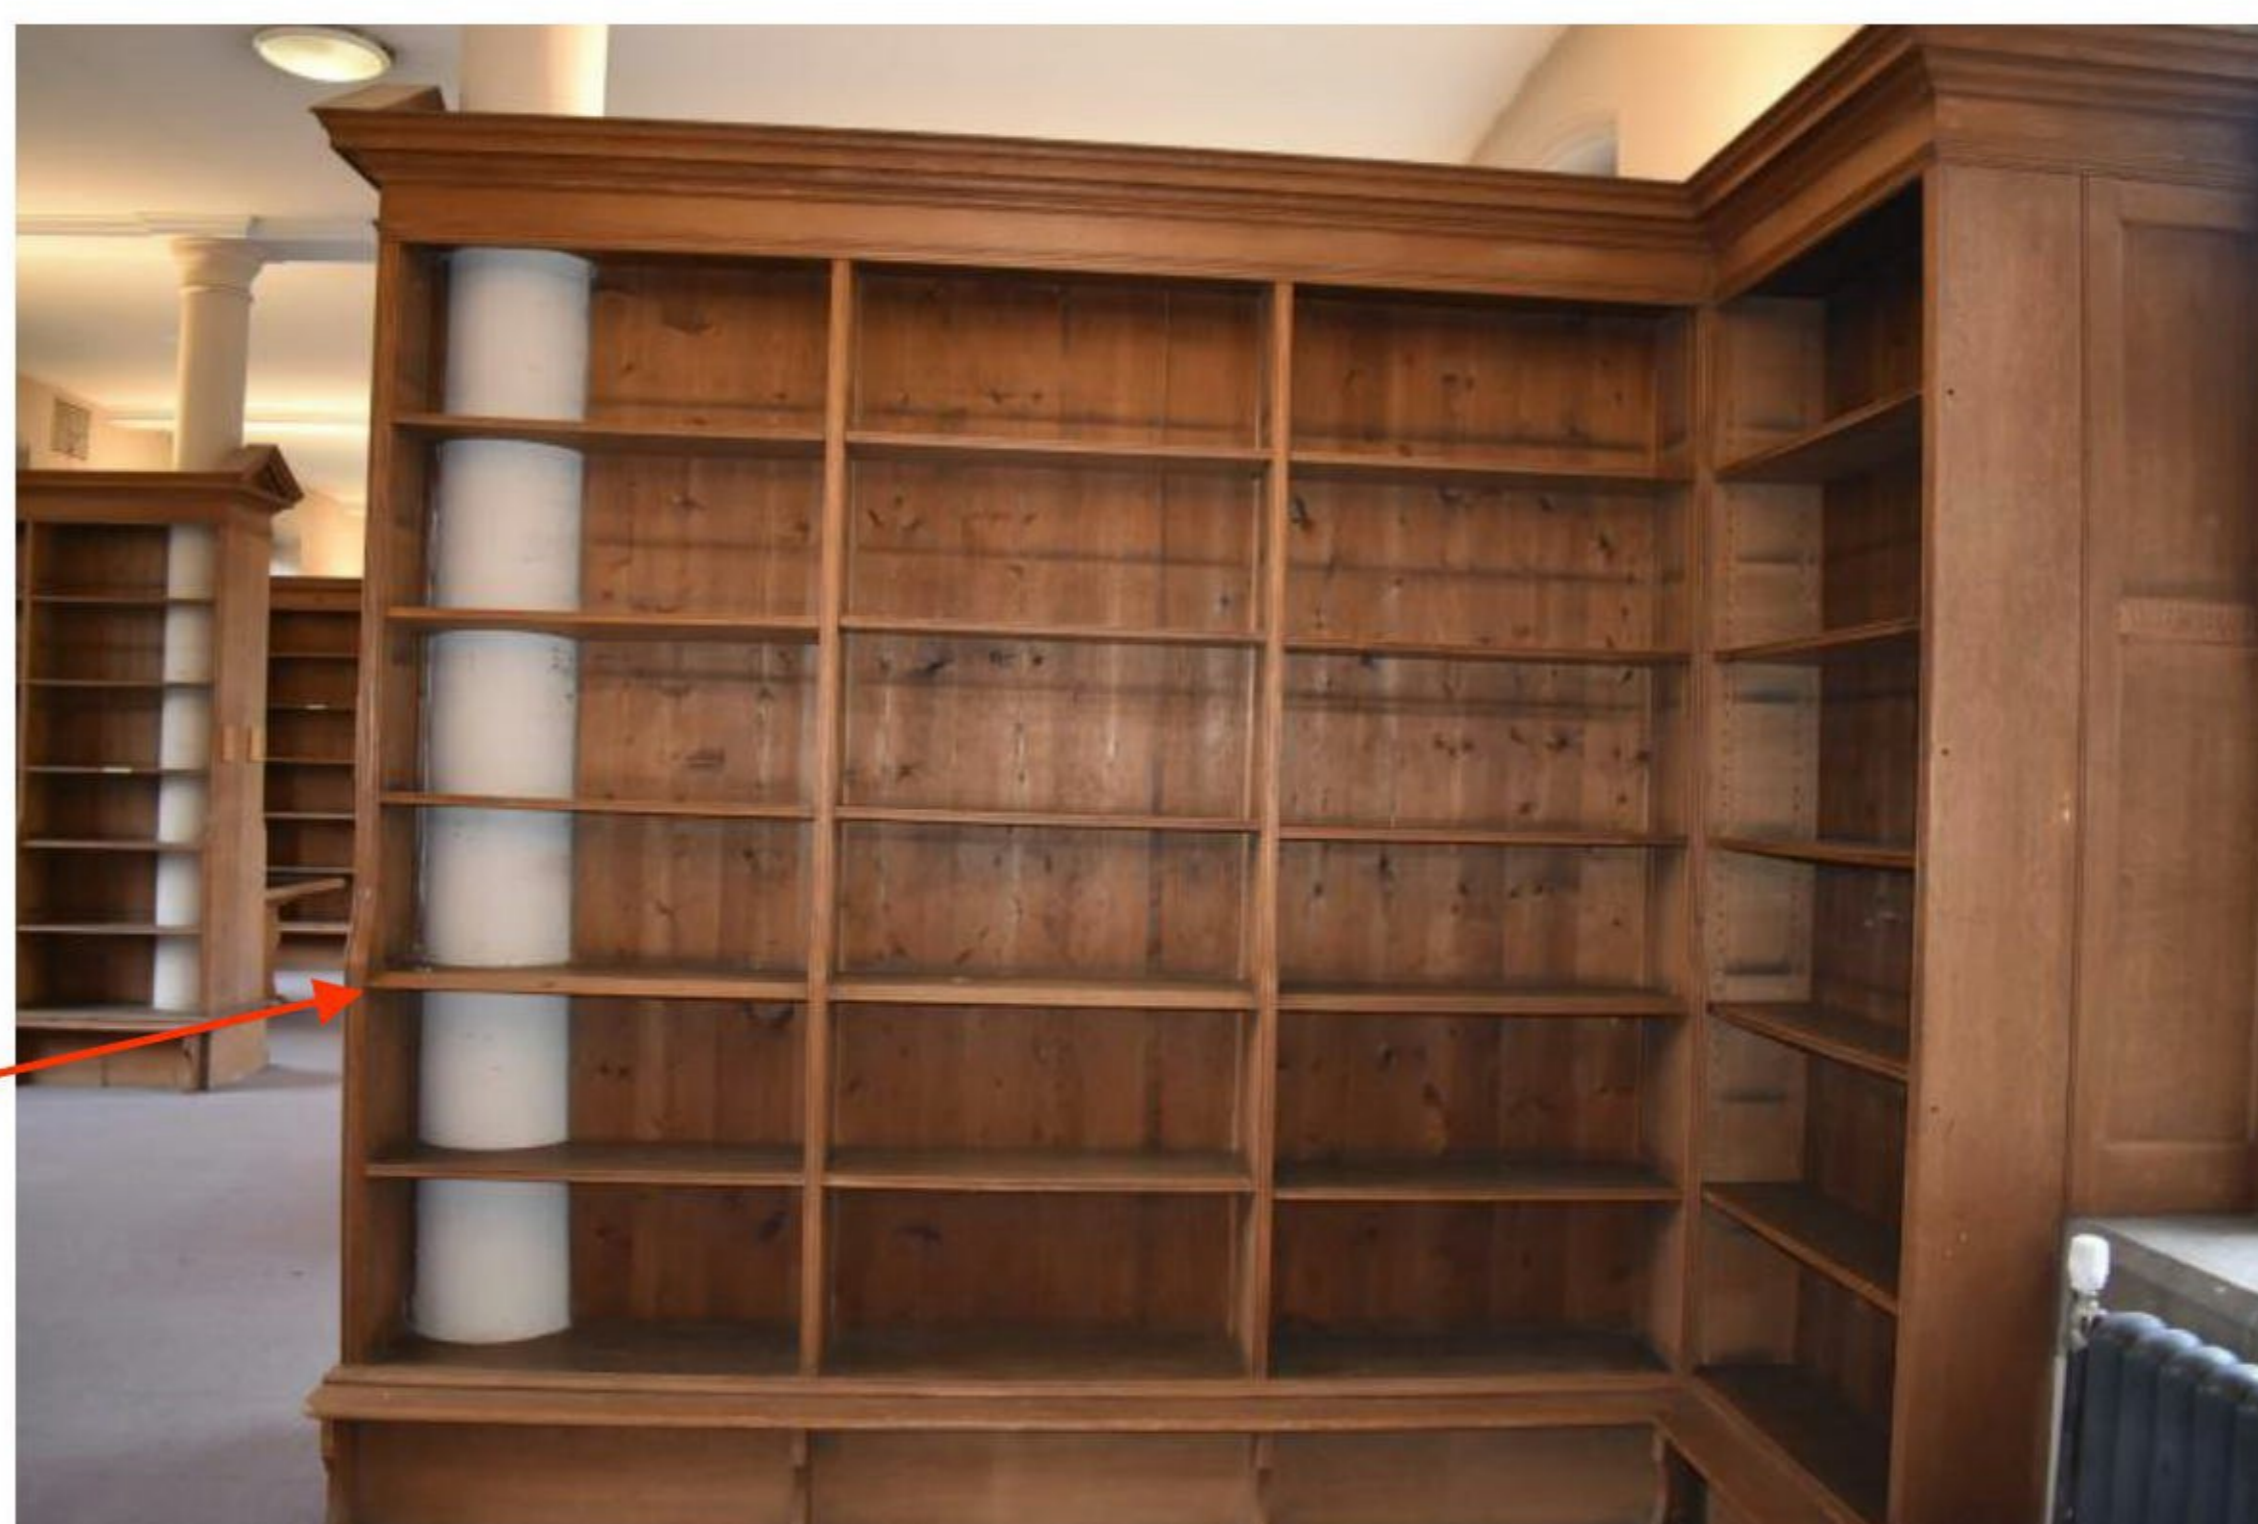
Shelving Removal

The majority of the shelving is adjustable and can easily be removed. However, the second shelf from the base is structural and is screw fixed to the end and intermediate panels.

Fixed shelf unit

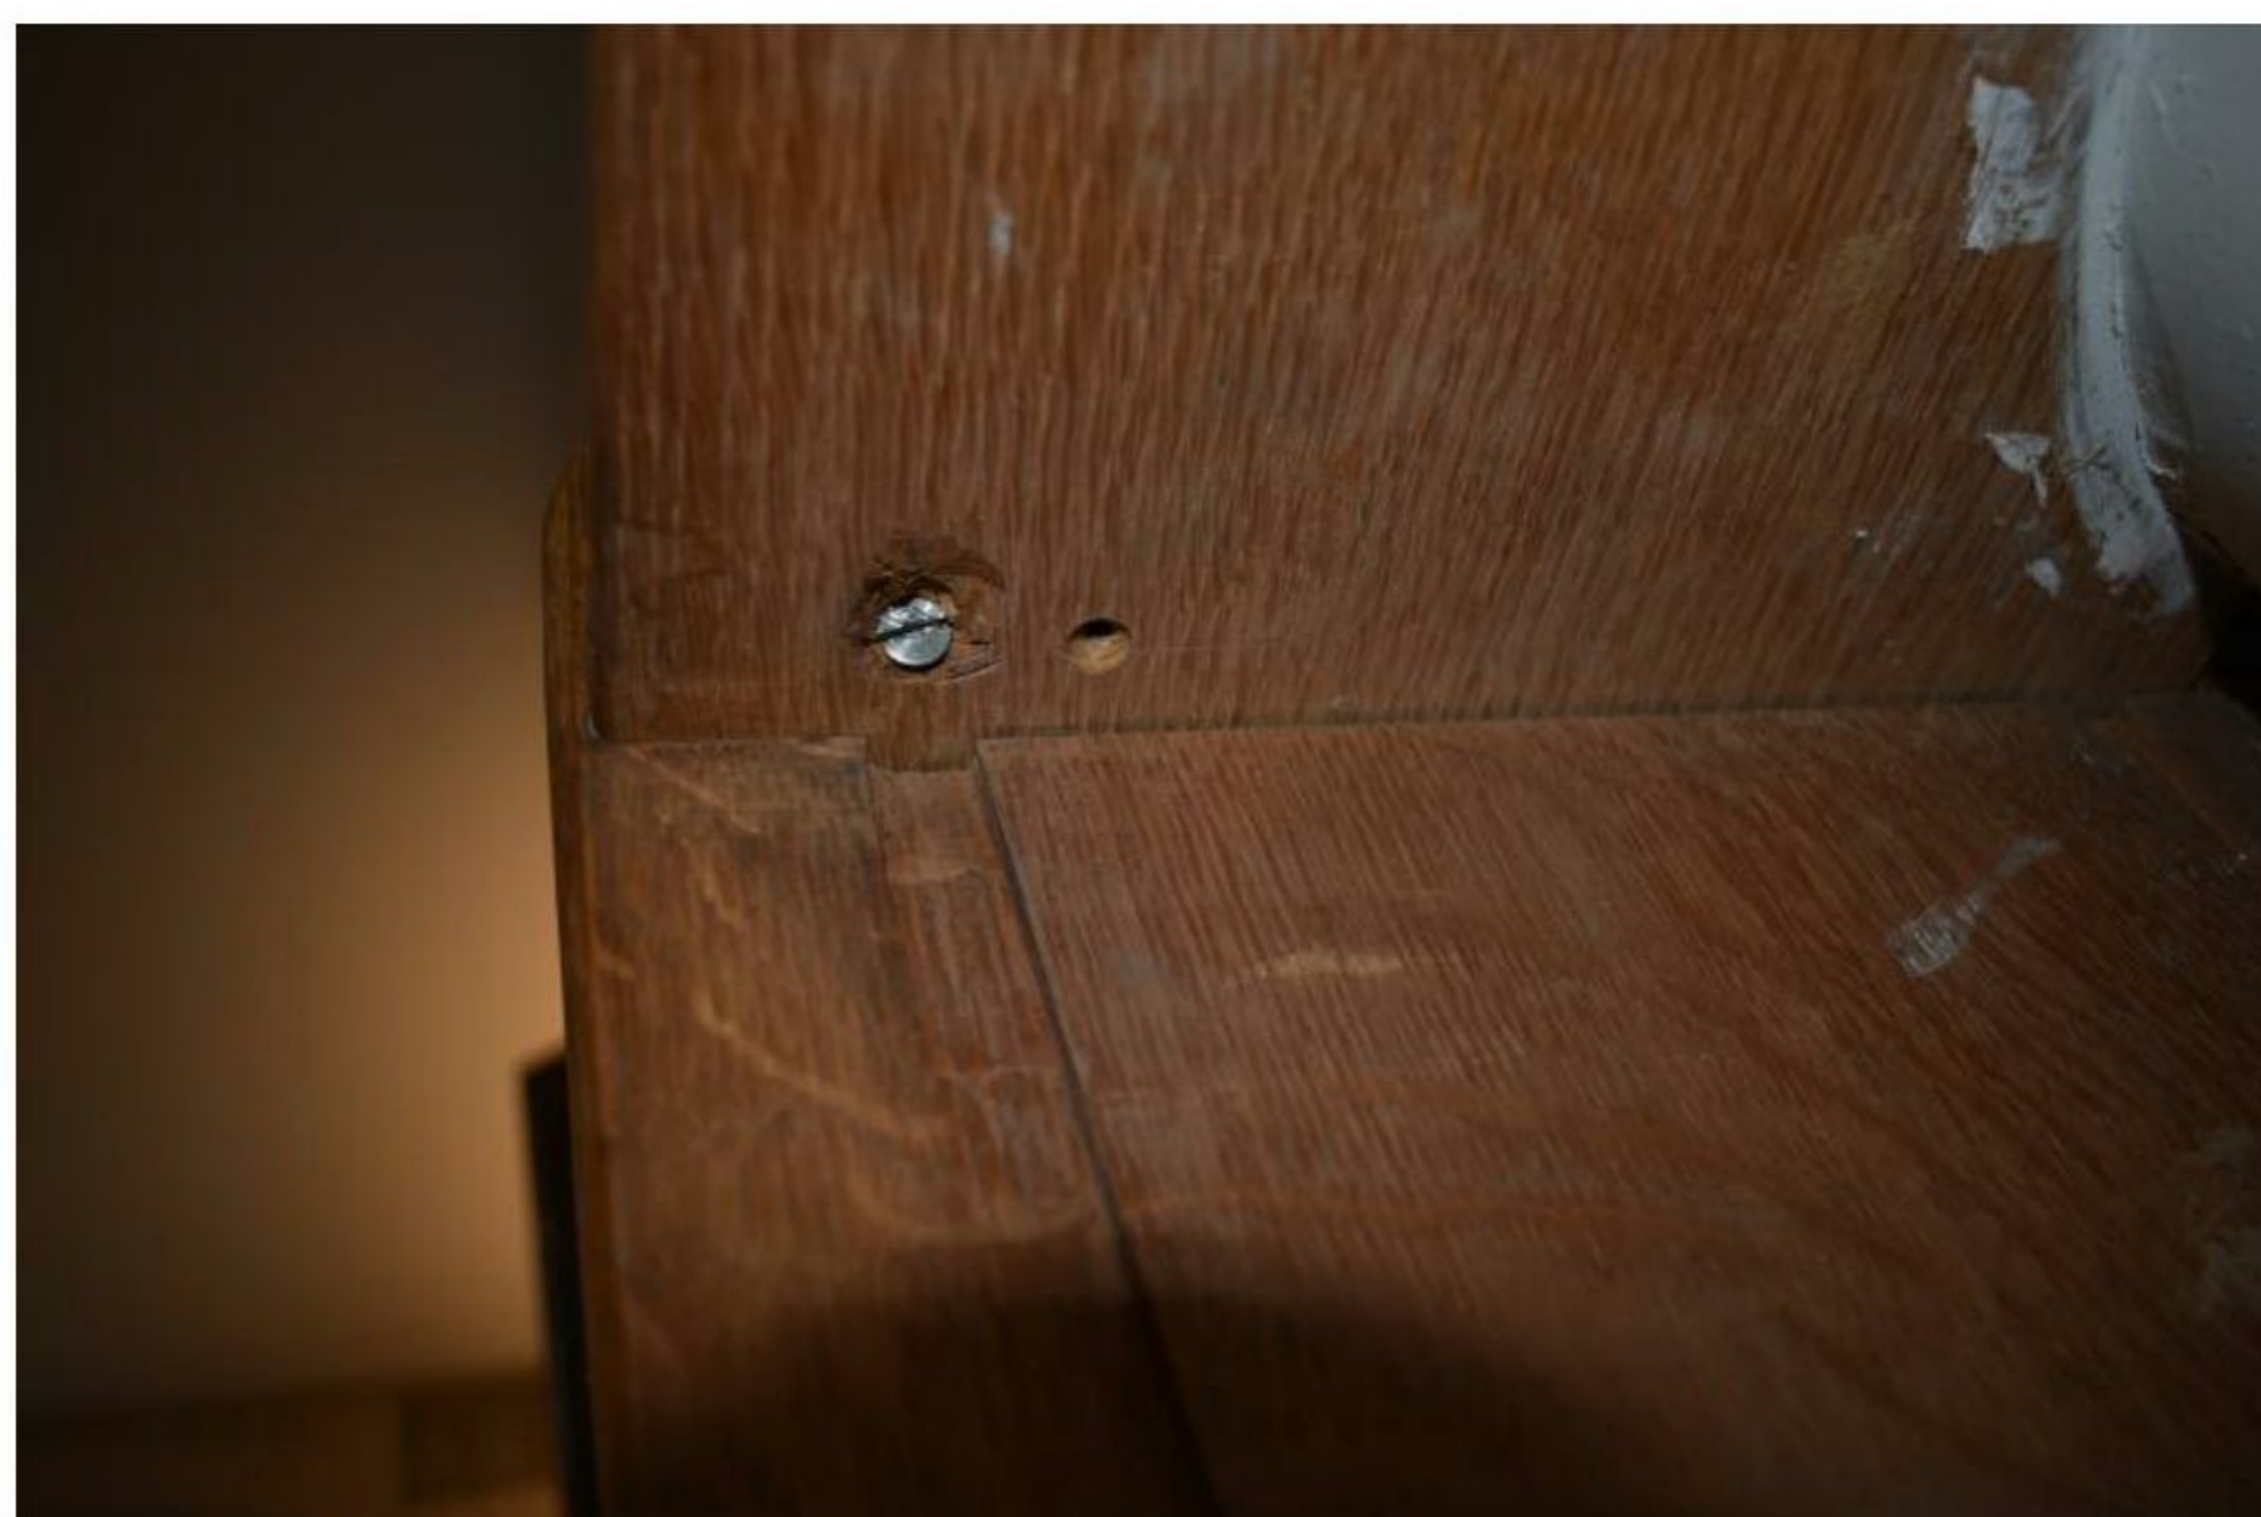
Screws connecting the fixed shelf unit to the end and intermediate panels.
