Reuben College – Works Methodologies

Task Sheet MS06 – Jackson Wing, Sample Wall and Ceiling Plaster removal as part of Asbestos Abatement Works. February 2021.

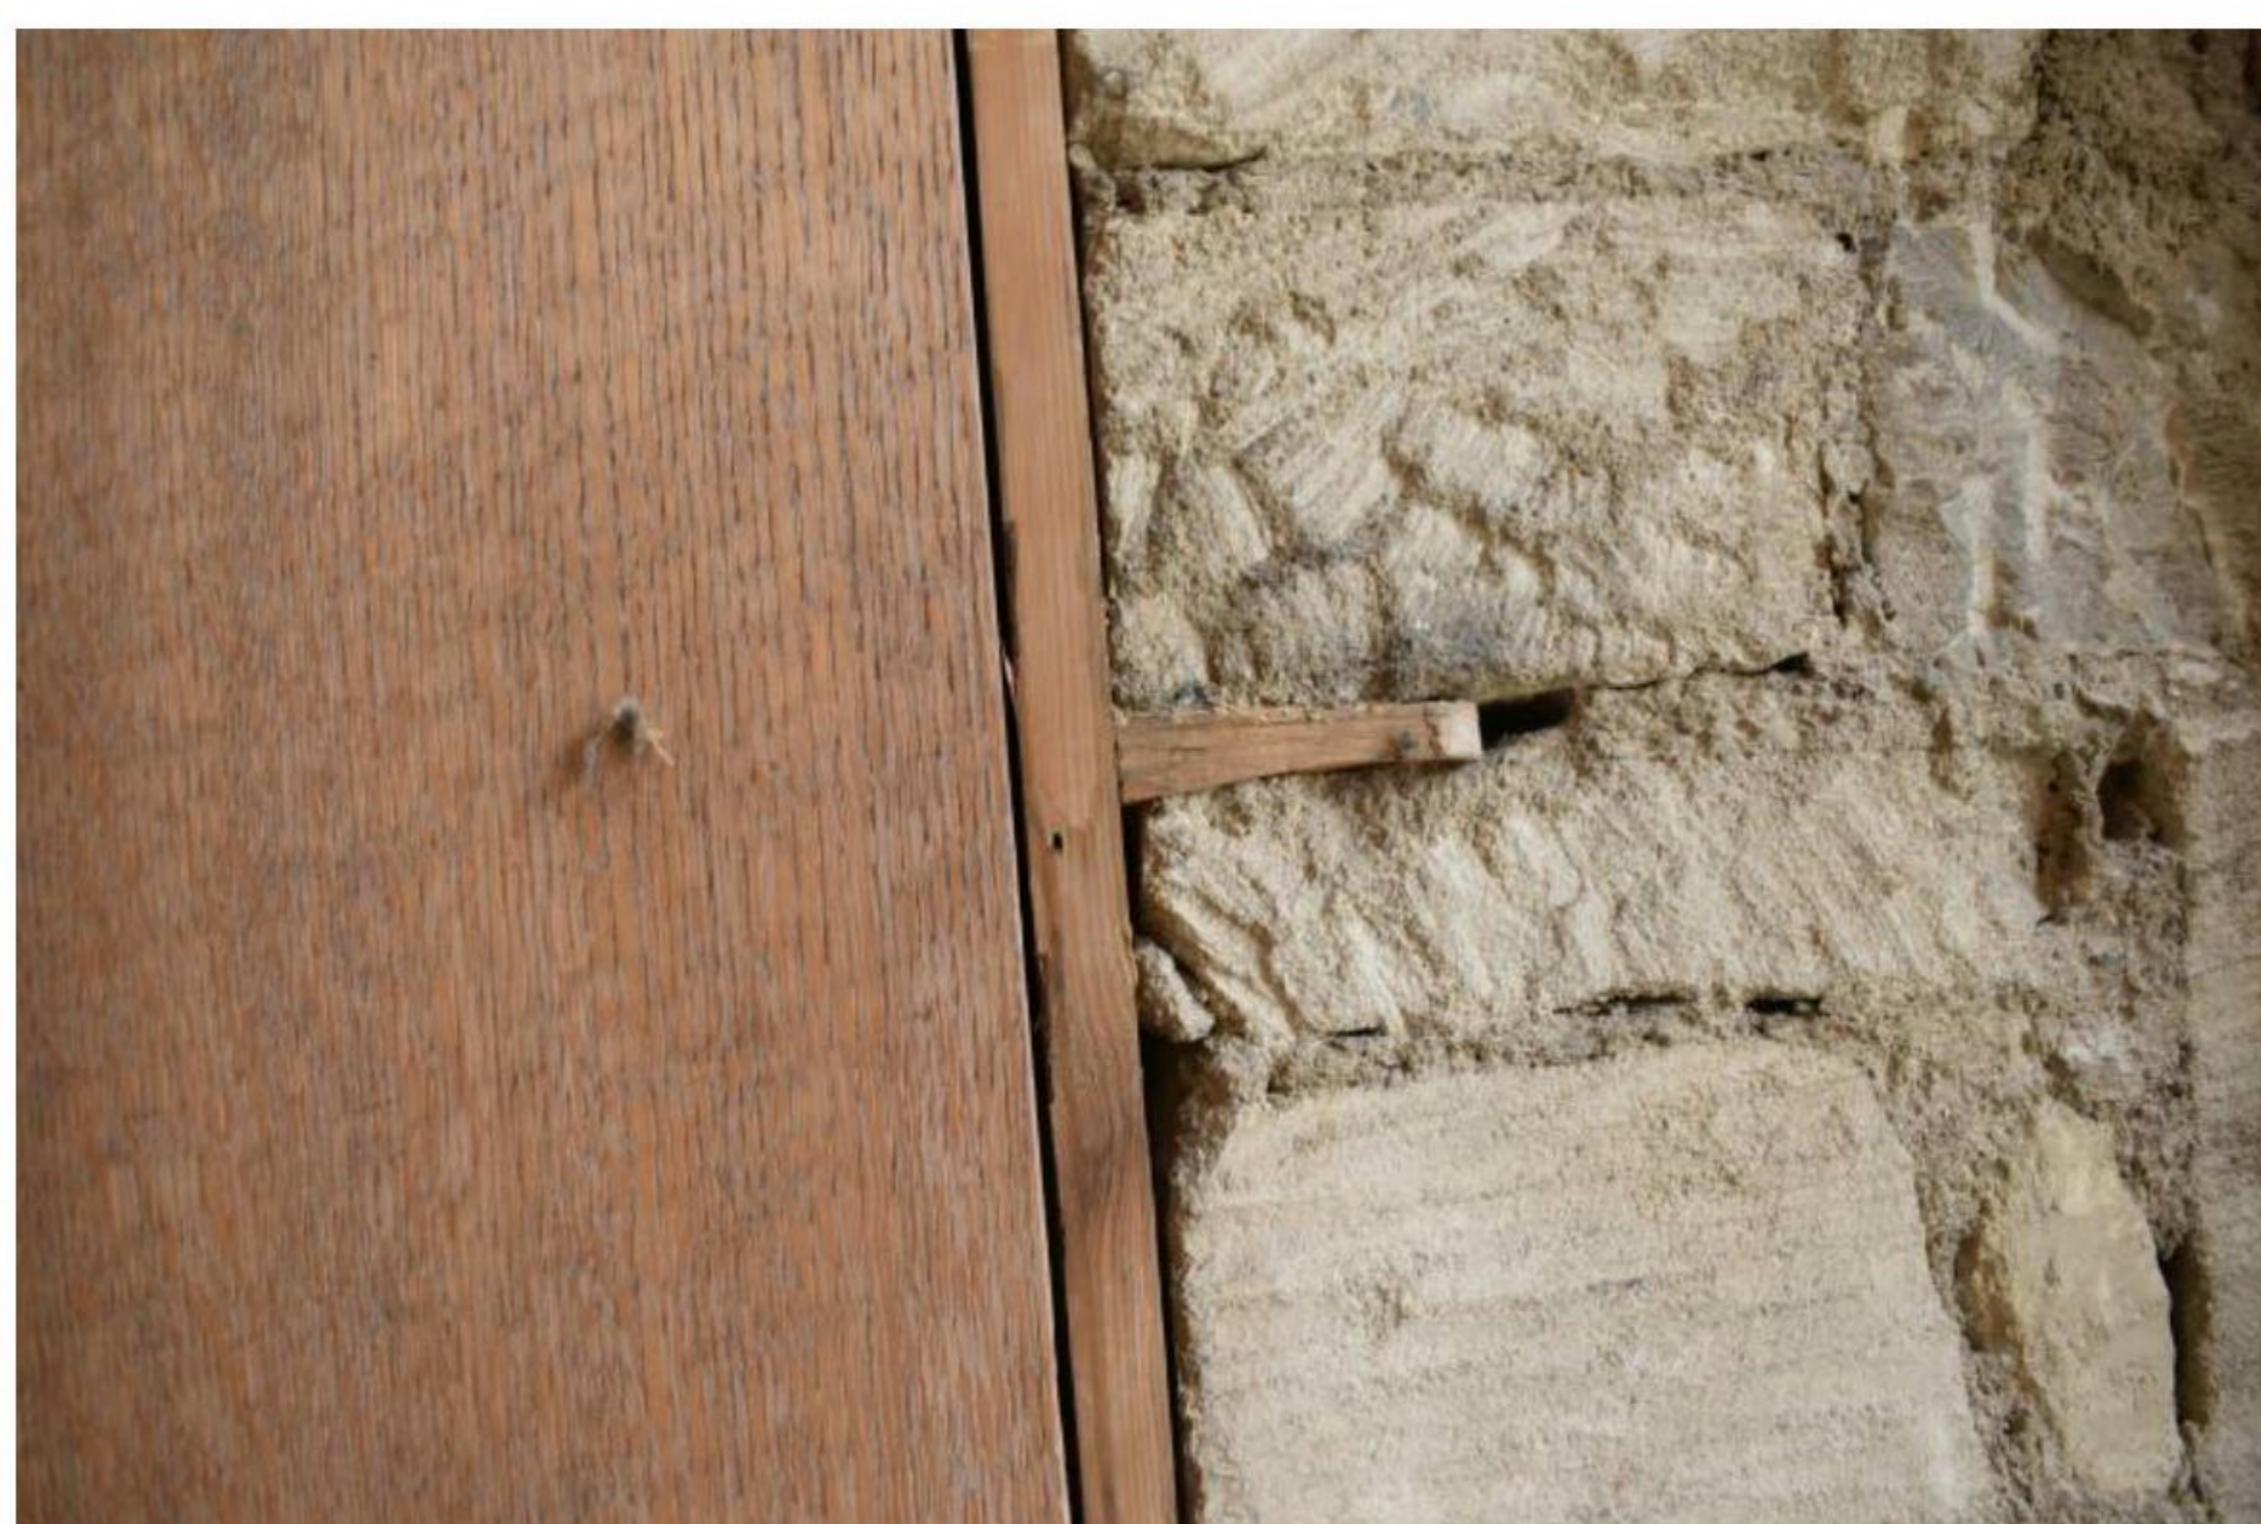
Casing Fixings

The wall mounted bookcase units are fixed to timber grounds which are themselves fixed directly to the masonry wall with timber blocks.

An additional batten at the head of the bookcases secures these in position.

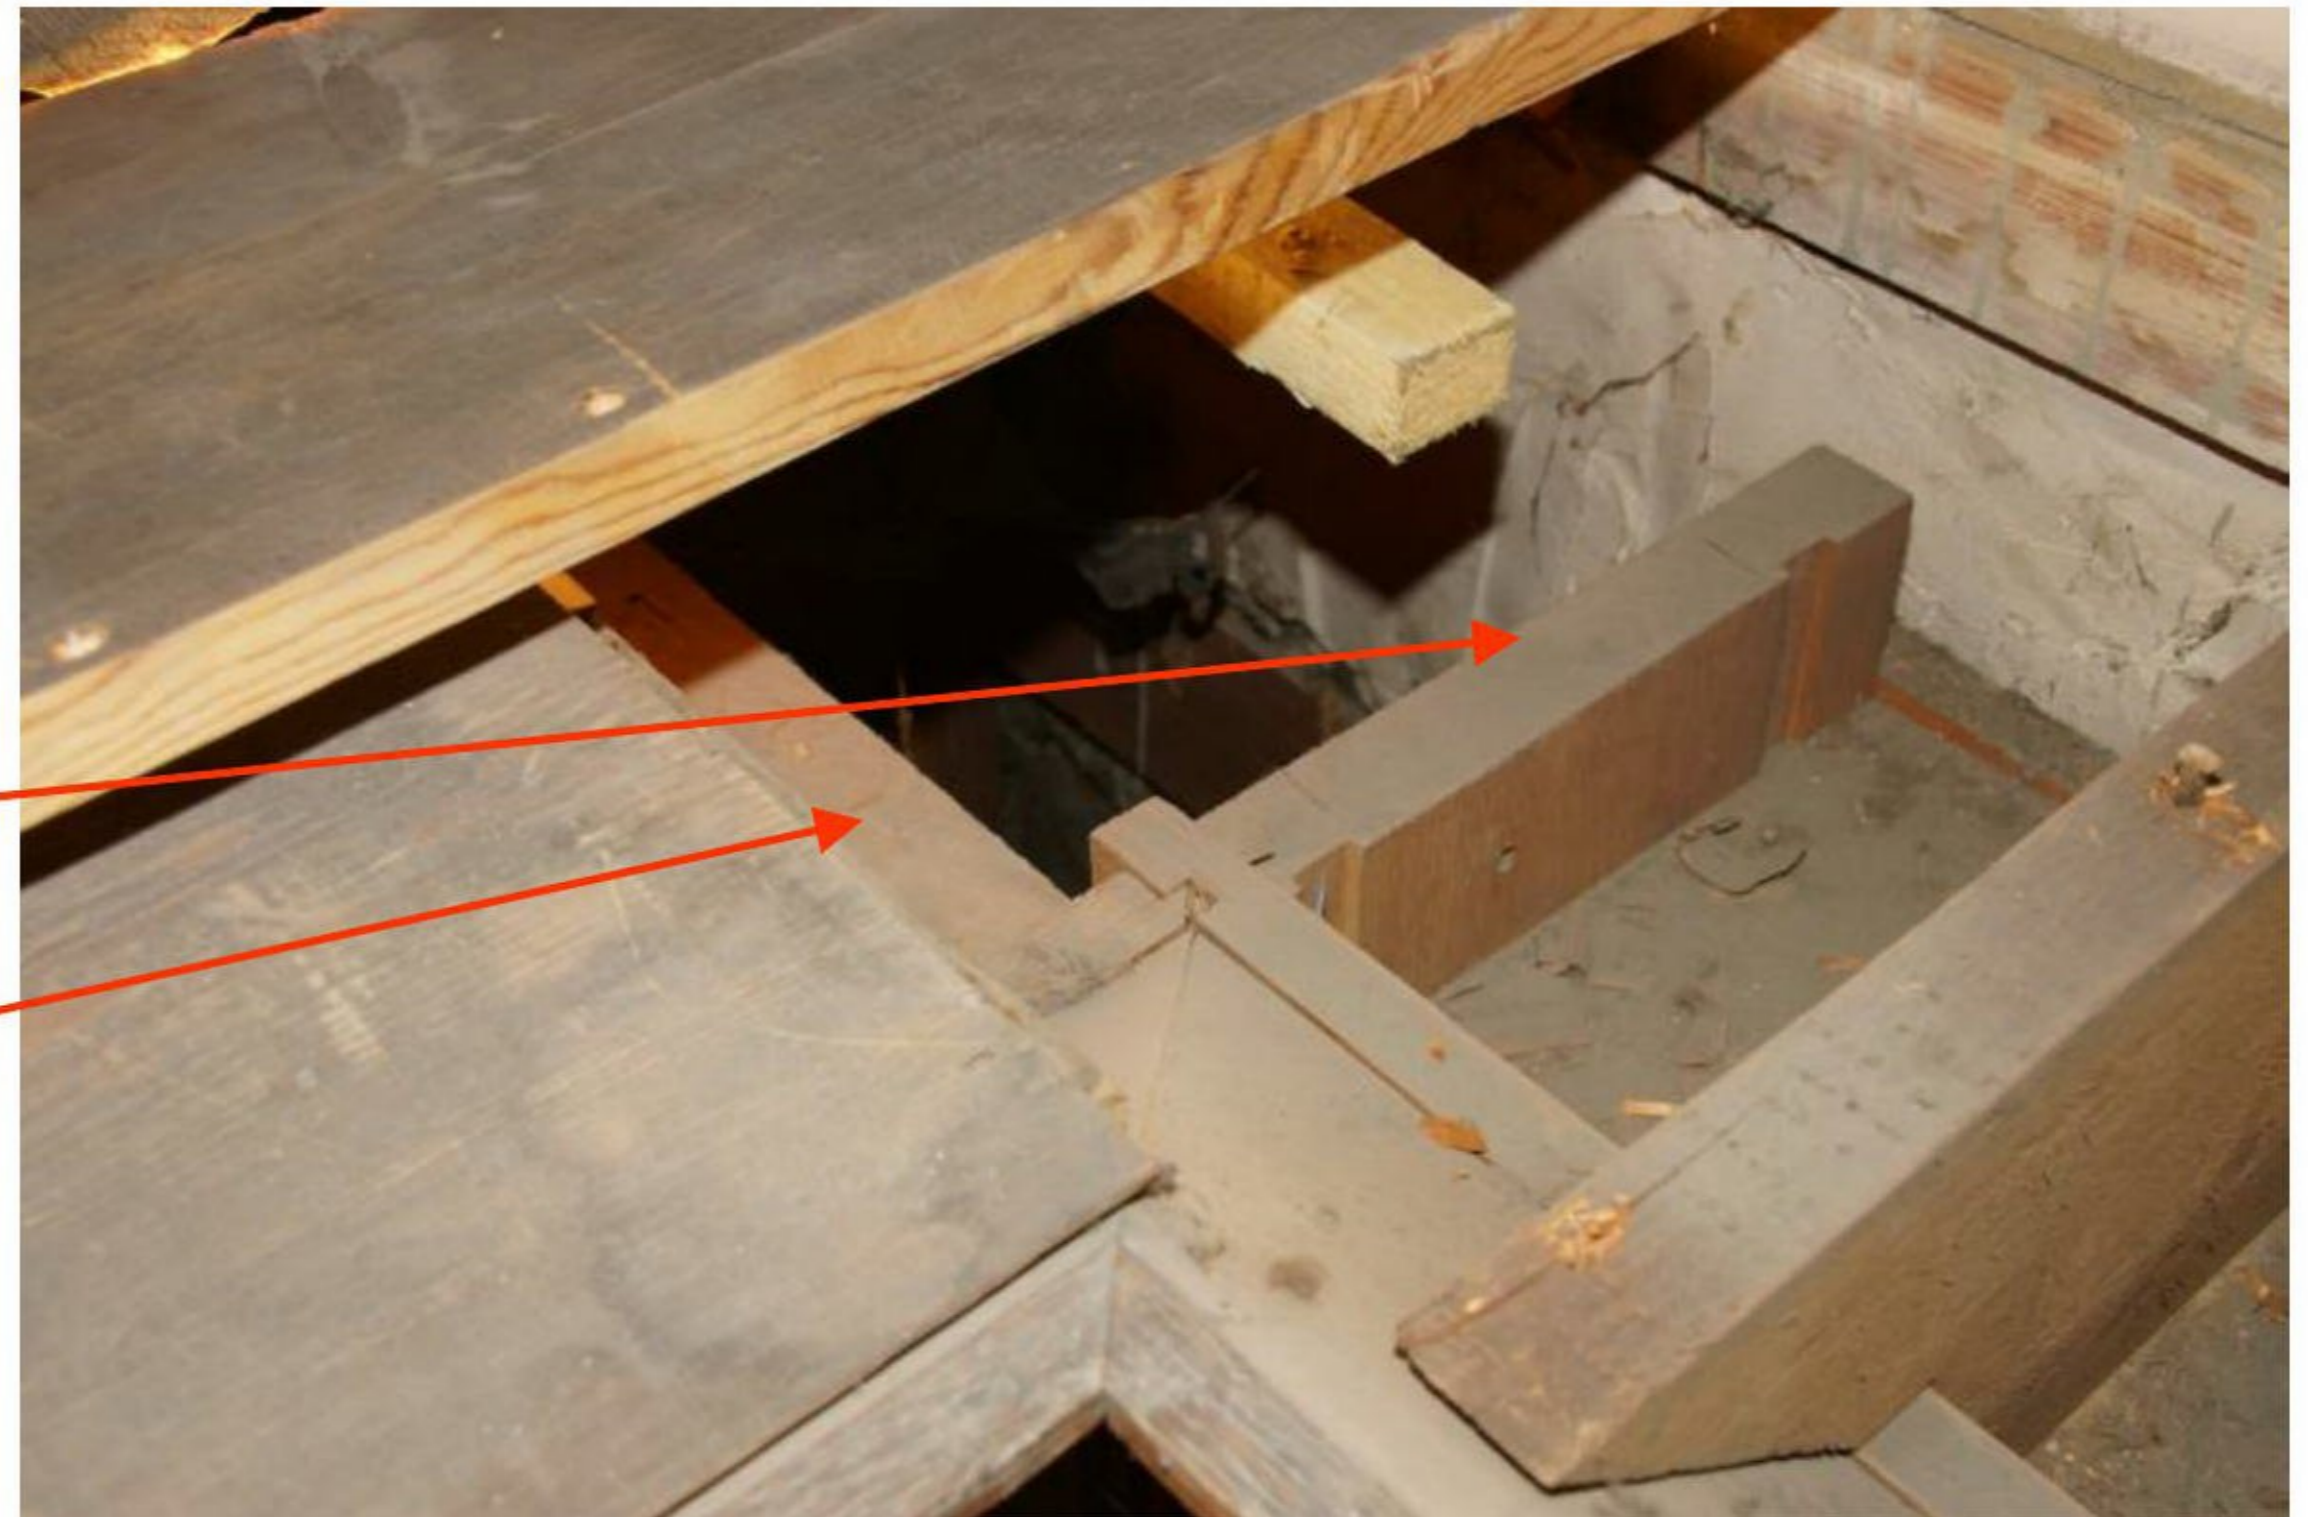
The wall mounted bookcases have been fixed in position prior to the projecting element which has a rebated joint into the end casing upright.

End of RHS bookcase.

End of projecting bookcase.

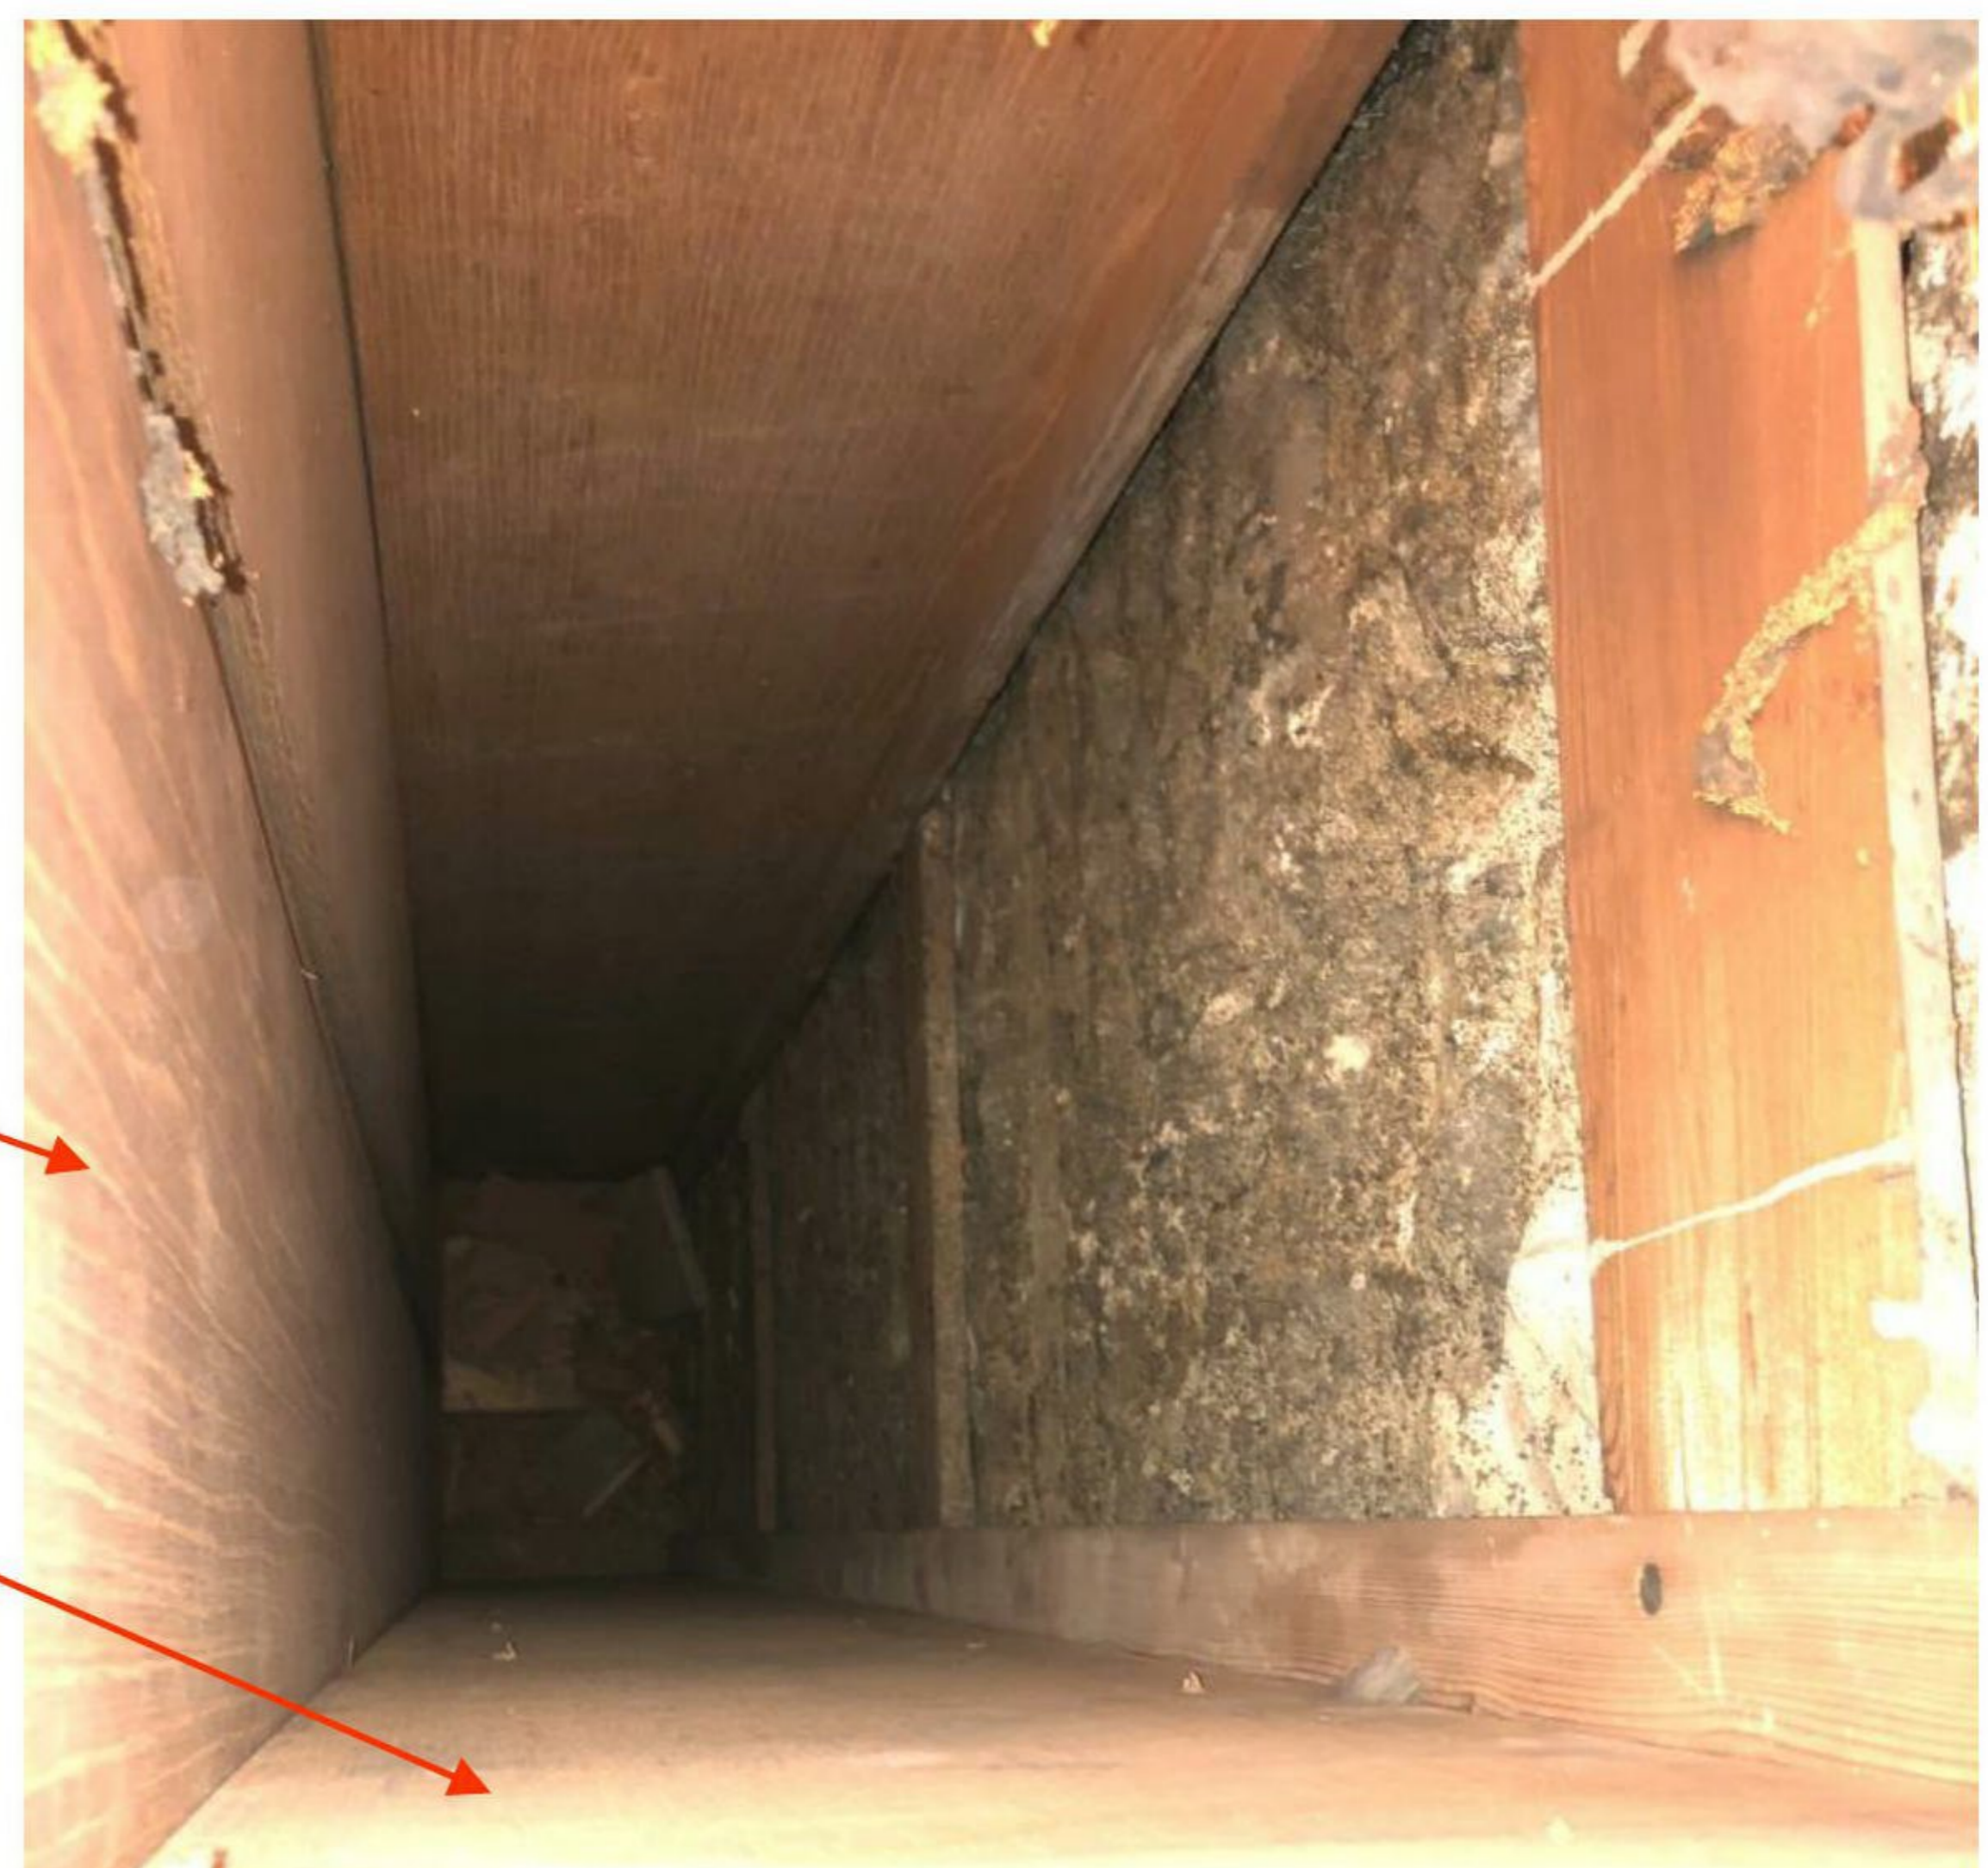
View into void area between the 3No bookcase elements.

Wall is not finished – grounds fixed directly to stonework.

End of projecting bookcase

RHS bookcase end
