APPLICATION FOR CONDITION DISCHARGE

DC/18/00428/PLF/EASTSE

Proposal: Erection of a dwelling following demolition of existing building

Location: 21A Eastgate, Lund, East Riding of Yorkshire

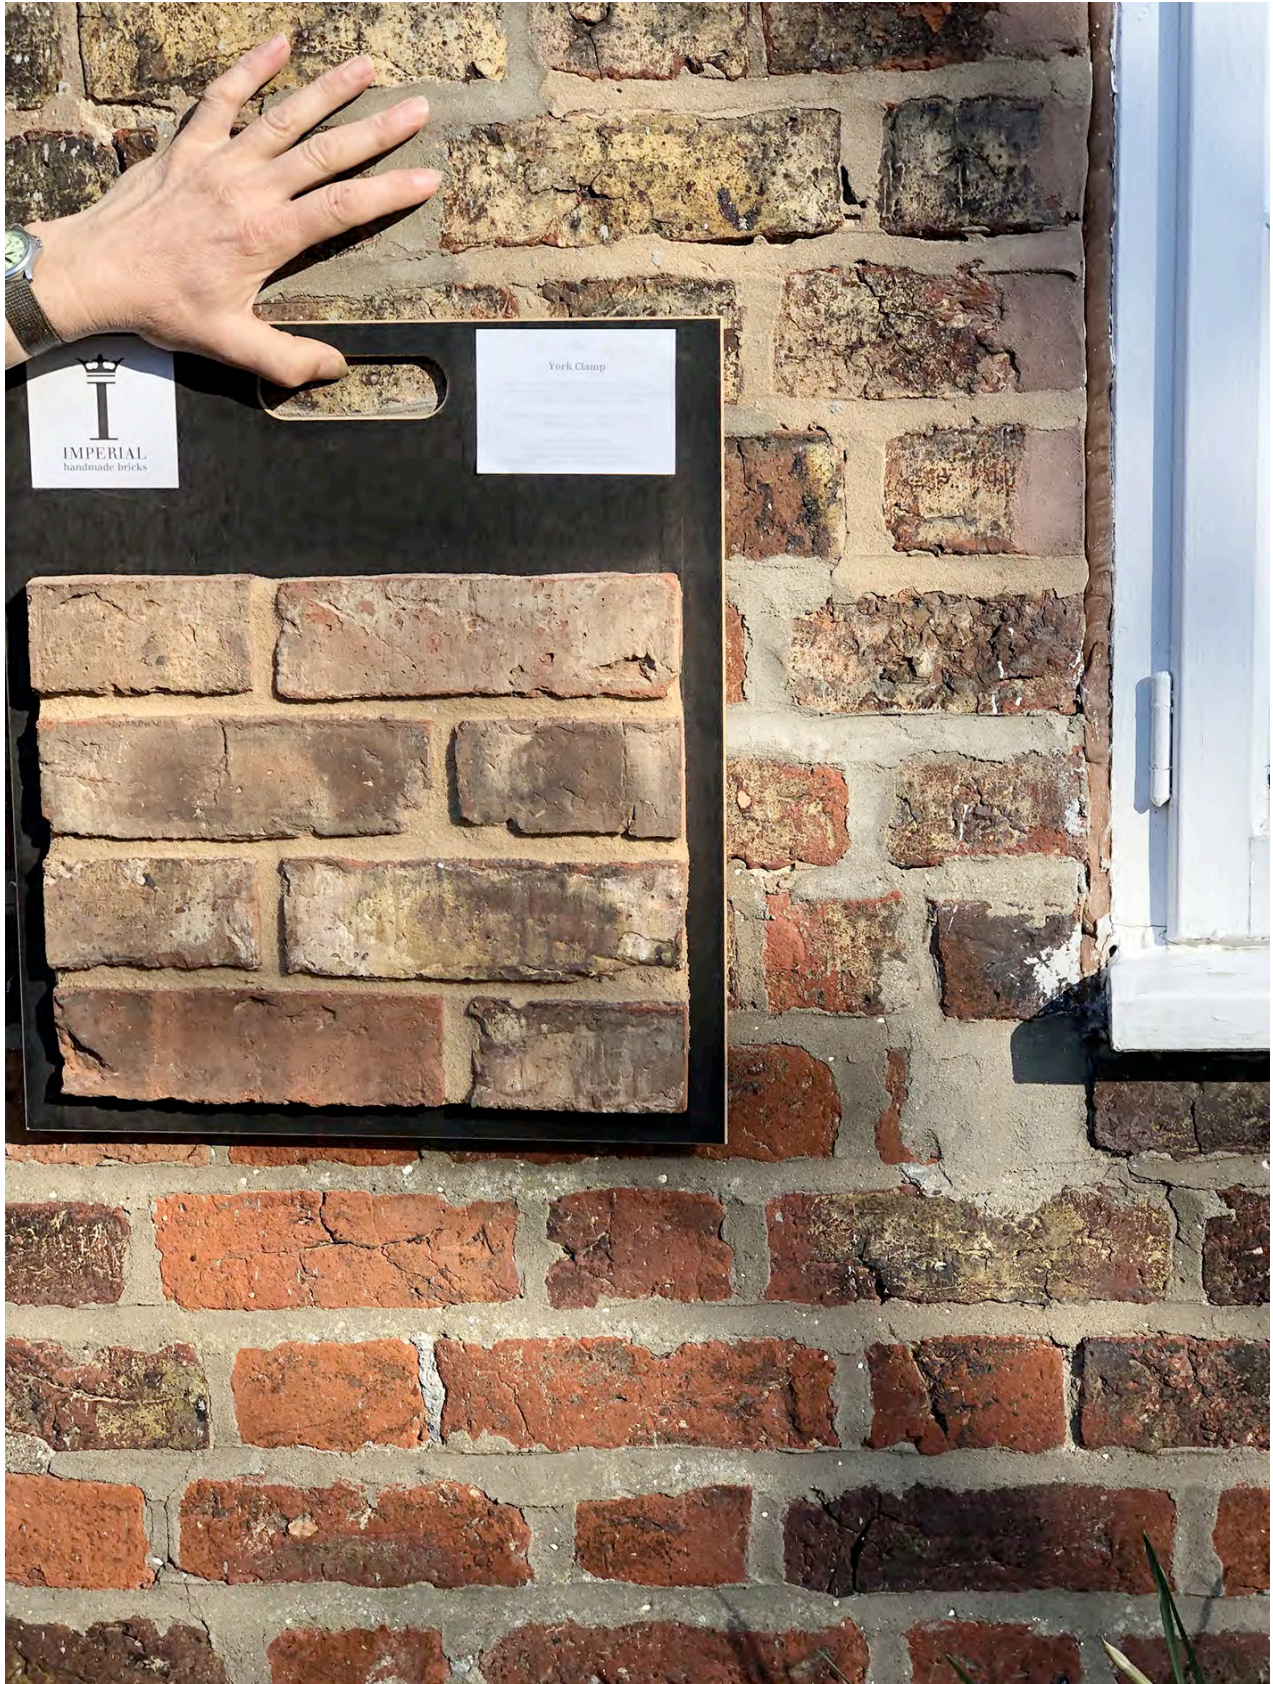
Bricks: York Clamp; Imperial Handmade bricks

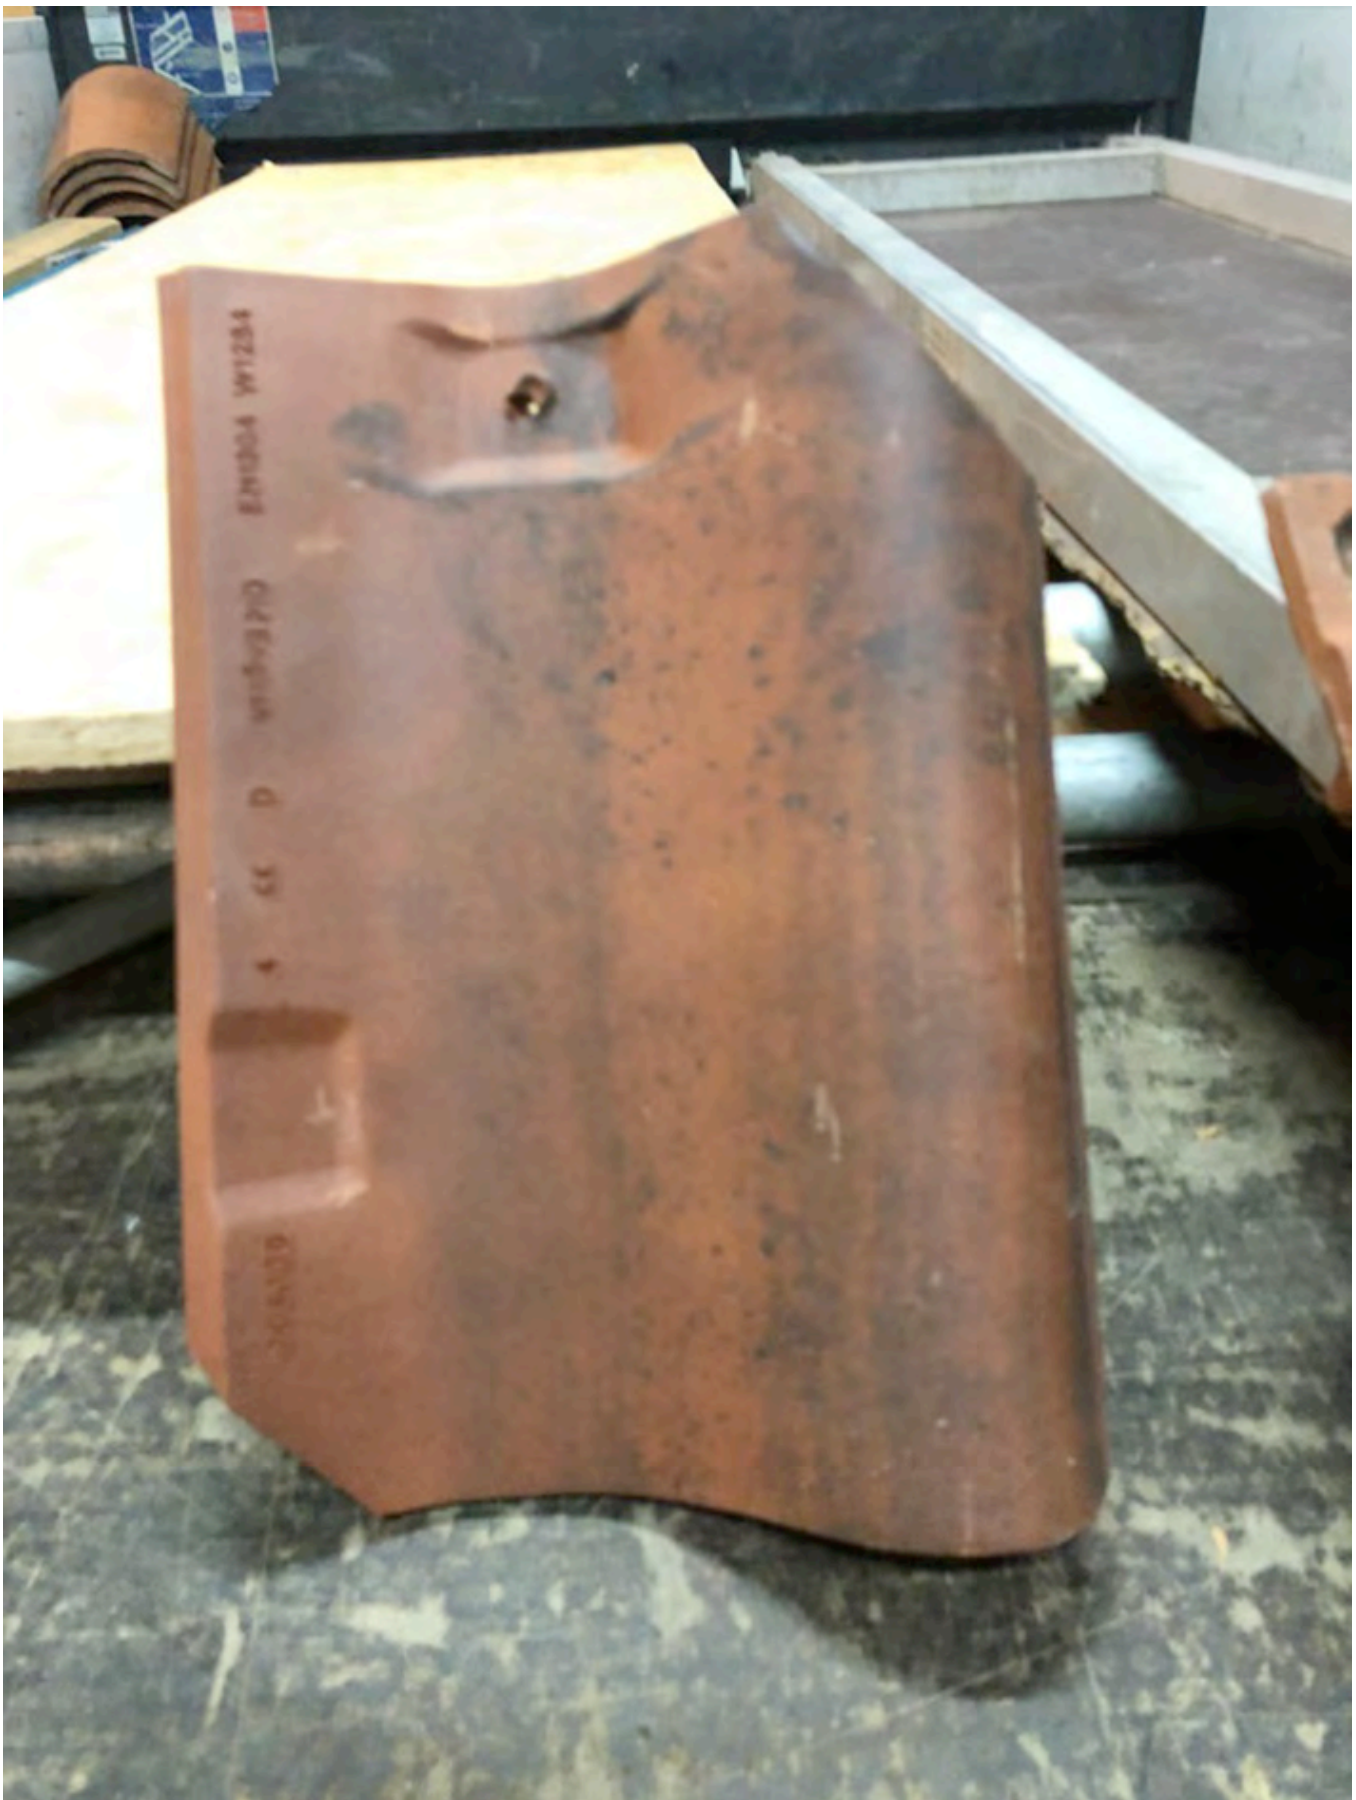
Roof pantiles: Sandtoft New Machine-made; Arcadia

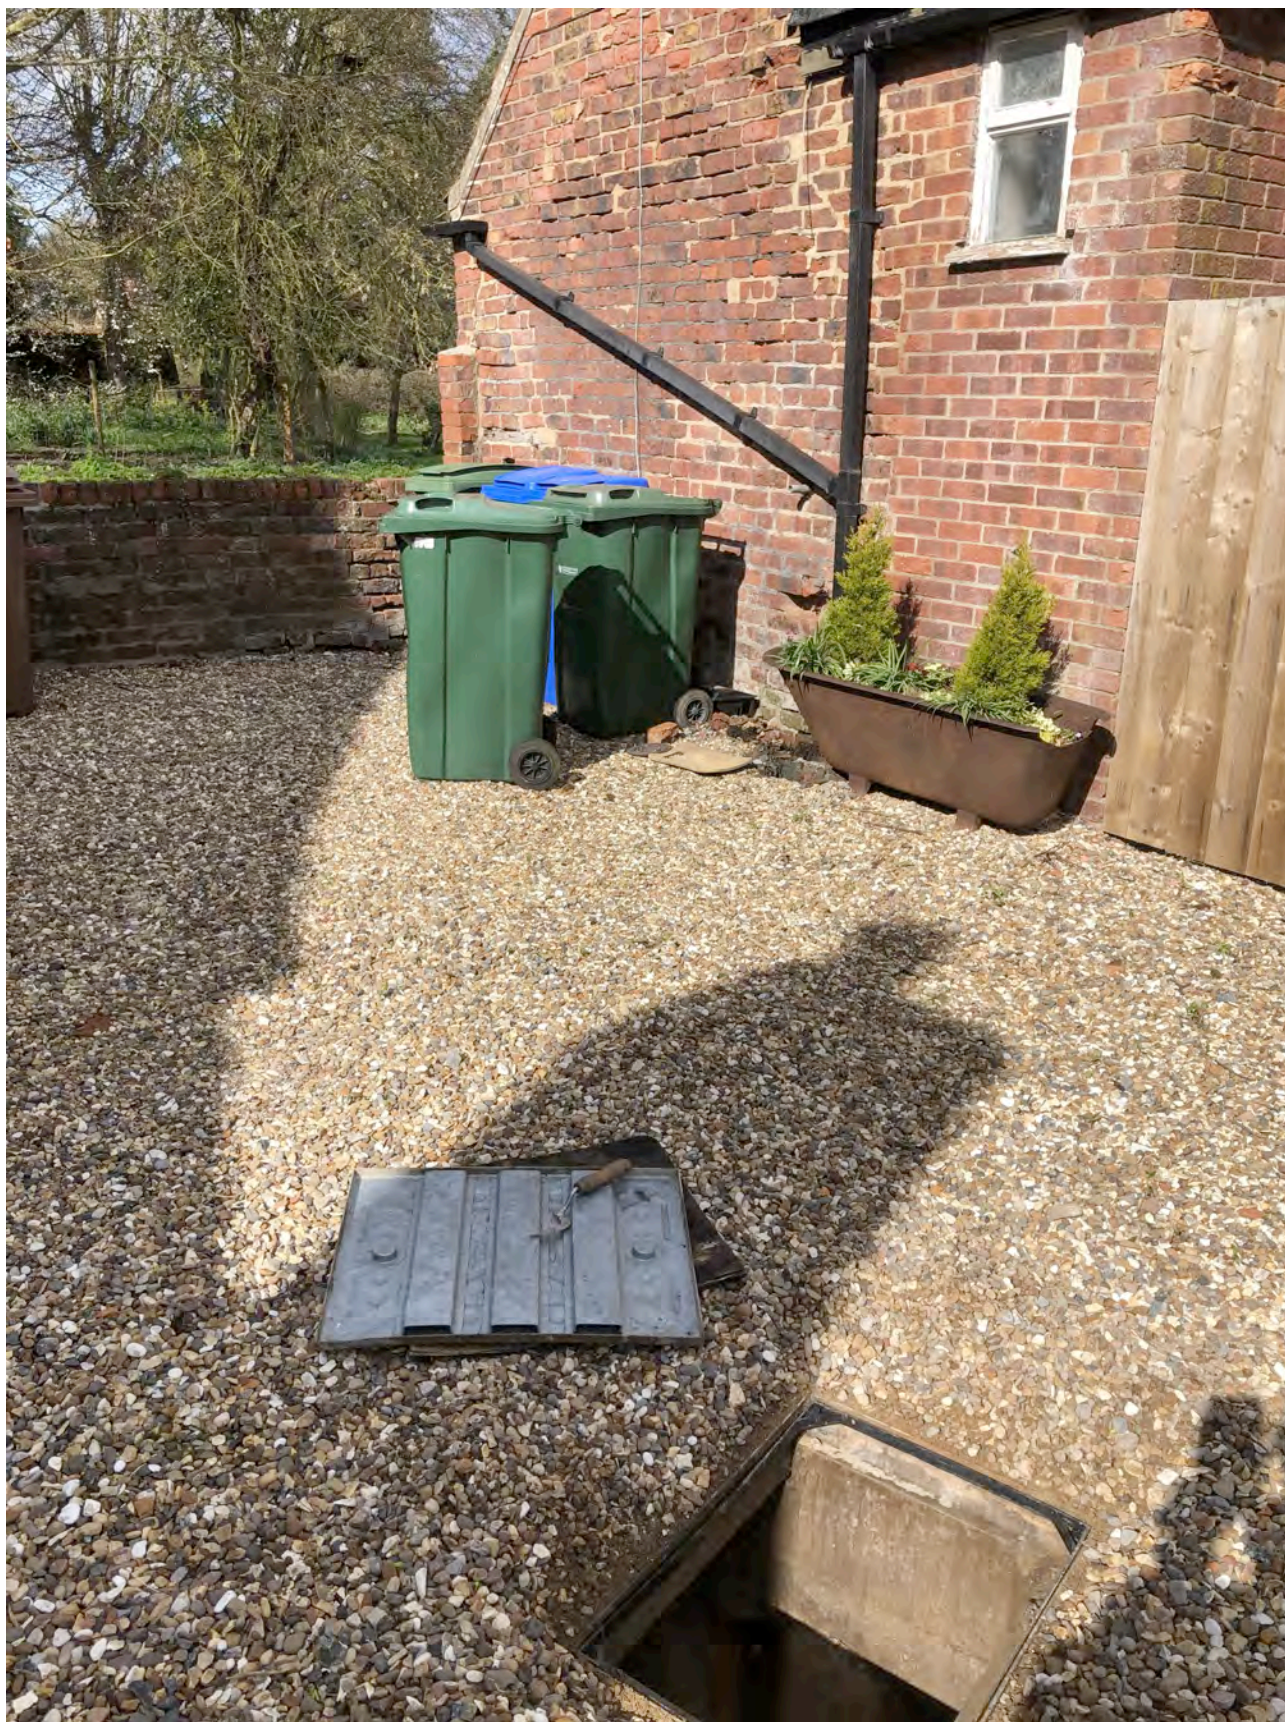
Gable end of No.21A (Application property) with rainwater downpipe visible, with Inspection chamber in the foreground.

The lane, Eastgate, runs behind the low brick wall in the left of the photo.

1. Evidence that surface water from the existing dwelling already drains surface water to foul sewer

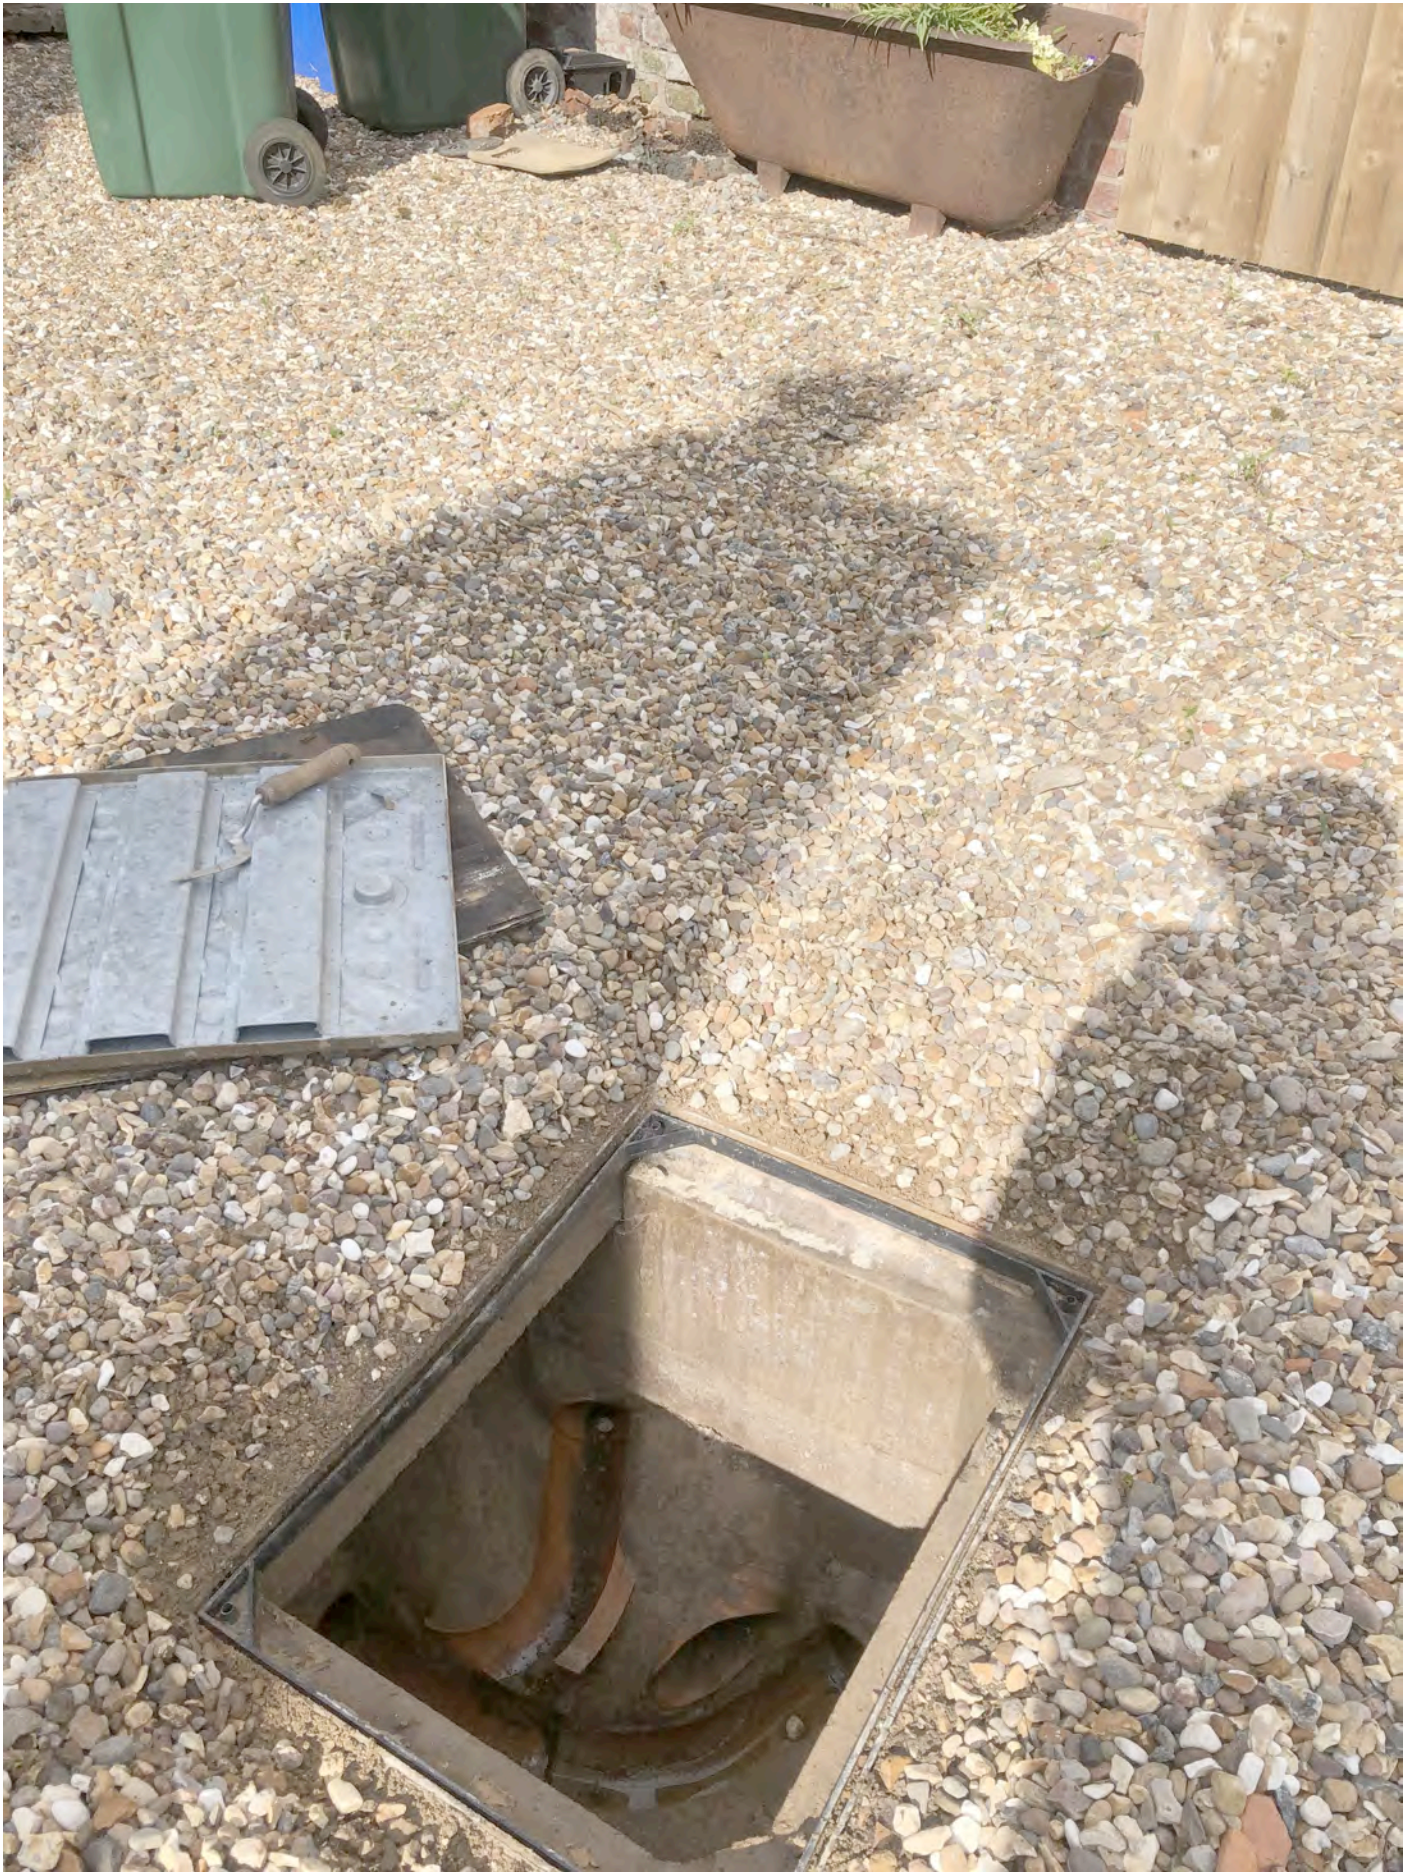
Inspection chamber, with internal arrangement visible

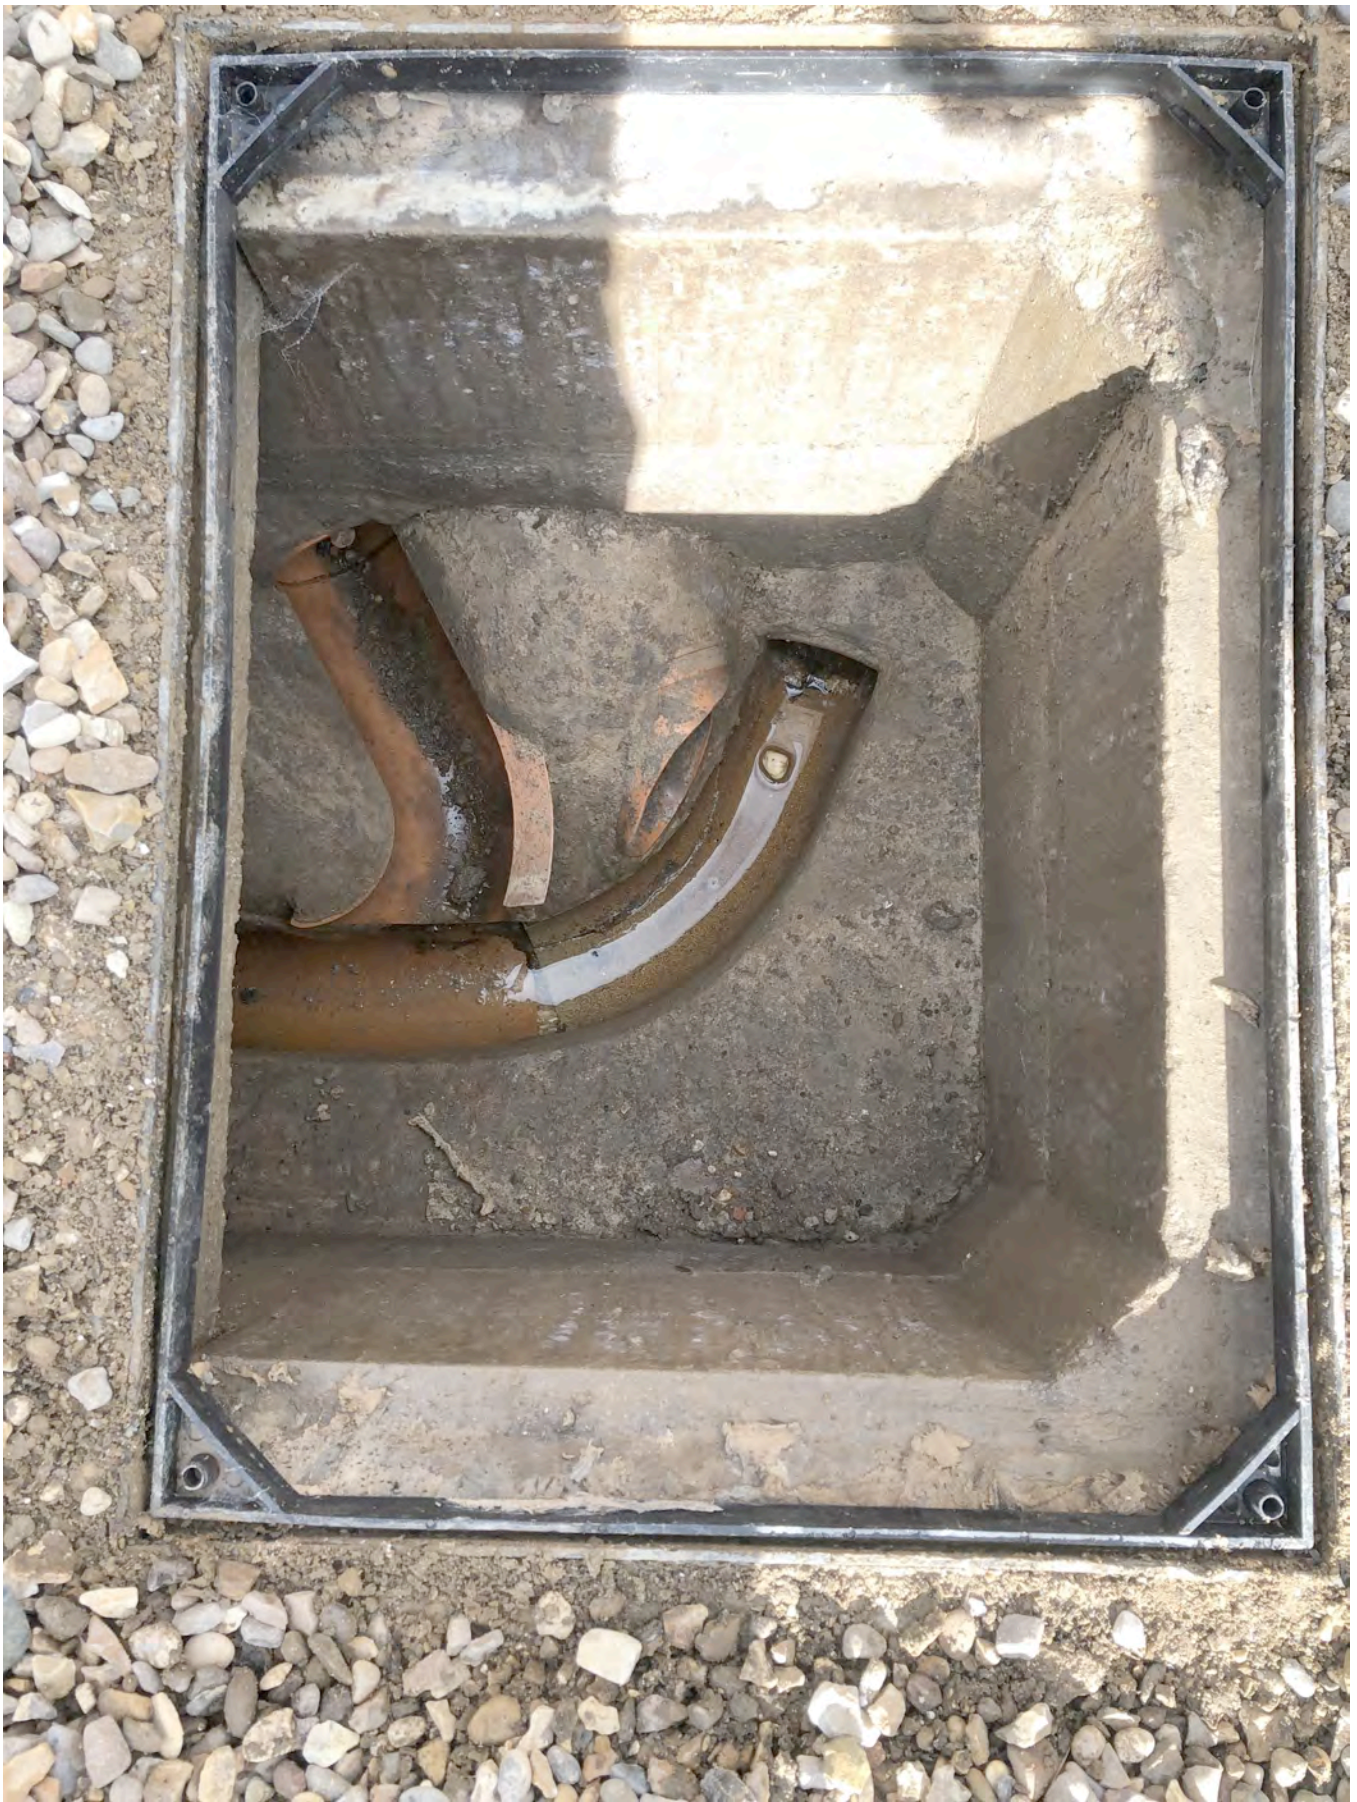
The inspection chamber receives: (L to R): Rainwater from No.21A gable; foul from No.21A; foul from No.21.
There is then the single discharge pipe to the main sewer under Eastgate.

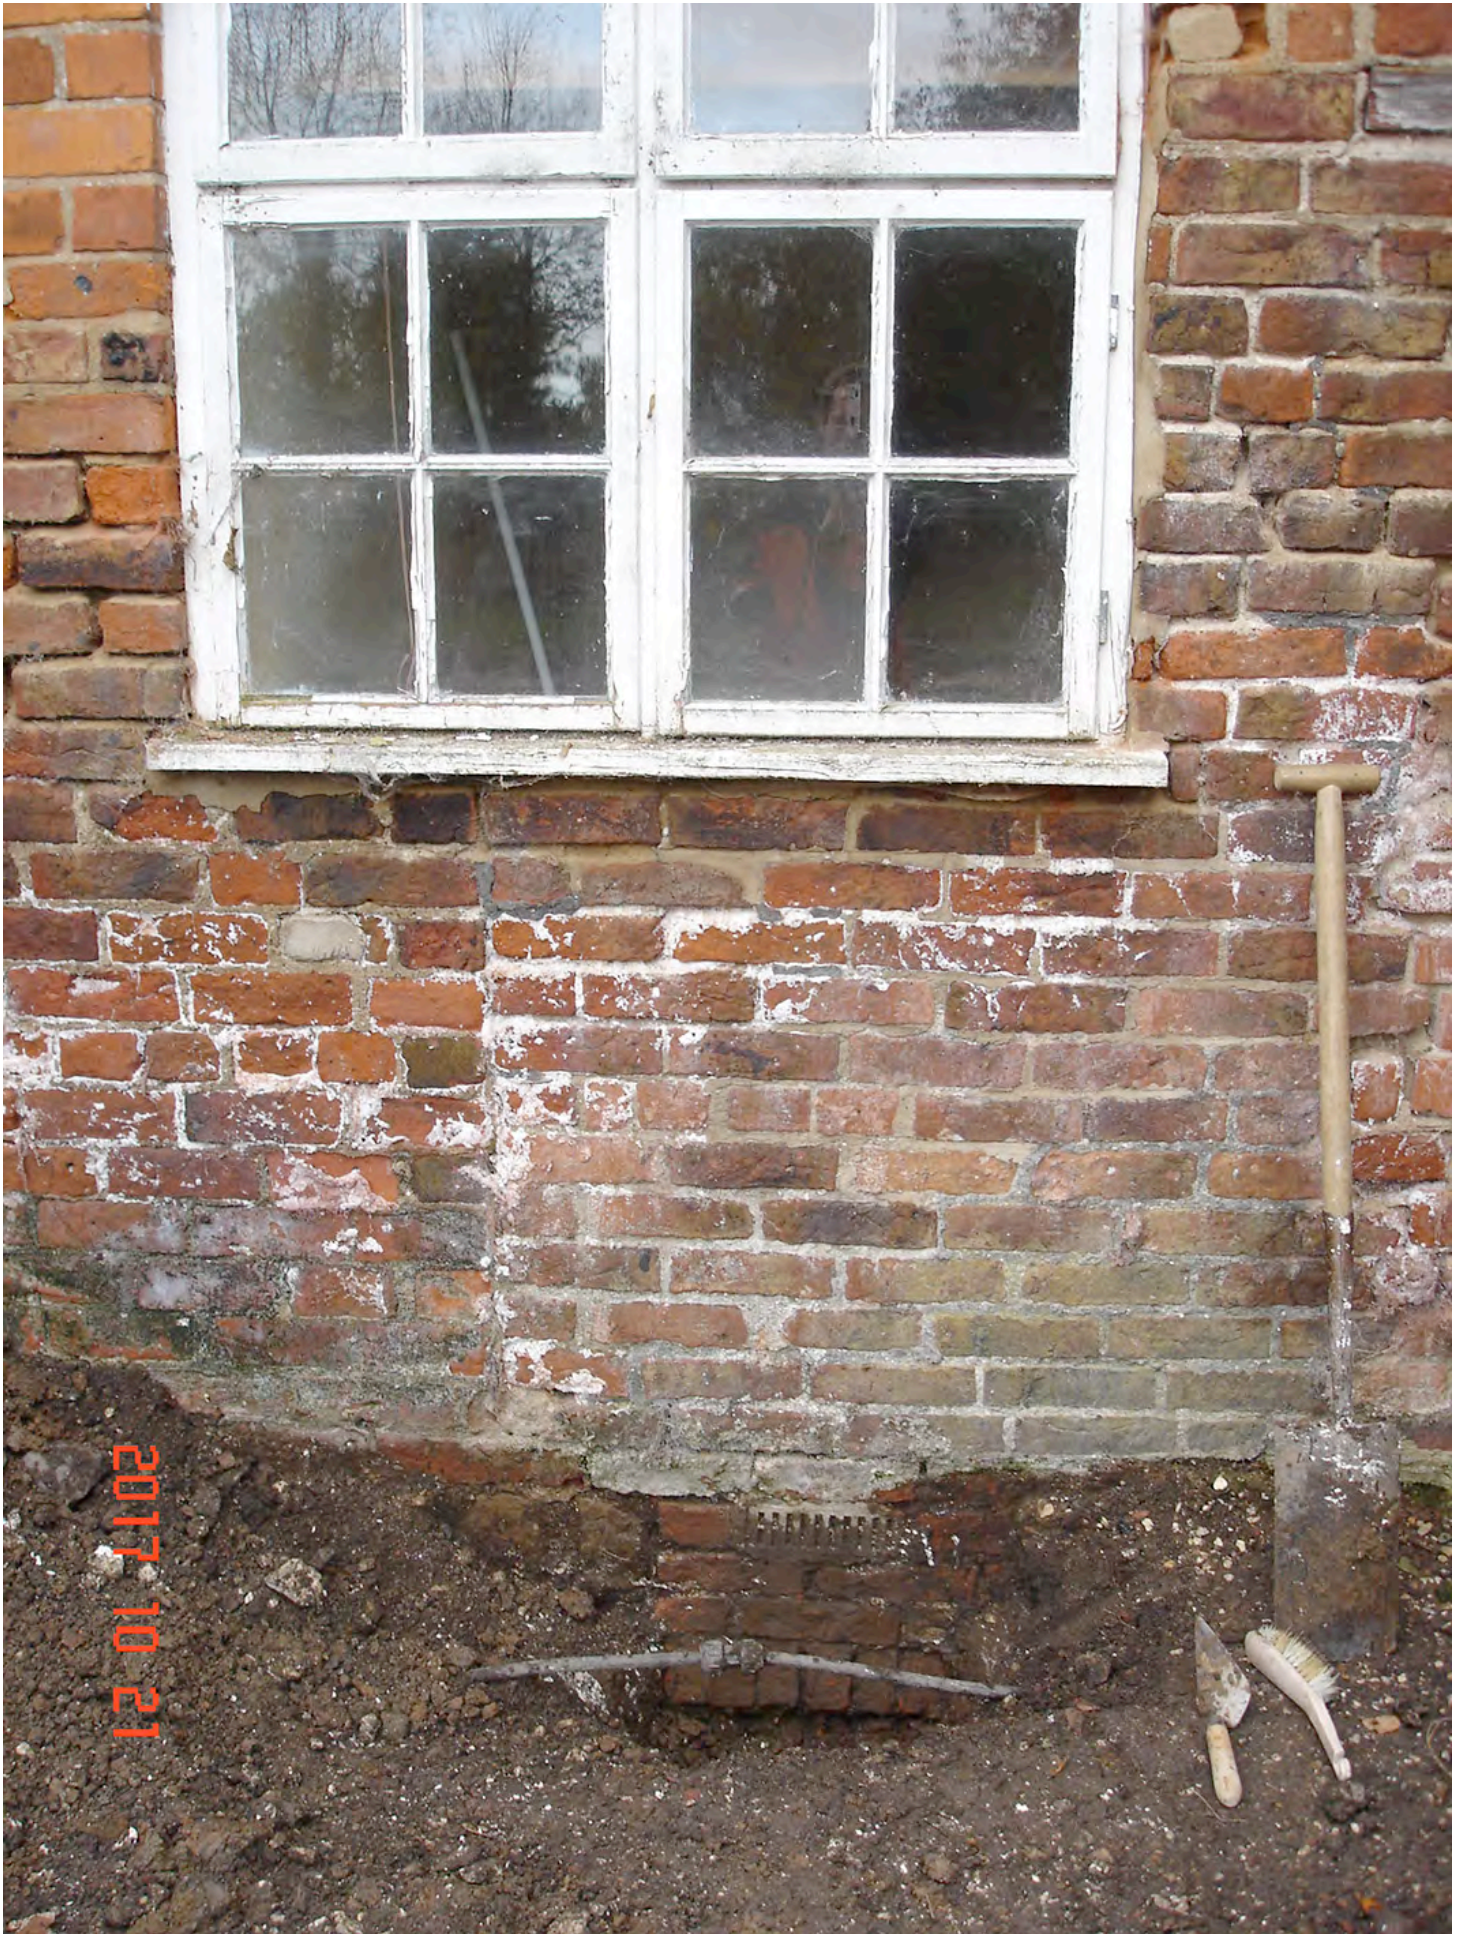
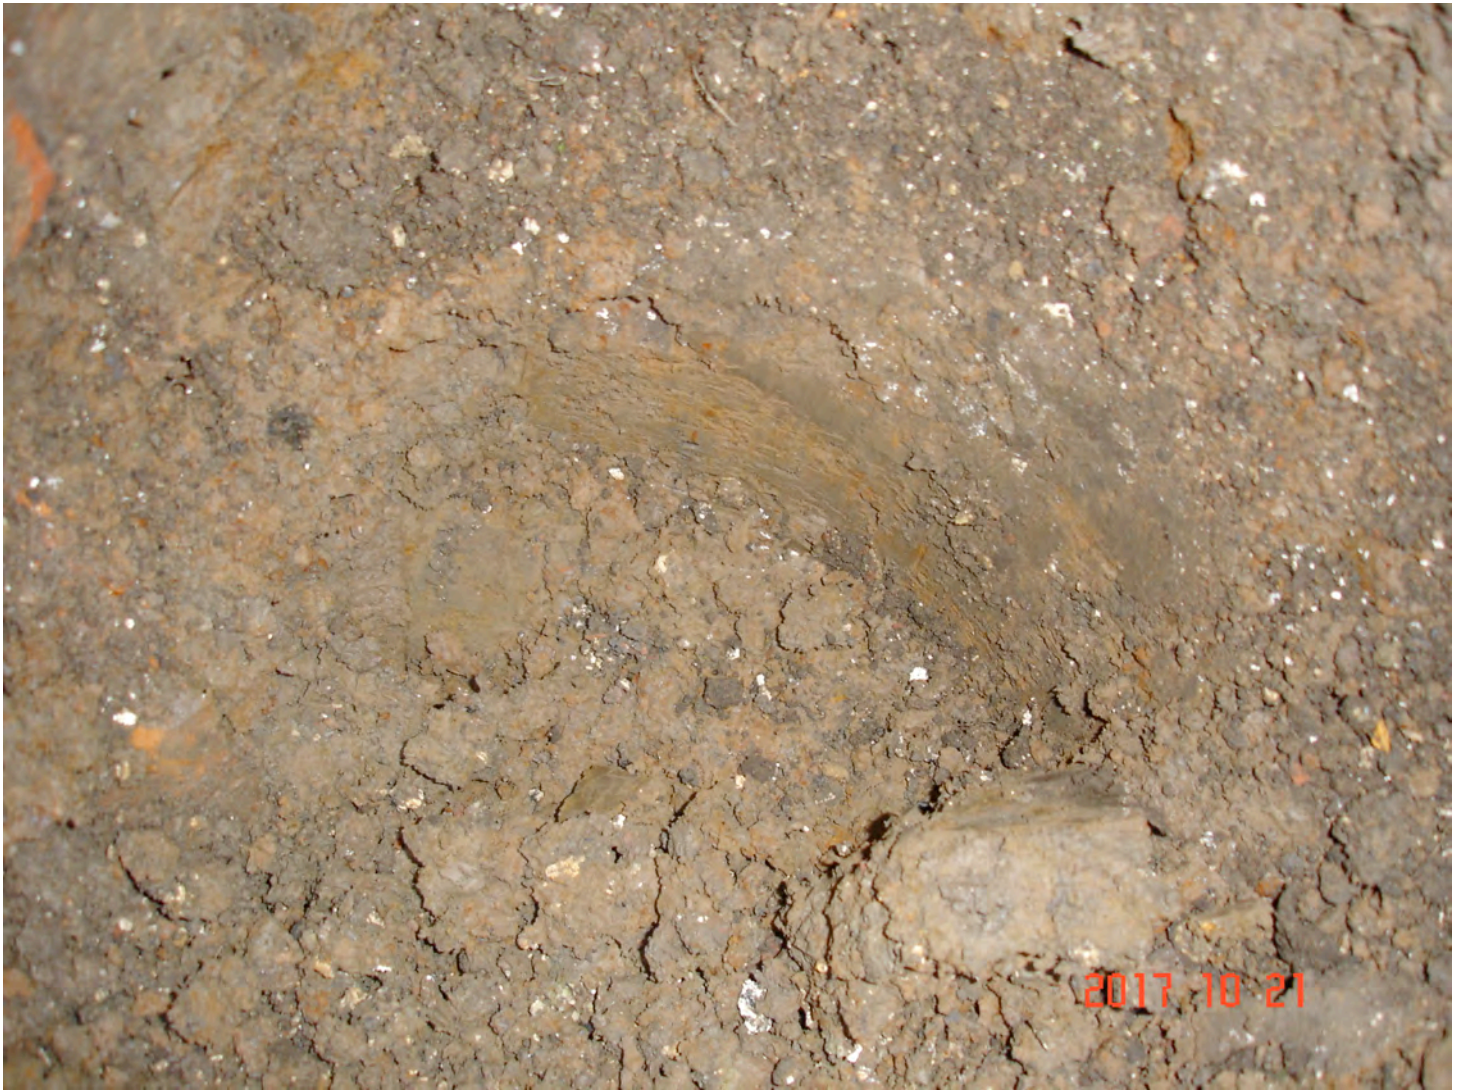
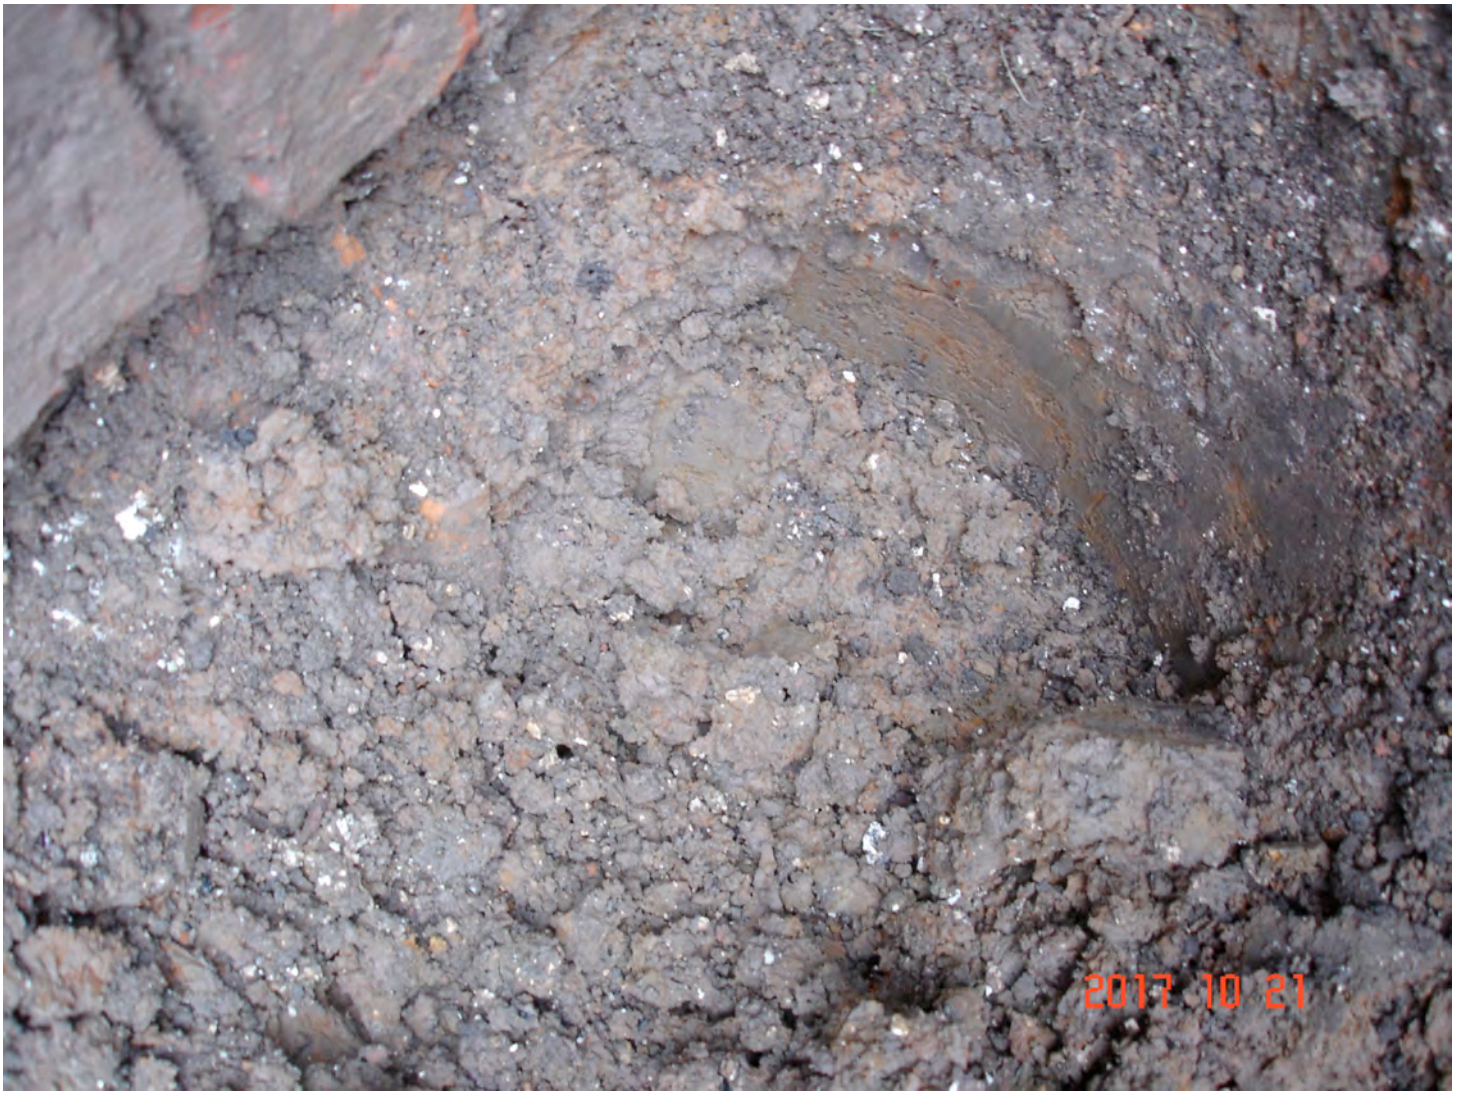
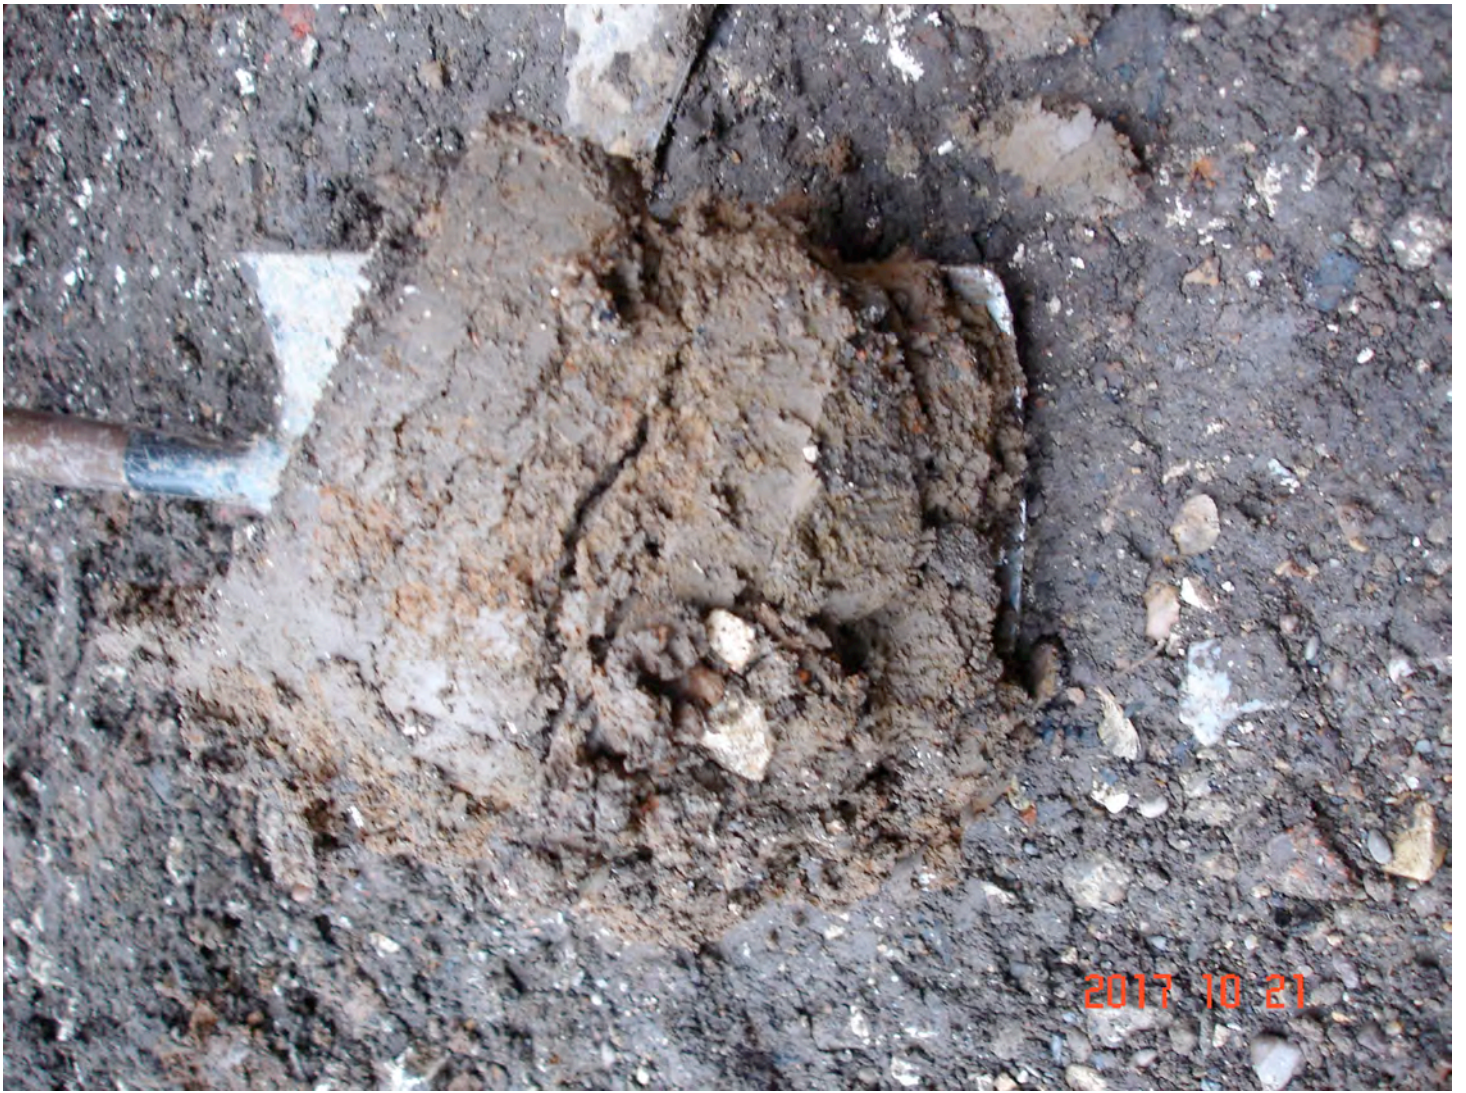
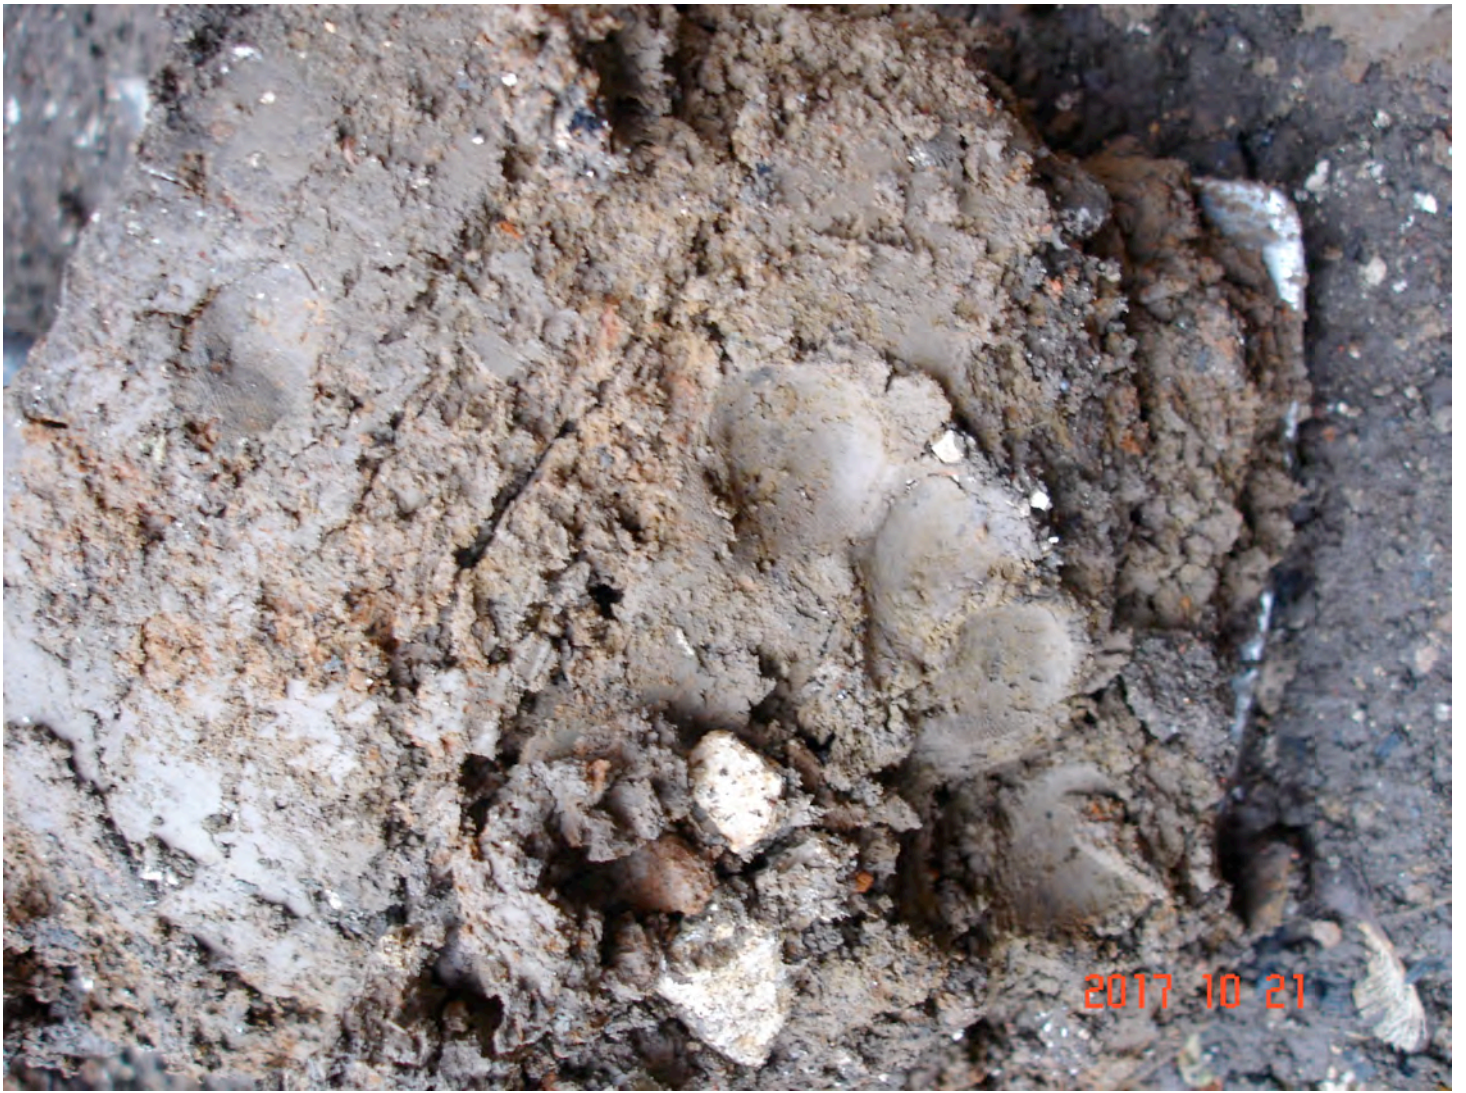
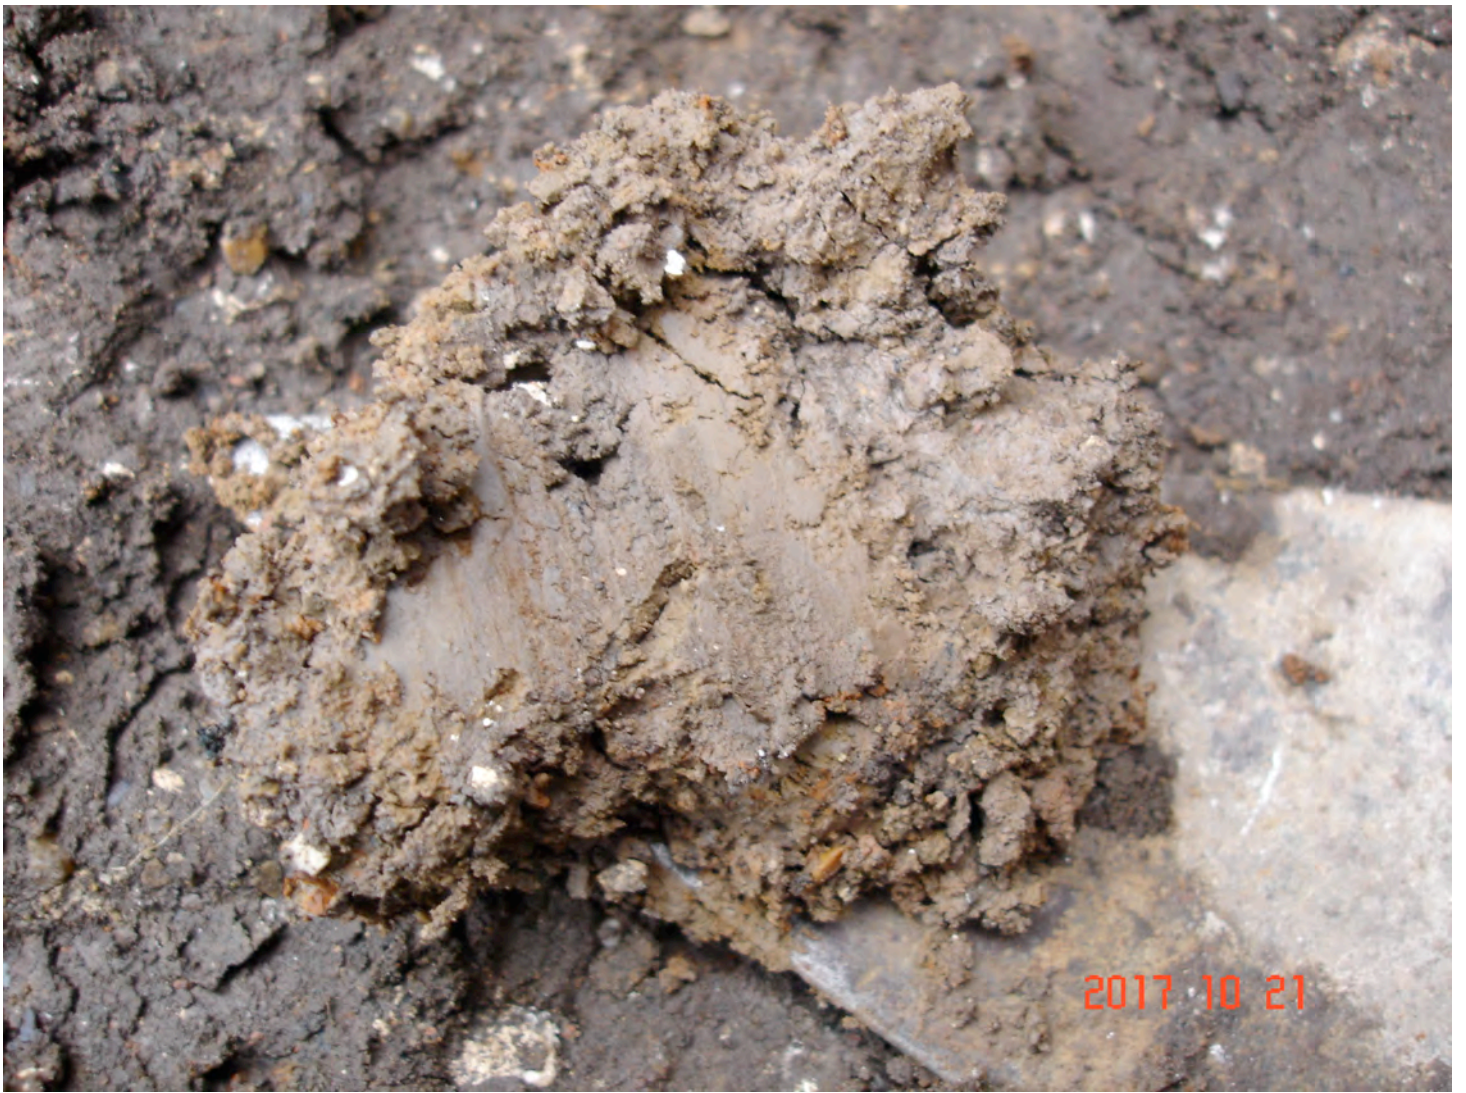
2017 10 21

Below is a photographic record of a trial pit dug on the site in order to establish the ground conditions for structural design.

Both a soakaway and drainage field have been considered, but have been discounted on the basis that ground conditions comprise thick clay with very poor permeability. The site is directly adjacent to an old clay brick pit at Chestnut Cottage. Infiltration rates of rainwater into the ground are known to be extremely poor.
