APPLICATION FOR CONDITION DISCHARGE

DC/18/00428/PLF/EASTSE

Proposal: Erection of a dwelling following demolition of existing building

Location: 21A Eastgate, Lund, East Riding of Yorkshire

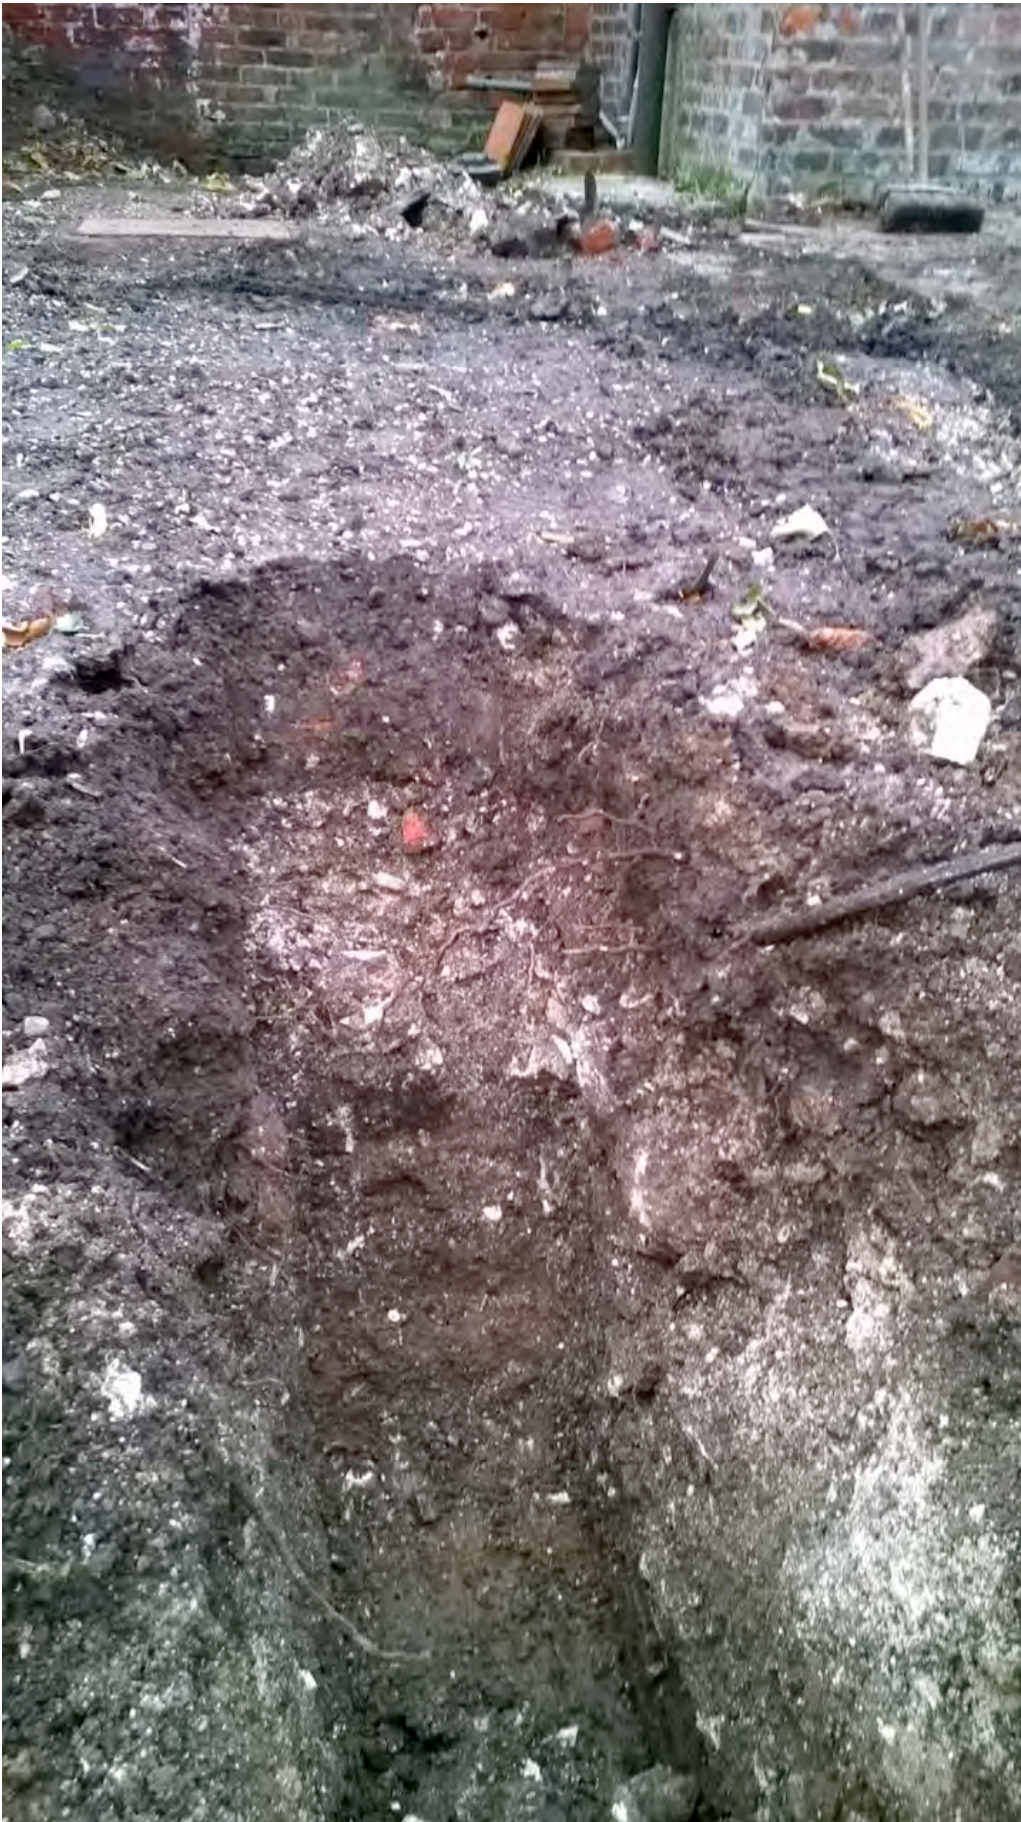
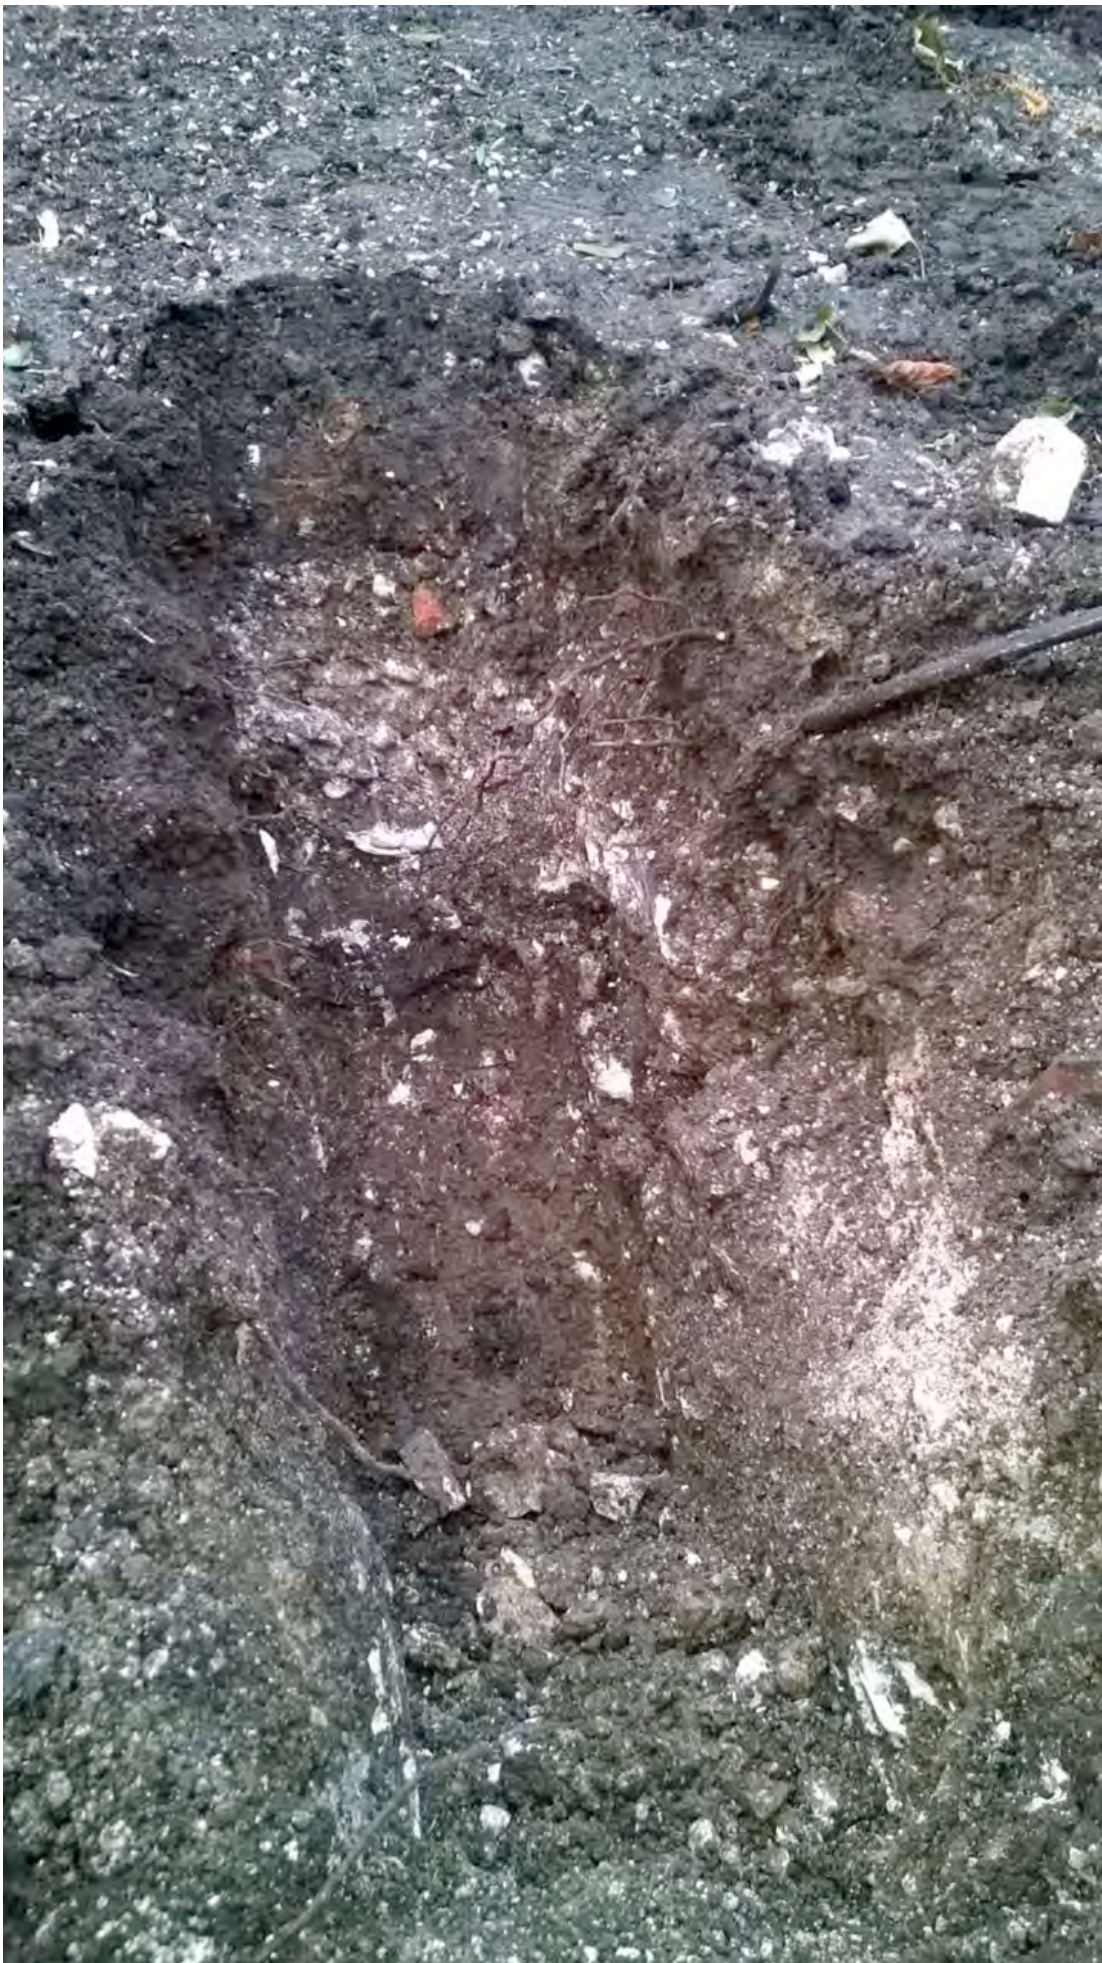
A further trial pit concluded the same heavy clay ground conditions:

Both a soakaway and drainage field have been considered, but have been discounted on the basis that ground conditions comprise thick clay with very poor permeability. The site is directly adjacent to an old clay brick pit at Chestnut Cottage. Infiltration rates of rainwater into the ground are known to be extremely poor.
