5. The proposals

5.1 Introduction to external proposals

The proposals for Norman Shaw North seek to deliver substantial and essential fabric and structural conservation repairs, building enhancements and an improved immediate landscape, benefiting access and logistics for site and Parliamentary use.

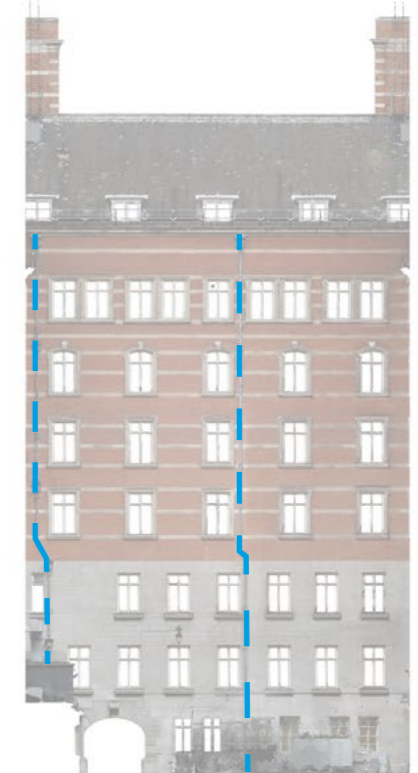
Existing rain water goods
Proposed rain water goods to match existing

Existing north courtyard elevation

Existing east courtyard elevation

Existing south courtyard elevation

Existing west courtyard elevation

5.5.3.4 The opportunity has been taken to rationalise a small number of the existing RWP runs, most notably on the east courtyard elevation where the pipe currently travels horizontally above the granite base but can be re-set as vertical as originally intended. New RWPs have been located in locations where there are consistent vertical areas of stone and brickwork. On the north courtyard elevation, the new pipes are located towards the corners of the available elevation to retain the legibility of the brickwork and its relationship with the chimneys above.

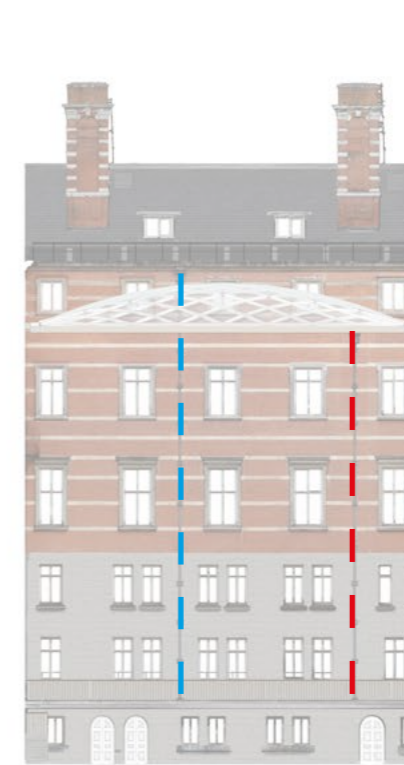
5.5.3.3 This strategy requires an additional three rainwater pipes in the courtyard. These will pass through into the basement, via the courtyard floor, where they connect into the basement drainage pipework, replaced and extended as required.

Proposed north courtyard elevation

Proposed east courtyard elevation

Proposed south courtyard elevation

Proposed west courtyard elevation

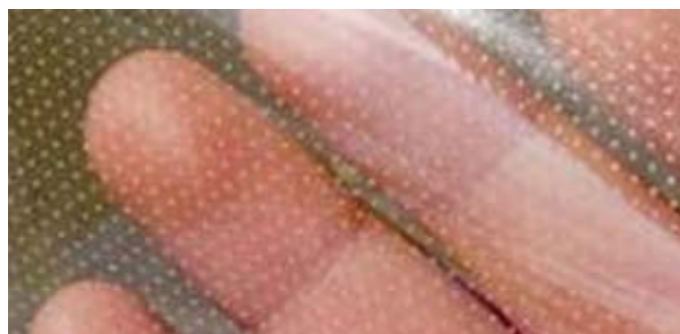
Microsorber Transparent acoustic film examples

5.5.4.4 It is envisaged that potential treatments to the proposed courtyard roof glass surfaces are explored through physical samples to support the detailed design proposals of the courtyard roof.

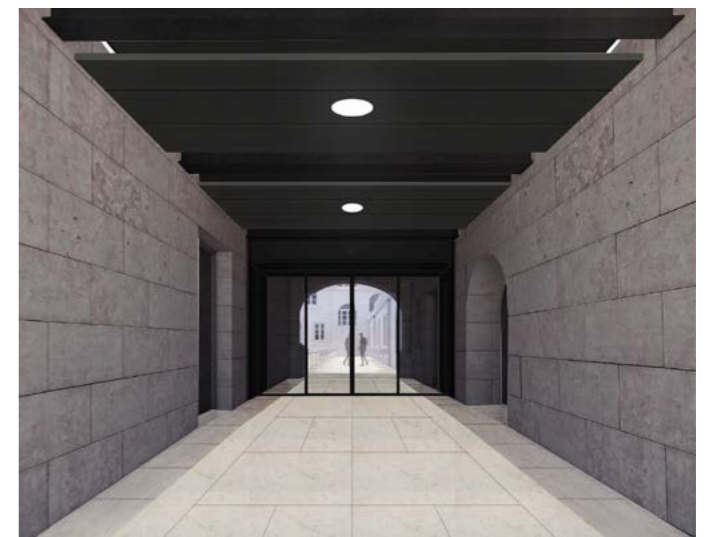
Existing arched opening on Laundry Road (above), leading to new lobby with fully glazed bi-parting doors (below)

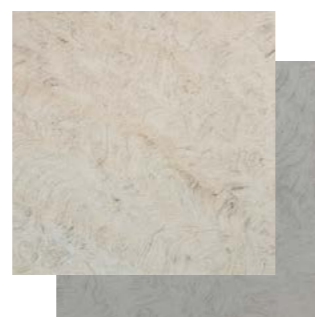
York Stone paving (grey stone borders)

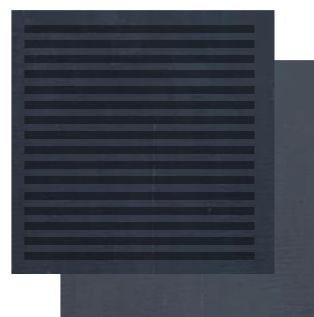
Blackened steel perimeter grilles

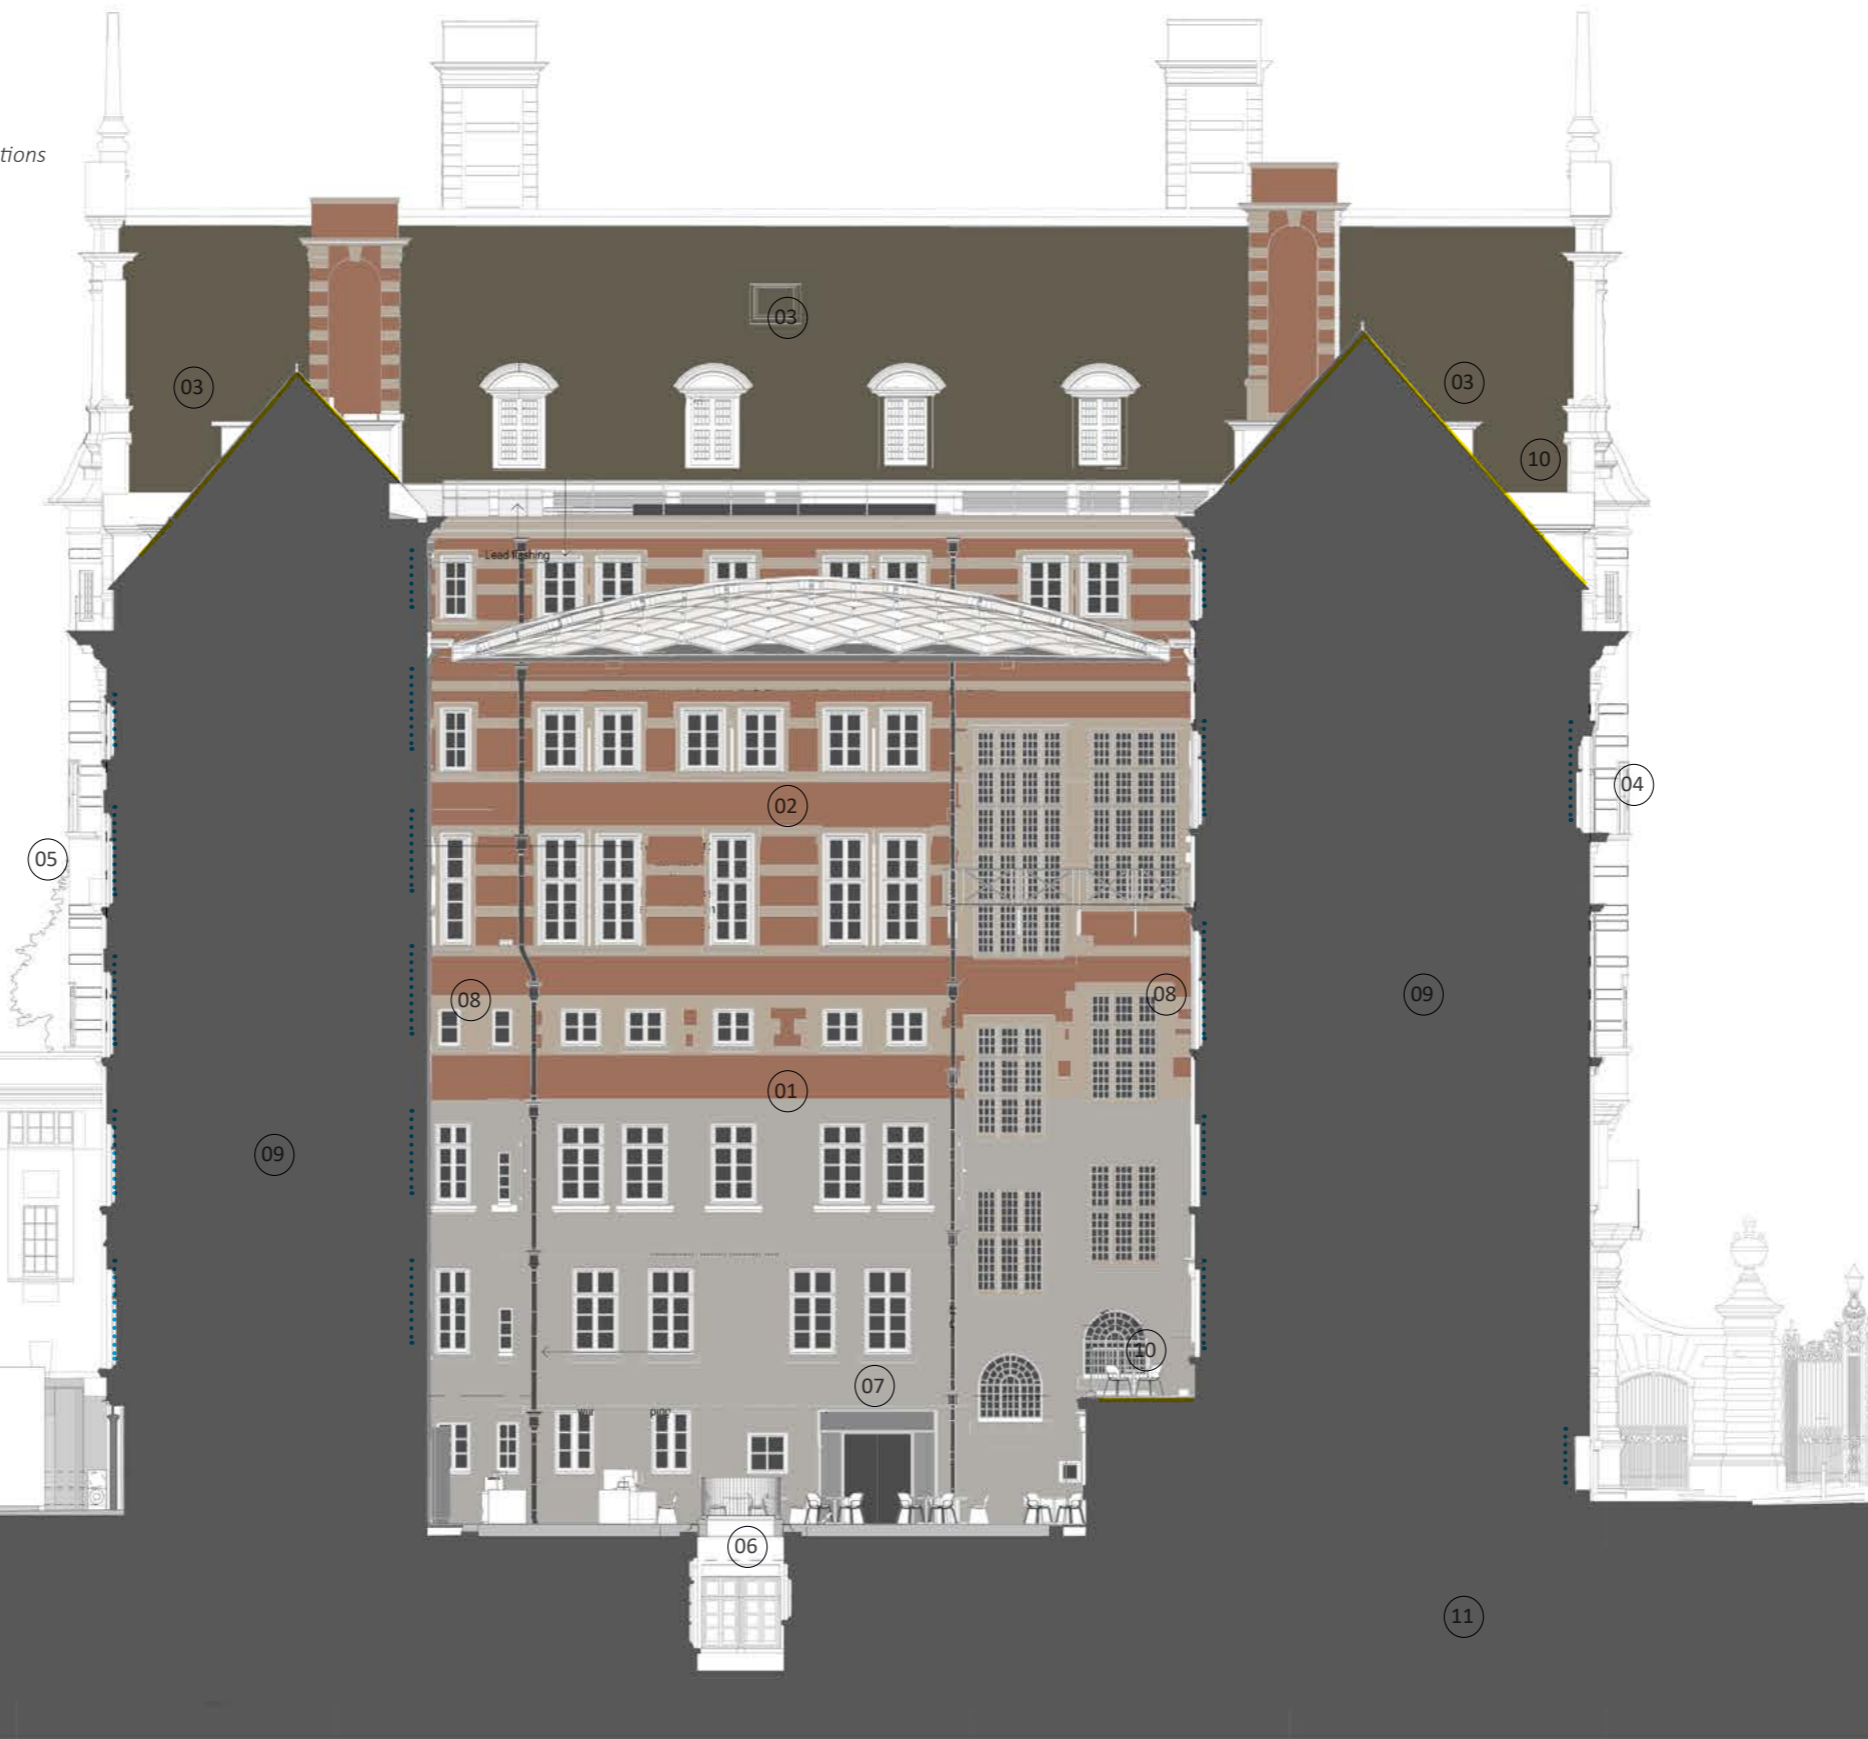
Key section (proposed)

- 01 405sqm of area transformed to usable, high quality space. Enclosure to courtyard reduces the thermal envelope and increases energy efficiency
- 02 Cleaning and repair works to internal courtyard elevations

- 03 Repair and refurbishment works to roof to address defects and thermal performance
- 04 Repairs to the external envelope to address defects
- 05 Acoustic and security enhancements to existing glazing via secondary glazing

- 09 Refurbishment to accommodation
Original features revealed and recovered where possible and insertion of new services and ceiling rafts
- 10 Refurbishment and new use of the existing roof area as an upper terrace

- 11 Re-organisation of basement areas and improved water proofing

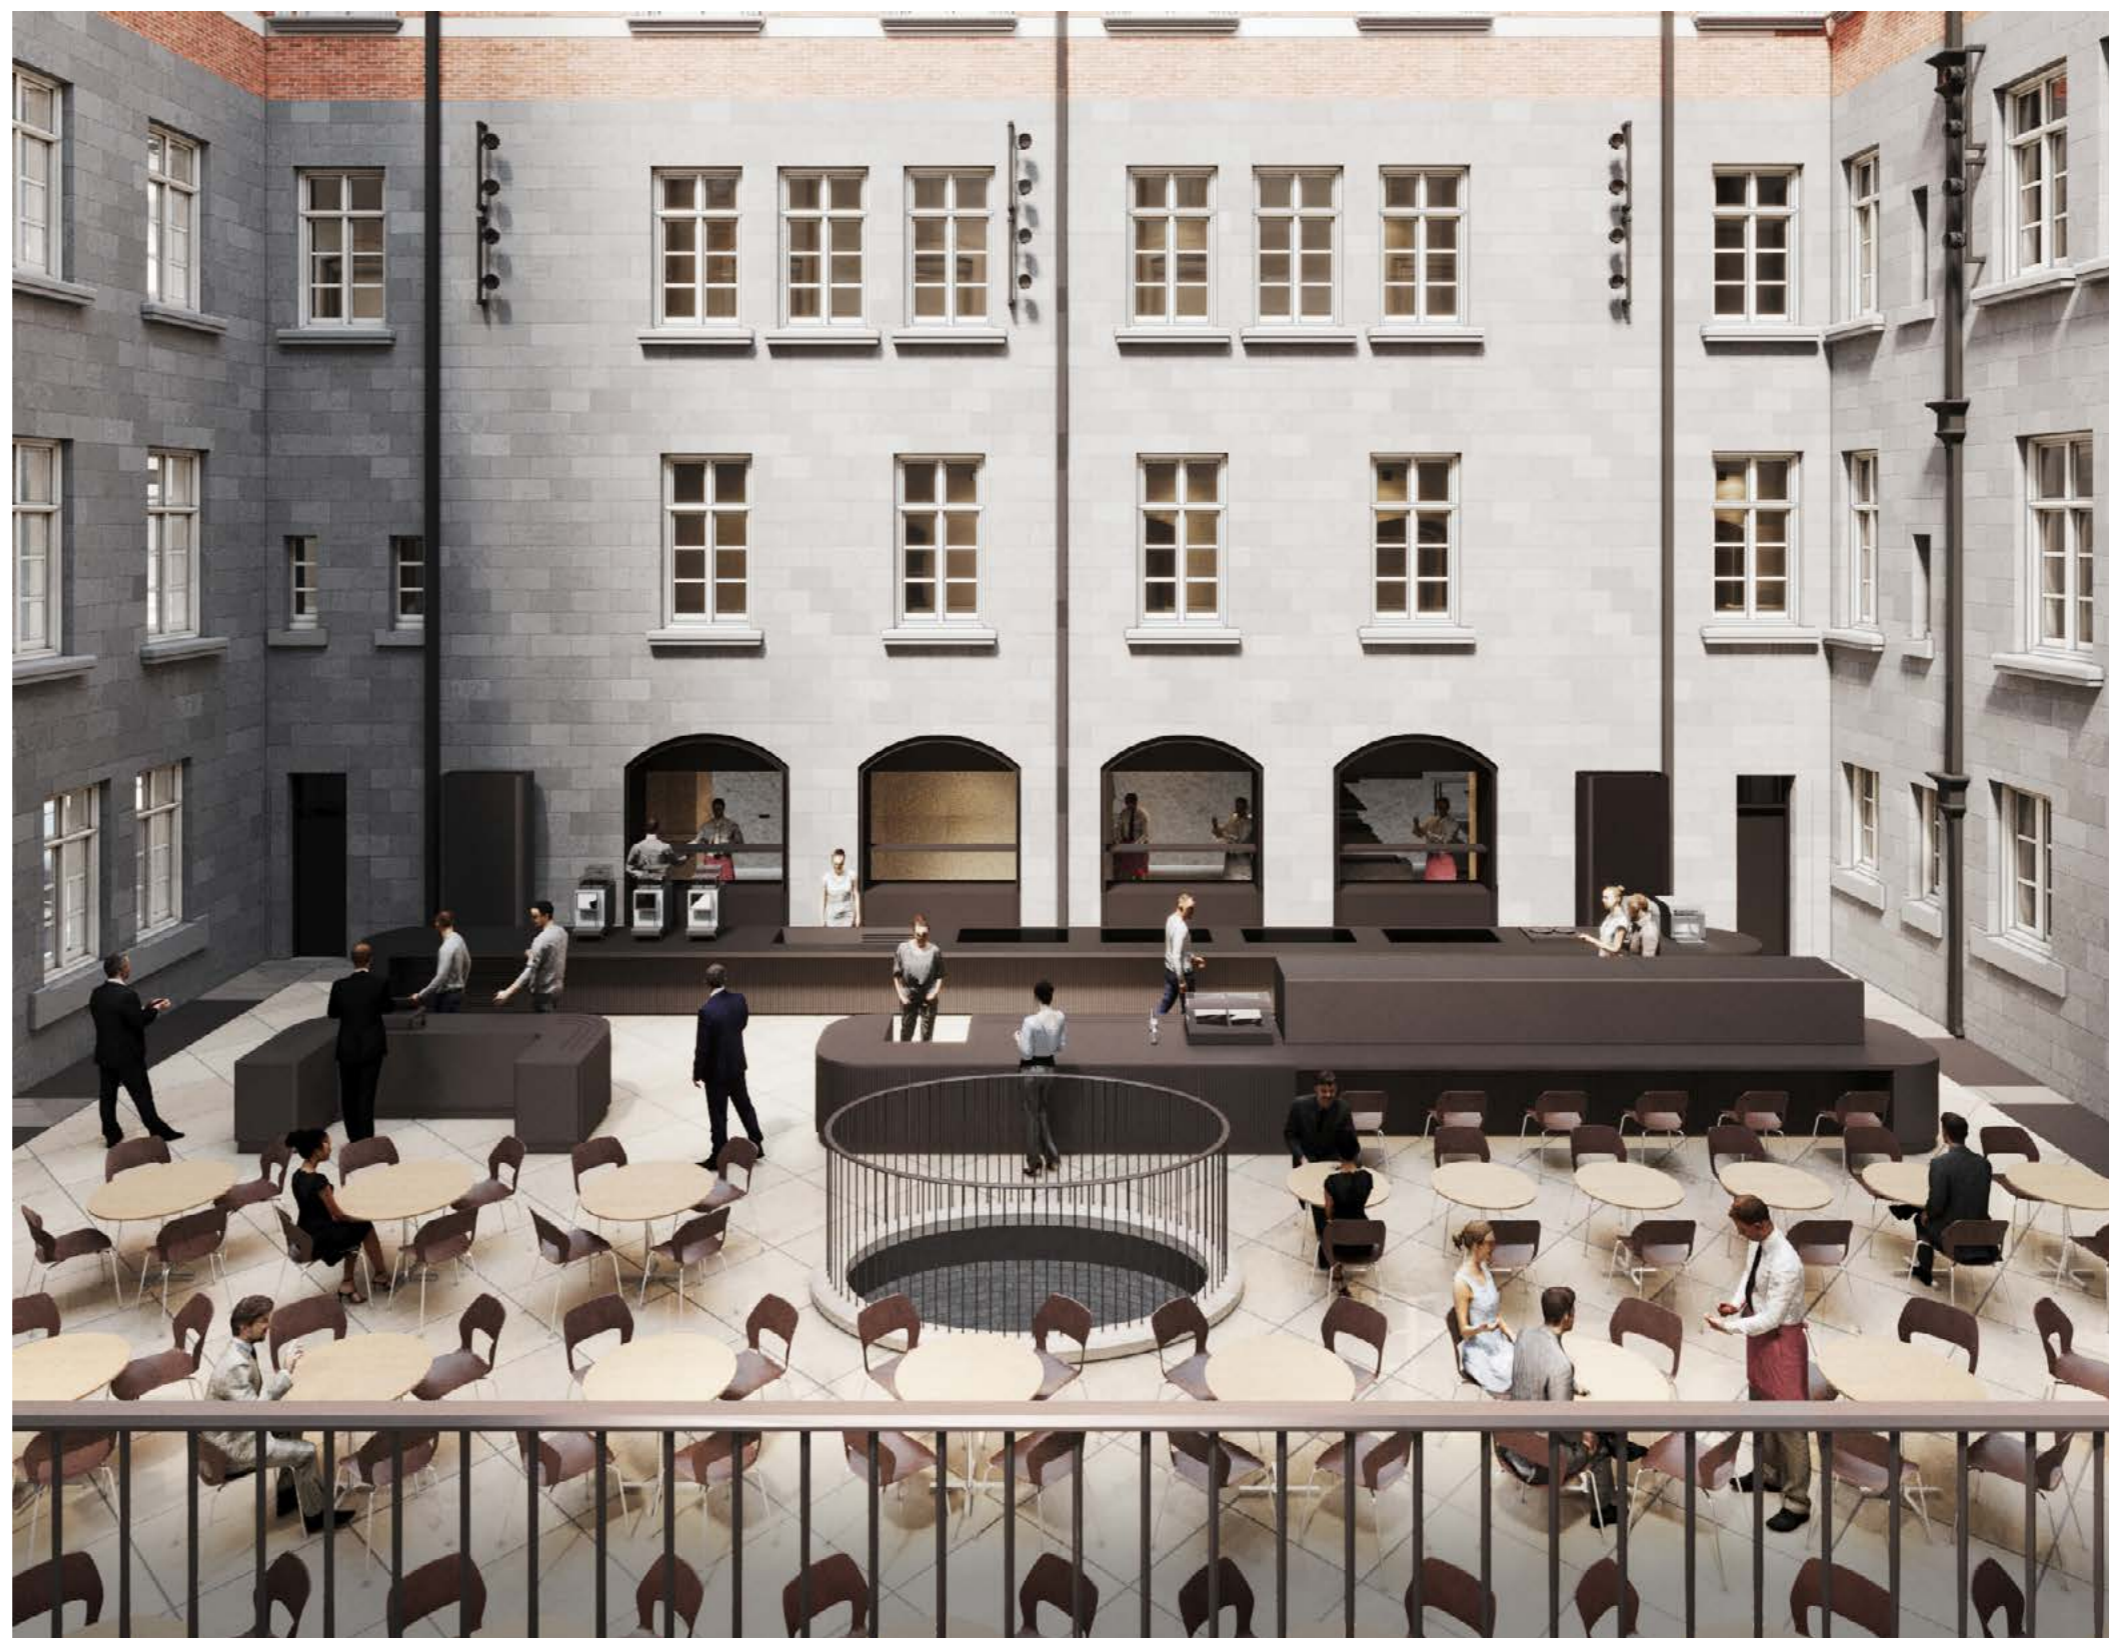
View from the upper terrace to the courtyard showing reinstated oculus, linings and restaurant serveries

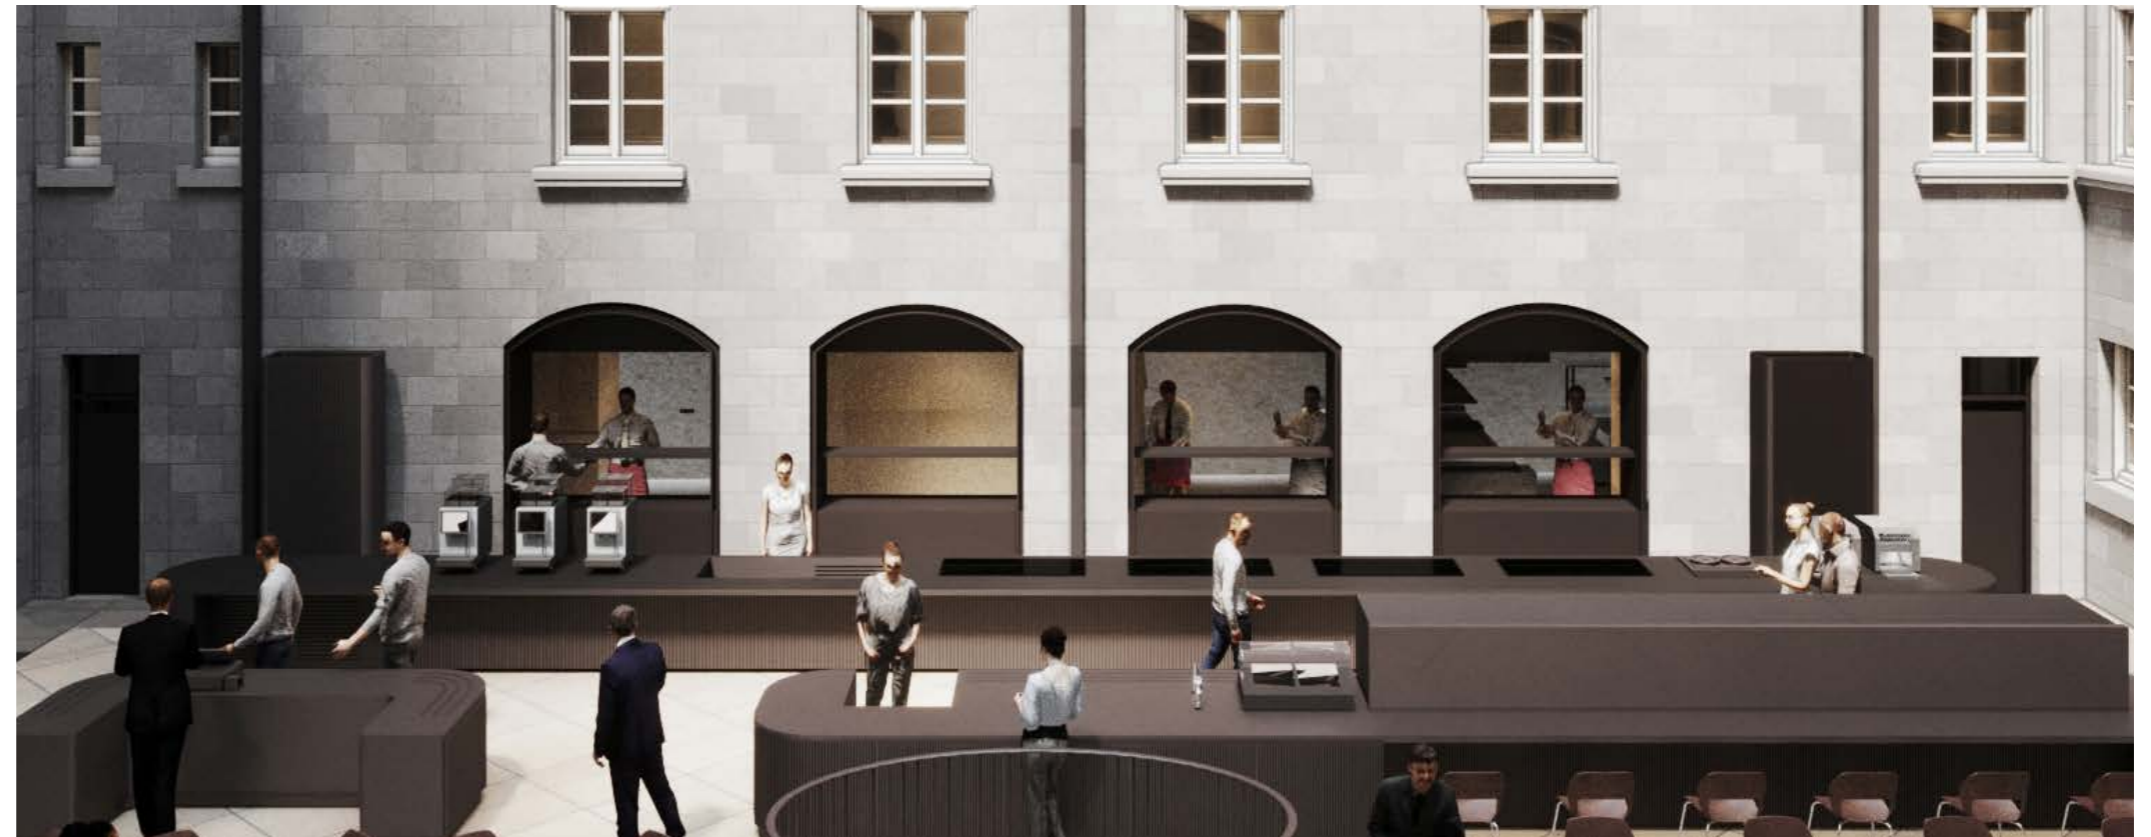
View of courtyard with lined reveals

5.7.9 The existing north courtyard elevation features four large existing arched openings with inset glazed timber-framed screens [installed in the 1970s], which are to be removed. In the proposal, this façade divides the back of house catering area from front of house catering, and incorporates manned hot and cold food and drink serveries set within new metal reveals that line the openings.

5.7.11 As well as improving the look and feel of the courtyard, the new reveals and over panels are integral to the fire upgrades and acoustic strategy. The heads of the arches are infilled with a perforate metal panel backed with absorbent material to improve the acoustic environment in the space by reducing the amount of reverberant sound bouncing off adjacent hard surfaces. The infill also provides an opportunity to conceal a fire curtain between courtyard and kitchen areas.

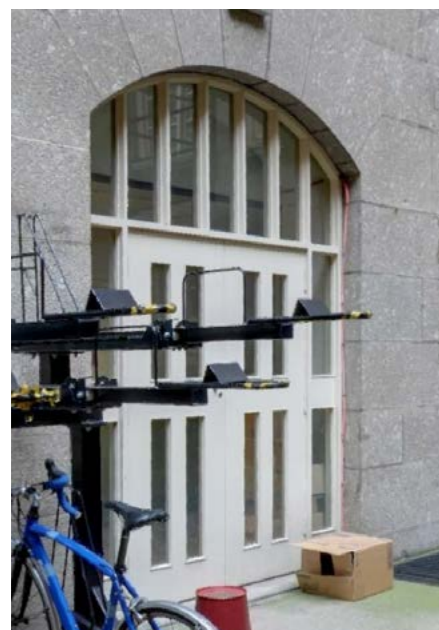
1970's doors to be removed

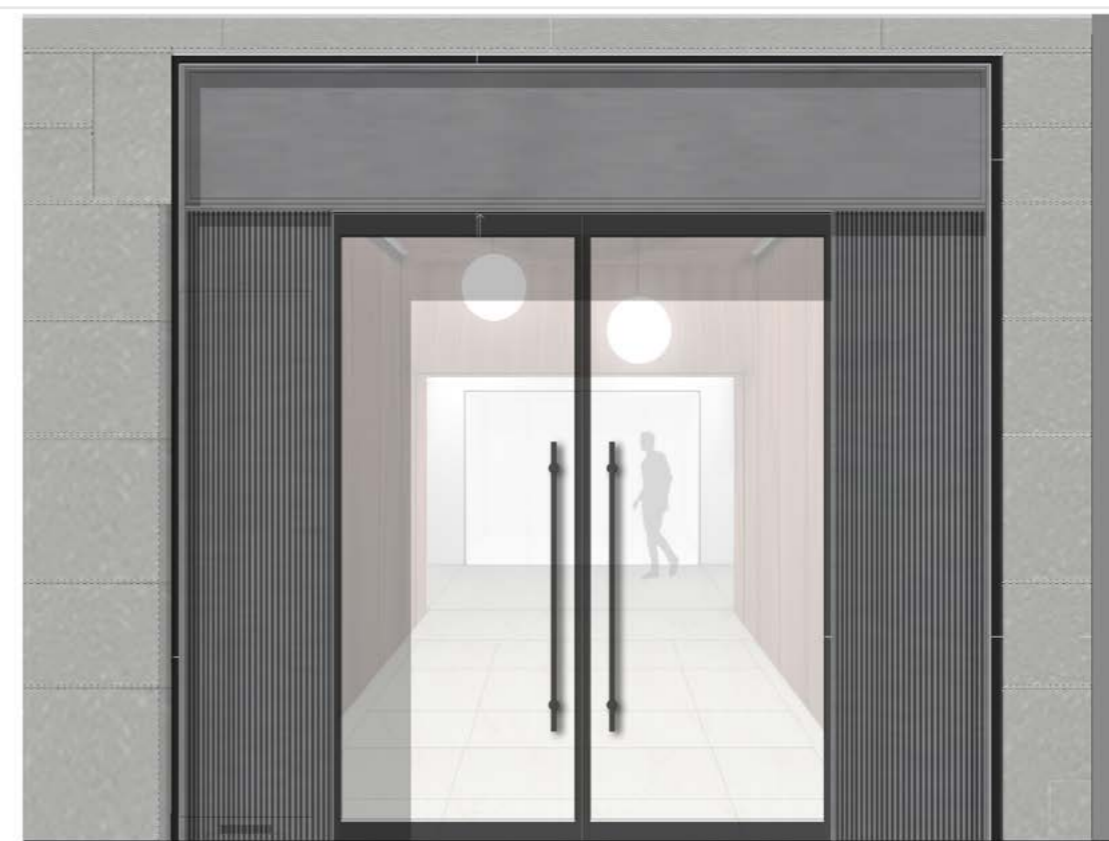
Illustrative plan and elevation of entrance door

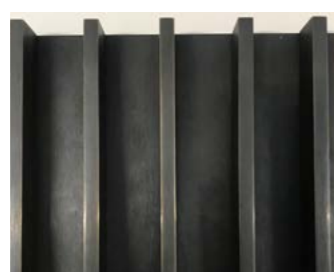
Fabricated diffuser screen

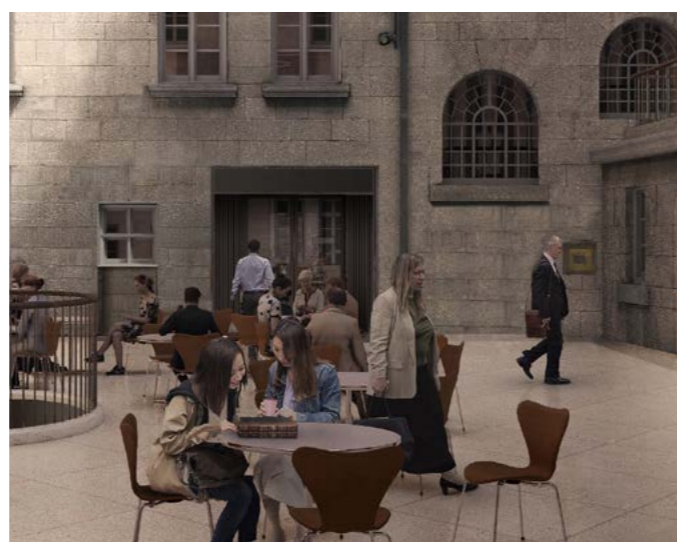
View of new entrance door

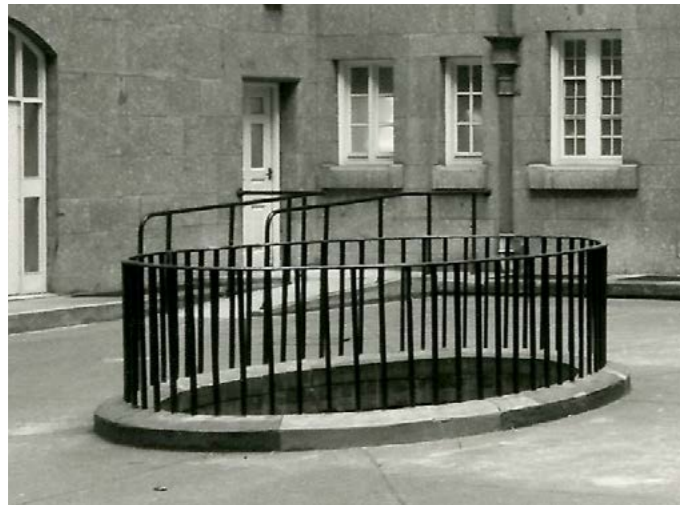
Photograph of oculus prior to removal and installation of portacabins

5.9.1 The reinstated central oculus detail is intended to match the configuration and materiality of the original oculus as depicted in historic photographs, removed when the portacabins were installed.

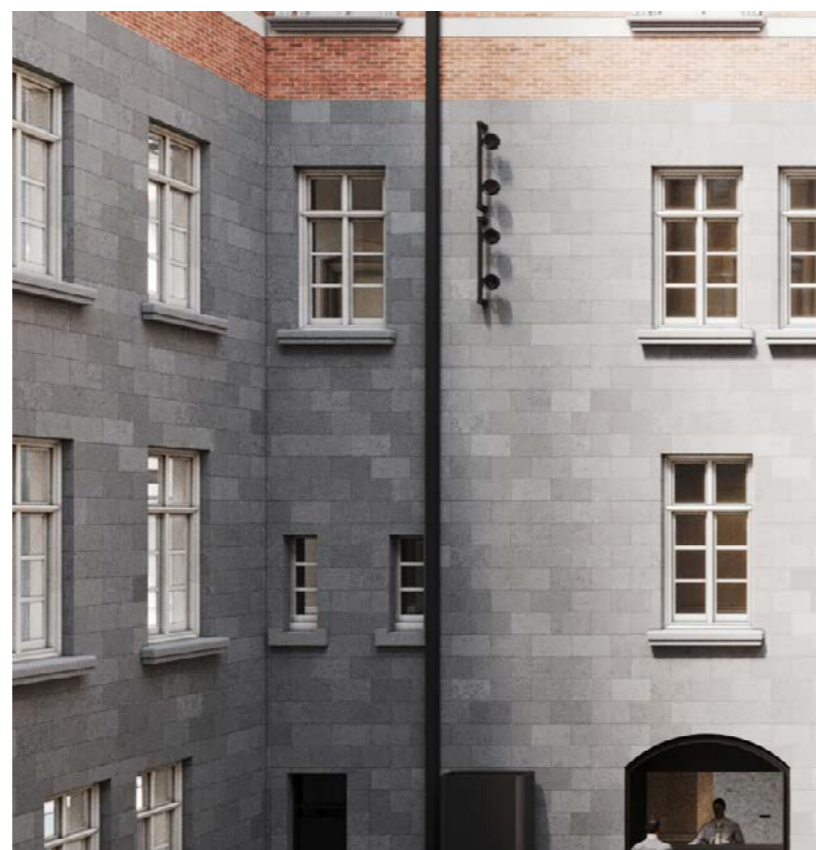
Montage showing same, shorter lighting bar co-located with rain water pipe

5.10.6 The intent for installing and fitting this lighting is to limit the impact on the fabric. First fix metal sleeving would enable conduit to pass through the masonry and be co-ordinated with joints in the facing granite. This cabling is distributed from the new cabling installed inside the building. Second fix bars, simple and utilitarian in aesthetic are then sleeved over and connected to a concealed track within the vertical element; enabling flexibility in positioning of the actual light fixtures.

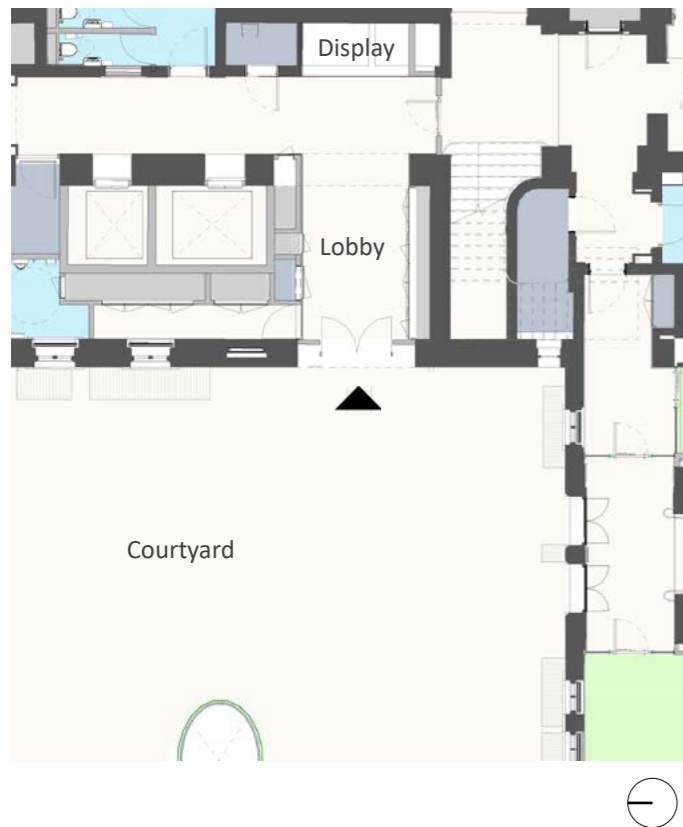
Entrance view towards display case and circulation beyond, with oculus void above

York Stone paving (grey stone borders)

Blackened steel reveal

Walnut veneer panels

Heritage paint scheme

Pendant light fittings

5.11.2 Entered via the new courtyard entrance doors, the visitor arrives within a timber-lined space (concealing services), conceived as a double-height volume, visually connected to the floor above. On axis is a display cabinet to showcase significant artwork or artefacts from the Parliamentary archives and help draw visitors through into the space and circulation routes either side.

5.11.3 An elliptical opening at the ground level above provides the double height visual connection between the two levels and is detailed with a slender metal post and timber rail balustrade, echoing the designs in the courtyard oculus. This connectivity also serves to orientate those approaching from Ground Floor level providing a visual link back to the entrance lobby and courtyard space beyond.

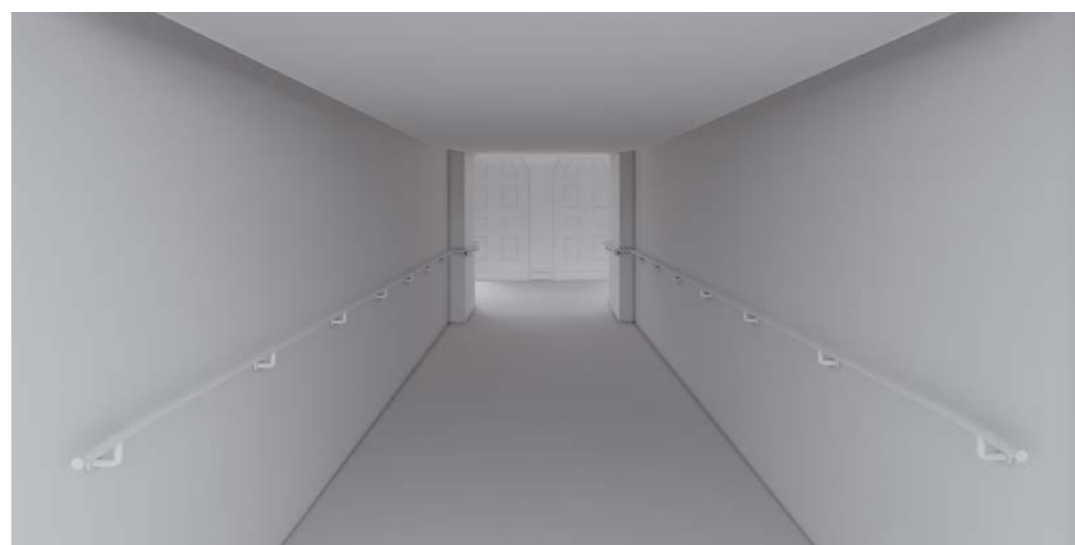
Views from entrance (bottom) and to entrance (top)

5.12.5 The space would be simply detailed with the new ramp finished in stone, in keeping with the west passage. A suspended ceiling is introduced to conceal new services. The original external doors are retained and adapted with new ironmongery for access control.

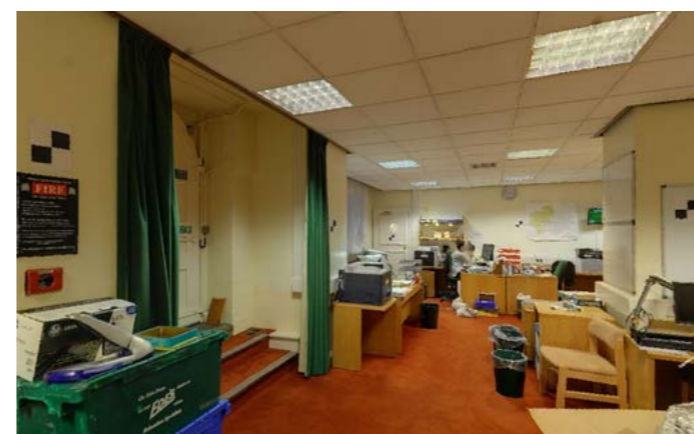
As existing view looking west - no defined passage

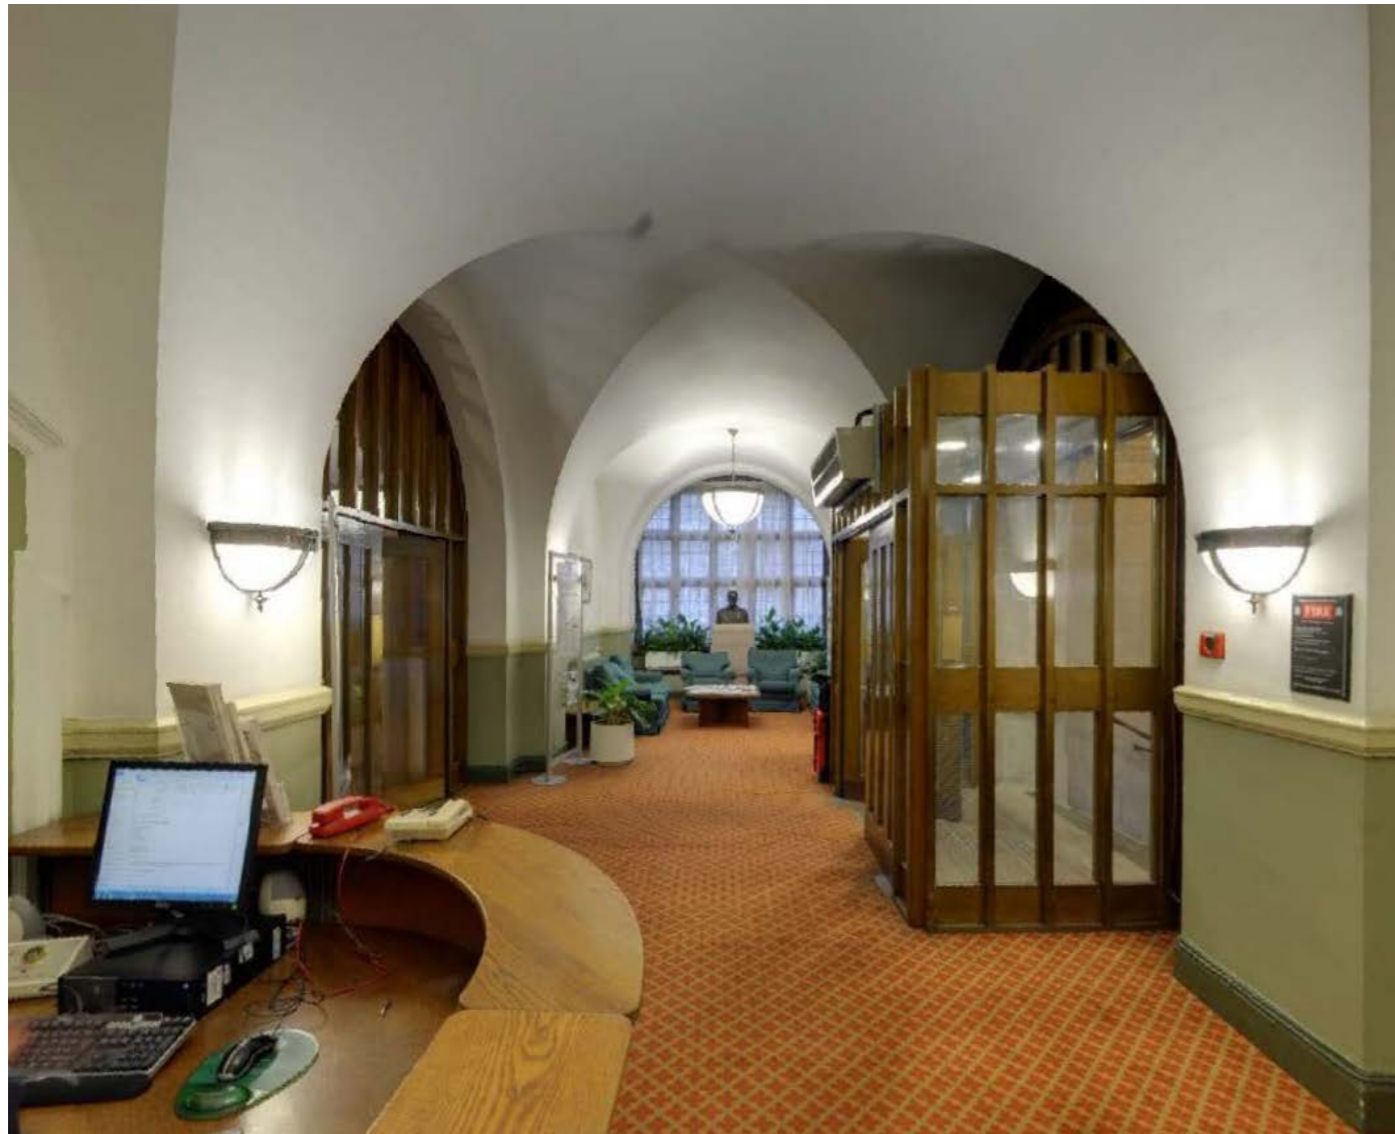
Existing entrance lobby

5.12.6 The proposed new entrance door from the stepped South entrance replaces the existing modern internal lobby. The intent is for a 'lighter', modern volume, incorporating fully glazed doors and an over panel 'fanlight', to be read alongside the restored historic fabric. The design prefaces the family of new glazed cross corridor doors and screens deployed within the internal corridors.

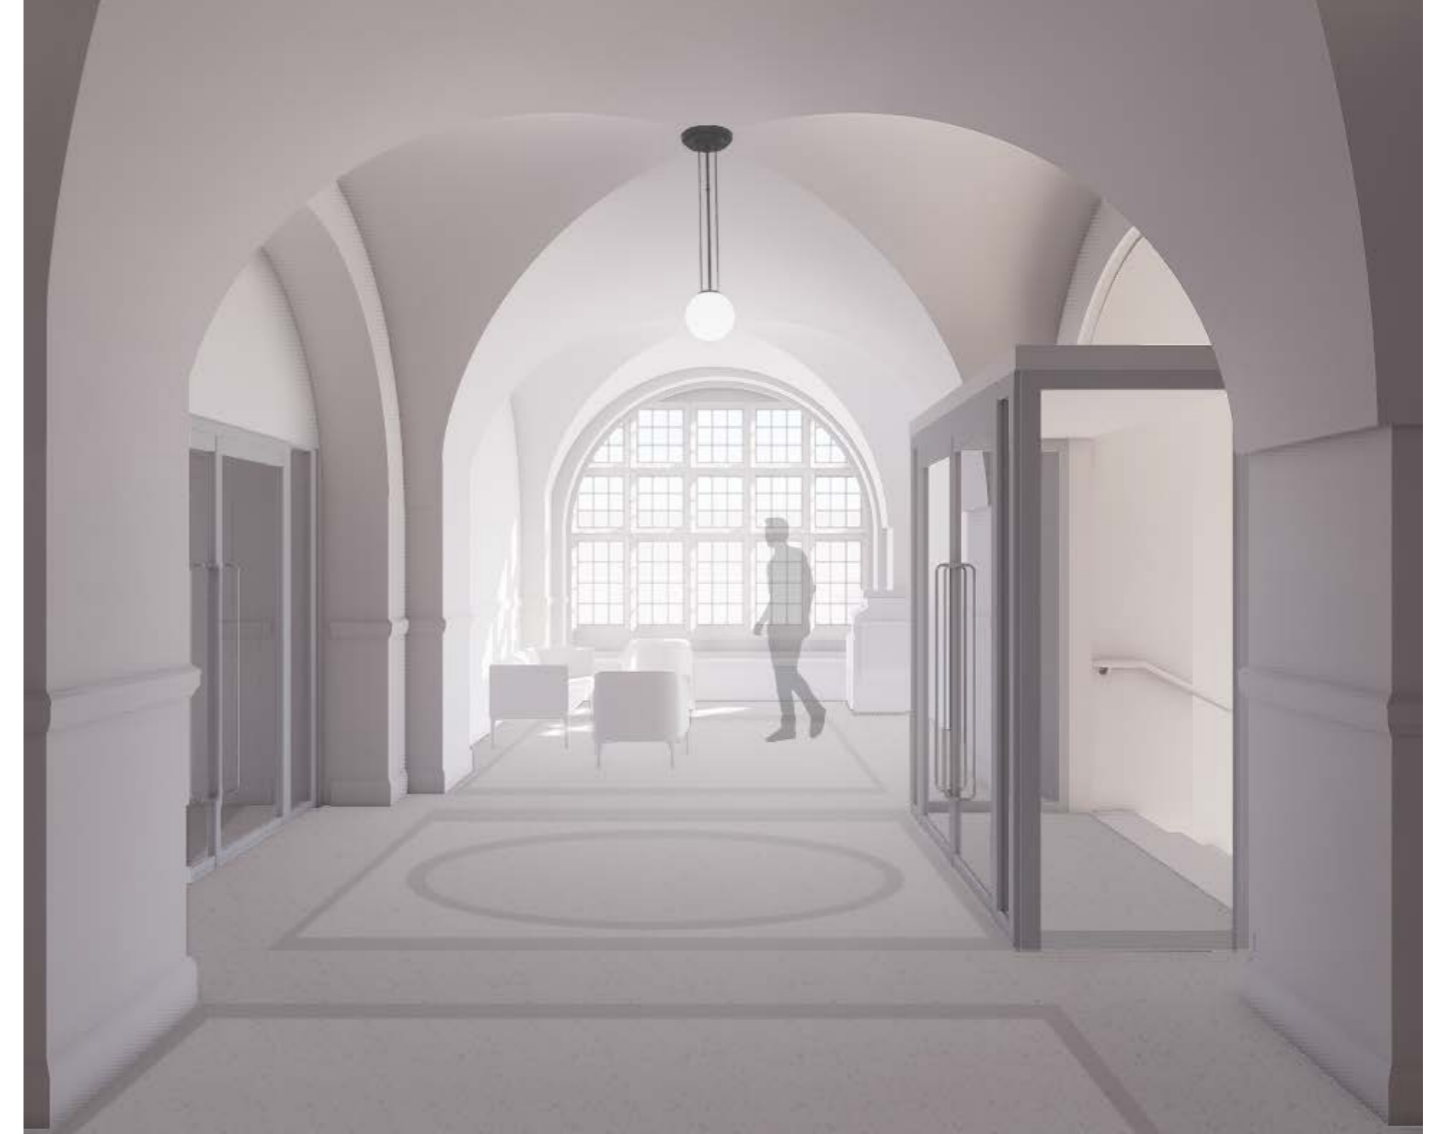
Proposed entrance lobby
