LEGEND: PROPOSED ELEVATIONS / SECTIONS

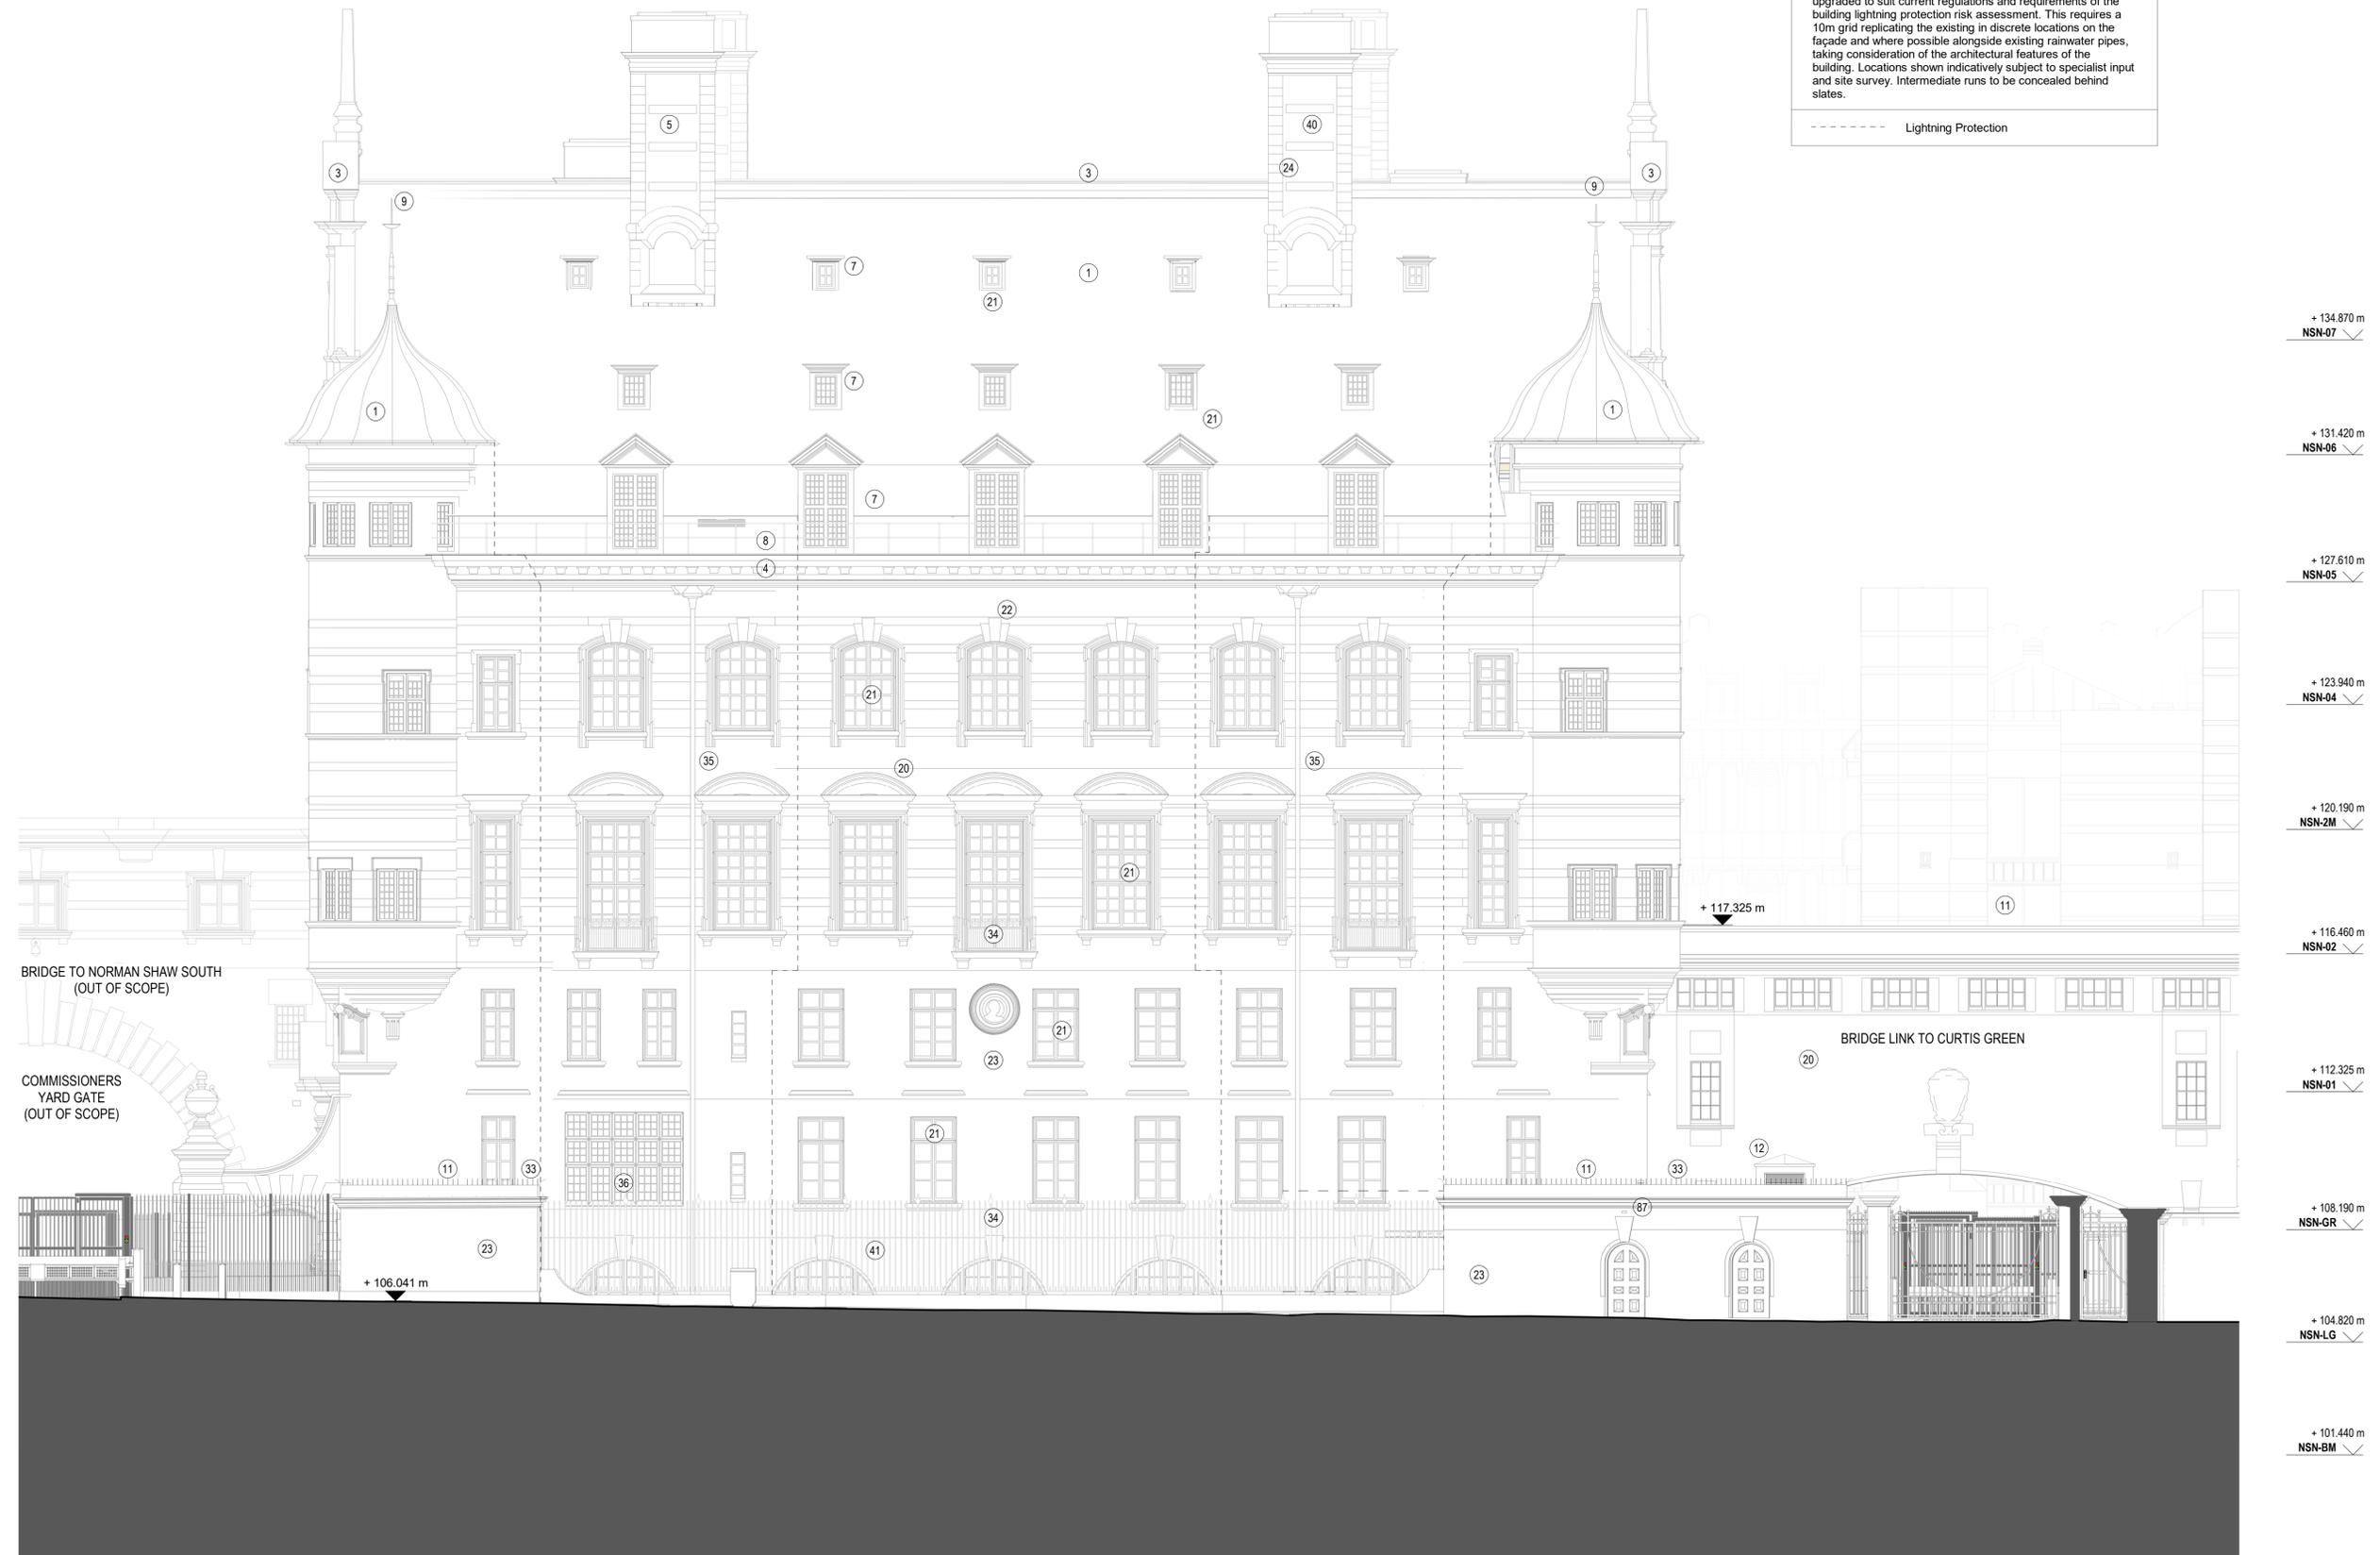
- ROOF**
- 1 Comprehensive roof repair, including slates (reusing existing wherever possible), leadwork, stonework and underlying substrate above truss and rafter line. Gutters repaired

- 2 Cutback to roof line to create new courtyard maintenance access gallery with rainscreen panel eaves detail. Refer to proposed details
  - 3 Stone repairs to pediment and ridge

- 4 Stone repairs to cornice
  - 5 Reconstruction of existing chimneys
  - 6 Stone and brickwork repairs at retained chimneys
  - 7 New leadwork to dormer roofs, cheeks, flashings and roof ridges / valleys

- 8 Existing metal railings to be repaired, consolidated and decorated
  - 9 Repairs to roof finials
  - 10 Dormer window extended to become a door
  - 11 New lead roof

- 12 New lead clad lantern vent
  - 13 New vertical lead cladding
- FACADE**
- 20 Careful facade cleaning and repair, including removal of organic matter, making good and preventing further deterioration

- 21 Windows refurbished and repainted
  - 22 Existing stonework cleaned and paint removed
  - 23 Granite facing to lower storeys
  - 24 Red brick with Portland stone banding

- 25 Existing iron grilles in plinth to be retained
  - 26 New metal balustrade
  - 27 New granite facing work, including cills, lintels, jambs, associated with reinstatement of original windows

- 28 Existing iron columns to be exposed and refurbished, works subject to condition survey following opening-up
  - 29 Original iron beam (exposed due to prior removal of extension structure) to be retained and refurbished, with new lead-clad drip inserted above into refurbished and repaired facing brickwork

- 40 New glazed entrance door to replace modern timber door
  - 41 Remove louvred infill. Reinstall glazing pane within retained existing window frame.

- 42 New dry riser inlet to replace existing
  - 43 New sliding glazed entrance door to courtyard entrance. Existing gate removed.
  - 44 New painted actuated window to replace existing store window

Note: Existing lightning protection system to be replaced and upgraded to suit current regulations and requirements of the building lightning protection risk assessment. This requires a 10m grid replicating the existing in discrete locations on the facade and where possible alongside existing rainwater pipes, taking consideration of the architectural features of the building. Locations shown indicatively subject to specialist input and site survey. Intermediate runs to be concealed behind slates.
