5.13 Interior design approach

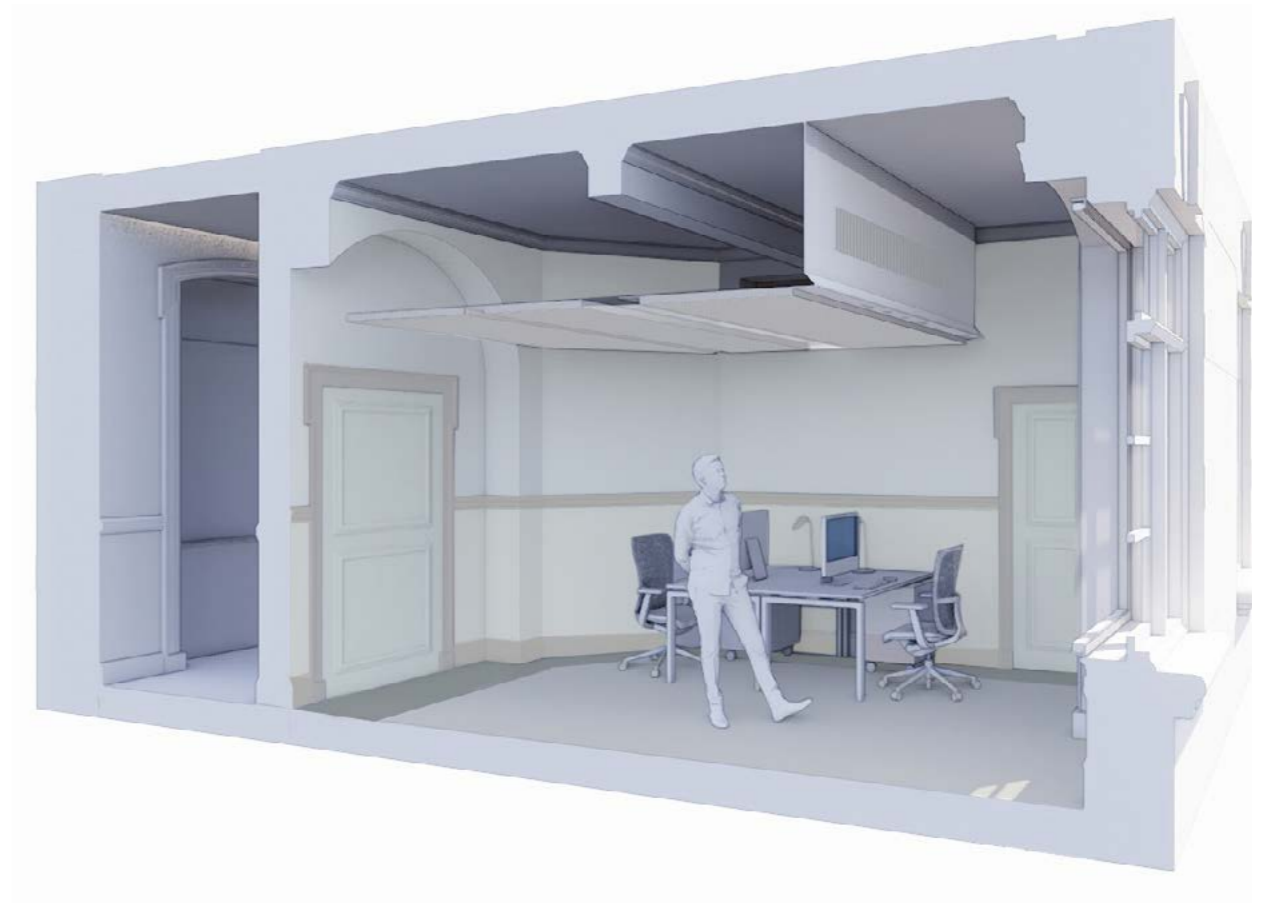
Typical Office (note: services not shown above raft ceiling)

5.13.2.1 New raft ceilings have been designed to leave clear views of the historic windows by stepping back from the perimeter walls. Lay-in grid ceilings have been avoided to reduce clashes with historic internal features. A shadow gap between the ceiling and the existing wall allows for separation between new and original elements.

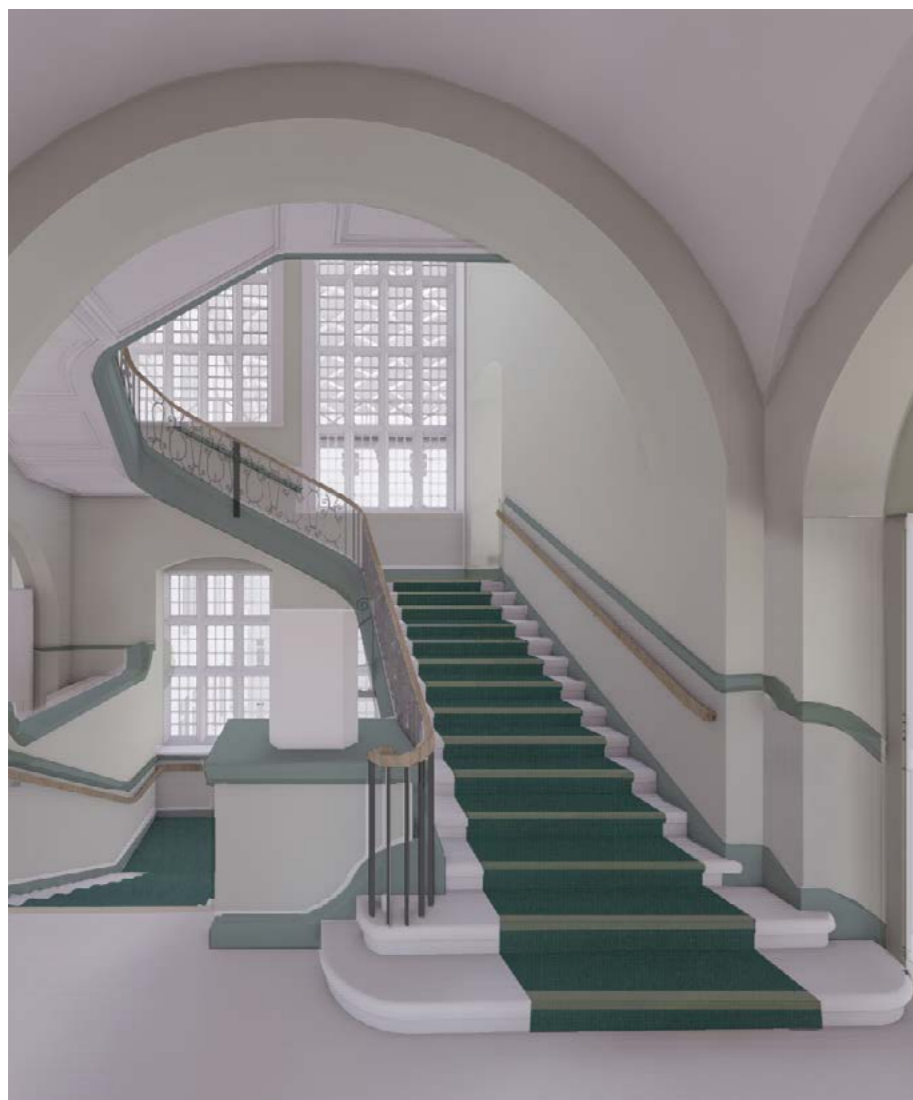
Principal staircase

5.13.1.3 A new broadloom carpet runner is proposed for the principle staircase.

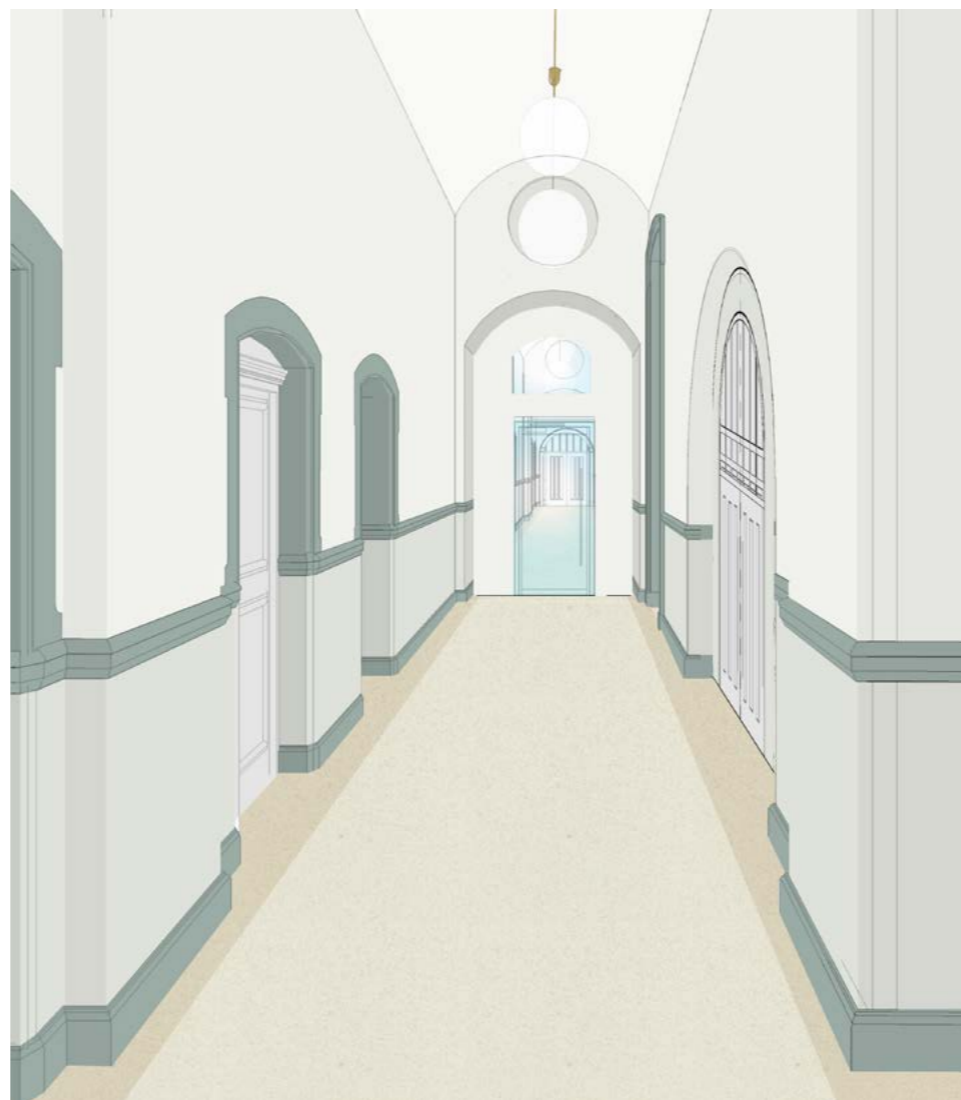
Primary corridors vaulted ceiling lighting strategy

5.13.5.5 The new lighting scheme has been designed to take inspiration from original layouts. Corridor light fittings will be chosen to match the existing circular pendant as much as possible.

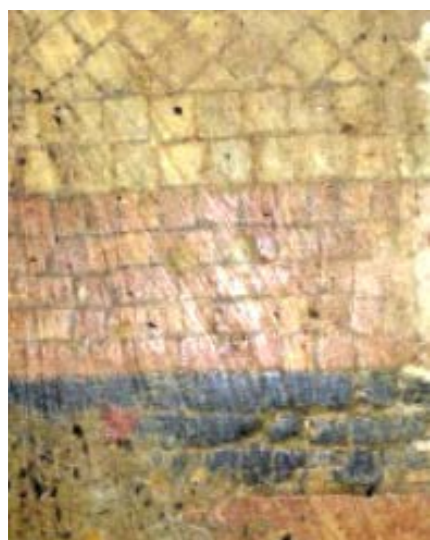
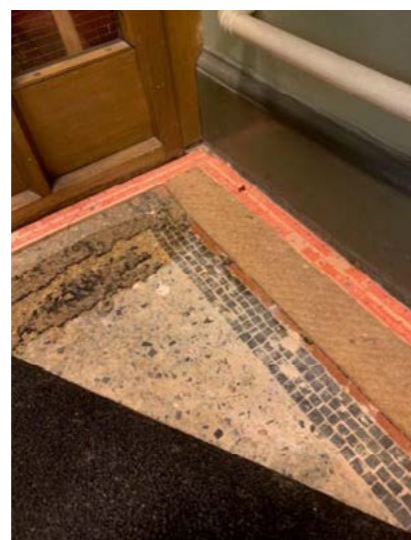
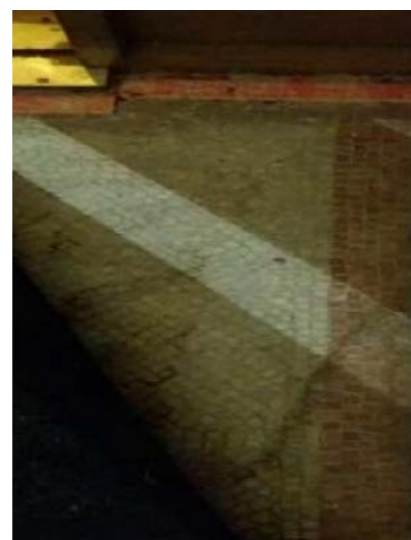
Existing floor finish to be refurbished in circulation areas

5.13.1.1 Archive research and investigations suggests that terrazzo and mosaic was used within the existing circulation areas. Woodblock and tile is seen in the corner Tourelle rooms.

5.13.1.2 Depending on the condition of the existing floors, the proposals allow for uncovering of the original terrazzo and mosaic floors and their refurbishment and repair. The woodblock and tile will be refurbished in the old Commissioner's Office, to be re-purposed as a conference room in the proposals. The aim is to reveal as much of the original surface as possible

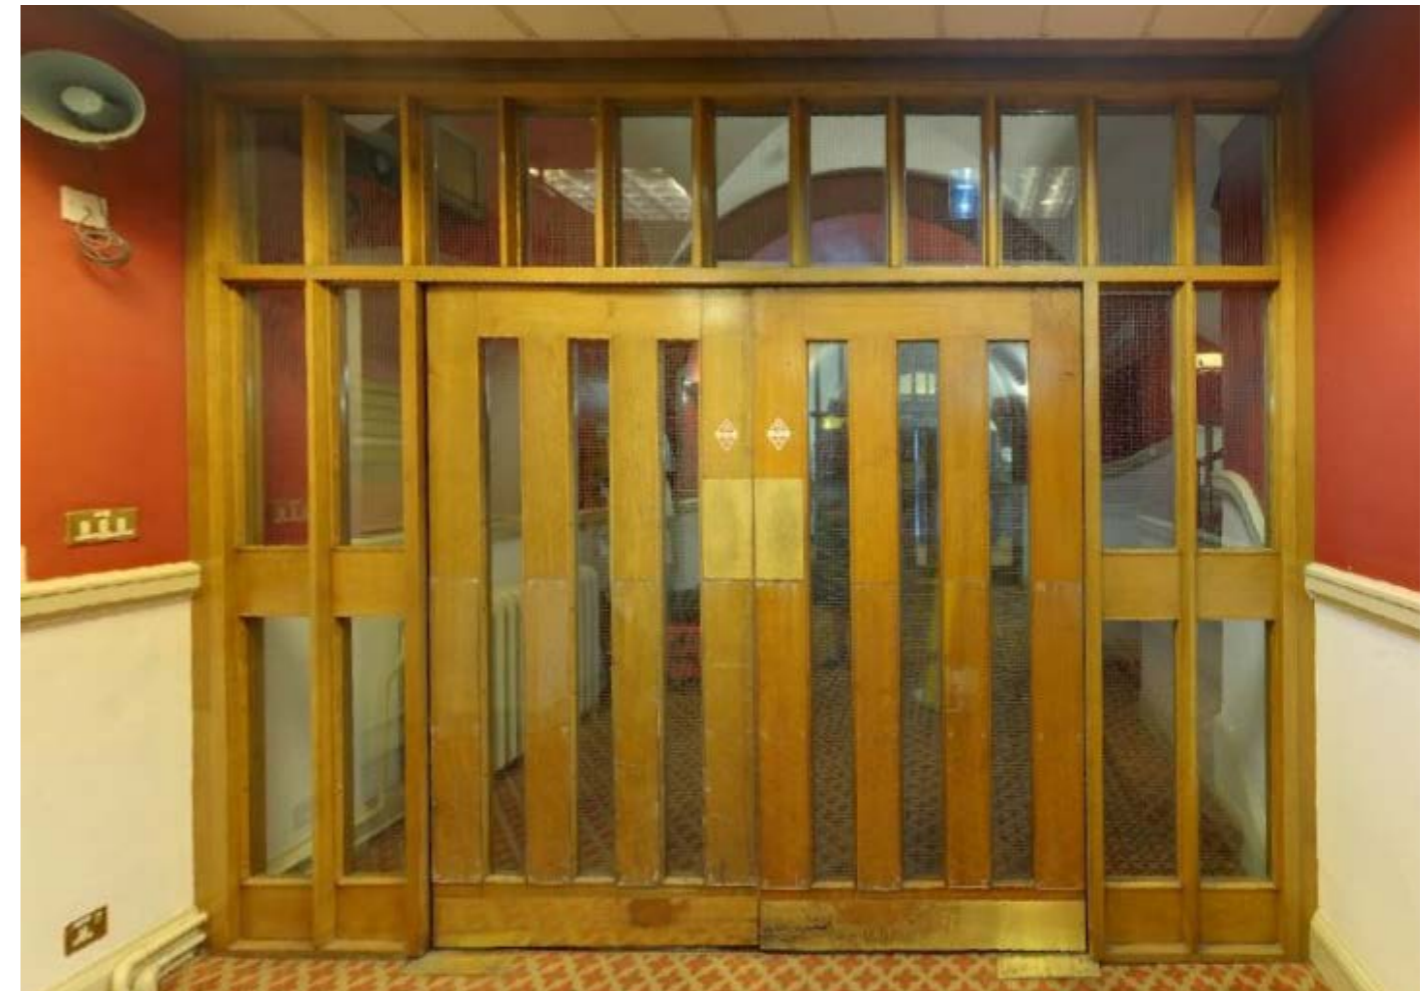
Existing timber cross corridor screen

5.14.2 Alongside the condition and performance of the existing timber and glass cross corridor doors, many of which are not compliant, the proportion and density of framing both vertically and horizontally currently blocks the majority of the view along the corridors in many locations. This undermines the viewer's understanding and experience of these key historic spaces.

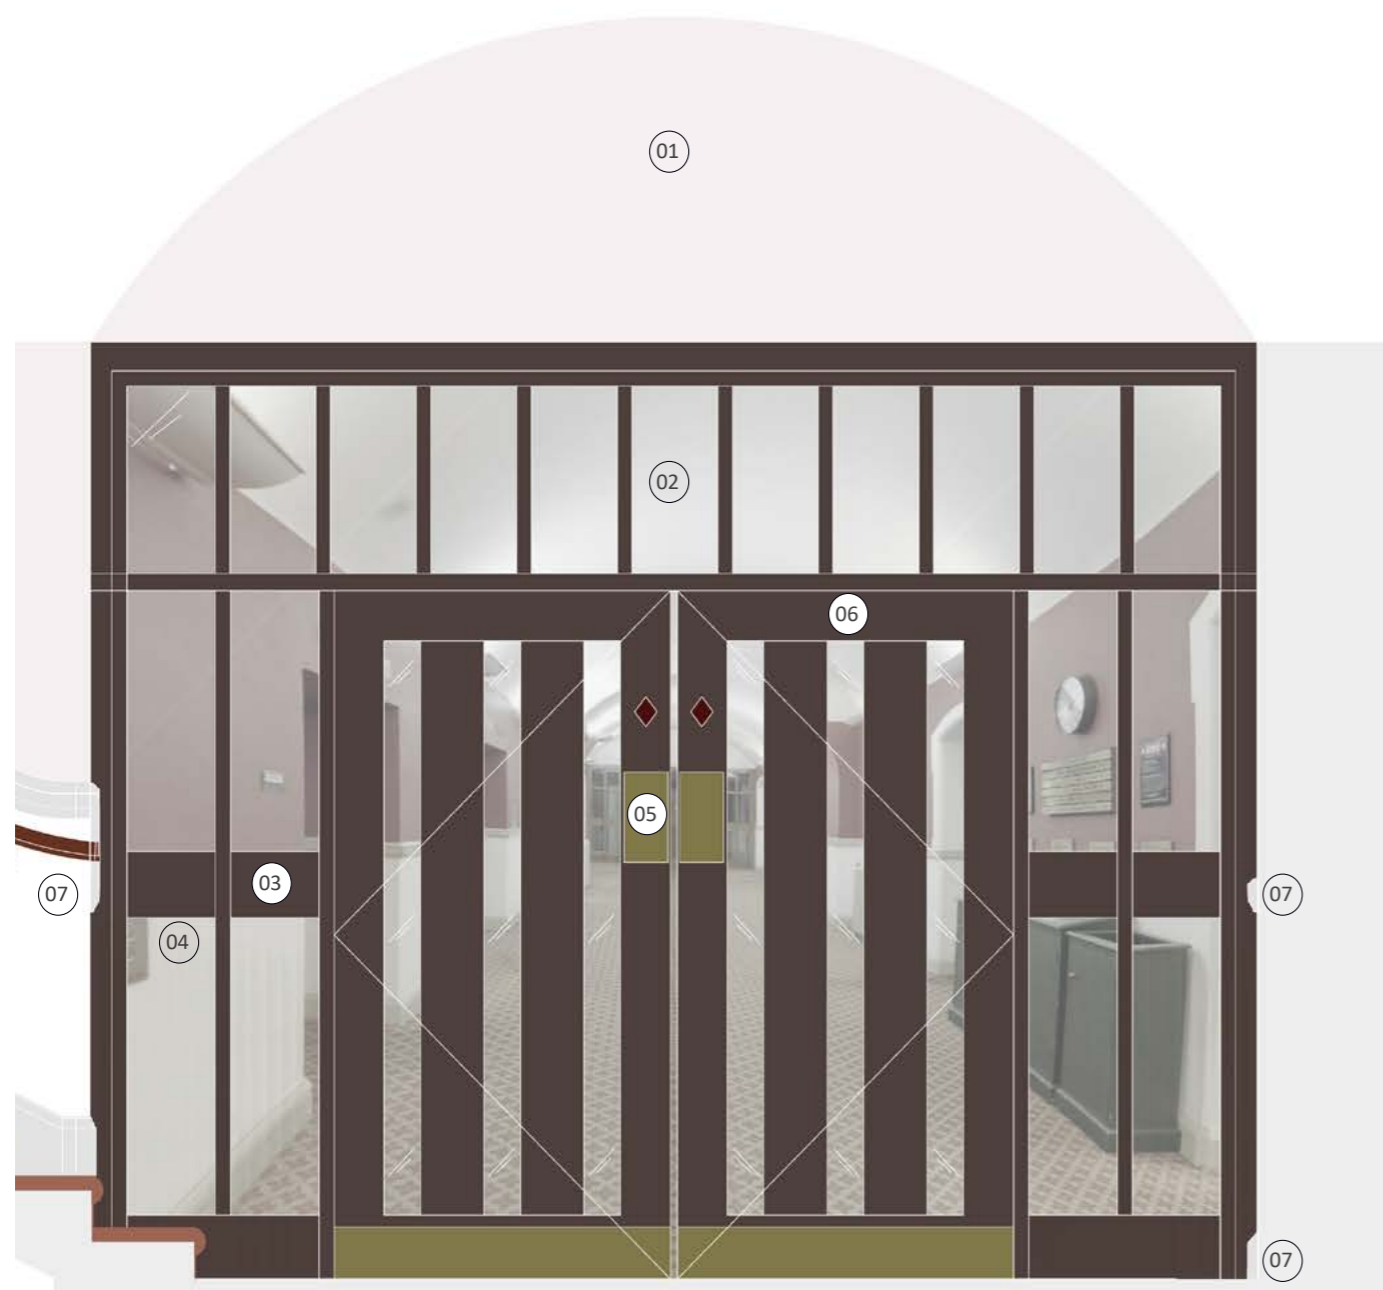
Existing 1970s timber glazed doors and glazed overhead

- 01 Painted solid over panel in original barrel vault
- 02 Timber glazed overhead
- 03 Thick timber sections to door leaf and frame
- 04 Lower glazed panels set out to original dado height
- 05 Brass push plate
- 06 Partially glazed door leaf
- 07 Existing dado rail

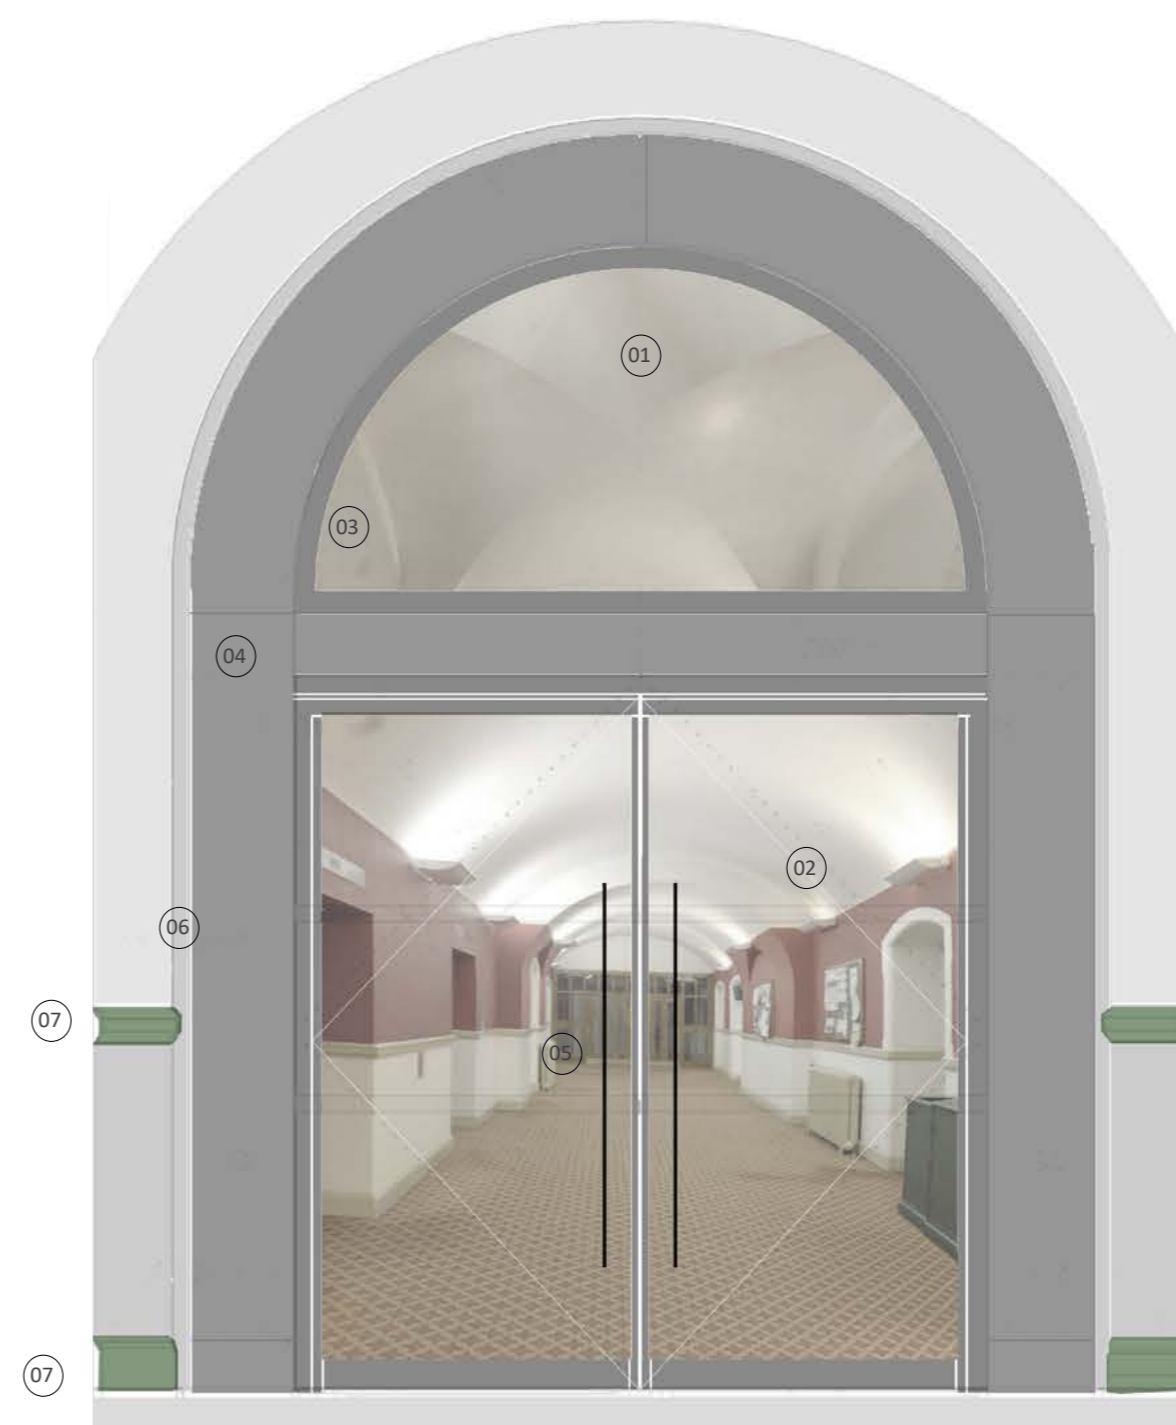
Design intent for glazed fire doors and screens typically to be used in areas of highest heritage significance

- 01 Glazed or solid over panel in original barrel vault - depending on corridor
- 02 Full height glazed doors (generally held open)
- 03 Slim metal frames support fire rated glazing
- 04 Solid surround to mediate vault and door geometry
- 05 Pull handles
- 06 Shadow gap detail to receive skirting and dado
- 07 Existing dado rail and skirting board

5.14.4 The proposal is to deploy fully glazed, cross corridor doors with slim metal frames that can meet the required performance. These will be on 'hold open' mechanisms which will help reinstate the original uninterrupted views. These will be set within a solid fire screen, that can manage the change in geometry between the doorset, the overpanel and the corridor. The overpanel will be glazed or solid, depending on the corridor condition and presence of ceilings.

5.14.5 The proposed door and screen illustration overleaf describes this approach. The new screens would be detailed with a 'shadow gap' at the wall interface to receive original dado and skirting features and help identify the screens as non-original interventions within the space.

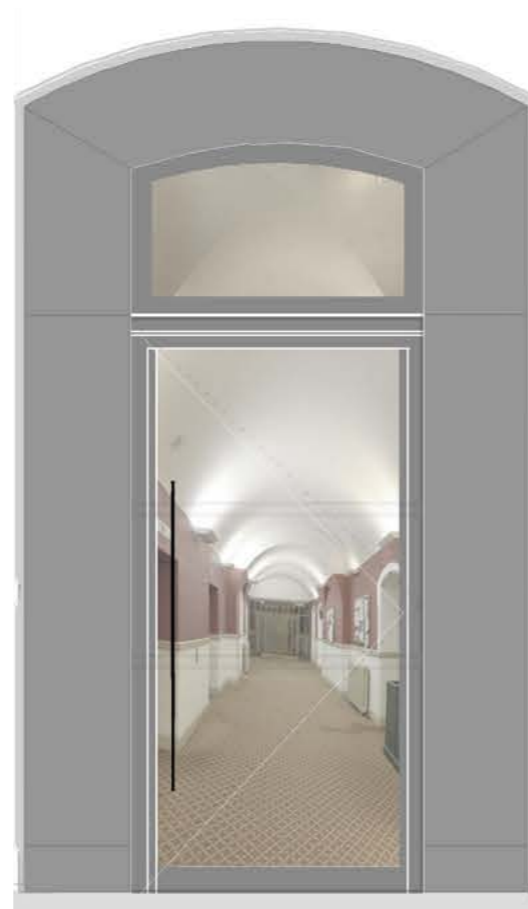
Proposal for narrow corridor condition

5.14.9 The layout of glazing panes including the geometry and dimensions of a top light above the doors will vary across floors and depending on the specific door location, along each corridor. A family of details will be developed to respond to different locations so that there is continuity in the overall format. In several areas, there are existing sections of downstand ceiling above the doors that conceal crossing services. In light of this, and to maintain a consistent approach within the building interior, our proposal is for these to be back-painted or solid panels. The effect of this will be a simple 'family' of screens which vary in their abutment and height but maintain the same aesthetic and format.

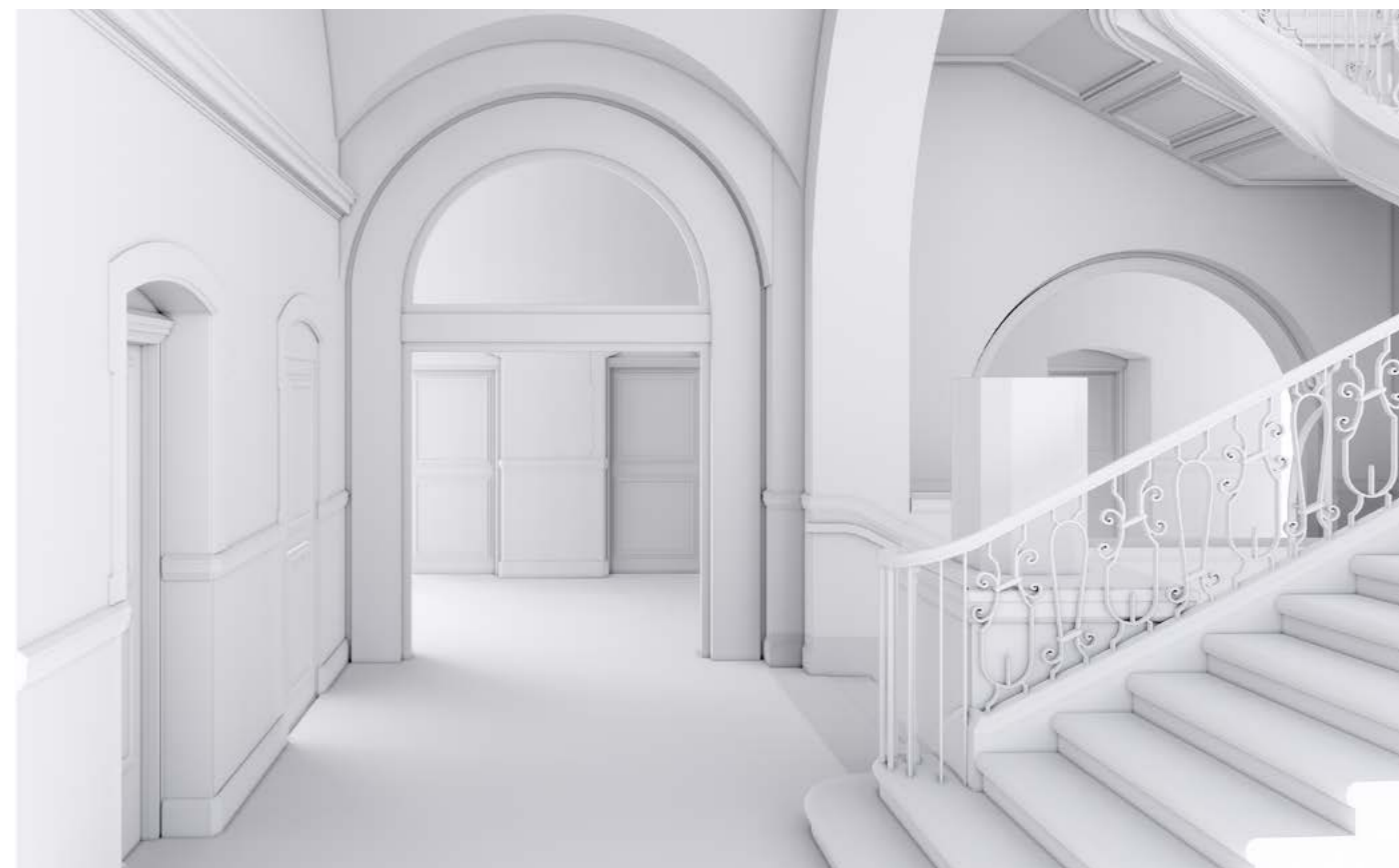
Proposal for large cross corridor screen in south east corner, adjacent to main stair

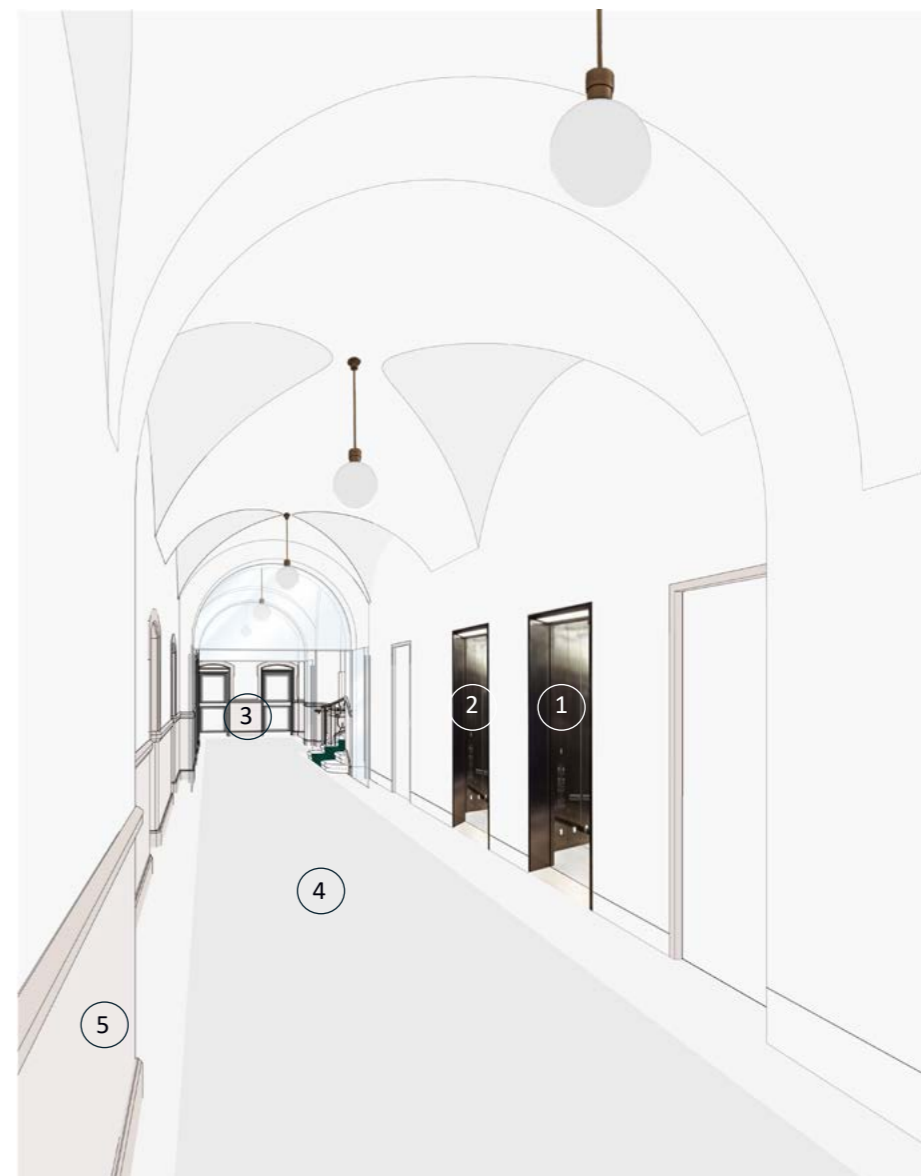
Proposed core lifts internal view

- ① Metal cladding to lift surround
- ② Integrated diffuse lighting
- ③ Slim frame glass partition
- ④ New carpet on existing terrazzo
- ⑤ New colour scheme

5.15.3.4 The new entrance areas to lifts will be designed as contemporary insertions into Shaw's original corridor settings. Datum levels of ceiling arches, dado rails and skirtings have been reflected in the design. The corridor lighting has been designed to emphasize the continuous view along the corridor axis.

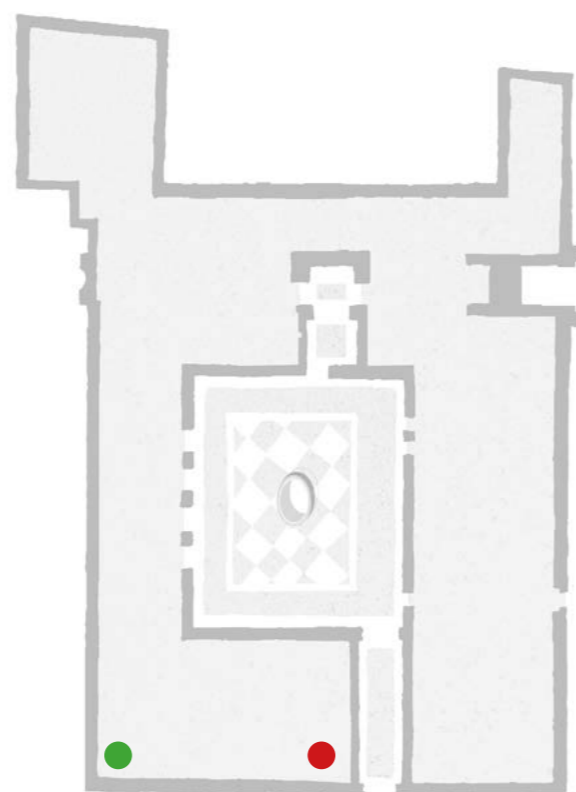
Location plan showing existing and proposed railings

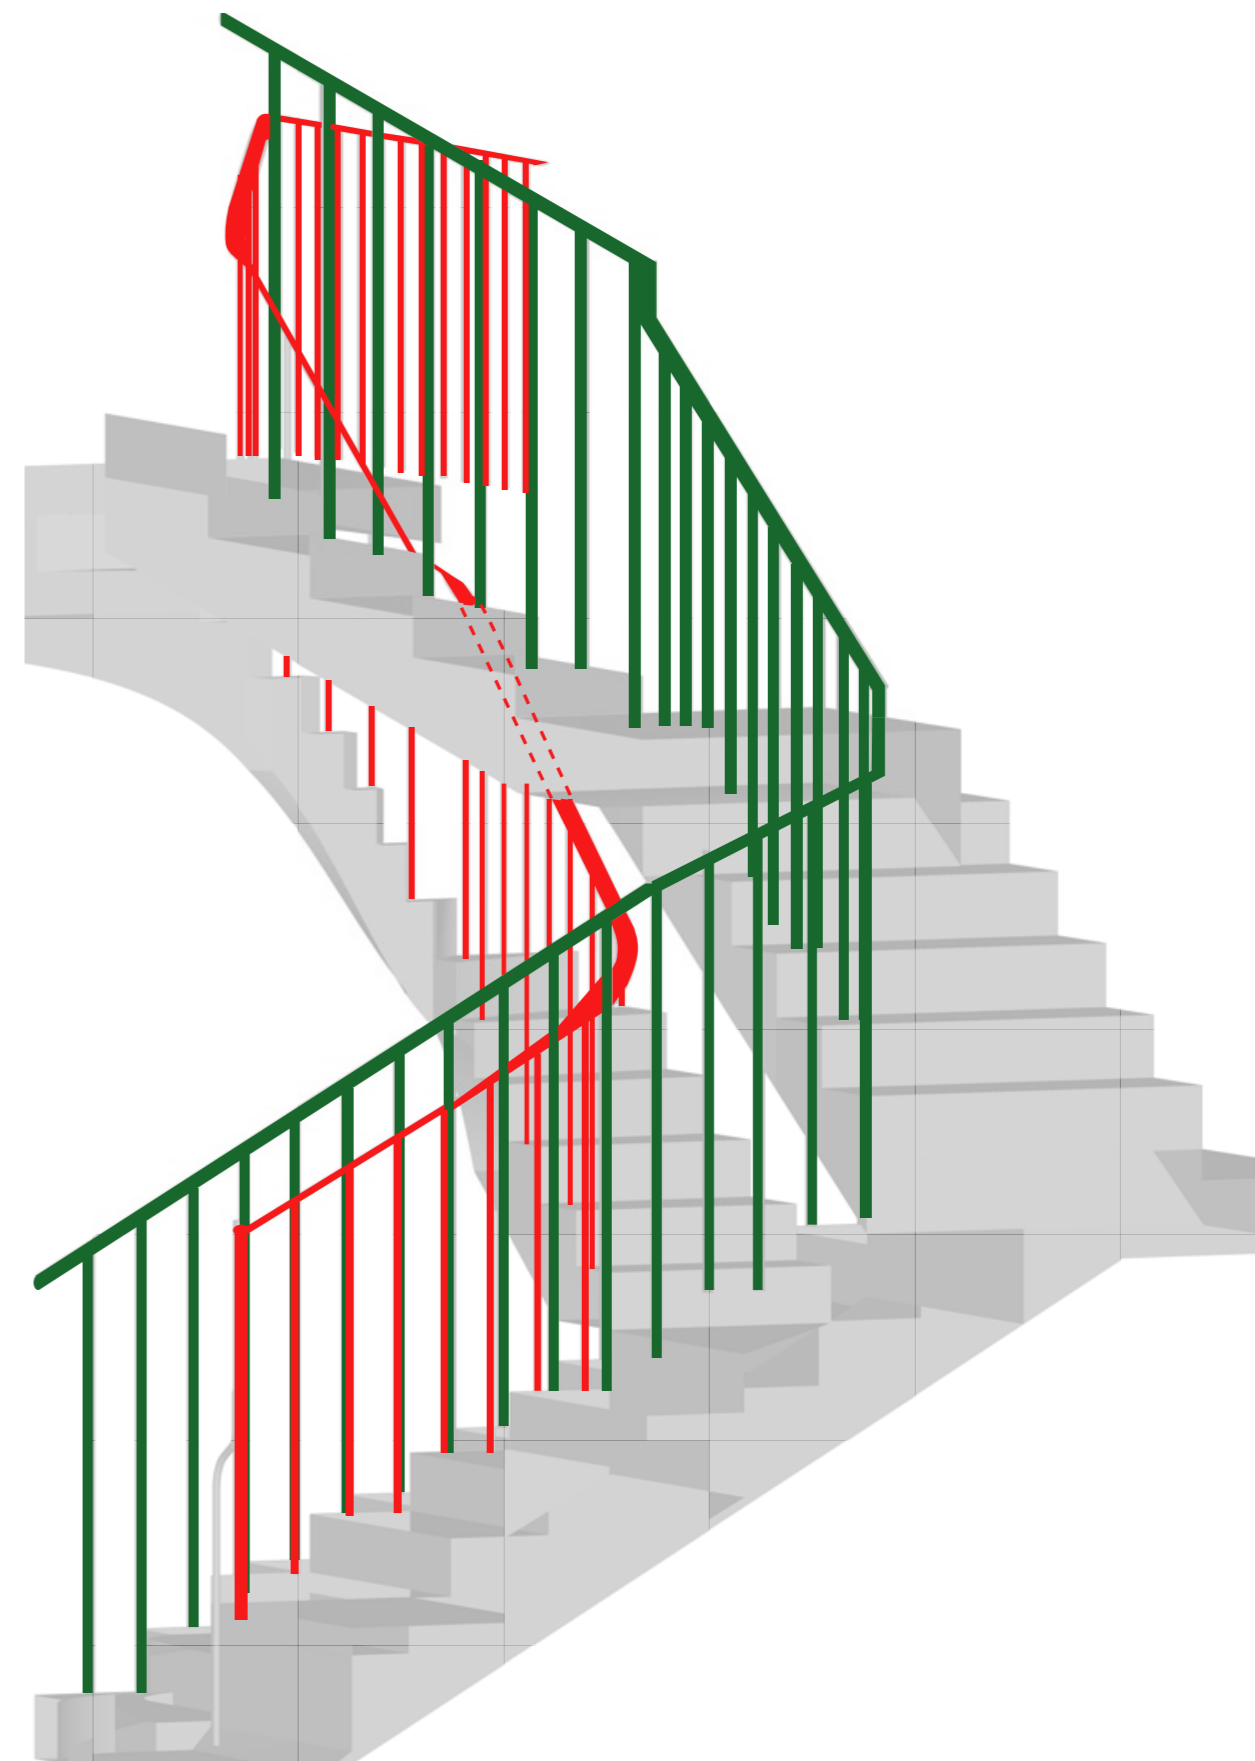
Overlay of existing and proposed staircases showing differences in railing geometry

5.15.4.3 The proposed railing is already regulations compliant. The staircase has 20 steps at a gradient of 29 degrees. The top railing is 1m in height and riser height is constant at 170mm.

5.15.4.4 The study shows that the existing railing would not be compliant in the proposed location and therefore cannot be reused.

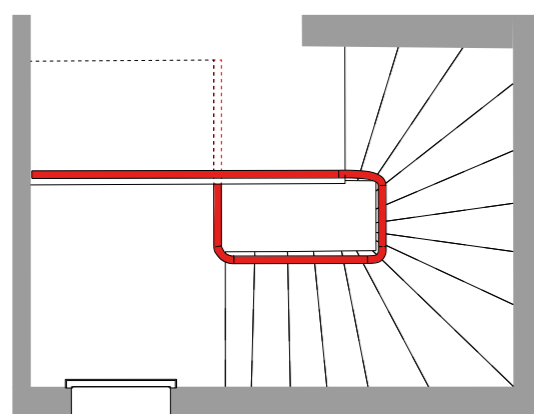
Existing non-compliant railing plan

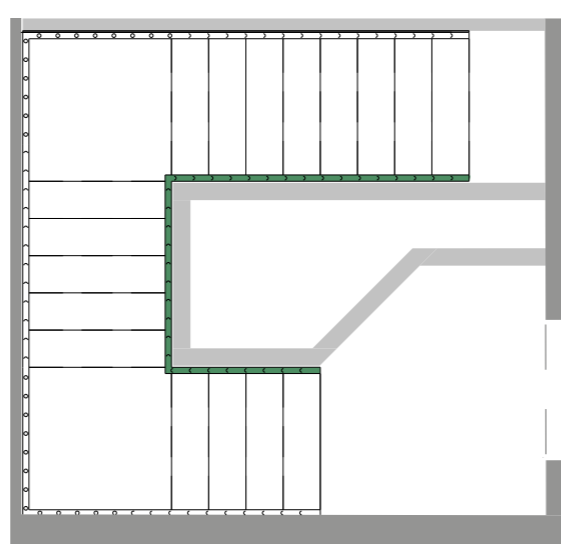
Proposed compliant railing plan

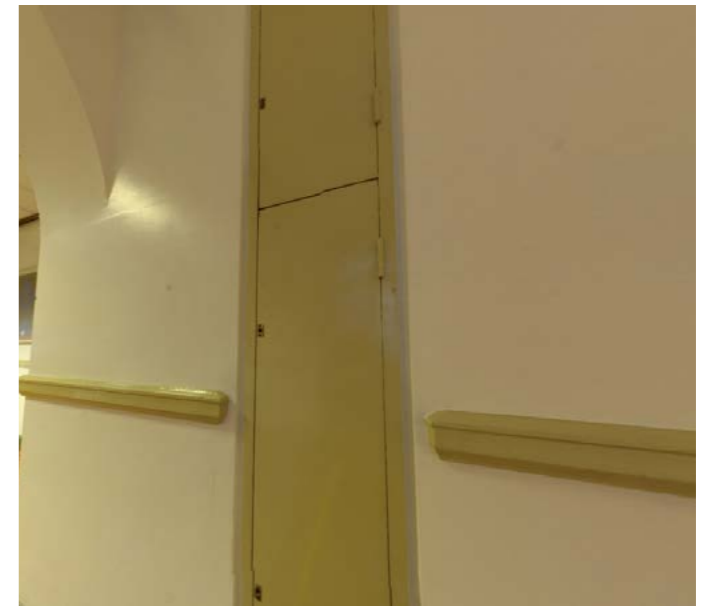
Example of joinery encasement in corridor containing rising electrical services.

5.16.1.5 Vertical distribution for cabling and telecommunications was concealed by joinery encasements located within the corridors. At the time of the completion of the project, the anticipated increased running cost was justified to the Secretary of State in terms of providing more efficient and comfortable working conditions, in comparison with other buildings of the time.

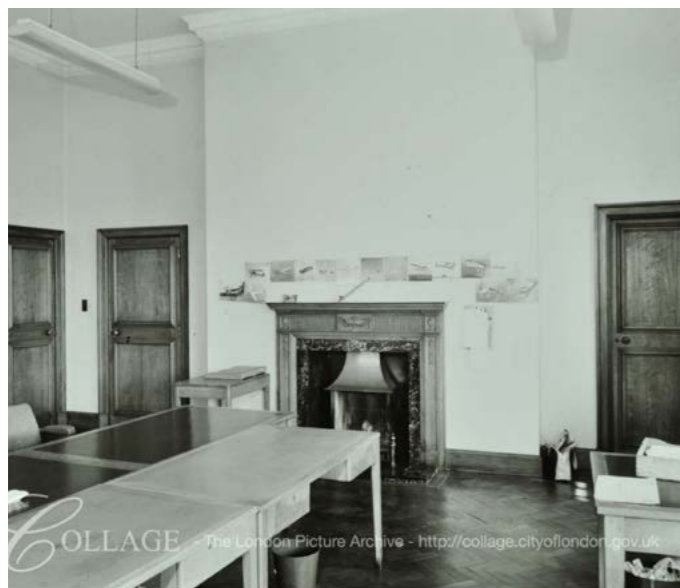
Interior photograph from the Collage London picture archive taken prior to the 1970s refurbishment and illustrating fireplace and utilitarian suspended electrical light fittings.

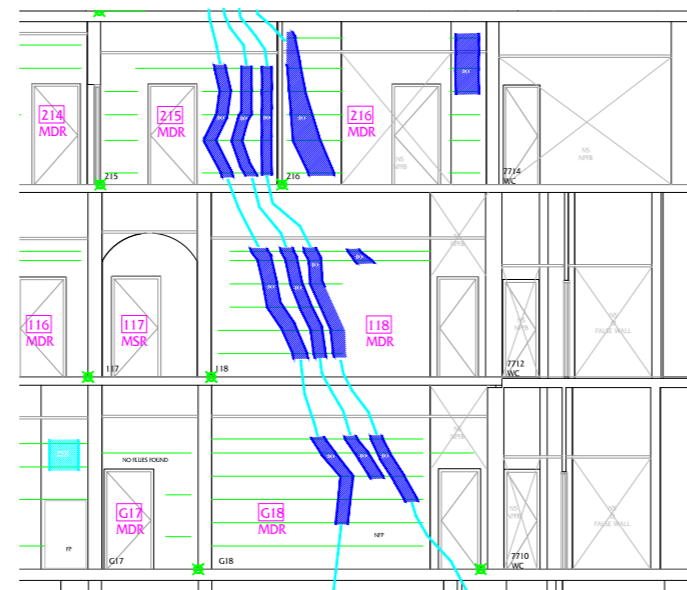
Extract taken from initial chimney flue survey demonstrating inconsistent flue routes unsuitable to utilise as primary services risers.

5.16.2.4 Whilst fireplaces still exist in most rooms, chimneys are capped and they serve a purely decorative function. Non-intrusive surveys of the chimney flue network have been carried out as part of the current proposals. These initial surveys demonstrate a complex and irregular system of limited sized flues within the building and as such it is not practical to use individual flues for new services routes.

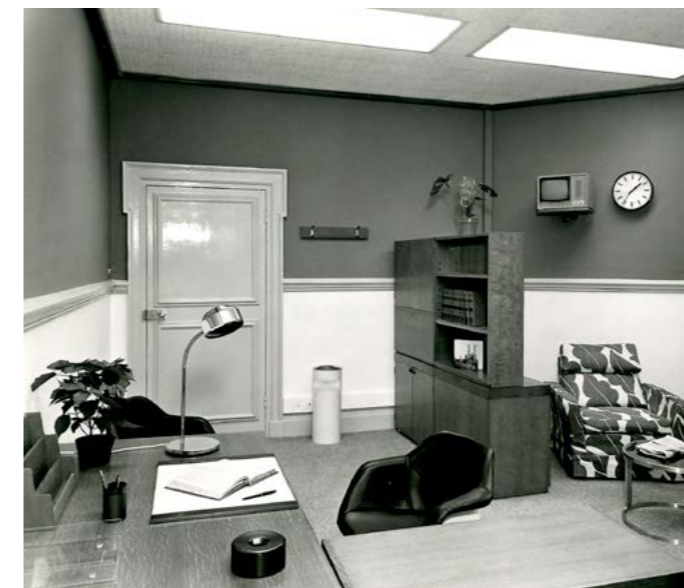
Typical office post 1970s refurbishment illustrating new suspended fabric ceilings, low level surface mounted trunking and new decorative finishes throughout

5.16.2.3 The most significant change to the building resulted from the insertion of suspended ceiling in most rooms and corridors, altering their proportions, and fire compartmentalised screens across what were originally free-flowing corridors [in line with attitudes at the time in relation to modern servicing expectations and working patterns associated with passholders and Commons' use - the Metropolitan Police having moved-out of the building in the 1960s]. In the 1990s, further repairs and refurbishments were undertaken to address disabled access and fire precautions and means of escape, as well as new mechanical and electrical services throughout. In both the 1970s refurbishment and 1990s upgrade works, the decision to surface mount power and data services in dado trunking has resulted in the removal of sections of existing dado and skirting.

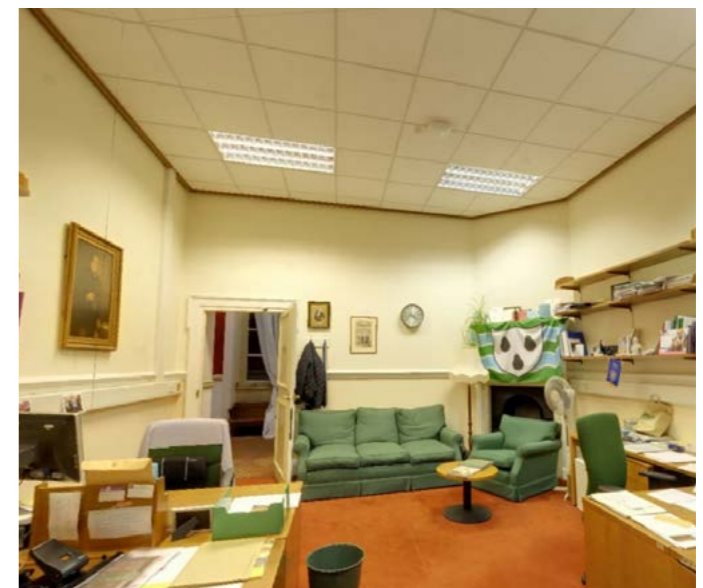
Current office illustrating piecemeal modifications to services including suspended grid ceilings, mid level surface mounted trunking and renewed decoration. Note impact of trunking on dado rail.

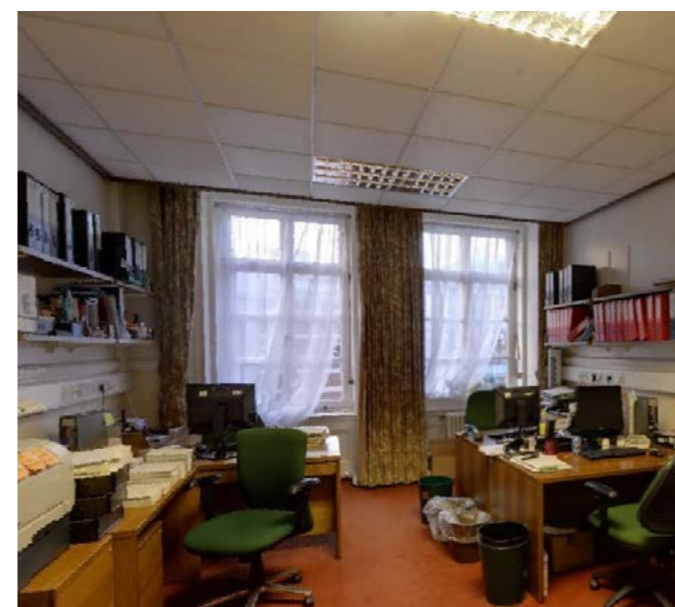
Example of office space with suspended grid ceiling, radiators beneath windows and surface mounted services trunking on the walls. Windows currently restricted opening and single glazed.

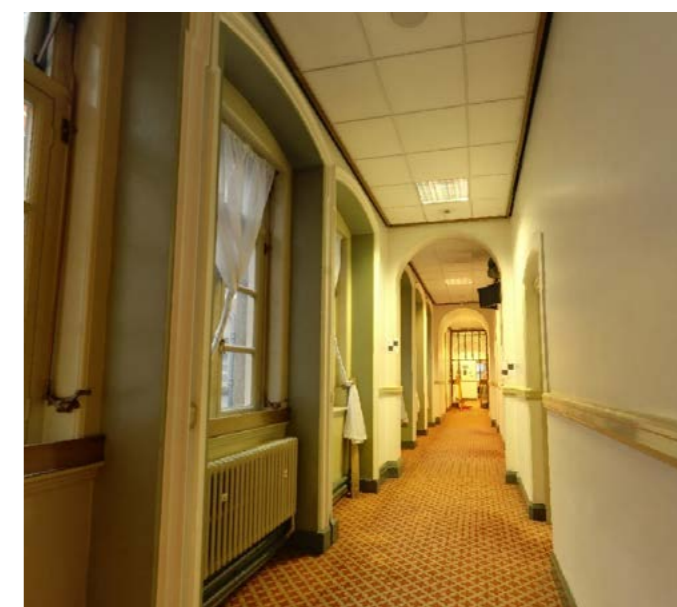
Example of corridor space with suspended grid ceiling, radiators beneath windows and timber cross corridor screens.

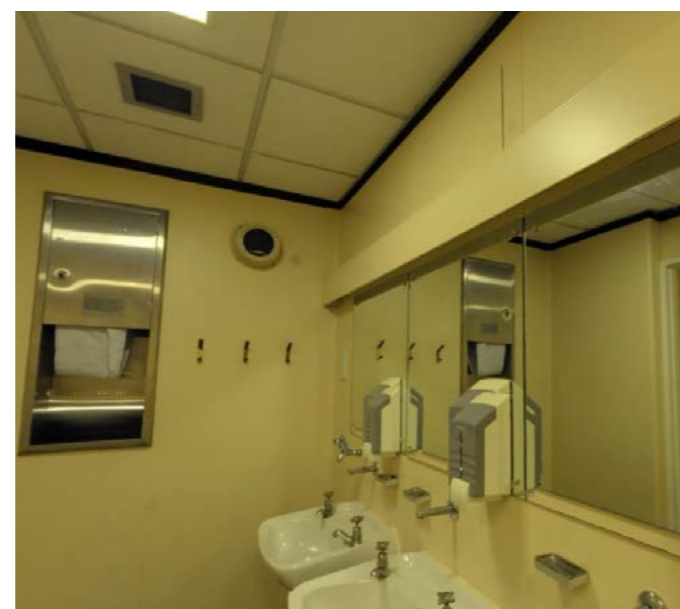
Existing WC with minimal servicing and no heating.

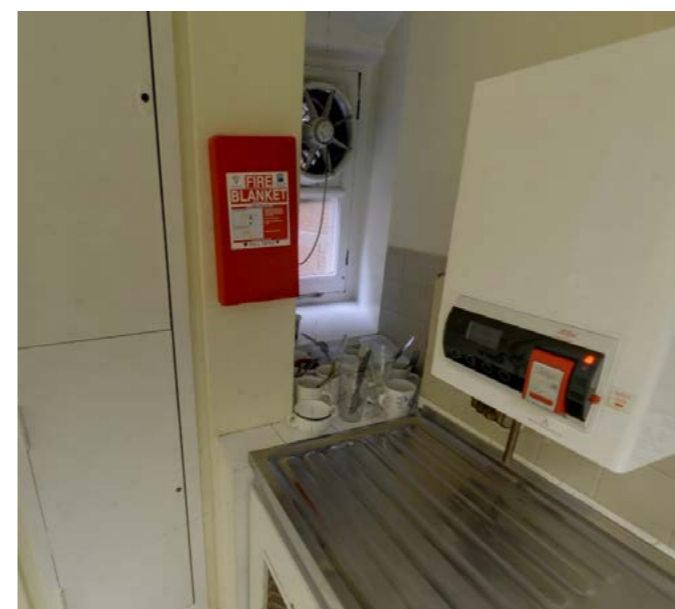
Existing tea point with local extract fan mounted in courtyard facing window

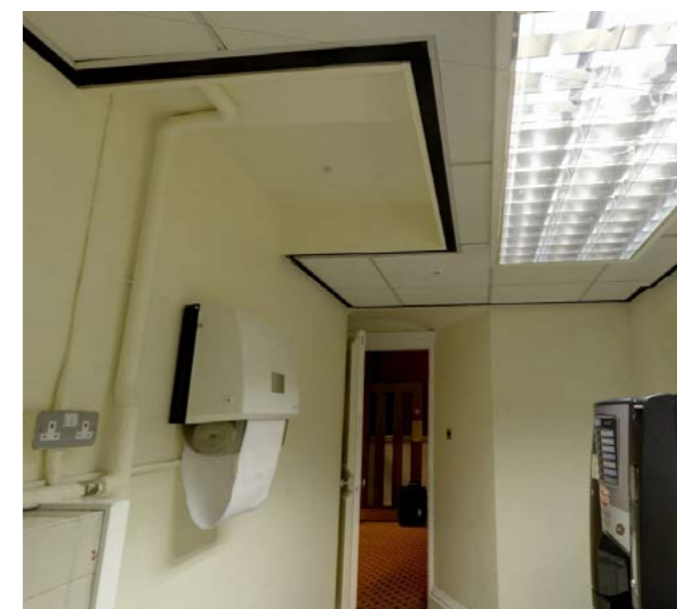
Existing pipework exposed with insulation damaged and worn out

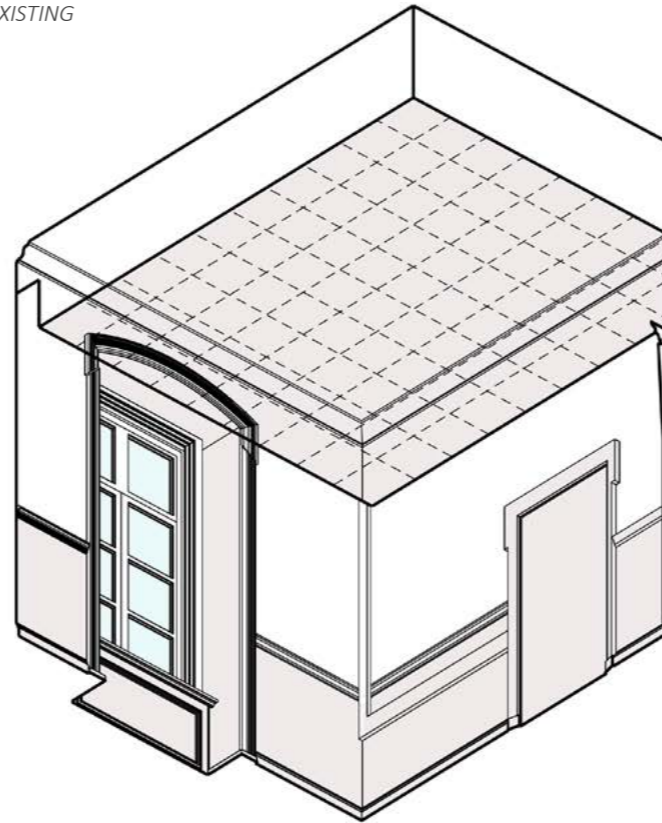
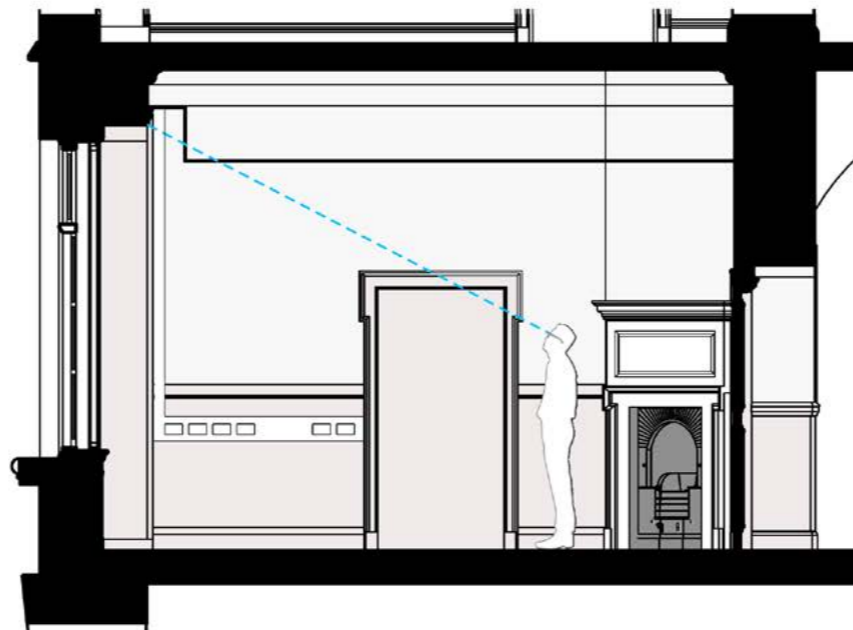
EXISTING

Suspended grid ceilings throughout
Surface mounted trunking cutting through dado rails

5.16.4.6 The diagrams adjacent illustrate the sequence of refurbishment of a typical office.
