5.13 Interior design approach

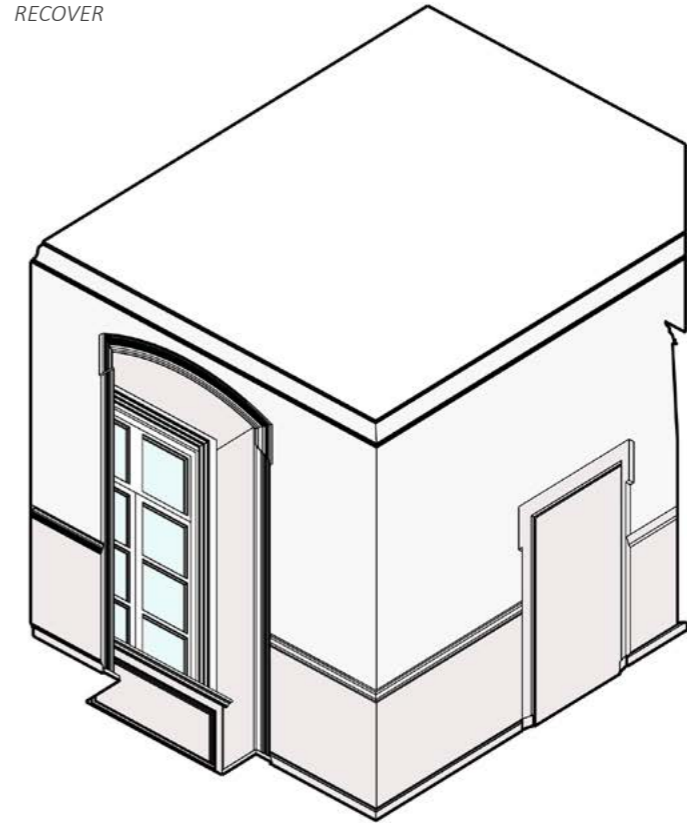
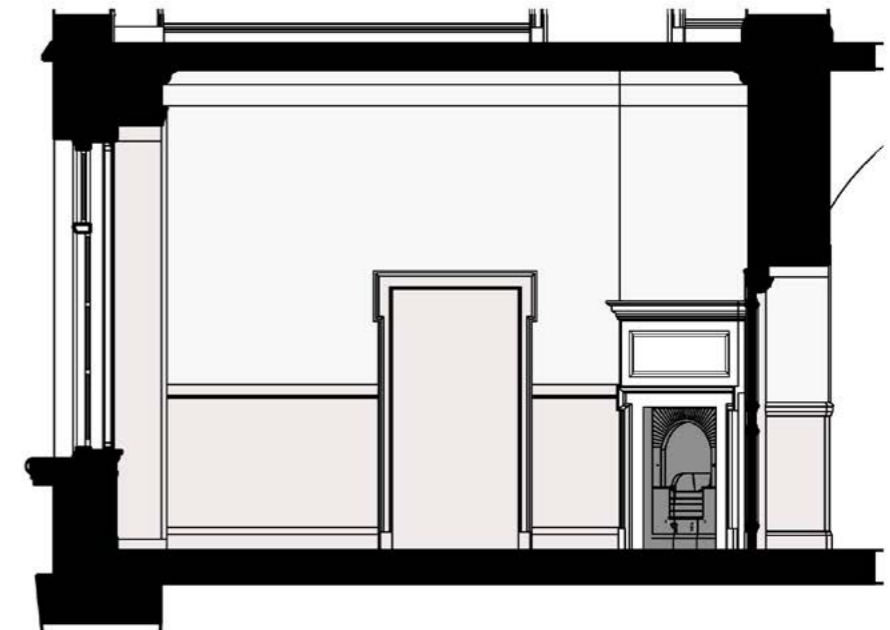
RECOVER

Removal of suspended grid ceiling and surface mounted services
Repair and reinstate decorative elements compromised by current arrangement.

5.16.4.6 The diagrams adjacent illustrate the sequence of refurbishment of a typical office.

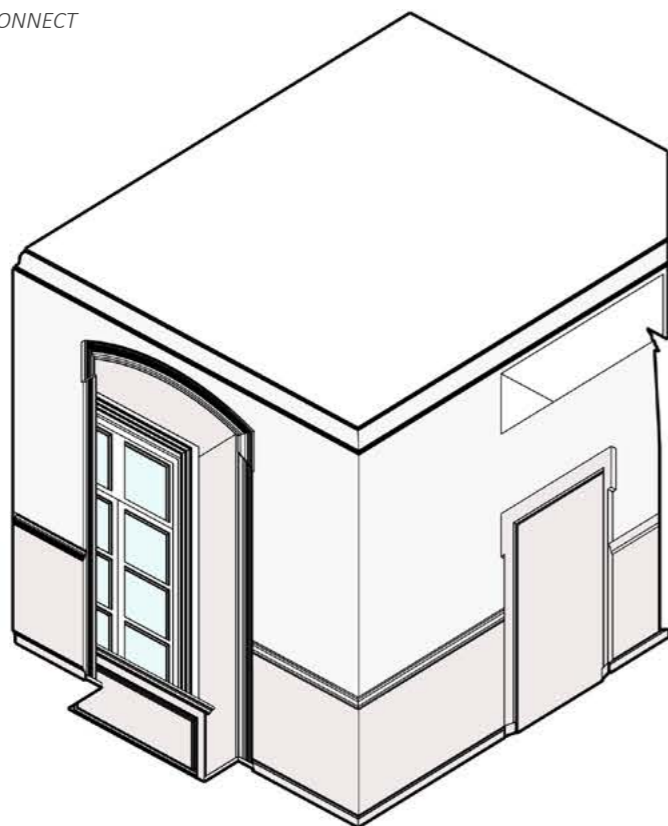
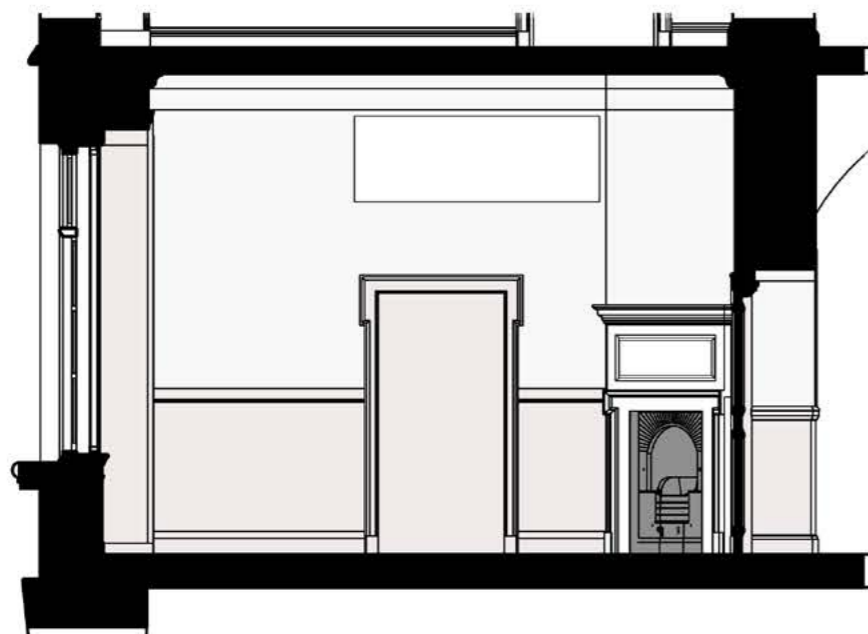
CONNECT

Creation of physical openings within office partition walls .
Set as high as possible within the room but beneath existing cornice and downstand features.
Set out to avoid clashing with corner chimney pieces.

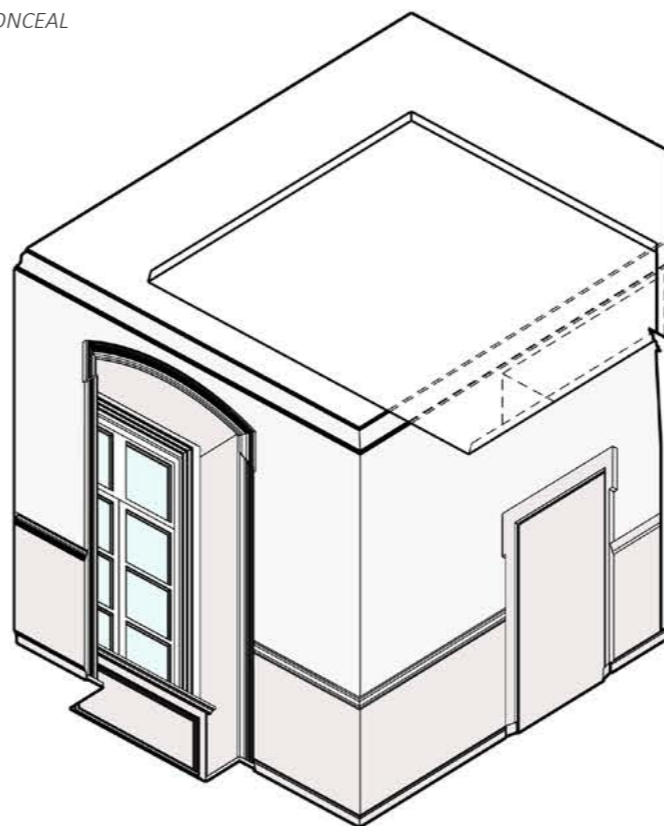
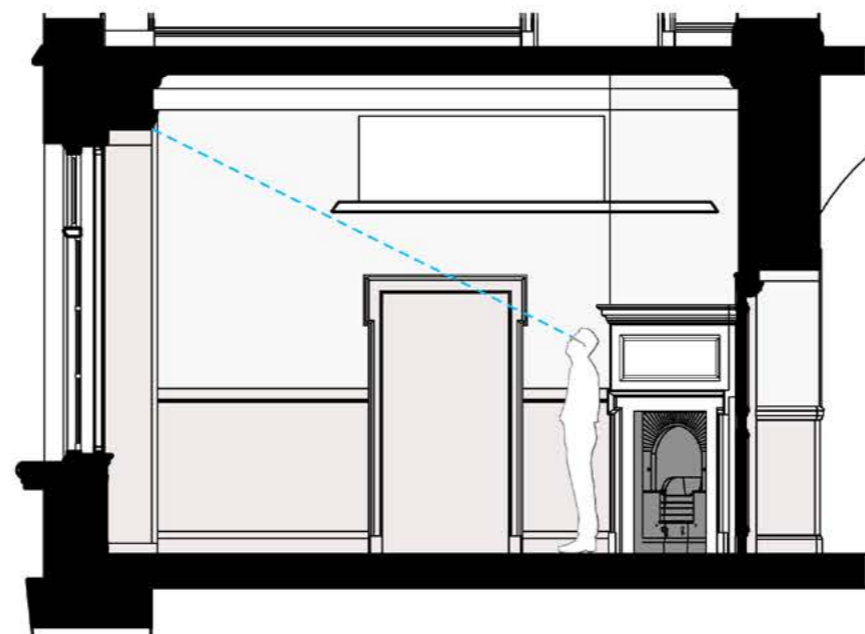
CONCEAL

Suspend a simple raft to conceal services
Set off from the existing walls and as far from the external window elevation as possible

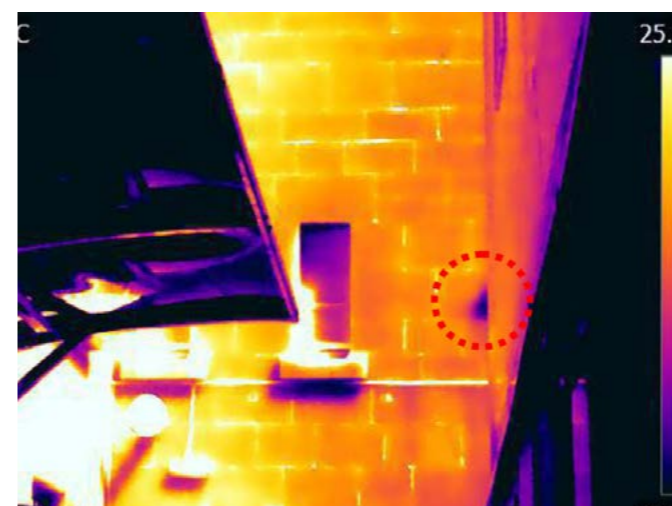
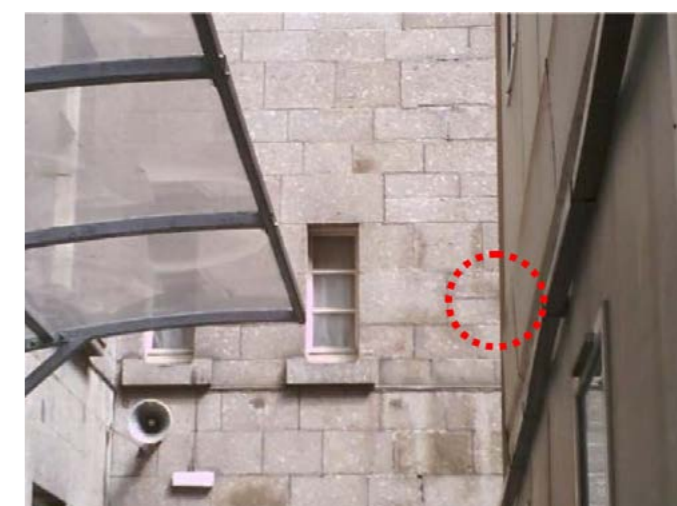
Thermographic survey example images

5.18.5.1 This was undertaken using a nondestructive remote sensing survey technique of Thermography that uses a long wave infra-red thermal camera to locate variations across the external facade surface of the structure. Temperature differentials identified through the use of thermography can be directly attributed to conditions such as elevated moisture, spalling and/or voiding. This technique can identify locations where water may be retained on the wall surfaces and consequently areas where likely stone deterioration - i.e. the development of cracks, spalls/delamination etc

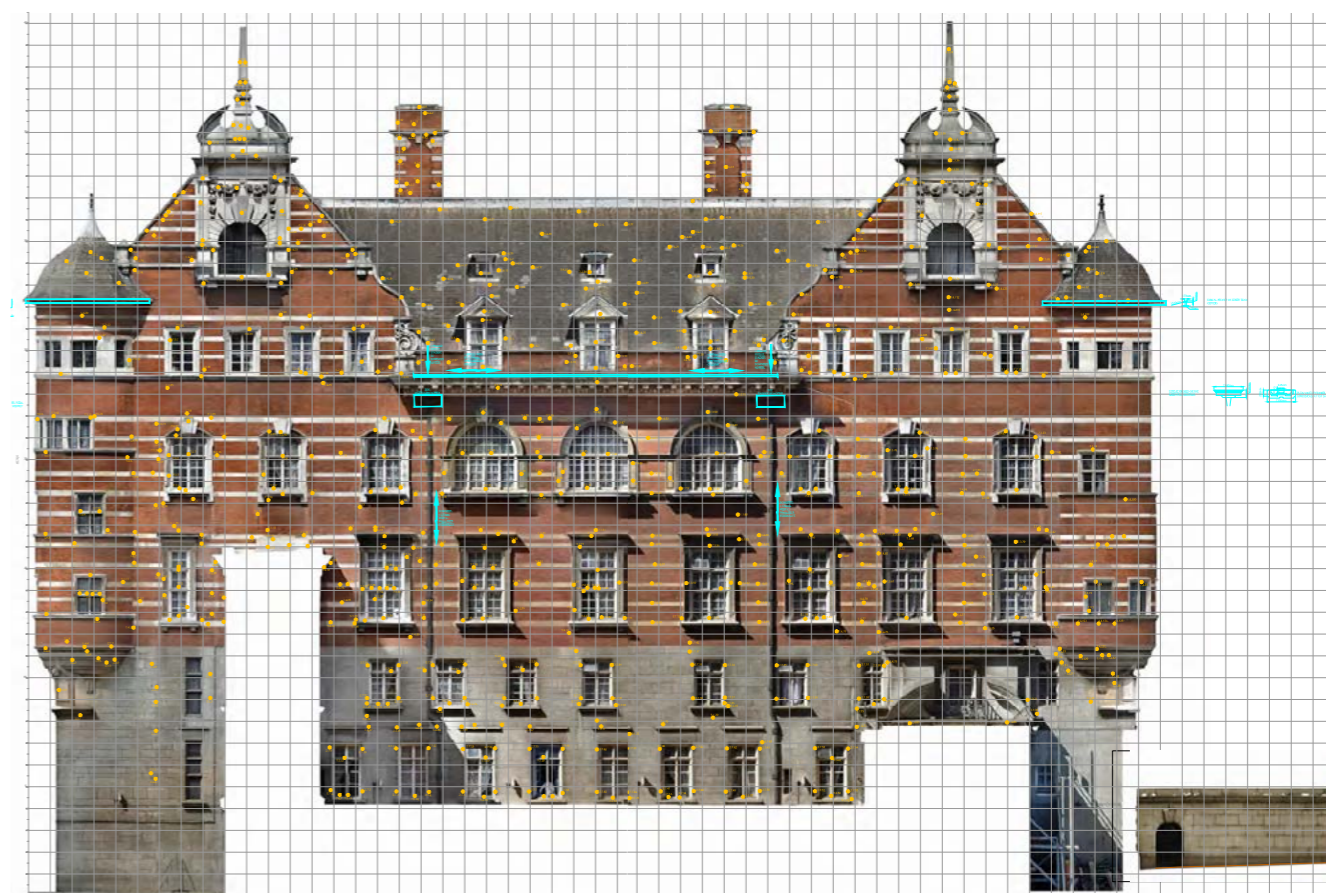
South elevation - visual inspection of external fabric and drainage condition

5.18.4.1 A detailed visual assessment of the external envelope of the building was undertaken. The survey was carried out at a distance of 4 metres approximately from each facade, depending on access, and used a high resolution digital camera and wide angle lens to record the findings. A series of overlapping images was taken in a grid arrangement. Each image has been catalogued, defects logged for reference and location, and have been electronically 'stitched' together to provide a seamless mosaic, of a complete facade.

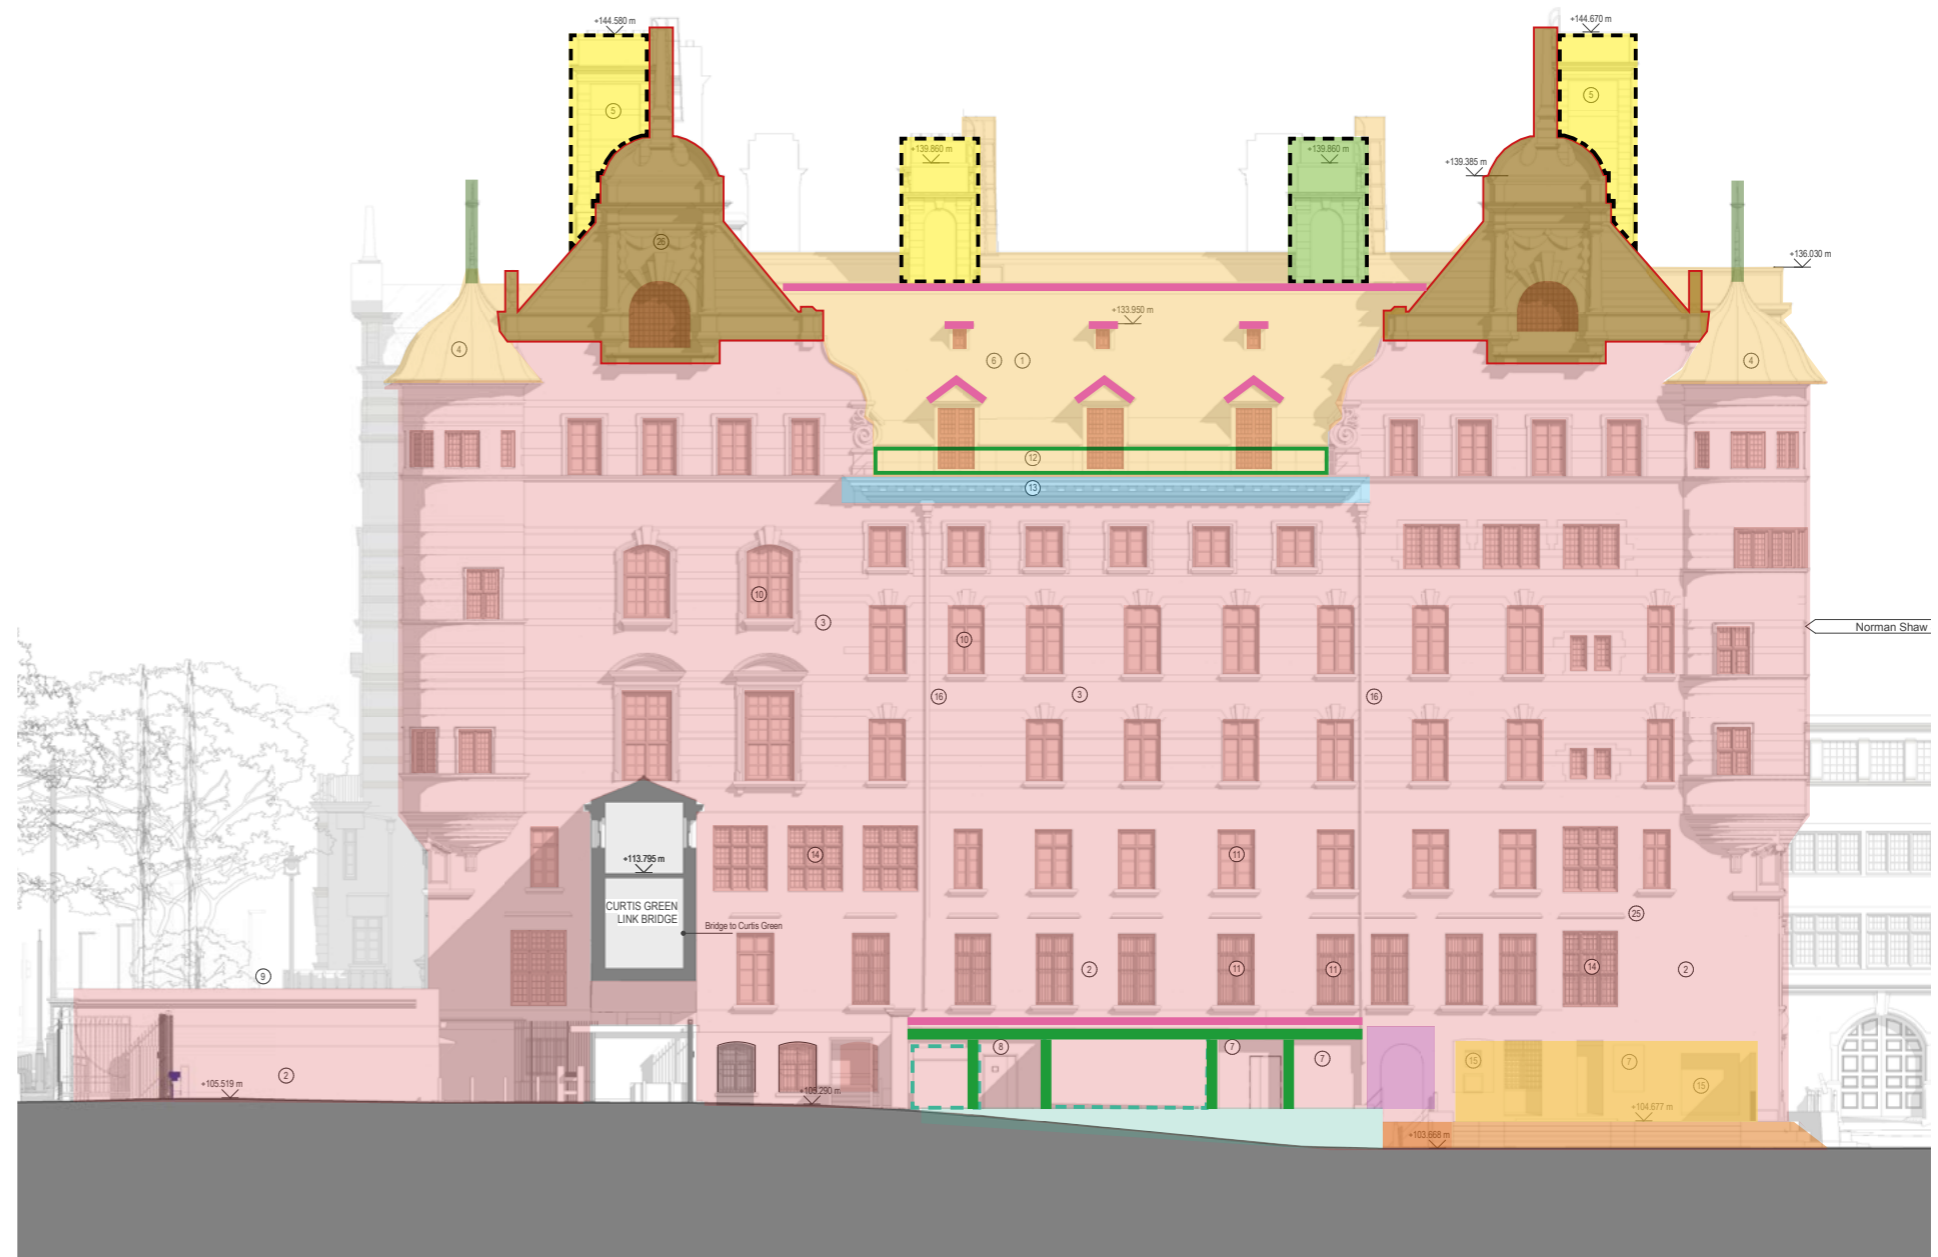
- Careful facade cleaning and fabric repair, including removal of organic matter, making good and preventing further deterioration.
- Windows repaired, refurbished and repainted.

- Comprehensive roof repair, including slates (reusing existing wherever feasible), leadwork, stonework and underlying substrate above truss and rafter line. Insulation introduced between rafters. Gutters repaired. Lightning protection replaced and re-integrated.

- Stone repairs to pediment and ridge.
- Stone Repairs to cornice
- Reconstruction of existing chimneys
- Repairs to Portland stone and brickwork at retained chimneys

- New leadwork to dormer roofs, cheeks, flashings and roof ridges / valleys. New lead drip over refurbished ironwork
- Existing ironwork revealed, repaired and refurbished, including new paint protection

- Existing metal railings to be repaired, consolidated and decorated
- Repairs to roof finials
- Reinstatement of original paired window reveals and windows with inset louvred grille to one pair.

- Door reinstated within recovered granite opening
- Window removed and cill lowered to make new door opening
- Removal of portacabin and shed
- Decking removed, felt roof replaced with new hard landscaping prior to installation of plant

- Plinth reconfigured as part of landscape re-setting. Balustrade added

Illustrative proposed north elevation showing scope

5.18.6.1 The following items outline the elevation repair and refurbishment works, using the north elevation as an example.

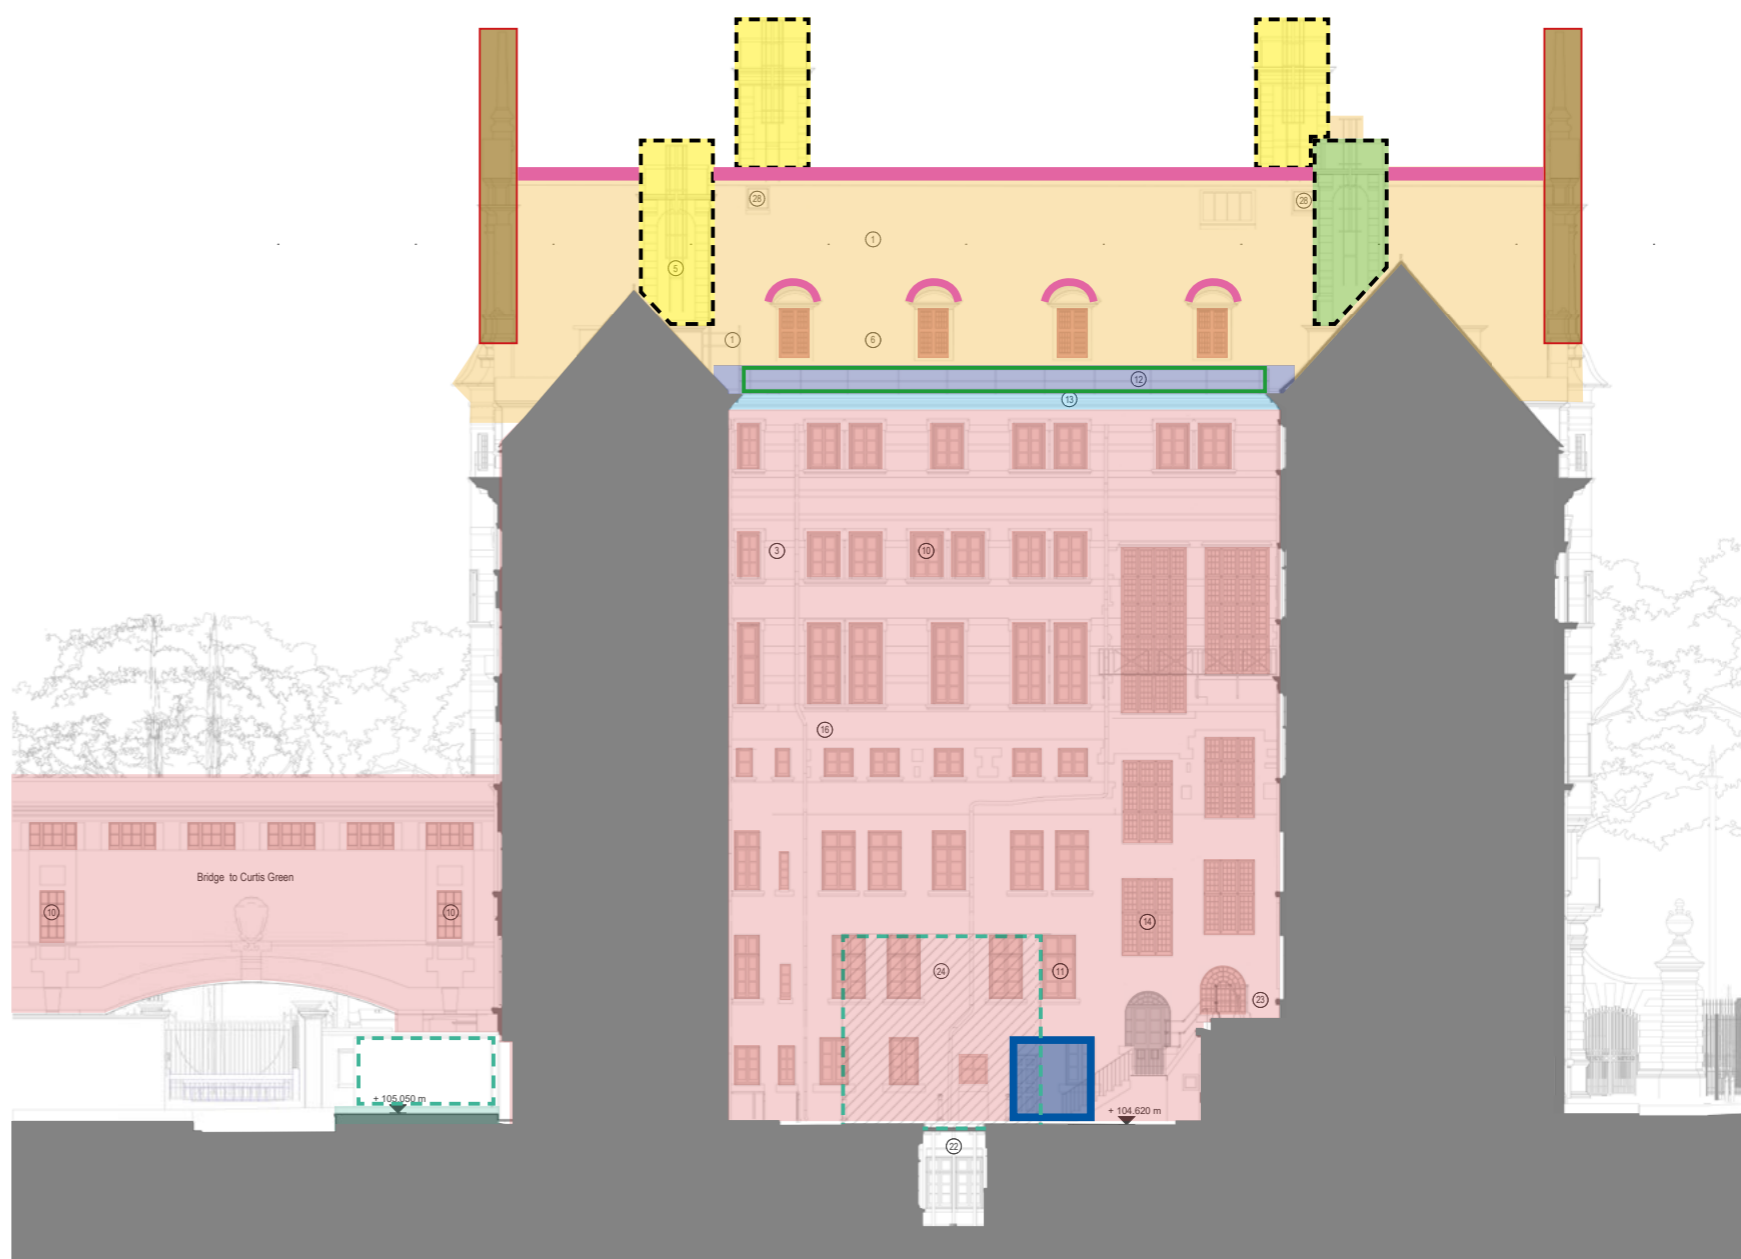
Illustrative proposed courtyard section showing scope

5.18.7.1 The following items outline the courtyard elevation repair and refurbishment works, using the east elevation as an example.

- Cutback to roof line to create new courtyard maintenance access gallery with louvre panel eaves detail.
- Stone repairs to pediment and ridge.
- Stone Repairs to cornice

- Removal of portacabin, external furniture and fittings
- New opening to make new accessible building entrance
- Removal of non original steps and restoration of facade and window to original format

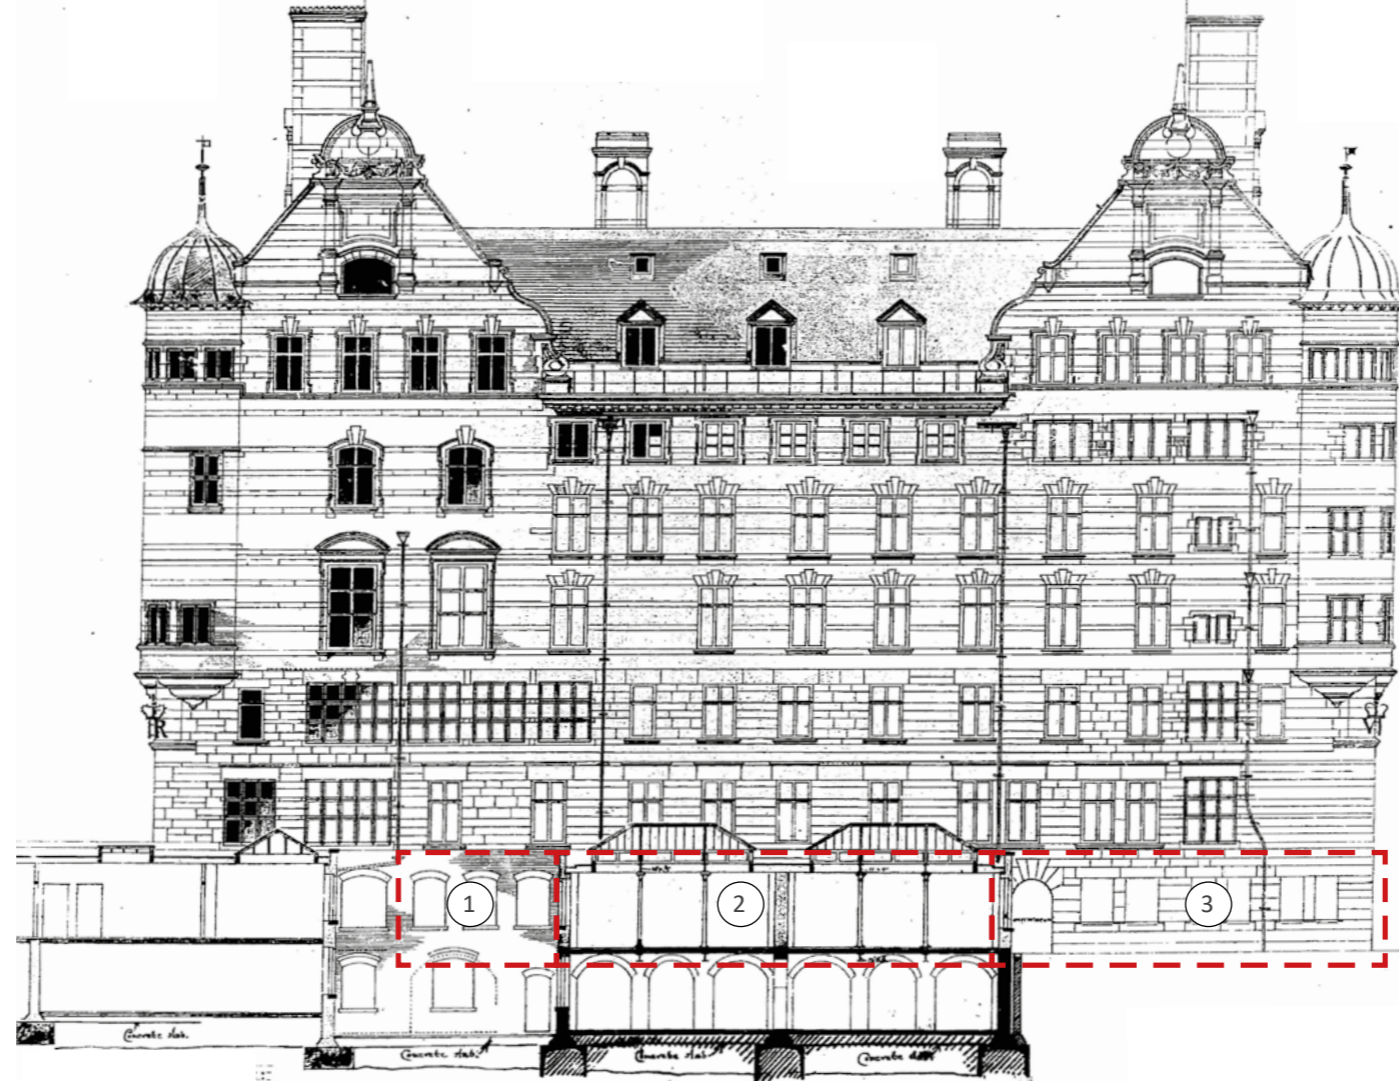
Shaw's original drawing for the north elevation showing laundry pavilion

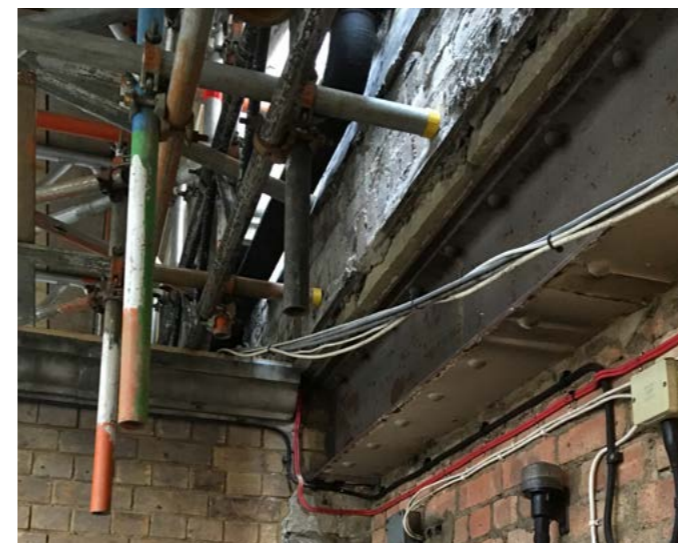
Existing condition of beam

- Facing brickwork to be cleaned and re-pointed, including removal of existing bitumen and loose/broken bricks replaced with matching
- Introduction of new lead-clad drip to provide weathering and protection to retained iron metalwork
- Repair and re-painting of the wrought iron metalwork, beam and columns
- Simple, infill facade set behind the column line, incorporating a clerestory light to bring daylight into the kitchen space behind

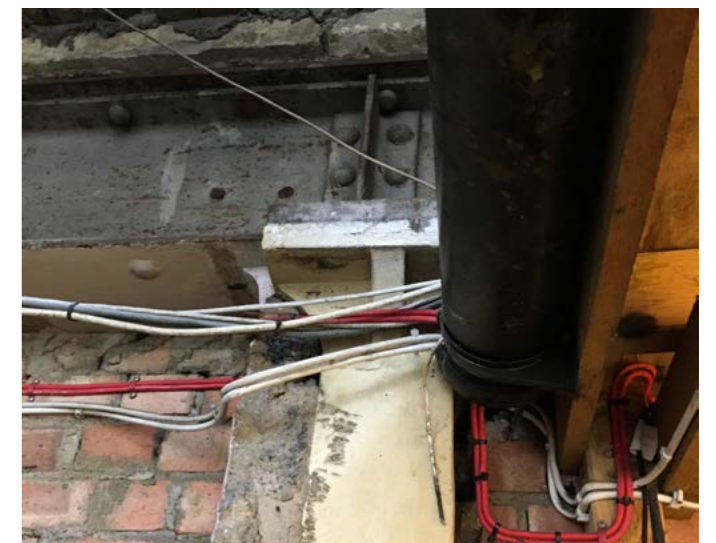
Existing condition of columns

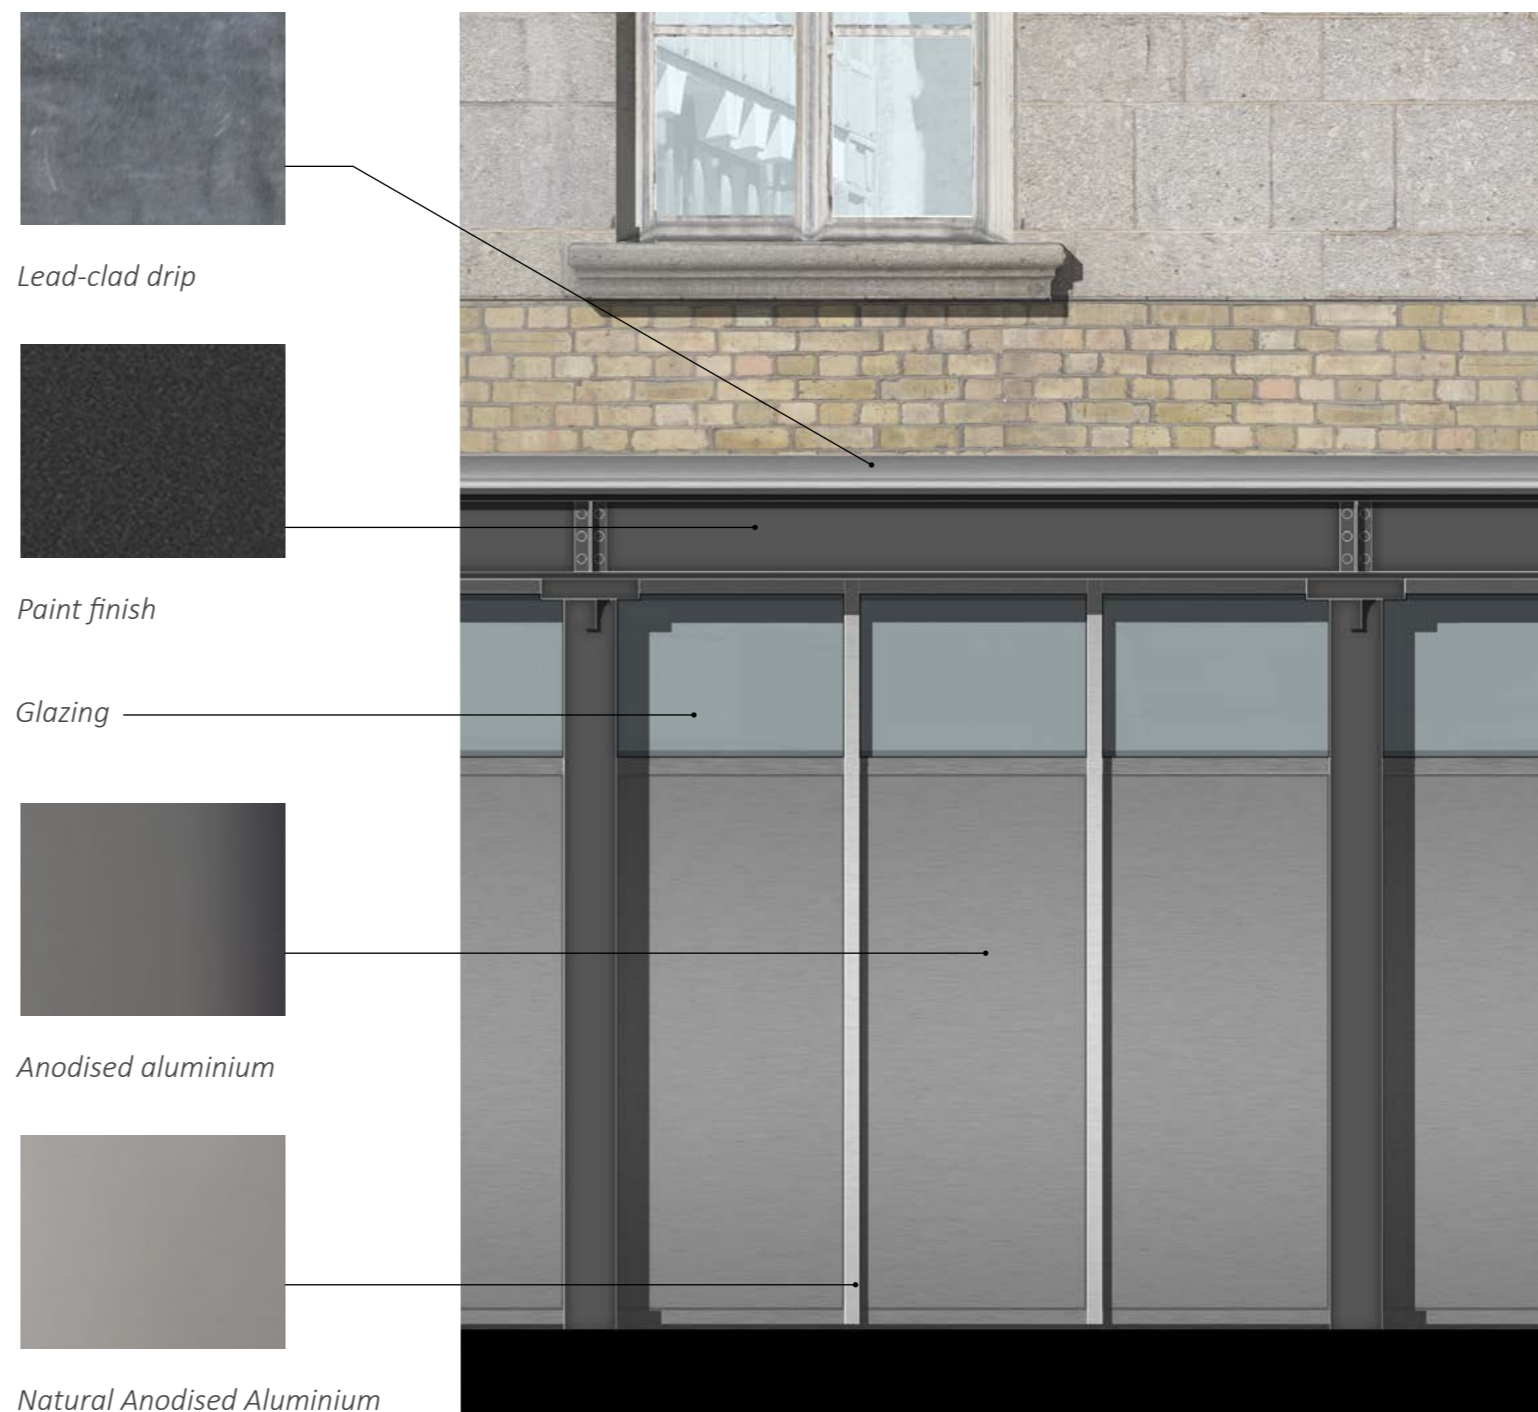
North elevation bay study

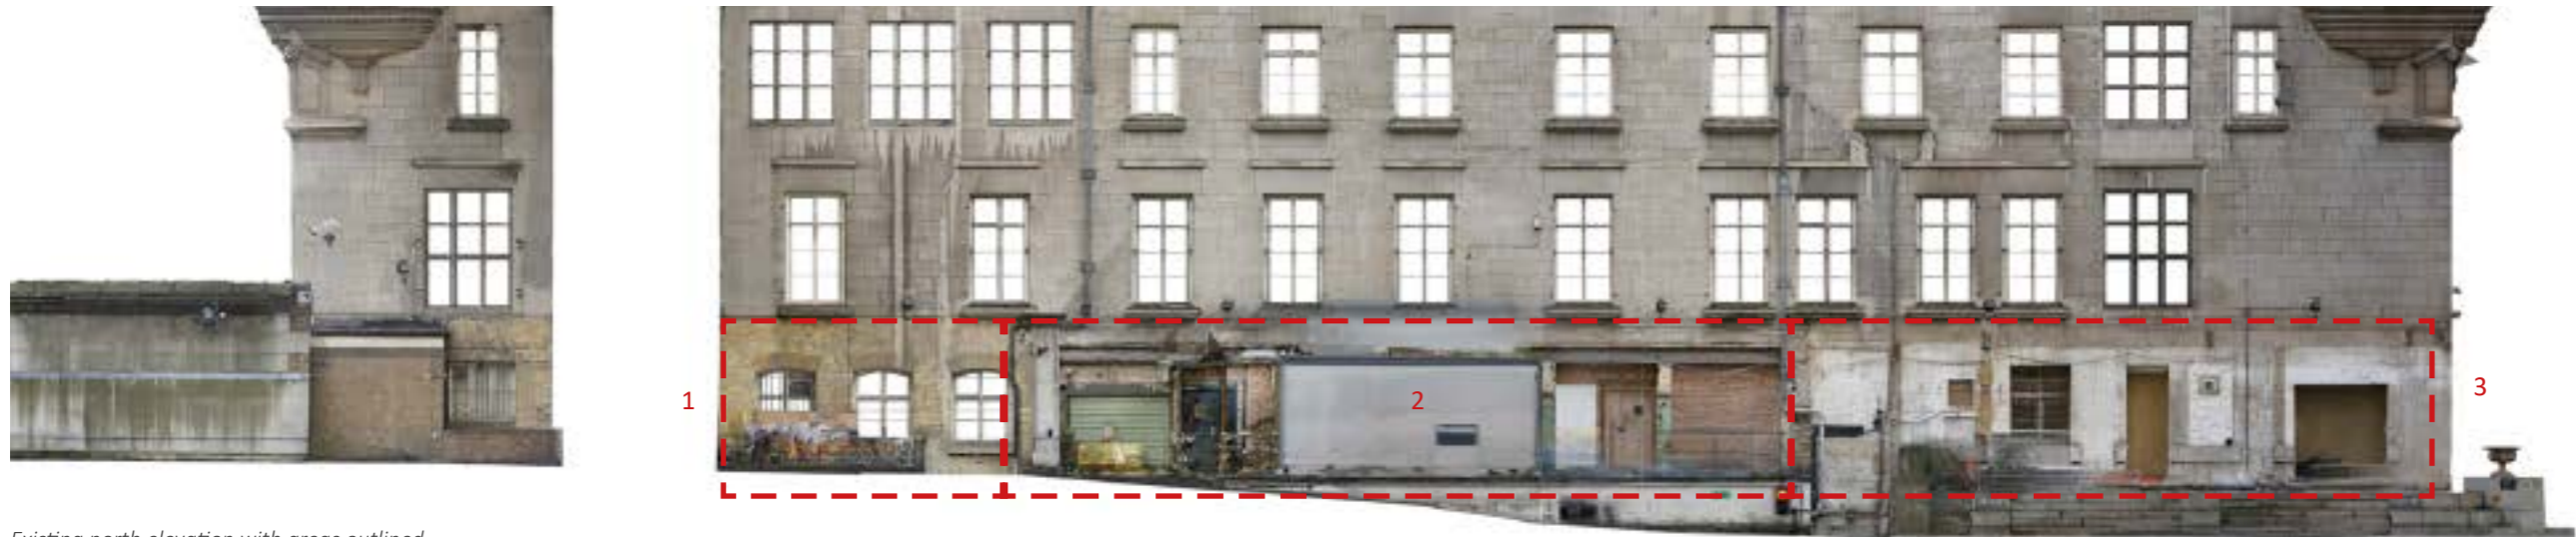
- ① Modification of an existing window to provide a new fire fighting access
- ② Refurbishment of existing columns and beam with infill construction.
- ③ Reinstatement of existing door and window openings, one with louvred infill

Existing north elevation with areas outlined

5.19.2 In addition, the plant enclosure and landscape proposals in this area can provide a degree of consolidation and re-presentation at the base of the building. Proposals for the elevation have developed in three sections, the areas of which are outlined in red on the elevation drawing.

5.19.3 Three windows set within a section of brickwork adjacent to the Curtis Green Bridge (see Area 01 on the adjacent elevation) represent a material and architectural language shift in the existing elevation. Proposals seek to modify one of these windows to provide fire fighting access and egress and also accommodate a new dry riser inlet.

5.19.4 The area to the centre of the elevation (Area 2) is where the former laundry pavilion has been removed and rough blockwork infill construction fills the gaps between the original iron structural elements, that are variously encased or exposed. The restoration and consolidation approach comprises:

5.19.5 Whilst clearly modified over time, Area 03 within the elevation reveals the window openings, heads and cills of the original design intent drawings and construction. It is proposed that these are reinstated and the stonework surrounding the openings repaired. The eastern most window will be fitted with louvres to support the ventilation building services to the catering areas behind. The original arched door opening will be reinstated with a new door matching the design intent of the original, to provide service access from the north.

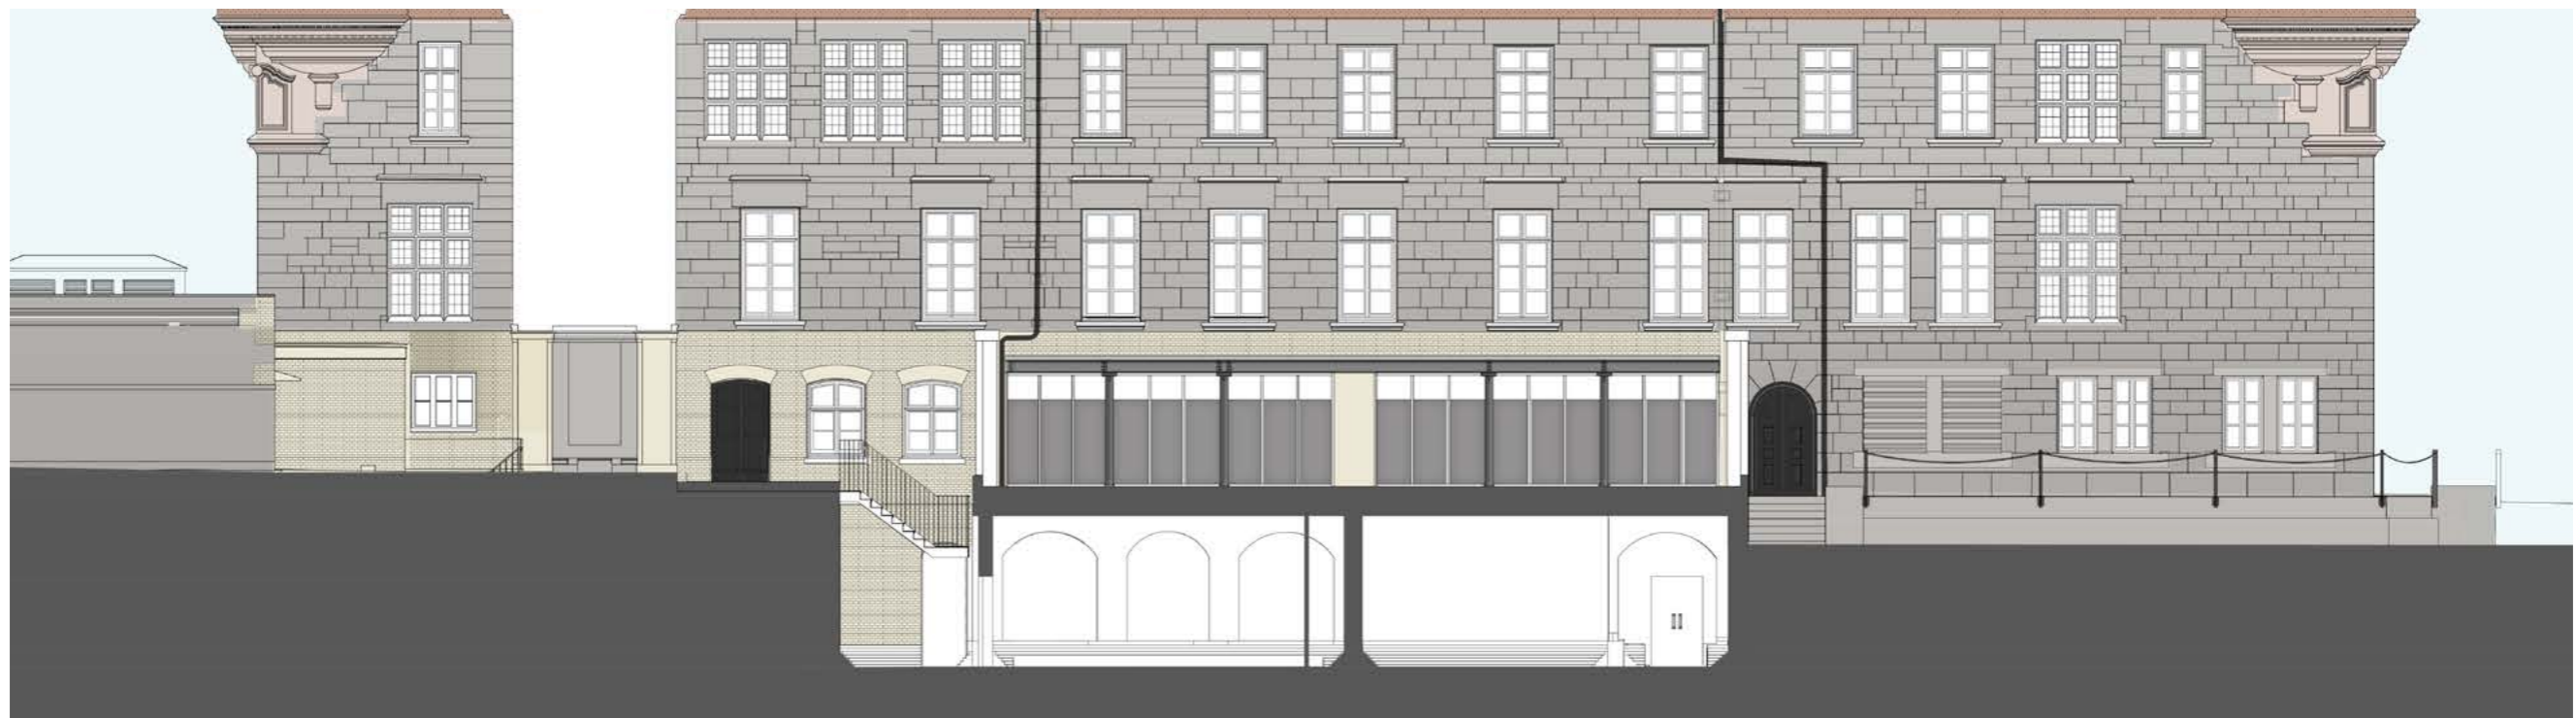
Proposed north elevation

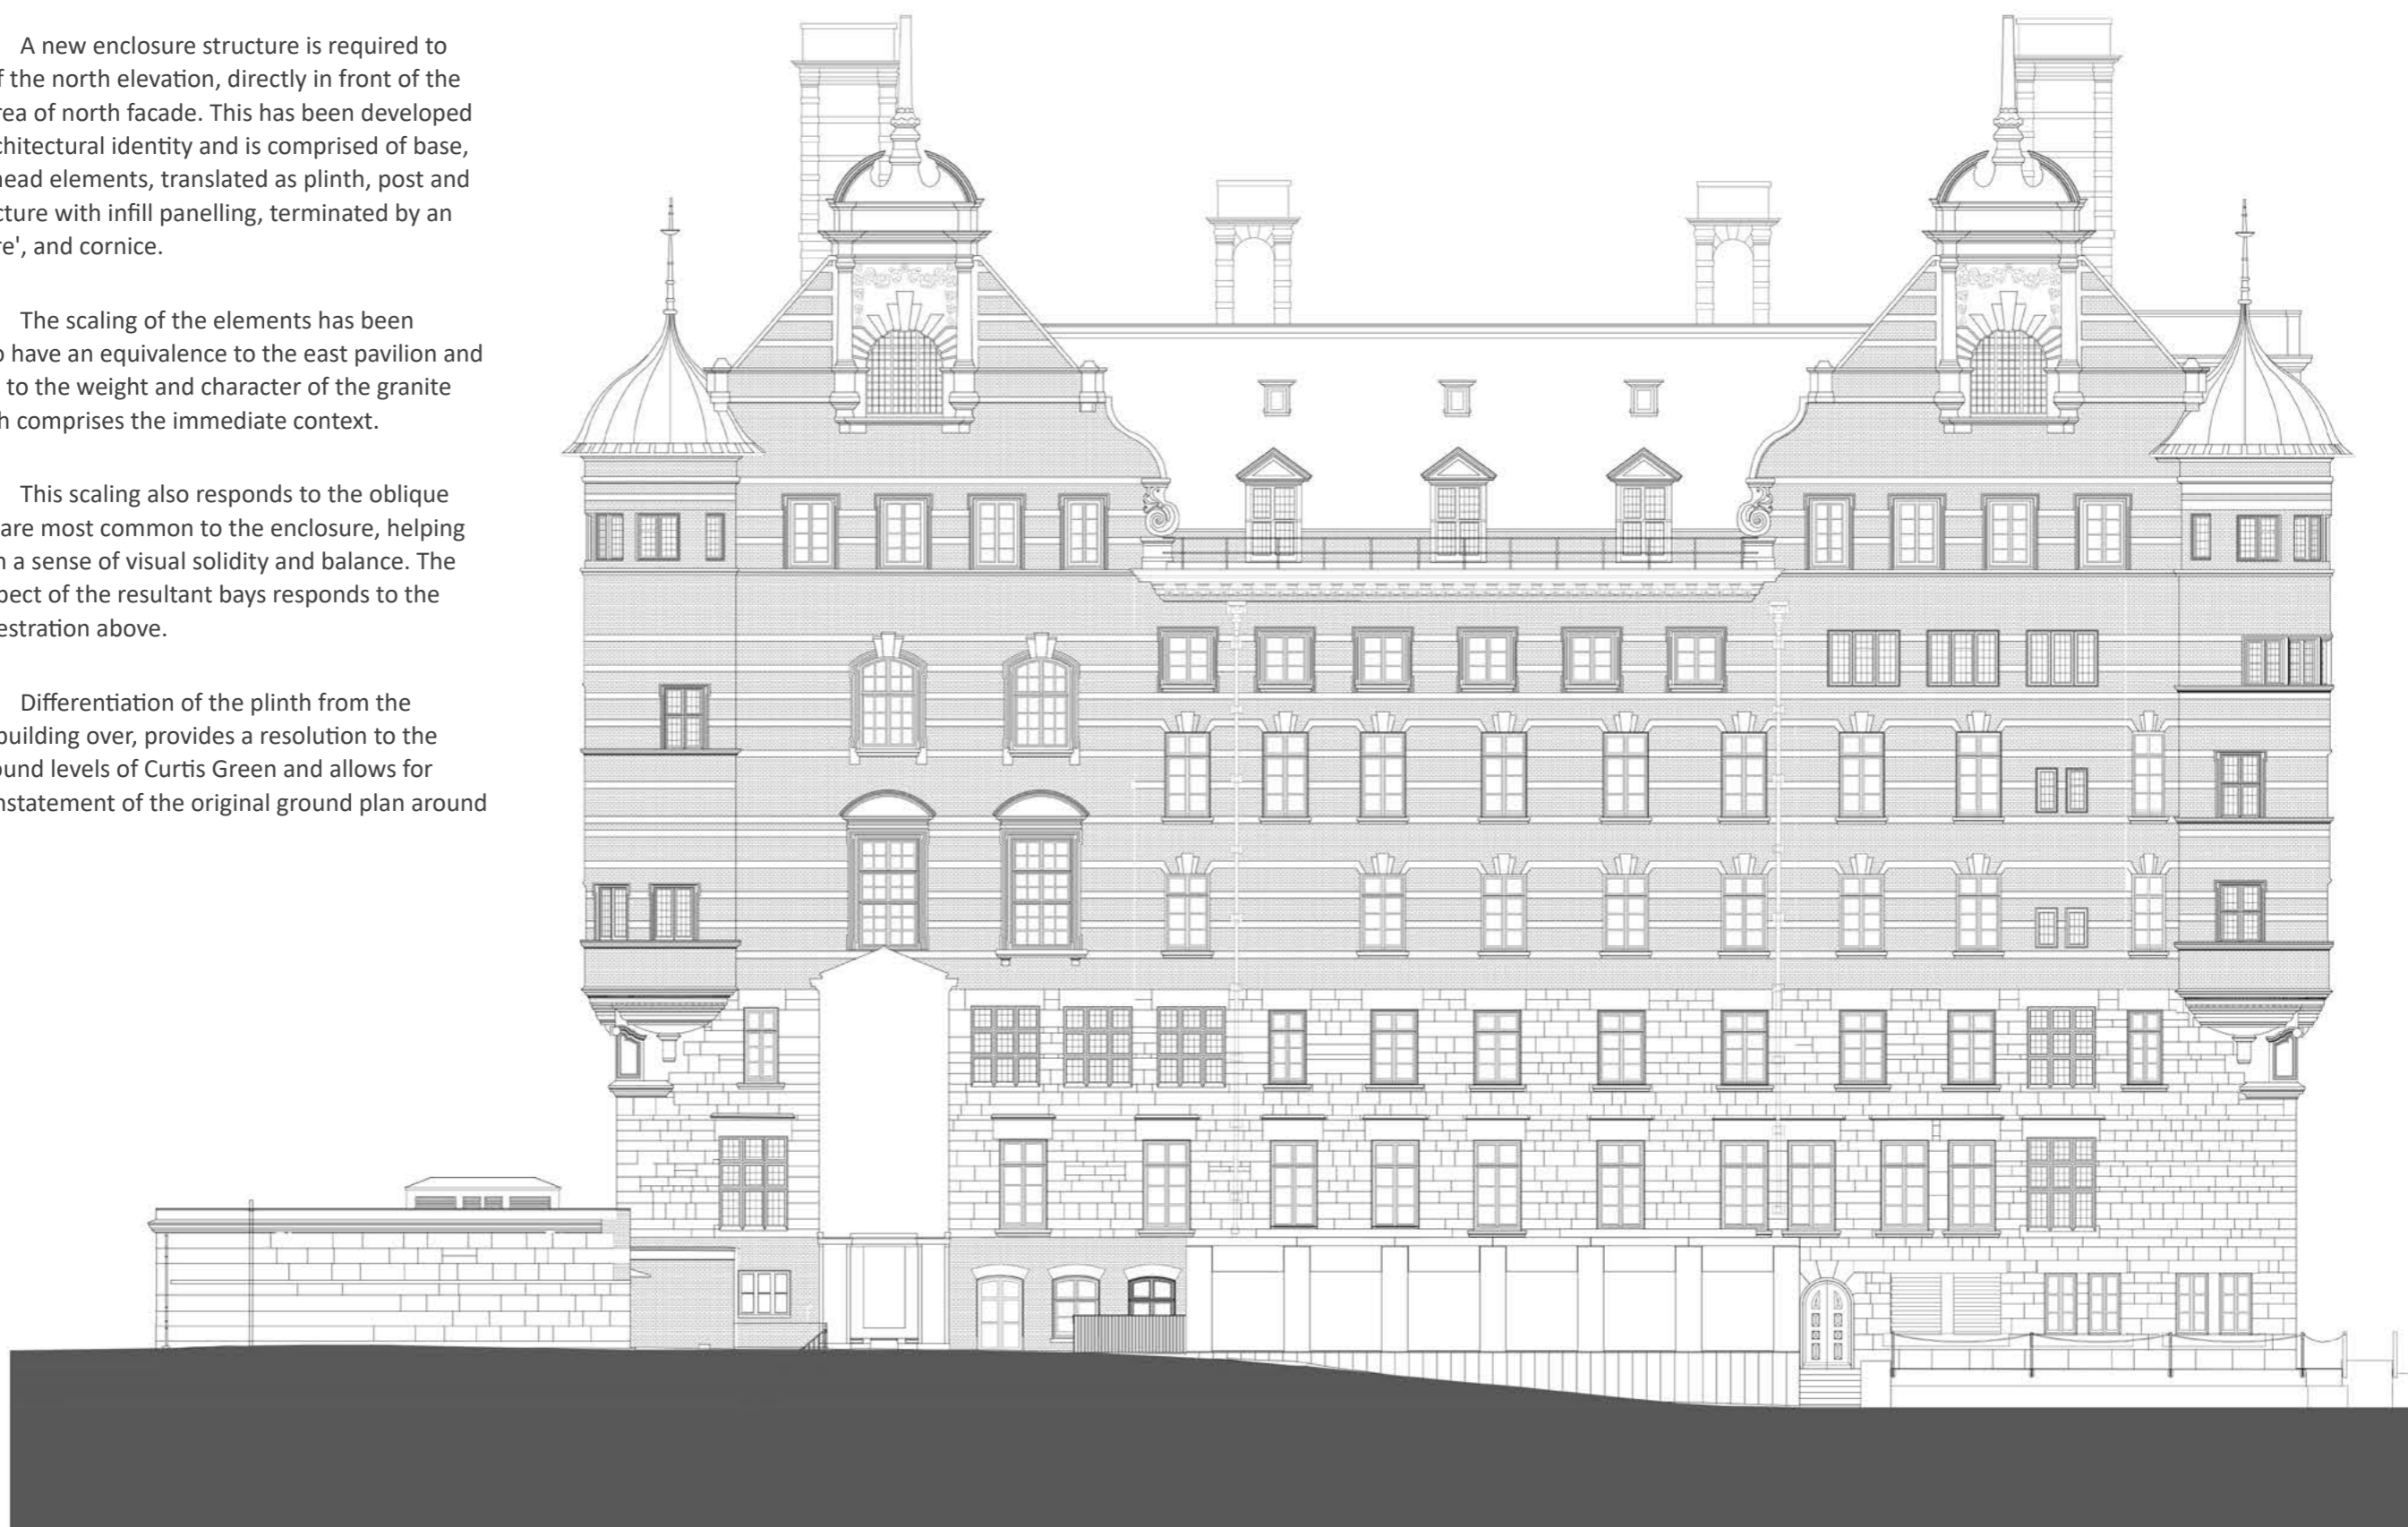
Enclosure elevation in the context of the full North elevation

5.19.6.5 The enclosure is proposed as a structural metal construction with overcladding. The structural grid references the original structure, restored as part of the elevation repair works, to result in the same number of bays.

5.19.6.7 The height of the enclosure matches the height of the lost structure that previously occupied the space, and is set one brick course beneath the granite cill of the ground floor windows above.
