5.13 Interior design approach

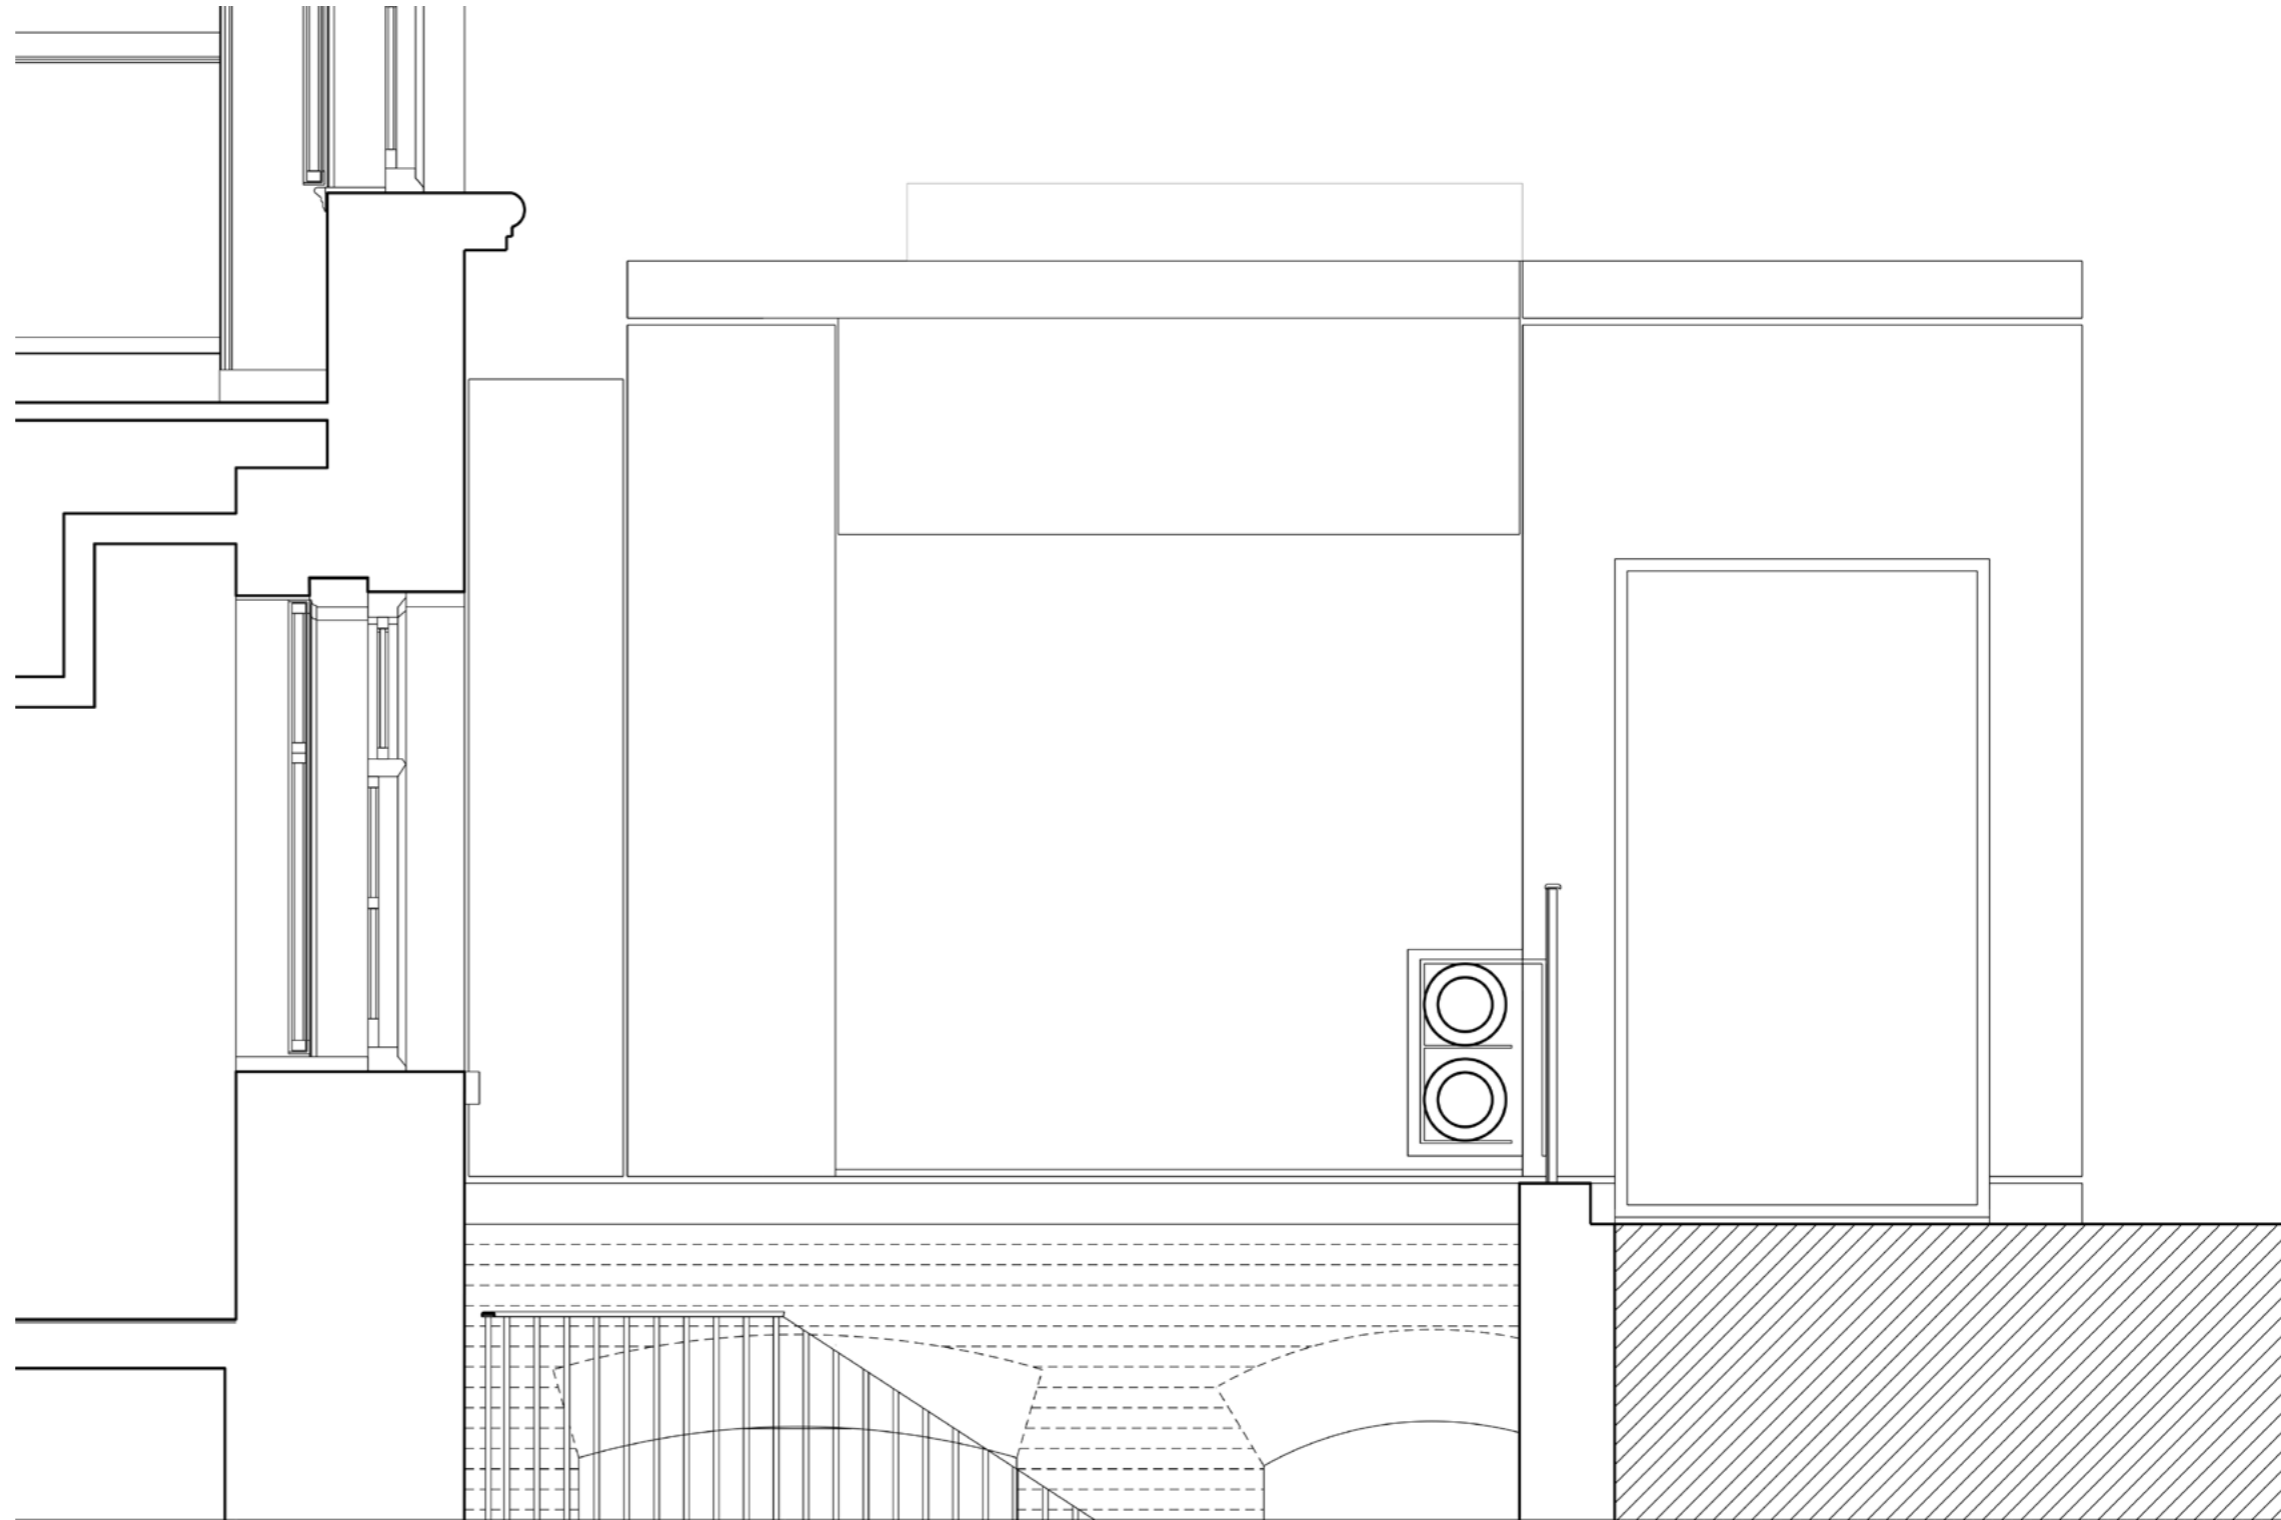
East elevation

5.19.6.8 An offset 'shadow gap' has been introduced to space the enclosure from the building. This has been tested to provide the right balance between divorcing the enclosure and revealing too much of the facing brickwork that was never designed to be seen (particularly from the western view).

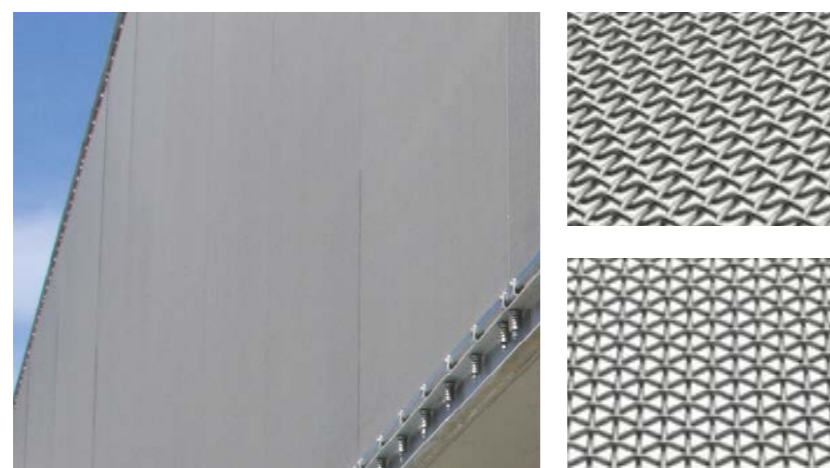
Example stainless steel wire mesh - tone and 'solidity' in oblique view
DOKA-MONO 1601 by Haver & Boecker

5.19.6.9 The proposed finishes for the enclosure comprise metal over-cladding, such as self-finished or painted steel and architectural wire mesh that together compliments the granite tones.

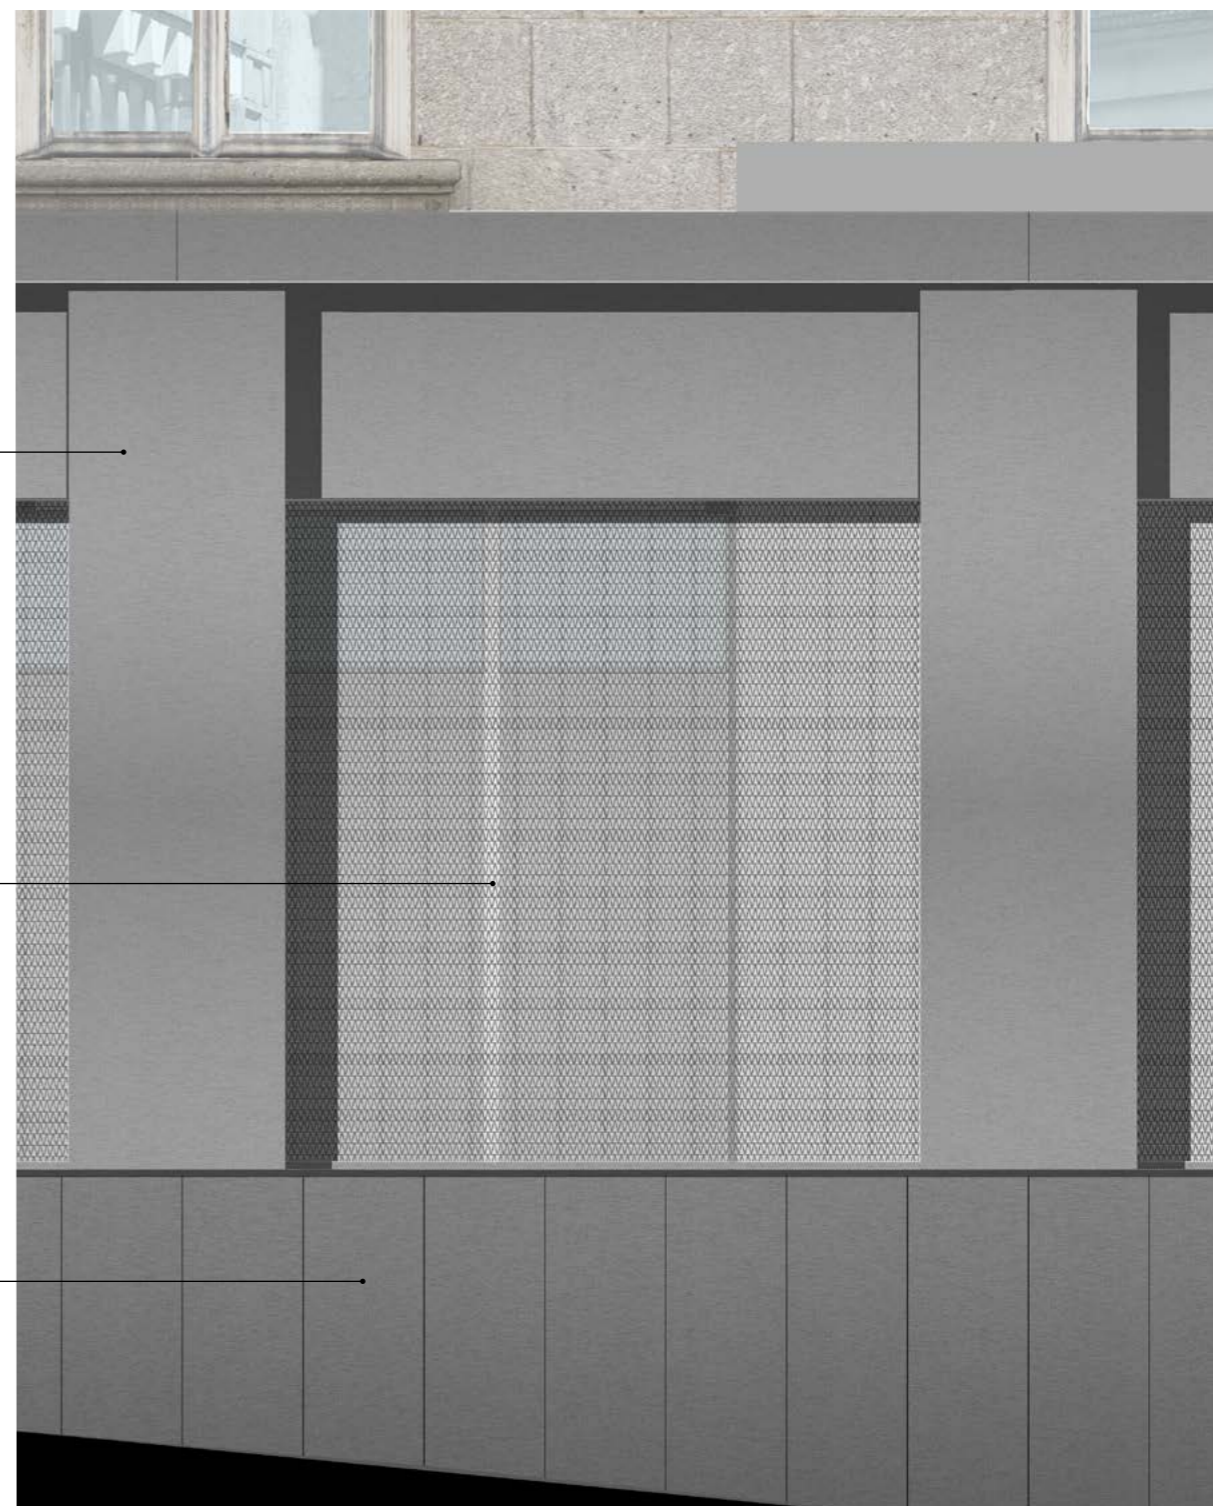
North elevation Enclosure bay study

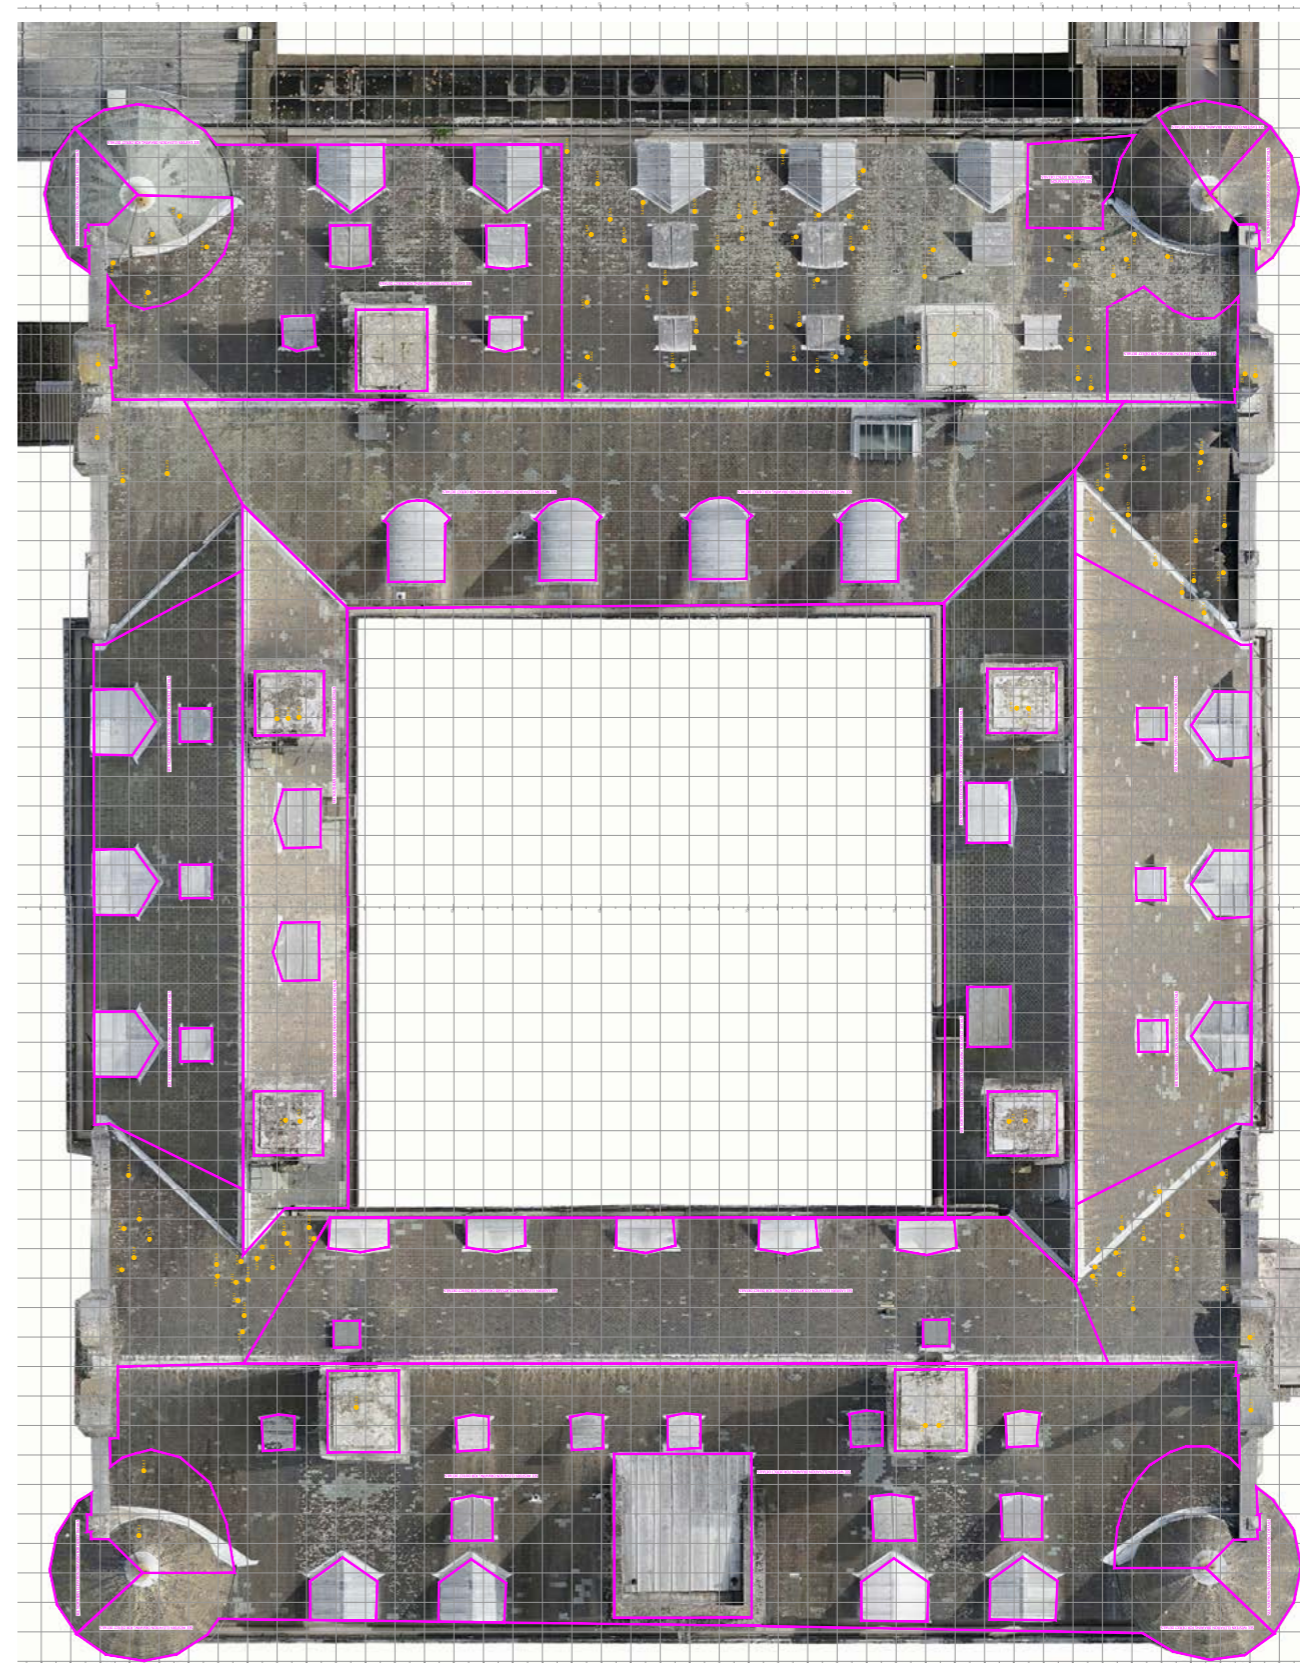
Existing roof photo from above, showing defects

5.20.1.1 There is comprehensive package of structural and fabric repairs proposed as part of these works, including replacement of sections of rotten rafters, purlins and sarking boards, repair to steel rafters, replacement of leadwork, and the lifting and relaying of the existing roof slates, as well as repairs to the asphalt gutters and replacement of failing lead pipe outlets and downpipes.

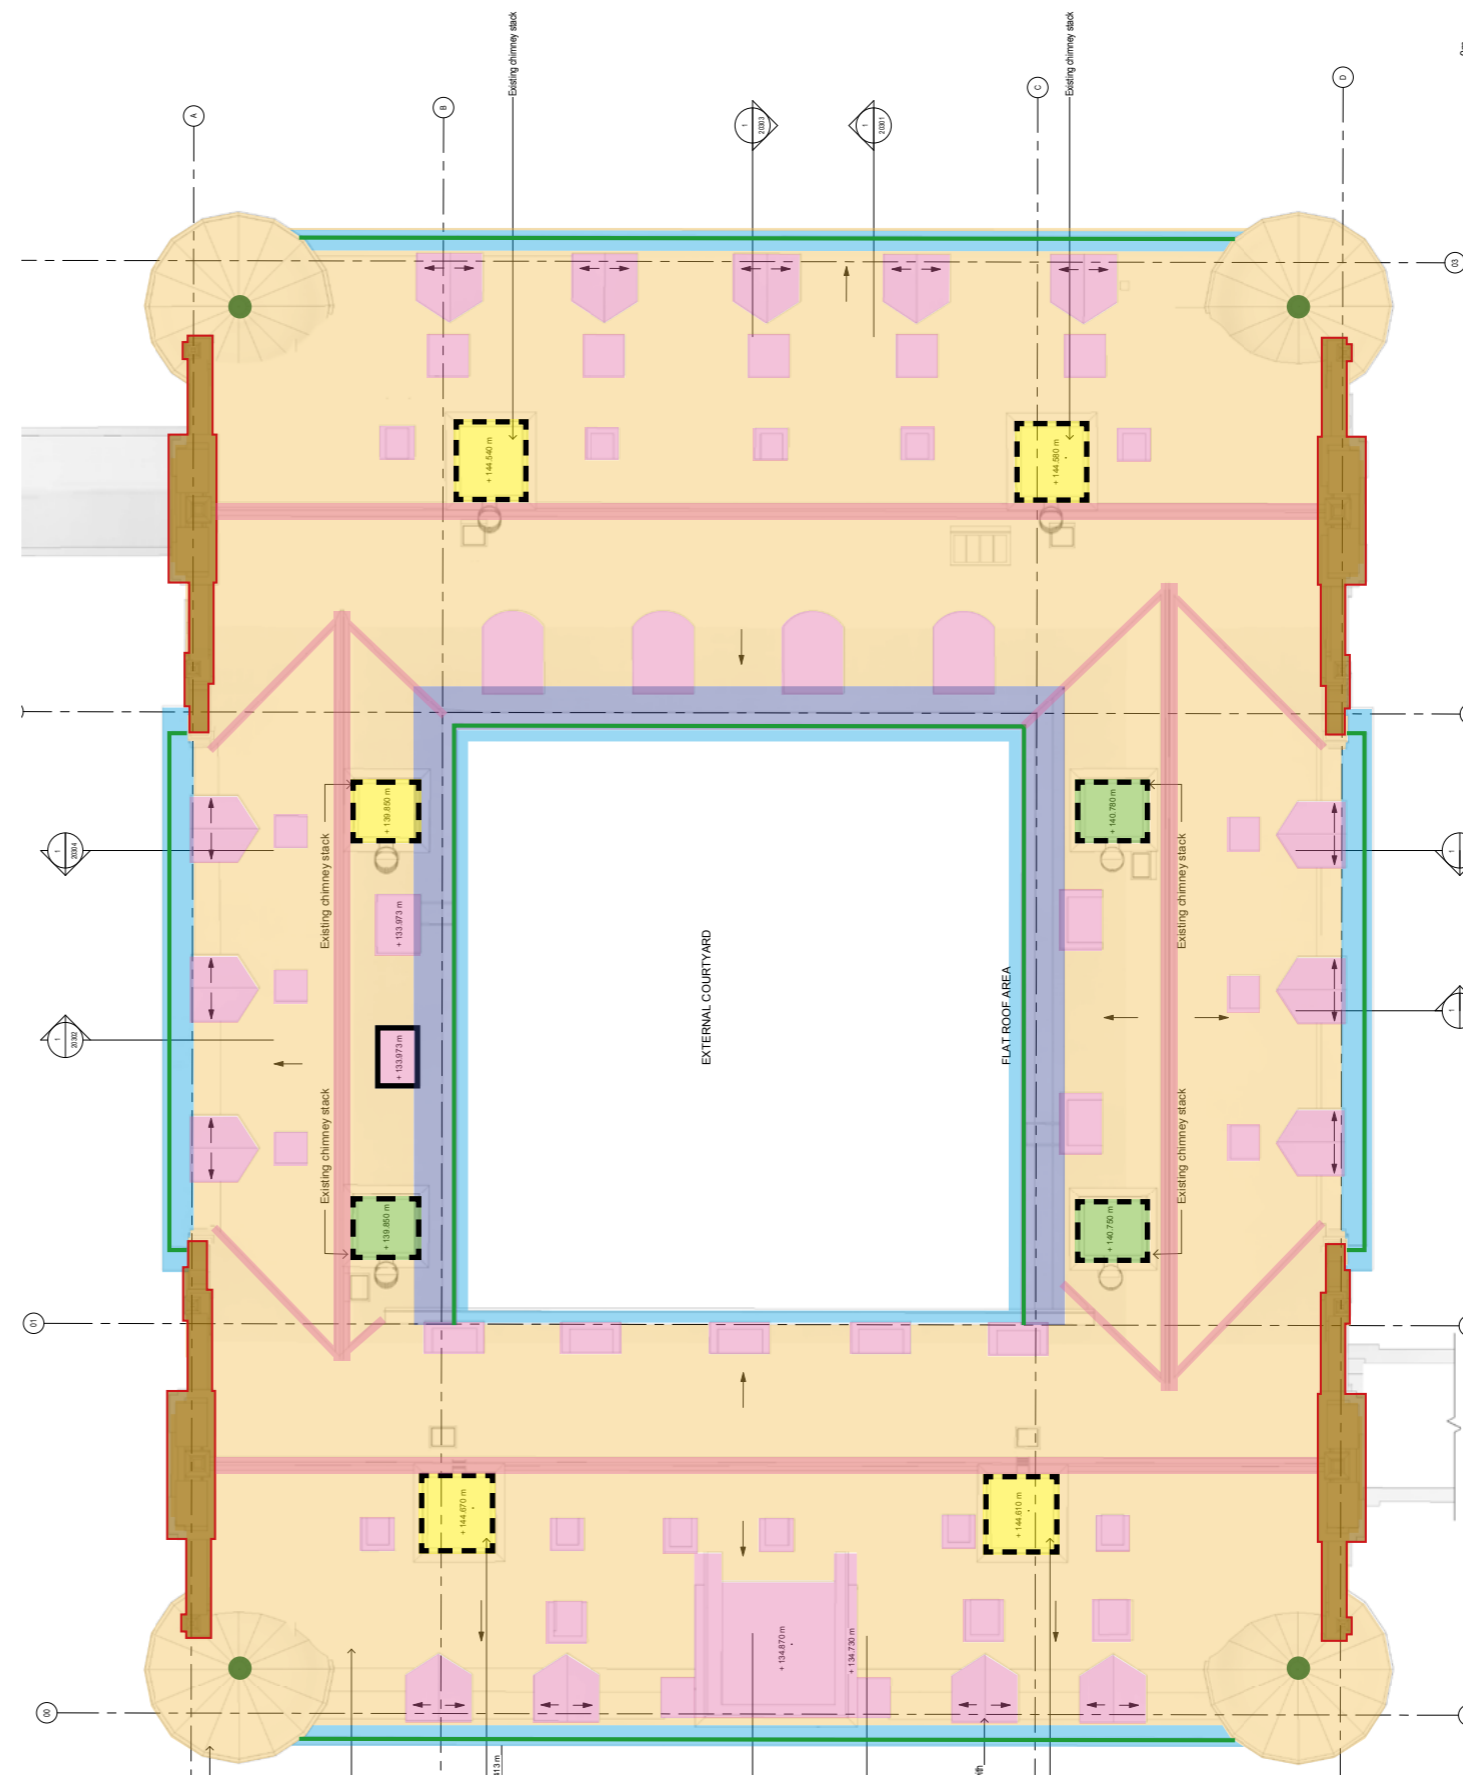
- Comprehensive roof repair, including slates (reusing existing wherever feasible), leadwork, stonework and underlying substrate above truss and rafter line. Insulation introduced between rafters. Gutters repaired. Lightning protection replaced and re-integrated.
- Cutback to roof line to create new courtyard maintenance access gallery with louvre panel eaves detail.
- Stone repairs to pediment and ridge.
- Stone repairs to cornice
- Reconstruction of existing chimneys
- Repairs to Portland stone and brickwork at retained chimneys
- New leadwork to dormer roofs, cheeks, flashings and roof ridges / valleys
- Existing metal railings to be repaired, consolidated and decorated
- Repairs to roof finials
- Dormer window extended to become a door

Illustrative roof proposals

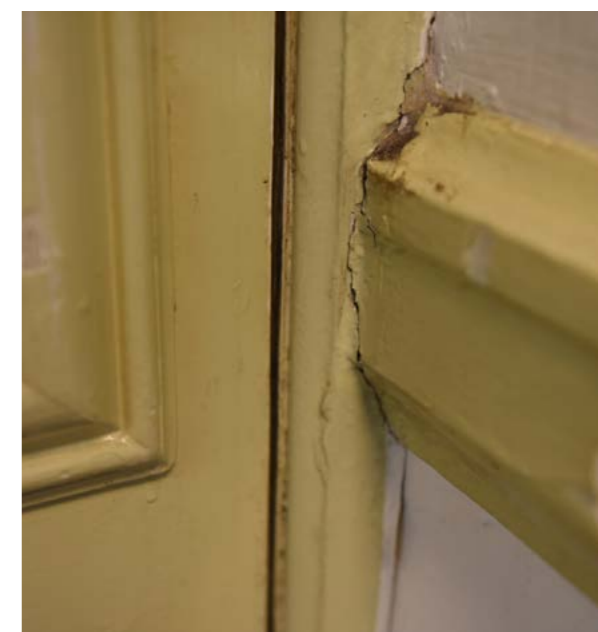
Example of existing damaged joinery item to be repaired

5.21.9.1 Repairs to the framing of panelling are best carried out in situ by carefully cutting away damaged or decayed timber, and piecing-in suitably shaped timber inserts.

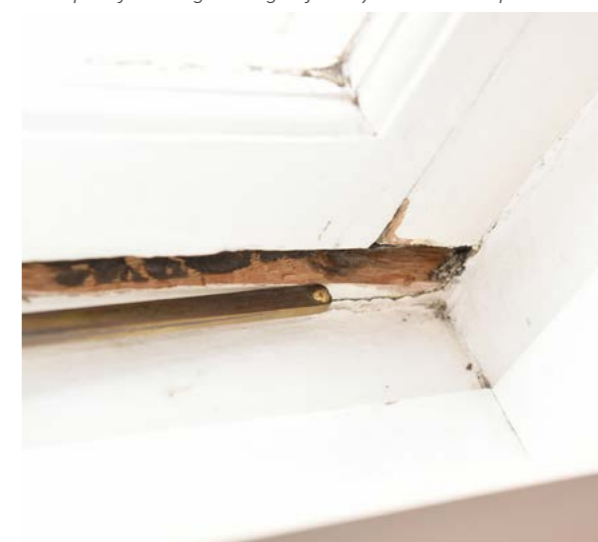
Example of existing damaged joinery item to be repaired

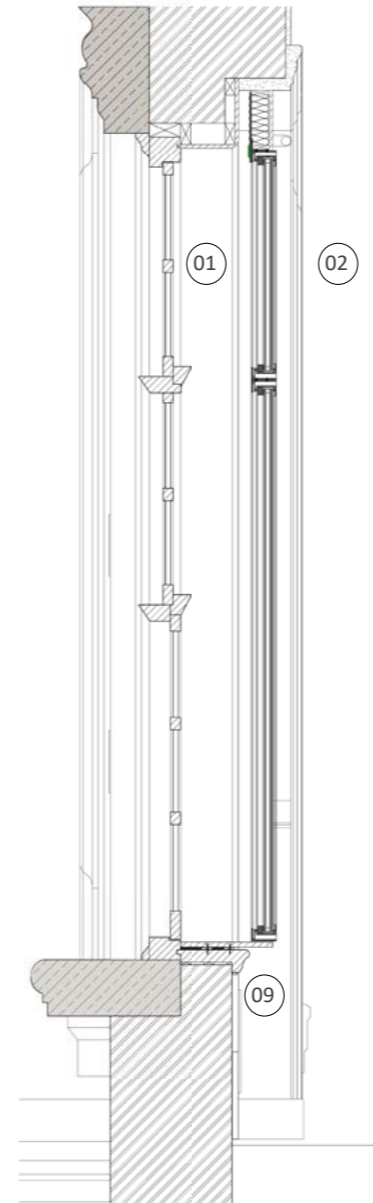
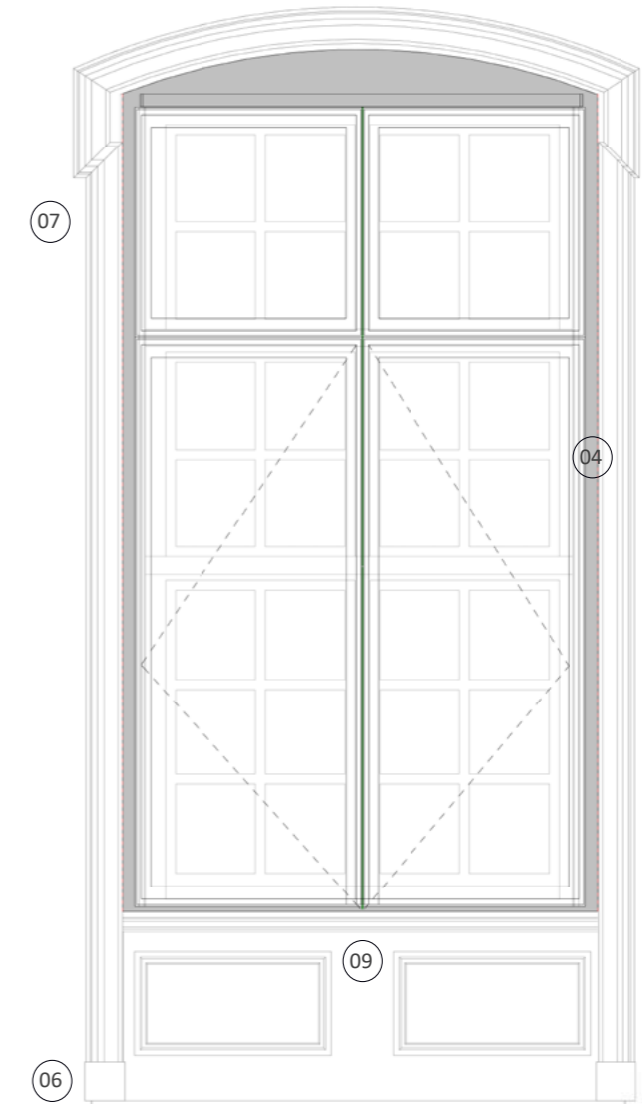
Principles of secondary glazing

- 01 Refurbished and repaired existing windows
- 02 New secondary glazing and framing, profile and arrangement to suit performance criteria
- 03 Secondary glazing fixed to masonry with local repair to existing finishes (e.g. Keene's cement)
- 04 Shadow gap 'picture frame' perimeter detail between existing reveal and framing
- 05 Existing decorative mouldings to be retained and repaired / refurbished
- 06 Existing skirting retained
- 07 Existing decorative architrave retained
- 08 Requirement for supporting structure to be confirmed with specialist fabricator
- 09 Original timber profile reinstated to suit glazing installation, where new cill is required, to match existing profile

5.22.11.5 The principle adopted for the secondary glazing looks to minimise any removal, alteration or adaptation of the existing window and reveals. Subject to pull test surveys the secondary glazing would sit within the depth of the window reveal with a 'shadow gap' between the existing reveals and the secondary glazing frame. Where existing linings are removed these will be re-instated and / or repaired. Where adaptation is required to cills, linings, etc these will be local to suit the specifics of each location / window type.

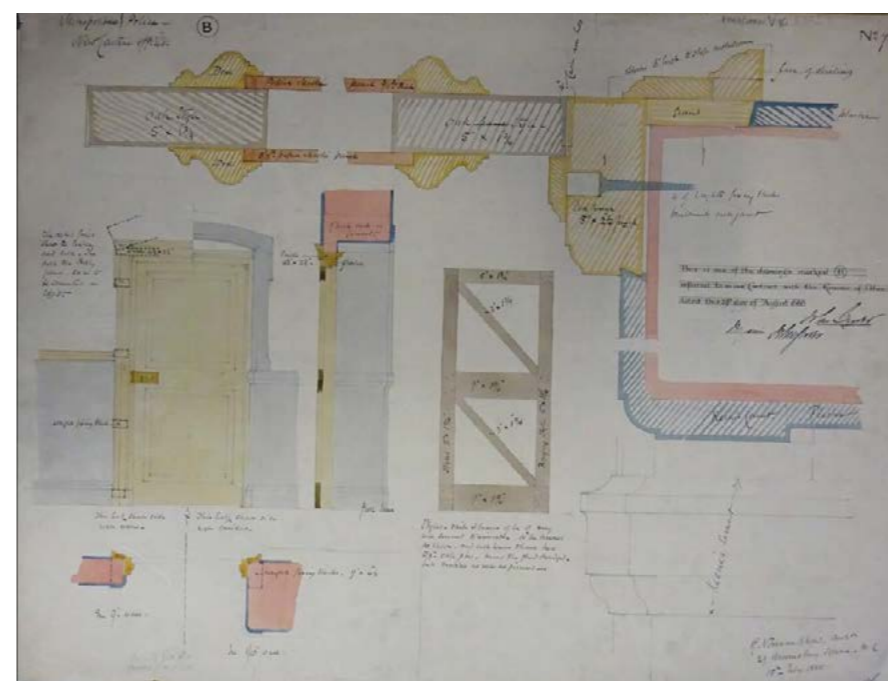
Archive Information: Contract drawing for the doors with 'papier mache' panels and pegged construction © RA Drawings Collection
