THE ROYAL OAK, MONK SOHAM
DESIGN, ACCESS & HERITAGE STATEMENT REVA

This statement has been prepared in support of a planning and listed building submission to Mid Suffolk District Council for the repair and extension of The Royal Oak, Monk Soham. The property has been neglected for a number of years now and is in poor condition, the works are to ensure the continued longevity of the property through repair and alteration to allow the house to be suitably used as a single private dwelling.

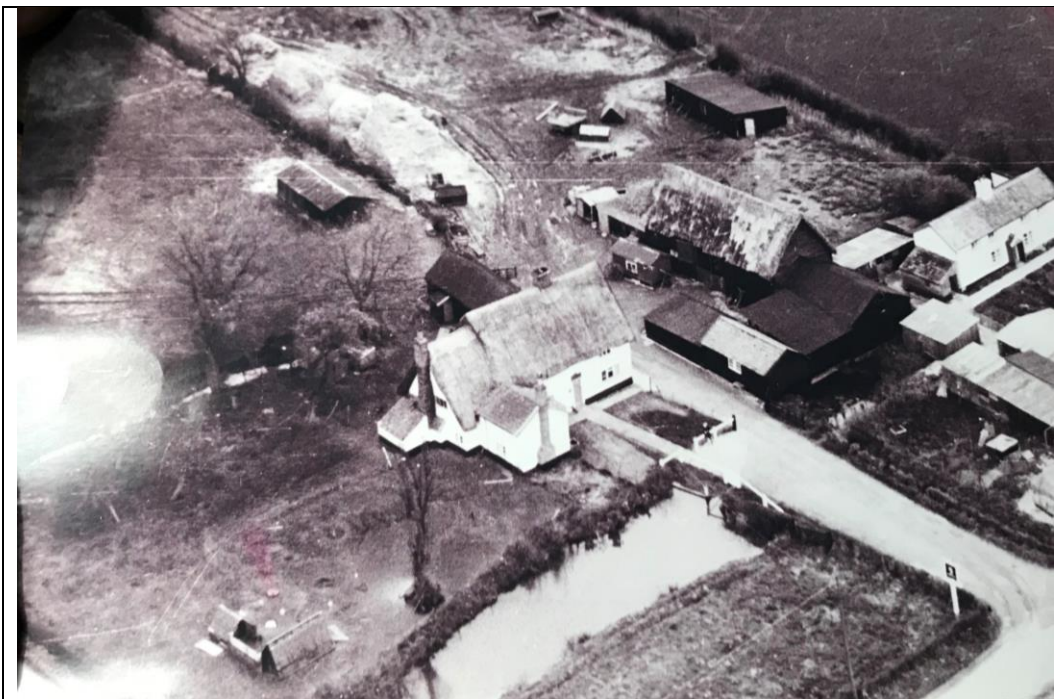
Historic photo presumably from the mid C20

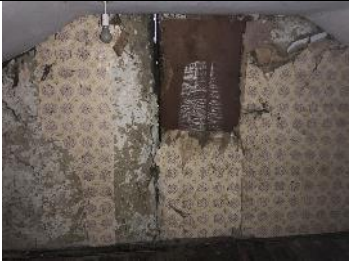
1

Item	Rebuilt clay lump elements and roof structure.
		Significance	High
		Risk	Medium
		Benefit	High
		Mitigation	Due to the poor condition of this element and deterioration of the clay lump it is required to be rebuilt. It would be financially unviable to form this from clay lump and so it is proposed to recreate the form in a timber frame with masonry stack and vaulted ceilings. In order to make the upstairs room more usable (current head height of 1500-1800mm) it is proposed to raise this section 200mm, retaining the lower eaves to mimic the subservient nature and existing roof pitch.
2		Item	Replace cement/gypsum render/plaster with lime based materials, where lined remove modern fibre/hard board and replace with heraklith with lime plaster finish.
		Significance	Low
		Risk	Low
		Benefit	High
		Mitigation	Beneficial improvement
3		Item	Carry out timber frame repairs as required upon inspection of timber frame once render removed

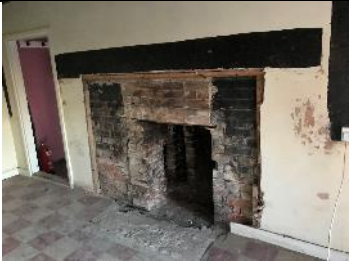
Item	Remove modern infill fireplaces to existing kitchen, study, lounge and dining room.
		Significance	High
		Risk	Medium
		Benefit	High
		Mitigation	Structures to be assessed by structural engineer, method statements to be produced for safe removal of masonry. Hearth / repairs brick & mortar specification to be secured by condition. On removal of front surround the fireplace to the lounge has a series of infilled sections. These are of low quality brickwork with the faces delaminating due to cement renders. A number of sections are not tied in indicating later installations. By removing the infilled sections which are of lower quality it will reinstate the earlier inglenook. This would also tie in with the other proposals within this section of the higher quality historic core allowing the original form to be read in a clearer fashion.

- 5) Update decorations
- 6) Remove modern infill fireplaces to existing kitchen, study, lounge and dining room.
- 7) Replace deteriorated/modern windows and replace with slimlite traditionally detailed casements whilst retaining historic windows in good condition, reopen window to southerly bedroom.

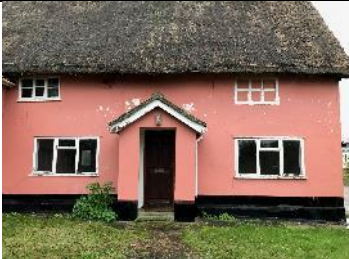
Item	Remove modern blockwork porch and replace with timber lead dressed canopy
		Significance	Low
		Risk	Low
		Benefit	High
		Mitigation	Beneficial improvement, details of door and canopy to be secured by condition.
9

- 8) Remove modern blockwork porch and replace with timber lead dressed canopy
- 9) Remove modern studwork wall to lounge
- 10) Remove modern studwork wall to bathroom

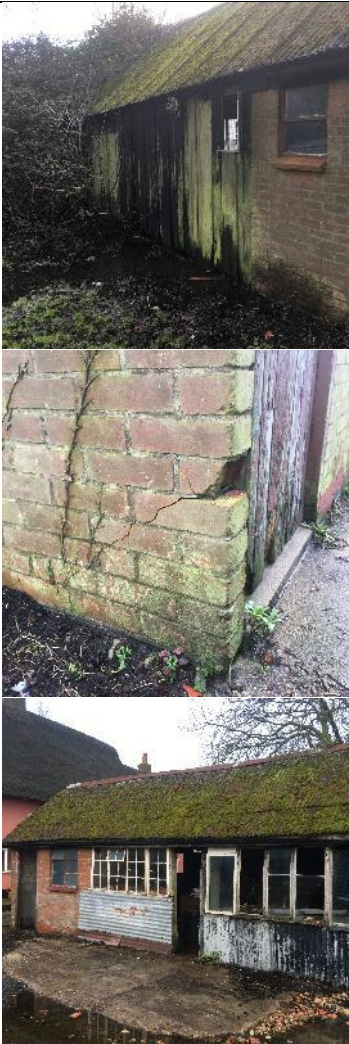
<p>Benefit Mitigation</p>	<p>High</p> <p>The existing structure first appears in the OS map for 1903, it would seem to have been used as an external store and the mens WC when the dwelling was used as a public house. The tiled wall urinal is still in situ.</p> <p>The westerly section of structure is half skin masonry in stretcher bond to eaves, above of timber construction with vertical timber board on board cladding. The masonry has been repointed with a cementitious mortar, the internal wall seems to a modern insertion of creased soft red bricks, with a wide cement mortar differing from the thin profile mortar and uncreased soft reds to the external walls. A cement render has been applied internally to chest level internally, presumably when used as a WC. The corners of the masonry seems to be suffering from movement with diagonal cracking to lower west corners. The easterly section is timber frame, this is in a poor condition with no sole plate and posts sitting on earth which are severely deteriorated. Most of the timber frame structure is of softwood with a few oak posts, presumably all used from elsewhere as available. The roof has been reformed in the late C20 with new purlins and cladding.</p> <p>Internally in the late C20 a partial cement slab has been formed.</p> <p>When inspected a portion of the building had standing water within and advised that water flows from the house and pools around the east end of the building. This presumably is why the timber frame is in poor condition and the potential movement to the masonry section.</p> <p>The joinery and glazing are severely deteriorated. The windows are a mixture of crittal style and modern soft wood casements.</p> <p>Whilst the previous use is interesting and should be recorded the building is in a poor condition, due to the alterations it does not hold significant historic value and is detrimental to the appearance of the listed building. As such its is recommended that a photographic record of building to be taken and deposited at local archive prior to removal.</p>

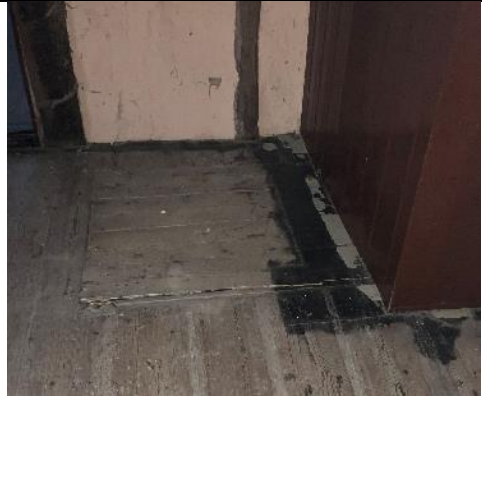
14

<table><tr> <td>Item</td> <td>Remove northern staircase and upstairs porch structure</td> </tr><tr> <td>Mitigation</td> <td> <p>Following the pre-application we were advised to carry out some investigation works. This enabled analysis of the fabric of the staircase in order to make an informed balanced judgement.</p> <p>The timber within the ground floor staircase appears to be machined softwood, alongside the tongue and groove panelling which also seems to be machined. The upstairs boxing and downstairs panelling are of the same detailing and so it would seem probable that these were both constructed at the same point.</p> <p>The detailing of both elements is relatively basic, the boxing is poorly scribed around the principle C16 timbers. The treads are of differing lengths of which the top three are</p> </td> </tr></table>

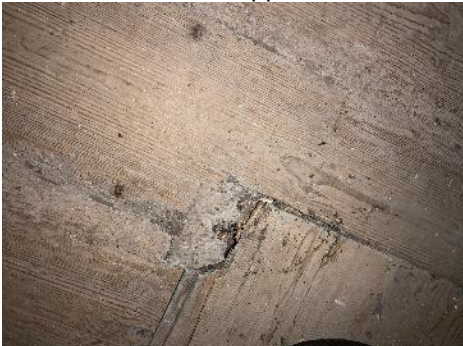
<p>Floor boards laid in opposite direction</p>

<p>Sawn post/historic newel</p>

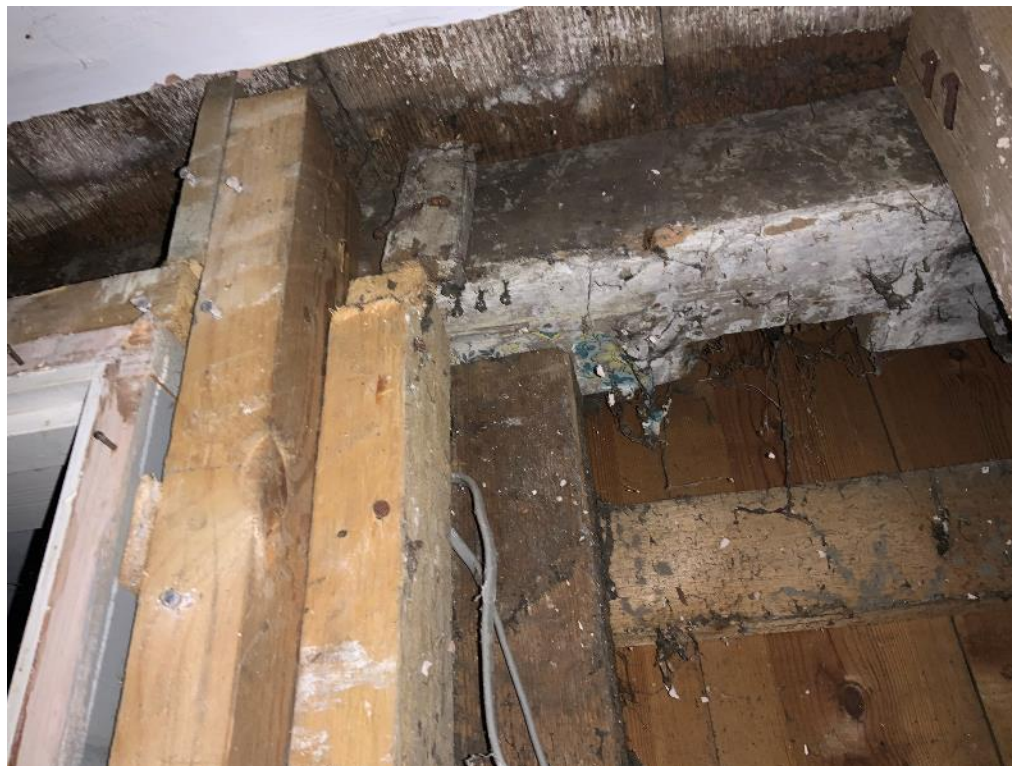
Historic floor joist with diagonal half lap joint. Historic wall paper under staircase studwork structure.

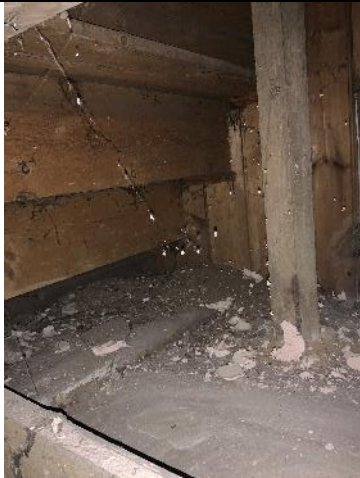
Brick floor and historic timber plate

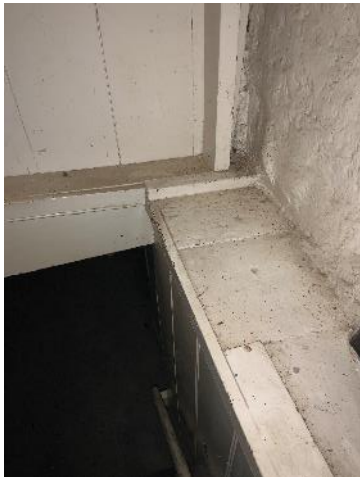
Sawn floor boards

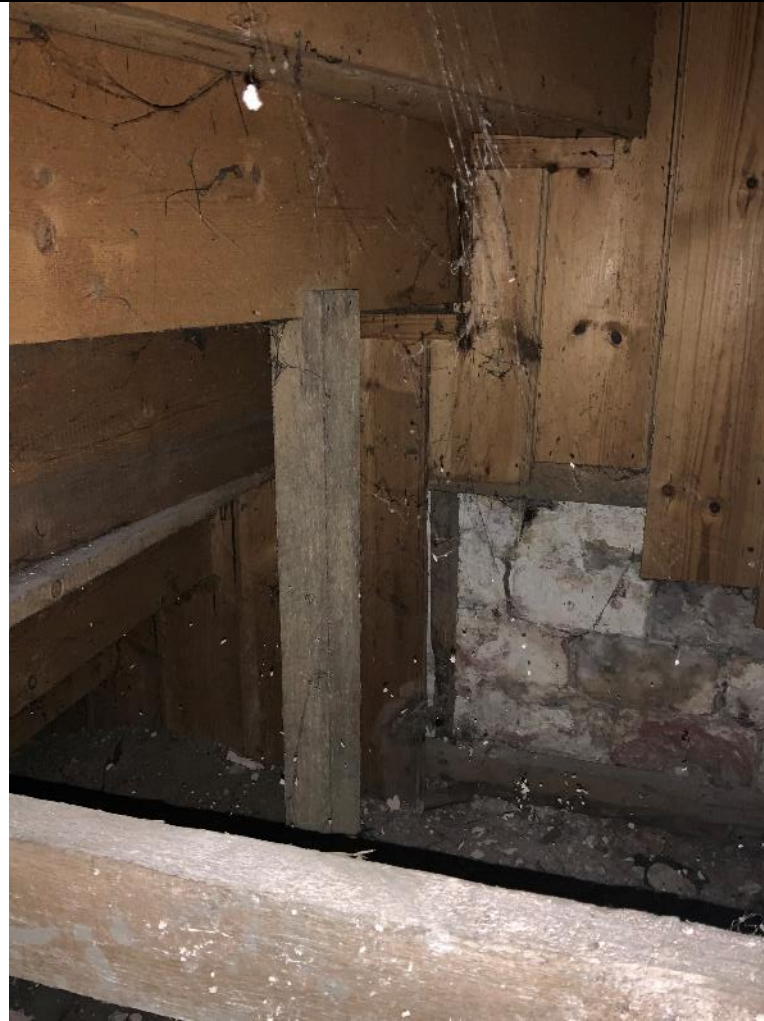
Poorly detailed panelling and general construction

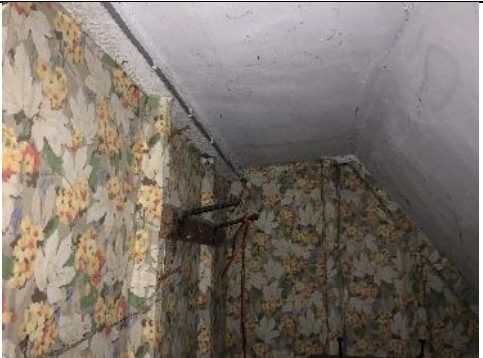
Poorly scribed around timber and lightweight structure

Risk	Low
		Benefit	Low
		Mitigation	<p>The original proposals were to move / remove and rebuilt this cupboard forming a larger room to create an en-suite. However the removal of the historic fabric would be detrimental to the building. Also this would alter the internal proportions and understanding of this element of the property.</p> <p>As such the proposals have been scaled back and the existing historic fabric retained in its current format and a WC and sink installed to this area. Drainage and ventilation runs should be subject to detail.</p>
16

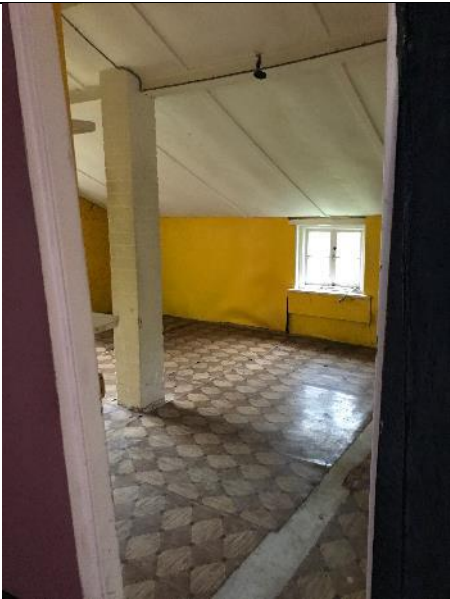
<p>Mitigation</p>	<p>The existing structure first appears in the OS map for 1903, it would seem to have been used as a store and tap room when the dwelling was used as a public house. This would have served the stable door with shelf and sliding window to the dining room, accessed by the rear hall.</p> <p>The structure is a mixture of masonry plinth with timber frame over. The rainwater goods do not direct the water away from the building as such this has caused severe deterioration to the structure. The C20 hardboard linings to the walls are warped and cracked due to water penetration. It is assumed the internal frame is severely deteriorated.</p> <p>Internally the roof structure is formed from small section sawn soft wood members supported by a central purlin. The roof has a late C20 modern hardboard lining, and a late C20 common brickwork post to the centre of the room, presumably to support the minimal structure.</p> <p>A late C20 stainless steel sink and water heater have been installed at low level on the southerly wall.</p> <p>Due to the poor condition of this element and the alterations it has seen, whilst interesting in terms of eaves height it holds little heritage value as such a photographic record should be taken prior to its removal and forming of new extension.</p> <p>The original proposals were discussed with the Heritage Officer and since these have been scaled back, moving the northern wall south away from the upstairs window, and also decreasing the height of the eaves so the roof pitch correlates to that of the existing lean-to. Following guidance from BRE guide to daylighting and sunlighting the proposals have been pushed further than required in order to not impact daylight to this window. The proposed extension is set back from the side elevation and is subservient to the existing dwelling. The rear elevation being mostly obscured currently this will have minimal impact on the dwelling.</p> <p>The use of high quality detailing sympathetic to the existing dwelling, cast rain water goods and well proportioned windows detailed sympathetically, correlating to the proportions found on the front of the property provide a beneficial improvement to the overall appearance.</p>

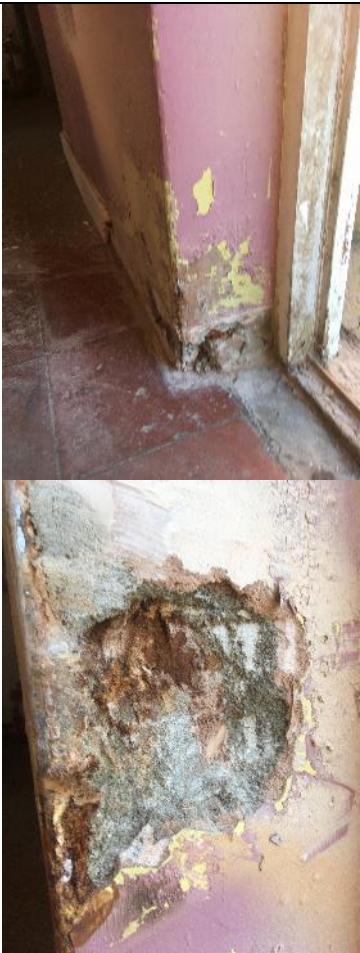
18

Item	Remove modern window and door and break out section of masonry to below window forming new hall from new extension.
		Significance	Low-Medium
		Risk	Medium
		Benefit	Medium
		Mitigation	The proposed joinery to be removed is late C20, the masonry is not original to the house and assumed installed as the timber frame deteriorated, as indicated under the stair cupboard presumably during the early C20. The masonry has late C20 gypsum finish internally and cementitious finish externally. Whilst a small amount of masonry will be removed the loss of fabric is minimal and has late C20 finishes.
19		Item	Remove doorway and seal between lounge and new extension
		Significance	Low
		Risk	Low
		Benefit	Low

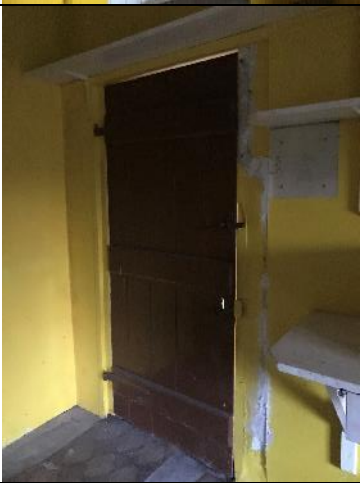
Item	Retain and fix doorway to rear hall and line on side of new extension
			Significance	Medium
			Risk	Low
			Benefit	Low
			Mitigation	The door is original to when the lean-to extension was formed. Retain in place and fix shut and keep exposed in hallway to understand narrative of building. Line externally to kitchen.
21			Item	New ledged and braced door to between new utility and lounge
			Significance	Low
			Risk	Low
			Benefit	Low
			Mitigation	Install new ledged and braced door following detailing of existing, details subject to condition. Beneficial improvement.

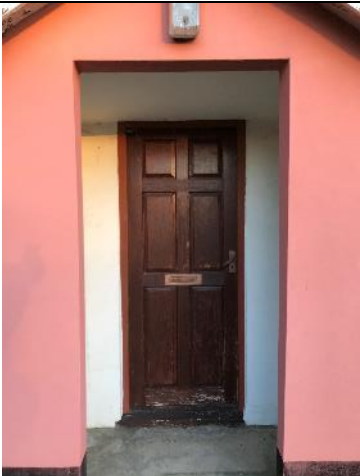
22

Item	Replace front door
		Significance	Low
		Risk	Low
		Benefit	Medium
		Mitigation	Existing door is a modern softwood paneled door. Details secured by condition. Beneficial improvement.
23		Item	Improving thermal efficiency by insulating voids to frame
		Significance	High
		Risk	Low
		Benefit	High
		Mitigation	Once timber frame is exposed, voids to be filled with hempwool insulation. Providing historic fabric is not removed where unnecessary, beneficial improvement.
24		Item	Rewire the property (removing cabling from face of principle frame).
		Significance	Low
		Risk	Medium-High
		Benefit	High
		Mitigation	Removal of wires from faces of principle timbers is beneficial. Locations of cable runs and penetrations in fabric to be kept to a minimum and confirmed by condition in order to not impact historic fabric.
25		Item	Improving 'green' credentials by installing a ground source heat pump to northern store
