## Daylight and Sunlight Report (Neighbouring Properties)

Chapel Gate (Car Park 14), Basildon,  
Essex SS15 5AB

8 April 2021

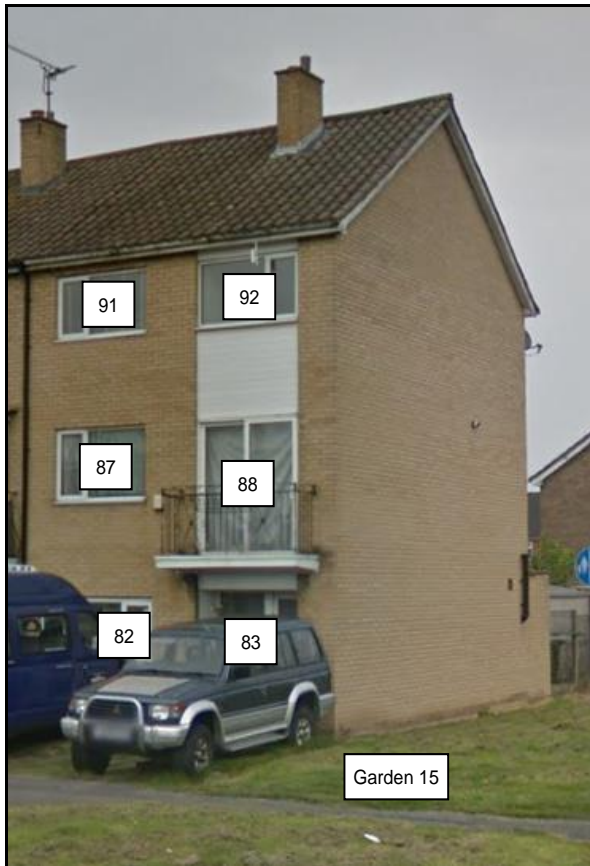
**2 Great Knightleys**

Garden 15

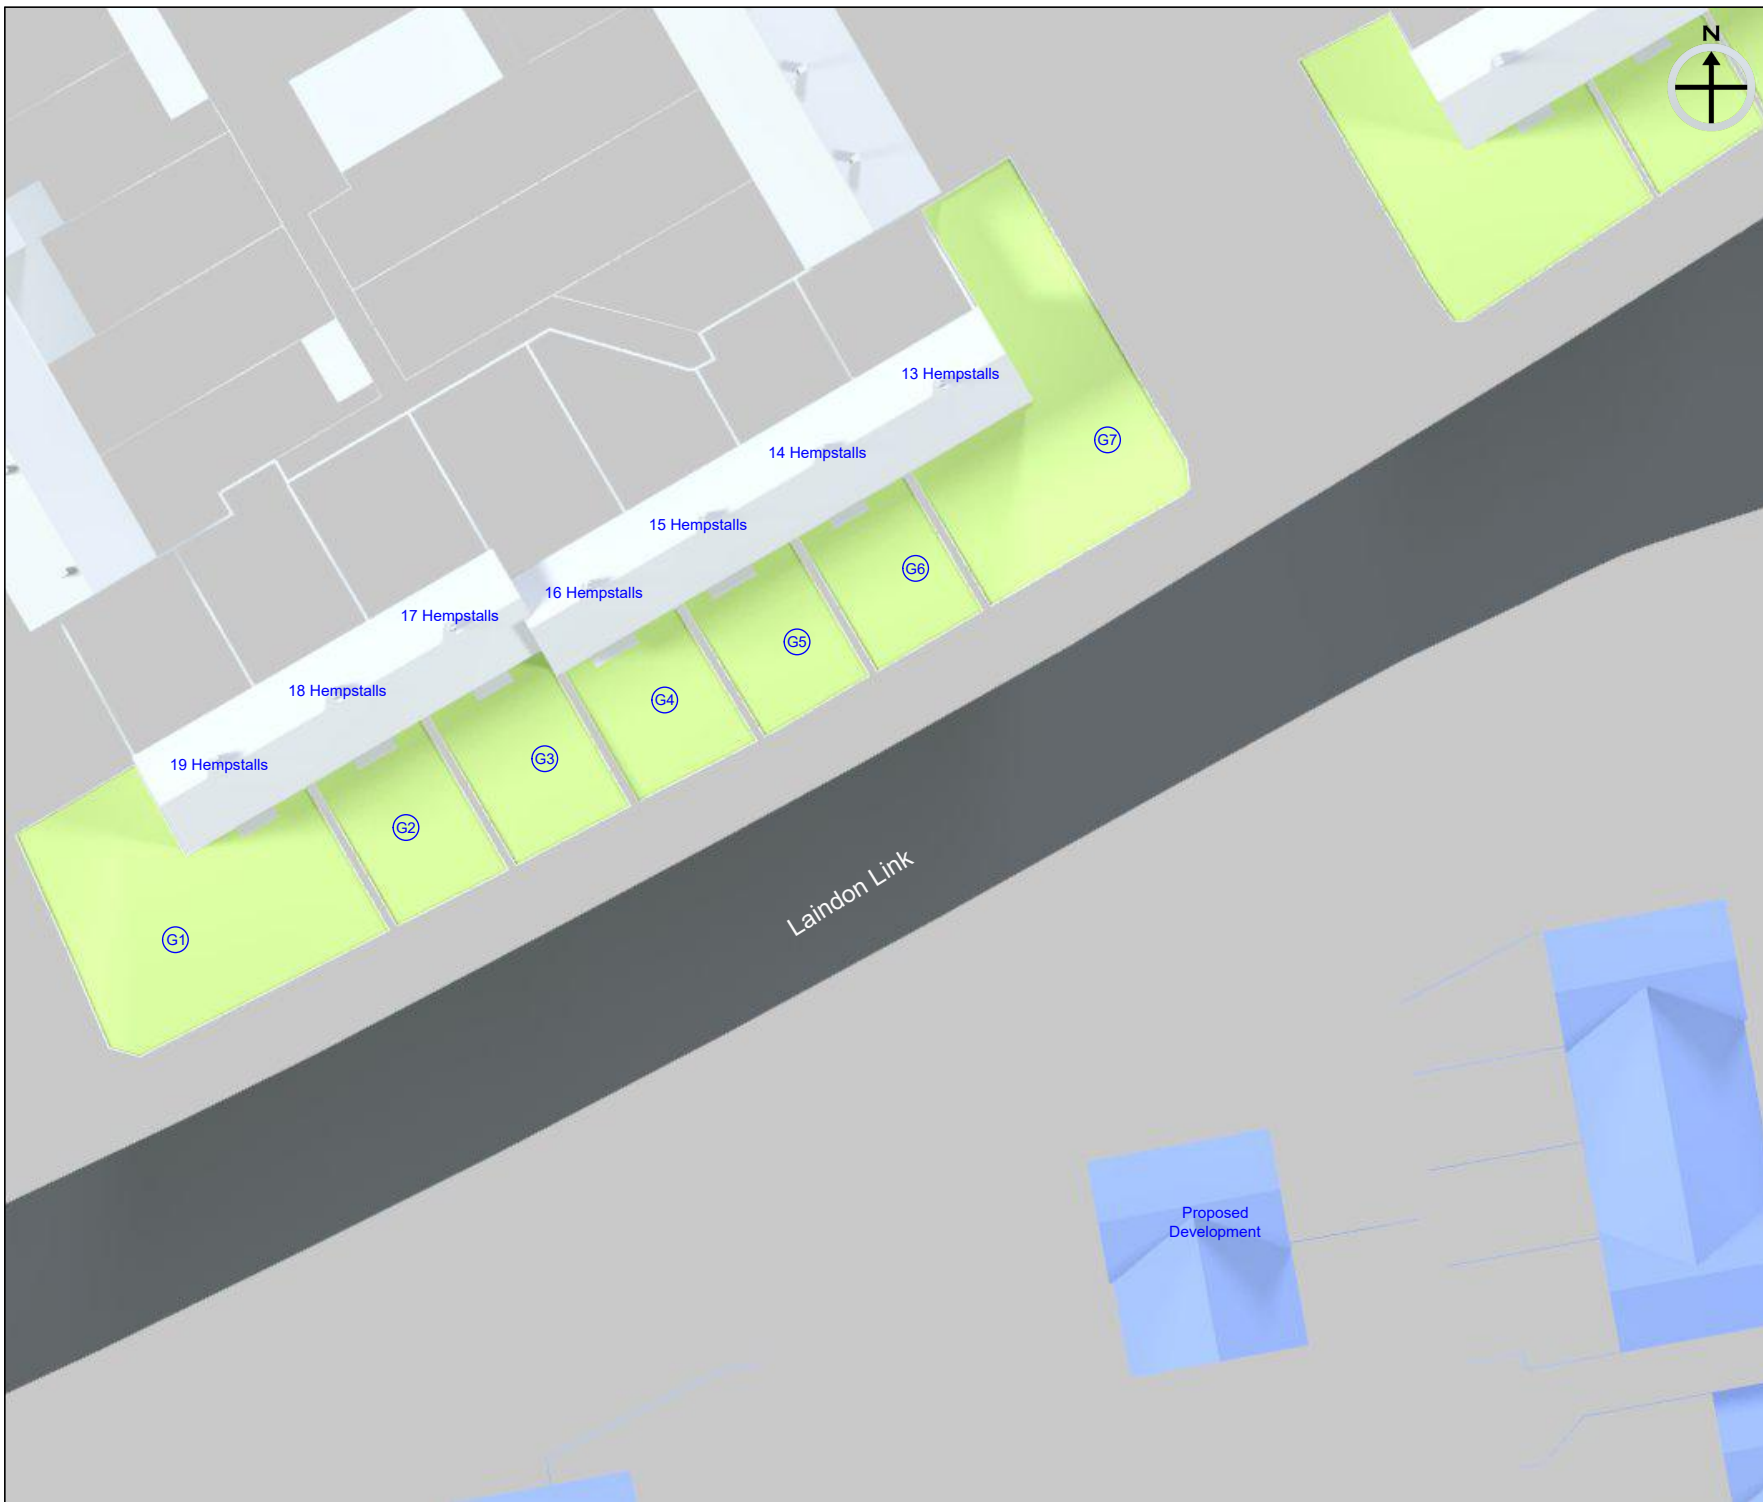
### **OVERSHADOWING TO GARDENS AND OPEN SPACES**

- Key**
- Receives under two hours sunlight on 21st March before and after the development.
  - Receives under two hours sunlight on 21st March before the development; but will receive at least two hours sunlight on 21st March after the development (light improved).
  - Receives at least two hours sunlight on 21st March before the development; but will receive under two hours sunlight after the development (light loss).
  - Receives at least two hours sunlight on 21st March before and after the development.
  - G1 Neighbouring Gardens and Amenity Areas

3.5.3 The BRE guide also contains an objective overshadowing test which has been adopted for the purpose of this study. The guide recommends that at least 50% of the area of each amenity space listed above should receive at least two hours of sunlight on 21 March. If as a result of new development an existing garden or amenity area does not meet the above, and the area which can receive two hours of sunlight on 21 March is less than 0.8 times its former value, then the loss of light is likely to be noticeable.

- 4.4.1 All gardens and open spaces tested meet the BRE recommendations.

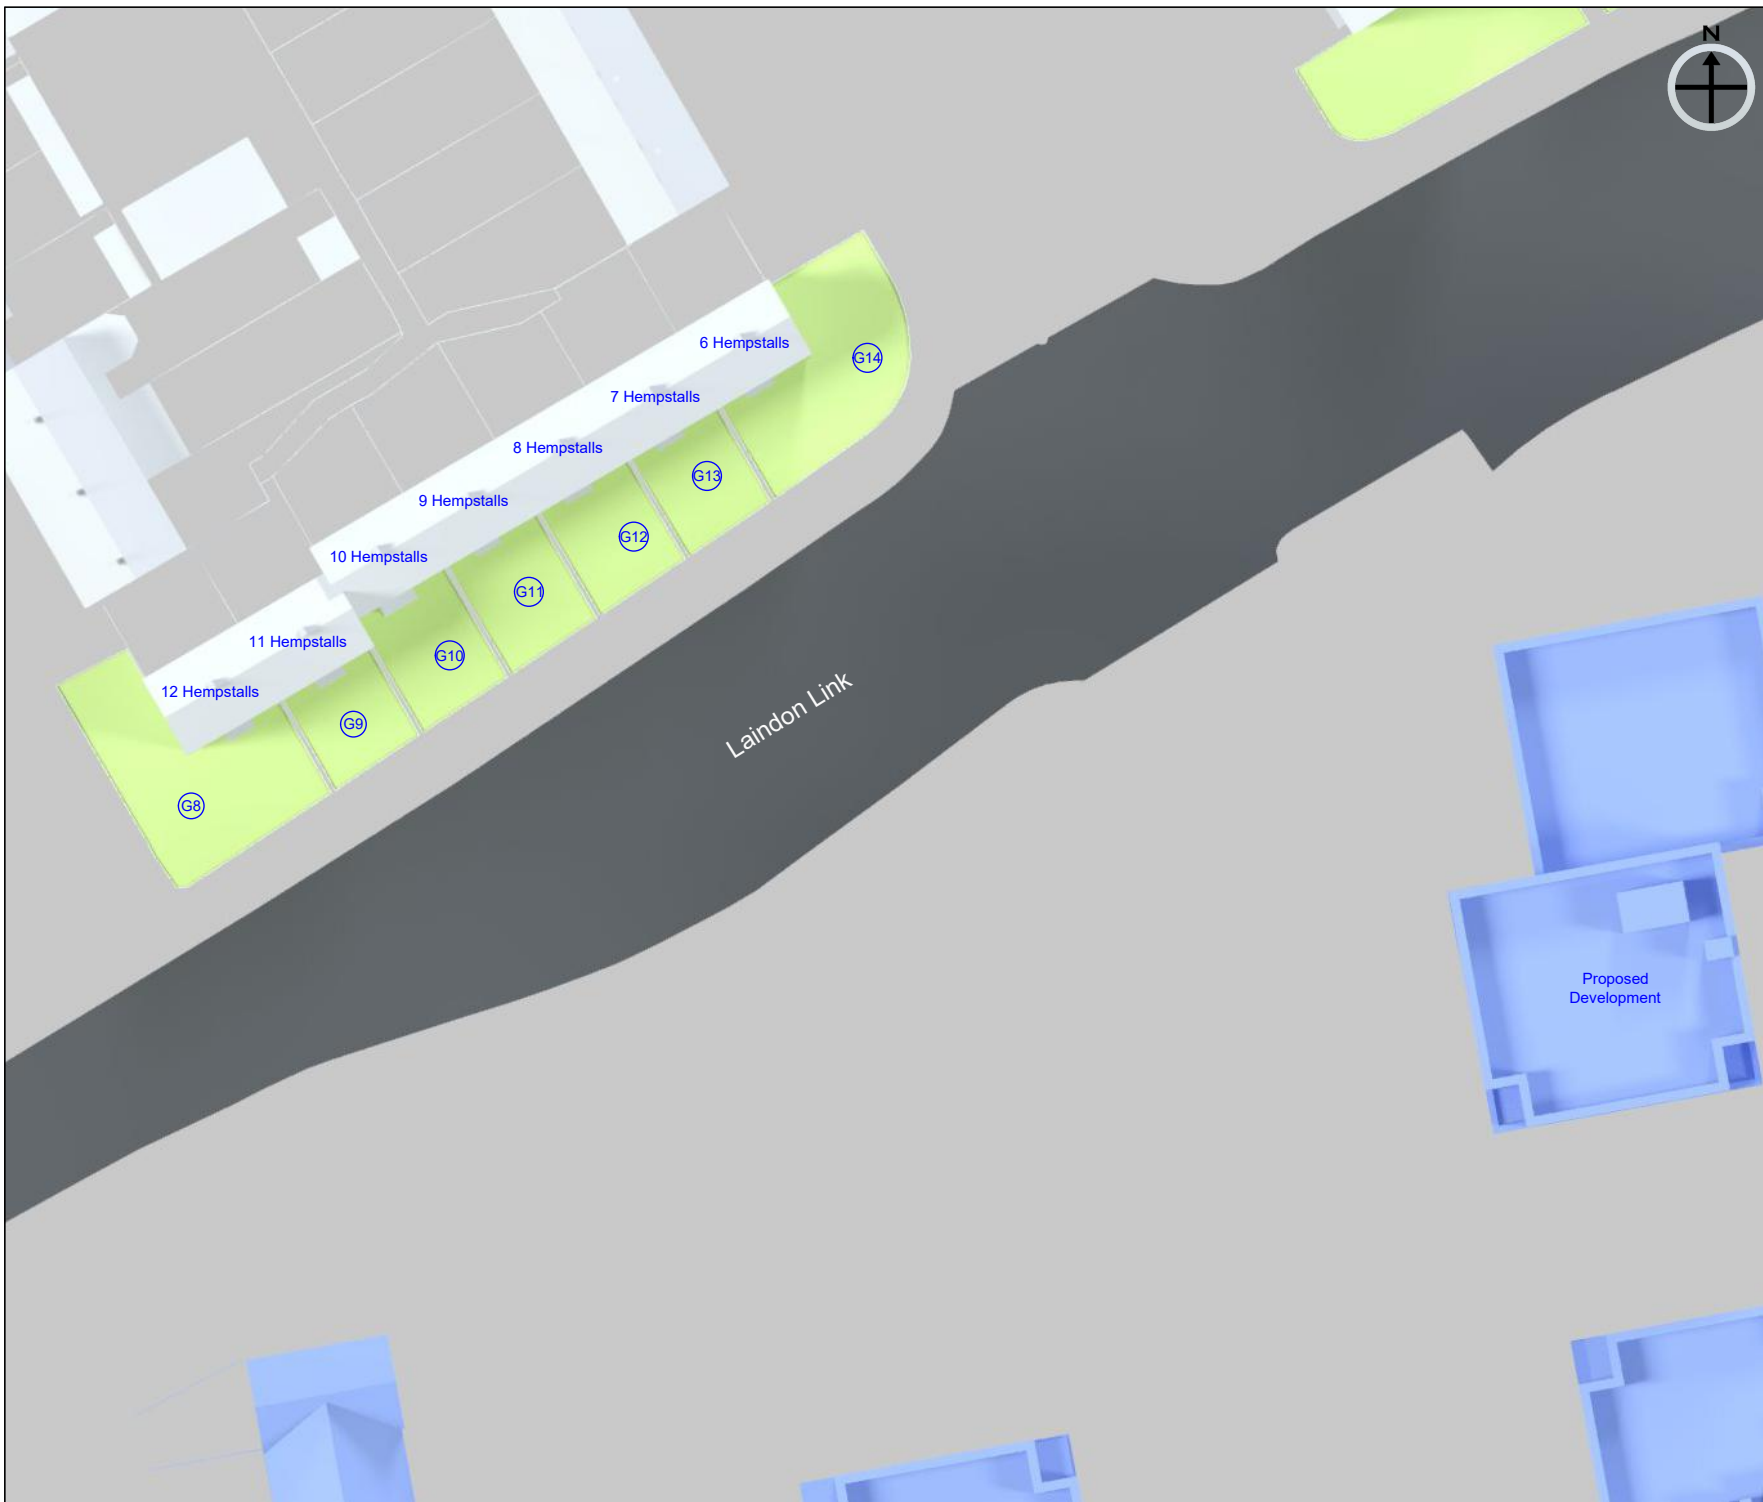
- Key**
- Receives under two hours sunlight on 21st March before and after the development.
  - Receives under two hours sunlight on 21st March before the development; but will receive at least two hours sunlight on 21st March after the development (light improved).
  - Receives at least two hours sunlight on 21st March before the development; but will receive under two hours sunlight after the development (light loss).
  - Receives at least two hours sunlight on 21st March before and after the development.
  - G1 Neighbouring Gardens and Amenities Areas

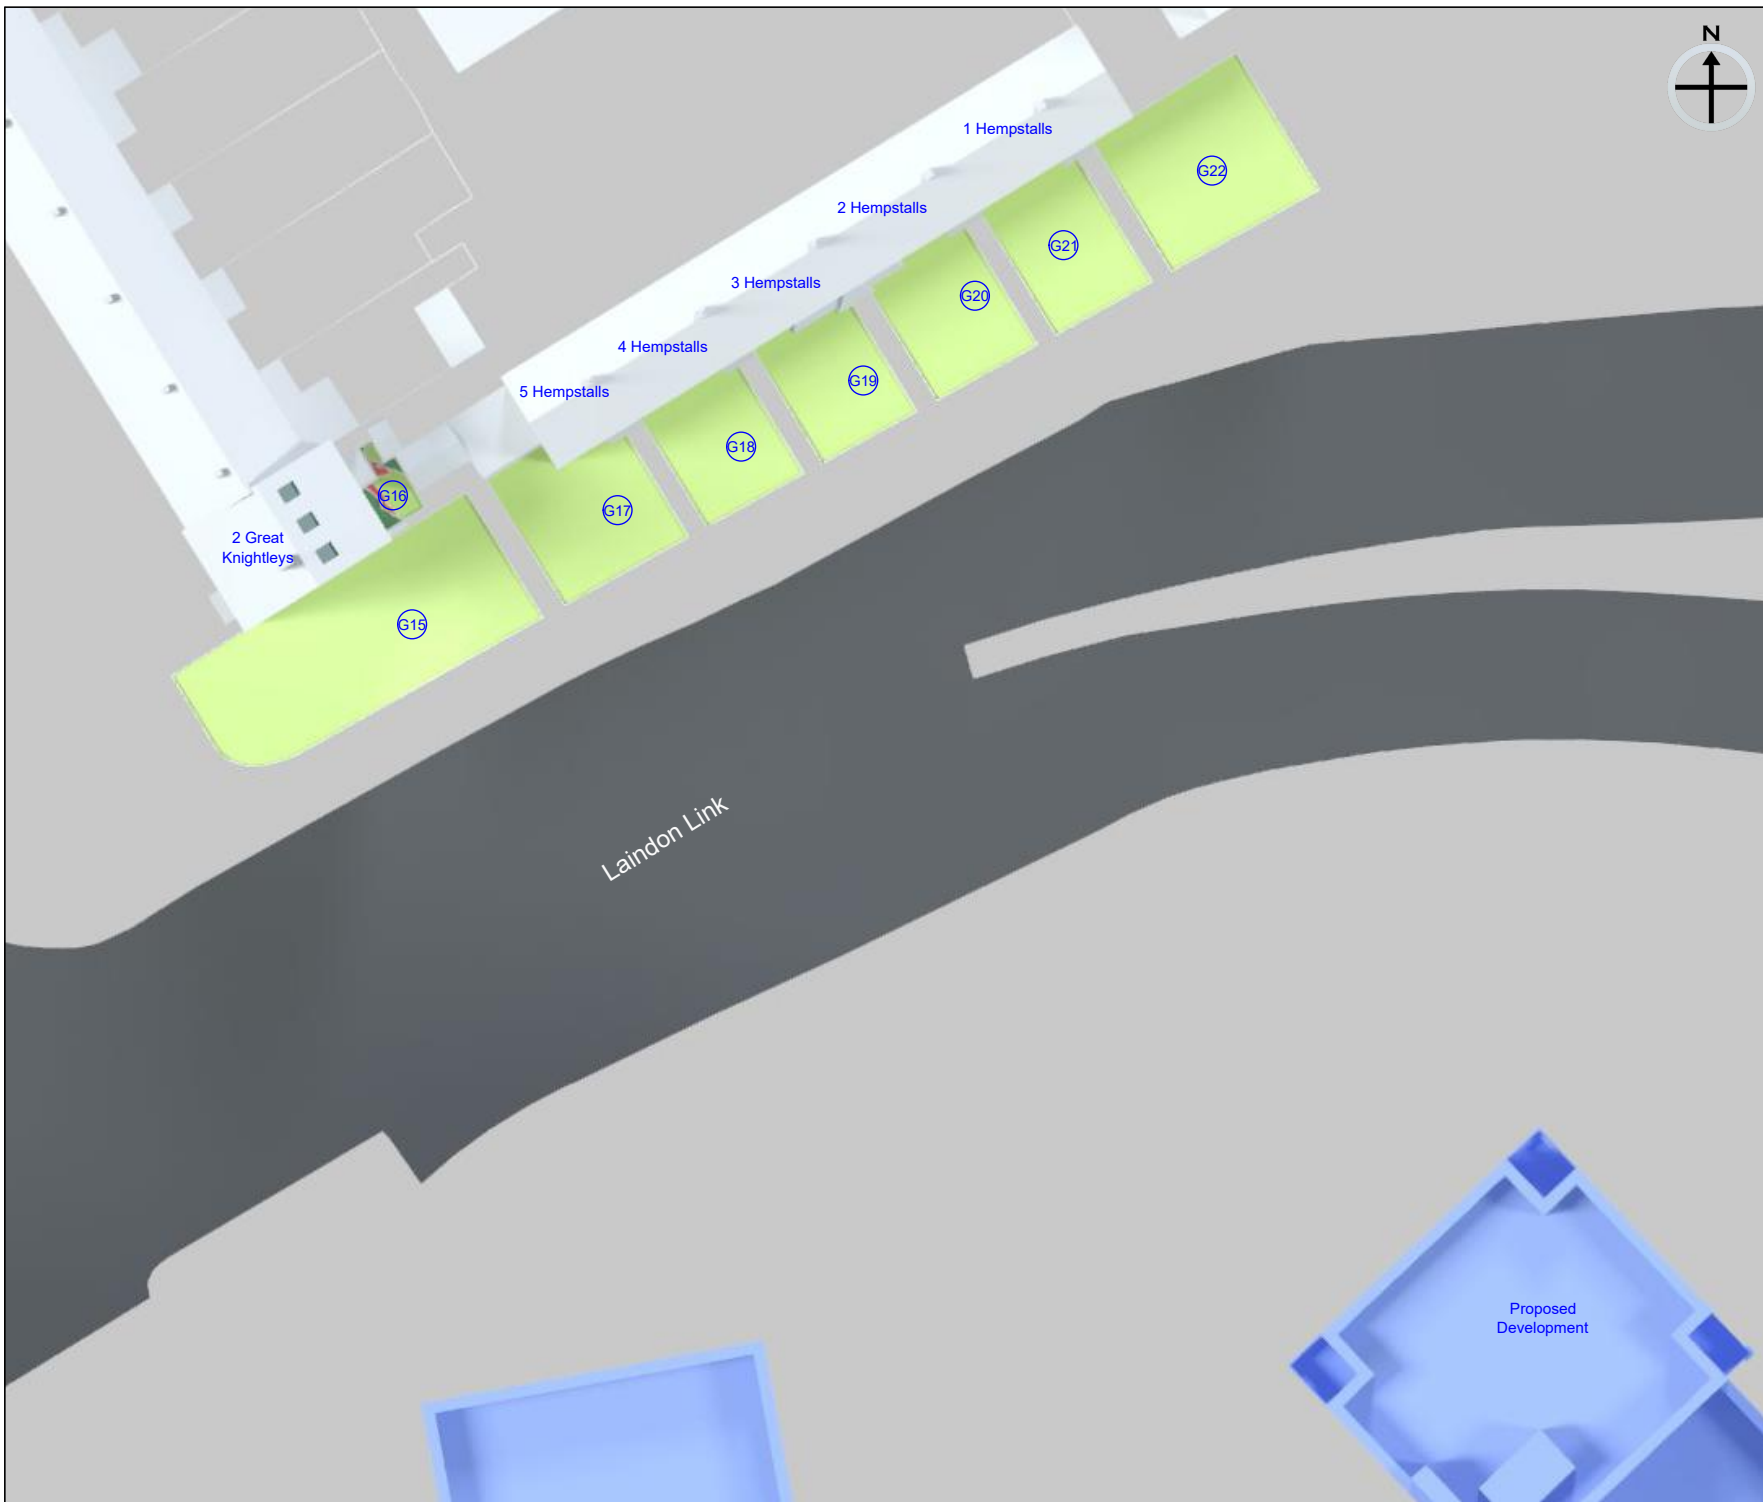
**Key**

- Receives under two hours sunlight on 21st March before and after the development.
- Receives under two hours sunlight on 21st March before the development; but will receive at least two hours sunlight on 21st March after the development (light improved).
- Receives at least two hours sunlight on 21st March before the development; but will receive under two hours sunlight after the development (light loss).
- Receives at least two hours sunlight on 21st March before and after the development.
- G1 Neighbouring Gardens and Amenity Areas
