DESIGN, ACCESS AND HERITAGE STATEMENT FOR PROPOSED NEW INTERNAL OPENING AT THE OLD RECTORY, ELFORD.

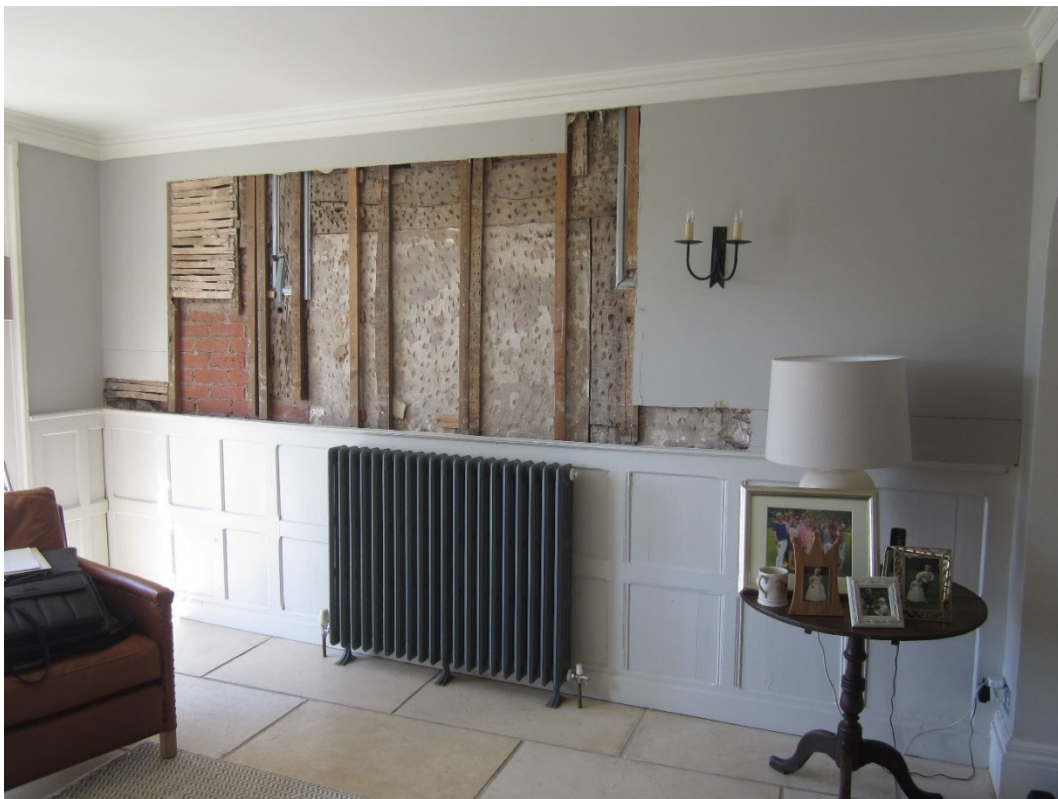
East face of wall between rooms G7 and G8, where it is proposed to make an opening.

13. It can be seen that the east face of the wall as now visible in G7 was originally limewashed before being plastered direct over the timber frame and infill panels. This plaster, evidenced only by the keying marks, was then removed and a new plastered lining installed over vertical battens and horizontal laths, some of which remains in place on

unexposed areas of the wall. In turn, much of the lath and plaster has also been removed, and replaced with new plasterboard on new battens.

12. It was apparent that the present surface finish to the west side of room G7 was of modern plasterboard, so it was advised that a limited amount be removed, sufficient to reveal the nature of the underlying fabric without destroying anything historic. Then it could be seen whether there was any timber framing that could present a constraint to the proposed new doorway. Drawing 3 is the result. On the kitchen side the wall appears to be plastered direct to the underlying wall and much of the surface is covered by kitchen fitments.
