Cuerden Hall, Chorley

Proposed Office Wing FF Sheet 2

240729-PUR-00-XX-DR-A-2044

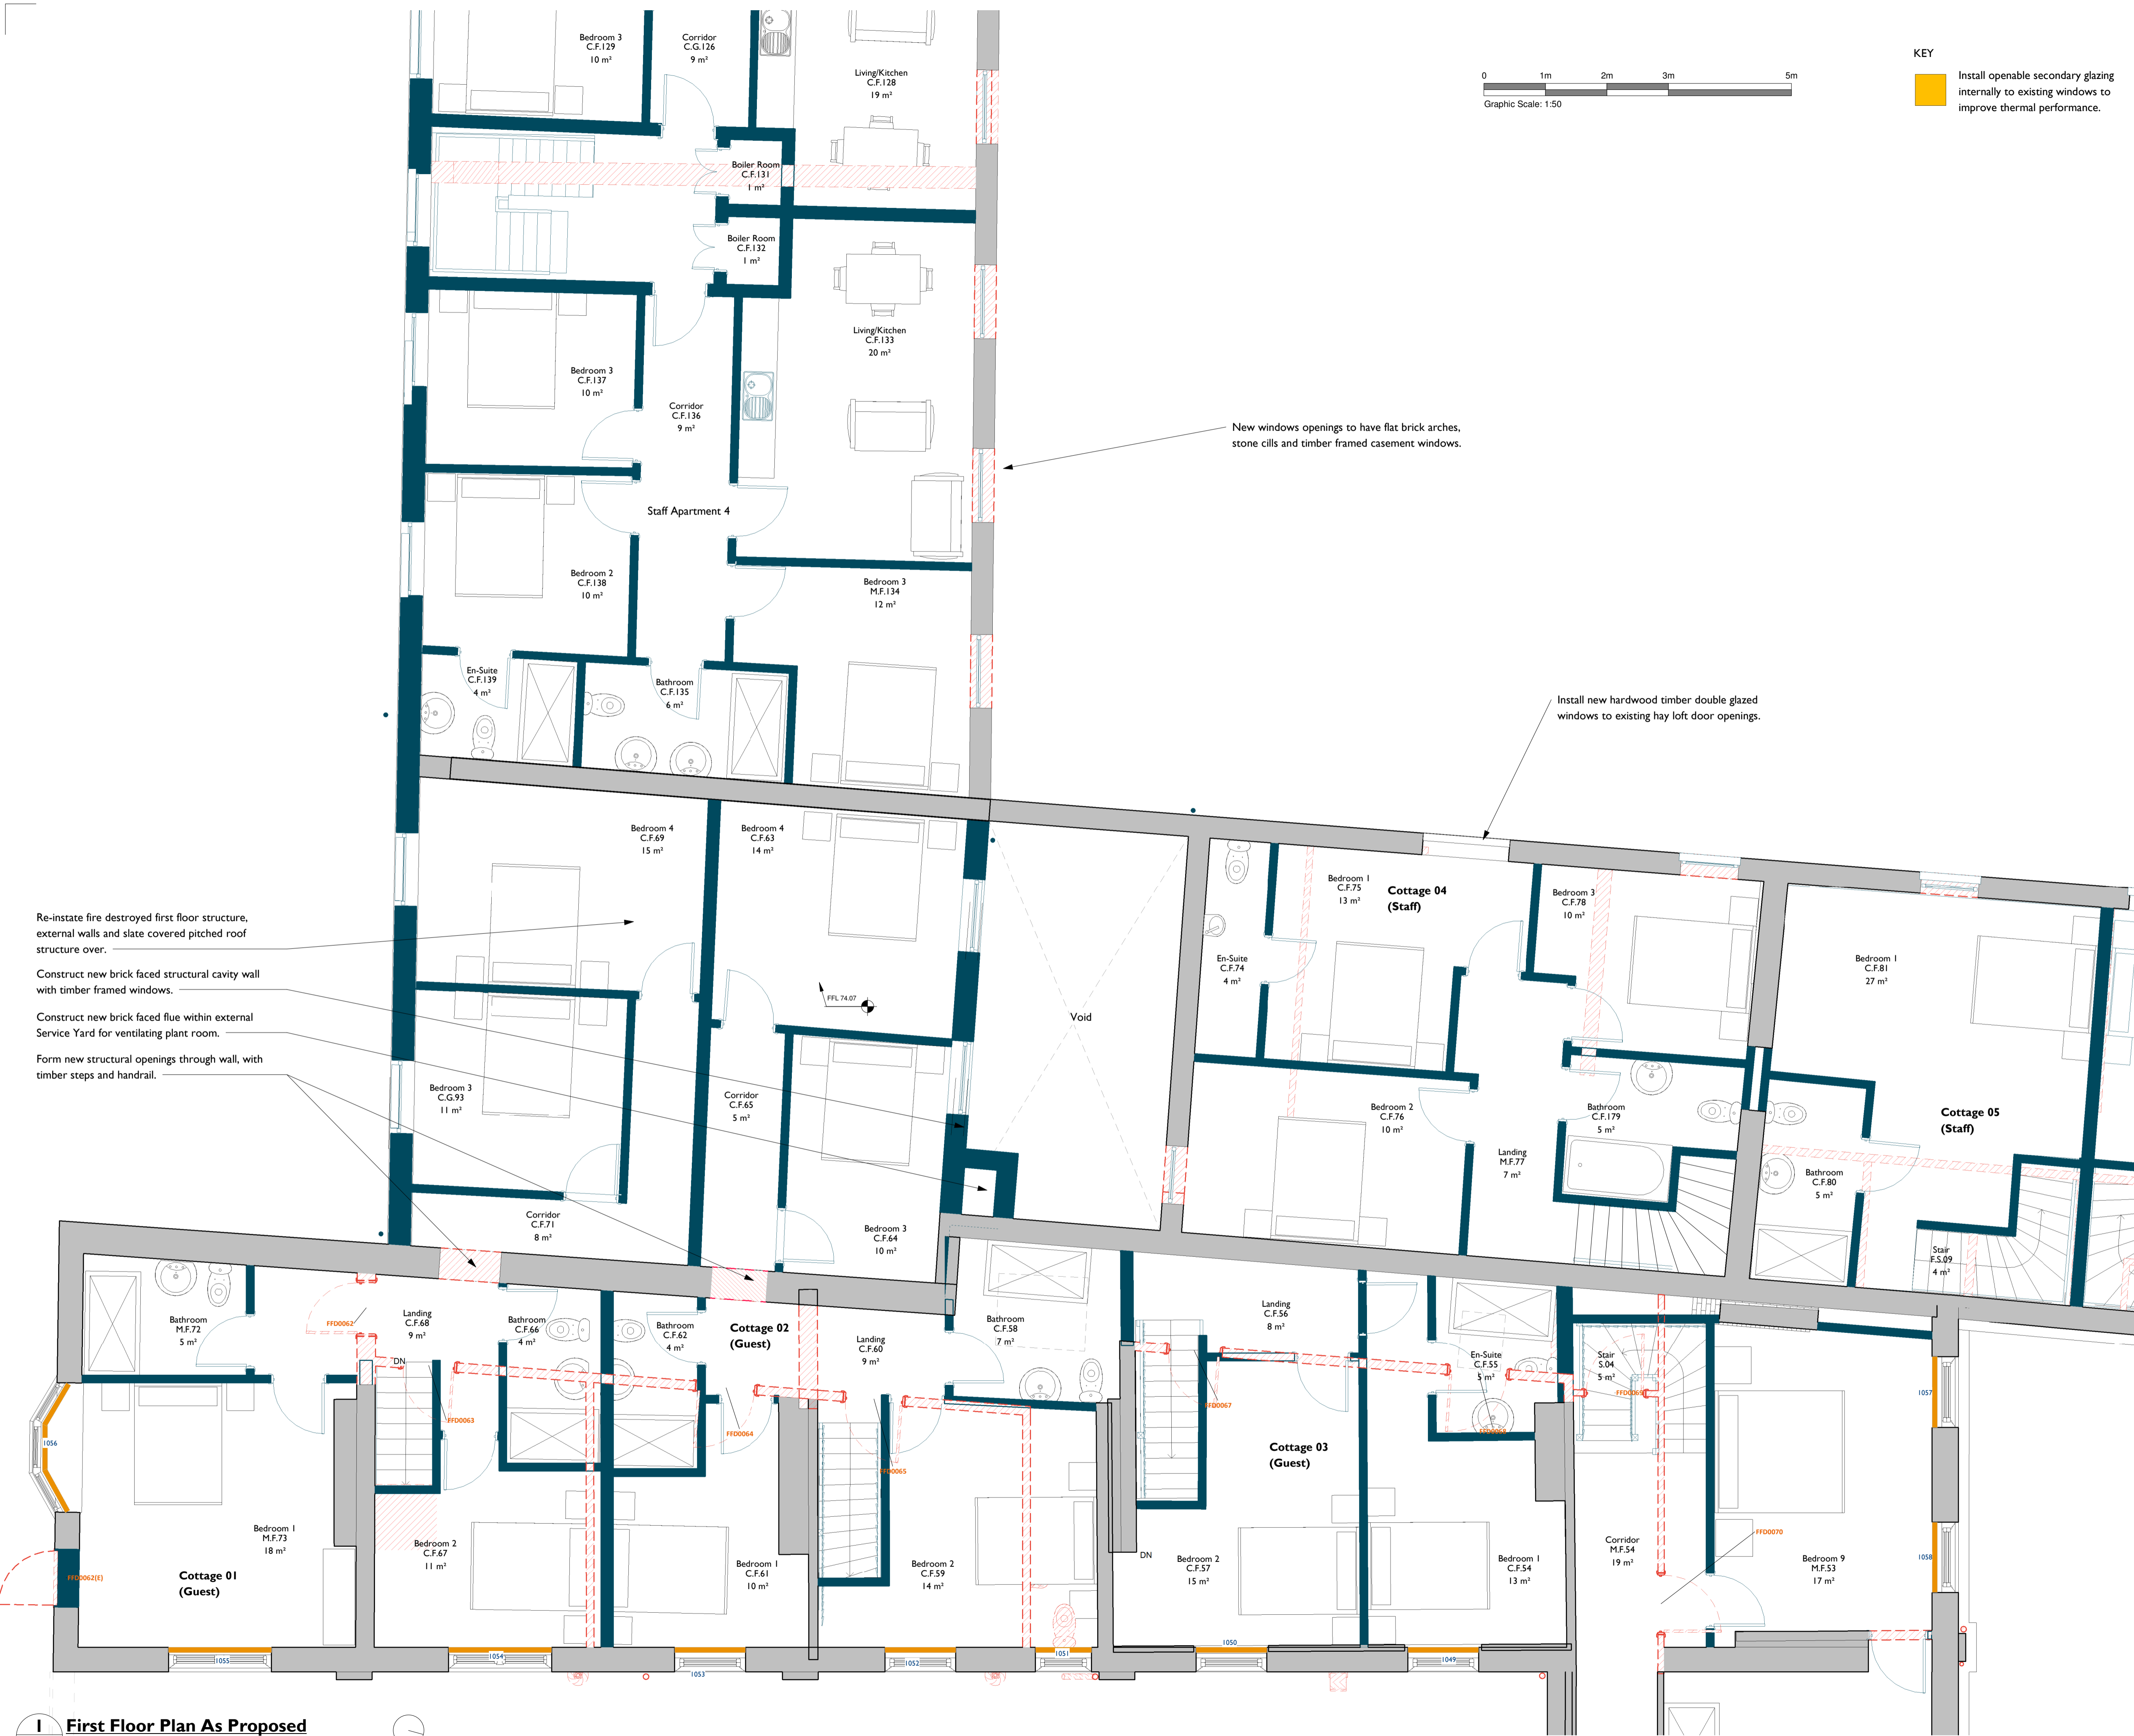
**KEY**  
 Install openable secondary glazing internally to existing windows to improve thermal performance.

New windows openings to have flat brick arches, stone cills and timber framed casement windows.

Install new hardwood timber double glazed windows to existing hay loft door openings.

Re-instate fire destroyed first floor structure, external walls and slate covered pitched roof structure over.  
 Construct new brick faced structural cavity wall with timber framed windows.  
 Construct new brick faced flue within external Service Yard for ventilating plant room.  
 Form new structural openings through wall, with timber steps and handrail.
