PROJECT
 Cuerden Hall, Chorley

TITLE
 Proposed Stableyard FF Sheet 5

DRAWING NUMBER
 240729-PUR-00-XX-DR-A-2046

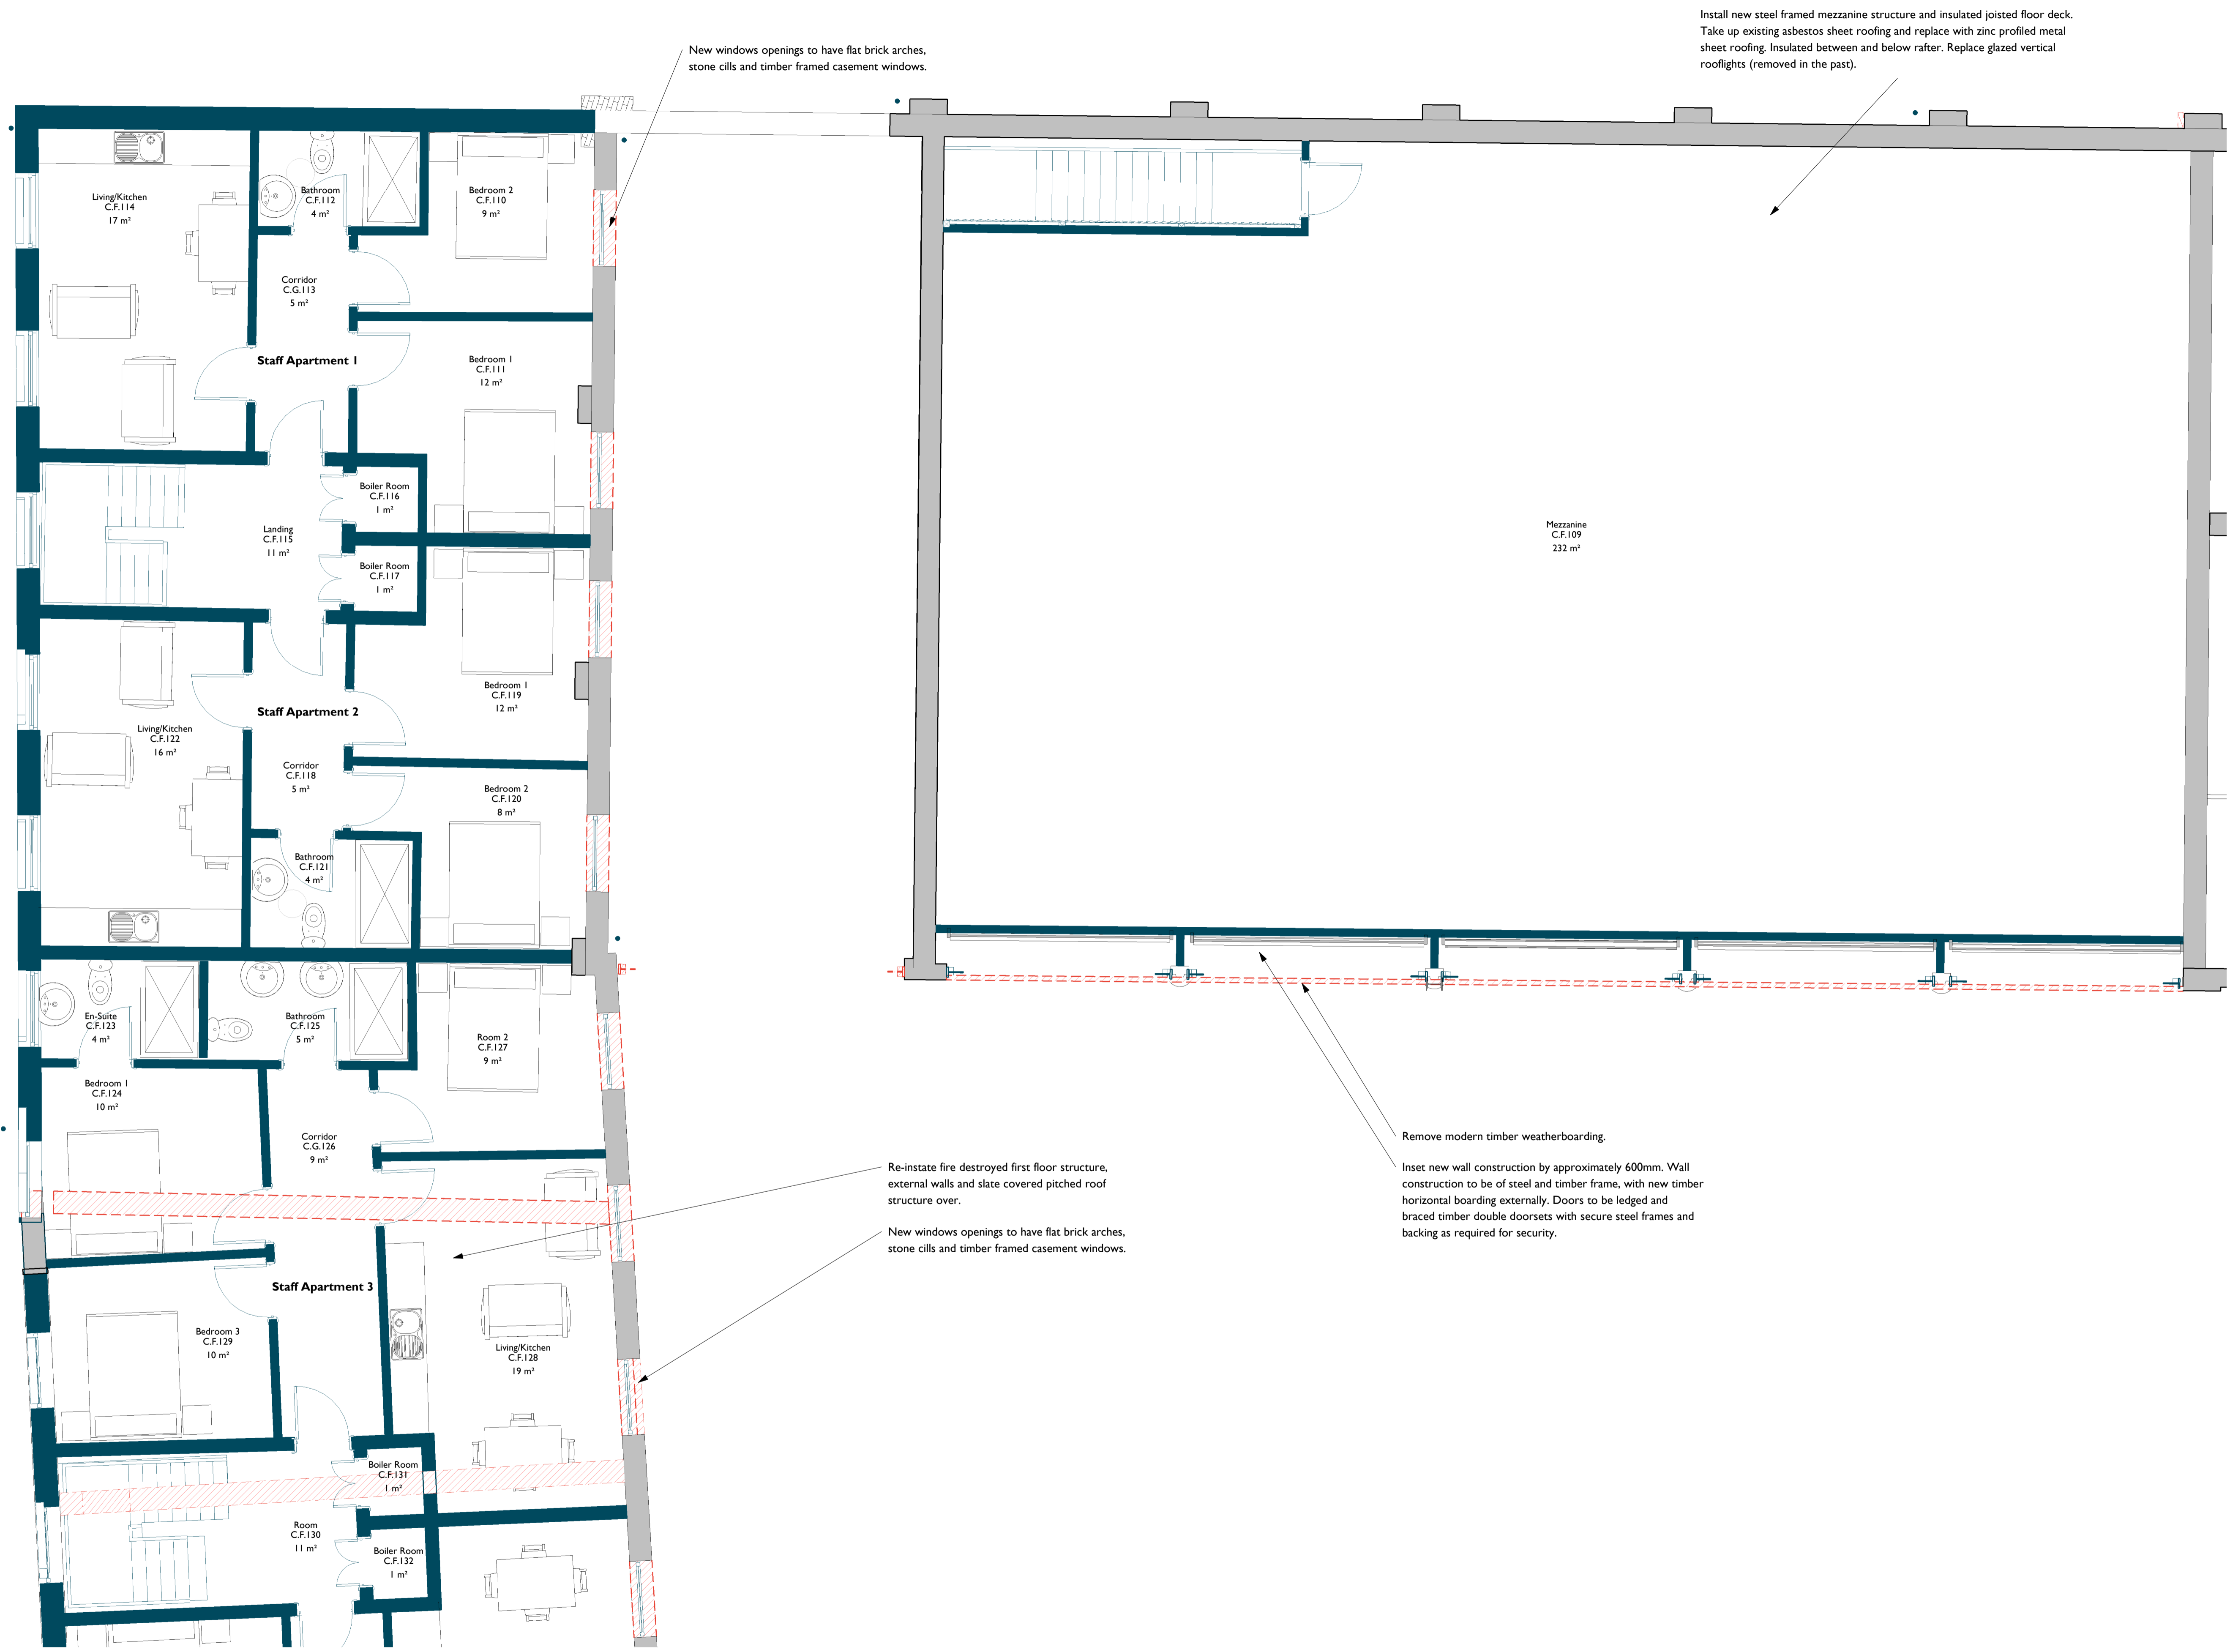
New windows openings to have flat brick arches, stone cills and timber framed casement windows.

Install new steel framed mezzanine structure and insulated joisted floor deck. Take up existing asbestos sheet roofing and replace with zinc profiled metal sheet roofing. Insulated between and below rafter. Replace glazed vertical rooflights (removed in the past).

Re-instate fire destroyed first floor structure, external walls and slate covered pitched roof structure over.

Remove modern timber weatherboarding.

Inset new wall construction by approximately 600mm. Wall construction to be of steel and timber frame, with new timber horizontal boarding externally. Doors to be ledged and braced timber double doorsets with secure steel frames and backing as required for security.
