**PROJECT**  
 Cuerden Hall, Chorley

**TITLE**  
 Proposed Stableyard FF Sheet 4

**DRAWING NUMBER**  
 240729-PUR-00-XX-DR-A-2045

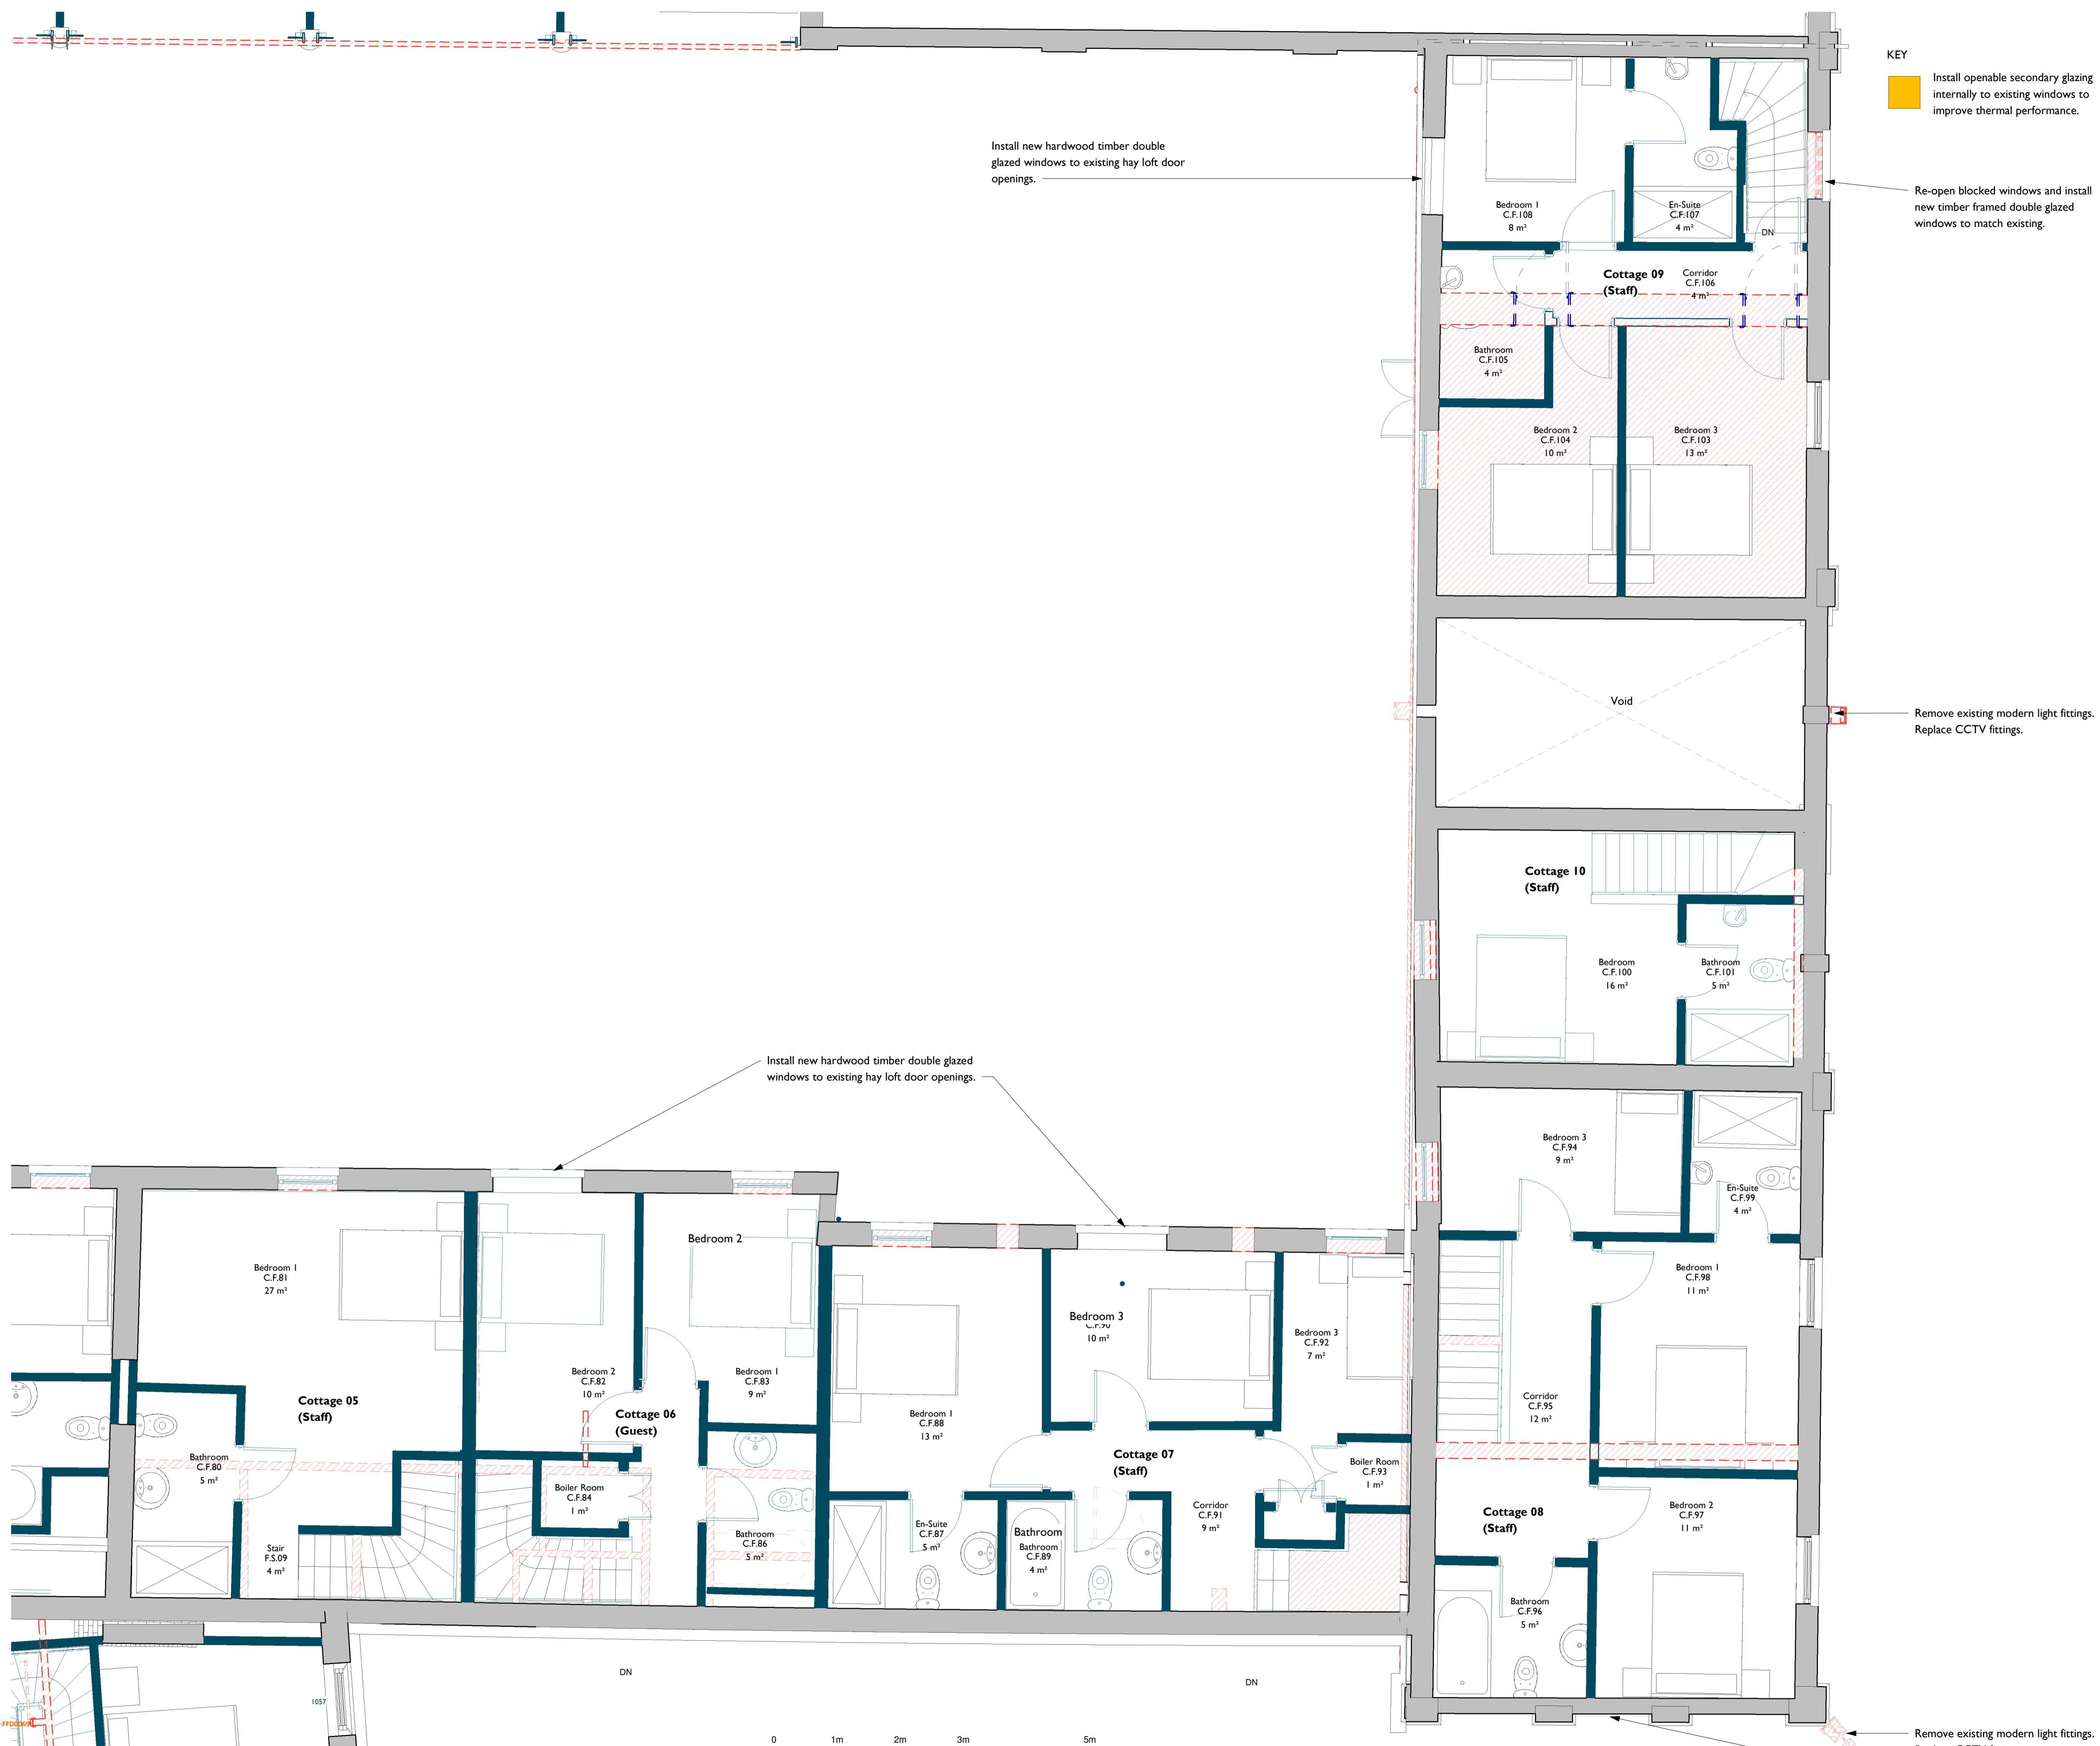
**KEY**  
 Install operable secondary glazing internally to existing windows to improve thermal performance.

Re-open blocked windows and install new timber framed double glazed windows to match existing.

Install new hardwood timber double glazed windows to existing hay loft door openings.

Remove existing modern light fittings. Replace CCTV fittings.

Refurbish existing clock to gable wall.
