Job No: G8705  
Client: HMH Clyde One Ltd

## Oswald Chambers, Glasgow Structural Survey

**Date: May 2021**

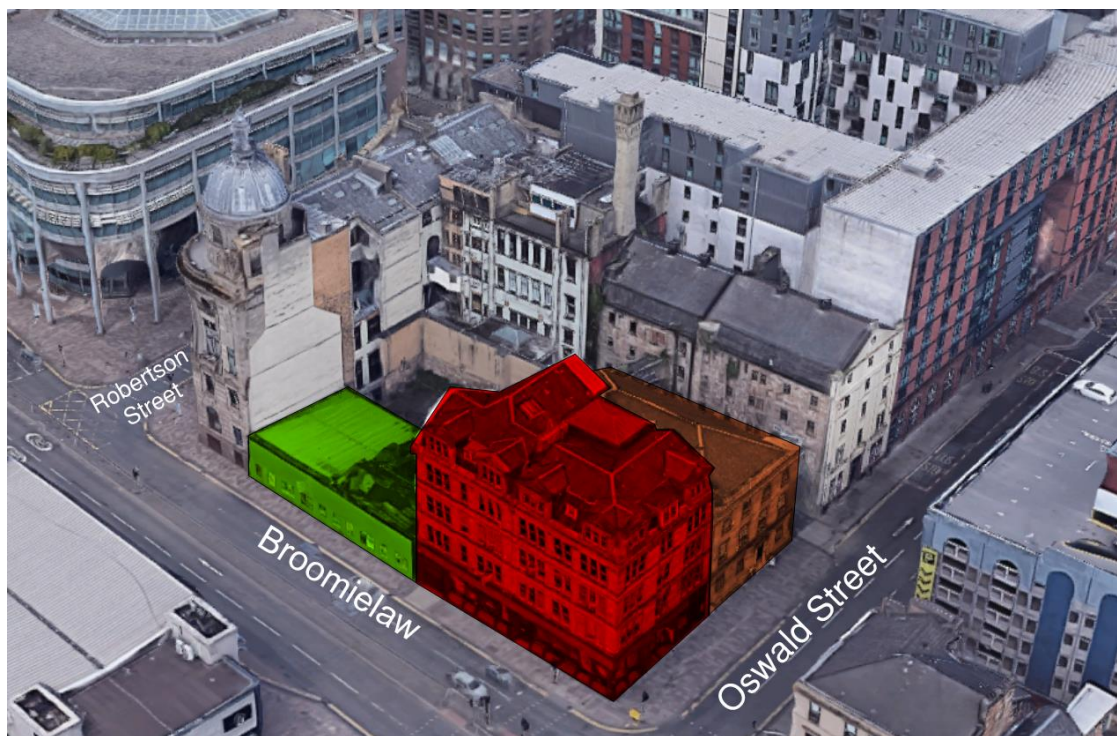
Figure 2. Aerial view of proposed site – (green) Old Public House (red) Oswald Chambers (orange) 9 Oswald Street
