Design & Access and Planning Statement

**Incorporating Schedule of Works
& Heritage Impact Assessment**

The Old Vicarage

Abbots Langley, WD5 0AS

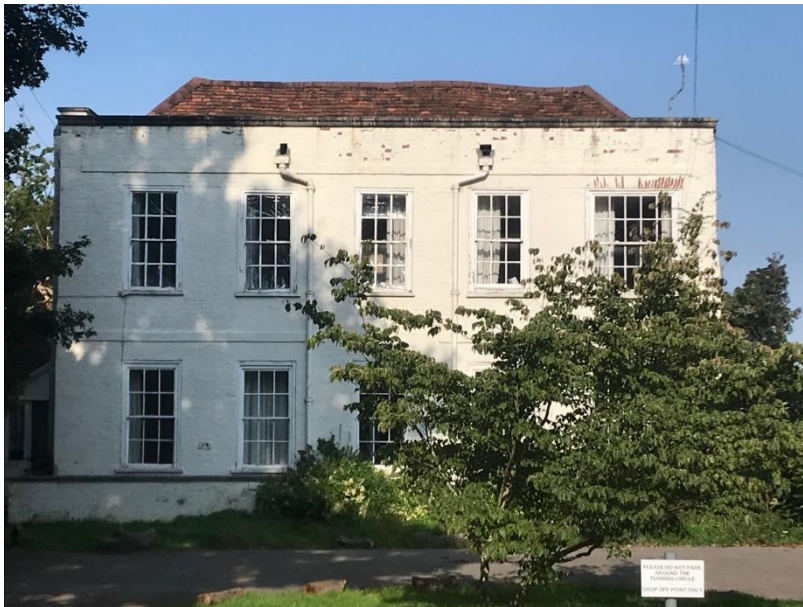
8.1 South Eastern Elevation

This is the main public facing elevation and can be viewed from the approach to St Lawrence Church from the High Street. It is the original Georgian façade and largely unchanged. Note however the truncated chimney stacks and the brick work painted white. It is assumed that originally there was a central door which was replaced with window and the right hand windows were widened.

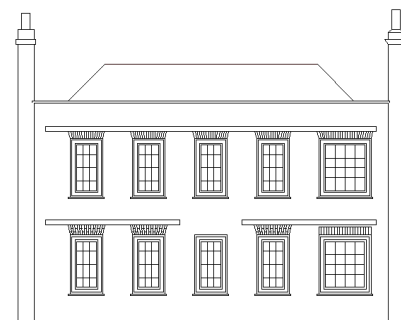
Proposed

Schedule of works	Impact on heritage asset
1 - Following paint removal under permission granted via 20/1430/DIS, repair brickwork and repaint and leave brickwork exposed	1 - Enhance appearance of building by returning to finish to authentic brickwork
2 - To rebuild the chimney stacks in a similar manner to original (general throughout - see detail below)	2 - Improve aesthetic in setting by restoring proportion and appearance to the building
3 - To repair the sash windows (general throughout)	3 - Continue the life of these heritage components and retain the original glass

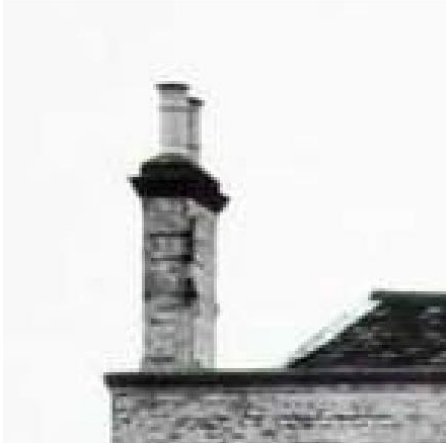
Photograph of original chimneys (see HBA)

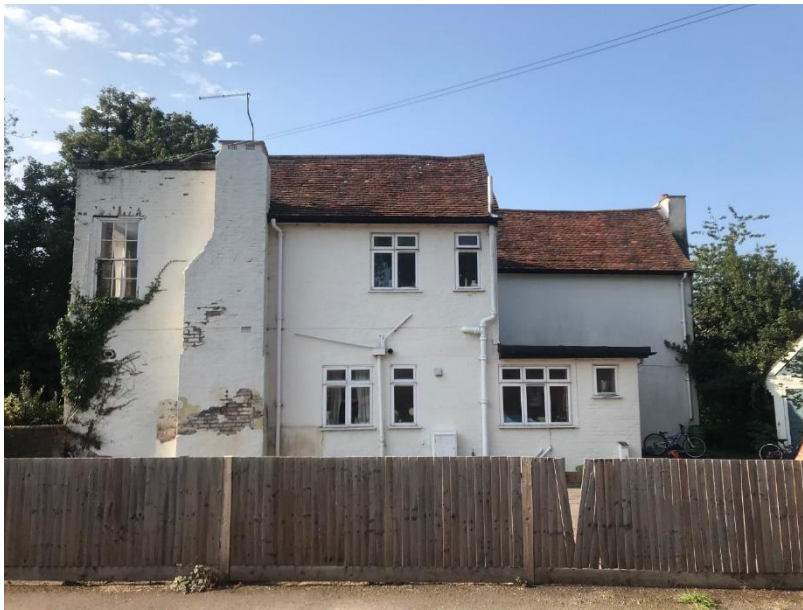
View of the NE Elevation from the Old Stables

This is the second most public facing elevation which has been most affected by the demolition of a wing in the 1960s and subsequent reconfiguration. Internal reconfiguration at this stage has been done to form bathrooms upstairs and downstairs. The position of the windows has been determined by this internal reconfiguration and has given rise to an irregular external appearance. A single storey extension has been built to create a kitchen and pantry with double glazed casement windows and a flat felt roof.

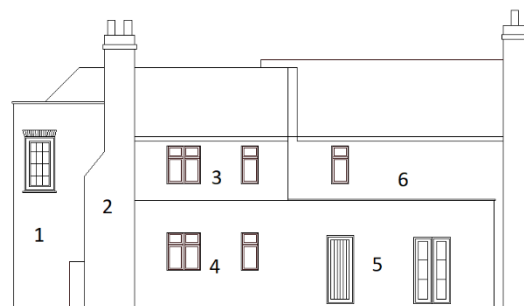
Proposed (see item 1 below for wall section notes)

1. Leave original brickwork
2. Leave original brickwork
3. Leave original brickwork if brick in good condition, otherwise lime render
4. Lime render ground floor original building
5. Cement render existing and new extensions
6. Repaint colour match to render

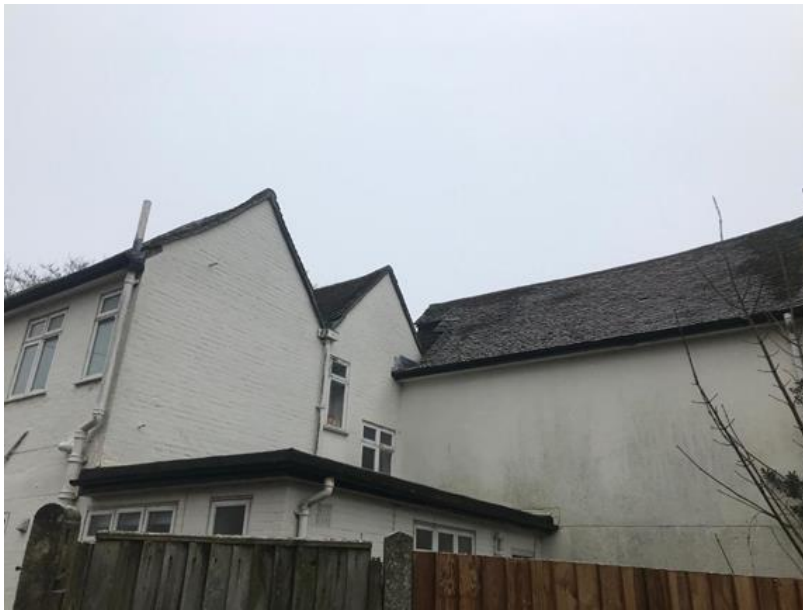
8.3 North Western Elevation

This is visible to a limited number of neighbours in St Lawrence Close and from the Church Hall car park. It is currently mostly obscured by the existing 1960 garage which itself has no heritage value. The brickwork to the gables shown is modern stretcher bond and there are windows on the first floor irregularly placed. The existing single storey flat felt roof is prominent

View of the NW Elevation from the Church Hall car park

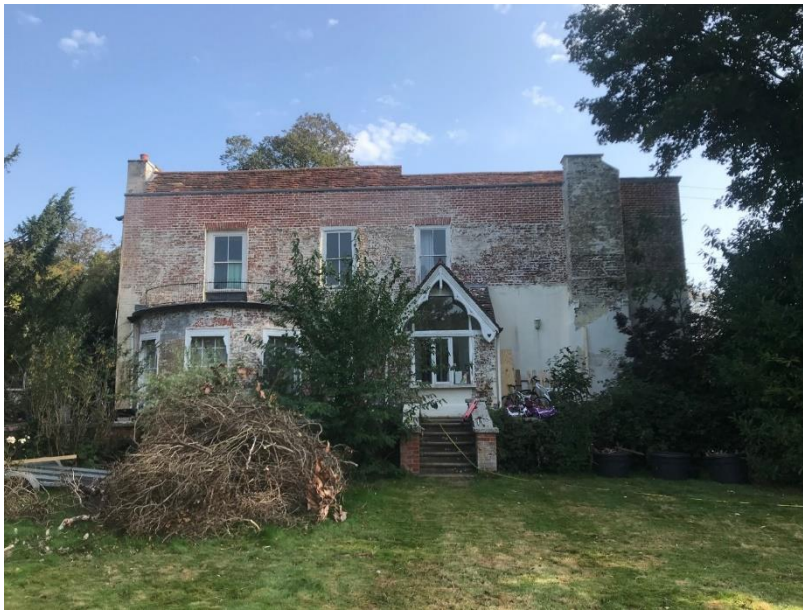
8.4.1 South West Elevation

SW Elevation from the garden with some of the paint removed

This elevation is mostly obscured from public view by trees in the garden and is primarily only visible from the garden itself. It has been painted white with modern waterproof paint. This elevation has truncated chimney stacks at either end with a parapet wall that extends the full length of this elevation. The elevation to the right comprises the early Georgian building and to the left, the mid Georgian addition with porch added later. The first floor windows have been moved with reveal outlines showing in multiple places

The bay has moved and the exterior brickwork been partially coated in cement tosh to conceal breaks in the brickwork covering up the fine pointing to the headers above the windows. Tests have shown Snowcem or similar material and indeed patches of thin cement render both on the bay and on the main frontage.

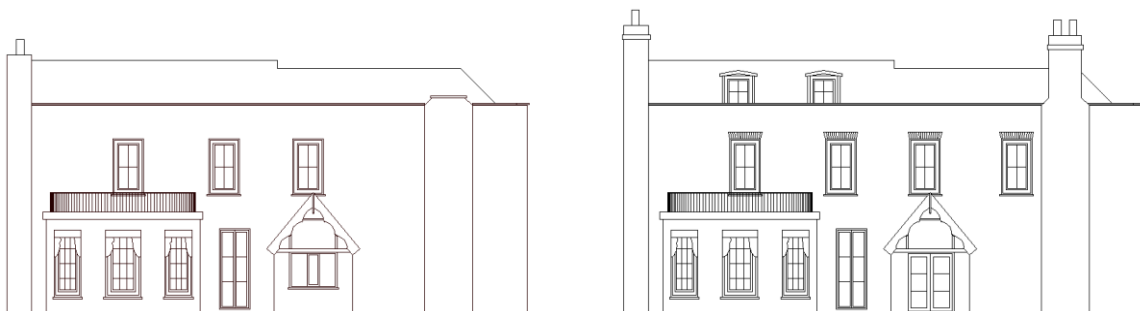
Existing

Proposed

Schedule of works	Impact on heritage asset
1 - Following paint removal under permission granted via 20/1430/DIS, repair brickwork and repoint and leave brickwork exposed	1 - Enhance appearance of building by returning to finish to authentic brickwork
2 - To repair the bay window as per Hallam Consulting Method Statement	2 – This would preserve the bay window and restore the appearance by repairing harm done by what appears recent poor repairs
3 - To reinsert a window that existed previously on the first floor on the right side of this elevation	3 – This would be reintroducing a component that was previously removed. See note below

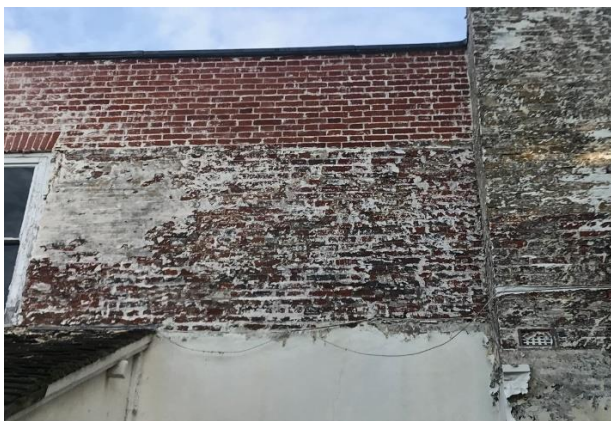
Above - evidence of bricked up window revealed through poorly toothed in brickwork

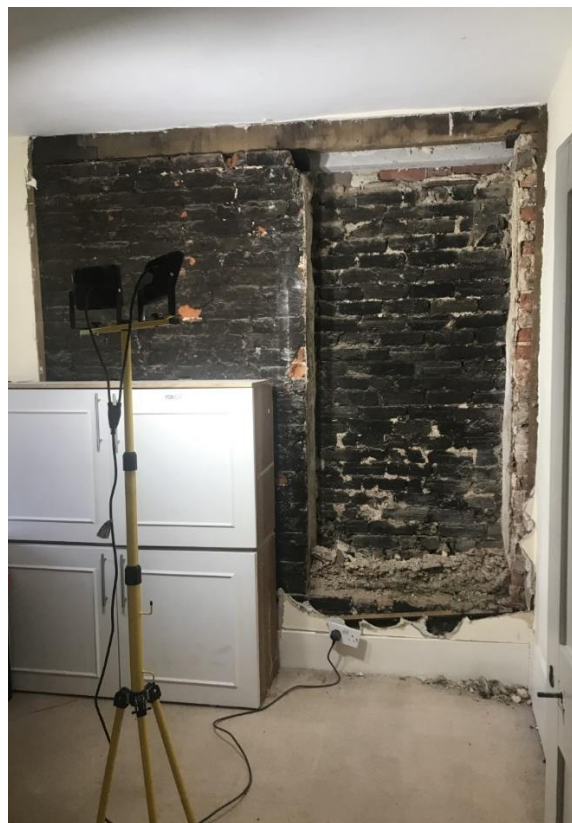
Right – following the evidence, we removed modern plasterboard cladding and discovered existing window reveal. This is similar dimensions and height to the existing windows. Note the modern lintel above following the rebuilding of the parapet walls in 2007

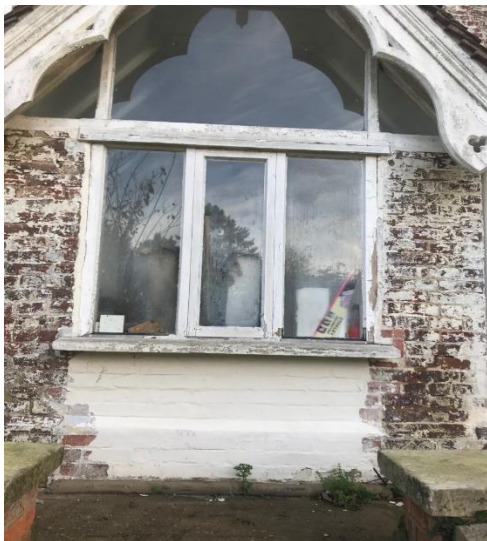
Garden face of porch showing modern bricked up section and original step

We note the existing porch doors facing the SE are double doors. The garden facing elevation of the porch has been bricked up and the width of the bricked up opening is consistent with double doors. Double doors also feature in the internal porch doors and the French doors to the Drawing Room. Double doors also seem to show on the 1912 photo of the original porch in the HBA.

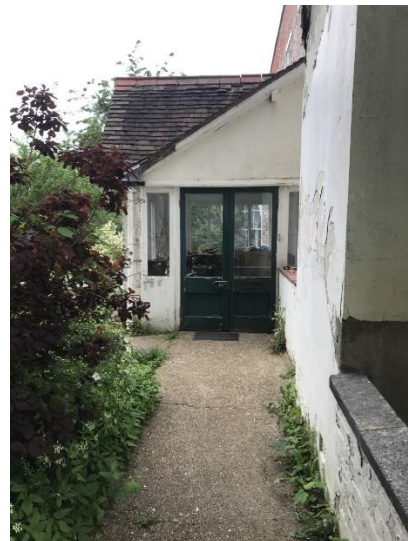
Existing porch with old double doors

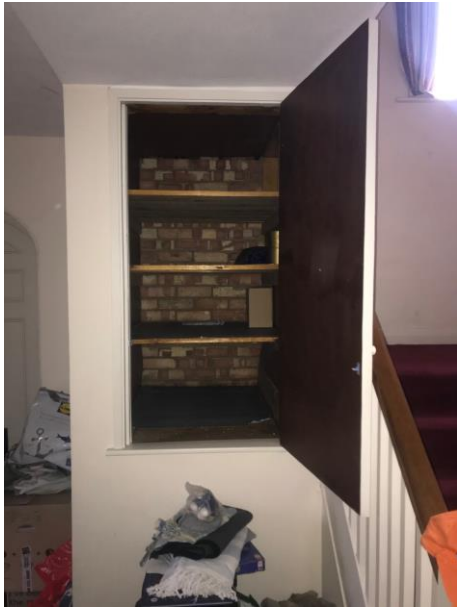
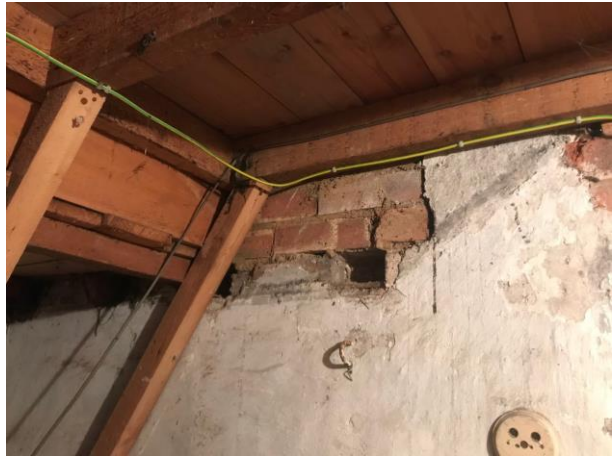
We suspected this first by seeing the back of the cupboard in the hallway was constructed out of modern common brick suggesting this was an opening until recent times. We also saw evidence from under the existing staircase that the original staircase used to occupy the full width of the stair well (below where the current landing is to bedroom 5).

Photos from position 1 and 2 showing common brick upwards from height of original quarter landing. Evidence also of stairs being full width of stair well incorporating what is now the cupboard

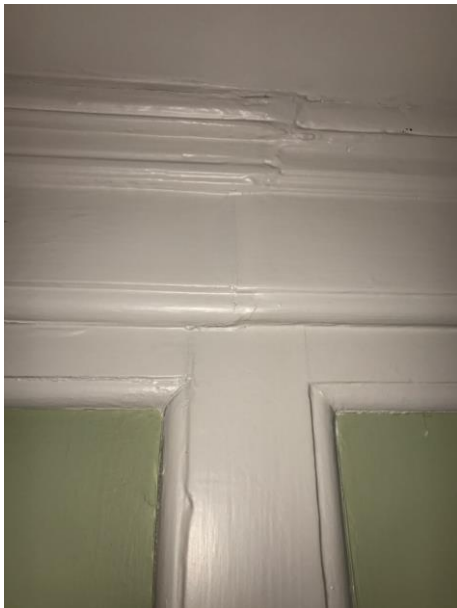
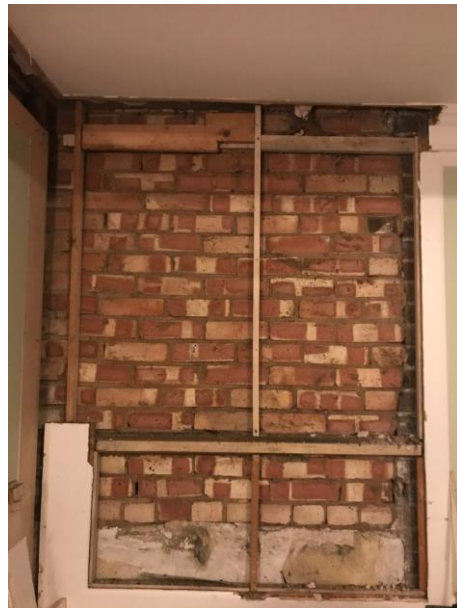
On carefully opening up this section, as expected, we found modern common brick infill from the quarter landing height of the original staircase upwards.

Photos from position 3 showing panel join lines and after carefully opening up panelling

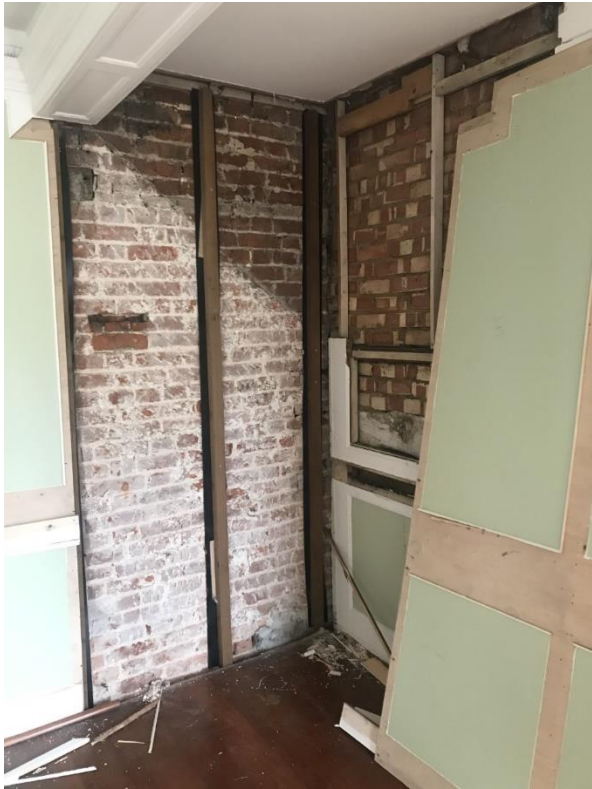
On opening up the adjacent panel in the drawing room, we could see the original brickwork wall. As noted in section 9.1.3 below, this room was original plastered and wall papered and much of the panelling is modern reproduction.

Photo from position 3 showing line of old plaster on wall behind modern panelling below old stair line (now removed). Note the modern reproduction panelling formed of 6mm plywood and stuck on lath.

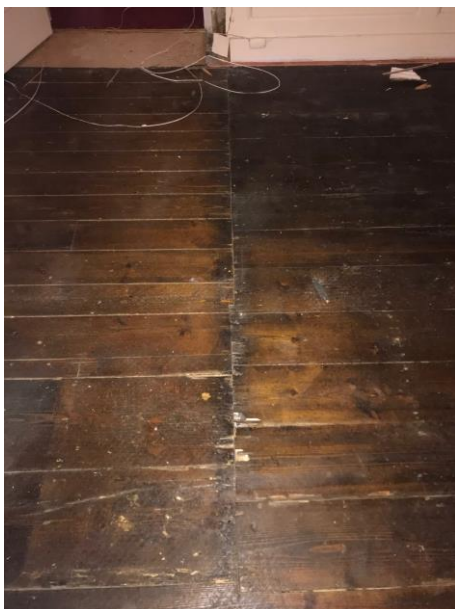
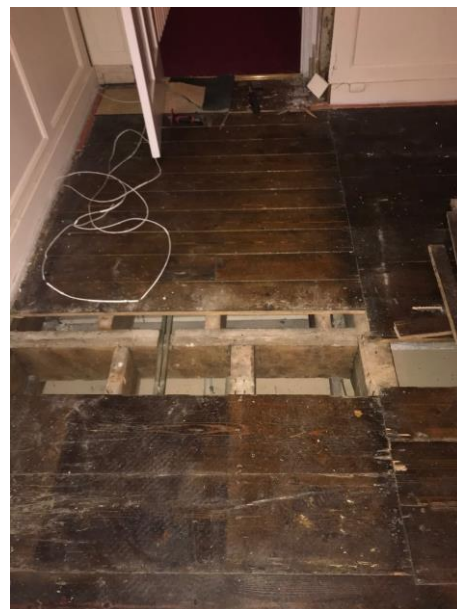
We lifted the carpet in bedroom 5 and saw evidence of new construction by a line in the floor boards and the same modern tongue and groove flooring used as is used for the existing landing to bedroom 5. When we lifted some of these boards, we could see evidence of trimmer and landing directly above the line of the stairs below.

Photos from position 5 showing join line of flooring – then opened up showing trimmer and landing

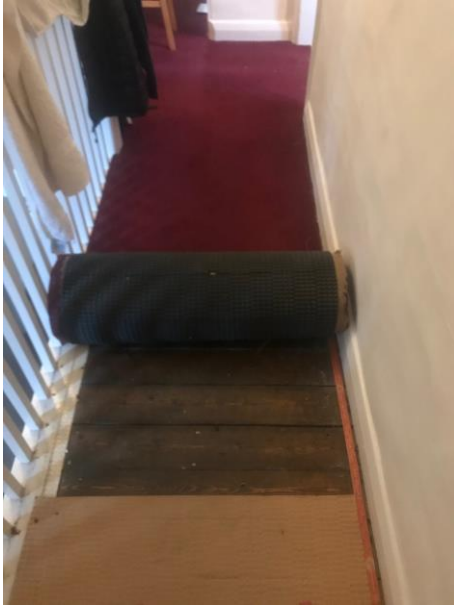
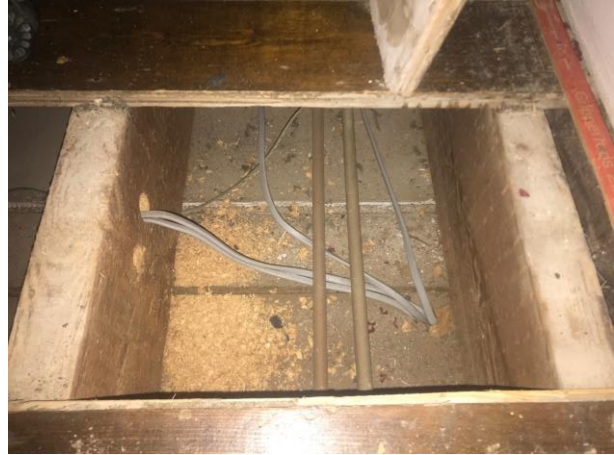
Similarly on the landing, the structure itself is of much more modern materials such as cut joists, plasterboard ceiling and tongue and groove flooring. Other evidence such as nails suggest this construction is part of the 1960s reconfiguration.

Photos from position 6 showing modern joists and floorboards forming landing to bedroom 5

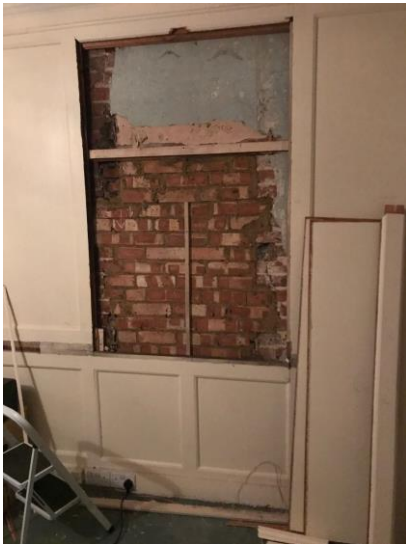
We examined the panelling in bedroom 5 where the landing would have been and noted differences in construction (join lines, method, materials and quality).

On opening up this panelling, we saw a section of brickwork in the shape of a doorway made with common brick - so we assume access to the now demolished late Georgian section was via this stair way and landing.

Photo from position 7 highlighted in bright yellow on layout.

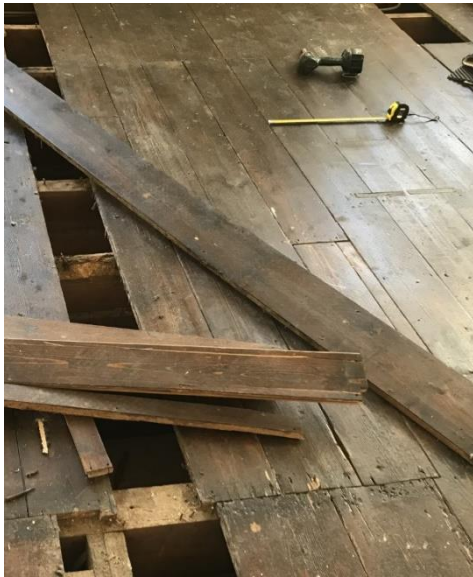
We examined the floorboards further in bedroom 5 and noted that the area adjacent to the stairwell and landing were of a different width to those of the rest of the room.

Photo from position 8 showing narrower boards in pale yellow section of bedroom 5 floor.

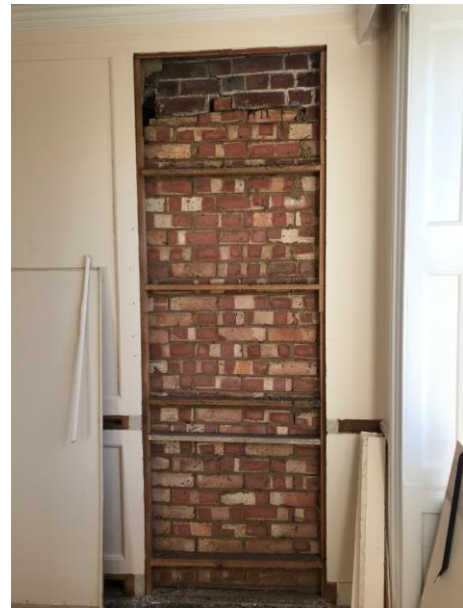
Photo from position 9 showing modern common brick of earlier doorway (highlighted orange on layout)

We then examined the panelling in this area in more detail and noted a section of different construction (join lines, method, materials and quality) against the wall of the original early Georgian house. On carefully opening up this section, we found modern common brick in the shape of a doorway suggesting direct access between what is currently bedroom 4 and what is now bedroom 5.

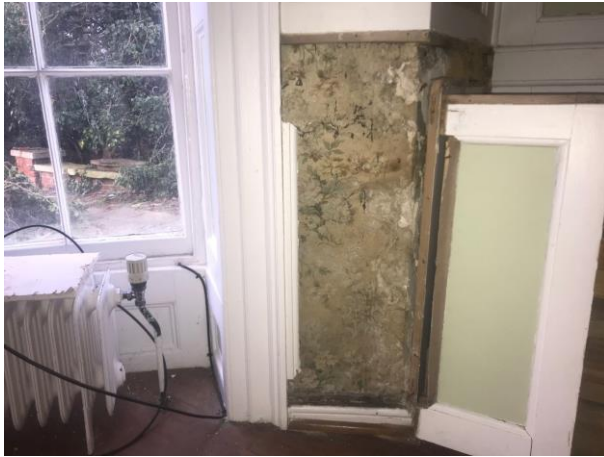
Photos from position 4 showing wall paper full height behind panelling

We have carefully opened up some of the panelling in the drawing room to consider how best to address damp and beetle damage and in doing so, found evidence that the panelling was put on over existing wall finishes.

This explains why there exists the awkward detail of the panelling sitting on top of the skirting and the top detail obscuring what we believe to be the original egg and dart cornice. There is evidence of floral wall paper - as expected long past service life, but showing how the room would originally have been presented.

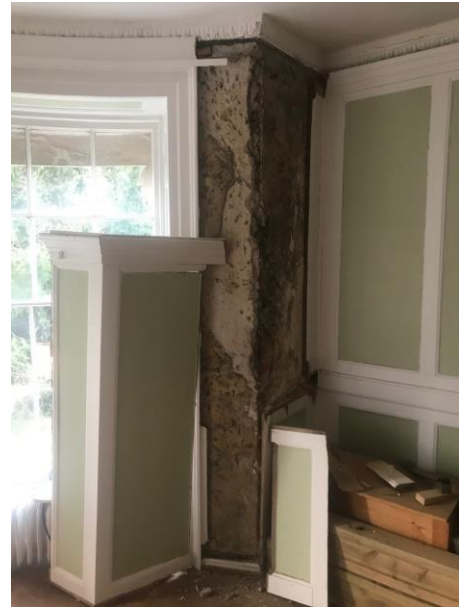
We found also that behind adjacent panelling evidence of painted plaster finishes suggesting the panelling was fitted some time after the original construction as shown in section 1 above from position 7.

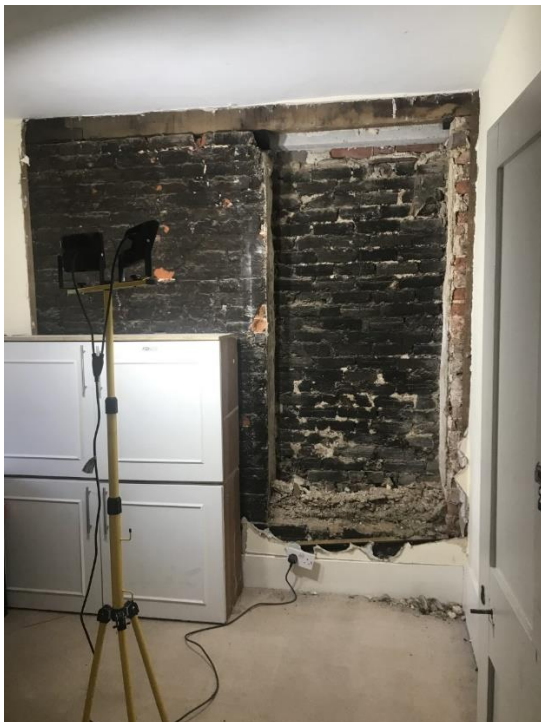
Photo from position 10 after opening up plasterboard covering – evidence led by seeing brick suggesting bricked up window. Note original rendered window reveal and low sill height similar to that of other windows in the main SE facing elevation.

9.1.4 There was a window on the SW elevation in bedroom 3

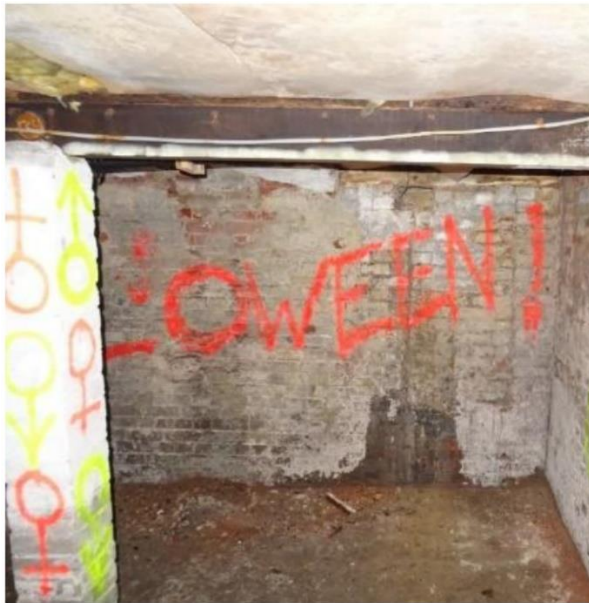
Showing view of NW wall of basement under drawing room (graffiti by others)

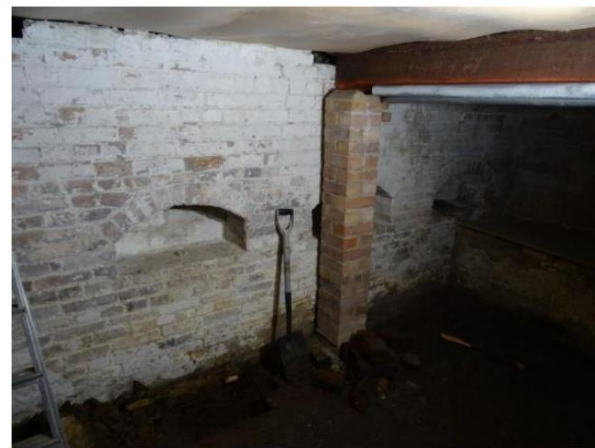
Basement under dining room with modern pillar

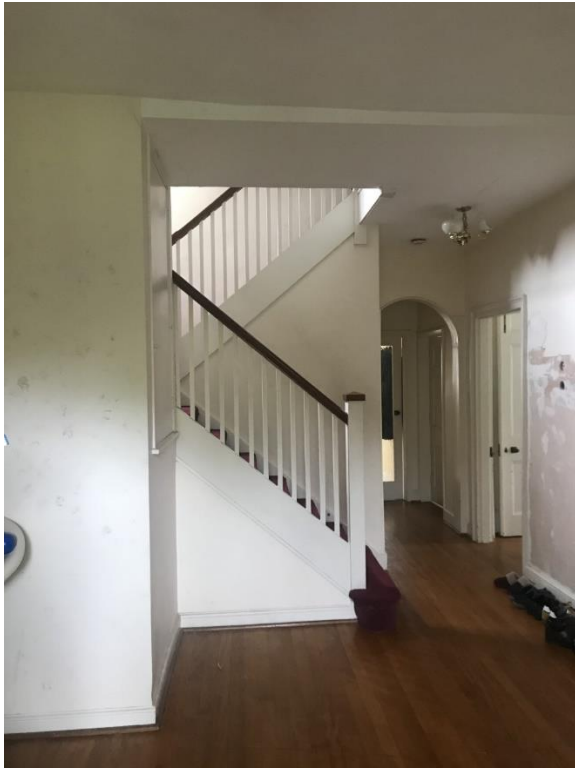
Stair way viewed from front porch

The stairway is a modern installation, assumed to be from the reconfiguration in the 1960s. It is in approximately the same place as the original, though a narrower and simpler arrangement.

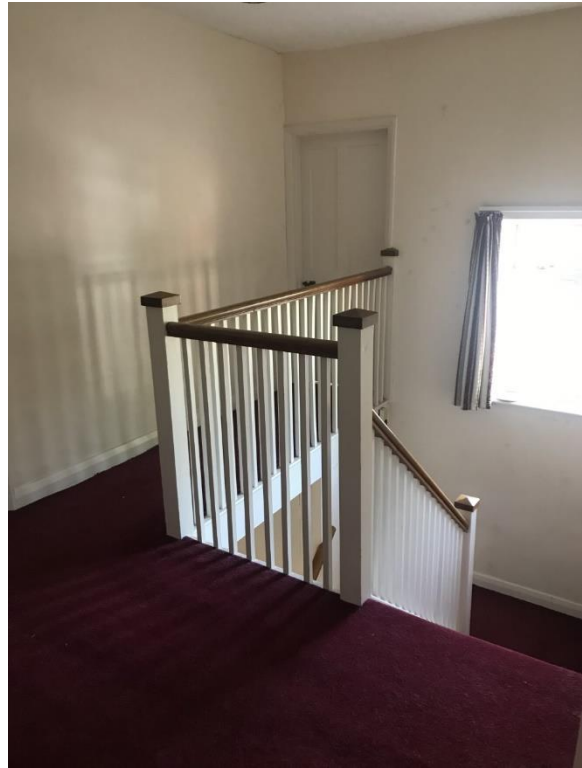
Stairway viewed from upper landing

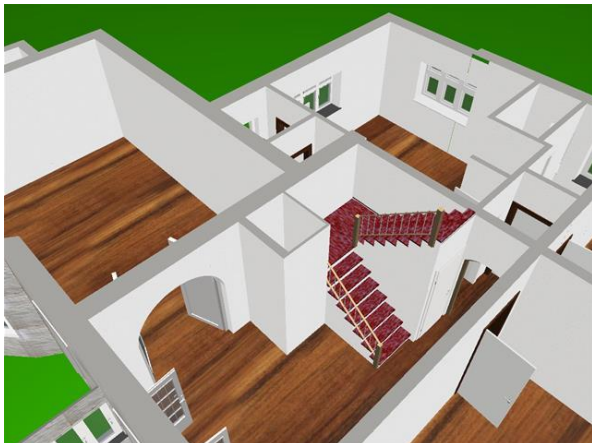
3d model - Existing stair arrangement

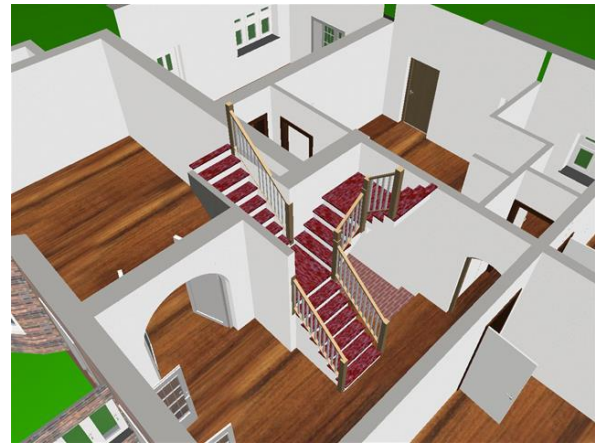
3d model - Proposed stair arrangement

1 – To replace the 1960s staircase with staircase the full width of the stair well. This will necessitate removal of the landing structure above which has been revealed to be of modern construction and reopening wall through to drawing room

1 – This proposal returns the arrangements close to that of when the mid Georgian addition was first built. It adds legibility to the phasing showing how the late Georgian section would have been accessed and removes modern materials

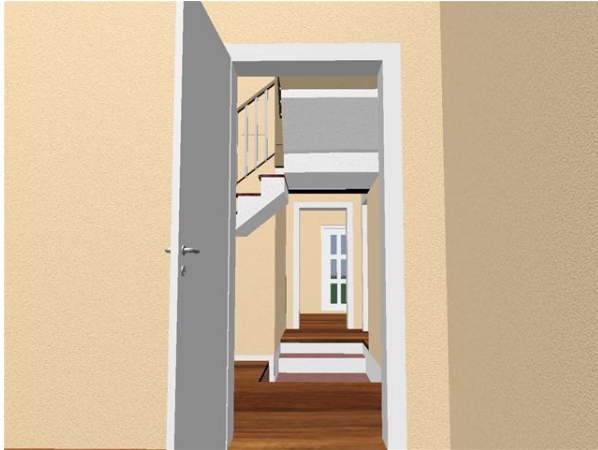
3d model – proposed route to new extension under new stairs from hallway

The proposed route through to the proposed study is what we understand to be the original route to the basement and old rear door. This steps down to the original brick finished floor under the existing staircase.

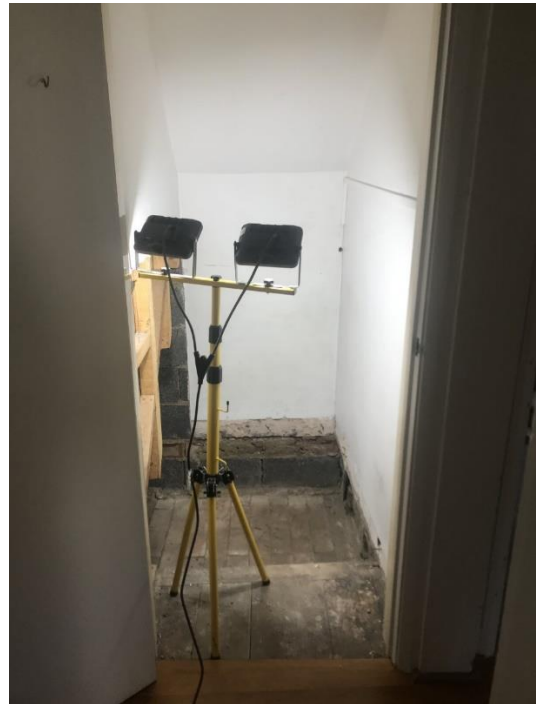
Photo of under stairs showing original brick floor

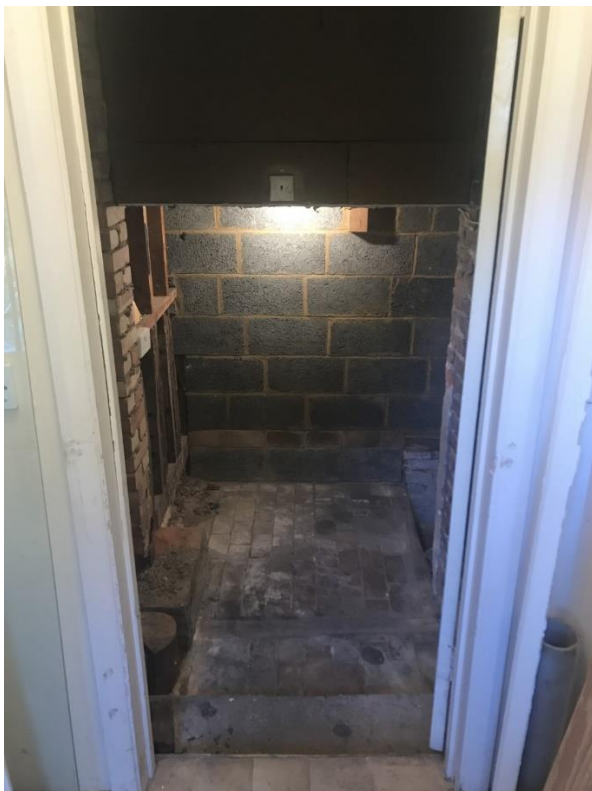
Photo of entrance to basement stairs showing original brick floor

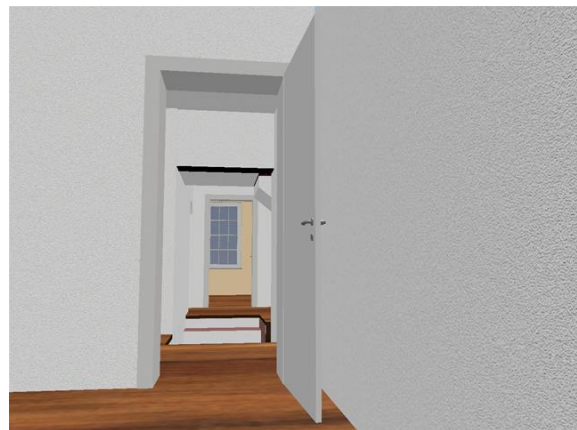
3d model – proposed route to hallway under new stairs from new extension

Note that there will be a step down and back up again between the study in the new extension and the existing hallway. This is acceptable to us as it helps separate the study from the rest of the existing house.

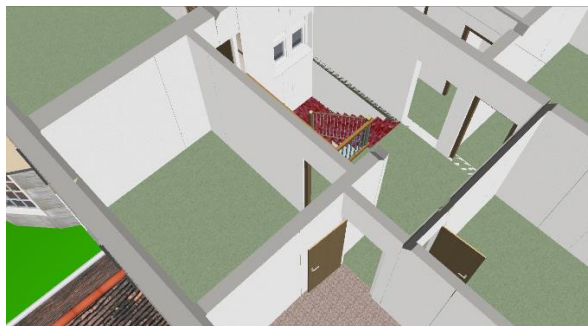
Existing bedroom 4

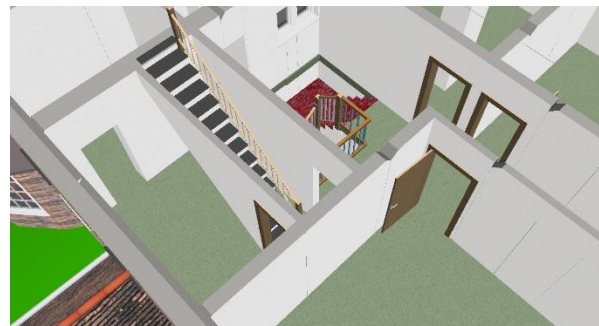
Bedroom 4 with stairs to loft reinstated

Schedule of works	Impact on heritage asset
1 – Introduce staircase to 2nd floor and open out stairwell above. Existing ceiling joist will have be further trimmed to allow the stairwell to be moved as the steelwork fitted in 2006 to reinforce the roof occupies part of the original stairwell.	1 – This will be approximately in the location of the original stairwell to the habitable section of the 2nd floor and introducing this will return the layout to something closer to original. Note that the trimming was first done upon construction of the mid Georgian addition
2 – Fit partition wall between staircase and new WC space	2 – No heritage component affected and no material impact on layout
3 – Form opening through brick wall into new shower area in bedroom 5	3 – This opening was bricked up in the reconfiguration of the 1960s and opening this will return the arrangement to something closer to original

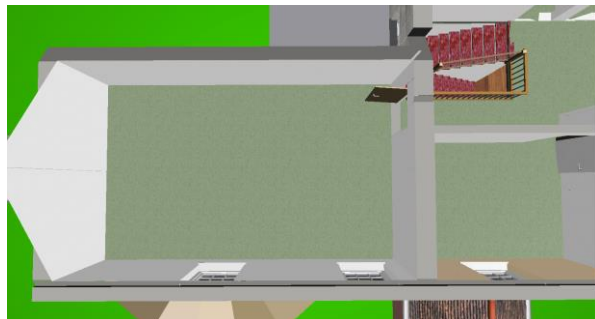
Simplified 3d model looking into bedroom 5 as existing

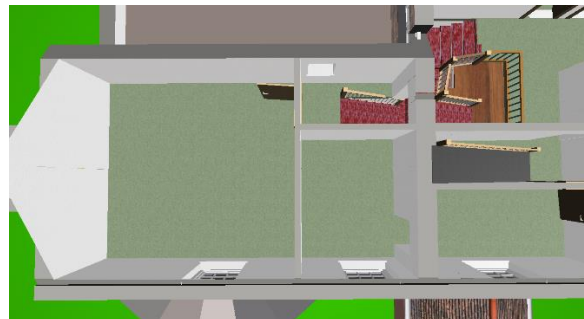
Simplified 3d model looking into bedroom 5 proposed

4 – Construct walls and door to separate newly formed landing and shower room from bedroom 5	4 – There is some evidence this is the original arrangement. Existing panelling can be joined into by careful joinery
5 – Open window to NE elevation from newly formed landing using one of the existing single casement windows in the place of the bricked up doorway shown in the Findings of Opening Up Survey	5 – The section of wall affected was a doorway to the demolished section until the reconfiguration of the 1960s. It adds to legibility of phasing by drawing attention to how the late Georgian section would have been accessed
6 – Fit enclosed shower cubicle with services to newly former shower room	6 – Minor impact on heritage components such as ceiling penetration

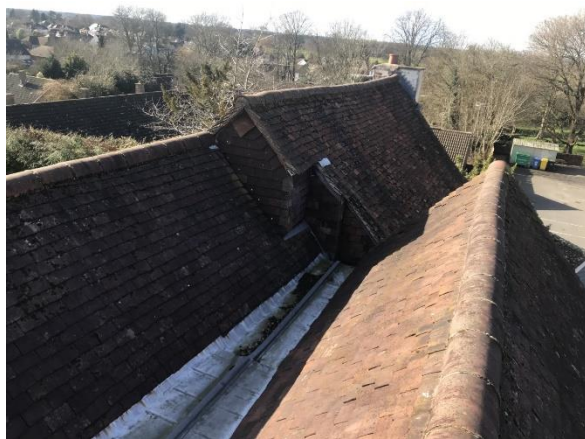
Roof as existing

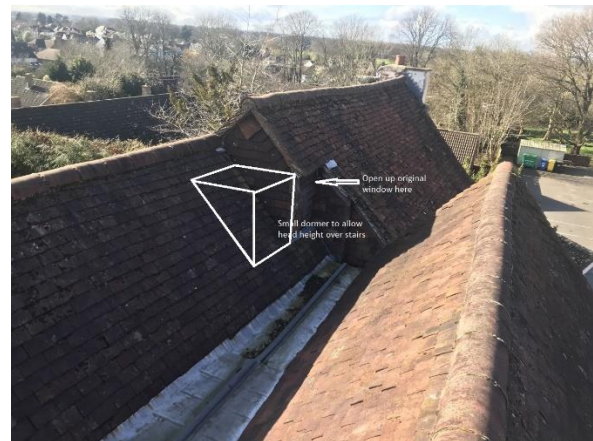
Indicative size and location of small dormer to allow head height over stairs to loft

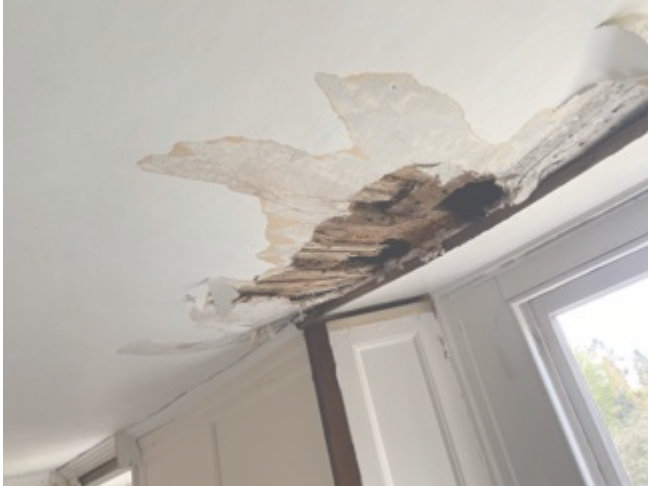
An existing primary Oak beam floor and roof support to the first floor ceiling of the rear extension is in a heavily degraded condition. Refer to the Structural Surveys for further detail. We have asked the current incumbent to temporarily prop the beam end (support from below) until these essential repair works are carried out. The beam itself looks to have its bearing above a window, over a window lining with no apparent original, robust support such as a lintel. We recommend strengthening this degraded beam, from above and strapping this beam end to a new steel beam over, with the following rationale and approach;

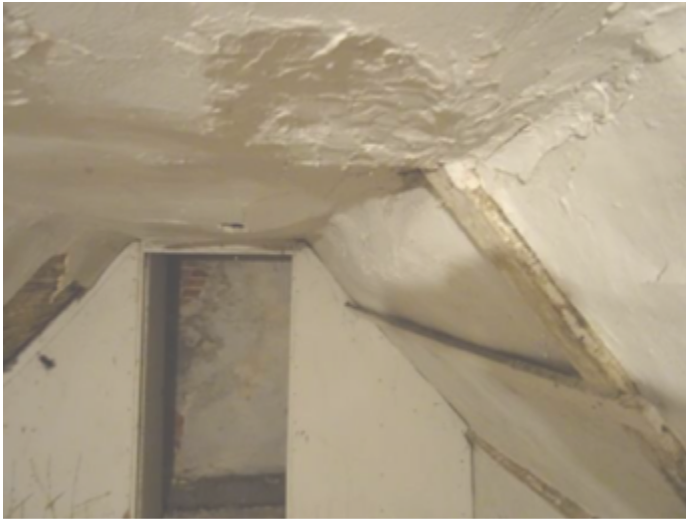
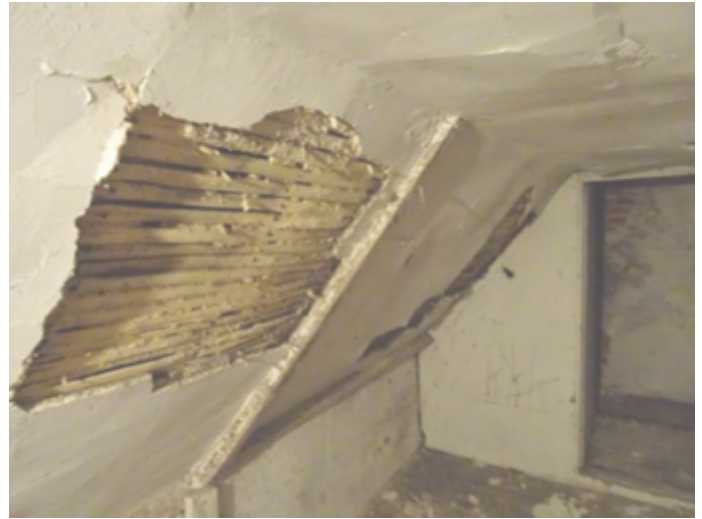
The proposal seeks to install dormer windows into the plane of the roof, behind the parapet. New timber framing works to be installed alongside the existing retained rafters, also themselves supported from the new steel beam. From which the covering fabrics should then be reinstated.

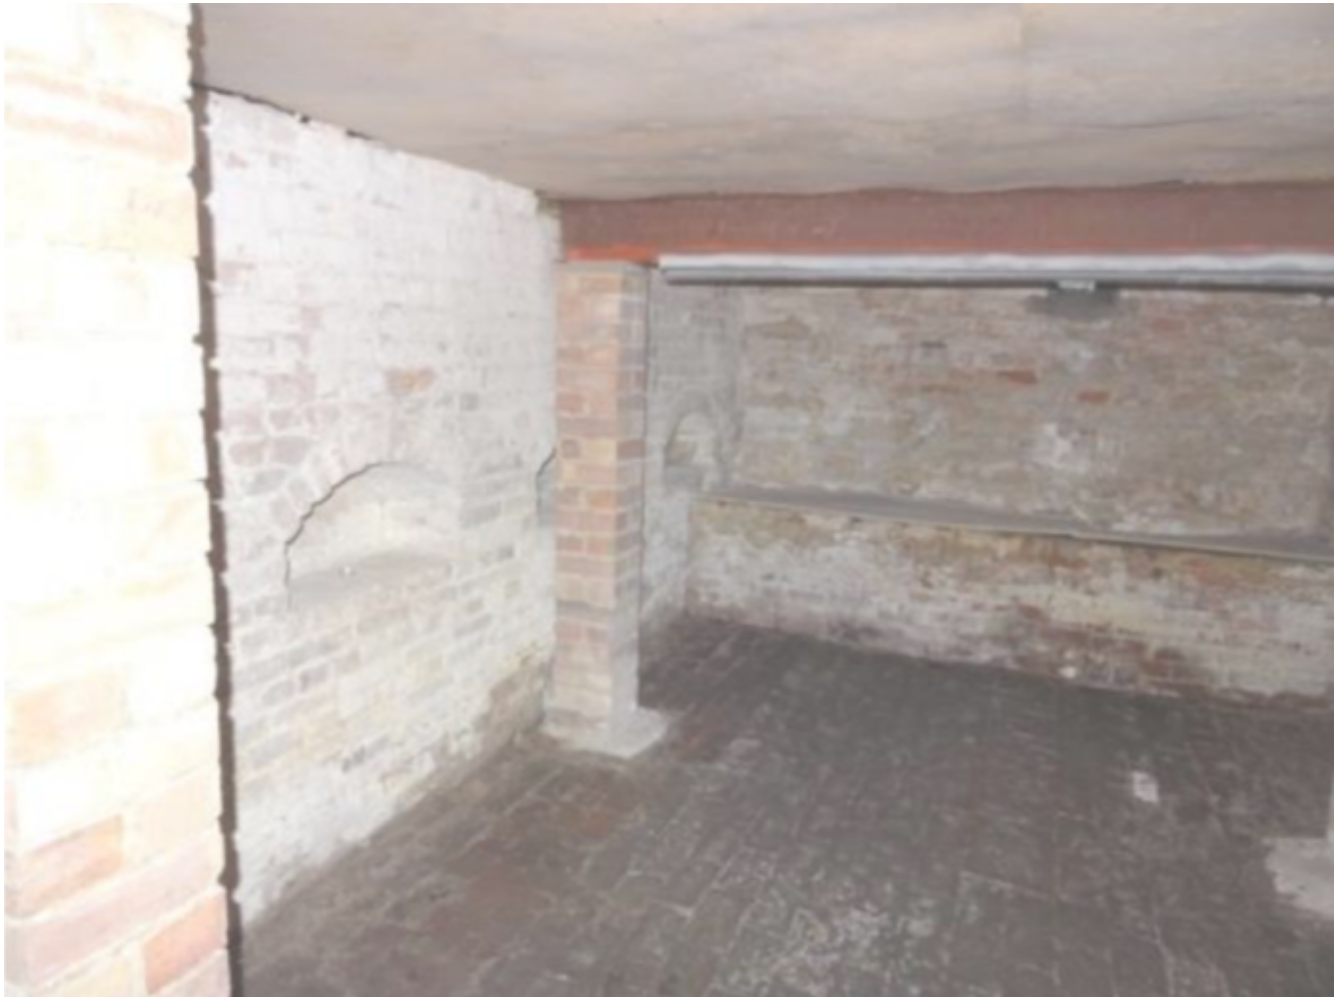
The intention is to reduce the level of the current brick lined basement floor to achieve a comfortable floor to ceiling height, through localised low level underpinning of the perimeter walls.

The new floor would include dpm, dimple sheets on the wall. No insulation would be required on the floor due to inherently stable ground temperature.

From conservation point of view, the existing perimeter basement walls will be preserved through the approach to underpin. The detracting modern brick piers will be removed and the floors strengthened to suit. The only loss of fabric will be of the existing brick floor tiles on their replacement with a reinforced concrete slab, which the conservation specialist noted that the brick floor was of minimal value.

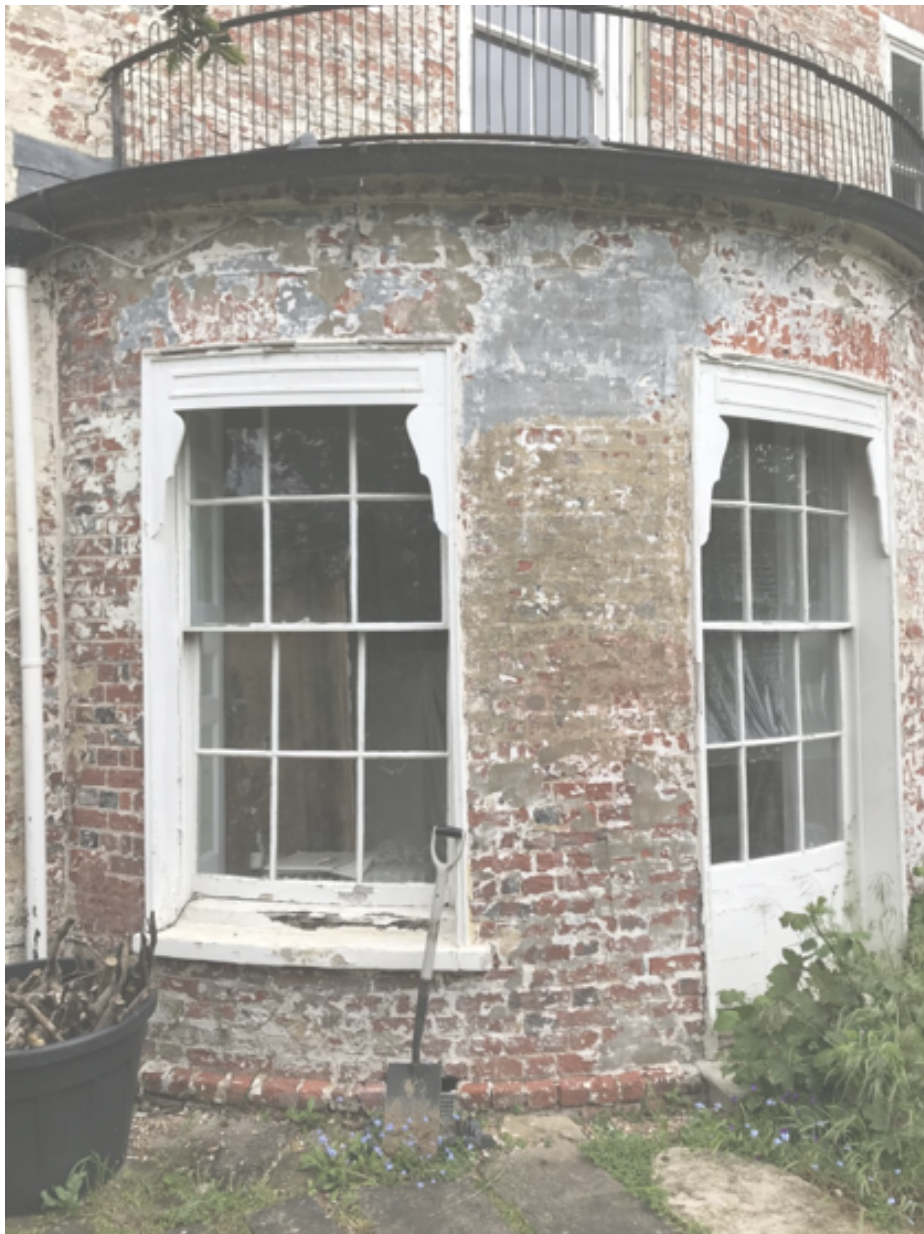
A previous Listed Building Consent has permitted the stripping off of non-breathable paint applied finishes to the external brickwork. On this central pier of the bay window a previous cementitious repair render had also been applied under the paint. The consented methods were not able to successfully remove the cement. As such, the next stage of progression is to look to locally remove the damaged bricks for either individual cleaning and reinstatement or their replacement. It is noted that the original lime mortar is soft and easily removeable.

An initial exercise has been to carefully excavate a trial pit alongside the foundation to assess the existing depth and whether there had been any localised settlement, hence whether underpinning was necessary as a first exercise. The existing foundation of the bay is a brick corbelled footing at circa 500mm depth, which is sufficient to suggest that it is not the foundation of the bay creating a potential settlement problem.

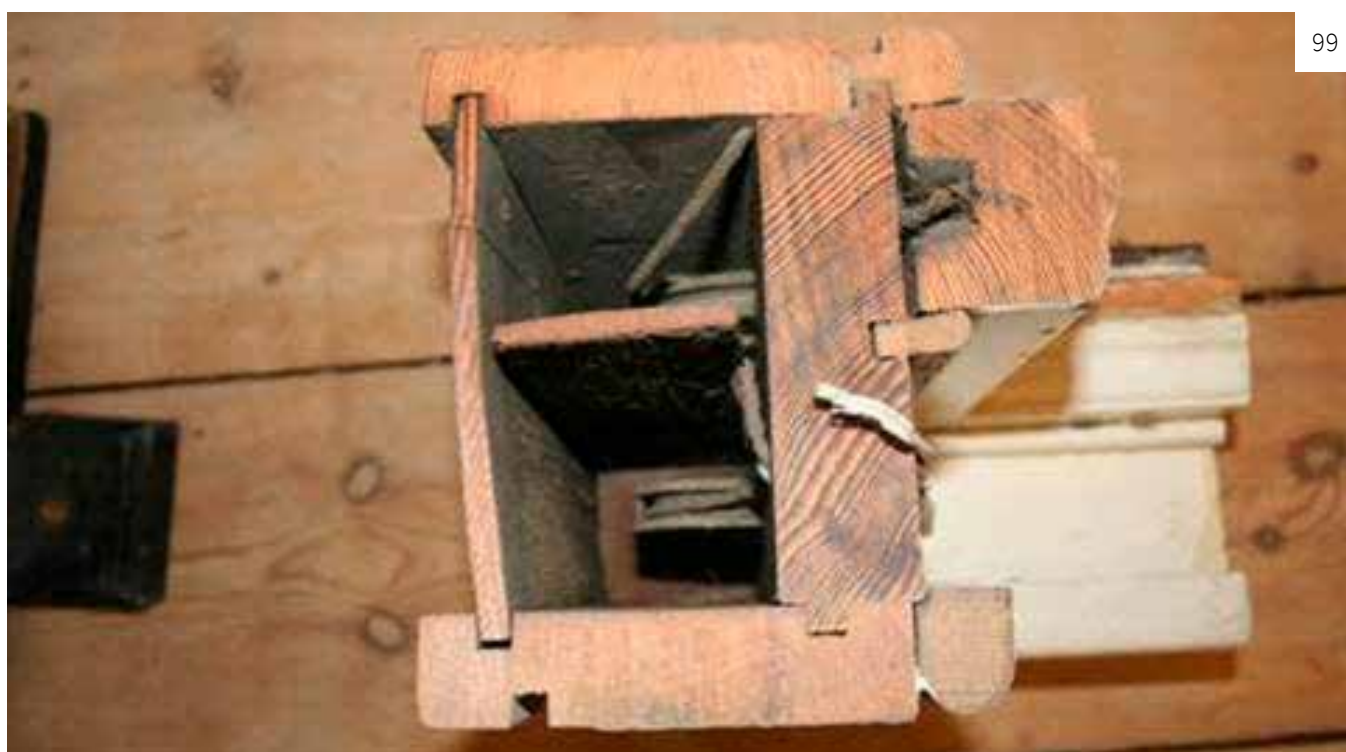
Image 99

This section through a sash box shows the high quality of the timber used during the 19th century.

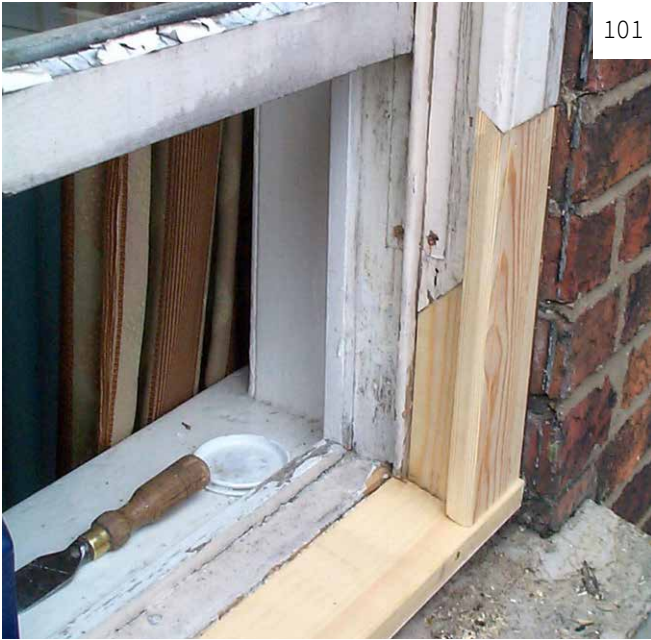
101

- 101. Decayed timber at the base of the pulley stile, the outer lining and the exterior of the cill has been cut out and new timber inserts have been pieced in.
- 102. Careful piecing in of new timber has saved this window whilst retaining as much historic fabric as possible.
- 103. Splicing in new timber
- 104. An example of skilled joinery repair in the workshop where the central mullion and cill have been replaced.
- 105. Metal angle brackets are one of the least invasive ways of reinforcing damaged timber casements and sashes. They are more obtrusive than carpentry repairs, and should therefore be positioned on the interior of the frame, but they have the great advantage that the glass does not need to be removed to make the repair.
