Trewin Design Partnership

Building Survey of: Barn at Great Tregastick,
Widegates,
Looe,
PL13 1PZ

For: Mrs S Rowe
Prepared by:- DAVID TITHECOTT DIP SURV MRICS MBEEng
CHARTERED SURVEYOR
Date: Wednesday 6th October 2010
Weather: Dry and Sunny

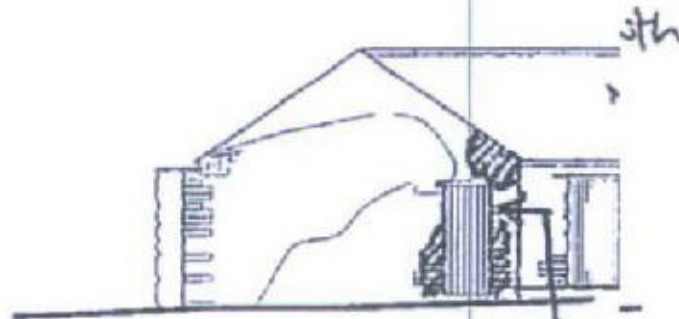
North East elevation 1:100 at A1

REP
of
ST

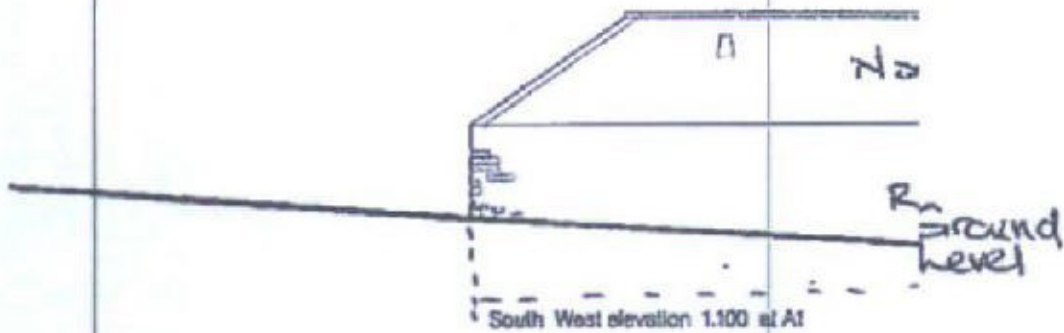
South West elevation 1:100 at A1

R_g
ground
level

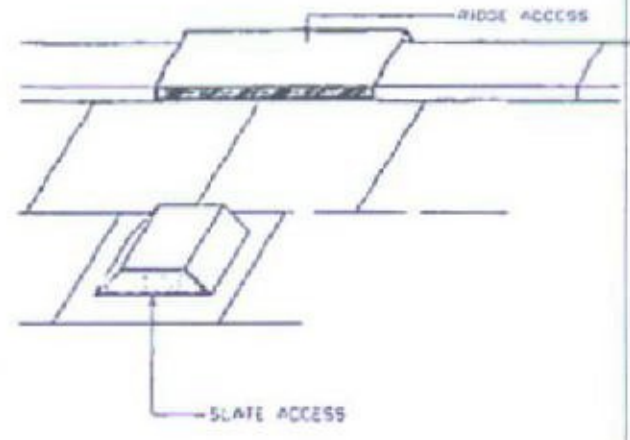
Typical Bat access to roof - not to scale

For most species of bat only small holes or slots are needed and this helps to prevent bats from nesting. A gap of 20mm wide by 50mm long is often adequate. The ideal position is between the soffit & the wall.

Unlike birds bats can land on a vertical wall and crawl up through a gap to their roost behind the soffit or in the roof. A rough surface is essential for the bats to grip on.

Building regulations specify that roofs be ventilated which is essentially achieved via the soffit. This in turn allows adequate access for bats to be installed at the same time. Other suitable locations for access are at gable ends, under lead flashings or any gaps between tiles & slates.

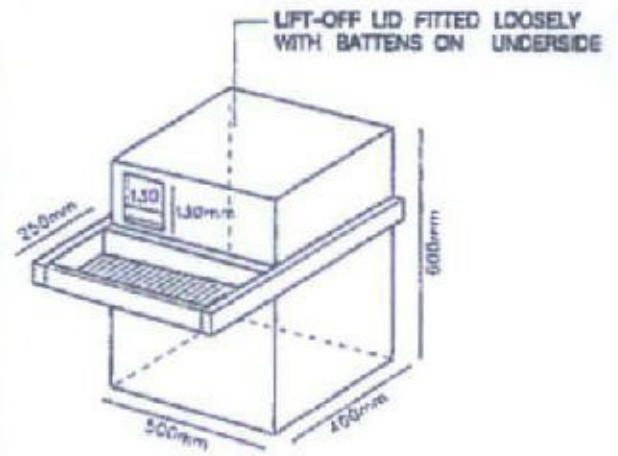
INDOOR NESTING BOX not to scale

BOX TO BE CONSTRUCTED USING 9mm CANADIAN OR SCANDINAVIAN SOFTWOOD PLY (CDX) AND BATTEN AS NECESSARY
