1 Cavendish Square, London

## 03. Historical Background

## 04. Design Evolution

## **04.** Design Evolution

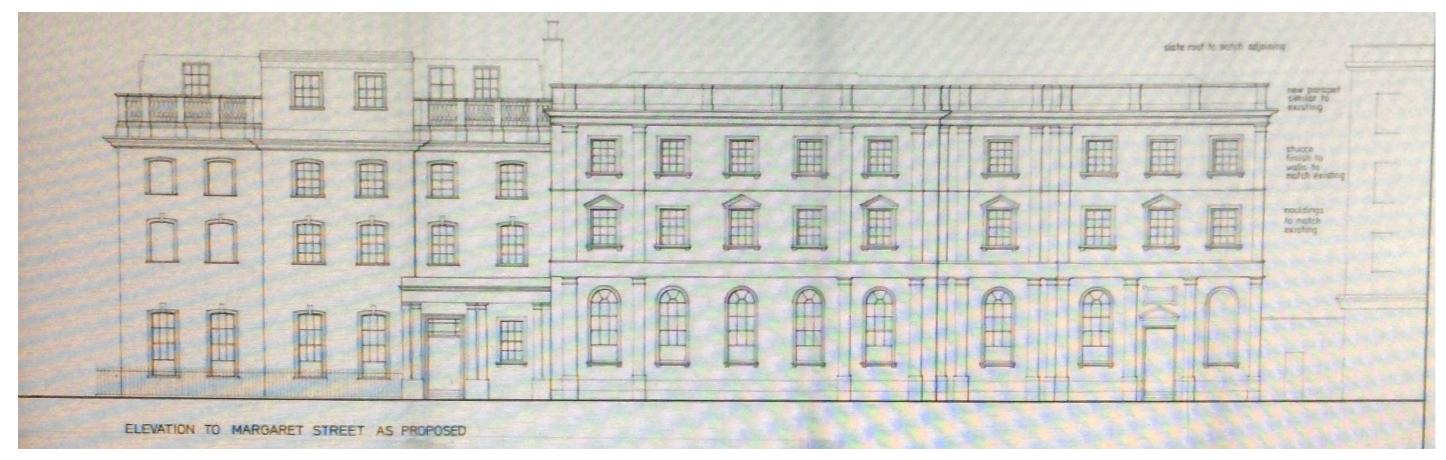
Approved two storey extension, internal alterations and change of use approved in 1991. Source: Westminster Planning Archives

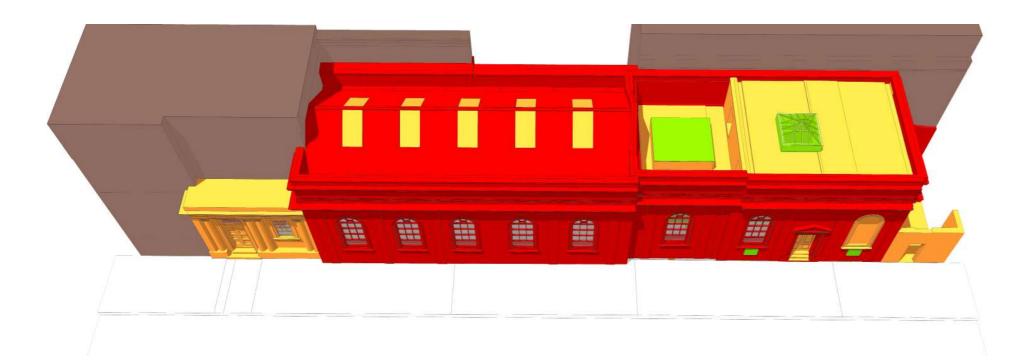
#### Sectional view through Pitched Roof

# Of no significance/ detriment Moderate/Neutral significance Of historical significance Other buildings Lead covering (green) but hidden skylight of moderate importance

#### Roof

The pitched roof is historic, although skylights have been infilled and ventilation stacks removed. This application does not propose to alter any of the historic fabric of the roof.

The central skylight is in a historic location, but is not to the original design and is now concealed by a lead finish and hidden within a false ceiling. However it does have some merit and consideration has been given to its retention and refurbishment for reuse within the proposals.

The eastern roof level has been altered and the eastern skylight is likely to be post war.

No design alterations are intended in the roof space.

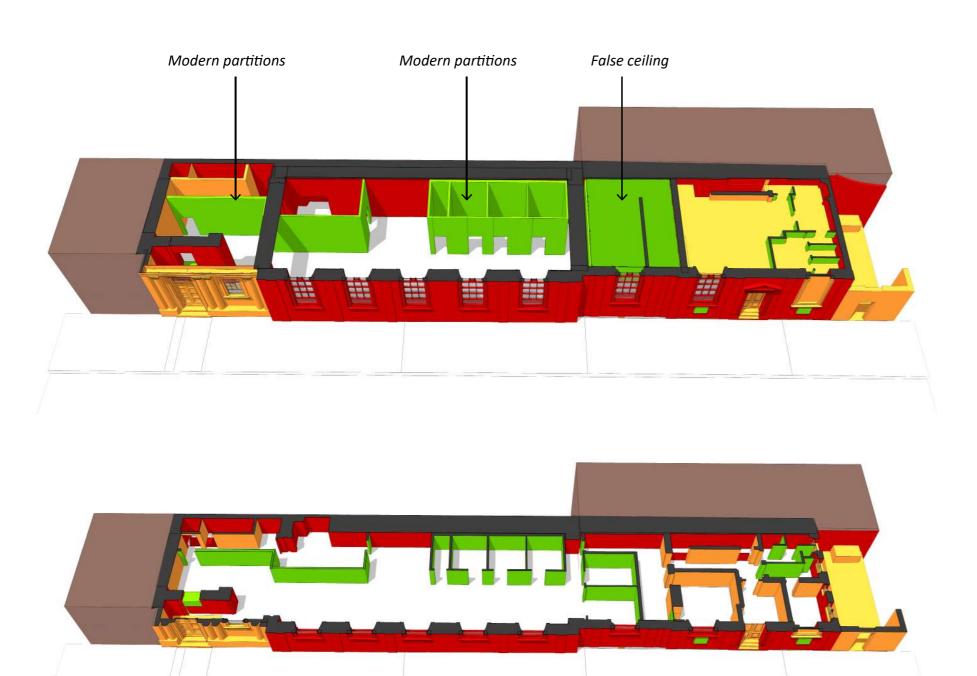
#### Section view through main hall

The main hall contributes as the most important internal feature and to the overall character of the building. Modern stud partitions necessary for use as a bank have altered the proportions and character of this space. It is intended to remove such partitions and reinstate the grand space.

A false ceiling creates a service zone and hides the skylight within the banking hall's eastern extension. This also cuts through the double height arch window. The significance of both the double height window and the skylight are lost with this false ceiling. It is intended to remove all false ceilings and reinstate such significant features of the building, where possible.

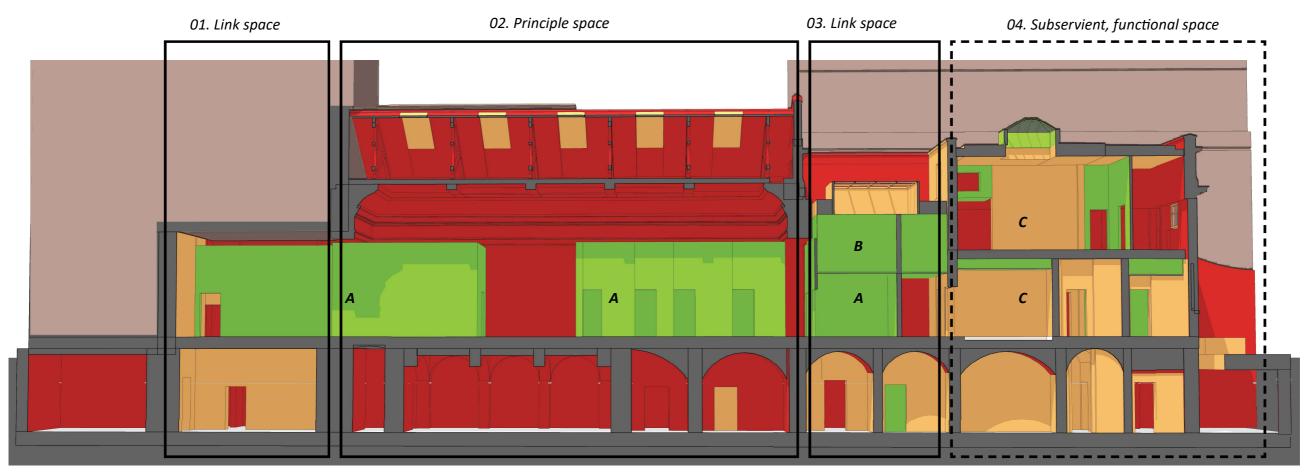
Long Section through building

## Removal of Detrimental Fabric

Removing the modern/ detrimental elements (green) provides the first step of the design intent and has great benefit in reinstating the historic significance of the primary areas of the building. In accommodating the change of use for the vacant building a compromise will need to be carefully integrated to allow function to necessitate.

The building has been designed and extended so that the principle space is served by two wings which provide circulation/ link areas. This sequence is important in the historical function and sequential layout of the building and the principles of such will look to be retained in new proposals. The east wing is an additional, functional space. It is subservient to the principle public areas, allowing the building to perform in its use. It is of less aesthetic significance than the other three spaces. The link spaces allow lateral and vertical movement from the street, basement and upper levels.

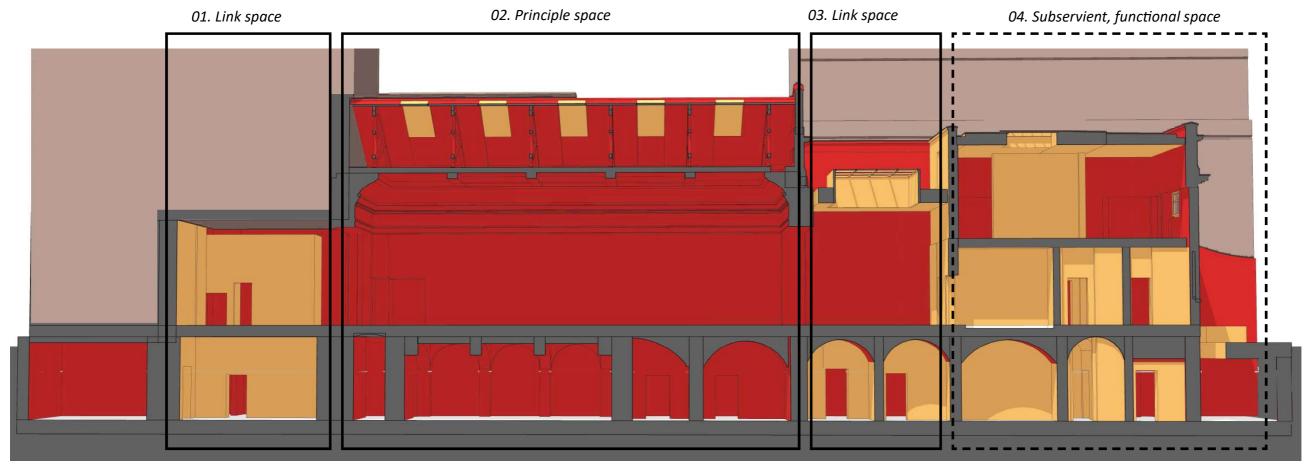
Long Section through building

Insertions

In terms of hierarchy all spaces will perform to reflect their historical function and significance;

The main hall will be the principle dining space, the circulation space and buffer space to the east side provide vertical movement throughout the building (with the skylight to be relocated at higher level to again bring light down through the height of the building into the extended eastern end of the main hall) and the subservient functional space will provide the Kitchen/ service functions at lower level and secondary seating at higher level.

New floor levels provide effective use of the space to accommodate restaurant covers.

The existing skylight (hidden within the false ceiling) will be relocated at a higher level, reinstating the historical use of this space as vertical circulation. A retracted void space between mezzanine and first floor will allow plenty of natural light to fill the spaces and the double height arch window to be reinstated to its full appreciation reflecting the verticality this space would have originally provided.

The stairs will continue into the basement, where it has been carefully placed to be introduced centrally within a single vaulted space, the opening of which will be increased to its full extent. The vaulted ceiling will be retained.

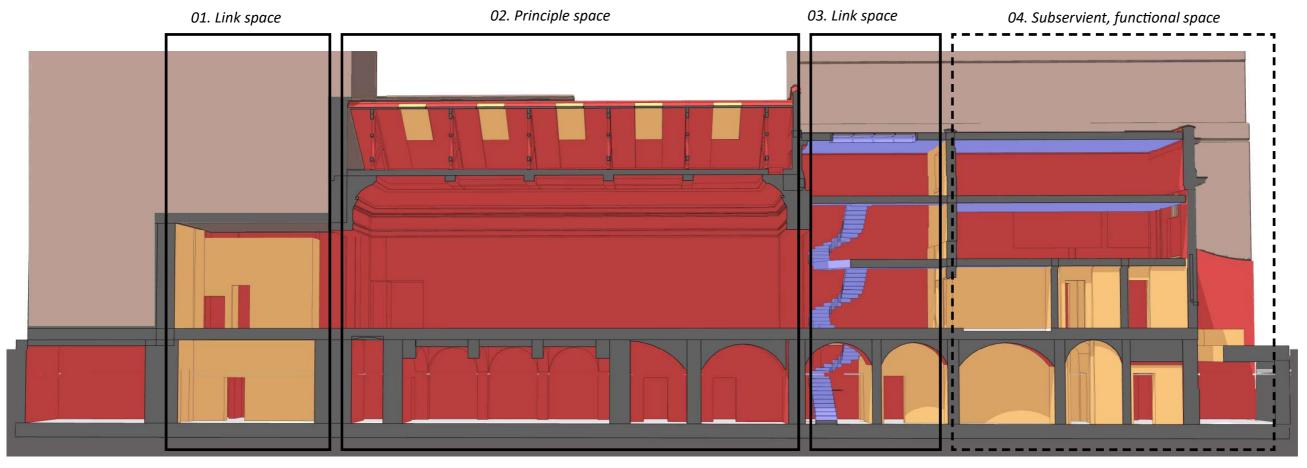
Long Section through building

## Design with Heritage Assets

The designs to this point have stripped back the detrimental fabric and have allowed for new carefully designed and discreet insertions.

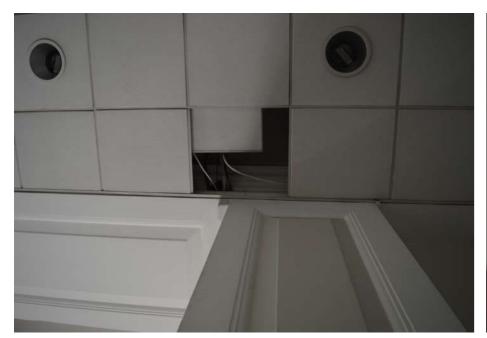
A: False ceiling with cornicing hidden (looking up)

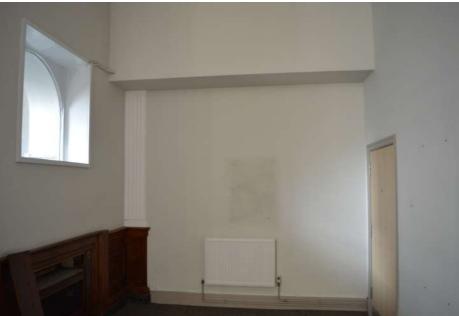
B: End wall infilled to separate properties

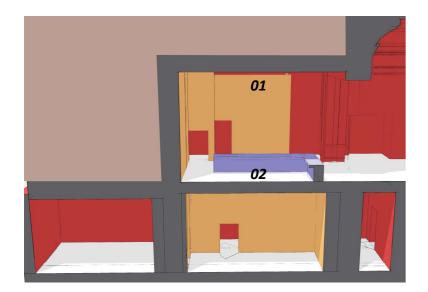
Integrating a feature bar/ buffer space

#### 01 False Ceiling removed

This exposes original cornice detailing which will be repaired and reinstates as necessary.

#### 02 New Bar

A new bar space is proposed at the top end of the hall to serve the main restaurant space

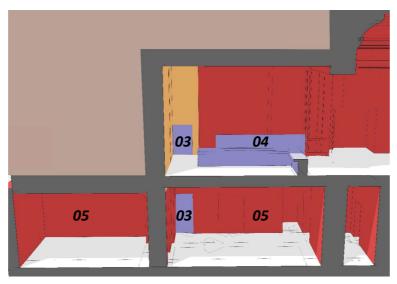
#### **Enhancement of Spatial Qualities**

#### 03 New cupboard doors to match

The redundant service lift will be removed and new cupboard doors to match the main hall will be added

#### 04 Glass Balustrade

A glass balustrade will replace the 1927 stud partition wall, allowing for the stairs to provide a more tangible link down to the lower areas and for more natural light to filter into the space below.

#### 05 Separating walls removed

The separating walls (added 1927) are removed to reinstate the original room proportions of this basement area.

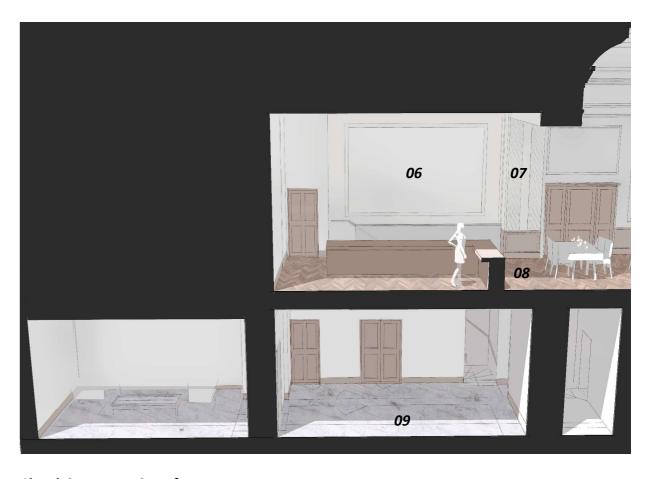
#### Sketch interpretation of space

**06** Wall molding detailing to match main hall

**07** Pilasters unaltered or restored where necessary

**08** Parquet flooring extend through into main hall

**09** Stone flag floor reinstated and extended as necessary within lounge seating areas

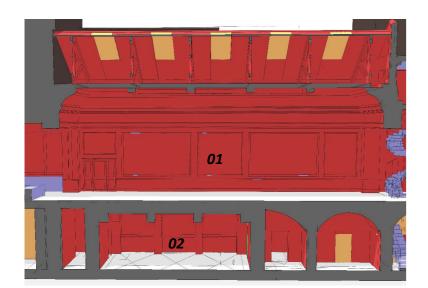
Stripping back to historic elements

#### 01 Restoration of detailed elements

Removing the modern partitions will reveal the deteriorating wall paper lining, plaster, molding, dado rail and skirting details. These will be repaired and restored to match adjacent materials, so their value is reinstated to the space.

#### 02 Restoration of Vault space

The main vault, used for banking storage purposes, has an enchanting character which adds to the heritage of the building. This will be restored and seating will be carefully integrated so that it becomes one of the primary spaces in the proposals.

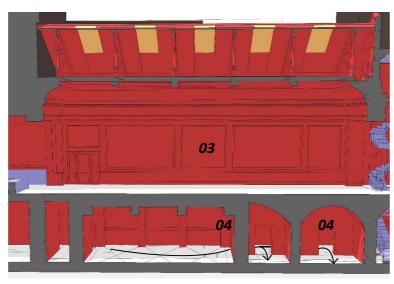
Stripping back to historic elements

#### 03 Main Restaurant

The merits of the primary space are in its historic proportions and detailing. These will be carefully reinstated. No intervention, apart from repair works and reinstatement of the historic detailing, is proposed in the main restaurant space.

#### 04 Historic Openings

Reintegrating the historic plan is not only a benefit to the historic significance of the Listed building, but also allows sufficient circulation and use of the vault spaces.

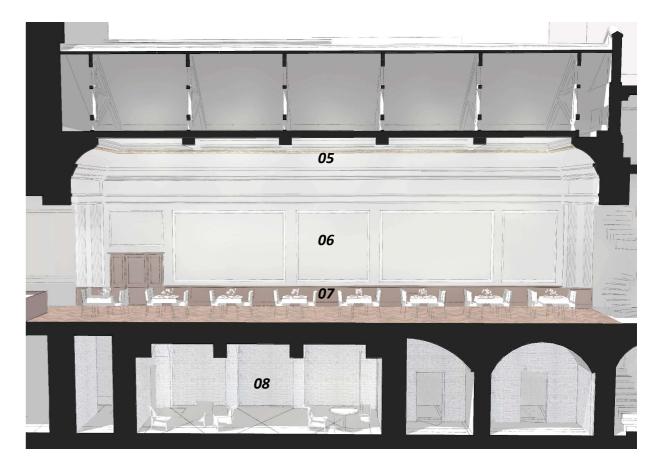
#### Sketch interpretation of space

**05** No changes, bar any repair works, to the cornicing and ceiling details

06 Reinstatement and restoration of wall moldings, plaster, dado rails and skirtings

07 Reinstatement of Parquet flooring

08 Vault spaces restored and integral to character of the new use.

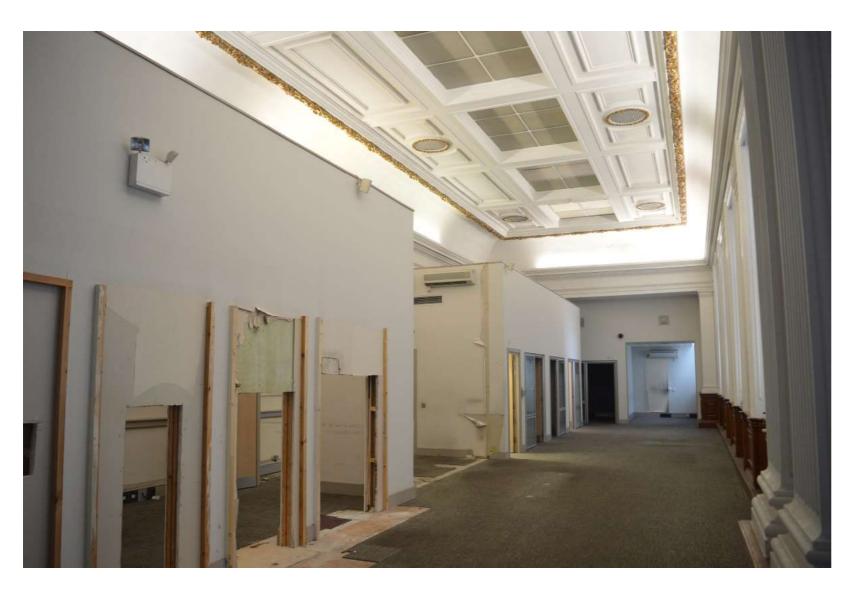
#### **Principle Hall**

The ornate detailed elements to the principle hall date back to 1927.

However, further modern stud partitions and rooms have been added throughout to allow the bank to function to modern requirements. These modern partitions have altered the proportions, scale and character of the principle space and have damaged some of the walls, lining, plaster, moldings, dado and skirting rails. Removal of the modern partitions will reinstate the grand hall and careful repair and restoration of the hall will reinstate its historic detail and character. The ceiling will remain unaltered.

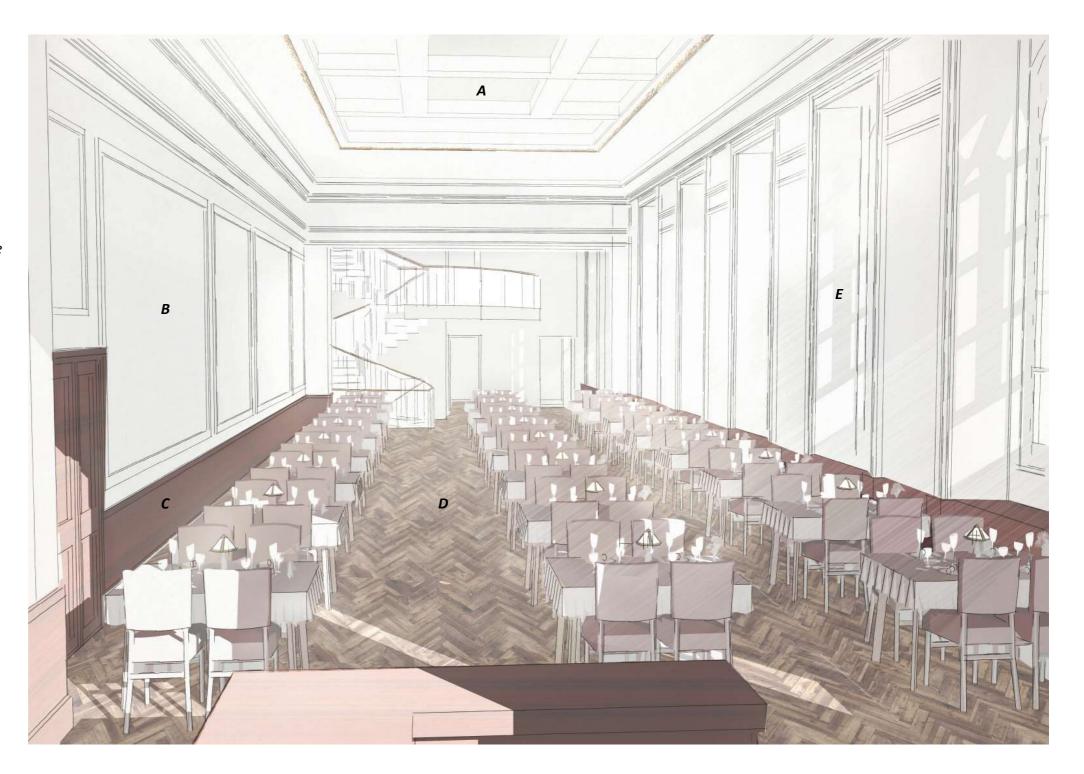
#### **Positive Contributions**

#### A Restoration of ceiling detail

The existing ceiling detailing will be carefully restored. The existing fluorescent back lighting will be replaced by modern LED, daylight simulation lamps (detailing for lighting to be conditioned).

#### B Restoration of historic fabric and wall moldings

The historic walls, linings, plaster and molding details will be restored and reinstated into the space

#### C Wood panelling

The wood panelling beneath the arch windows will be reinstated through the main hall, creating consistency in design

## D Reinstatements of Parquet flooring

The parquet floor will be reinstated through the principle areas.

#### E Double height arch windows

To be restored

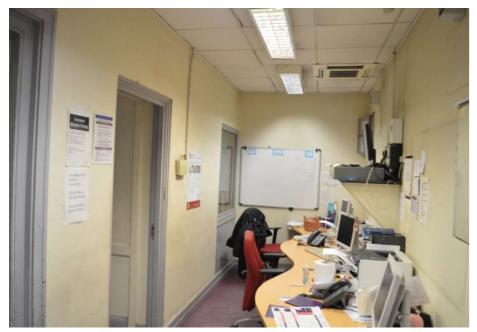
A: Offices area with stud walls and false ceilings

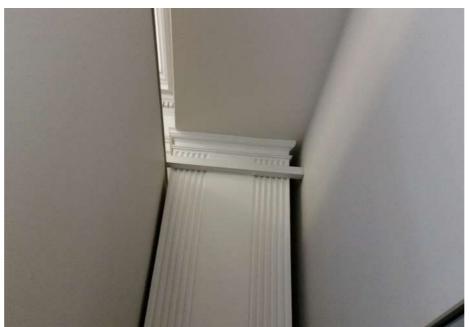
B: Pilaster sandwiched between stud walls

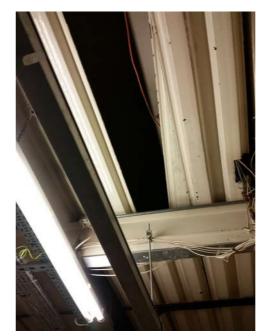
E: Service areas to vault

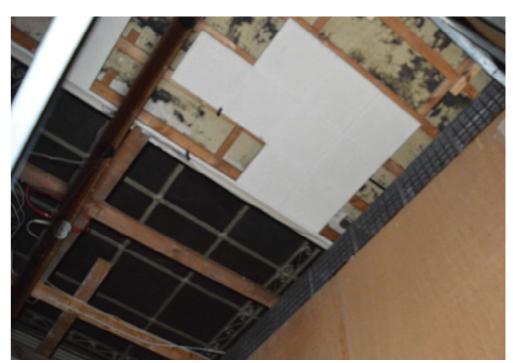
### Ceiling void rooflight

Within the false ceilings of this links space a skylight was discovered. The top of this (accessible from the external plant area) has now been covered in lead, possibly to prevent leaking into the spaces below.

Historic plans show that a skylight did exist in this location, emphasising the historic space as a double height area, the levels of which have been altered through time. Historic research however, shows that the original skylight was pyramid shaped and that this style of skylight was perhaps introduced in the 1927 renovation works. It is different to the much more modern and unsympathetically detailed aluminium skylight to the eastern most wing and, while it has remained hidden and enclosed, it has some historic value and character. It is our intention to restore and relocate this skylight, reintroducing its purpose to the building and providing natural light to the full height link space.

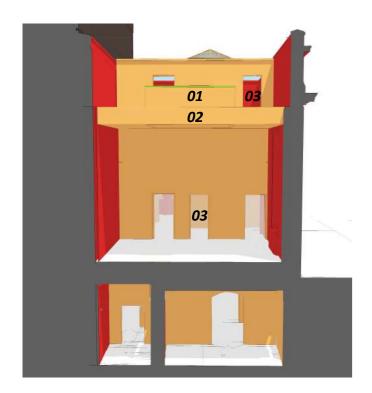
#### Stripping back to historic elements

#### 01 Concealed skylight

The skylight, which is present in the historic extended plans of the building (1873) but which has been altered in its design (post 1927) is concealed in lead

#### 02 Roof level

The roof level, which now hosts the external plant and services area, and which is concealed within a false ceiling

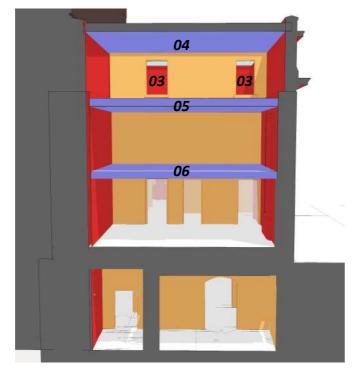
#### New floor levels

#### 04 New roof level

It is proposed to introduce a new roof level over this area, to allow the addition of an extra floor. The new roof level will be below the existing parapet level. It is evident from on-site investigations that alterations to the roof levels on this side have previously occurred

#### 05 New first floor level

The new level will be at the approximate level of the existing roof. Its design will be condensed so that it is structurally and thermally efficient modern requirements.

#### 06 New mezzanine level

A new mezzanine level allows effective and efficient use of the space

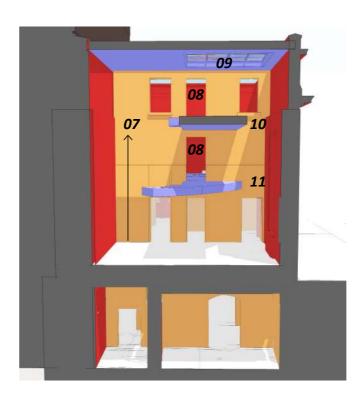
#### Sympathetic Design

#### 07 Circulation void

Pulling the floor level away allows for vertical circulation to be integrated.

**08** New openings to match existing ground floor

**09** Restoration and Relocation of existing skylight

#### 10 Retracting from facade

Pulling the floor away from the facade allows the double height windows and relocated skylight to be appreciated and fulfil their functions filling the spaces with plenty of natural light.

The space is enhanced and adds great benefit to the historic character.

At mezzanine level, the void is further exaggerated as the floor sweeps towards the main hall

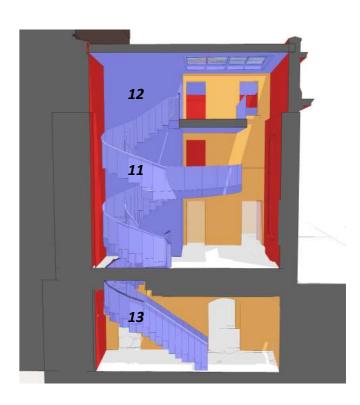
#### Circulation Core

#### 11 Sweeping stair
