PROJECT:  
 1 Cavendish Square  
 London, W1G 0DA  
 CLIENT:

DRAWING:  
 Proposed Demolitions  
 Detailed Proposals

DRAWING No.: E17-011 DEM003  
 SCALE: 1:100 @ A3  
 DATE: 15.01.18

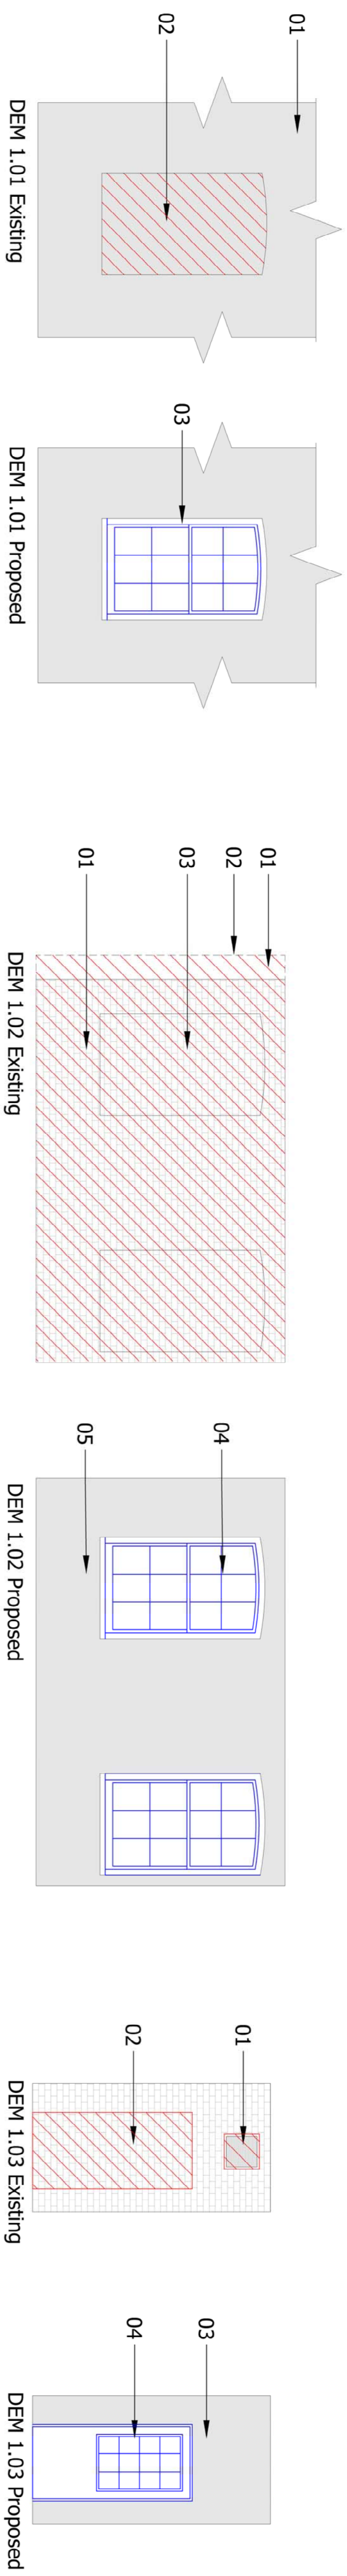
DEM 1.01 Existing  
 DEM 1.01 Proposed

01 White painted render external face of historic house  
 02 White painted render infill (1927) blocking up historic window  
 03 Reinstate historic window opening with timber sliding sash window to match existing in facade.  
 04 Reinstate historic window opening with timber sliding sash windows to match existing in facade.  
 05 Remove additional build up and reinstate historic room proportions and make good historic walls

DEM 1.03 Existing  
 DEM 1.03 Proposed

01 Existing M+E Grille  
 02 Modern brick infill (1927) of lightwell  
 03 White painted render finish to match external facade  
 04 New opening into lightwell, door detail to be conditioned

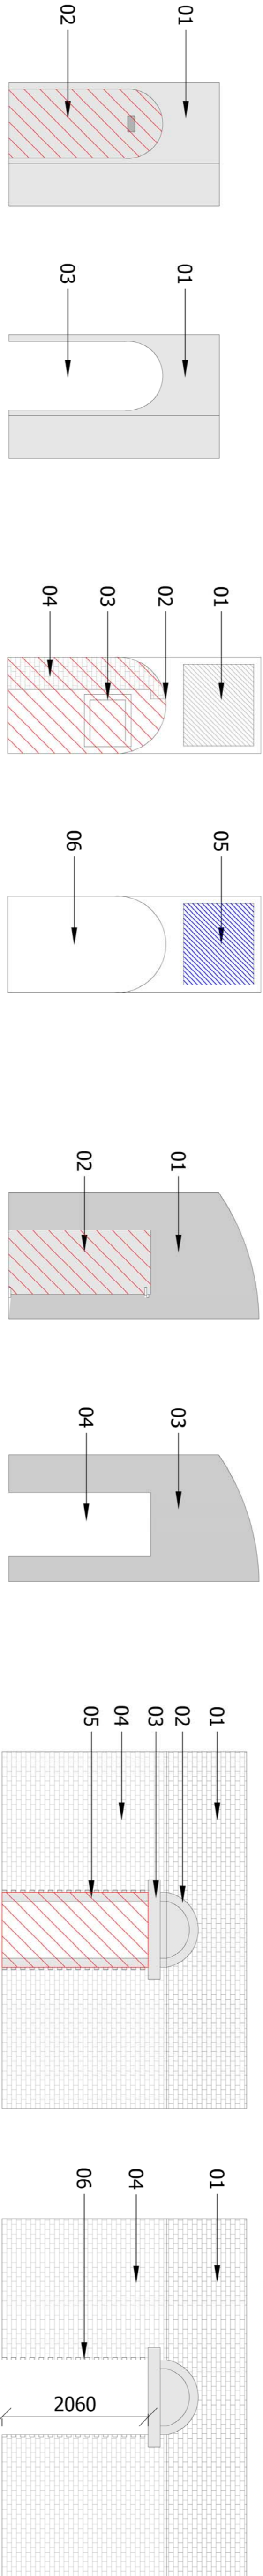
DEM 1.04 Existing  
 DEM 1.04 Proposed

01 White painted render finish of historic opening  
 02 White painted render infill (1950s)  
 03 Restored historic opening

DEM 1.05 Existing  
 DEM 1.05 Proposed

01 Services void  
 02 Vaulted Ceiling  
 03 Redundant Safe  
 04 White painted smooth brick infill beyond  
 05 New M+E services  
 06 New opening to allow adequate circulation and means of escape

DEM 1.06 Existing  
 DEM 1.06 Proposed

01 White painted render  
 02 Door fixed shut and painted over and bricked up to other side  
 03 Strip and repaint white to match  
 04 New opening in historic location

DEM 1.07 Existing  
 DEM 1.07 Proposed

01 Vaulted ceiling  
 02 White painted door arch infill  
 03 White painted Lintel  
 04 White painted brick  
 05 White painted smooth brick infill reducing size of historic opening  
 06 Reinstate full width of historic opening and make good

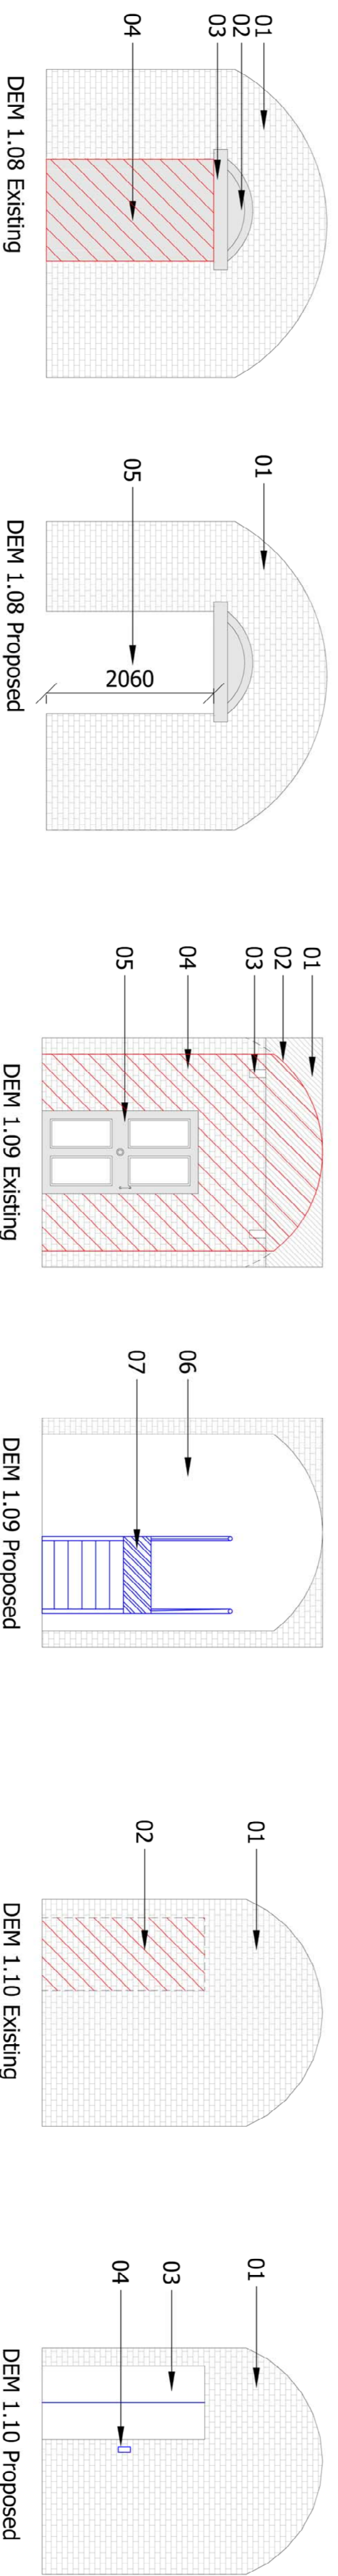
DEM 1.08 Existing  
 DEM 1.08 Proposed

01 White painted brick  
 02 White painted door arch infill  
 03 Steel painted Lintel  
 04 White painted smooth brick infill (1950s) of historic opening  
 05 Restore historic opening

DEM 1.09 Existing  
 DEM 1.09 Proposed

01 Services area to be removed  
 02 Line of vaulted ceiling beyond  
 03 Steel beams to be removed  
 04 White painted brick  
 05 Vault Door to be relocated

DEM 1.10 Existing  
 DEM 1.10 Proposed

06 Increase opening to meet vaulted space and to allow for new stairs  
 07 New feature stair to basement

01 White painted brick  
 02 Position of historic opening  
 03 Reinstate historic opening to accommodate new lift opening  
 04 New lift operating buttons
