DEM 1.14 Remove modern stud partition walls and reinstate historic proportions of main hall.

Modern stud partitions have been added throughout the years to assist with the operation of the bank. It is intended to remove these walls and reinstate the grand historic proportions of the main hall.

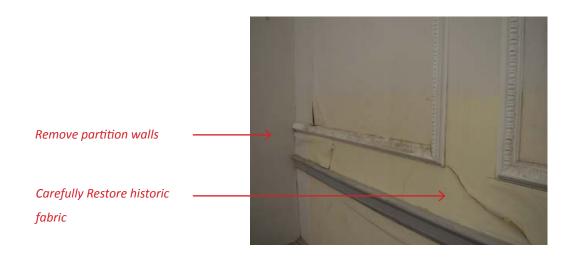
Demolition Plan (See DEM001)

Retain solid historic walls

Remove partition walls

Remove modern skirting and replace with new skirting to match main hall
