Design & Heritage Statement (incl. Statement of Significance)

Internal Alterations incl.

Sidmouth YMCA, Mill Street, Sidmouth, EX10 8DF

Revised July 2021

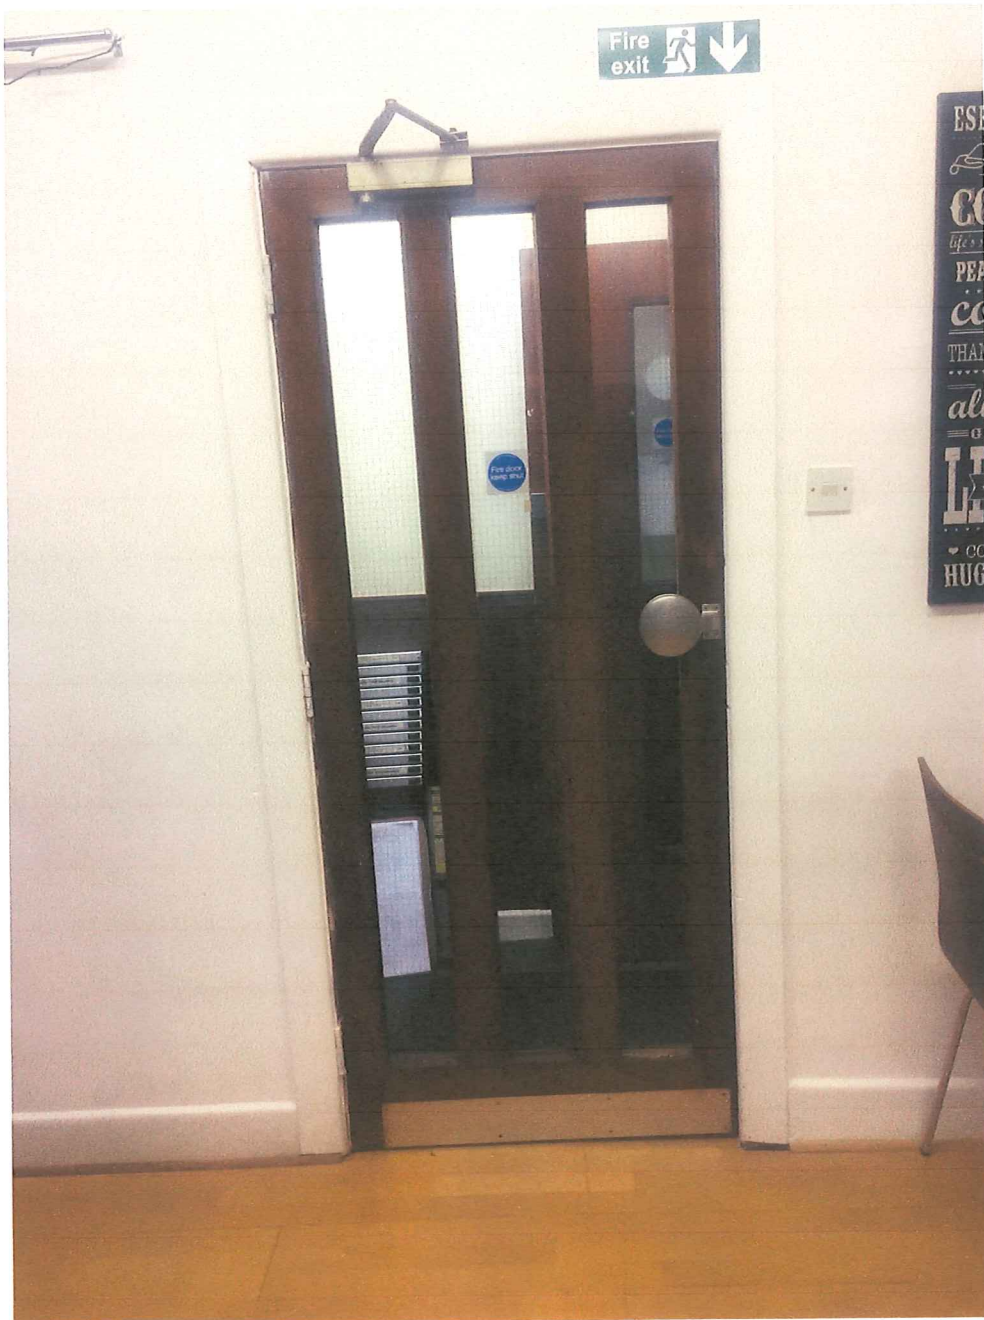
Fig 2 - Door D.2.

Door D.2 - Modern hardwood fire door with georgian wired polished plate glass. Partition within which door is set is modern (plasterboard and skim plaster) and skirtings and architrave are modern bullnose.

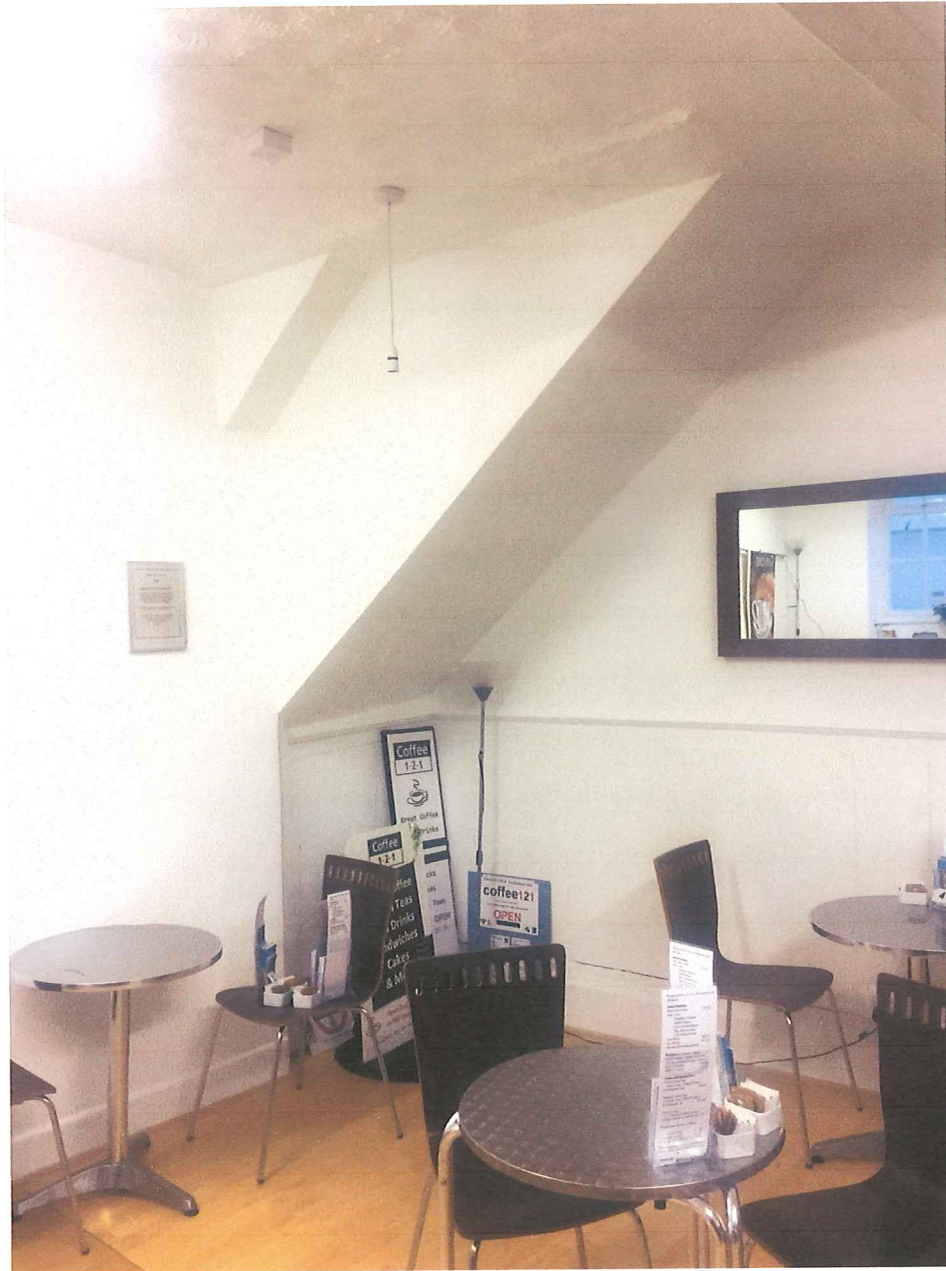
Fig 3 - Underside of Stairs

Partition on left is modern. Underside of stairs is clad with tongue and grooved boarding with 'bead' joint, overall board cover 165mm, refer to section on drawing 1132/21/07 and fig 4 over. Cafe ceiling is artexed, thought to be applied over lath and plaster. There are two early light hooks remaining in the ceiling, which would have no doubt been removed had the lath and plaster been removed? Wall to right is original wall with skirting, low level wainscot panelling and dado rail. See to section on drawing 1132/21/07. Also see fig 4 over page.

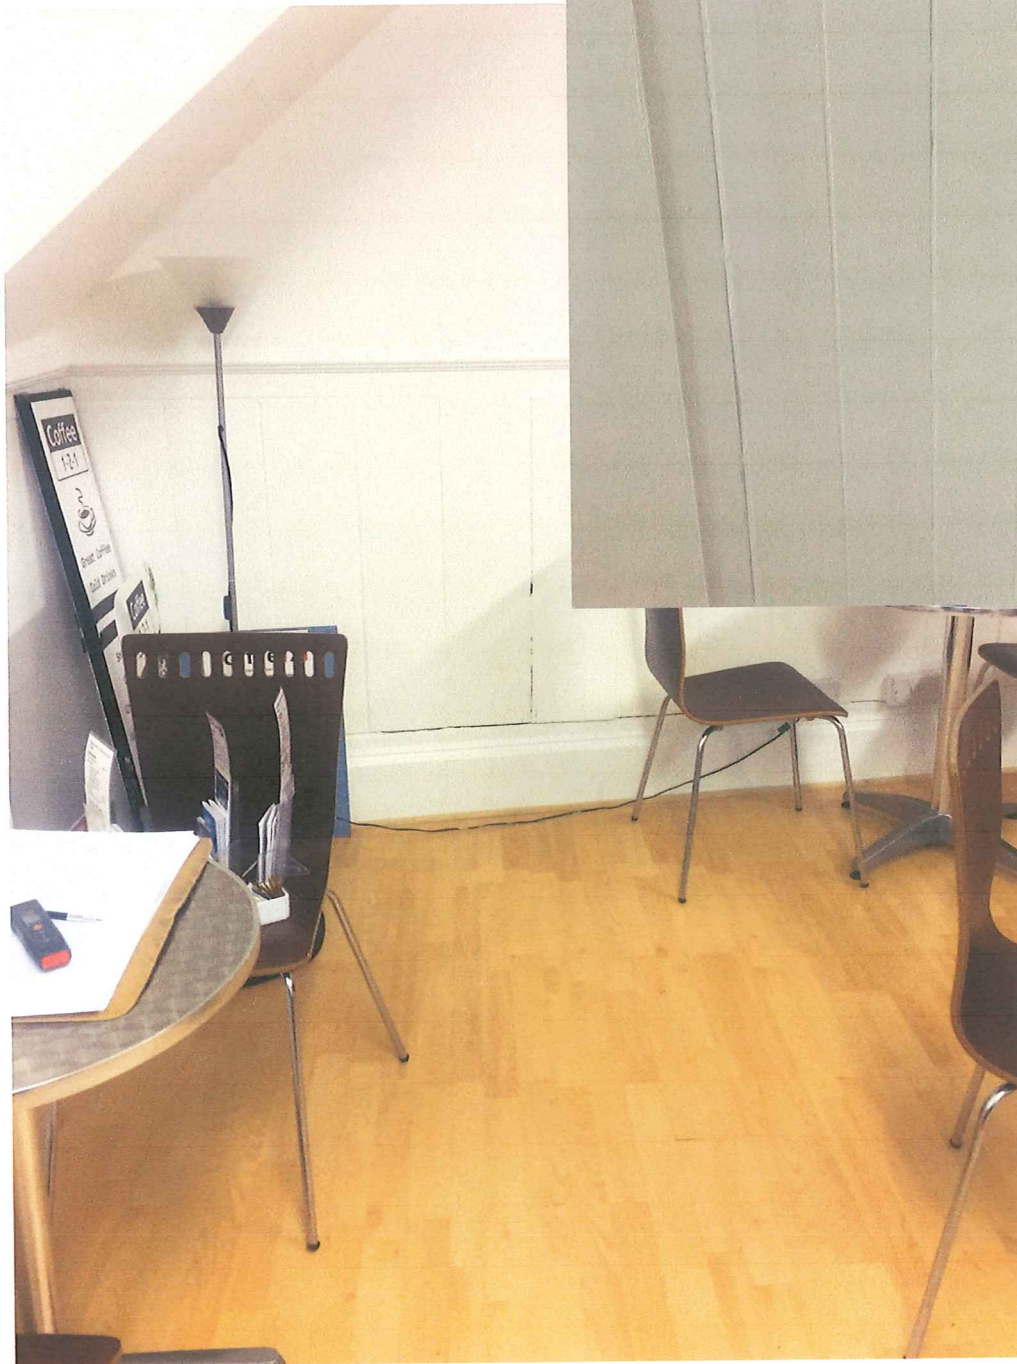
Fig 5 - Panelling, Skirting and Dado Rail in Cafe

Refer to section on drawing 1132/21/07. Wainscot board widths are 220 - 240mm. Boards have bead joint. For dado rail refer to drawing 1132/21/07 and type (i).

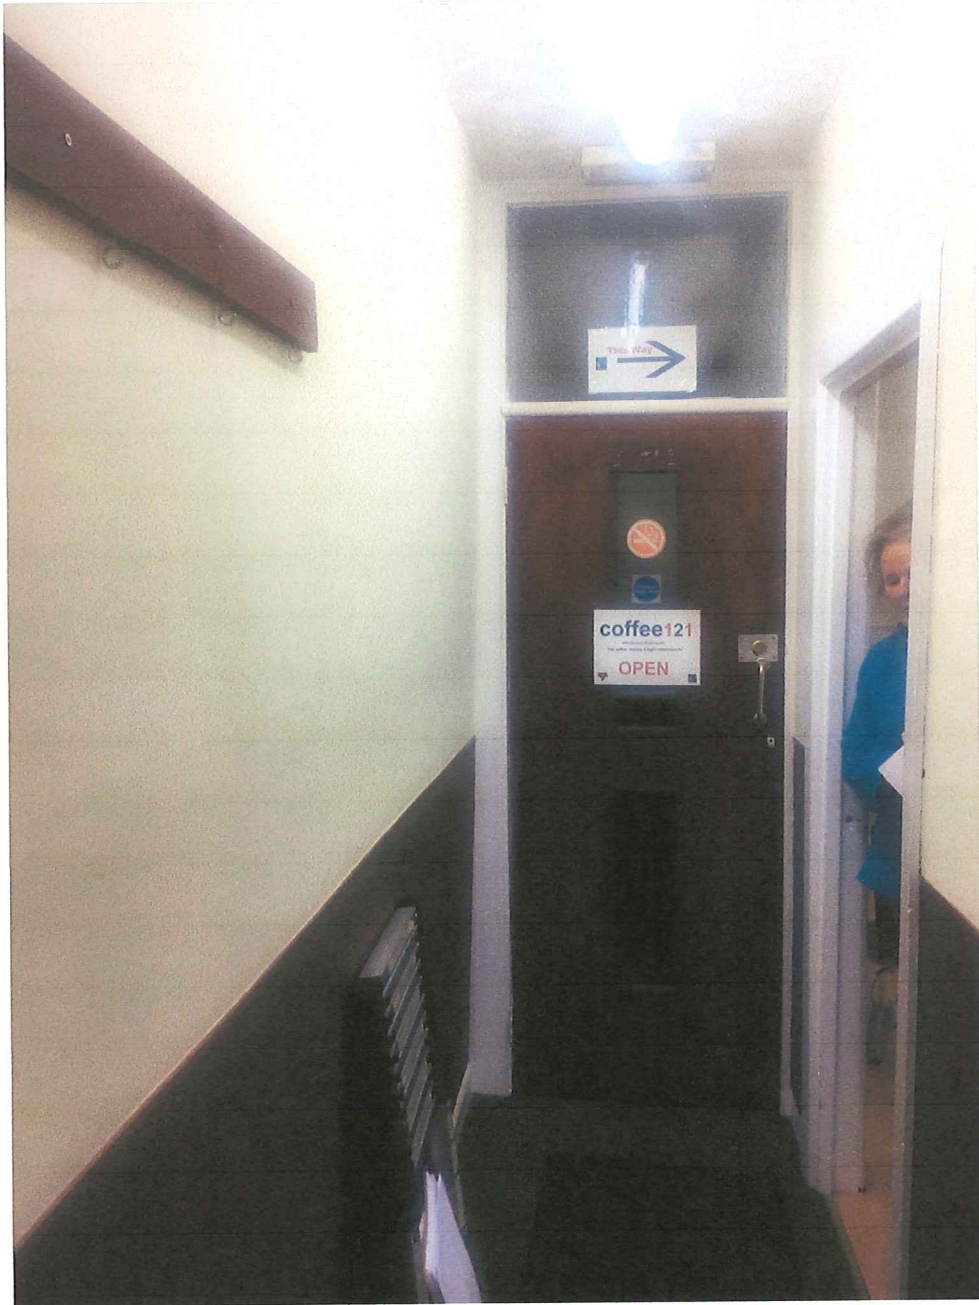
Fig 6 - Entrance Corridor

Doorway D.2 on the right and D.3. straight ahead. Architrave to door D.2 is modern bullnose, 20 x 95. Skirting in this area utilises the same size and profile. Door D.3 and frame is modern, as is transom glazing. Partition to left hand side is plasterboard and skim, dry lining with rubble stone wall (not plastered) behind. Walls either side of corridor are faced at low level with modern boarding. Ceiling has artex finish, however the ceiling is lower than the ceiling in the cafe and thought to be modern (plasterboard and skim plaster), suspended below the original ceiling.

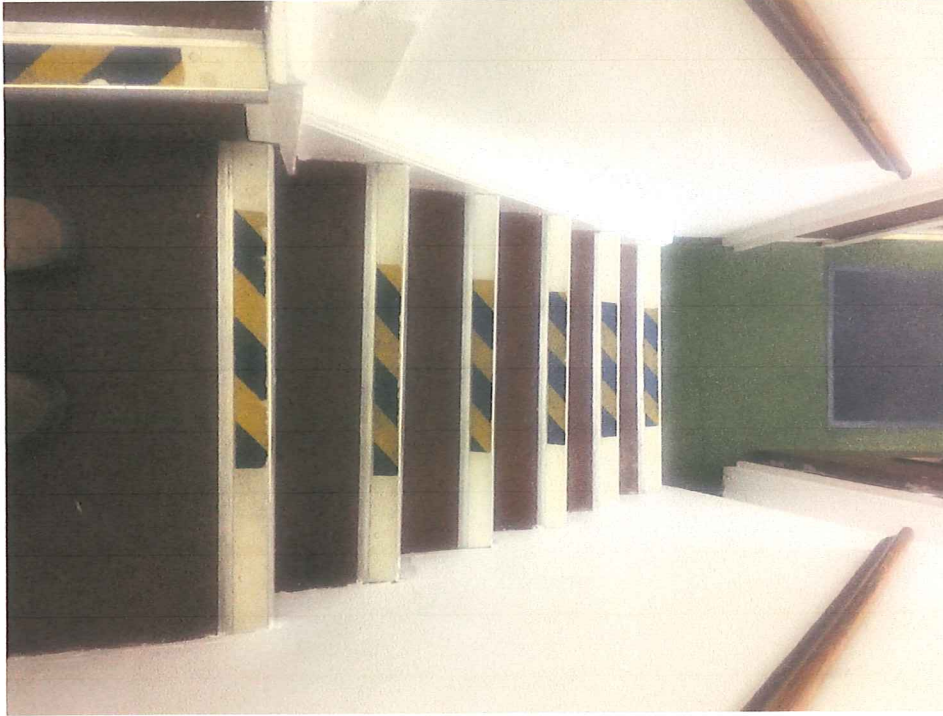
Fig 7 - Looking down stairs from Quarter Landing towards Door D.3.

Note that between the bottom step and the door frame (D.3) there is insufficient space. Wall facing to both sides of stairs consists plasterboard and skim plaster. Handrails are moulded in softwood and are certainly an older feature, thought to have been re-fixed from earlier wall finish. Refer drawing 1132/21/07 for handrail section (1:2 scale).

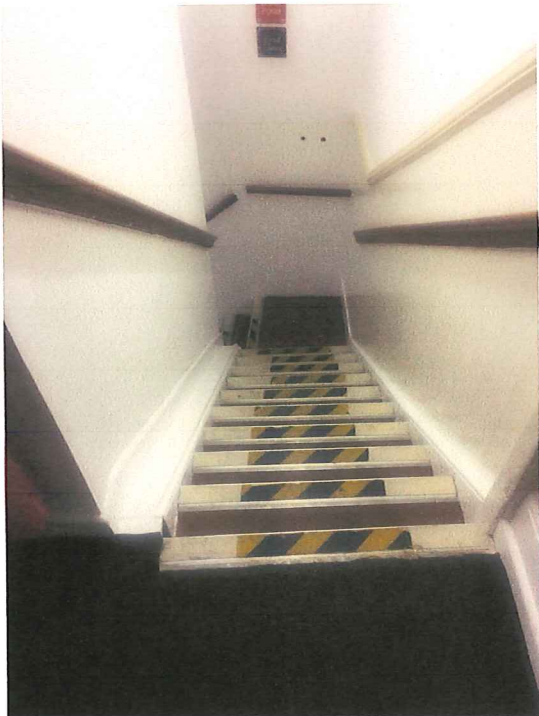
Fig 8 - Looking down stairs from First Floor towards Quarter Landing.

Early handrails either side of stair as noted above. Wainscot panelling, 142mm overall width boards with bead joint) to right side of stair with type (ii) dado rail as shown on section drawing 1132/21/07.

Partition to left is plasterboard and skim plaster.

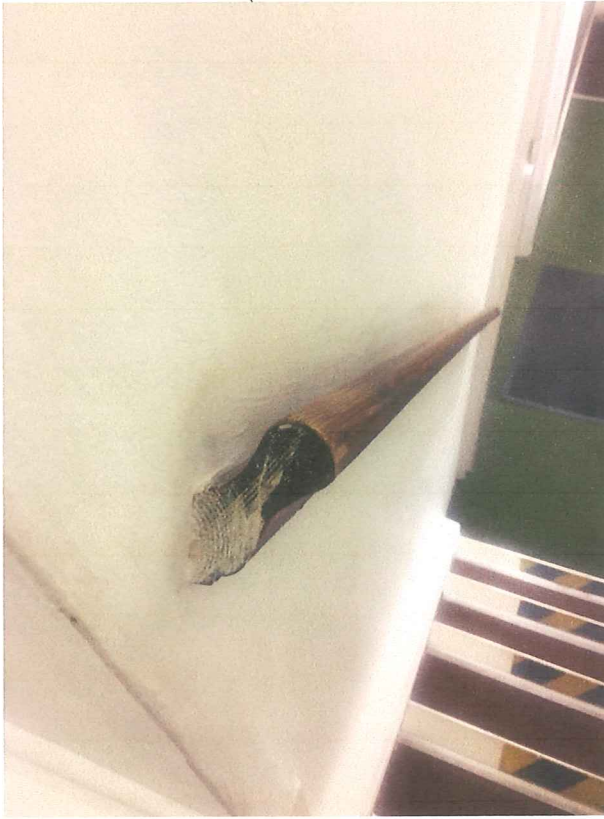
Fig 11 - Stair Handrail Section.

Refer to handrail section on drawing
1132/21/07.

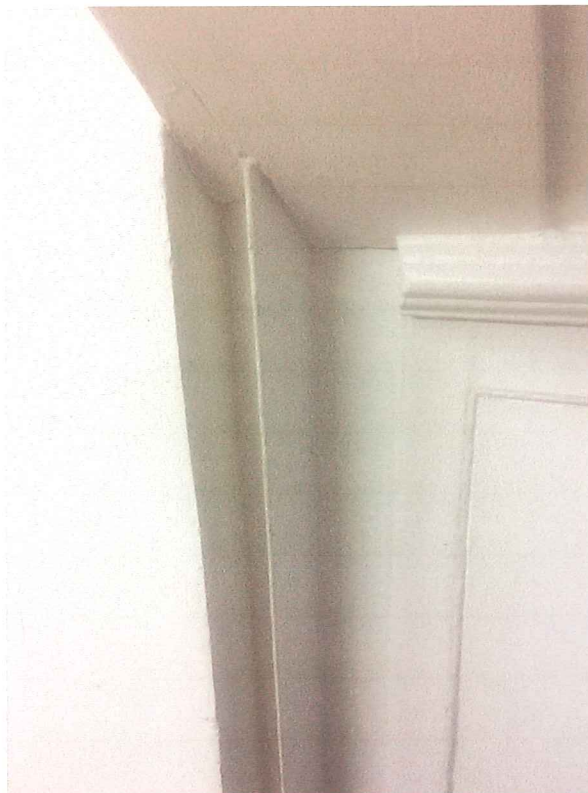
Fig 12 (a) Dado Rail in Cafe (under the stairs) and

Fig 12 (a) - Cafe Area (Ground Floor) - the wainscot panelling is framed, the frame having a simple bead detail. The vertical panels of the wainscot boarding are wide boards (220-240mm) with a bead joint. The bead detail has all but disappeared in the paint from many years.

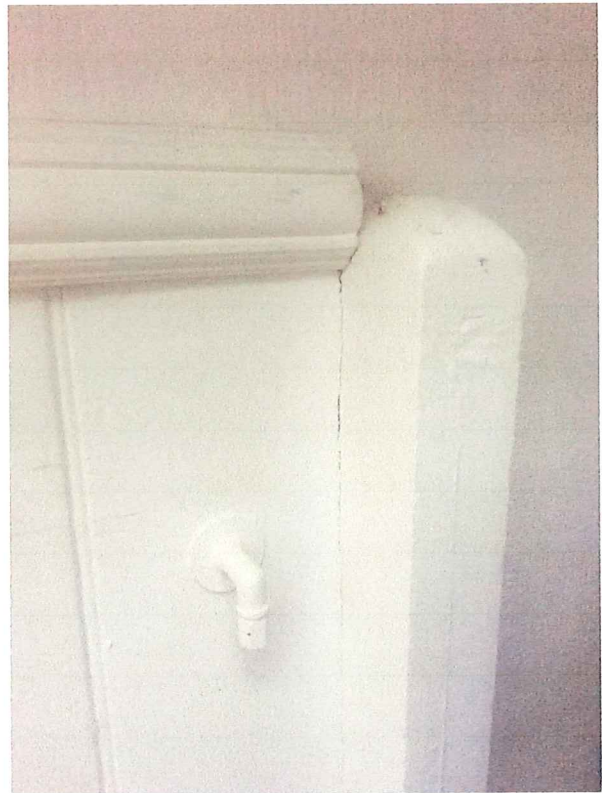
Fig 12 (b) - Dado Rail and former
Newel Post in First Floor Office.

Fig 12 (b) - The wainscot boarding shown in this image is found more or less throughout the whole of the perimeter of the first floor accommodation. The dado rail mould (type (ii)) shown differs to that found in the ground floor cafe area, but is found to side of stairs also. Other modern dado rail moulding have been introduced where indicated on the first floor plan (EXISTING) and as detailed on the section drawing 1132/21/07.

8.3.1 The current staircase is old and the wainscot panelling to the side is no doubt of the same age as the stair. What is curious is the two newel posts, one at the top of the stairs (figs 9 and 10) and one in the adjacent office (fig 12 B). Are they newel posts or something else?

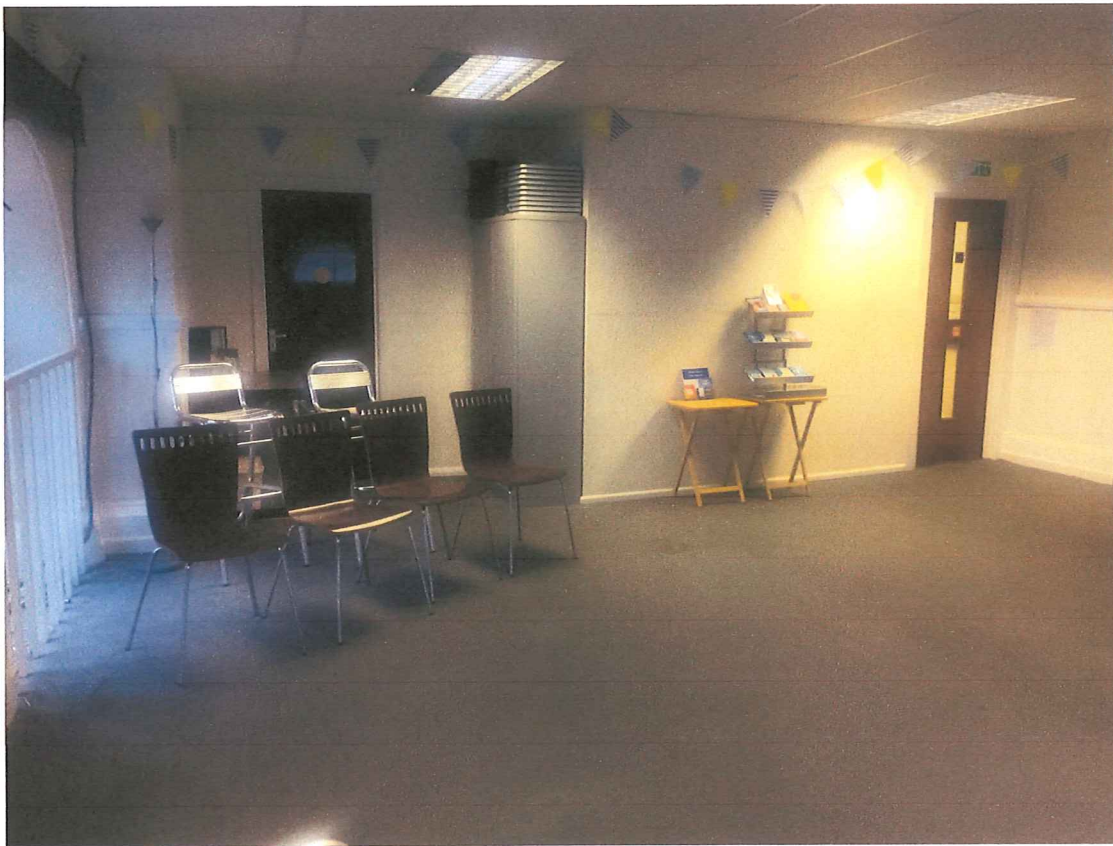
Fig 13 - Door D.12 to left and Door D.9 to right hand side.

Wainscot panelling to right hand wall, similar to fig 9 (b).

- At each window there is a handrail and simple square balusters to protect the windows / protect people from falling through the windows.
- The two small rooms are created with modern stud partitions and the doors are modern fire doors, refer to figs 13, 19 and 20.
- The West wall in the small room adjacent the stairs contains early wainscot panelling and a newel post, thought to be the remnants of a balustrade.

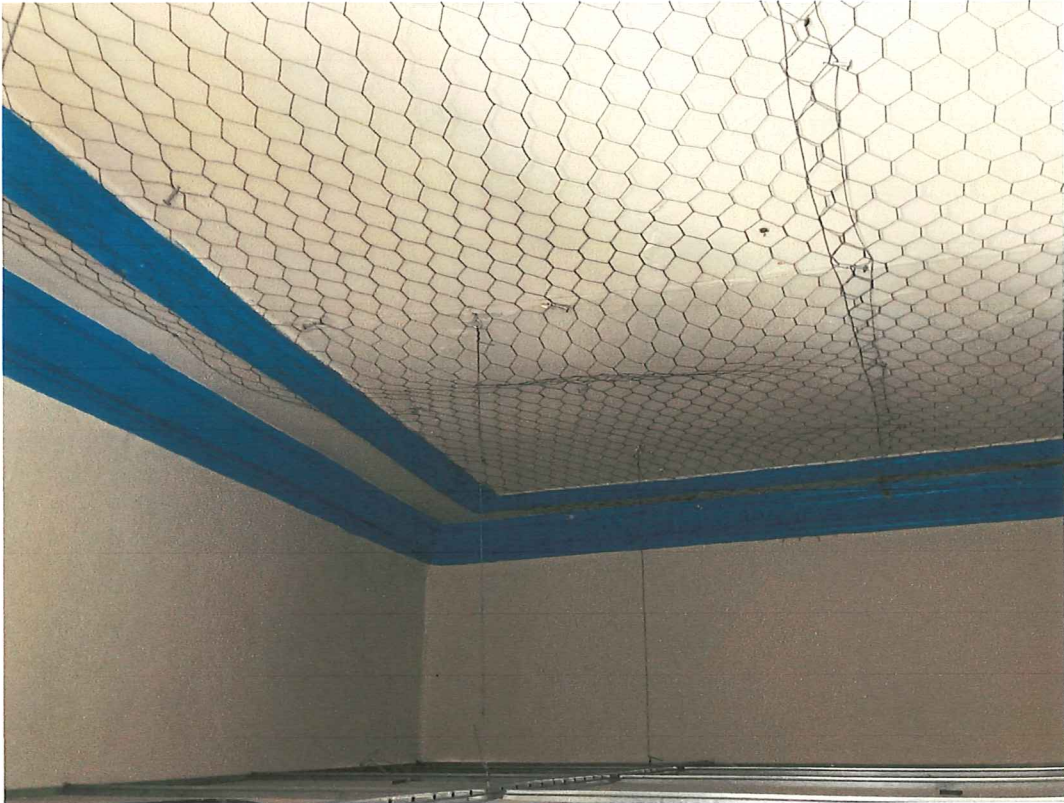
Fig 14 - Netted lath and plaster ceiling hidden above the modern suspended ceiling.

The ceiling is a modern suspended ceiling. Above this the original lath and plaster ceiling remains, netted with chicken wire. The original coving can also be seen still in place. Refer to fig 14 over.

- The roof structure consists a king post truss and a queen post truss, with purlins and rafters. Ceiling joists span between the trusses and end walls, finished with lath and plaster, now concealed by modern ceilings, however the lath and plaster ceiling can be seen above the lay in grid suspended ceiling. Netting has been secured to the underside of the lath and plaster (fig 14) to prevent plaster falls. There is original coving (refer fig 14), however it is not know whether this extends around the full perimeter of the building.

Original lath and plaster ceiling has been netted with chicken wire (refer fig 14).

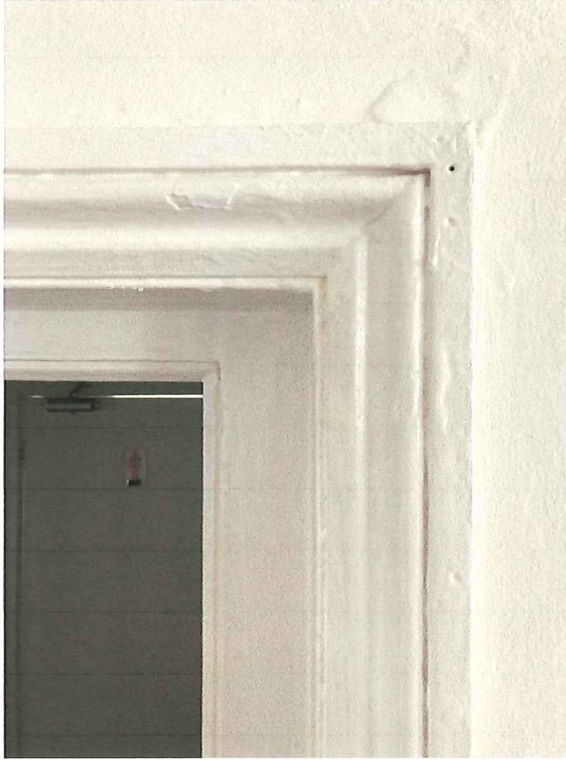
Fig 16 - Ogee architrave - Doorway D.5.

Refer to drawing 1132/21/07 for 1:2 scale section of traditional Ogee architrave mould and also door frame in this location.

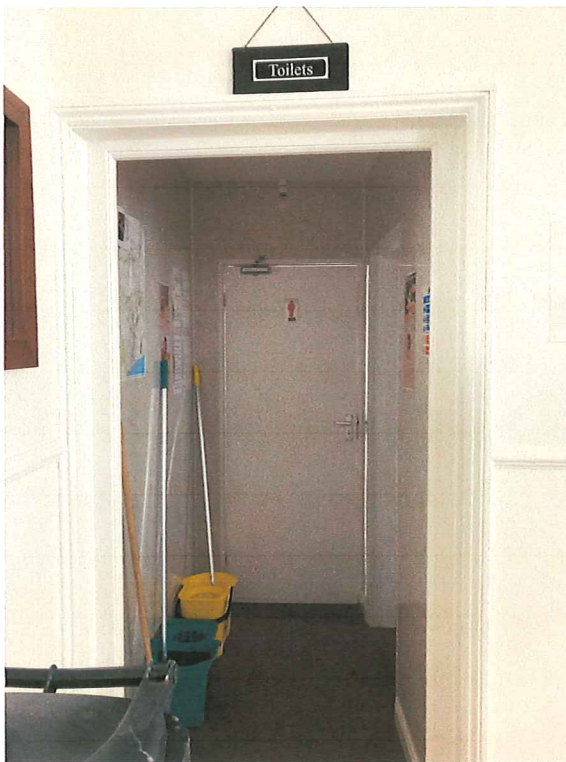
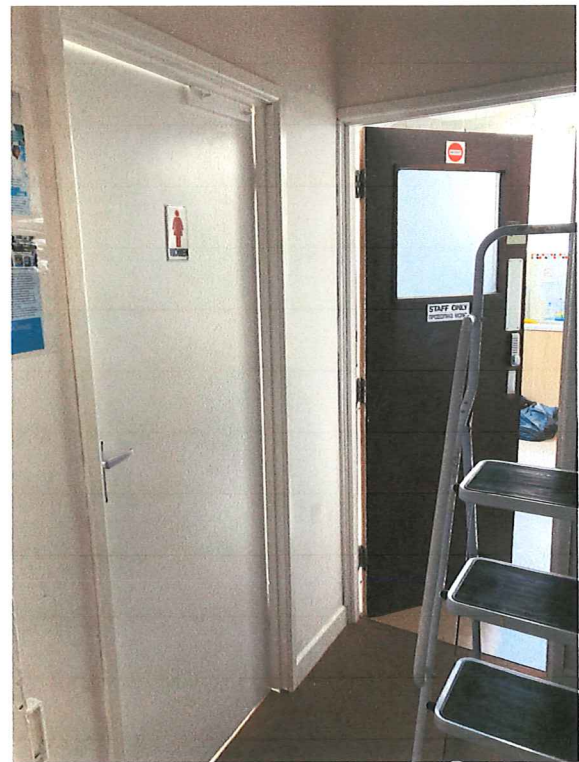
Fig 17 - Door D.6. (modern paint ply) in background. Fig 18 - Doors D.7 and D.8, both modern (Door D.4. is also a modern door similar to D.8. although it has eluded the camera).

- The door between the cafe and kitchen (D.4.) is a modern flush door with vision panel.
- Other internal doors are also modern, refer to figs 17 and 18.

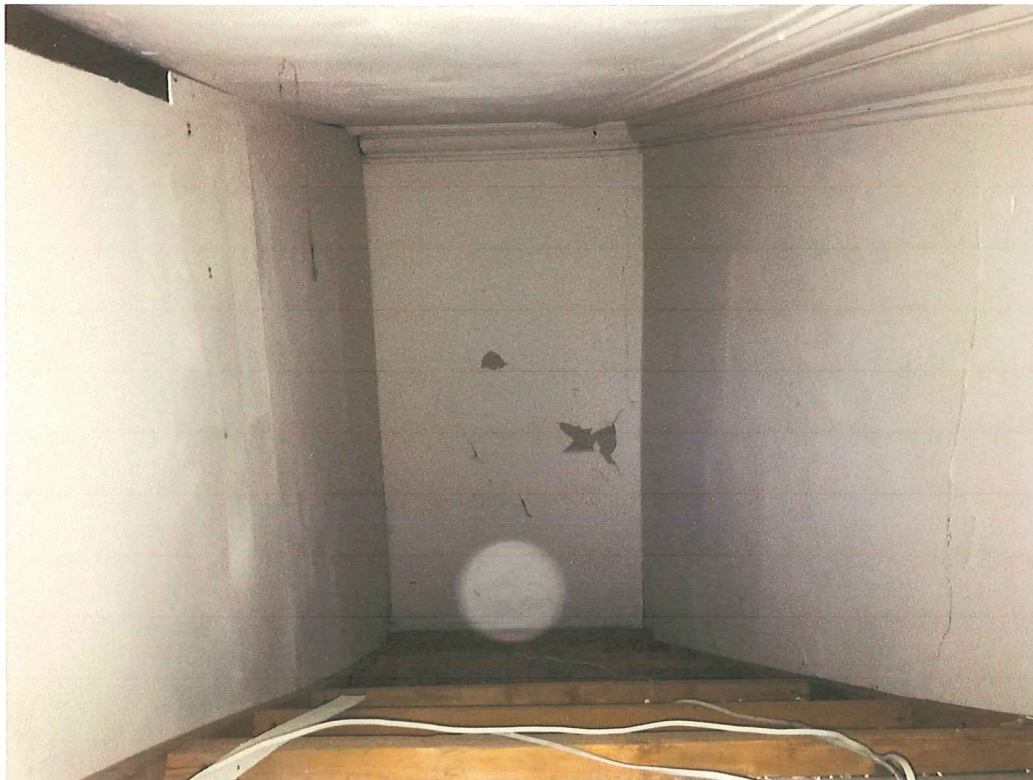
Fig 21 - Void over stairwell Ceiling, showing original ceiling and modern partition to the left.
