DESIGN AND ACCESS STATEMENT

**BROOK FARMHOUSE
COLCHESTER MAIN ROAD
ALRESFORD
ESSEX
CO7 8AP**

Prepared By: Philip Sciberras BSc (Hon) MRICS

Doc Ref: 210607WRI

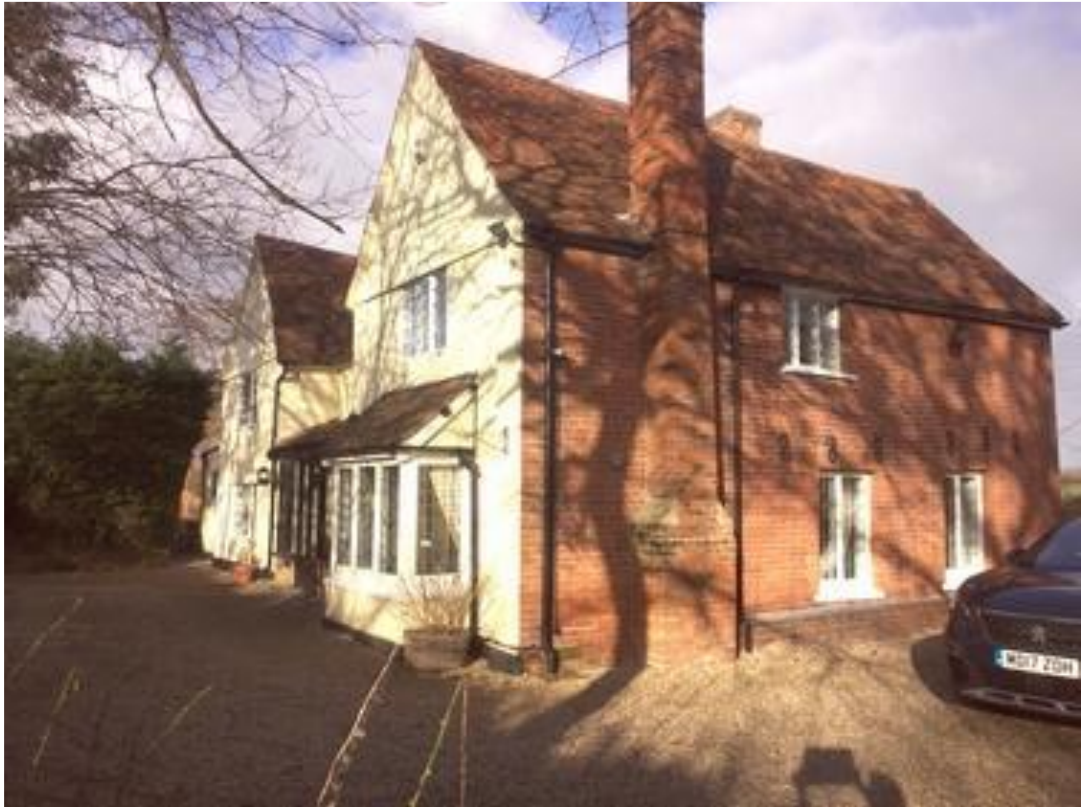
Photograph(s) of Property:

View from front Right corner

The two-storey building was constructed late 15th, early 16th century. The main structure is Timber framed with red brick and plaster faced. The floors are solid concrete and suspended timber, the property is covered with double gable fronted pitched and red plain tiled roof.
