HOTHAM HALL
HERITAGE STATEMENT
ISSUE 01 - MAY 2021

HOTHAM HALL: HERITAGE STATEMENT

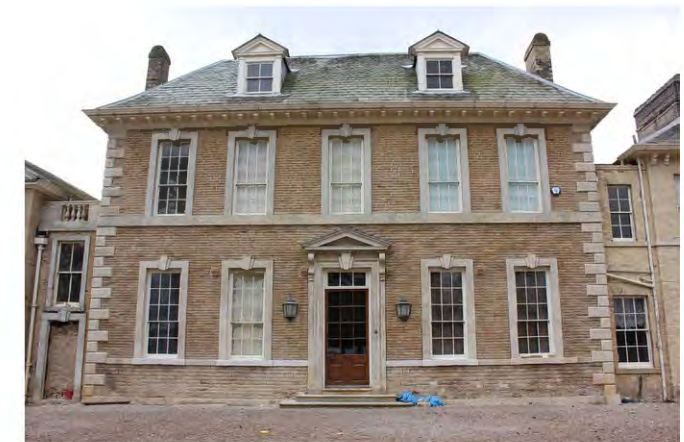
North elevation, restored to its 18th century form in the 1980s

The walls are of local hammer-dressed limestone with rusticated quoins and plinth with sill band to the ground and first floor. The entrance door and windows have ashlar stone surrounds with keystones. Above the deep cornice is a hipped roof with tall brick eaves stacks, and a Westmorland slate roof with dormer windows. The central doorcase has a pediment on console brackets which

was installed in the 1980s following the removal of the Victorian conservatory which had concealed the entire ground floor elevation. The uneven fifteen pane sashes appear to have been largely replaced and little historic glass remains.

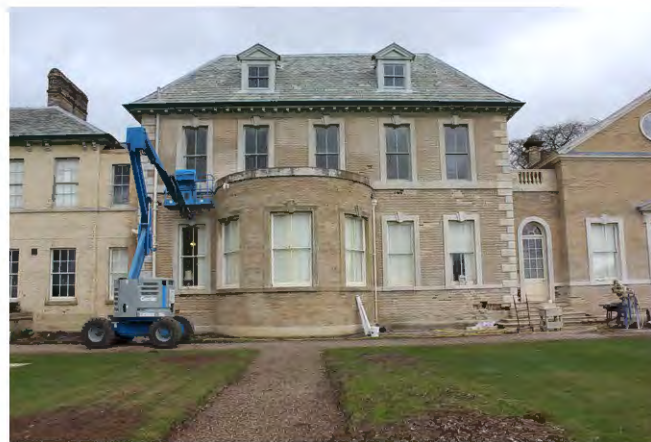
South elevation with later bow-bay window

The south front of the early 18th century house is similarly detailed, although an off-centre bow bay window constructed in the later 19th century now obscures bay two and three. It is likely that the south elevation originally had a central doorcase, complimenting the northern front. The windows have also been refenestrated with 19th century 2-over-2 sashes, which are out of character within the Georgian building. Only one window could be said to date to this period; a multi-paned sash window lighting the back staircase. It features heavy glazing bars and a number of lights with historic glass. The window is now partially blocked by a 19th century WC.

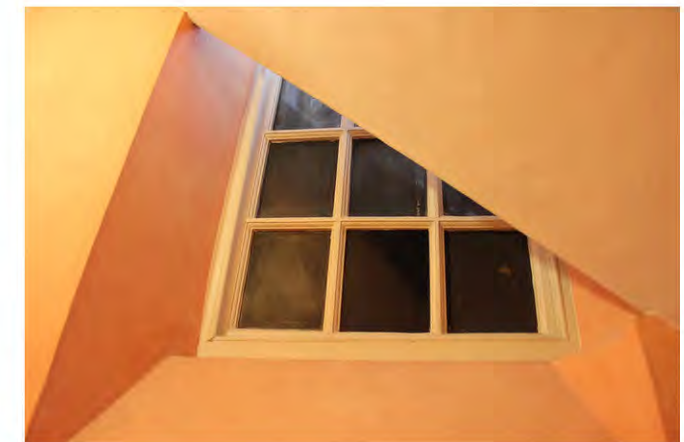
18th century window to the back stairs

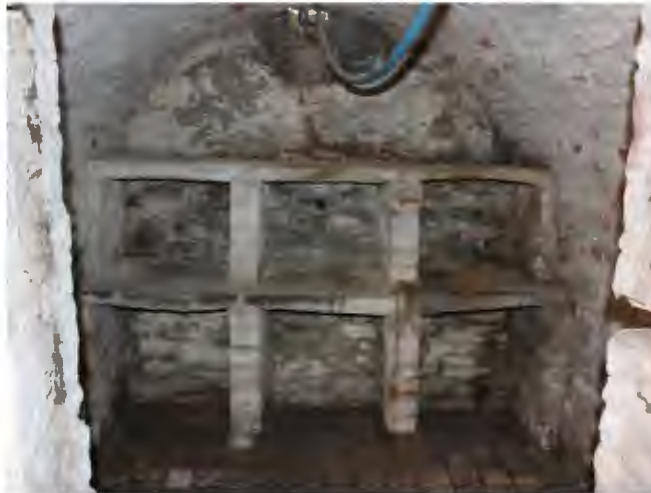
Phase 1 cellar with stone storage shelves

The cellars are extensive, constructed in coursed rubblestone and brick with low barrel-vaulted ceilings to many areas. Originally, access to the cellars was below the back staircase. The entrance is now part of an understairs cupboard and access can now be obtained from with the 19th century extension. The floors have stone slabs or sets and many of the storage areas retain their storage bins for wine and stone benches for barrels. The ceiling adjacent to the original entrance has wide timber boards, whilst adjacent there are exposed laths which may have been part of a limecrete floor above, probably now covered by later flooring.

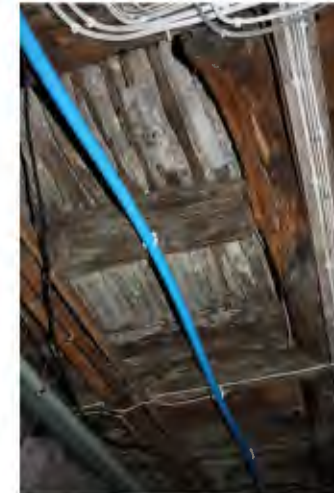
The underside of laths in the cellar plastered from above, providing evidence of a possible limecrete floor on the ground floor former service corridor in phase one

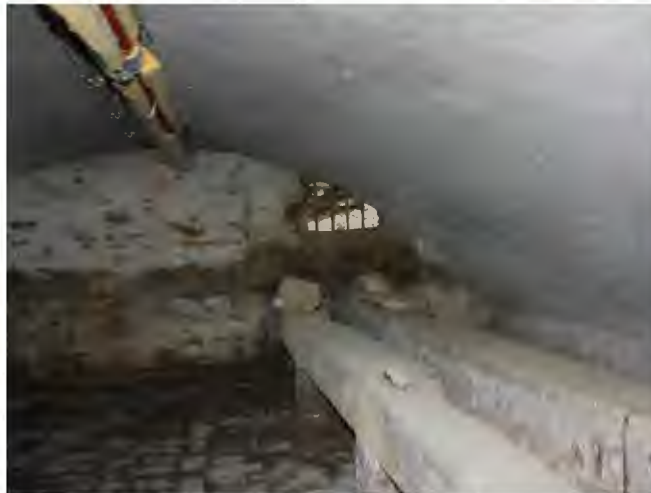
Phase 1 cellar with stone benches for storing barrels

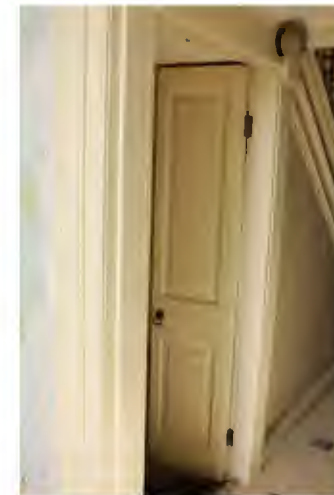
Phase 1 entrance to cellar - note the doors are later

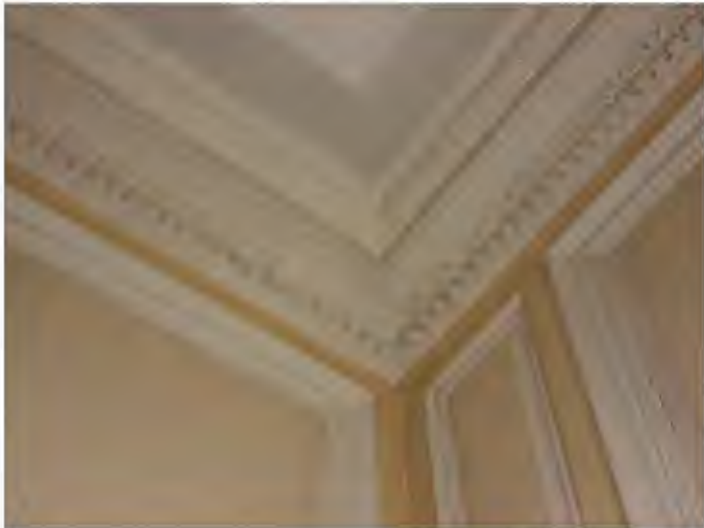
Heavily moulded cornice in the Drawing Room.

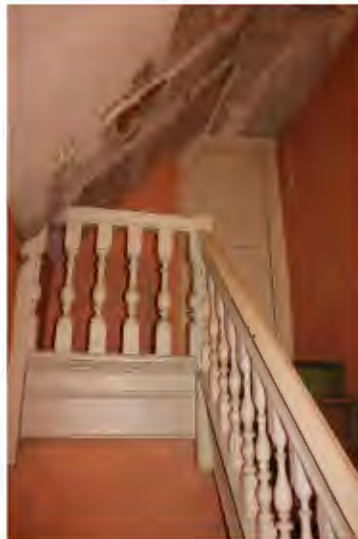
Back staircase from phase one with entrance to attics

The early 18th century back staircase leads to the attics. This space would have been occupied by the servants, but the original partitions and lath and plaster finish were removed in the 20th century to reveal the rafters. A number of two-panelled 18th century doors, a slopping-out sink and a 19th century cast-iron fireplace are the only evidence of their former occupants.

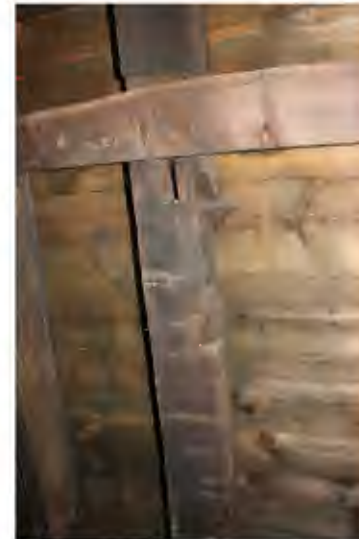
Evidence of reused timbers

It is noticeable that a number of the roof timbers appear to have been reused from elsewhere, having various empty mortices some with extant pegging. Also of interest are the historic floorboards with tooling marks which lie below the 19th century floor. Around 9-inches wide, these almost certainly belong to the original phase one house.

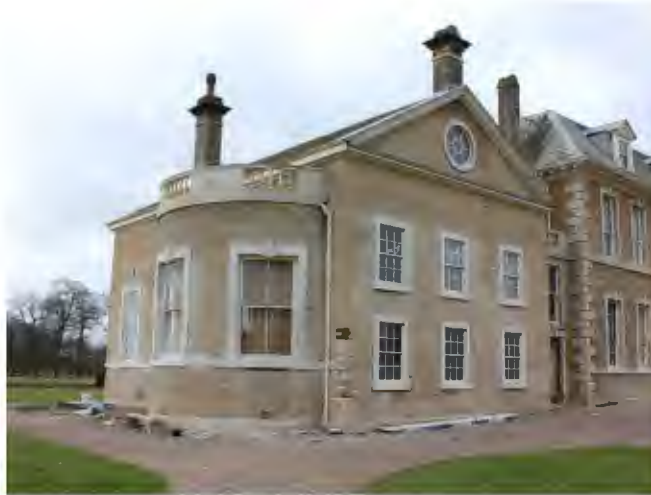
Pavilion northern elevation and bay window

The east pavilion is of three bays, with ridge stack and slate roof. The north elevation appears to be two-storeys with pedimented gable end to the front set with an oculus. However, the windows on the north front are blind and conceal a single storey element behind. To the right, the flat roofed link of one bay is set slightly back and topped by a stone balustrade below eaves level. The pavilion link is set with a blocked door with stone dressing and keystone, and a 2x2 window with stone surround. Fabric analysis shows that the door still retains part of a timber frame and was likely to have once been operable. The sill of the window above has been lowered, probably in the latter half of the 19th century when the 2x2 sash window was inserted and a service room created behind.

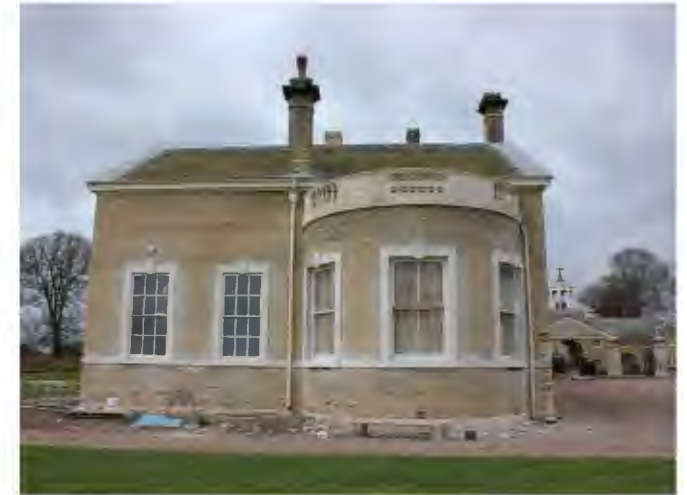
East facing elevation

The east elevation may have originally been four bays (note the two windows to the left are also blind) but a bow bay window was probably added to the pavilion at the end of the 18th century or the start of the following. The south front is of three bays with the central window with bracketed pediment. An oculus is also set in the pedimented gable end. To the left, within the single bay link building, is a glazed door with radial over light set in a stone surround.

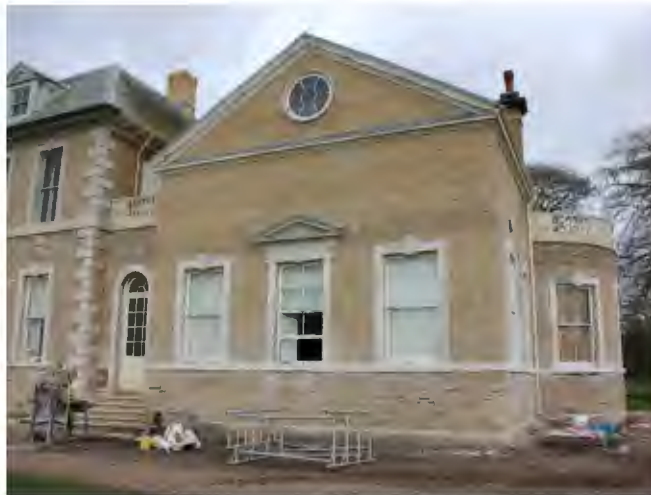
South facing elevation

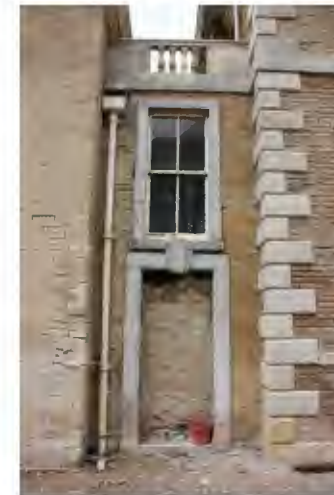
Blocked door with lowered window above to pavilion link

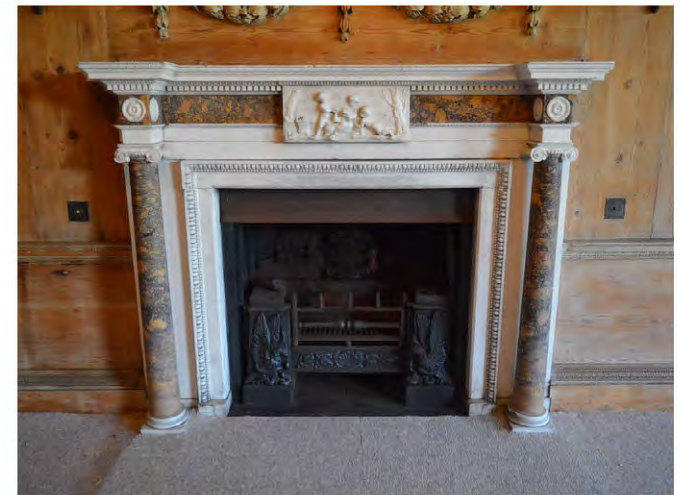
Detail of fireplace (Linda Clarke)

The pine panelling has been stripped back, probably during the 20th century, but would originally have been painted. The fine white marble fireplace has orange marble Ionic columns supporting a frieze. The fireplace in here and in the adjacent room may have been designed by the architect Thomas Atkinson. The floor is of stripped pine but has been largely replaced. A number of much wider and possibly late 18th century floorboards are still extant to the periphery of the floor.

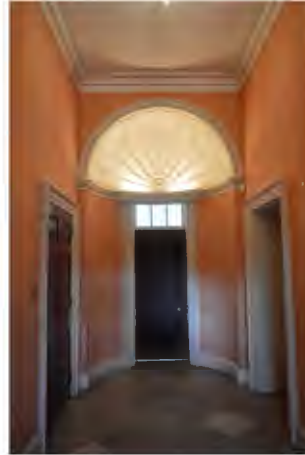
Shell niche in corridor / anteroom (Linda Clarke)

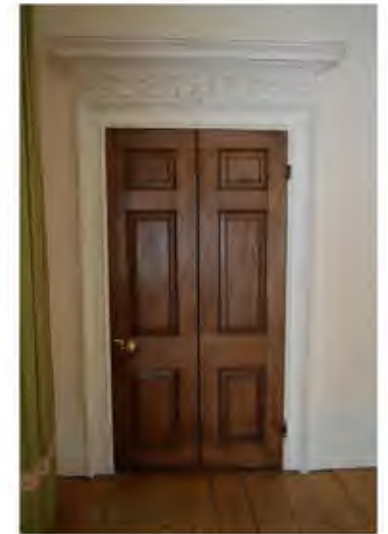
False door in library

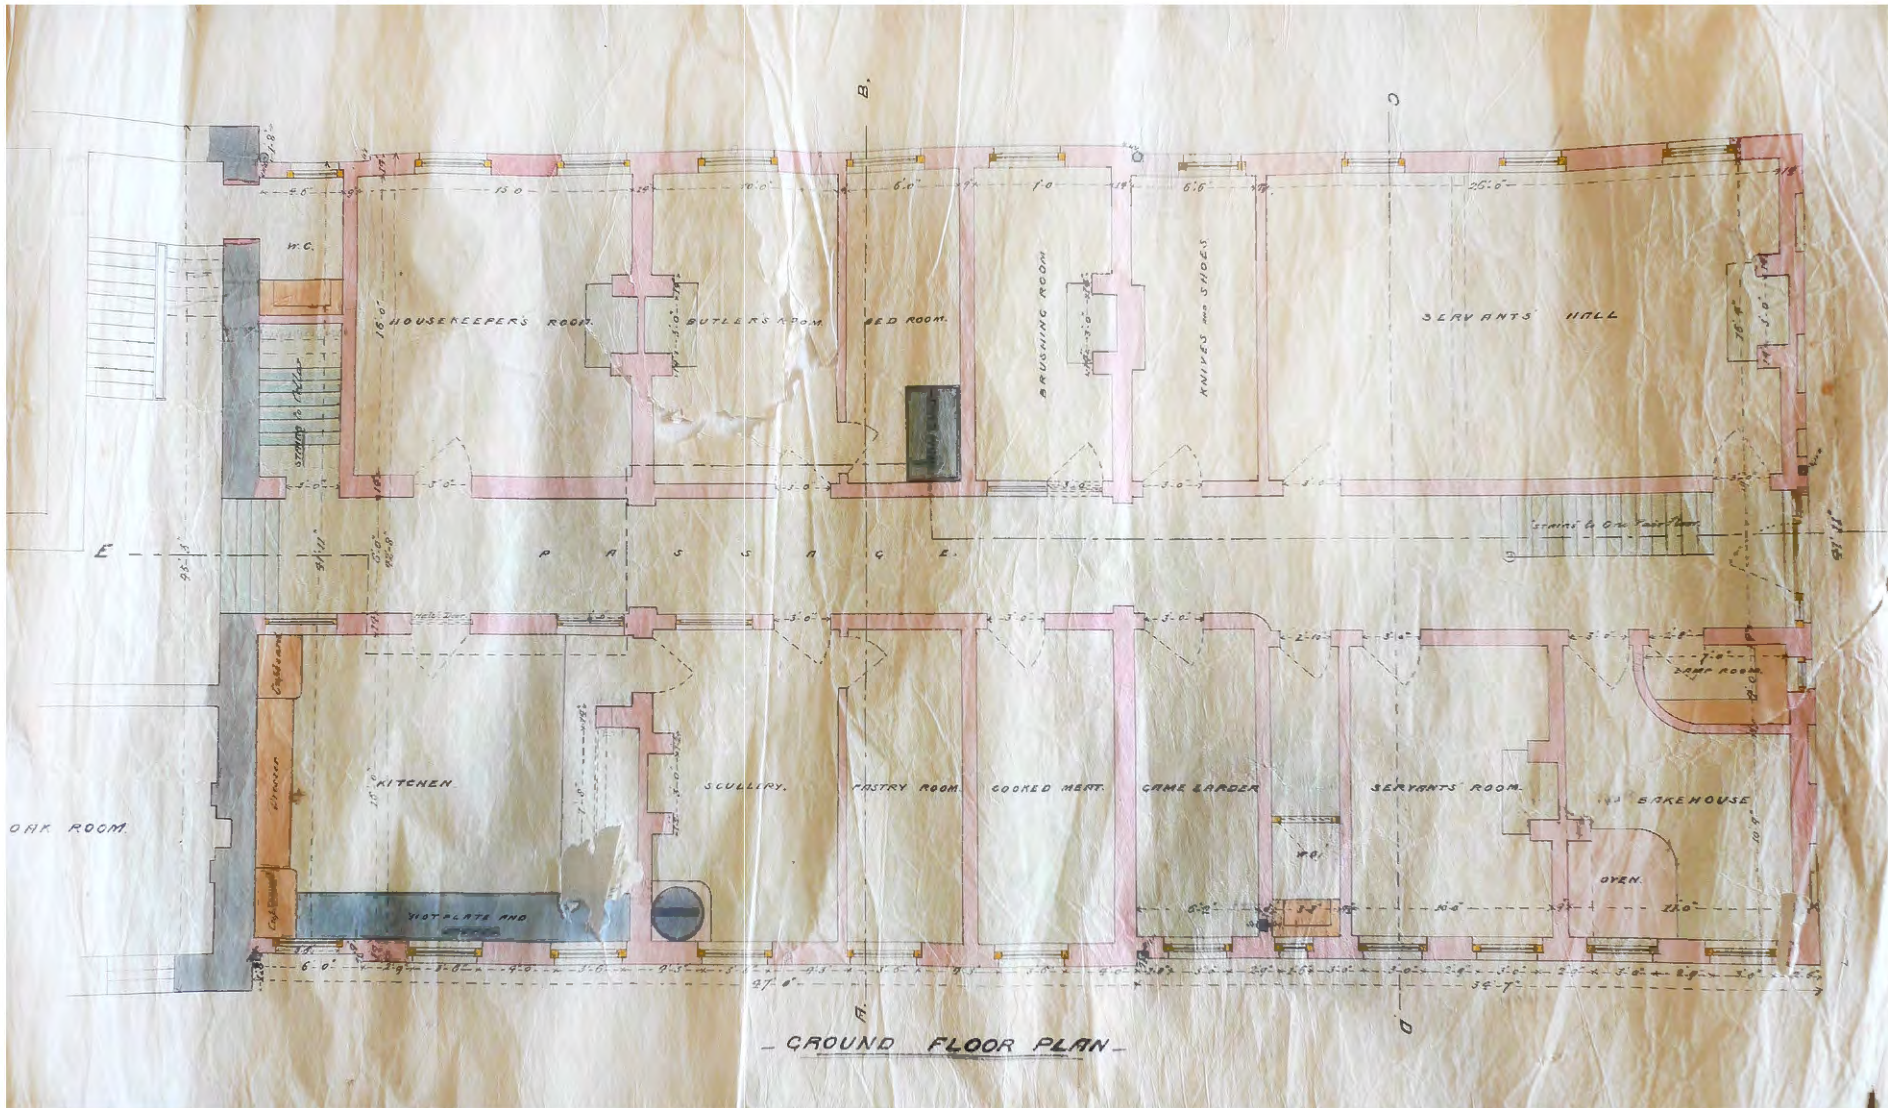
Ground floor plan of the proposed new extension

Moseley's original plans reside in the Hotham Hall archive. They show that the wing was intended as servant's offices on the ground floor. The service quarters were reached from the main house via a door adjacent to the back stair and down a short flight of steps. Although not built entirely to plan, the ground floor has rooms opening off a central corridor. They comprised (to the south) access to the cellars and a WC behind, housekeeper's room, the butler's rooms, brushing room, knives and shoes (though substituted for a WC) and the Servant's Hall. On the north side was the kitchen, scullery, pantry room, cooked meat, game larder, servants' room, bakehouse, and damp room. In an alteration to the architect's plan's the kitchen was not built adjacent to the 1720's house, but constructed further to the west, probably to keep smells further away from the owners and their guests. The scullery, pastry room and game larder may have been built in its place.

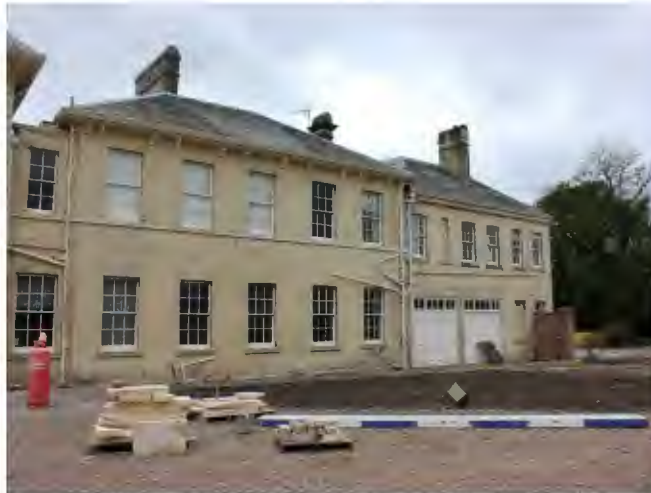
North elevation, west wing

The north elevation of the western 'villa' is of six unequal bays, set very slightly back from the adjacent building line. Its eaves are also set below that of the adjacent building, helping to break up the frontage.

The ground floor comprises two modern garage doors on the north elevation and attached is a short section of modern wall. The west facing elevation is of four equal bays. The west elevation contains the main entrance into the service quarters characterised by a series of blind windows and a tripartite stair window.

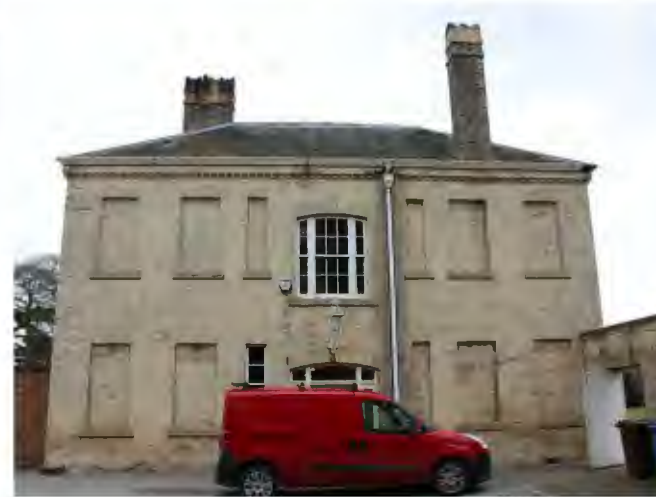
West elevation

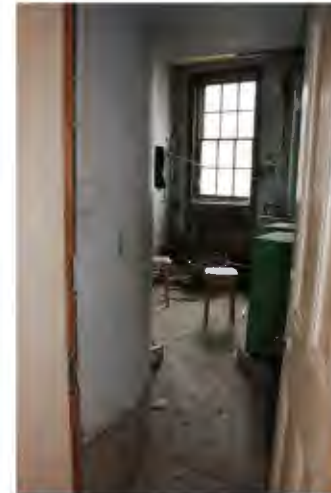
Former bakehouse (now boiler house with original floor, window, and rising shutter

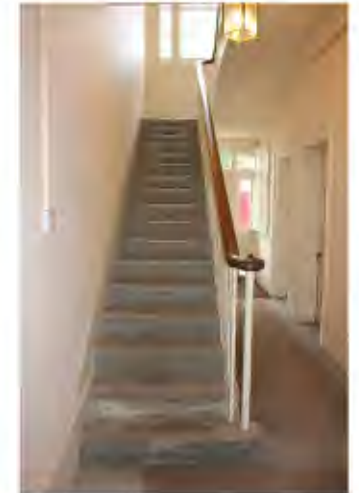
Open string stone back staircase

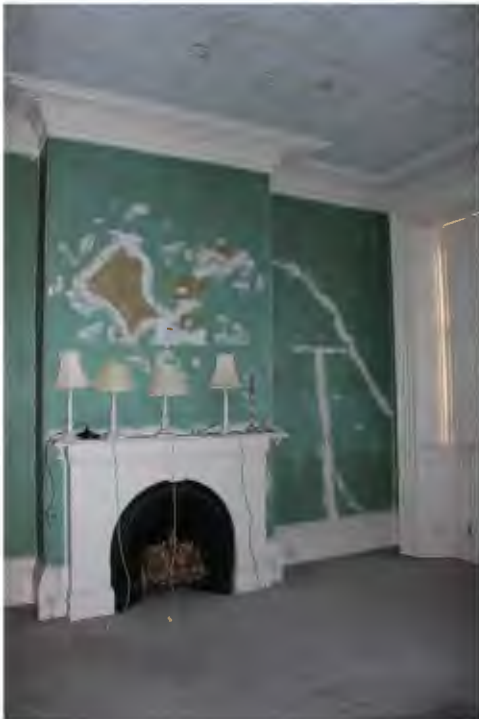
Bedroom FF12 with decorative cornice, marble fireplace and cast-iron grate and window shutters

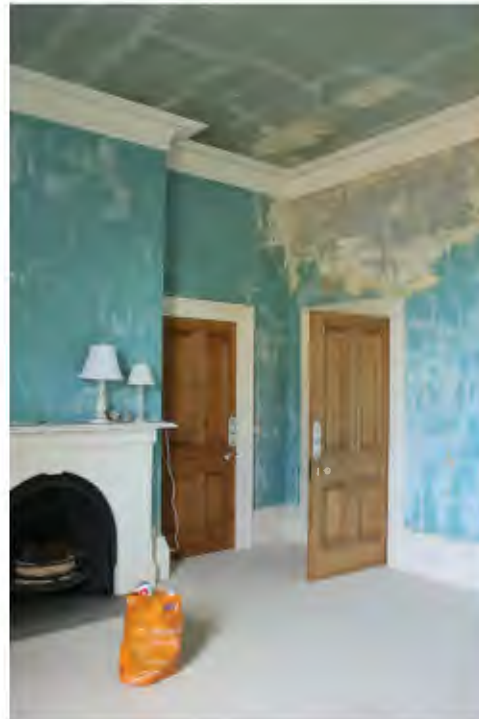
Bedroom FF22 with less decorative cornice

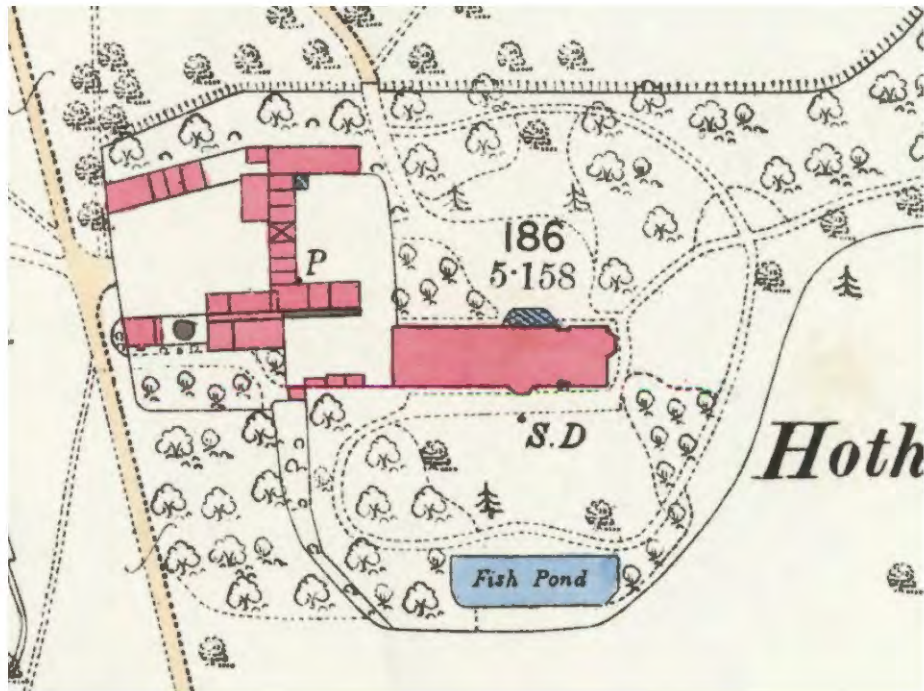
1890 (surveyed 1888) Ordnance Survey 25 inch of Hotham Hall. This shows the new western extension, conservatory to the north elevation and bow-bay window added to the south elevation.

Other works which are thought to have taken place at this time are believed to be the installation of a glazed conservatory on the north elevation, and a bow-bay window was also added to the drawing room (GF09) on the south elevation. These are first shown on the 1890 (surveyed 1888) Ordnance Survey 25-inch map.

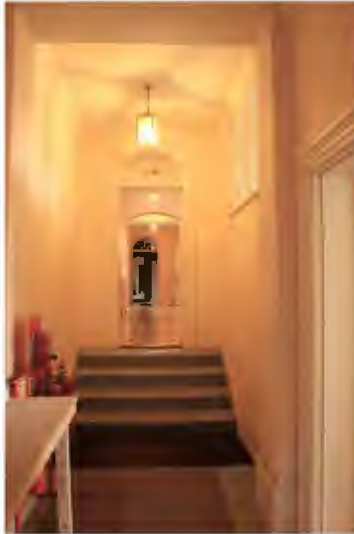
Mid-20th century staircase and raised flooring

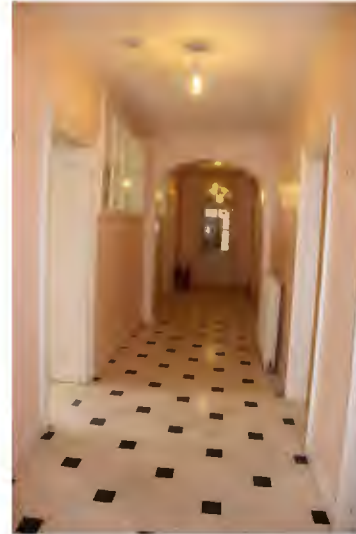
Former service corridor, now with modern raised floor and modern reformed archway.

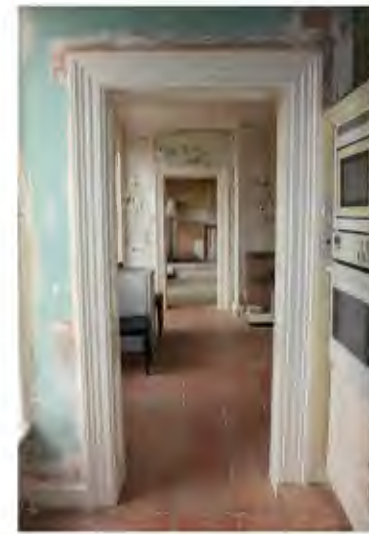
Inserted doors through GF12 to GF13. Note the foreground space was formerly a Victorian WC

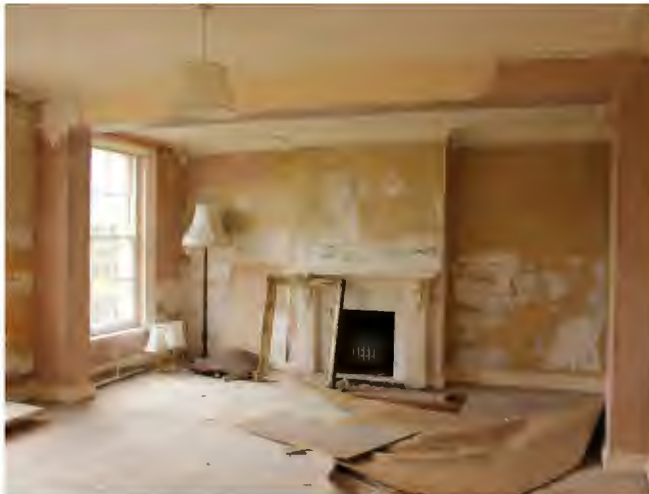
Breakfast room, formerly the butler's sitting room and bedroom. Note the raised flooring, removed wall, and relocated fireplace

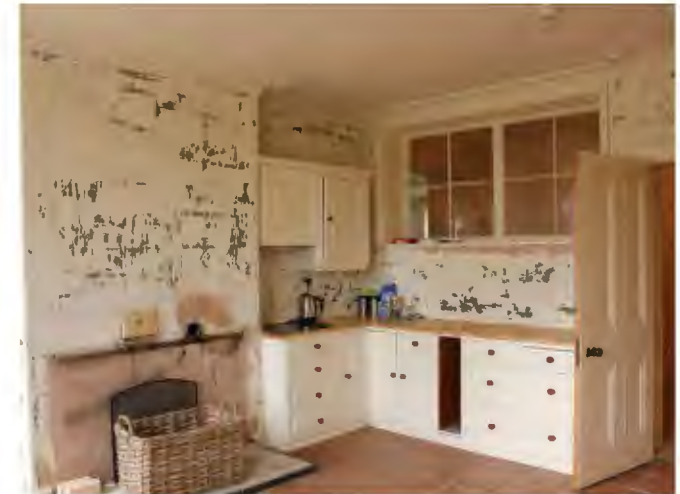
Modern kitchen in housekeeper's room. The borrowed light is from the 1870s.

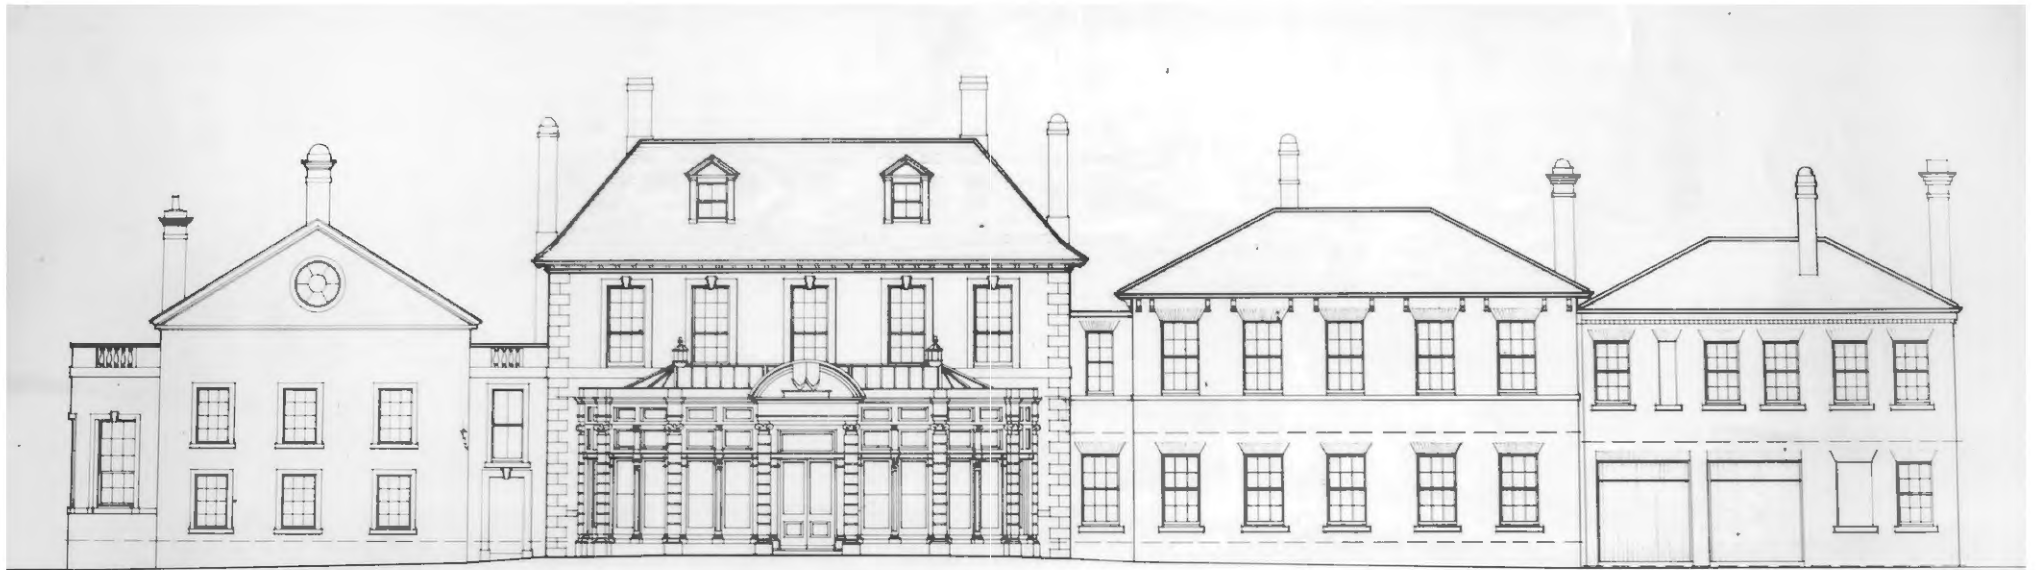
NORTH ELEVATION AS EXISTING

Survey of Hotham Hall by Francis F. Johnson & Partners 198

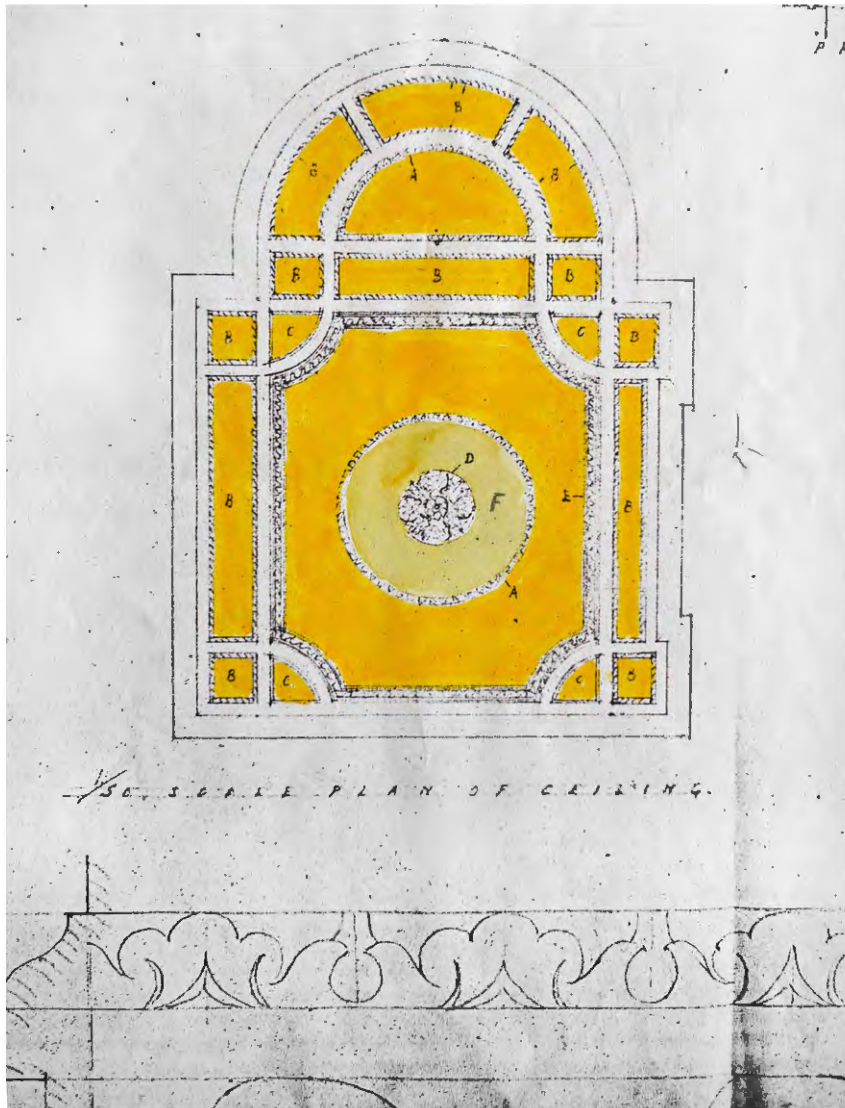
Unexecuted design for the drawing room ceiling (GF09) from the 1986

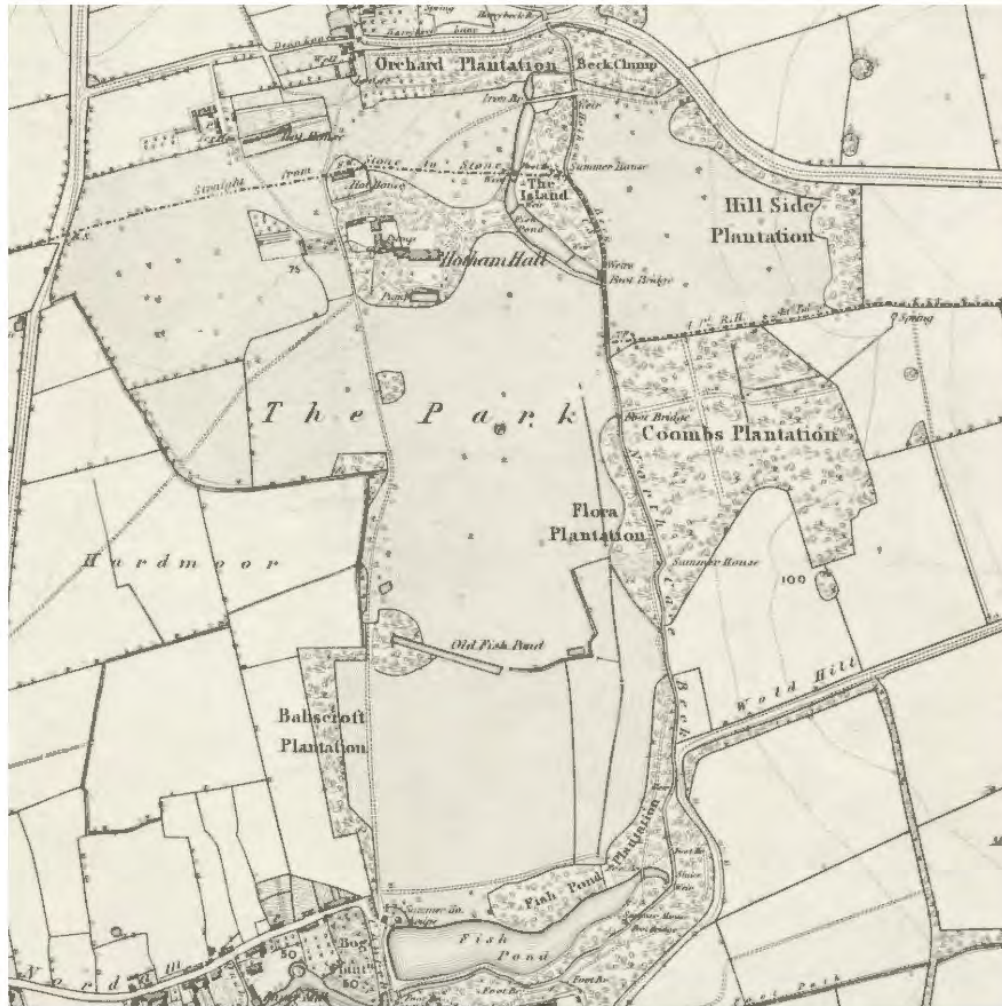
The 1855 (surveyed 1852) Ordnance Survey First Edition 6 inch showing the extent of Hotham Hall's park.

By the First Edition of the Ordnance survey, published 1855 and surveyed 1852, the extent of 'The Park' is clearly shown. When the Hall was advertised to let in 1850 it comprised 140 acres of land along with gardens and pleasure grounds. Little appears to have changed to the boundaries from 1813, however, further plantations have been established upon the northern border of the park, annotated 'Orchard Plantation', whilst Coombes Plantation has been extended and now features a summer house. To the south is the rectangular shape of the 'Old Fish Pond,' a stretch of water or canal assumed by Neave to have formed part of the early pleasure grounds of Hotham Hall. Further to the south, the Park terminates at Fish Pond Plantation and a lodge is also indicated at the end of the drive in North Cave. To the north and northwest of the Hall is another lodge, hothouses, and an icehouse.

The Hall is shown in an enclosed area, dotted with trees, and crossed by a network of paths. Directly to the south within the gardens of the Hall is a small pond with 'pump' annotated. To the east is The Island and Fish Pond – access to the former is via an 'Iron Bridge' and 'Footbridge.'

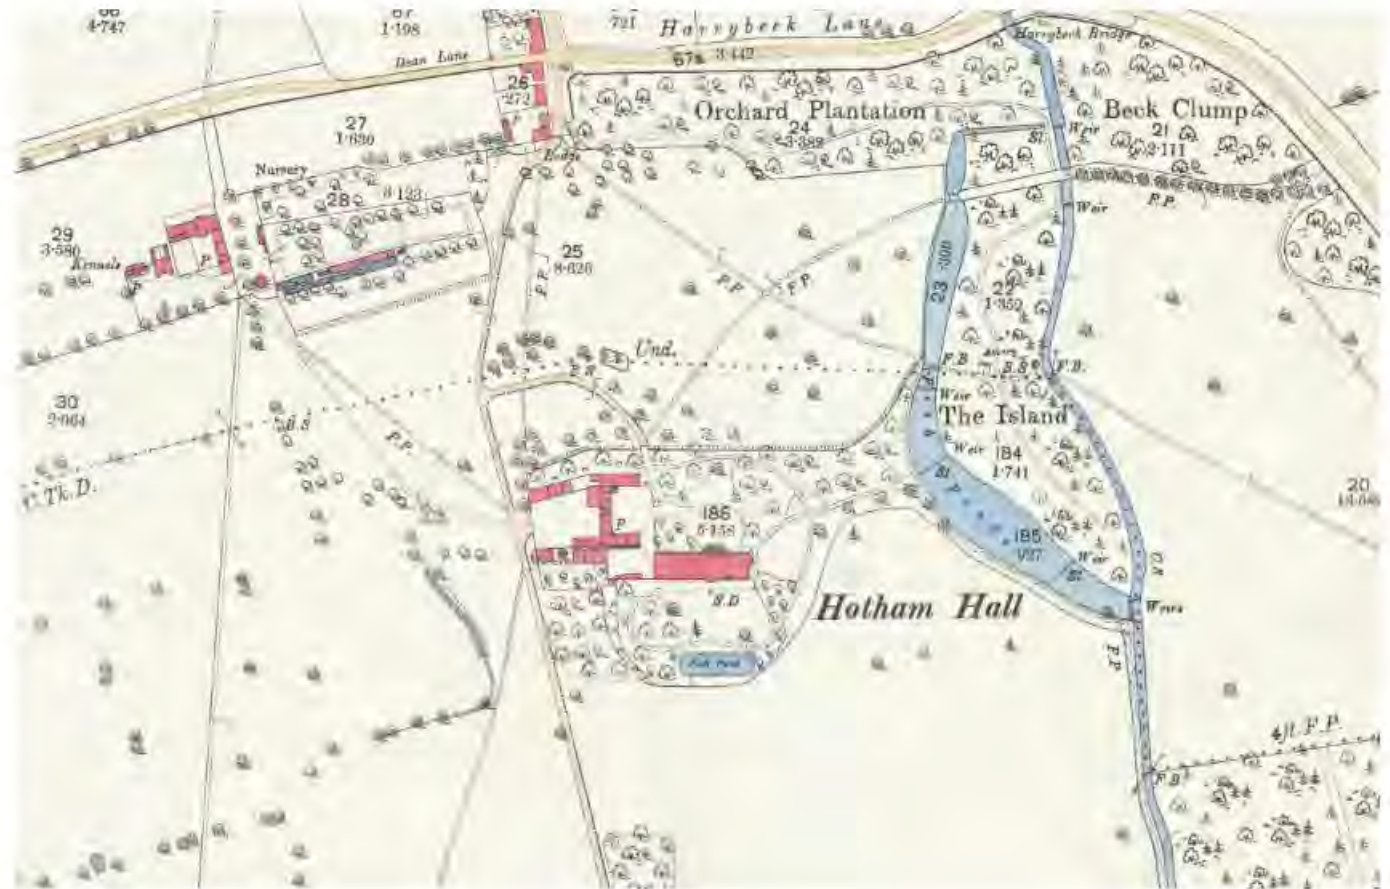
The 1890 (surveyed 1888) Ordnance Survey Second Edition 25 inch showing the north of Hotham Hall's park

The 1890 OS map shows the Park following his improvements which appear to include the ha-ha which is now clearly defined, a sundial below the south-front, and planting in front of the west wing's north elevation. A green house to the north has been removed, probably to enhance views as visitors approached the Hall. It is interesting to note that the approach is not via the stable yard as it is today, but via a curving drive which crosses the ha-ha before arriving at the north elevation. This approach is no longer extant, although the former access is still marked by a gateway near the stables.

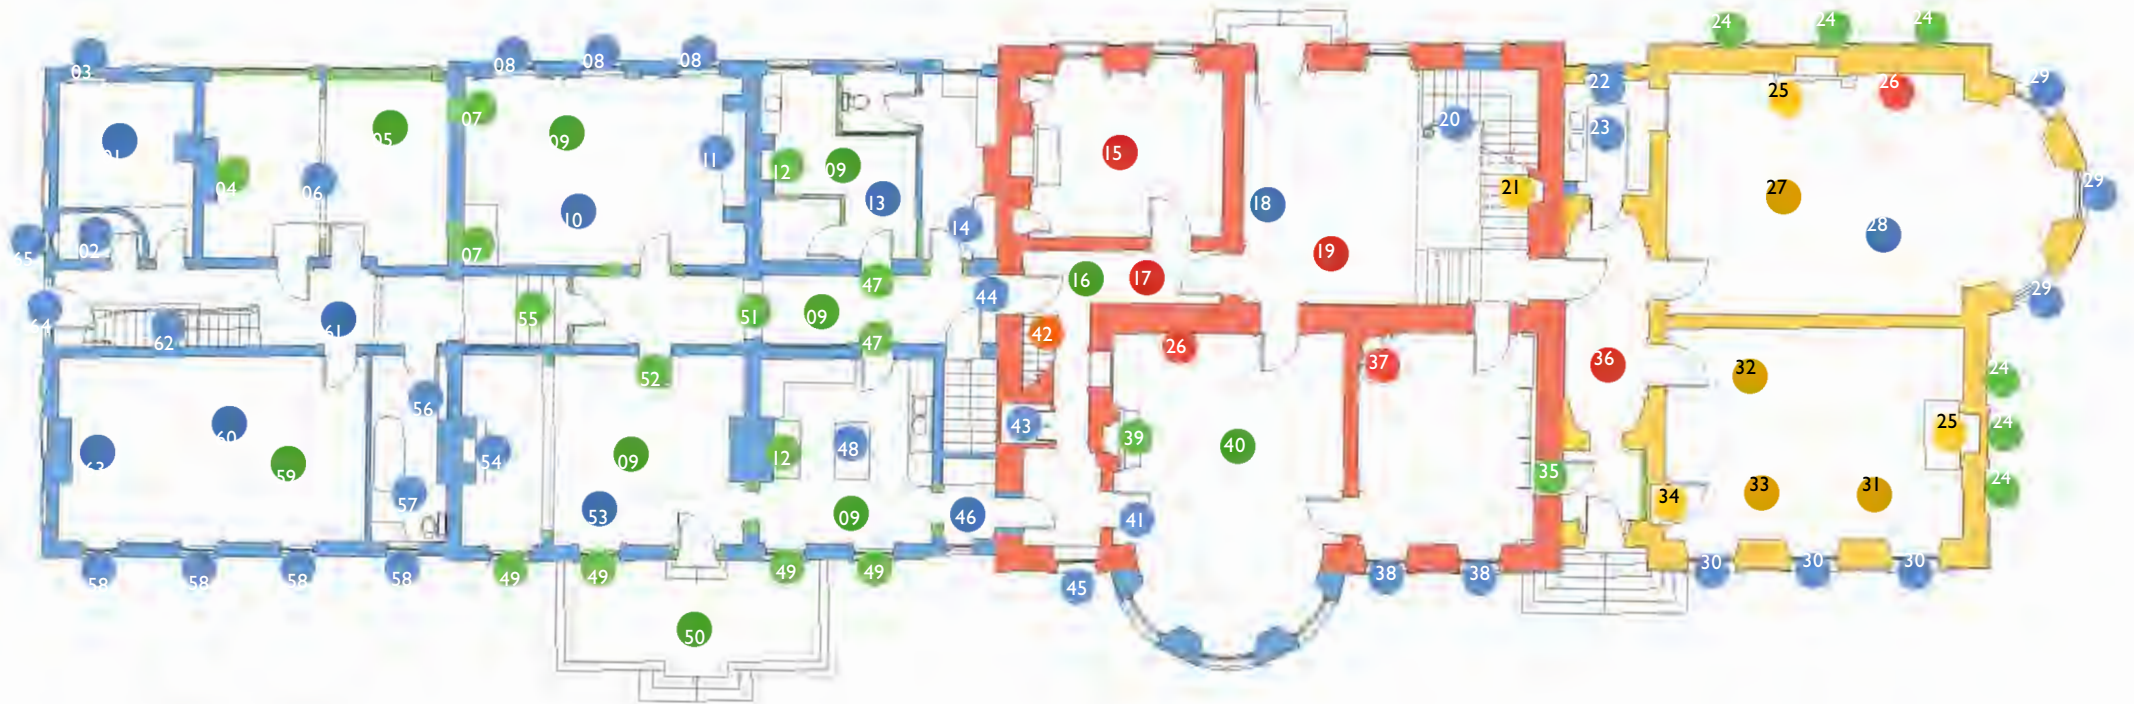
GROUND FLOOR

- 24 Windows replaced late C20
- 25 Fireplace late C18
- 26 Panelling early C18
- 27 Ceiling late C18
- 28 Floor largely replace circa C19
- 29 Windows later C19

- 65 Historic window bars extant

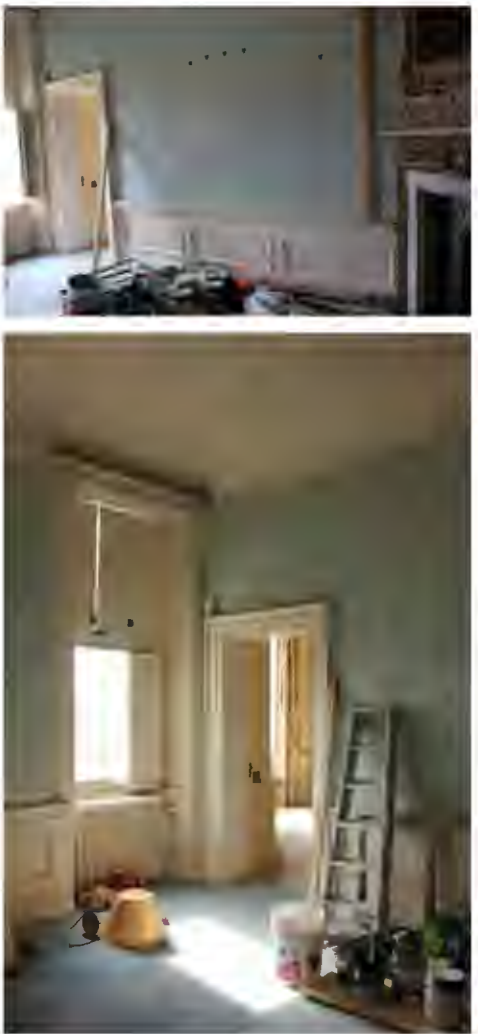
1	Walls	1720s			High	Minor	New double-door opening proposed for centre of wall between GF-08 and GF-09. Existing door will be blocked.	Low adverse impact	Low adverse impact to original circulation within early C18 house and impact on historic panelling. However, inclusion of doors within the new opening will help with readability of plan form.

2	Ceiling	Hist with modern finish			Medium	Moderate	No change	n/a		
	3	Floor	Hist with modern finish	Modern carpet. Flooring concealed			Medium	Moderate	No change	n/a	
	4	Joinery	1720s	Upper panels may have been removed historically. Appears to have been replaced with thin boarding above dado. Note extant panel full height panel between windows	Lower wainscot C18. Deep mouldings	High	Minor	Panelling carefully reconfigured to suit opening	Low adverse impact	Adverse impact by remodelling panelling, which is C18 at lower level.	
	5	Plasterwork	Mod	Documentary evidence installed in 1980s			High	Minor	No change	n/a	
	6	Decoration	C20th				Low	Major	No change	n/a	
	7	Windows	19th	Narrow glazing bars throughout C18 element - all (apart from service stair window) replaced and repaired C19 through to C20 and C21. Little extant historic glass in C18 part of house.	2x2		Medium	Moderate	Conservation repairs to windows	Medium beneficial

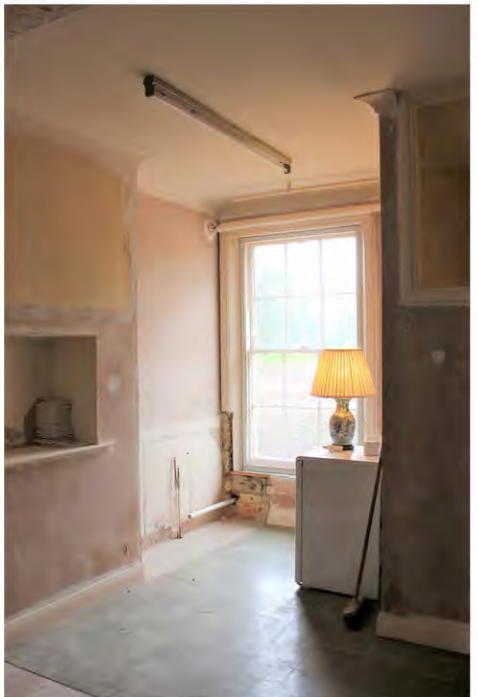
GF24 / 23	Pantry: former service room	Key dates	Research comments	Key features	Significance	Capacity for change	Proposals	Impact	Commentary

1	Walls	C19 / C20	Original plans suggest layout was changed after proposals drafted. Orig planform not clear but likely kitchen was swapped with scullery/pastry and cooked meat store. 1901 plan of new drains suggests GF24 / GF26 were three interconnected spaces entered by a single door from corridor.	This space has been altered - toilet in GF26 has been built into the original space as has modern larder (now removed)	Detrimental	Major	Removal of GF25 and GF23 wall partitions from within GF24, insert new wall partitions to form corridor and four individual WCs with GF25.	Neutral	Layout of GF24, 25 and 26 (pantry, WC and washroom) is partly a modern configuration. Modern internal partitions will be replaced with new partitions. Existing C19 wall to be retained but new door opening to be formed. Space retained in current use. No impact on significant features or values.

2	Ceiling	C19		Lath and plaster visible. Modern repairs	Low	Major			
	3	Floor	Modern raised floor		Marley tile finish corresponds to c1960 insertion of floor	Detrimental	Major			
	4	Joinery	Mainly modern apart from main door and window architraves which look historic.	Has joinery to raised door frames been reused or good reproduction?	Architraves to window in poor condition	Low	Major			
	5	Plasterwork	Modern cornice		Much modern patching, repair and alteration	Detrimental	Major			
	6	Decoration	Modern			Detrimental	Major			
	7	Windows	C19 / 20			Medium	Major	High-level window to GF21 (laundry room) to be removed	Neutral	High level window non-original insert.
	8	Doors	C19		Original door position to corridor. Four panel, moulded both sides	Low	Major	DG33 to be retained	Neutral	
	9	Fireplace	Blocked	Range said to have been removed in 1980s and opening has been poorly blocked and patched		Detrimental	Major	Fireplace to be incorporated into fixtures.	Neutral	Slight improvement but no change overall.

10	M&E	Modern			Detrimental	Major	New WC M&E	Neutral	
	11	Fixtures	Modern					Remove existing pantry, larder and washing fixtures and fittings.	Neutral	Modern fixtures
	12	Other

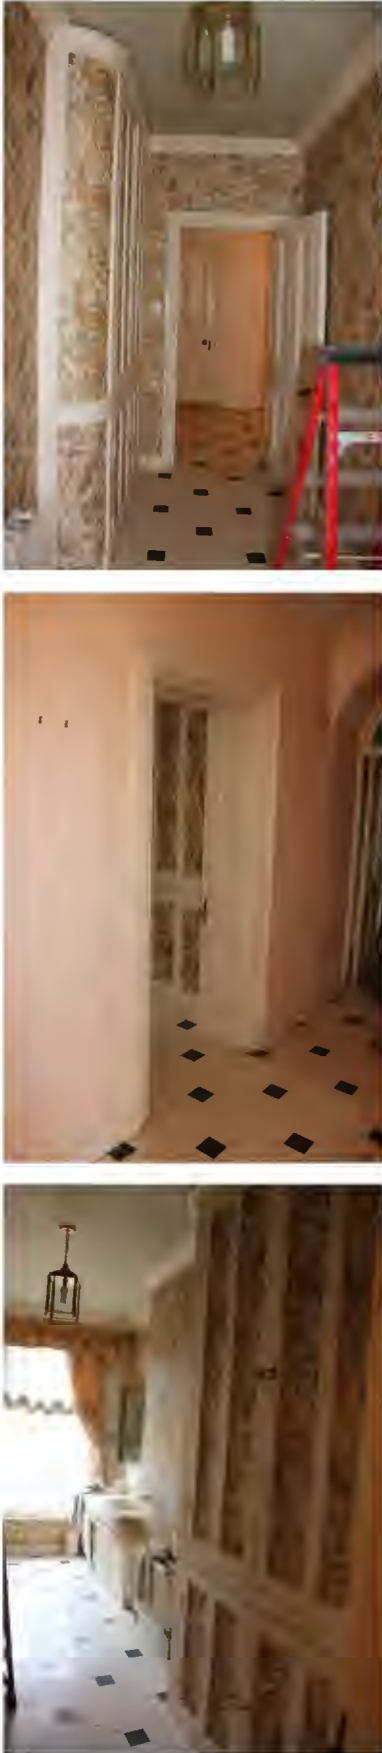
GF25/26	Washroom: former service room	Key dates	Research comments	Key features	Significance	Capacity for change	Proposals	Impact	Commentary

1	Walls	C19 / C20	Original plans suggest layout was changed after proposals drafted. Orig planform not clear but likely kitchen was swapped with scullery/pastry and cooked meat store. 1901 plan of new drains suggests GF24 / GF26 were three interconnected spaces entered by a single door from corridor.	Toilet GF26 protrudes into GF24 from adjacent GF25. Modern walls to WC	Low	Major	Form new door opening between washroom (GF26) and pantry (GF24), remove walls and fixtures of washroom (GF25). Addition of new partition to convert GF26 (washroom) into two individual WCs with wash facilities.	New opening through C19 wall slight adverse impact. Removal of modern partitions neutral impact	Layout of GF24, 25 and 26 (pantry, WC and washroom) is partly a modern configuration. Modern internal partitions will be replaced with new partitions. Existing C19 wall to be retained but new door opening to be formed. Space retained in current use.

2	Ceiling	C19			Low	Major			
	3	Floor	Modern raised floor		Modern covering	Detrimental	Major			
	4	Joinery	Mainly modern apart from main door and window architraves which look historic.	Has joinery to raised door frames been reused or good reproduction?		Low	Major			
	5	Plasterwork	C20		Non original door position to corridor but joinery and door likely reused. Four panel, moulded	Low	Major			
	6	Decoration	C20		Modern paper. Curtains obstruct shutters	Neutral / Detrimental	Major			
	7	Windows	C19			Medium	Moderate	Conservation repairs to windows	Medium beneficial	
	8	Doors	C19 / C20		Four panel, moulded both sides. Door may have been relocated from elsewhere.	Low		DG 35 to be retained. DG36 to be widened for wheelchair access.	Neutral	DG36 modern opening. Widening required for disabled toilet provision.
	9	Fireplace	NA							
	10	M&E	Modern			Detrimental	Major	New WC M&E	Neutral	Modern fixtures.
