HOTHAM HALL
HERITAGE STATEMENT
ISSUE 01 - MAY 2021

HOTHAM HALL: HERITAGE STATEMENT

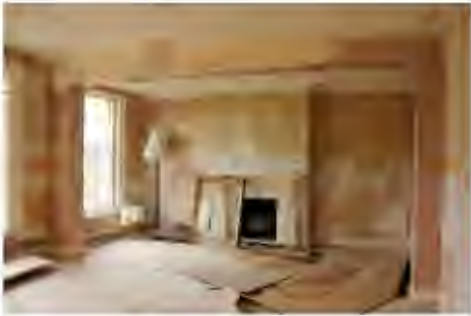
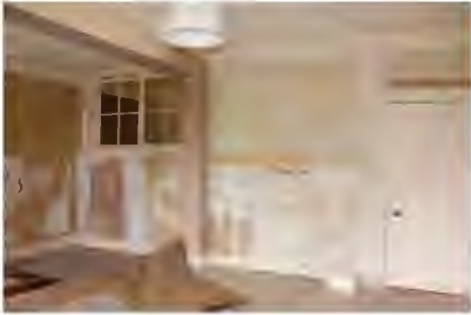
3	Floor	Modern raised floor			Detrimental	Major	Modern raised flooring to be removed and original historic levels restored.	Medium beneficial	
	4	Joinery	C19 / C20	Has joinery to raised door frames been reused or good reproduction?	Generally modern skirtings and architraves. C19 architraves to windows. Suitable mouldings.	Low	Major	Make good following lowering of floor to historic levels.	Low beneficial

5	Plasterwork	C19	Similar to housekeepers room - simple but suitable for servants quarters		Low	Major	Make good following lowering of floor to historic levels.	Low beneficial	
	6	Decoration	C20 with rudimentary C19 paint scheme below			Neutral / Detrimental	Major	Make good following lowering of floor to historic levels.	Low beneficial	
	7	Windows	C19/C20	One window is now a glazed door, created 1980s. Borrowed light window to GF22 corridor not shown on C19 plans - may have been relocated but more likely part of client's changes to proposals.	Borrowed light to corridor. Secondary rising shutters have been removed. Modern secondary glazing detrimental.	Medium	Moderate	High-level window to GF22 (corridor) to be removed. Removal of ground floor windows (windows WG-29 and WG-30) and openings extended down to floor level for the installation of a glazed timber single doors to new terrace.	Low adverse	Minor loss of C19 fabric to create doors from window openings. Shutters were removed in C20 when floor raised. Impact on external appearance to be assessed as part of external proposals.

8	Doors	C19 /C20		Door to exterior modern. Others four panel moulded	Low	Major	Loss of door to corridor as part of wall removal.	Neutral	
	9	Fireplace	C19 with modern log basked and back board	Raised or relocated from elsewhere? Missing CI grate.		Low	Major	Reinstate fireplace GFP06 with new hearth at original level. GFP08 to be opened up into double fireplace.	Neutral	
	10	M&E	Modern			Detrimental	Major			
	11	Fixtures								
	12	Other								
	GF17	Corridor to service rooms	Key dates	Research comments	Key features	Significance	Capacity for change	Proposals	Impact	Commentary
 	1	Walls	C19		C20 finish	Medium	Moderate	Steps to be removed. Walls to north and south (rooms GF21 and I3) removed to create large single space.	Low adverse	Opening up of walls into the corridor results in loss of fabric and some plan form but is mitigated by retention of nibs, downstands and remainder of corridor space. Floor coverings will indicate a change between the spaces and the wall loss is not full width. Steps of no heritage value.

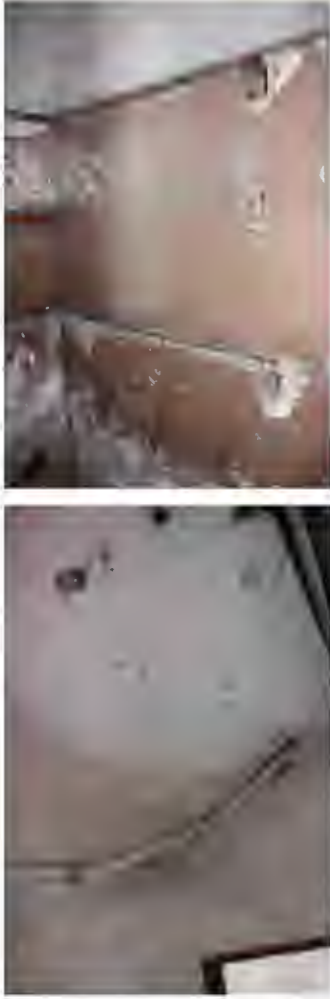
GF18	Store	Key dates	Research comments	Key features	Significance	Capacity for change	Proposals	Impact	Commentary

1	Walls	C19	C19 plans indicate this was a storage cupboard. The ghost lines of shelves would suggest this changed little until recently.	Curved wall separates this from boiler room	Low	Major	Removal of GF18 (store room) and associated walls.	Low adverse	Original 1870s store cupboard, loss of understanding and historic fabric.
	2	Ceiling	C19			Low	Major			
	3	Floor	C19		Stone flags in poor condition	Low	Major			
	4	Joinery	C19		Simple moulding to room with hist paint	Low	Major			
	5	Plasterwork								
	6	Decoration	Historic			Low	Major			
	7	Windows	C19		Small sash retains metal bars and historic paint finish	Medium	Moderate	Conservation repairs to windows	Medium beneficial	
	8	Doors	C19		Four panel - moulded to corridor and not to room. Retains historic paint finish internally. Hist rim lock and door furniture.	Low	Major	Door from GF17 (corridor) removed and blocked.	Low adverse	Minor loss of historic plan form/feature.

9	Fireplace	NA							
	10	M&E	Hist / mod		Lead water pipe runs around curved wall.	Low	Major			
	11	Fixtures			Fitted shelves			Removal of internal shelving	Low adverse	Minor loss of historic feature.
	12	Other								
	GF17 / 16	Corridor to service rooms / stair	Key dates	Research comments	Key features	Significance	Capacity for change	Proposals	Impact	Commentary

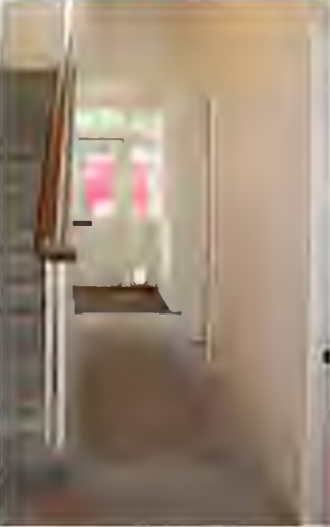
1	Walls	C19		C20 finish.	Medium	Moderate	Openings to GF19 and GF18 blocked off. Opening to GF20 reconfigured.	Low adverse	Minor loss of historic plan form.
	2	Ceiling	C19		C20 finish	Low	Major			
	3	Floor	C19 with C20 finish	C19 floor unclear - may be stone flags. C19 plans indicate that corridor was to be stone flags.	Marley tile probably C1960 - detrimental.	Low	Major			
	4	Joinery	C19		High skirtings and architraves	Low	Major			
	5	Plasterwork	C19		Simple, low moulding to cornice	Low	Major			
	6	Decoration	C20			Neutral	Major			
	7	Windows	C19		Borrowed lights to corridor. Stair and backdoor are glazed and historic	Low	Major	Conservation repairs to windows	Medium beneficial

8	Doors	C19 / C20		DG 31 leading up to raised flooring is a modern insert. Elsewhere historic four panel doors to all rooms. Back door historic with glazed upper lights and flat moulded external lower panels externally and deeply moulded internally. Retains shutters which have been damaged.	Low	Major	Formation of new double doorway to east.	Neutral	
	9	Fireplace	NA			Low	Major			
	10	M&E	C20		Pipework intrusive	Detrimental	Major			
	11	Fixtures	NA							
	12	Other	C19 / C20		Steps to GF22 modern and intrusive. Servants stair - stone open string stair with hardwood handrail, simple balusters and moulded skirting. Timber panelling to understair cupboard	Medium / Low	Moderate (hist stair) Major (modern stair)

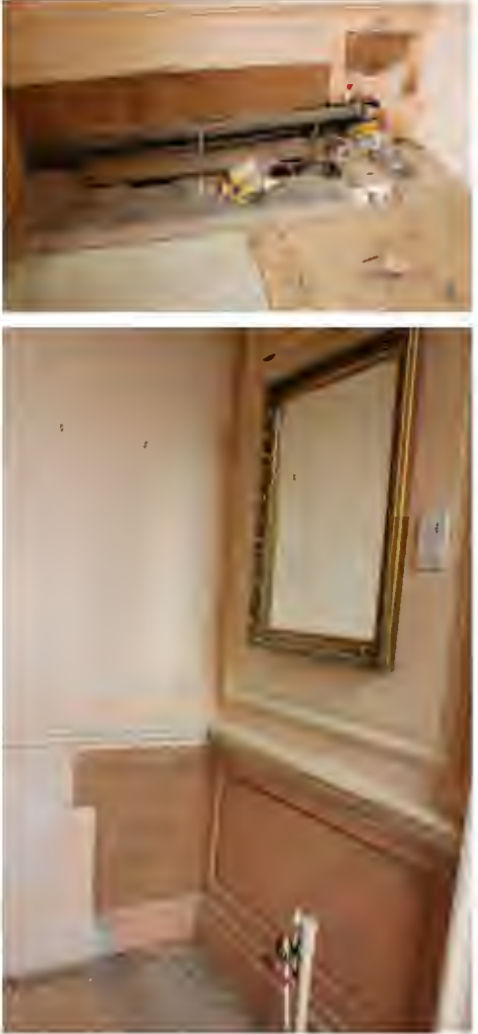
FF07	Ensuite (former dressing room)	Key dates	Research comments	Key features	Significance	Capacity for change	Proposals	Impact	Commentary

1	Walls	1720s		Walls hidden by full height panelling	High	Minor	Form new opening between FF07 (bathroom) and FF08 (bathroom).	Low adverse	Create small opening through original external wall fabric from 1720s house into 1870s. Some precedence for this set by C19 opening for FF09 (adjacent). Blind windows in this location also partly mitigate harm. Remodeling of full height panelling. Lower panelling has been historically damaged.
	2	Ceiling	Assumed historic			Medium	Moderate			
	3	Floor	Hist		Damaged by insertion of services	Medium	Moderate			
	4	Joinery	C18 and modern	Note handmade nails used to rear of upper panels, holding them in place (as seen in opening up works)	Lower panels damaged by insertion of services. Fielded panels below dado are mainly chipboard with some modern applied mouldings elsewhere. Panelling above dado is historic.	Medium	Moderate

5	Plasterwork	Historic		Moulded cornice	Medium	Moderate			
	6	Decoration	Modern			Neutral	Major			
	7	Windows	C19 / C20	Narrow glazing bars throughout C18 element - all (apart from service stair window) replaced and repaired C19 through C20. Limited evidence of historic glass throughout Hall.	2 x 2 inappropriate for 18th century element of hall	Medium	Moderate	Conservation repairs to windows	Medium beneficial	
	8	Doors	Hist		Note architrave mouldings similar to main door	High	Minor			
	9	Fireplace	NA							
	10	M&E	Modern			Detrimental	Major			
	11	Fixtures						Remove modern bath, WC, sink. New work surface and sink installed.	Neutral

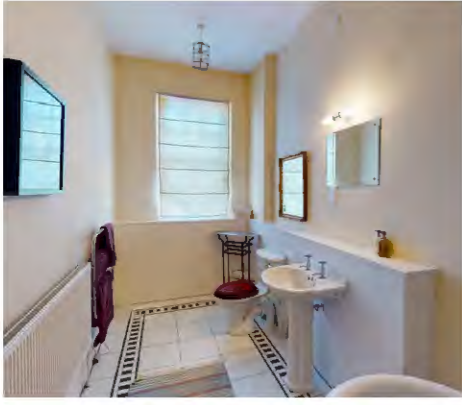
1	Walls	1872		Simpler than rooms further to the east. Lower ceilings, shorter doors.	Low	Major	Two new openings in wall between FF20 (bathroom) and FF18 (bedroom) to create en-suite and closet. New partitions within bathroom to create shower and WC rooms.	Low adverse / Neutral	Minor loss of historic fabric between two rooms. However, no features in this space of historic value.	
	2	Ceiling	C19		Hatch into roof space	Low	Major				
	3	Floor	C19 with modern finish				Low	Major			
	4	Joinery	Modern			Modern boxing of services, modern skirting	Low	Major

6	Decoration	Modern			Neutral	Major			
	7	Windows	C19			Medium	Moderate	Conservation repairs to windows	Medium beneficial	
	8	Doors	C19			Low	Major	Doorway to corridor (FF19) blocked.	Low adverse	Loss of plan form, but reversible.
	9	Fireplace	NA			Low	Major			
	10	M&E	Modern		Large panel radiator, pendant light	Detrimental	Major			
	11	Fixtures	Modern bathroom suite			Neutral	Major	Modern WC, sink and bath removed and replaced.	Neutral	
	12	Other								
	FF18	Bedroom	Key dates	Research comments	Key features	Significance	Capacity for change	Proposals	Impact	Commentary
 	1	Walls	1872		Simpler than rooms further to the east. Lower ceilings, shorter doors	Low	Major	Two new openings into FF20 (bathroom) in existing wall, to form en-suite and wardrobe.	Low adverse	Minor loss of historic fabric between two rooms.
	2	Ceiling	C19			Low	Major			
	3	Floor	C19 with modern finish			Low	Major			
	4	Joinery	C19		No shutters to windows. Panelling below	Low	Major

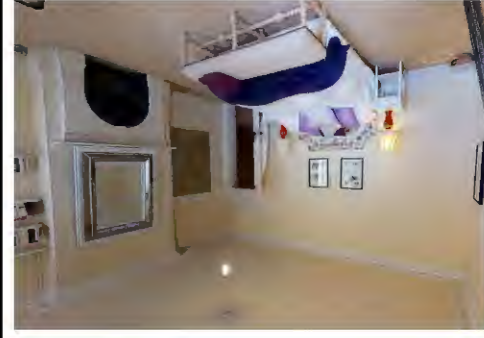
This bedroom feels like it's the last of the polite bedroom associated with the eastern end of this floor. Similar FP to bedrooms to east, window has shutters. This concurs with fabric evidence which suggests the door between FF23 into FF19 has been repositioned and was originally further west.
