TREE PROTECTION (DB-TP-21)

Site plan showing position of Category C Tree, Cedar T35
of report by Elliot Consultancy Ltd, Arboricultural Consultants
for Raby Estates 2008, planning consents 6/2009/2012/13/14/DM/LB/CA

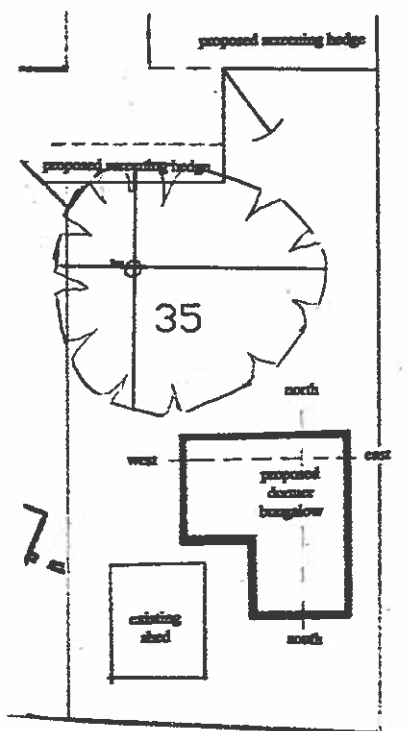
Scale 1:400 North ↑

The trunk at 1.5m high measures 2.28m, giving a diameter of 72.5cm. This means it needs a Root Protection Zone of 8.7m radius. The nearest point of the proposed bungalow is to be 9m from the tree.

The crown of the cedar shown on the diagram is from Elliot Consultancy drawing ARB/AE/296/TCP. The east side of the crown is shorter now because of the missing three branches.
