REMEDIATION METHOD STATEMENT

**LOWER BARN FARM
BAYLHAM
SUFFOLK
IP6 8JP**

**Reference Number 2938/Rpt 1v1
September 2021**

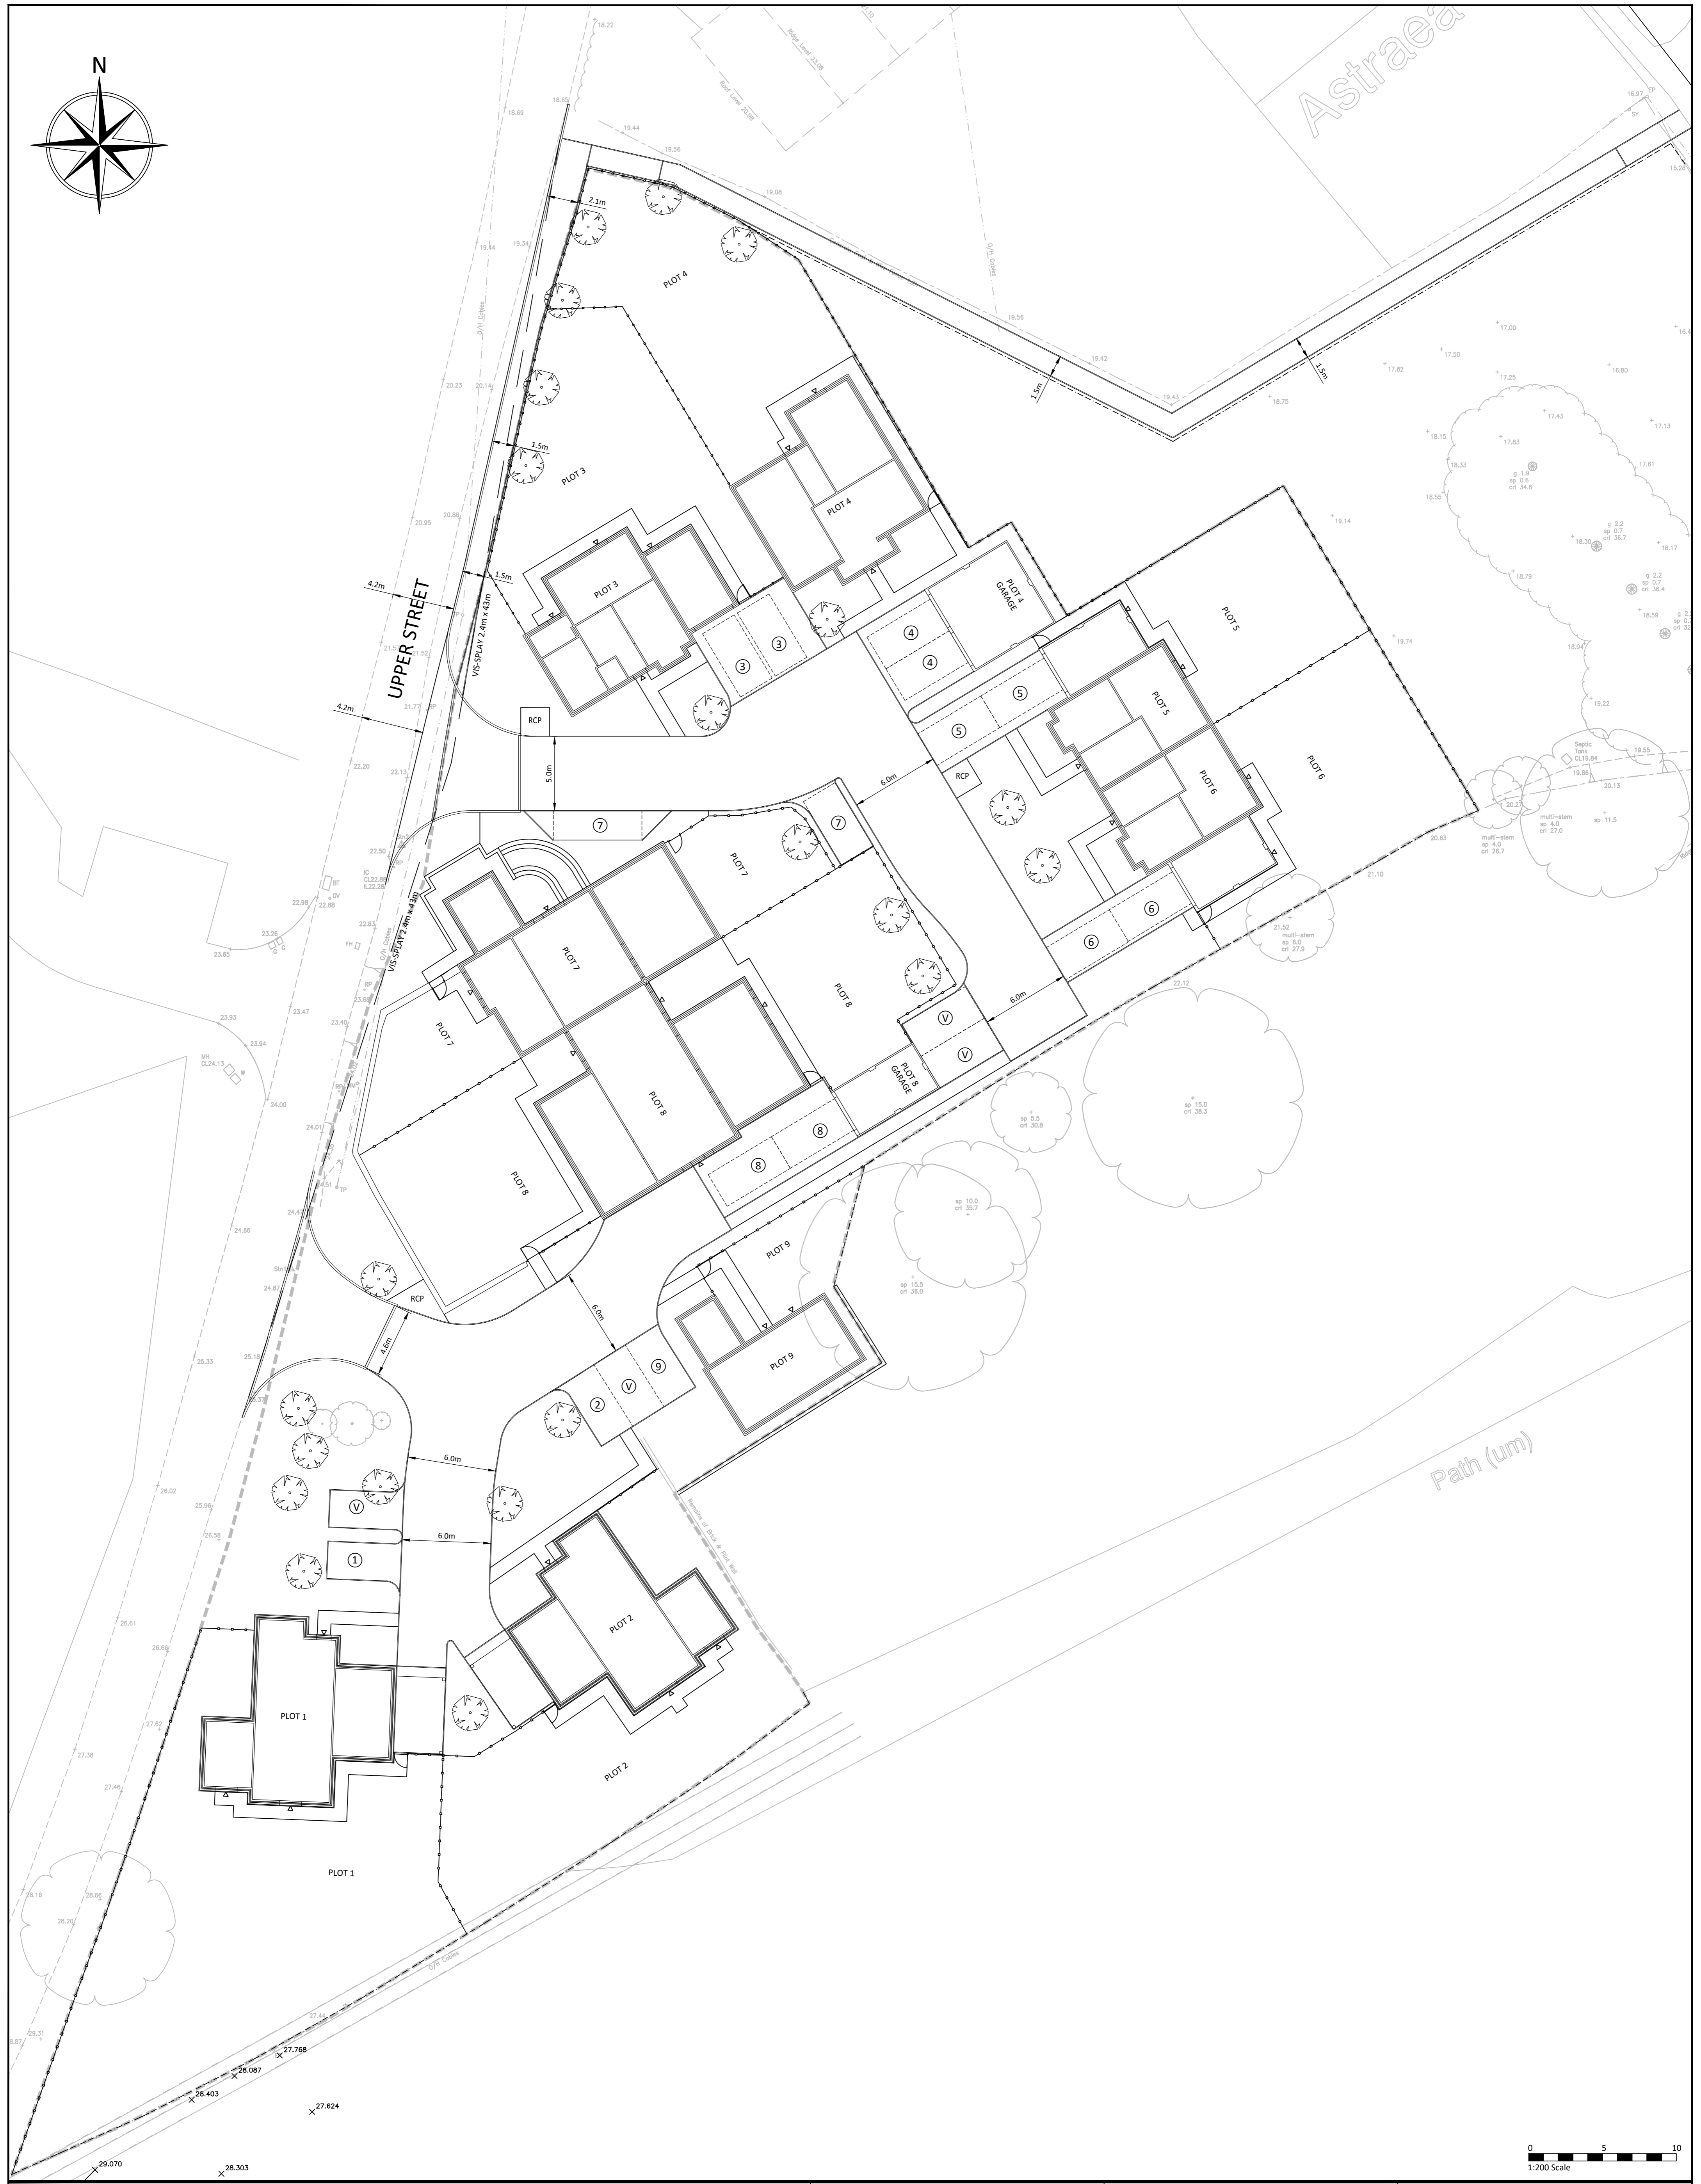
FIGURE 2
PROPOSED DEVELOPMENT LAYOUT

Scale @ A1 1:200	Date Nov 2020	Drawn By IC	Checked by MKP
PRELIMINARY			
Drg. No. 20-001/CE/001		Revision P7

The development consists of the demolition of the existing buildings and erection of eight dwellings with associated parking and private gardens. The proposed layout is presented in a drawing prepared by Icen Consulting, drawing number 20-001/CE/001 rev P7. The proposed development layout is presented in Figure 2.
