**Raby Estate – Park and Gardens**  
**Gas House**

Heritage Impact Assessment, Design and Access Statement

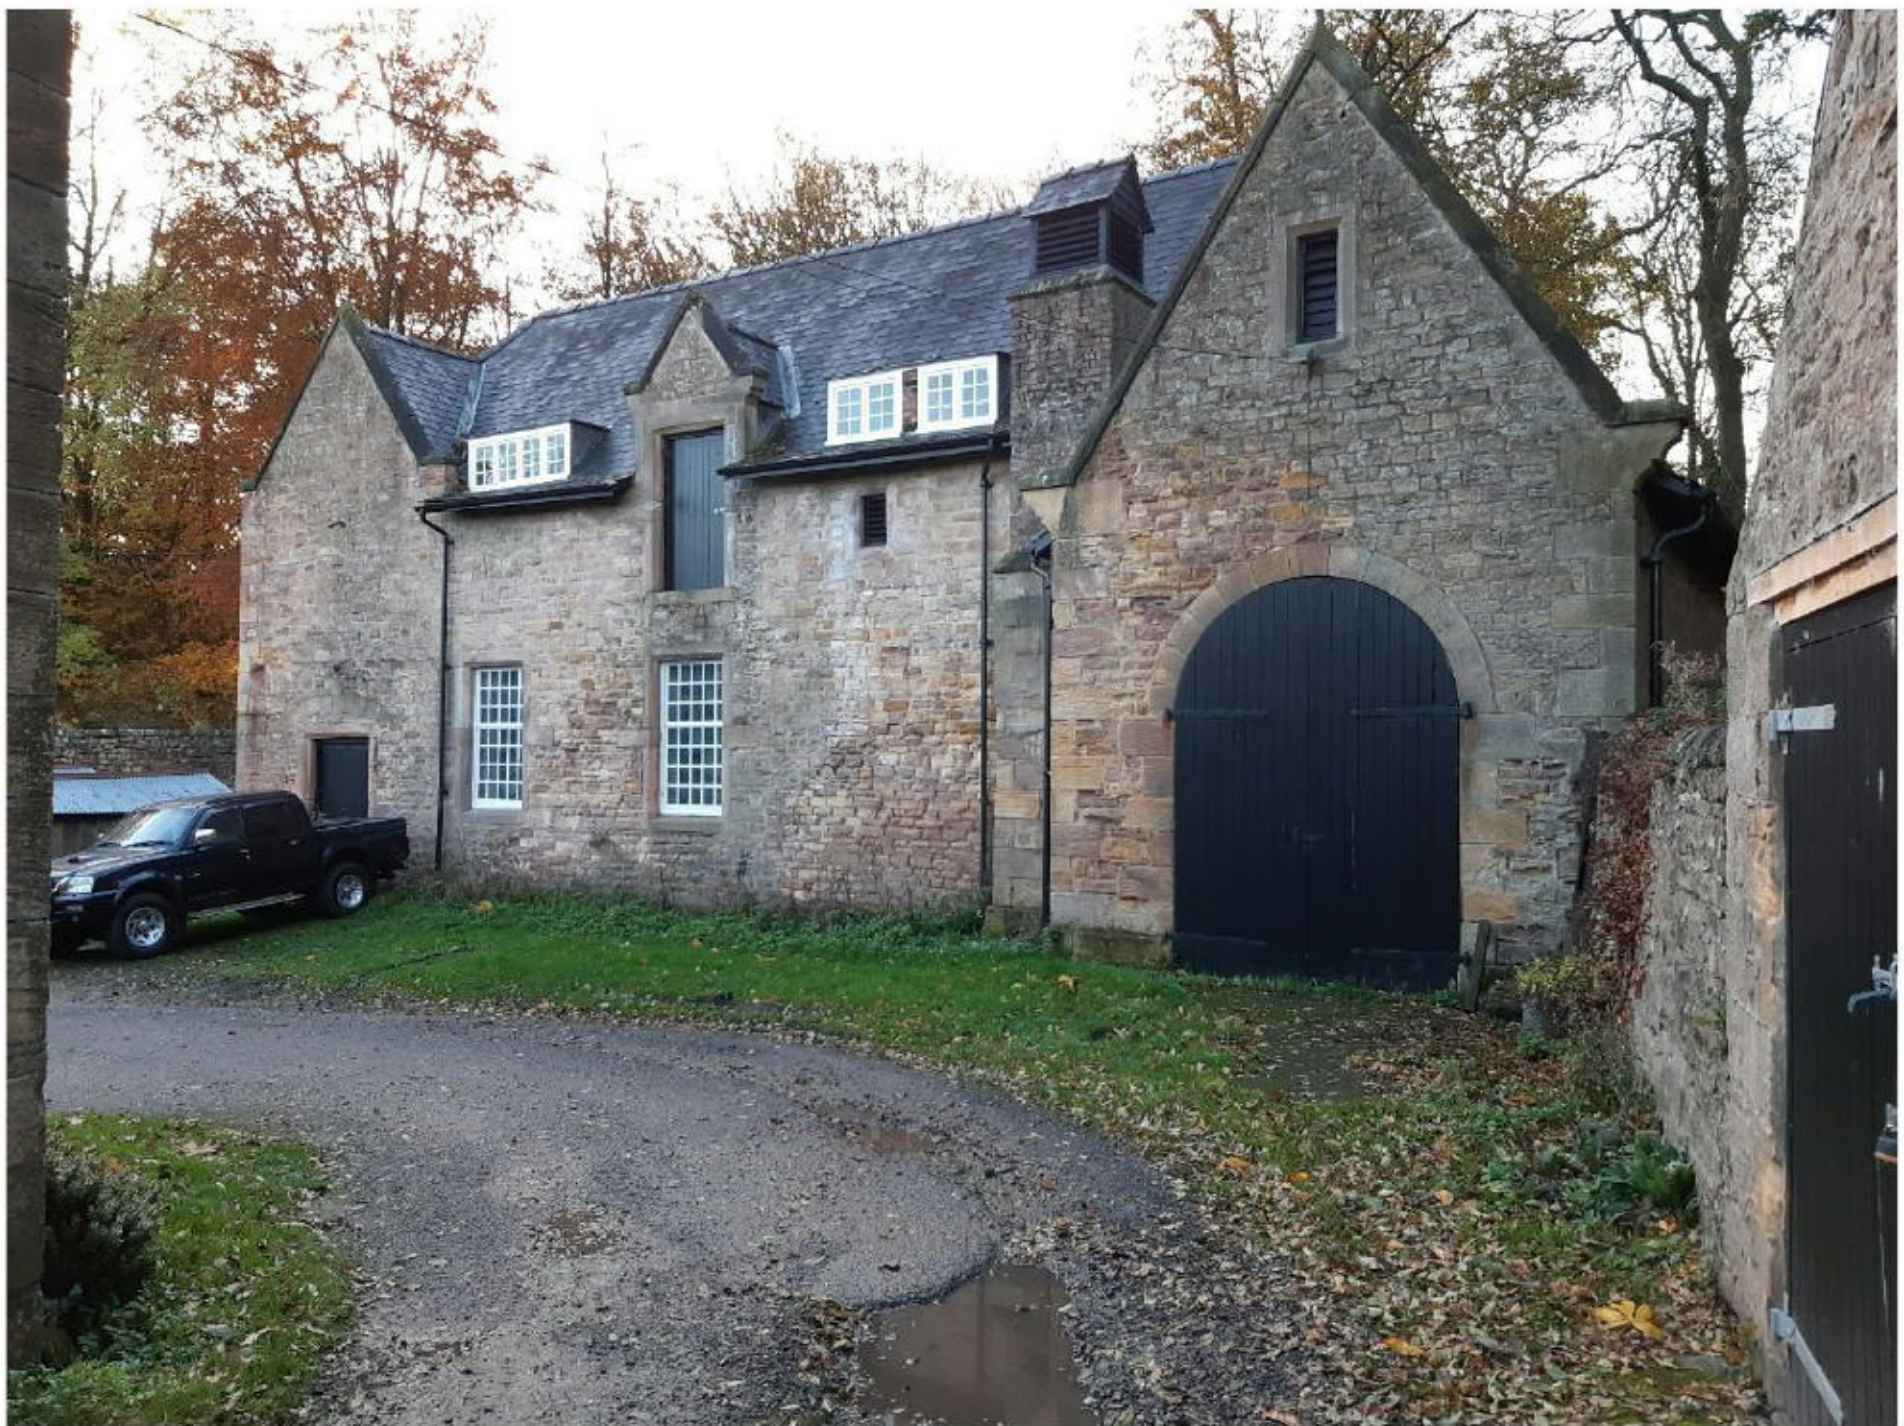
The Gas House from the East – November 2019

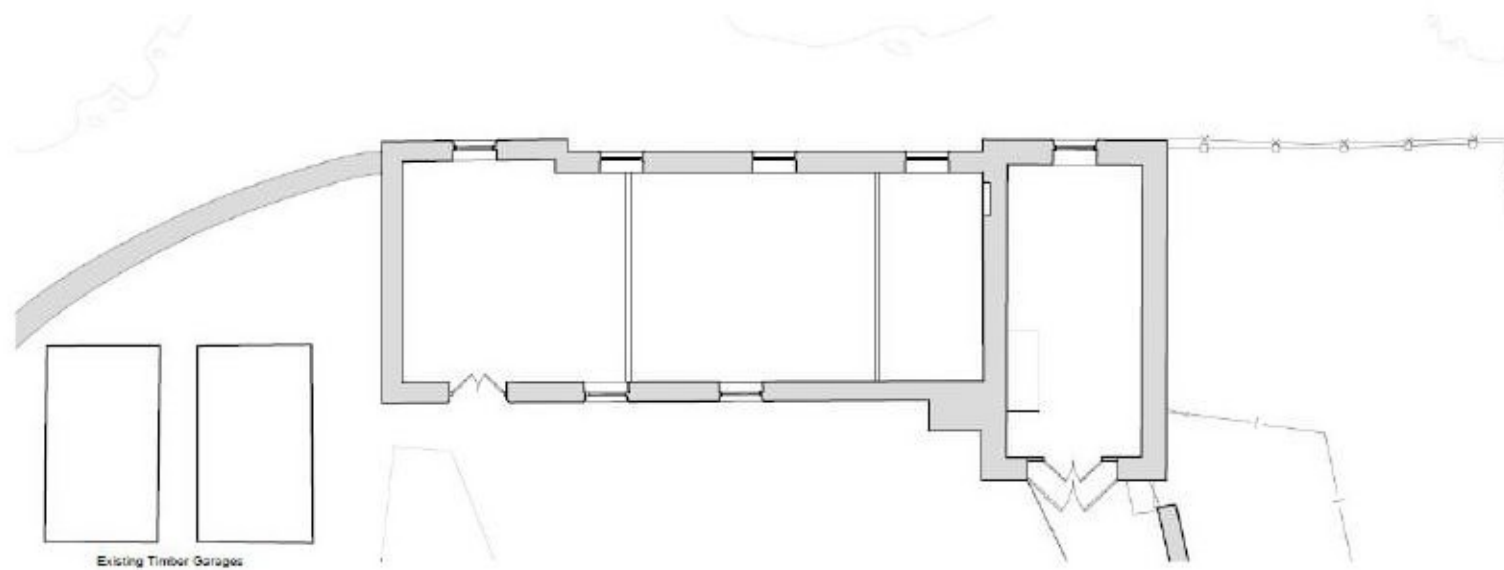
Image 1: Floor Plans

Ground Floor Plan as existing.

Internally, there are two spaces on the ground floor, which correspond the main part of the building, and to the transverse gable at the northern end. This northern space is currently sub-let and has been lined out, and has an internal stair to a loft storage space. The main space is lined with attractive glazed tiles up to dado height. Surfaces are otherwise plastered.

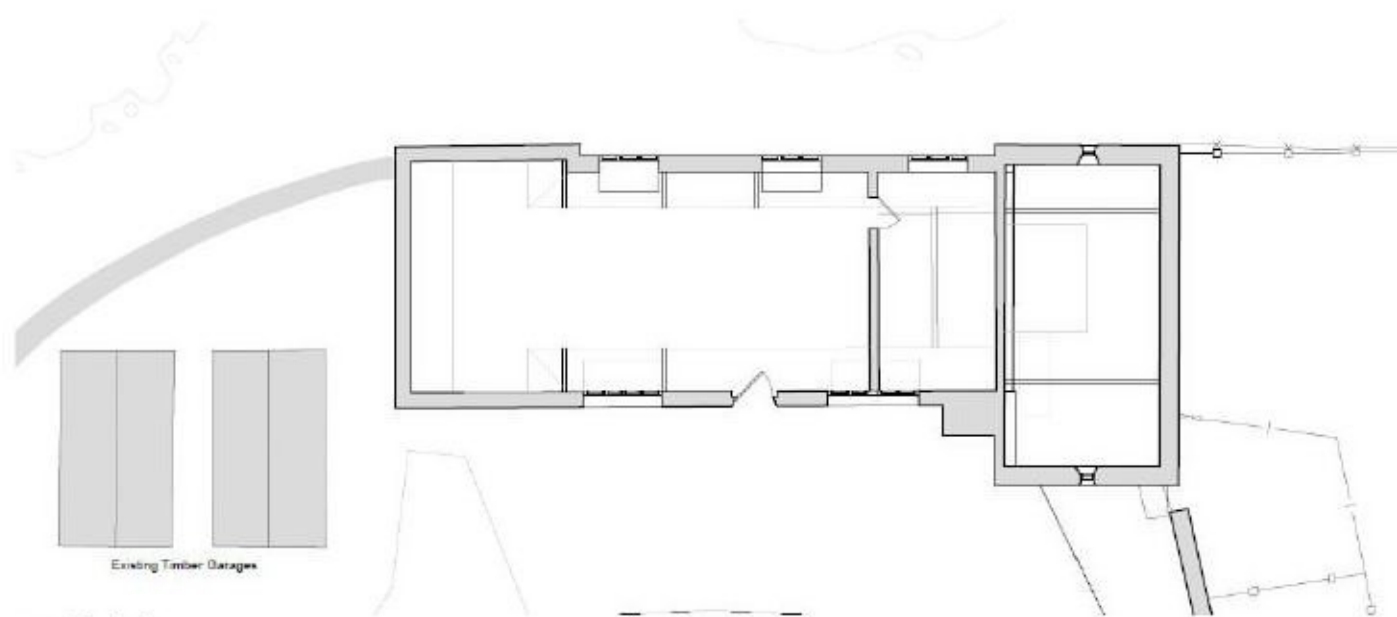
First Floor as Existing

The upper floor structure is of concrete between filler joists to give a fire proof construction some 300mm deep. Immediately below it there are two transverse steel beams which support small rolling pulleys for the lifting of the, now missing, generating equipment.

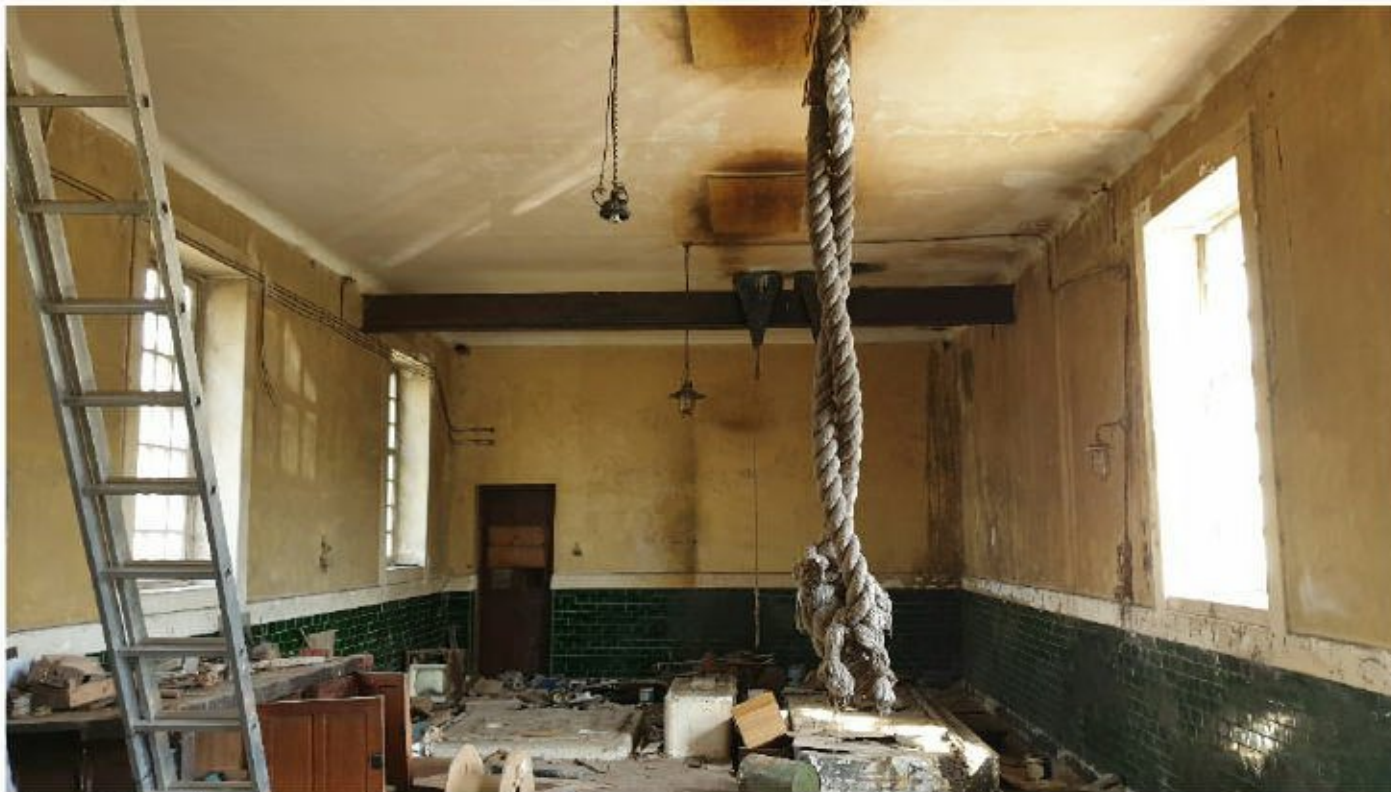
Plate 2: main ground floor room

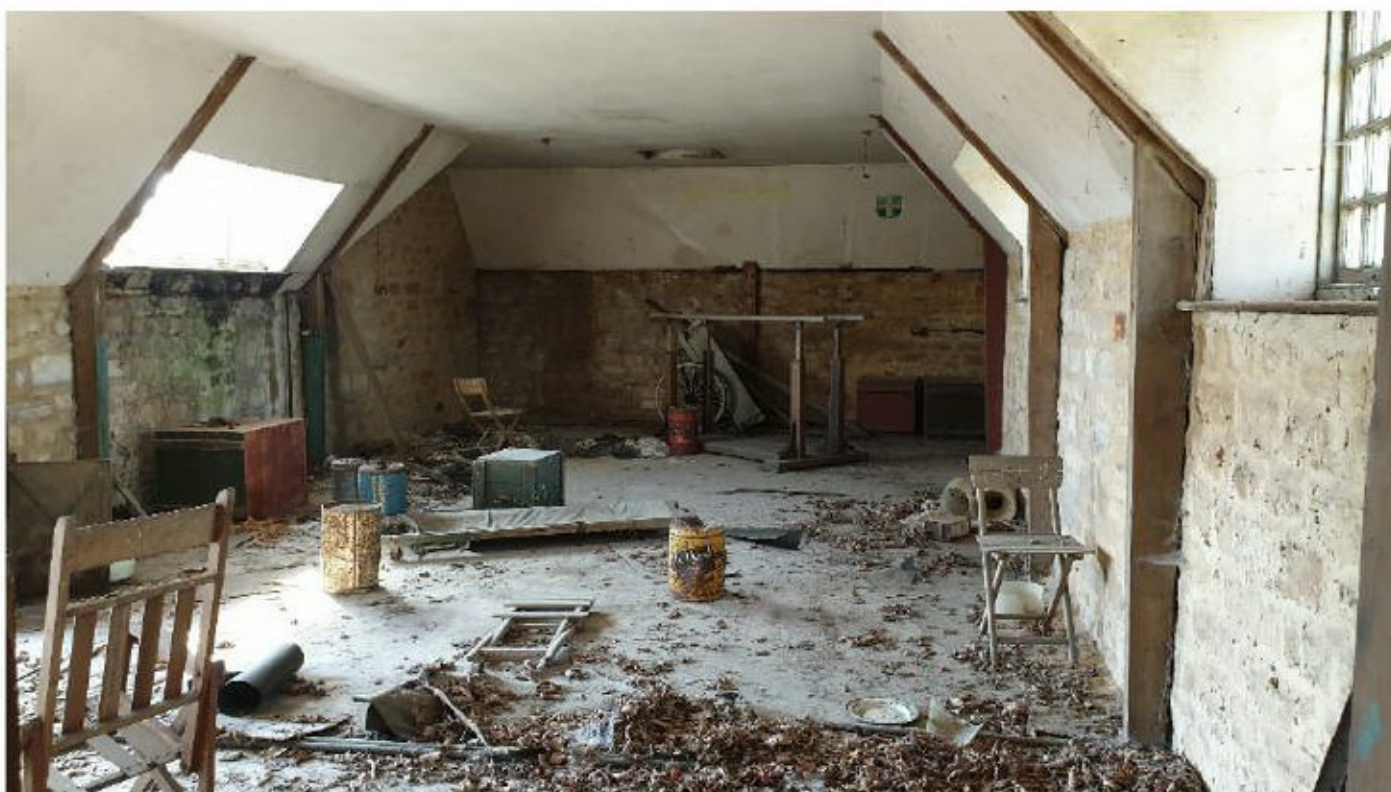
Plate 3: main upper floor room

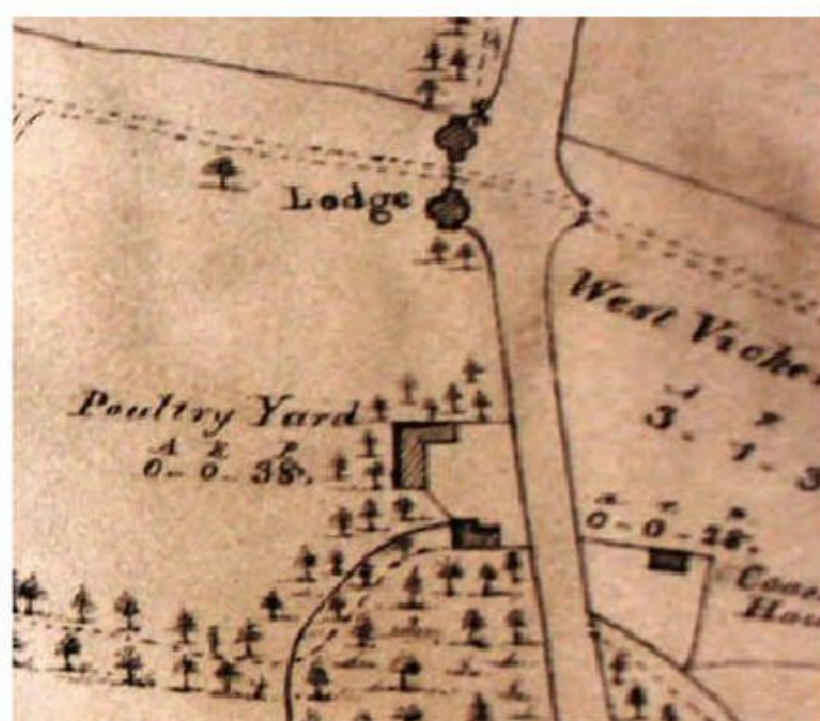
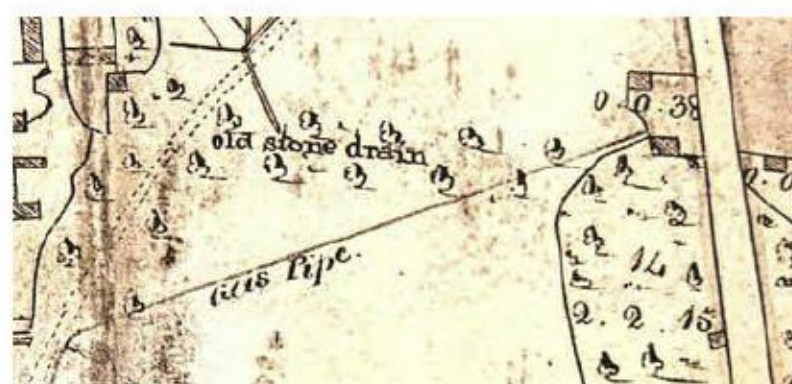
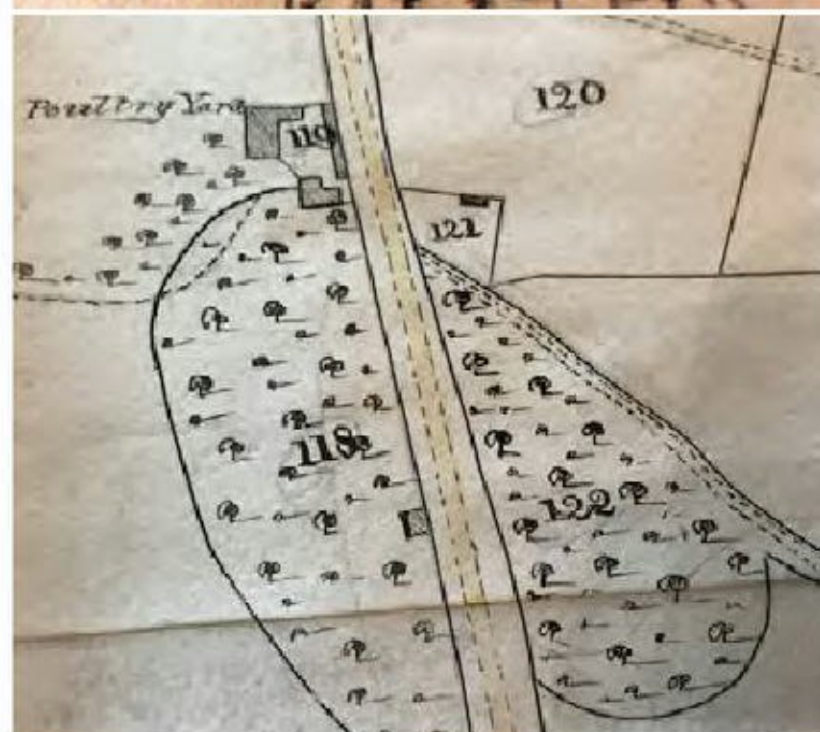
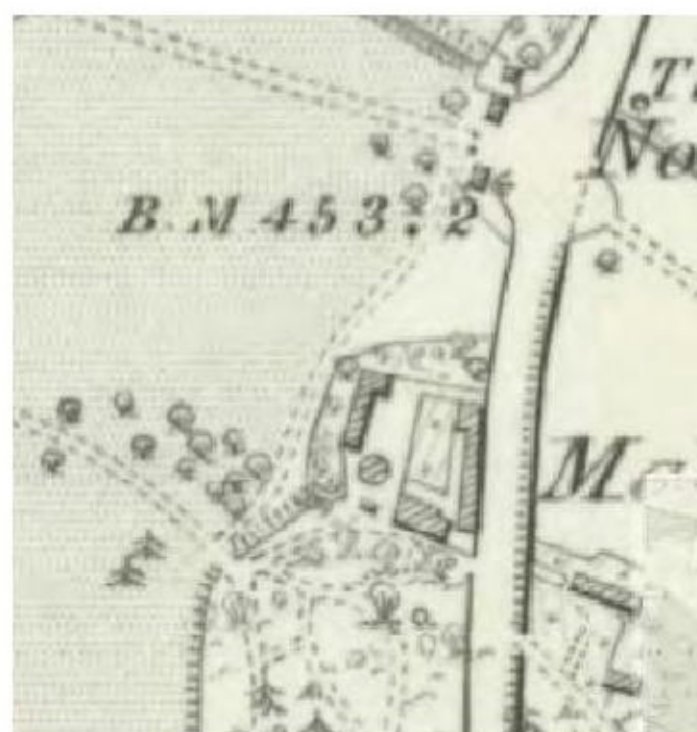
Plate 4 (left) 1812 Plan by John Dixon  
 Plate 5 (above) undated map 1830s.  
 Plate 6 (below left) 1839 tithe map  
 Plate 7 (below) 1856 Ordnance Survey.

The 1812 John Dixon map shows a poultry yard to the south of the north lodge, on the site of the current Gas House. The structure appears to relate to the current footprint of the Gas House, but with a larger L-shaped return. A smaller structure exists to the north. The 1839 Tithe Map shows a similar structure, still in use as a poultry yard. A long range has now been constructed along the road.

The Gas House, built to supply Raby Castle with gas lighting, is possibly first shown on the 1856 Ordnance Survey map for Raby Castle, as a rectangular structure with a short L-return to the north. The footprint of this structure is very similar to the extant building, which therefore dates the structure to the mid-nineteenth century, rather than 1910 as assumed in the list description.

The first Ordnance Survey map of 1856 shows three structures on similar footprints, but the gas house appears to have been built on the site of the older poultry shed. The other two buildings appear to have been retained. A circular gas holder is first shown on this plan.

A schematic, undated plan (assumed to date to the 1830s), is possibly earlier than the 1856 Ordnance Survey map, and shows a gas pipe running from this location towards the Castle. Only two small square structures are shown, which do not relate to any prior or subsequent buildings. The gas-works at Raby Castle were established in 1850 by Henry, second Duke of Cleveland, providing gas

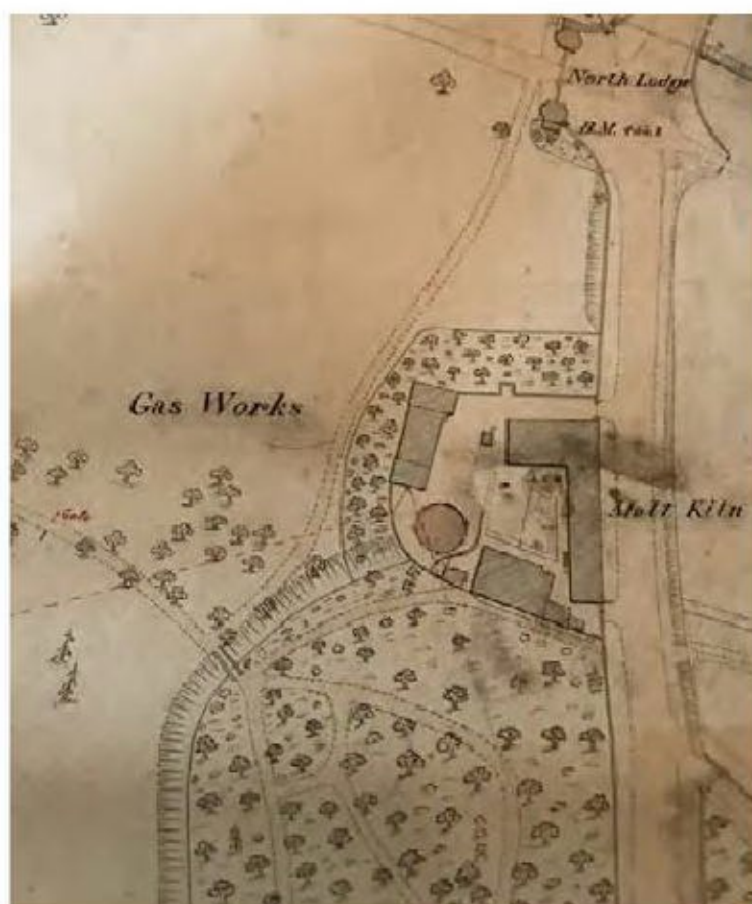
Plate 8 1893 Estate Plan

The 1893 Estate plan by clerk of works W. Livesey gives a detailed plan of the gas works area, which also includes the range along the road annotated as a malt kiln. The route of the gas pipe to the Castle is indicated by a red dashed line. The footprint of the Gas House appears to be exactly as it stands today, with a slightly projecting northern wing.

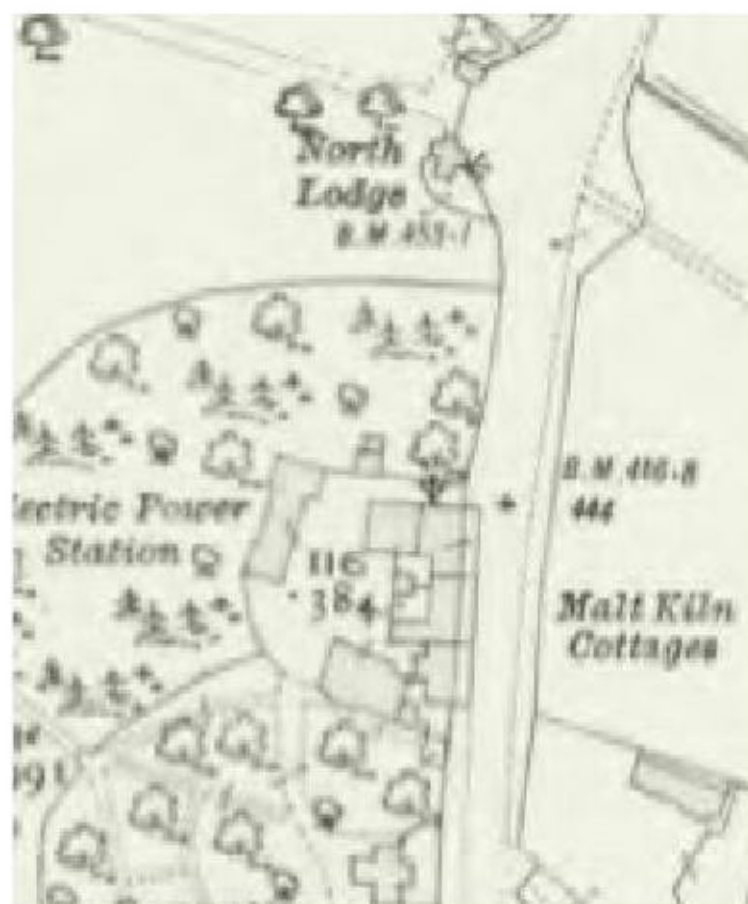
Plate 9 1914 Ordnance Survey map.
