BS5837 Arboricultural Impact Assessment

8 Aldridge Road Villas, London, W11 1BP

Client: **J Arbuthnot**

Job Reference: **03661R**

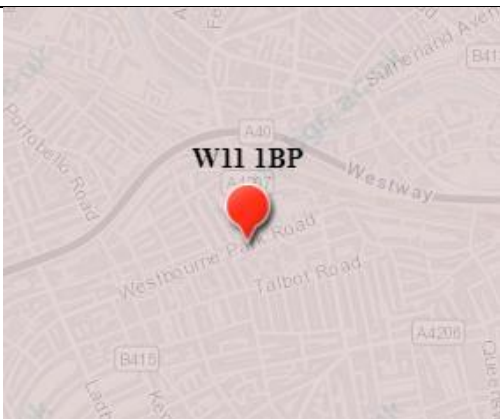
Soil Description

<p>Bedrock: London Clay Formation - Clay, Silt And Sand. Sedimentary Bedrock formed approximately 48 to 56 million years ago in the Palaeogene Period. Local environment previously dominated by deep seas.</p> <p>Superficial Deposits: None recorded.</p>

- 5.1.1 Soil is an important factor in tree growth and the type of underlying soil can impact on successful integration of new developments.
- 5.1.2 A free draining sandy soil containing sand/gravel is likely to lead to water being accessible in the upper horizons during the growing season and available at greater depths and trees will generally be forced to explore a larger volume/ depth on such soils. The structure of such soil also makes compression more difficult (by heavy construction plant) and root penetration is easier for the trees. By comparison, a clay soil is more easily compressed, particularly when wet and compression can have a greater impact on tree health.
- 5.1.3 As shown below the site is located within what is defined as clay. The clay has a thickness up to 150m in depth. (Source: BGS¹).

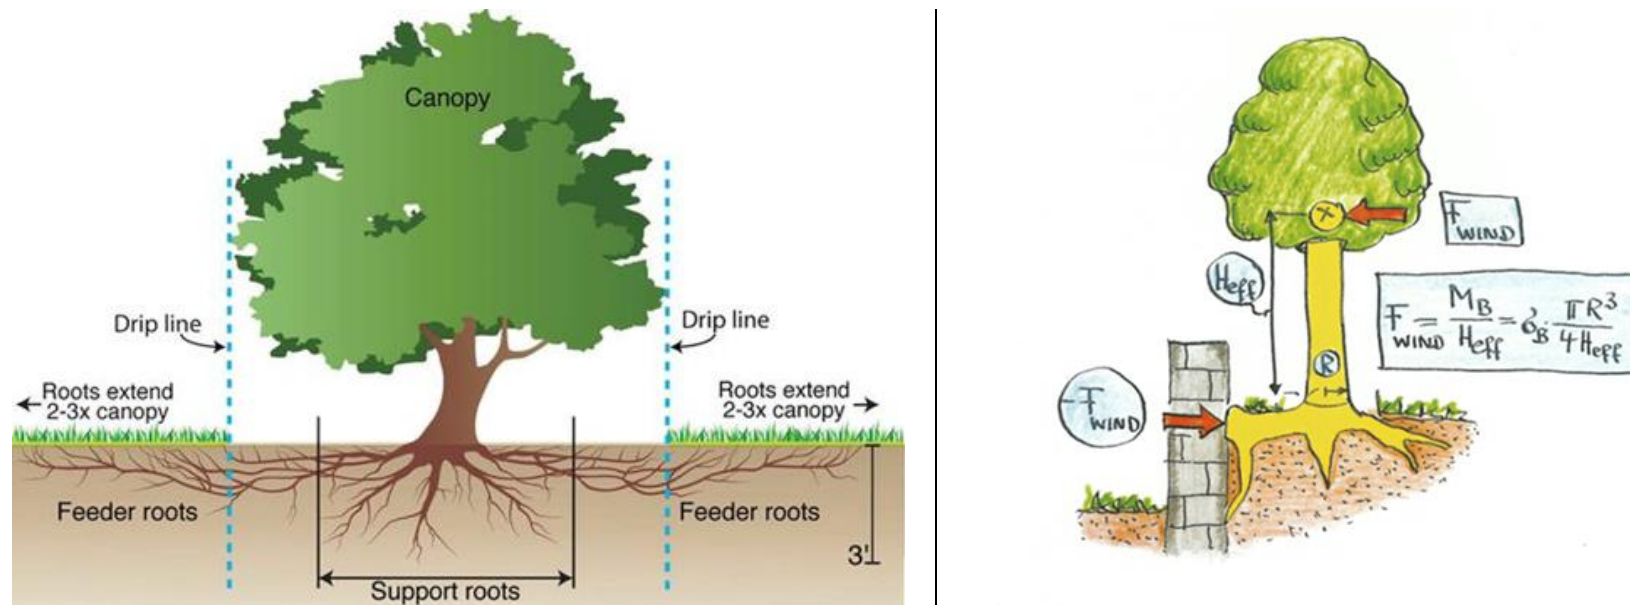
Fig 2 – Open grown trees or those with minimal obstructions close to their stems will have a network of structural roots supporting feeder/ fine root growth beyond (above left). In certain situations root morphology can be affected by structures close to the main stem (above right: Mattheck)

- 5.1.7 Within around 3 to 4m of the base of mature trees there will generally be a structural root system providing both support and the main structure/ root architecture for smaller roots to originate. These larger roots have the very real capacity to be influence by any significant structures (footings, roads to adoptable standard construction etc) where there may be a physical obstruction close to them and this can affect root morphology in such locations. In addition to this there will generally be a noticeable increase in structural rooting to the southwest of mature trees in the UK to reflect the prevailing wind direction, particularly where a tree may be isolated/ open grown increasing its wind exposure. Root growth and location will also be influenced by the presence of other trees, structures sheltering trees etc all of which can combine to affect the shape and location of a structural root system.

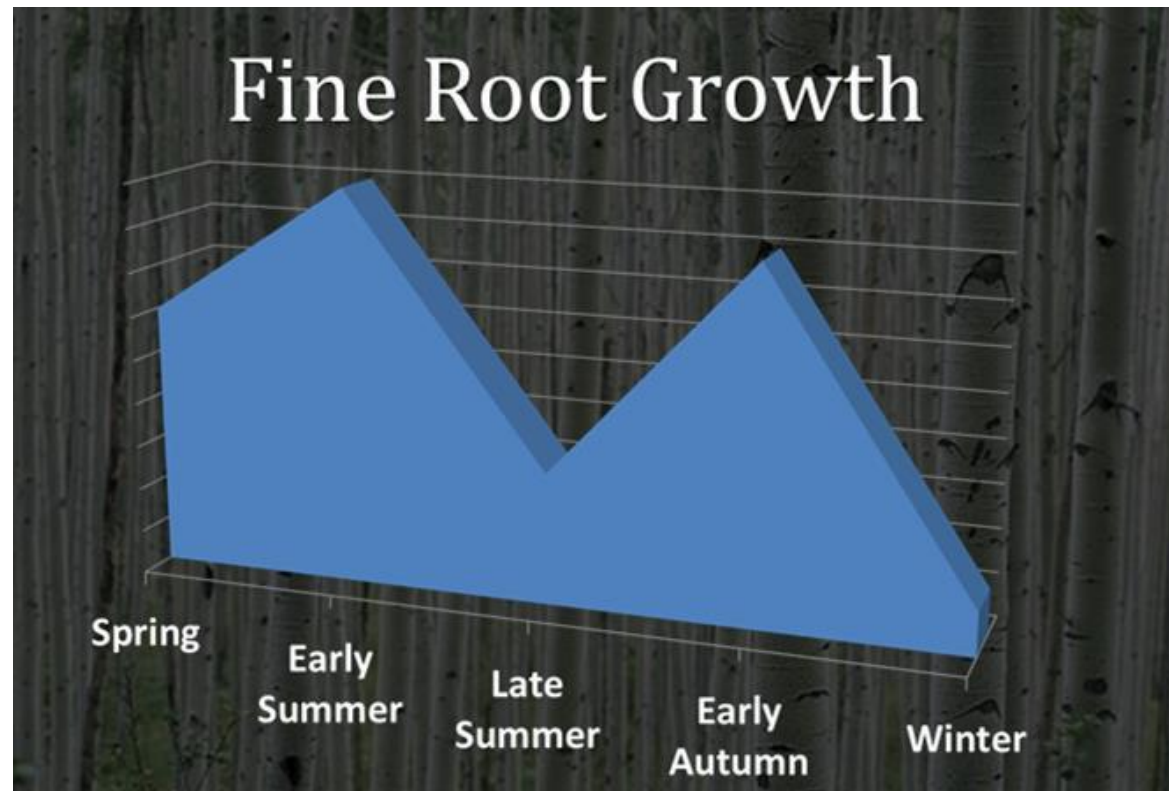
Fig 3 – Fine root growth is (generally) seasonal peaking in late spring and again in early autumn but dying back in winter dormant periods when photosynthetic production ceases. This is an important part of the soil nutrient cycle and demonstrates that a static RPA as calculated by BS5837 is a 'simplistic' view of the tree rooting dynamic. (Image Source: Tamla Trees)

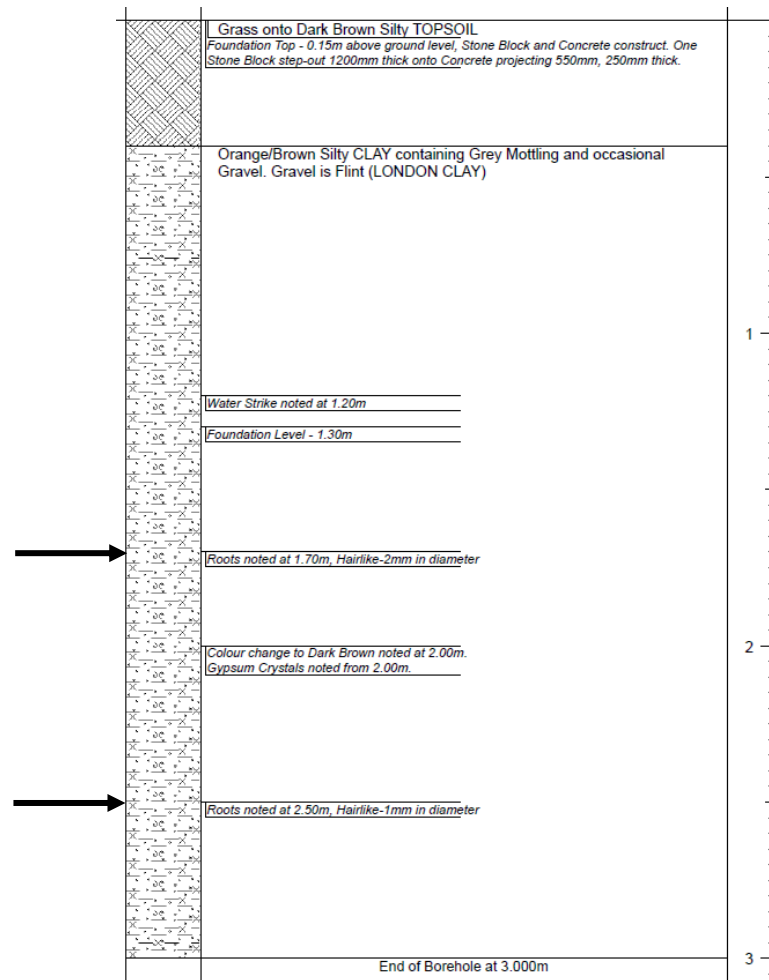
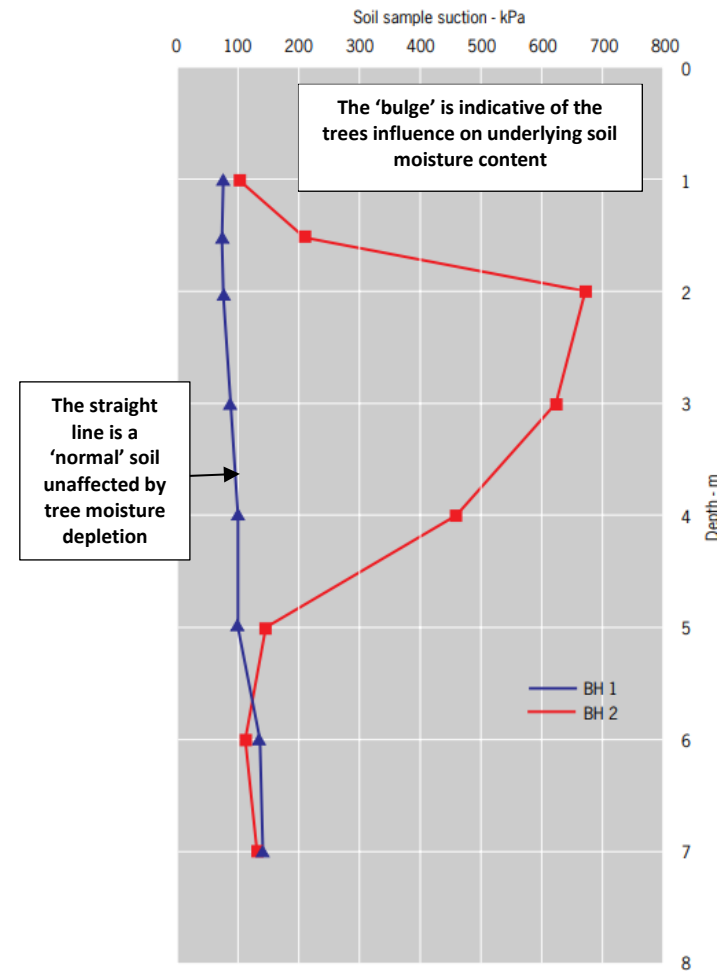
Fig 4 – Borehole log 10m from mature Oak tree on clay soil detailing fine roots to depths of 2.5m indicated with arrows (Source: Tamla Trees project) and annotated soil moisture depletion by trees showing a peak influence at 2m and extending to 5m (above right)

- 5.1.9 The fine root system shows species variation and will also vary in depth (depending on species dynamics and underlying soil conditions). Adopted highways generally have a footing that extends < 0.5m and most UK residential properties have footings in the range of 0.5-1.5m depth. Trees will easily root below these depths and this is evidenced by the fact that every year in the UK there are thousands of tree related subsidence cases.

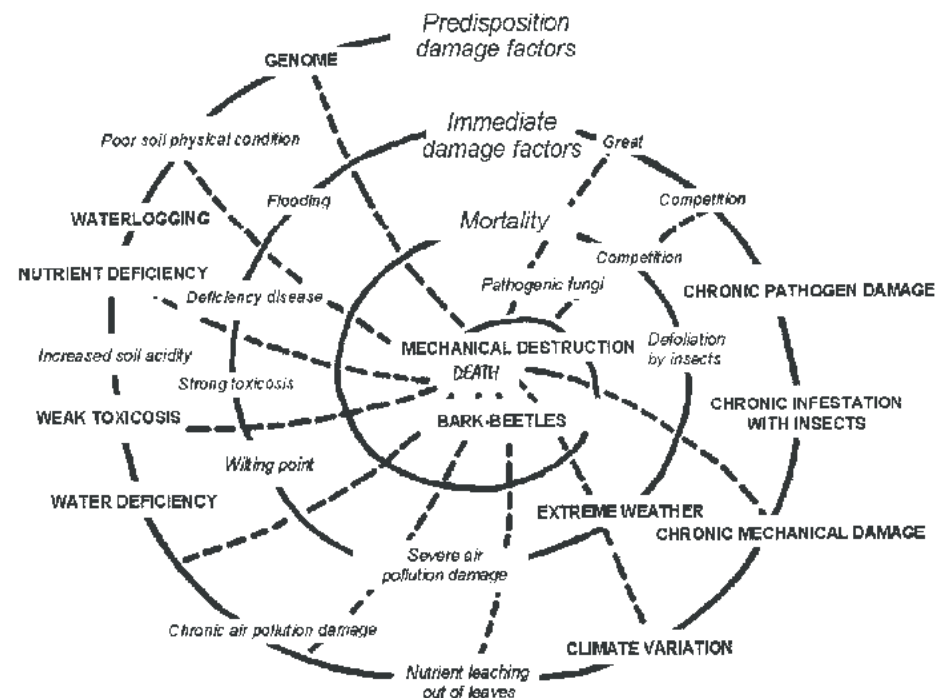
Fig 5 - Manion's spiral of tree decline for Norway Spruce (modified by Mrkva 1993)

5.1.10 Against this backdrop rooting information seeking to manipulate RPA shapes to account for the presence of houses, garages etc outside of the immediate zone of structural rooting (3-4m) is not considered appropriate. Unless ground obstructions are present within the immediate structural rooting area or to such a depth as to nullify potential fine root growth (below basements or retaining wall step changes in levels for example) Tamla Trees Ltd will show RPA's in a circular fashion but seek to maximise the quality and positioning of specified tree protection measures and encourage ground treatments (such as mulching – see Section 5.7). **Clients and developers must implement these measures for them to be effective. A failure to protect trees during the development process adversely affects soil and roots. Symptoms may not present themselves for a number of years following the development as the tree(s) enter a spiral of potentially irreversible decline.**

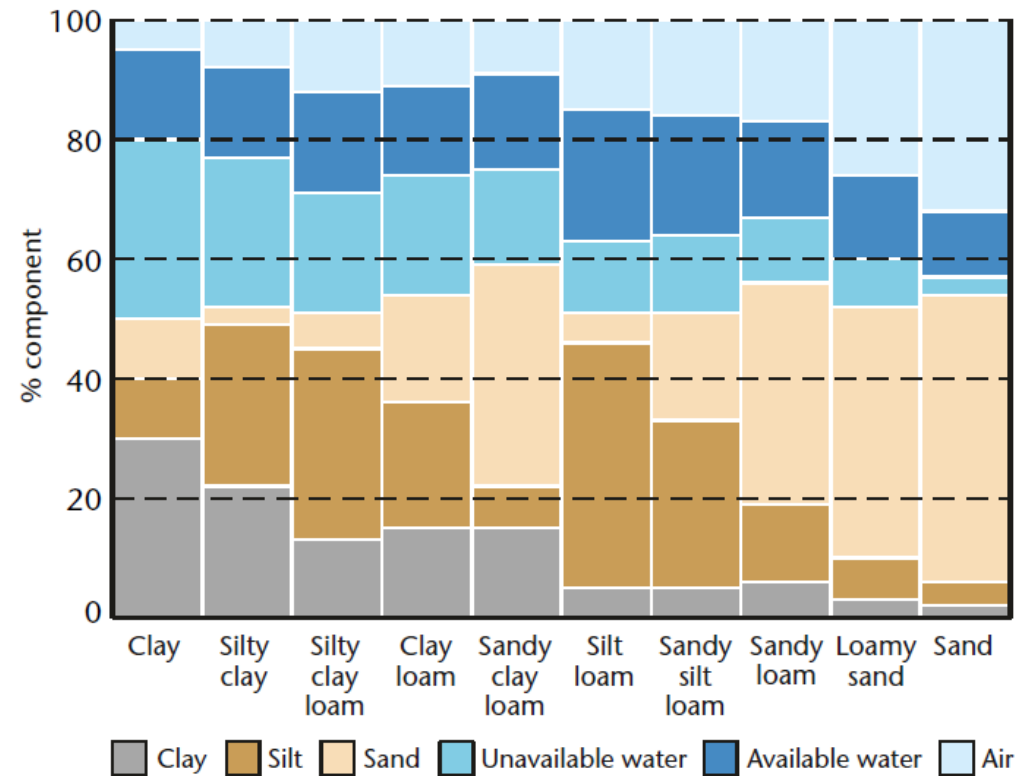
Fig 6 – Diagram showing the typical particulate composition and air/ water content at field capacity for mineral soil types⁵ The variation in soil type has a direct bearing on the potential impact of adverse construction techniques (such as soil compaction) as well as overall root system morphology & development. Clay soils tend to have shallower rooting as moisture remains readily available while soils containing free draining gravel and sand can encourage deeper rooting based on reduce soil bulk density and greater seasonal variations in moisture availability. The underlying clay means bound moisture within soils remains at a high level.

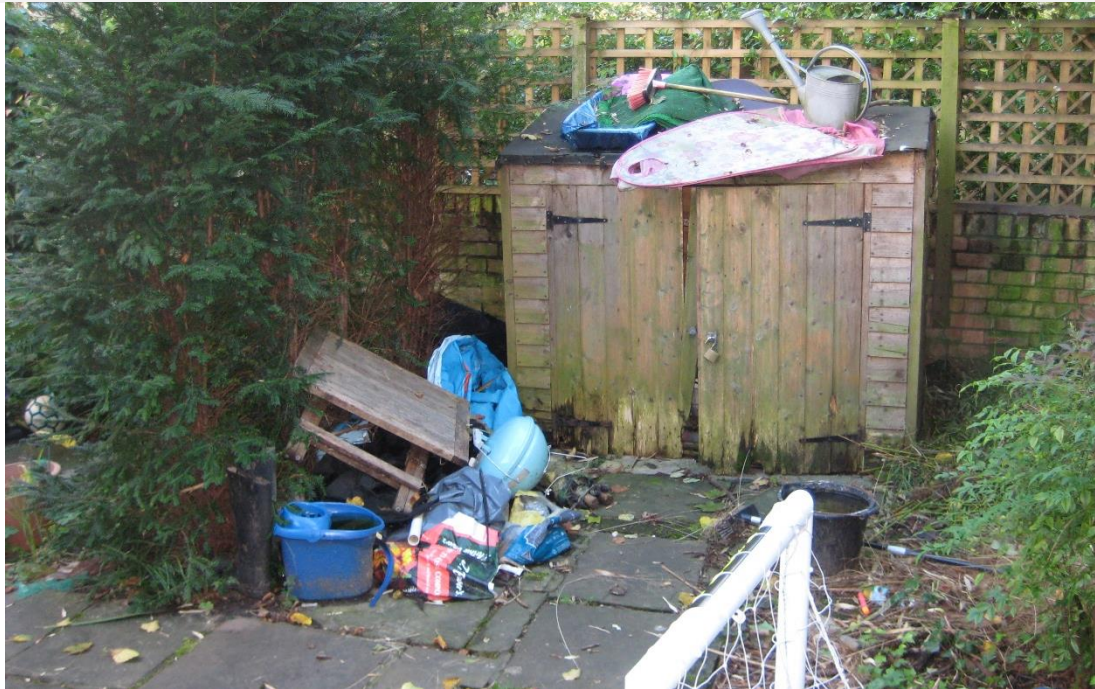
Existing Shed Removal

- Existing structure (shown left) removed by hand to provide access to/ clear work area.
- Paving slabs lifted as required.
- H1 visible (left).

5.4.1 The existing small storage unit and paving lifted as required, area to be cleared by hand prior to installation.

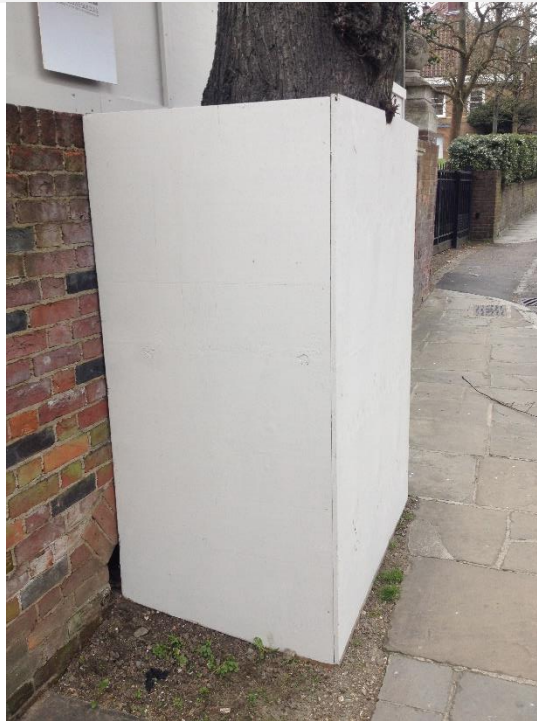
Tree Protection

- *Tree protection required internally to site (T1 & T3).*
- *Installed prior to any onsite works.*
- *Note: To be marked with signs (inset) and purpose to be briefed to all ground workers.*
- *Maintained for duration of the build.*
- *Bespoke plywood frames as indicated at Appendix 6.*

- 5.4.3 T1 and T3 will be basally shuttered with bespoke plywood frames given branch heights and space does not allow for panel (herras) fencing. Please refer to the plan at Appendix 6 for further information on locations.

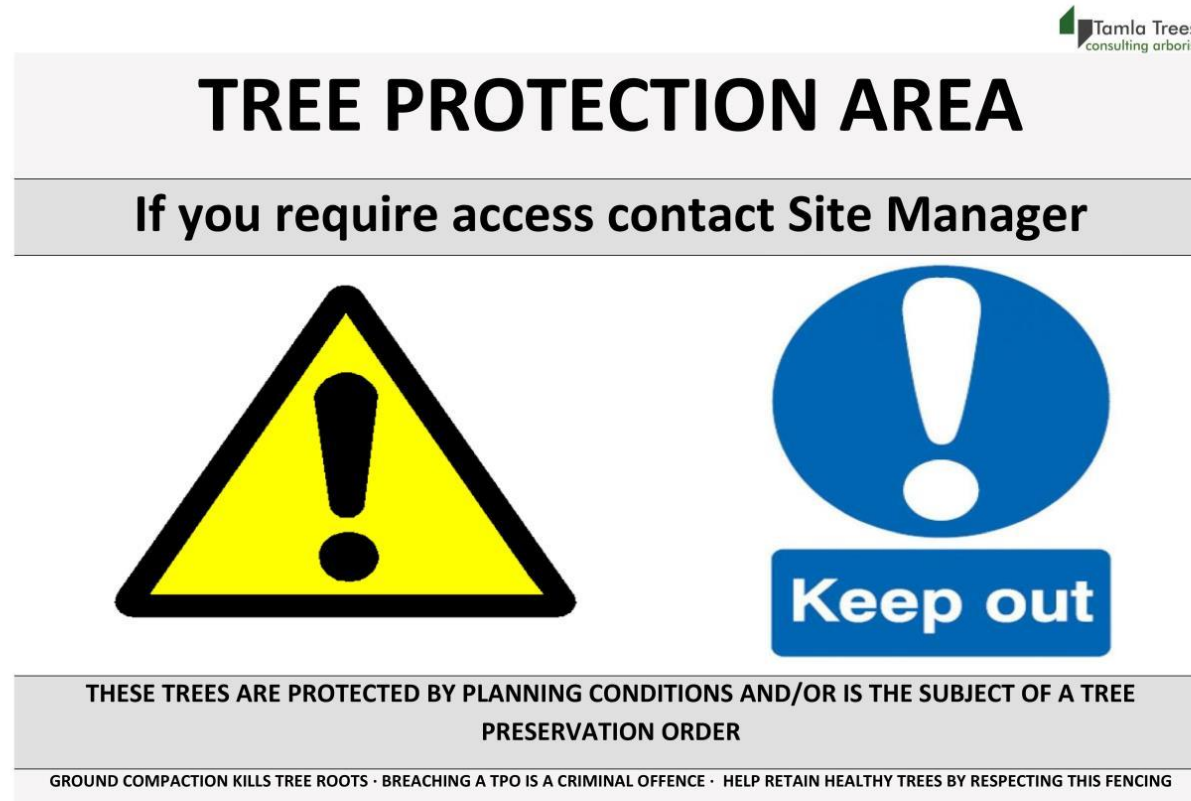
Fig 7 – Professional grade weatherproof tree protection signs no smaller than 297 x 420 mm (A3) will be located at 5m intervals and all ‘return’ faces for tree protective fencing

5.4.4 All internal tree protection must be appropriately signed to ensure that all site operatives know its purpose.

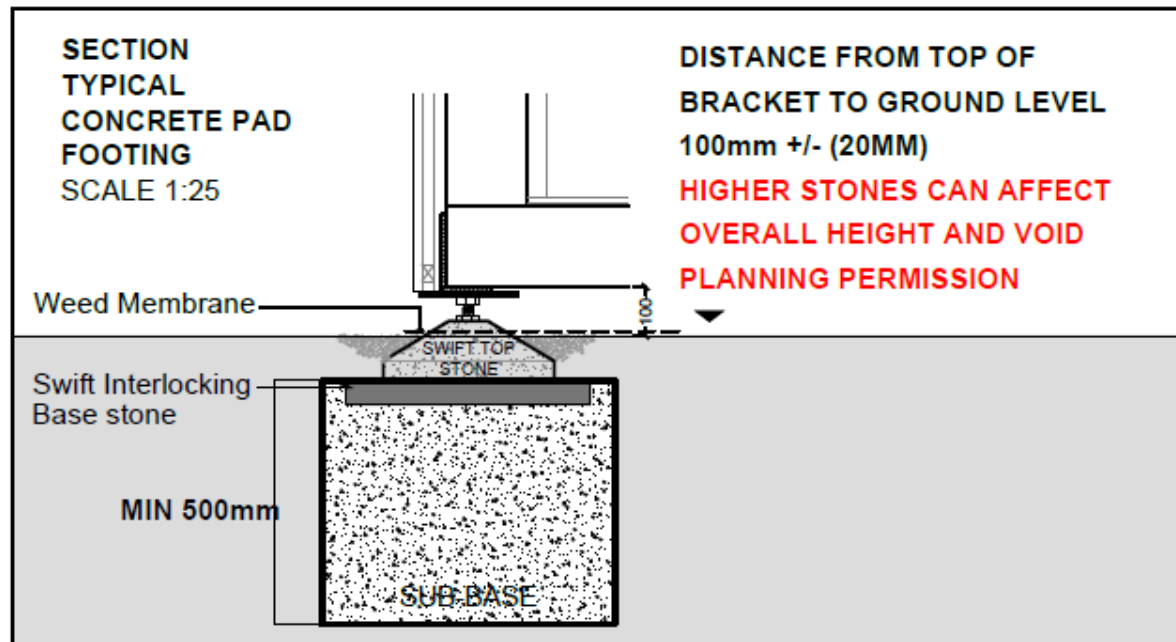
Pad Footing (cross section)

- *Marked out on site.*
- *Carefully hand dug.*
- *Any root over 25mm in size retained and pad location repositioned to accommodate retention.*
- *Competence and understanding of ground workers key to successful delivery.*

5.4.6 Pad footing is precast and located within hand dug hole manipulated in position to retain any root >25mm encountered on site.

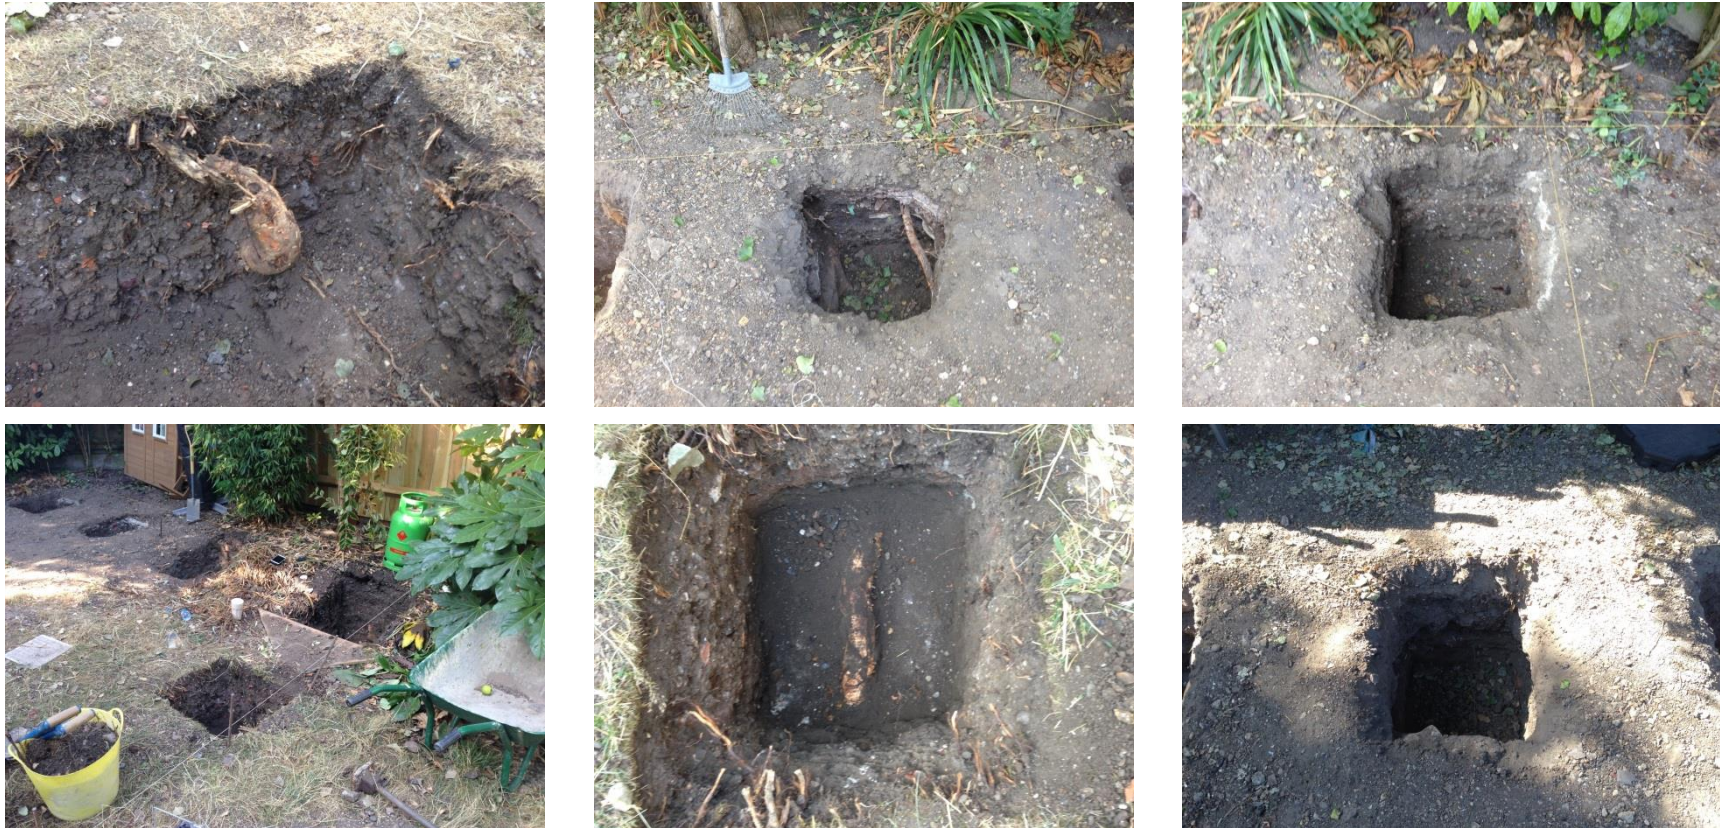
Fig 9 – Sample excavations for similar projects where careful hand digging is used and pad locations manipulated to reflect the presence of any root >25mm in diameter.

5.4.7 Pad locations are hand dug and repositioned in the event roots >25mm are encountered:

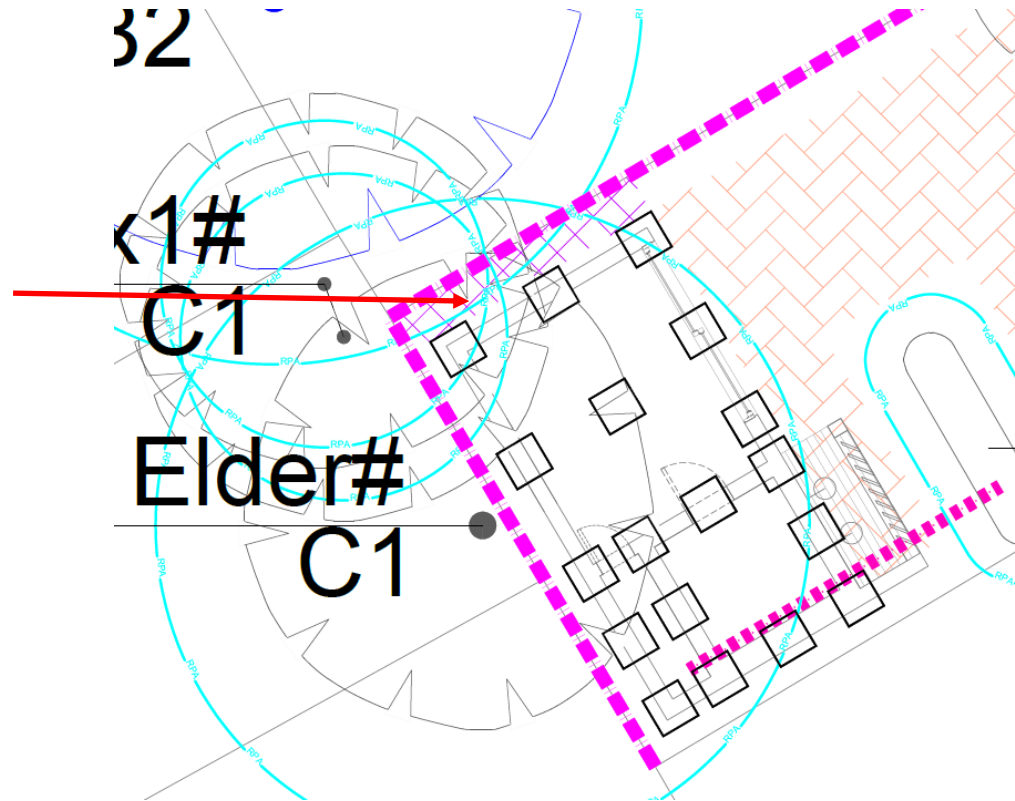
- Existing site access away from retained trees. Access through property garden limits size of machinery and materials which can be brought on to the site. This access route is already hard standing.
- Ground protection laid prior to any on site works (north of the proposal).
- Manipulated on site to reflect existing flower beds/ shrubs and trees as appropriate.

Fig 10 – Temporary ground protection will be installed in the small area to the north of the proposal.

- 5.5.1 Temporary ground protection will be laid to the north of the proposal to allow access. Access is through the existing garden which already benefits from hard standing.

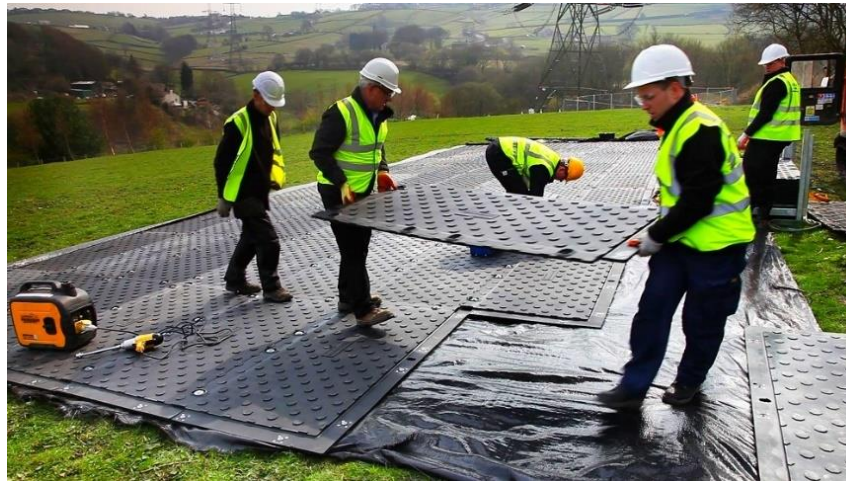
These loading guides are for firm, dry ground. If the weather is likely to turn wet, or the job duration is in excess of a week, please ask for advice about using a stronger product.

Fig 11 – An assessment of what type of tracking material is required will be relative to the form of access. In this instance only pedestrian/ access within the surface area appears to be required but this should be confirmed with the construction firm prior to any on site works.

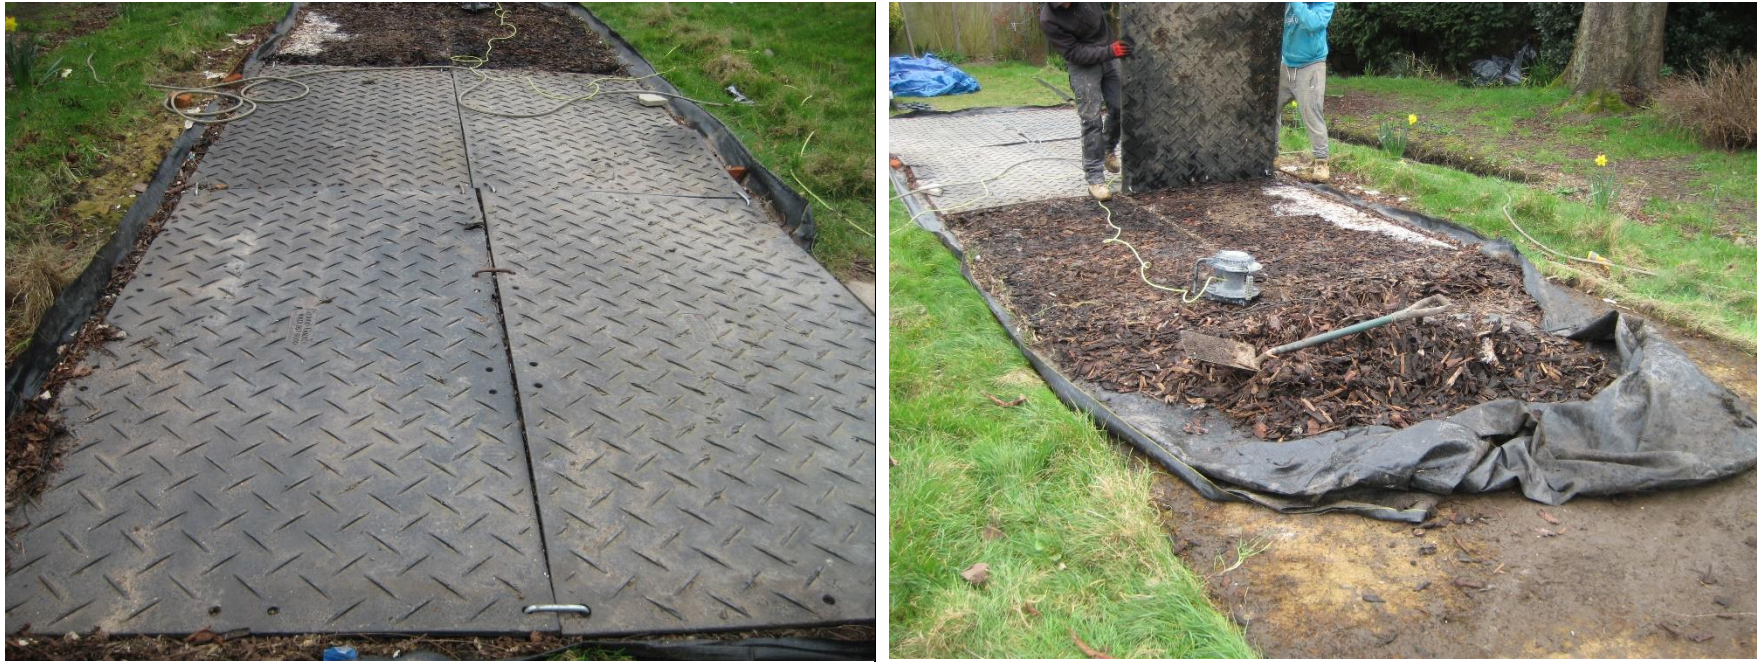
Fig 12 – Temporary ground protection is an effective way of allowing access through the RPA of retained trees. It must be installed prior to any on site activity and maintained for the duration of all works to be effective. Above left Tamla Trees project ground protection in place and above right being removed following the completion of site works. (Note: depending on the length of time it is in place it will adversely affect underlying grass ground cover which will need reseeded/ turfed accordingly)

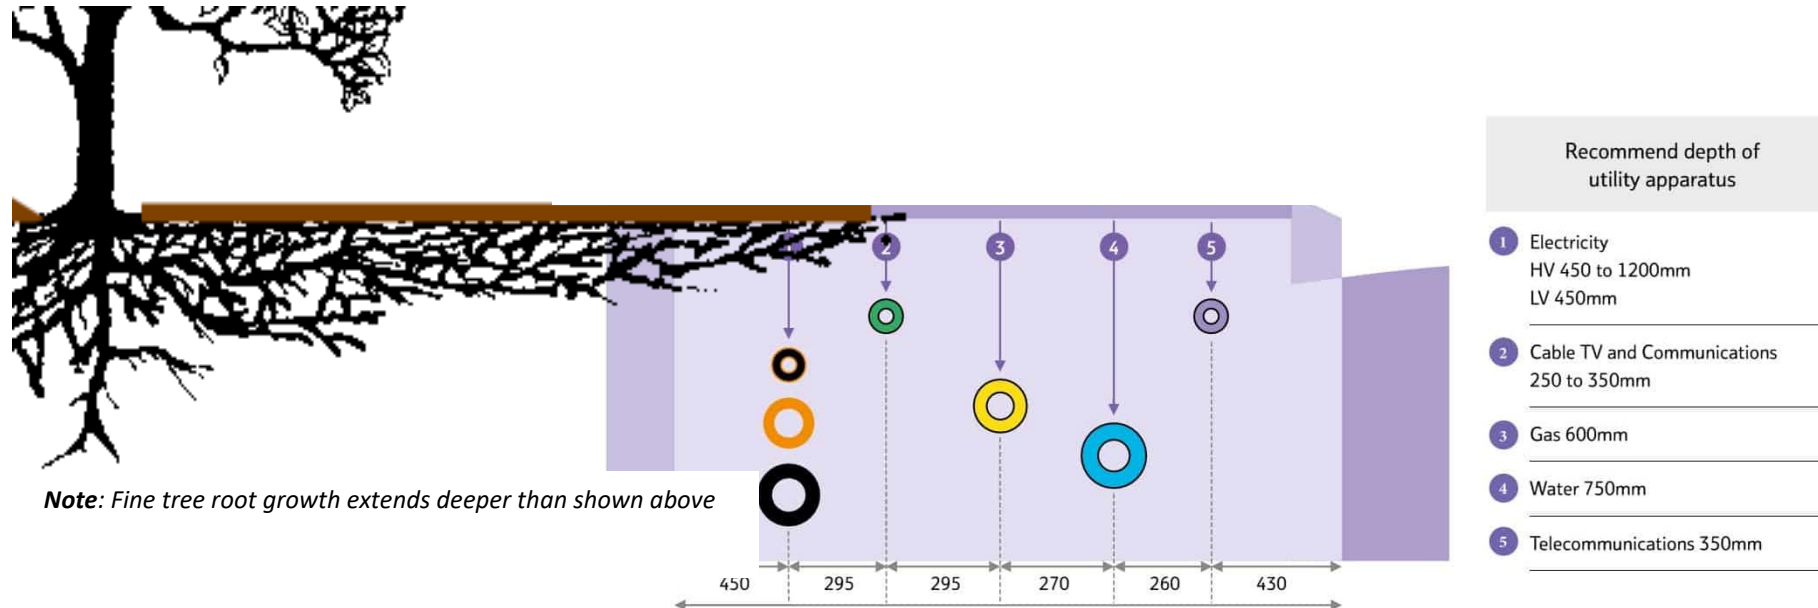
Fig 13 – Annotated service installation depth drawing (source: Thorne & Derrick). Service installations occupy the same soil volume/ depth where the greatest level of tree roots will likely be found but on this project, none are proposed.

5.6.1 The new garden room requires a service connection to the main property and this will be hand dug:

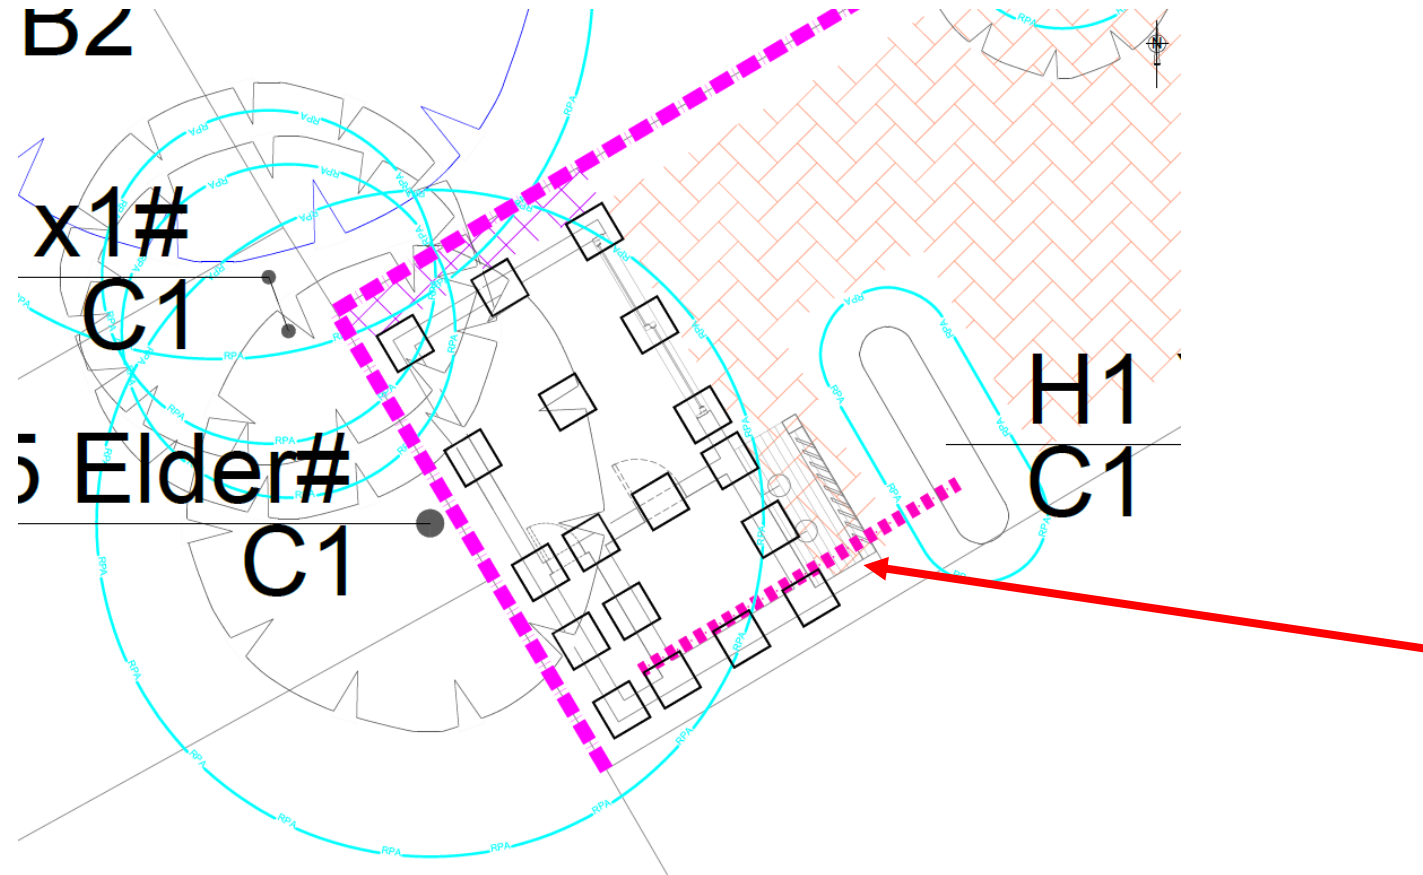
Fig 14 –Any services that pass through the RPA of trees will be hand dug. Note: roots may be encountered outside of RPA's and should be retained. Scope exists to feed below H1.

5.6.2 The new service trench will be hand dug (mainly due to access issues as it will not adversely affect retained tree RPA). utilising the hand digging principles detailed within this report where it is within the RPA of retained trees. All roots >25mm in diameter will be retained with service fed below them where relevant.

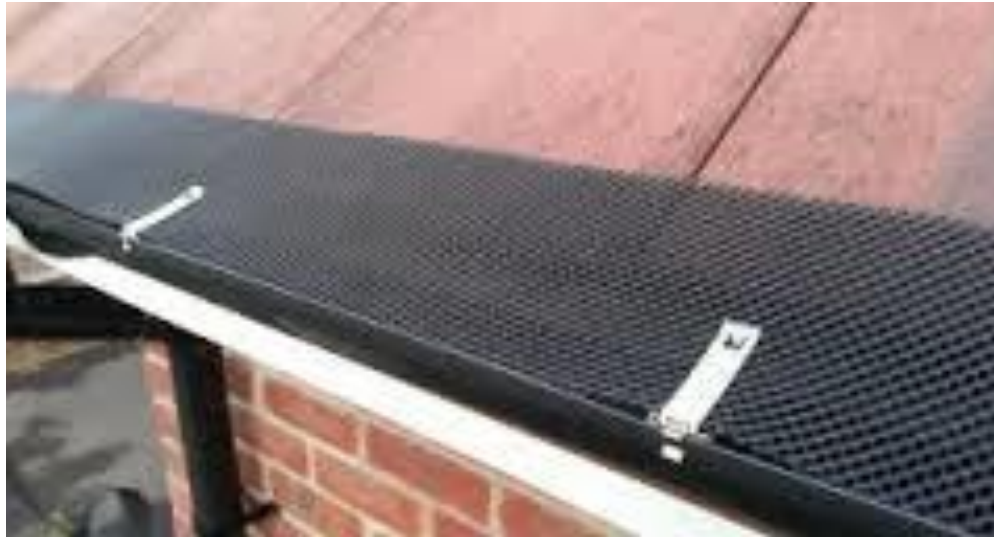
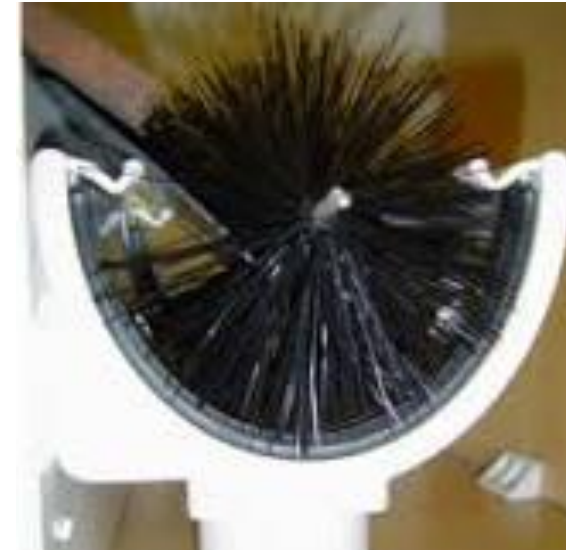
Fig 16 - Suitable gutter guards (2 types shown above) should be fitted to ensure that leaf drop from adjacent trees does not block new guttering leading to potential pressure for tree works.

5.6.6 To limit maintenance impact to the garden room from leaf drop given the proximity/ overhang of trees it is proposed that [gutter guards](#) be installed.

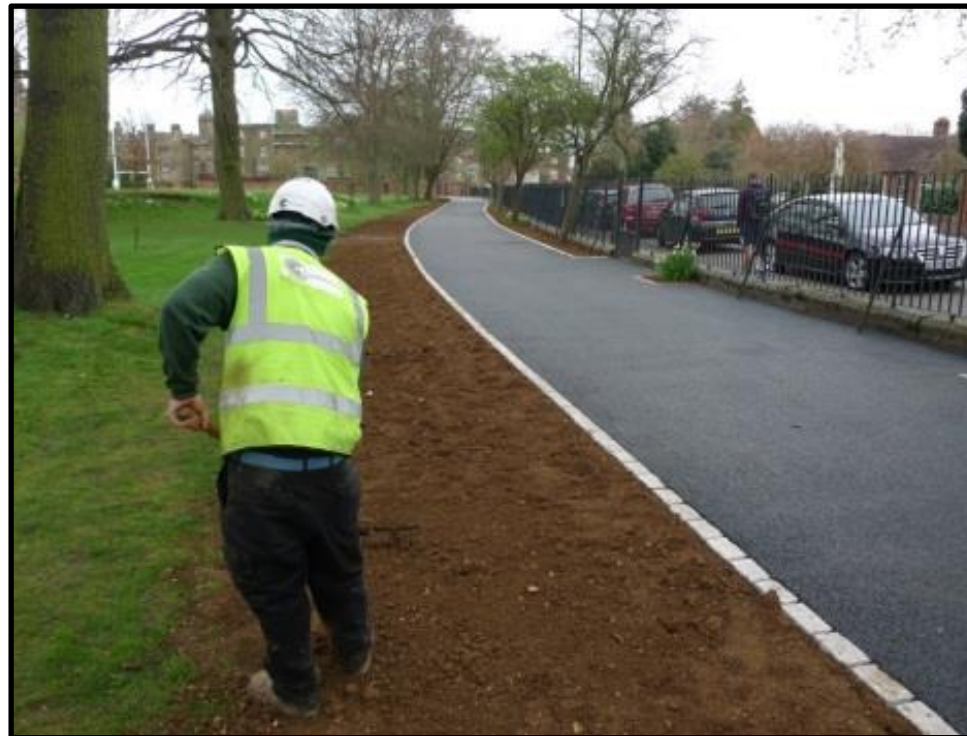
Fig 17 – In the event of 'making good' topsoil will be BS3882 compliant and raked out by hand to no greater depth than 100mm

- 5.7.1 No ground level changes within the RPA areas of retained trees are proposed other than pad stone footings detailed elsewhere. Following completion of the project any 'making good' will be with BS3882 compliant topsoil raked out by hand (to no more than 100mm depth within any tree RPA) and then seeded/ planted as appropriate. We encourage the use of composted bark mulch below tree canopies where possible to aid water retention and increase soil microbial activity.

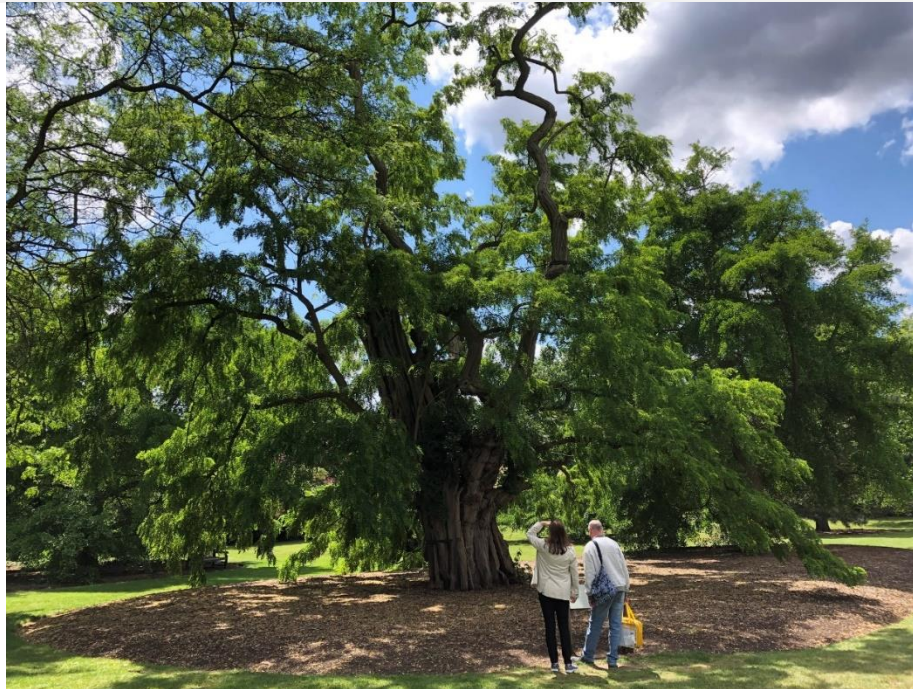
Mulching

Overview

- *Circular area edged to 50-100mm depth to stop mulch from 'creeping' on to surround lawn.*
- *Composted mulch then spread around below tree by hand – no need to lift or remove underlying grass.*
- *Mulch topped up annually/ as required.*
- *Positive benefits for mulched trees.*

Threat Level to Retained Trees

LOW

5.7.2 We recommend the use of composted bark mulch where possible within the retained tree RPA's. As well as aiding water retention and increase soil microbial activity it can design out issues associated with leaf and needle drop or lawns not establishing close to mature trees.

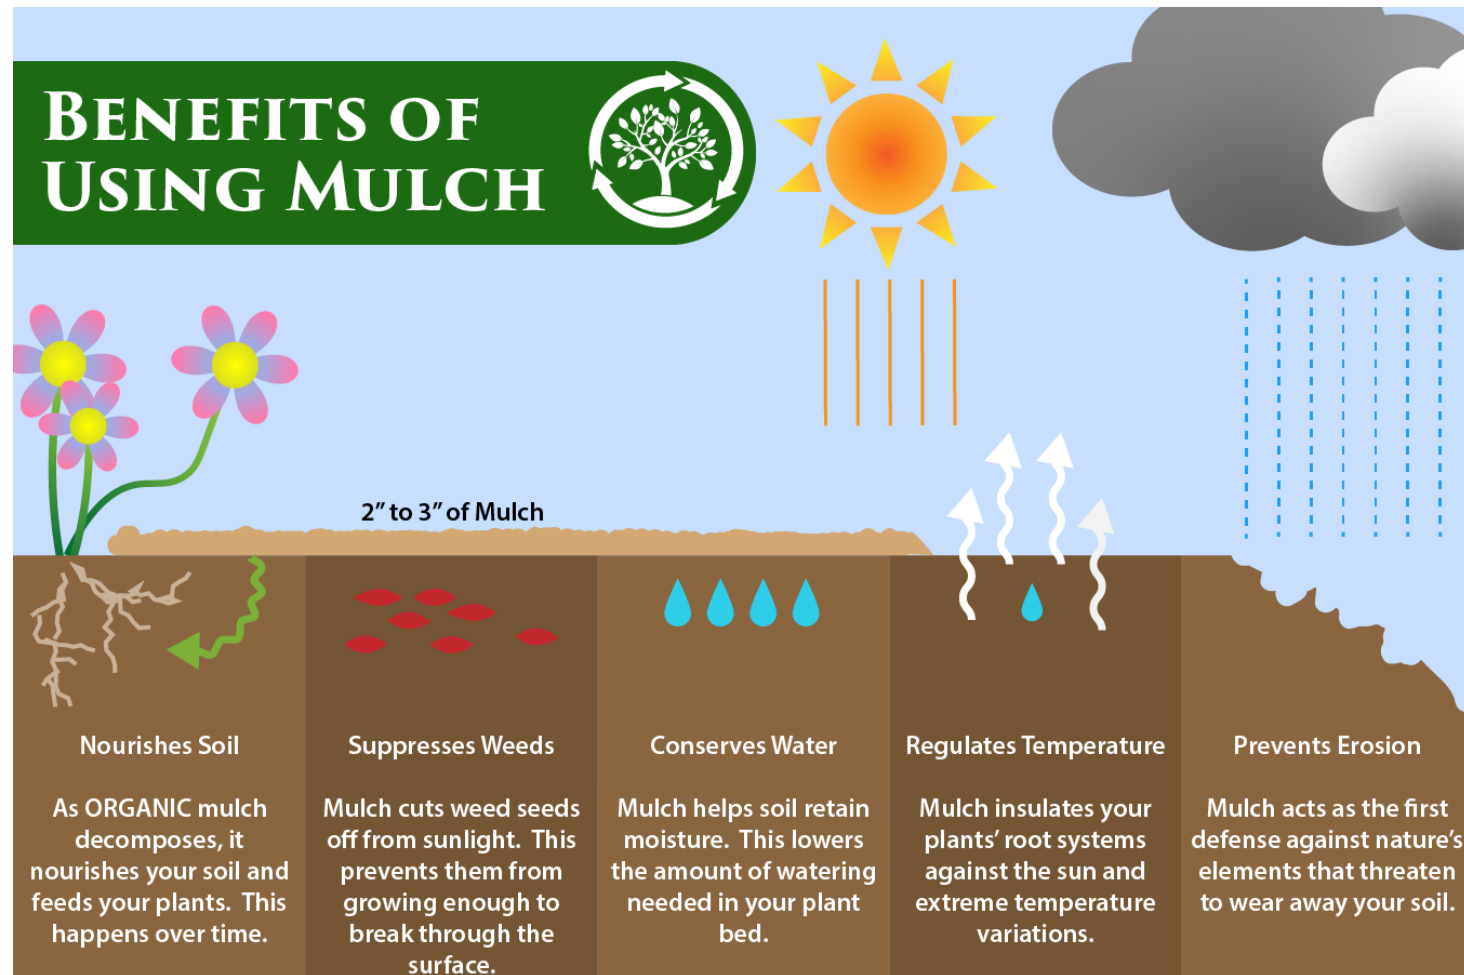
Fig 18 – Benefits of Mulch (Image Source 1st Stop Landscape Supply (US))

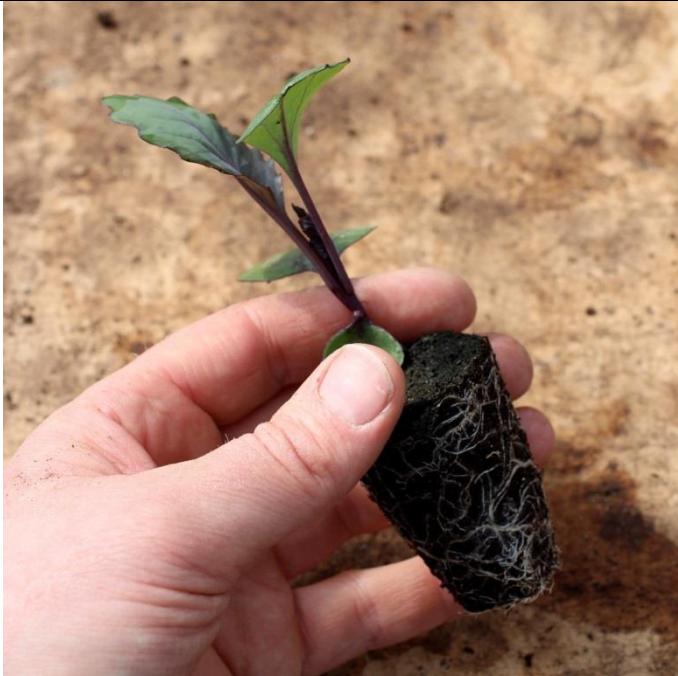
Plug and Pot Planting

Overview <ul style="list-style-type: none"> • Within 1.5m of retained trees planting should be with plug stock (left) • Small plant pot sizes <3l utilised for new planting in further areas. • Hand dug planting holes. • Top dressed in compacted bark mulch/ soil as appropriate. • Watered weekly May – September during season 1 & 2 	
	Threat Level to Retained Trees	LOW

5.7.3 Where soft landscape planting occurs within the RPA of retained trees, we advise the use of small pot sizes and plug planting where possible to minimize the risk of root disturbance.

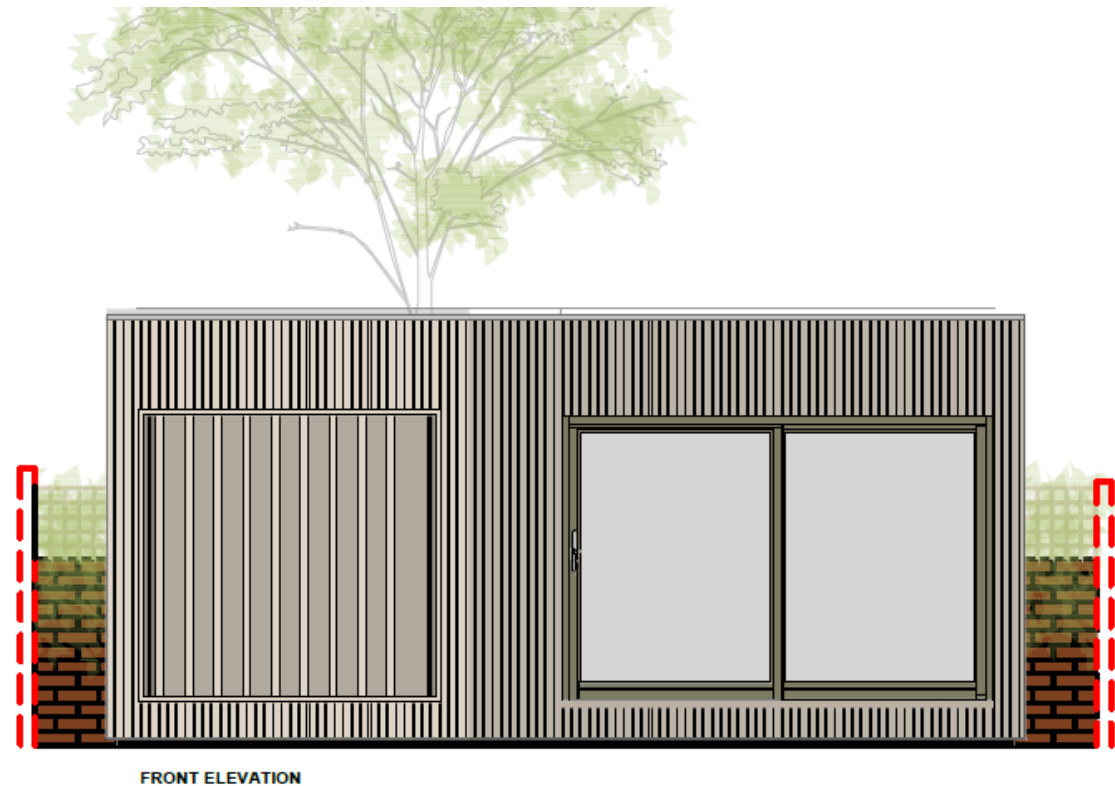
Fig 19 – The extent of glazing maximizes light penetration

5.8.1 The nature of the design is such that it benefits from large, glazed areas maximizing light penetration. It is also not part of the permanent residential property. Shading is therefore not considered of issue.
