BS5837 Arboricultural Impact Assessment

8 Aldridge Road Villas, London, W11 1BP

Client: **J Arbuthnot**

Job Reference: **03661R**

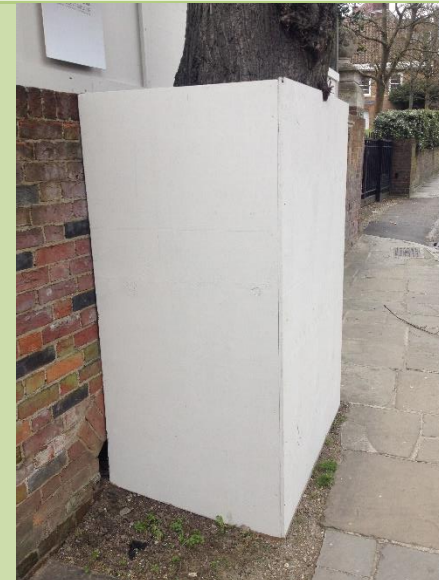
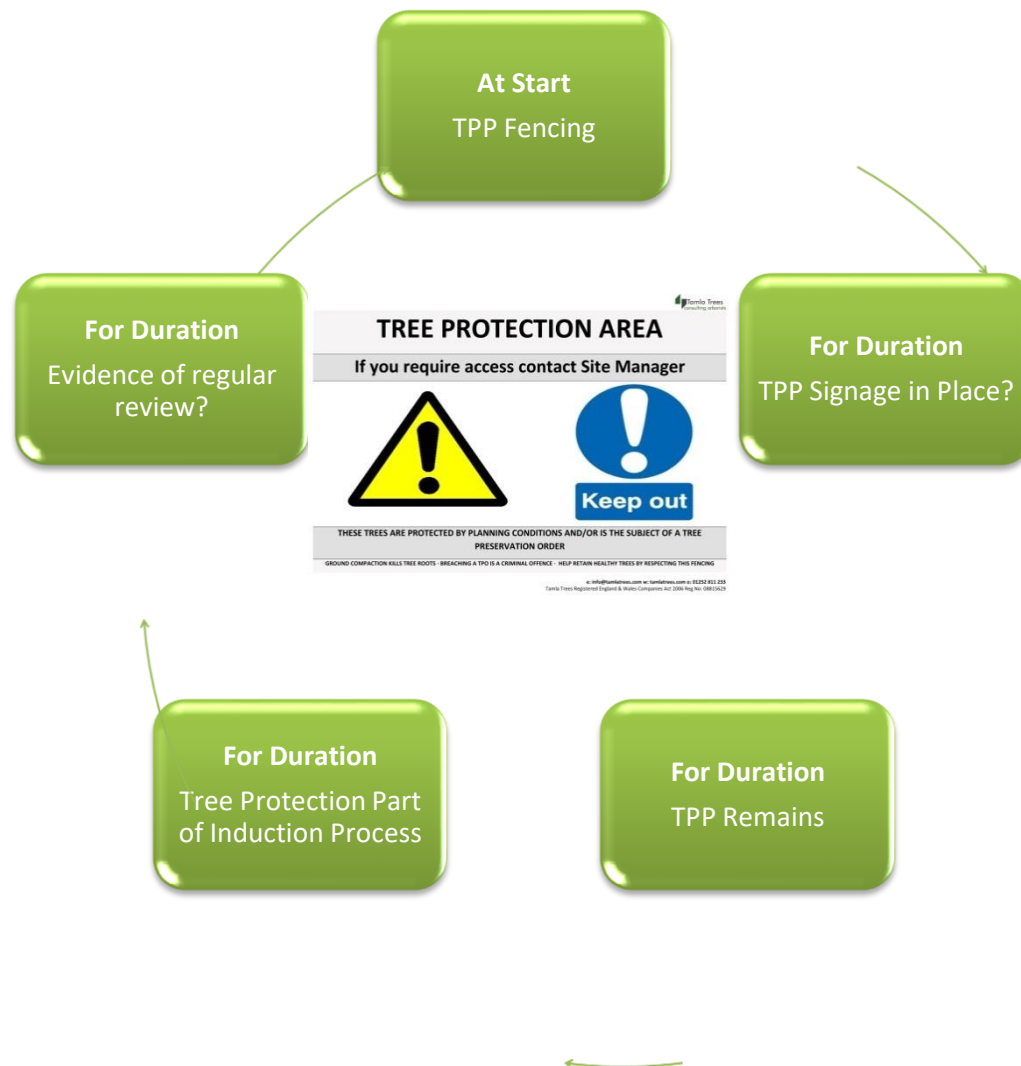
All our fencing specifications accord with advice and guidance within BS 5837. Modifications to fence types are possible but should be discussed prior to implementation. In all other instances the form detailed below should be shown. This offers the best protection to retained trees.

- All tree protection must be in place prior to any site activities. It is recommended that this fencing is installed prior to any site works (including demolition).
- To be effective Tree Protection must remain in place for the duration of the development and form part of the site induction process.
- Site operatives to be briefed on ground protection prior to work commencing.
- Physical tree protection provided by bespoke plywood frames.

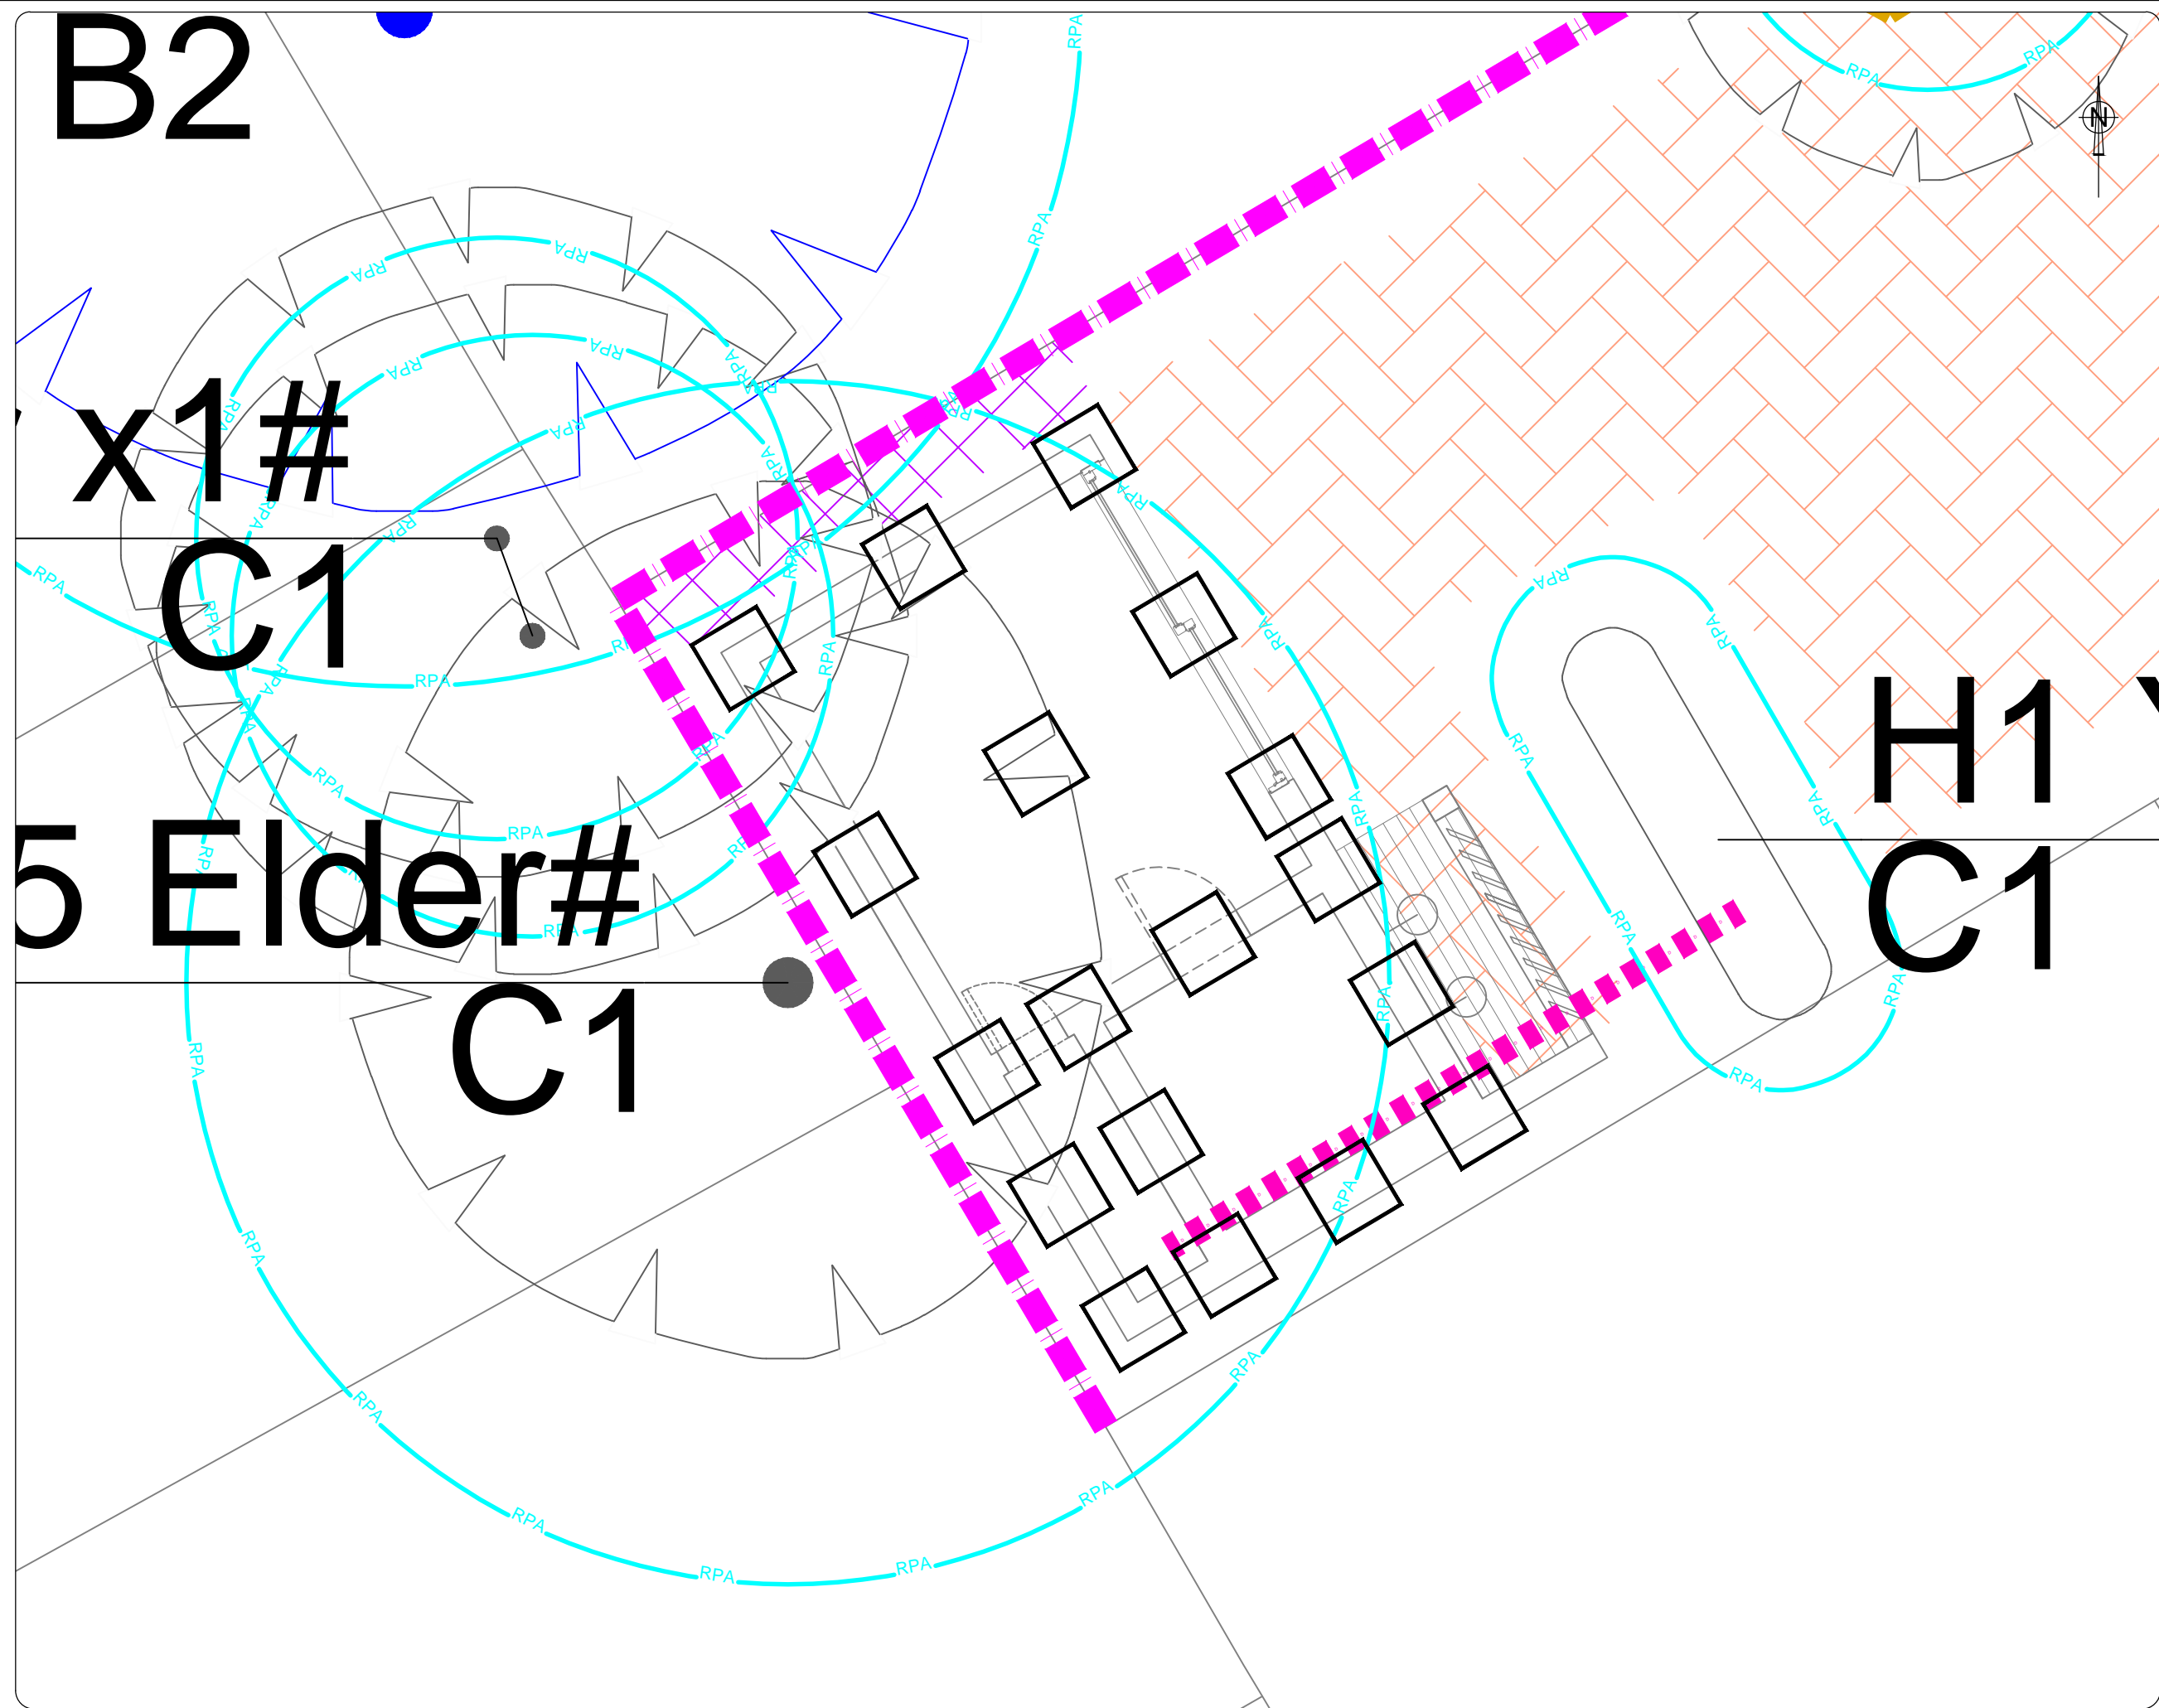
Job 03661R	Scale 1:50 @ A3	DRG NO 03661P_TPP_02	Revision -
Date 08/10/2021	Type a

- Retain existing on site hard standing if present for as long as possible.
- If indicated new temporary ground protection should be installed as part of the tree protection measures prior to work starting on site.
- For exposed unmade ground within Root Protection Area.
- To be laid on non-permeable membrane
- We recommend 3m x 1m x 20mm mats manufactured from recycled HDPE plastic, with carrying handles and an engraved grid pattern with minimum 150mm overlap to join together.

To cover all exposed unmade ground for tree Root Protection Area outside of Tree Protective Fencing

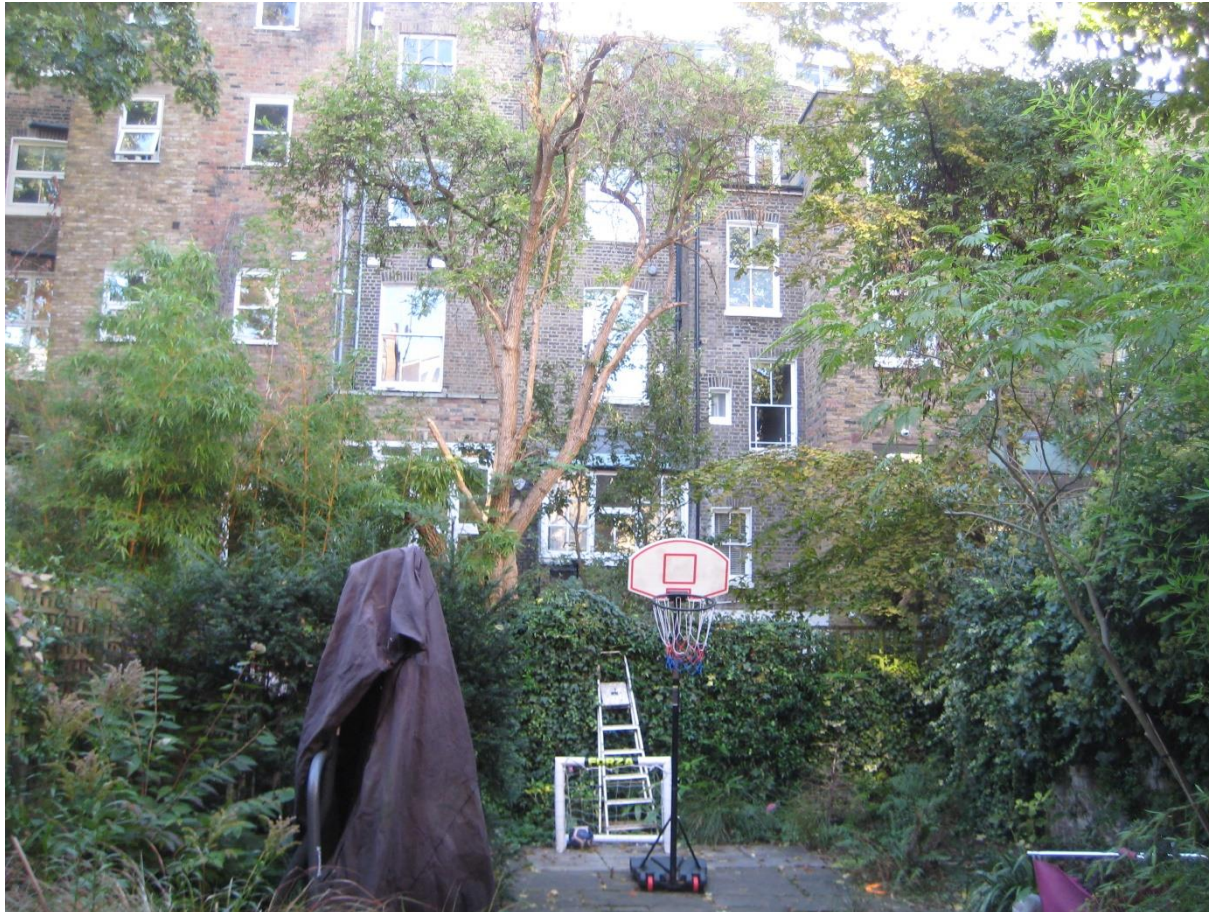
Image 1 – Proposal area with T5 visible

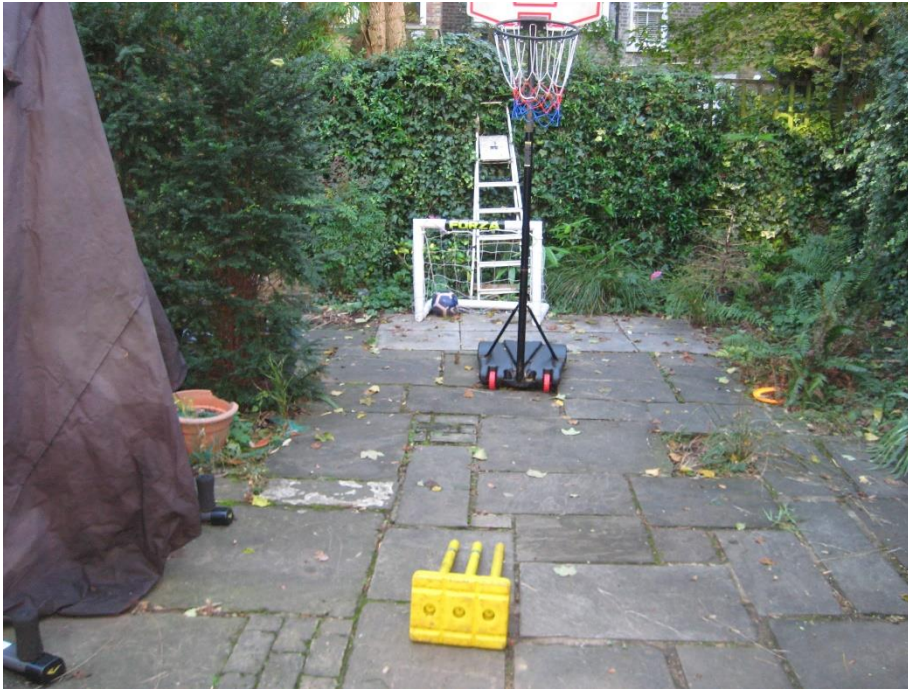
Image 2 – Existing hard standing

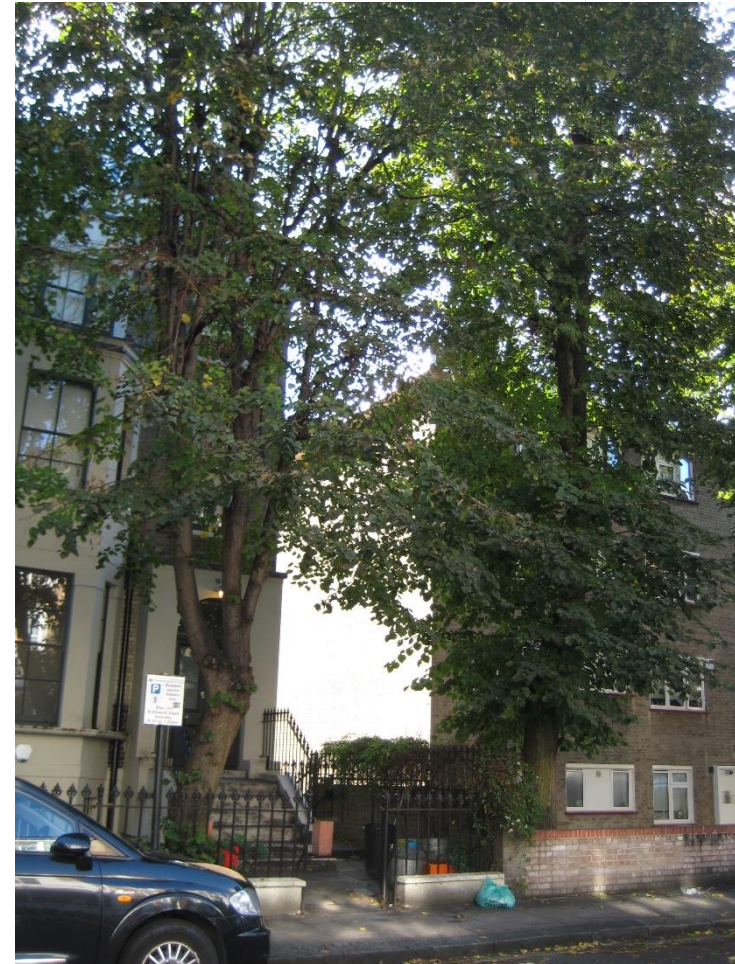
Image 3 –Front access with T1 (left) and T2 (right)
