GENERAL WOLFE INN, WESTERHAM,  
KENT, TN16 1RQ

## HERITAGE STATEMENT AND IMPACT ASSESSMENT

Report No. 2018356  
October 2018, Revised July 2021

Prepared by Maggie Henderson

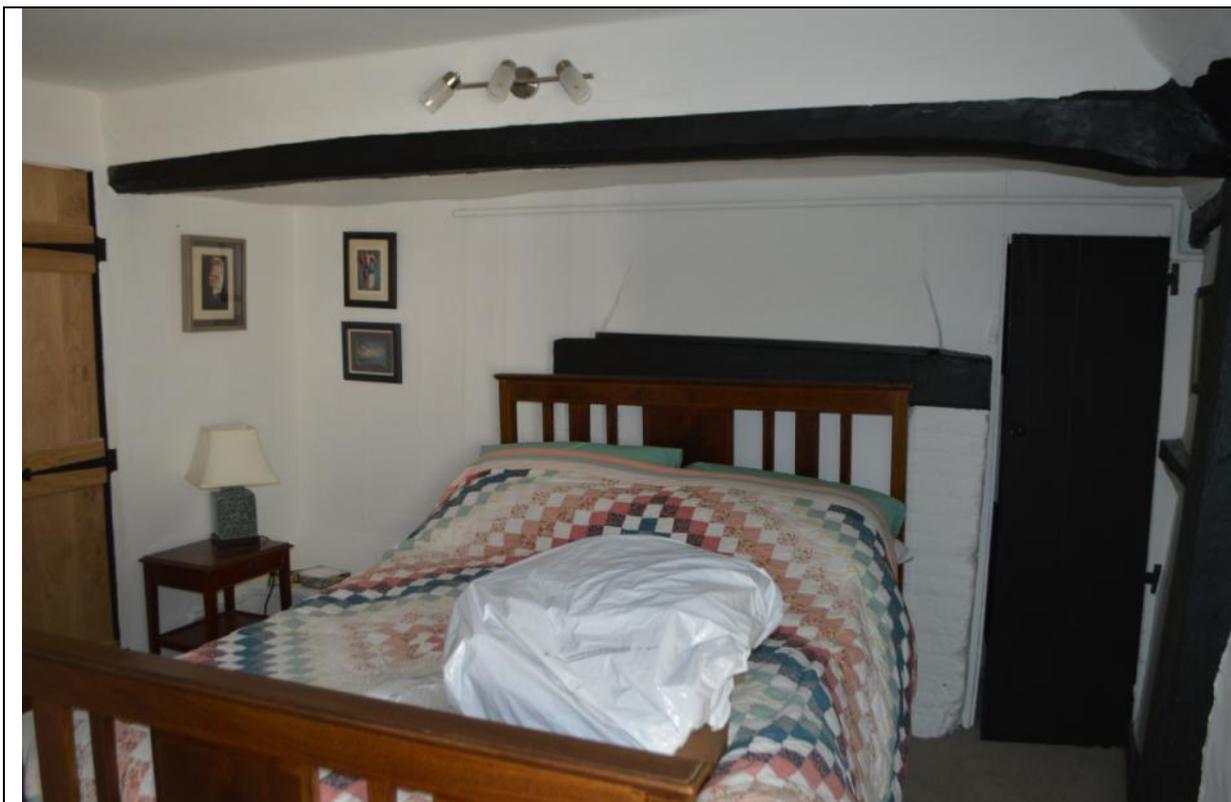
Plate 1: The phase 1 (c. 15<sup>th</sup> century) intermediate tie-beam of the open truss over the two-bay chamber

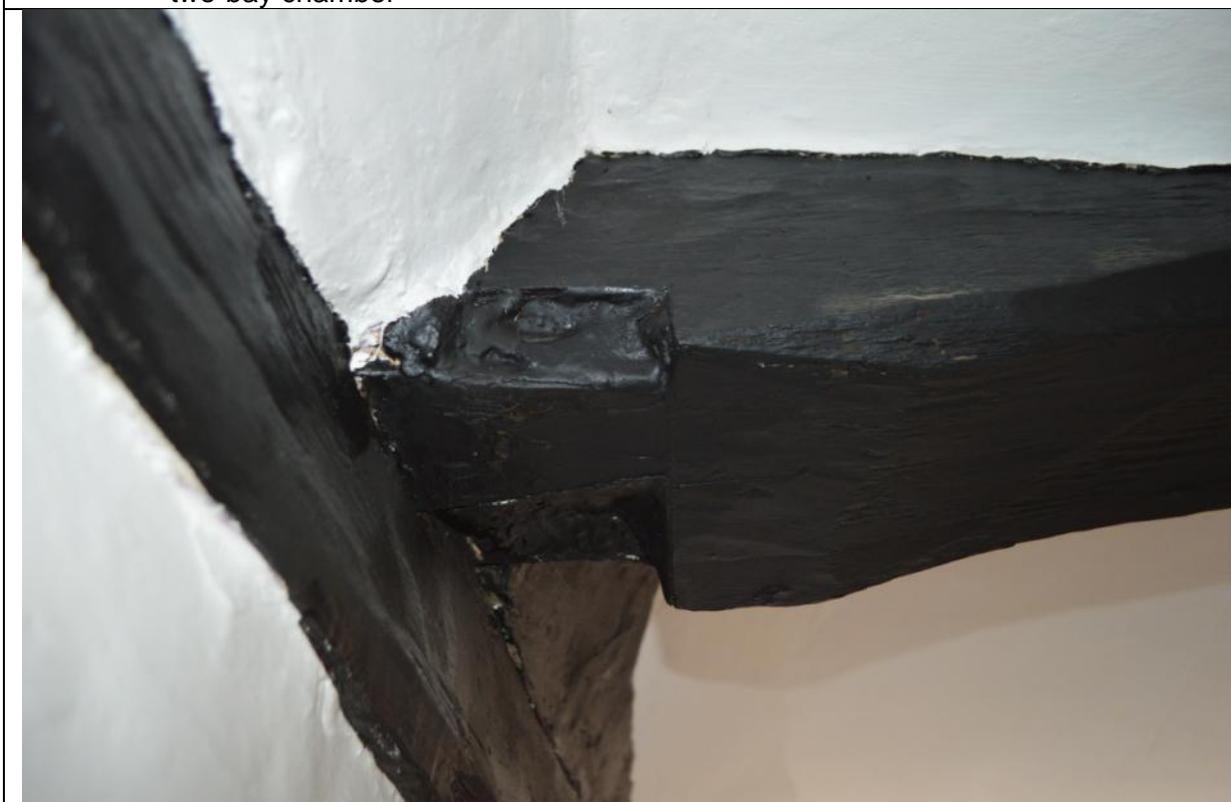
Plate 2: The north side of the eastern end of the intermediate tie-beam with dovetail to link it to the wall plate

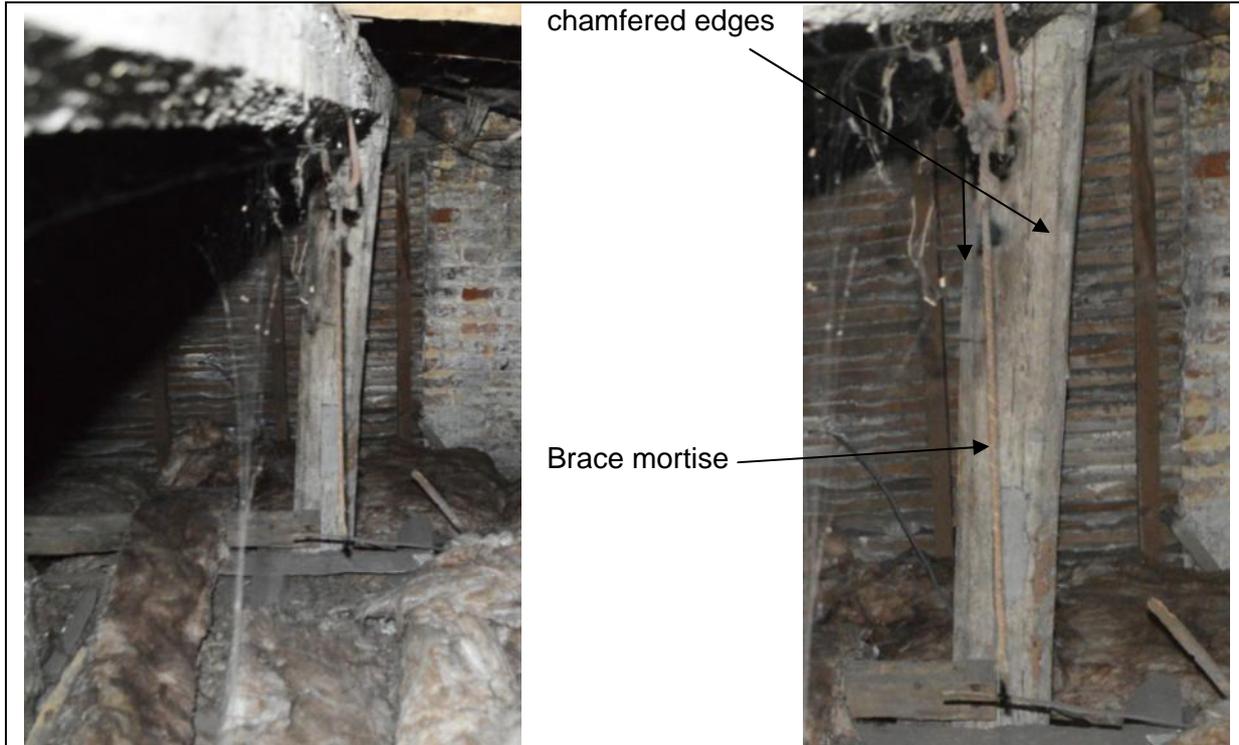
Plate 3: The decorated northern crown post of the open truss over the two-bay chamber

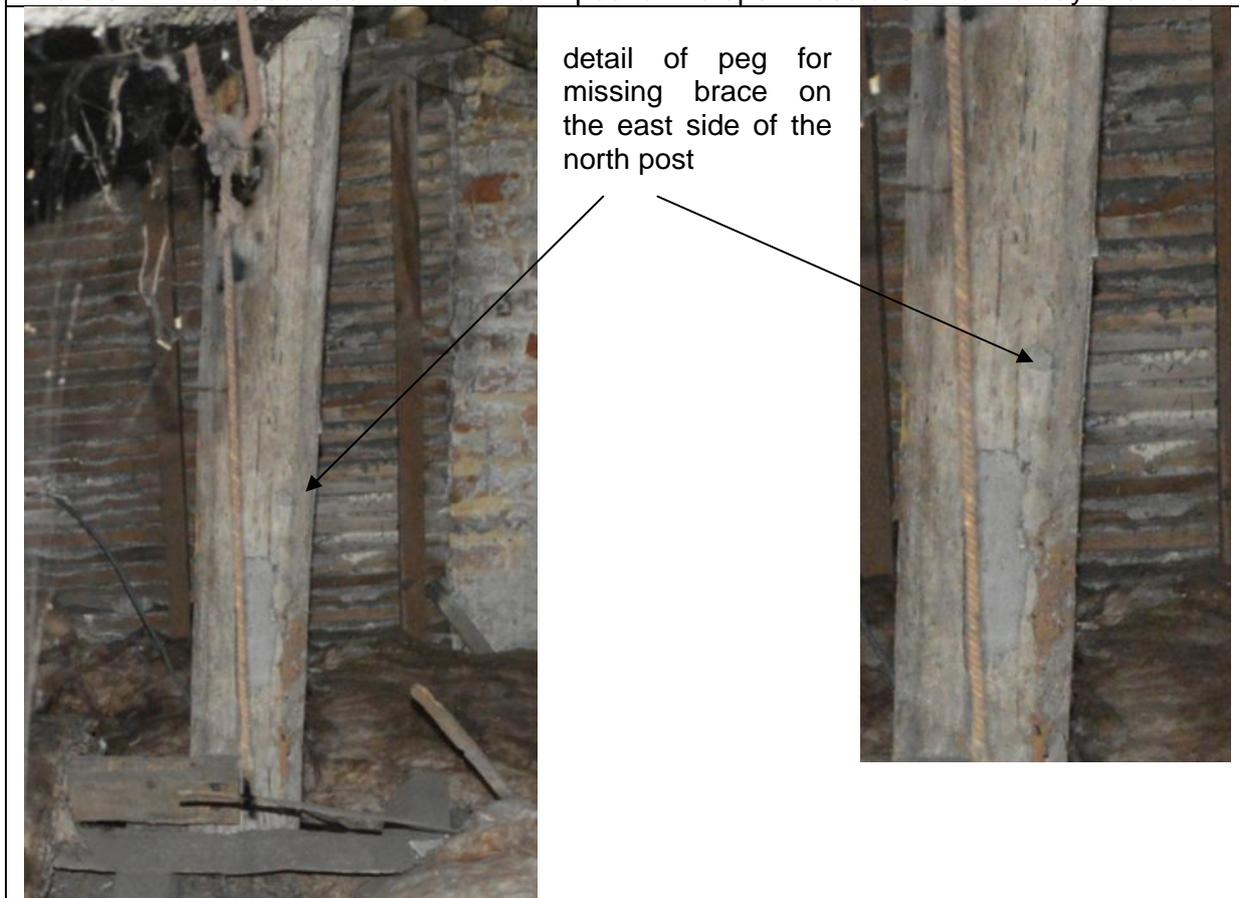
Plate 4: The north crown post – detail showing the pegs for the missing eastern brace

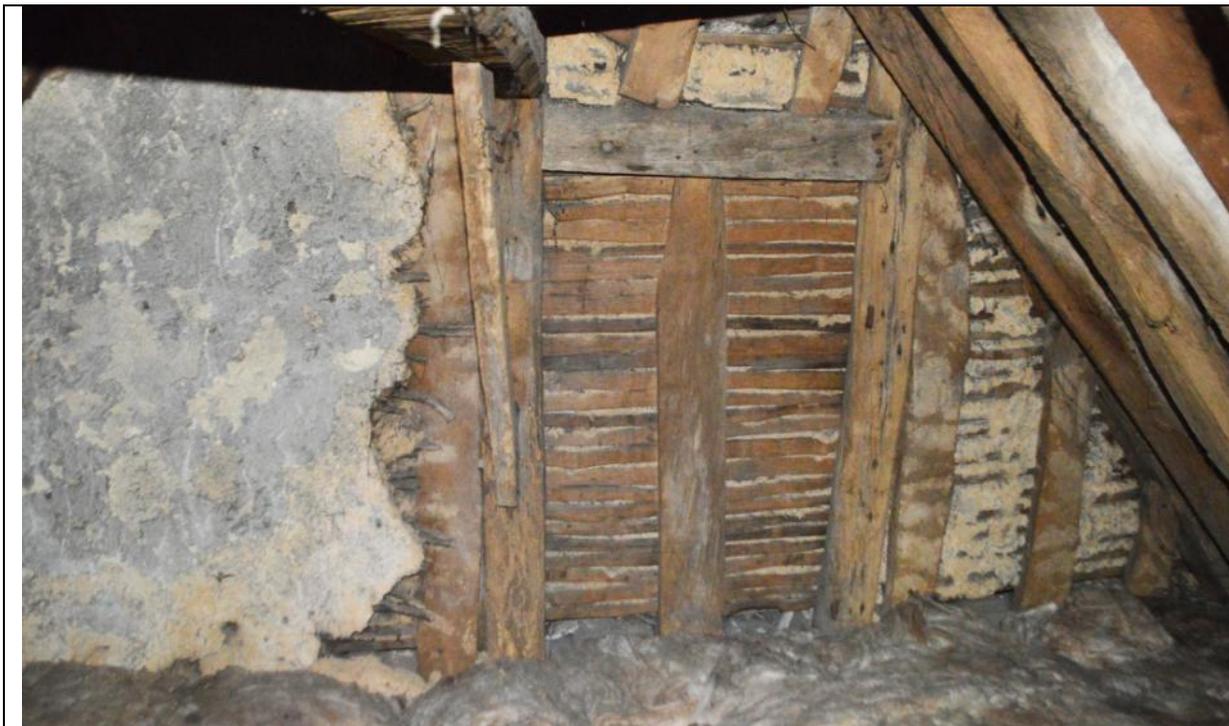
Plate 5: Partition truss, south crown-post

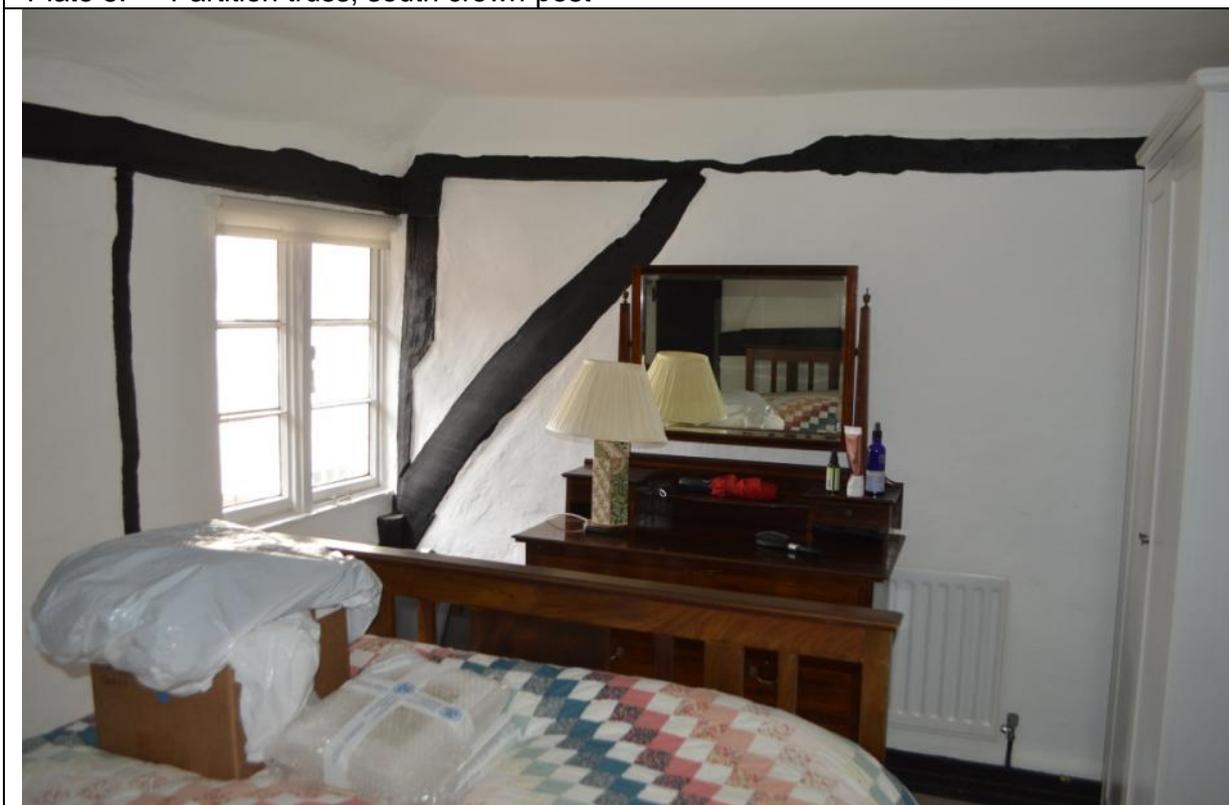
Plate 6: Principal post (east) and head-brace of the partition truss

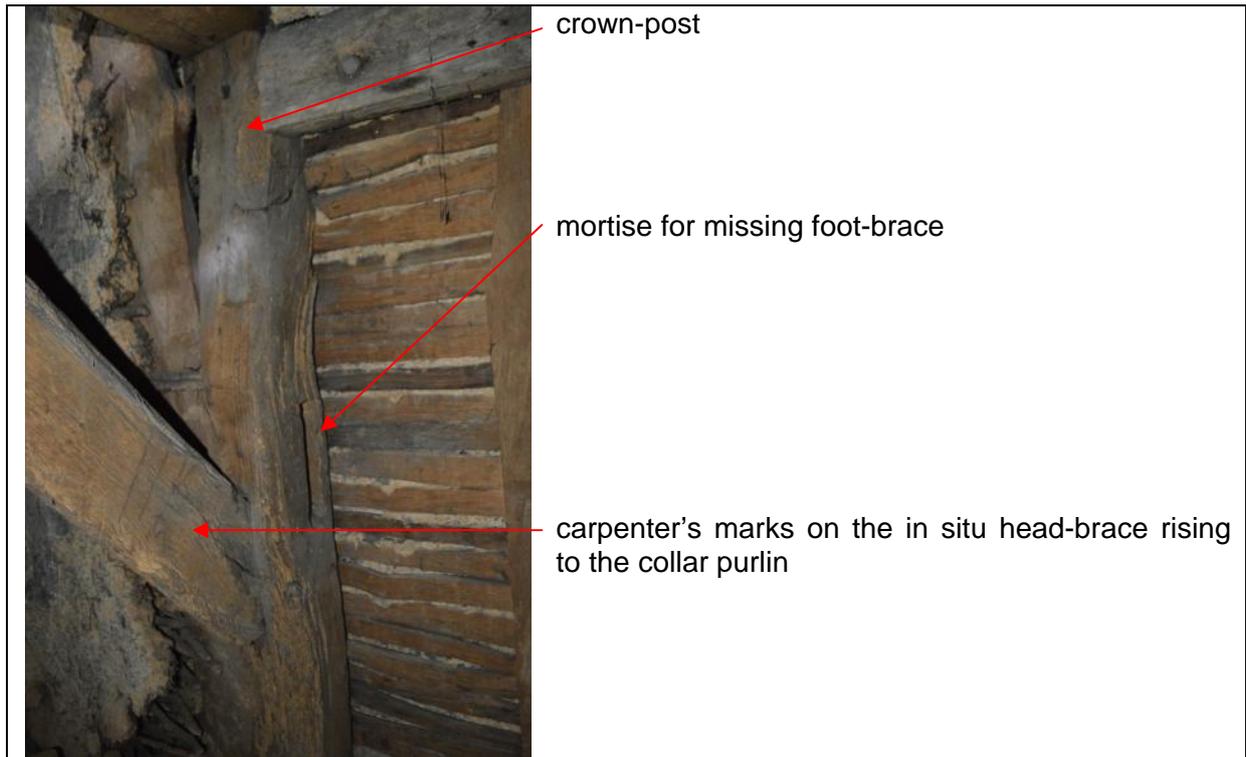
Plate 7: Comparatively plain south crown-post with plank-like head-brace rising to the collar purlin

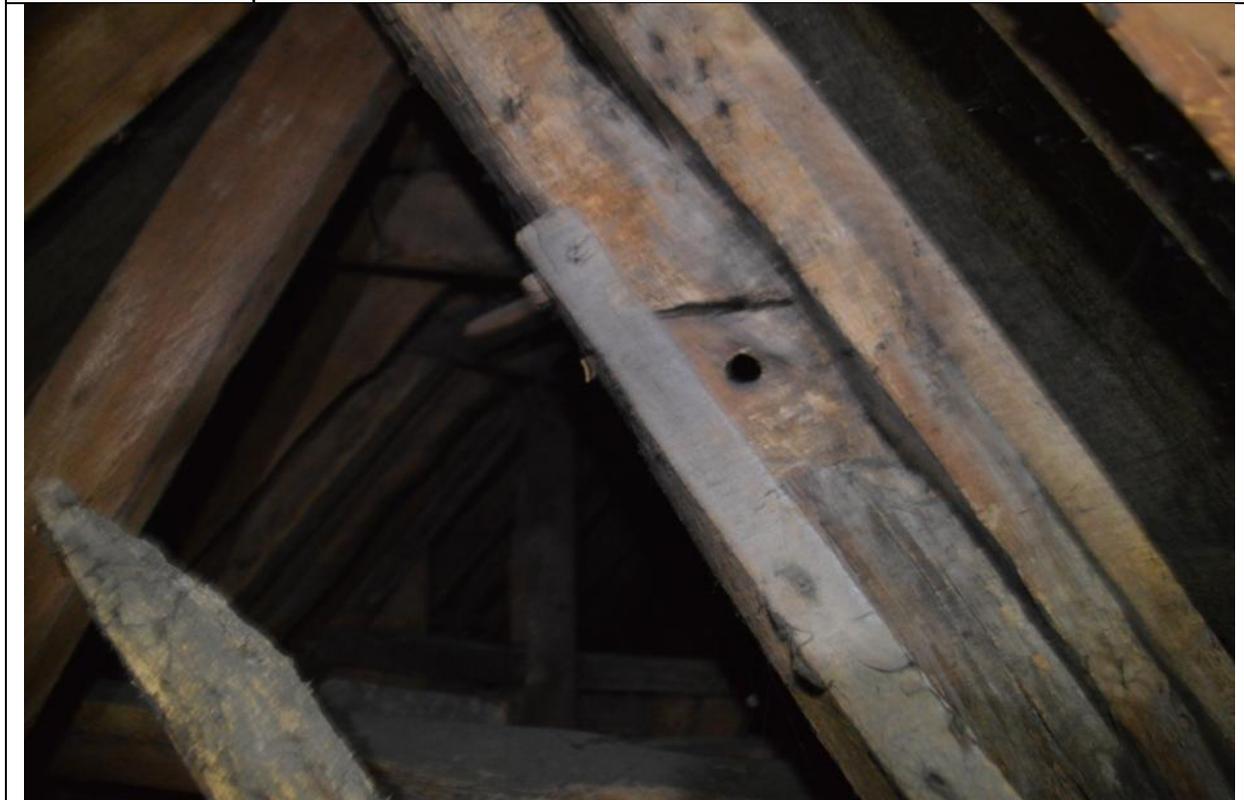
Plate 8: Redundant lap joint for a high-set collar indicating the former hipped southern end of the roof of the phase 1 building

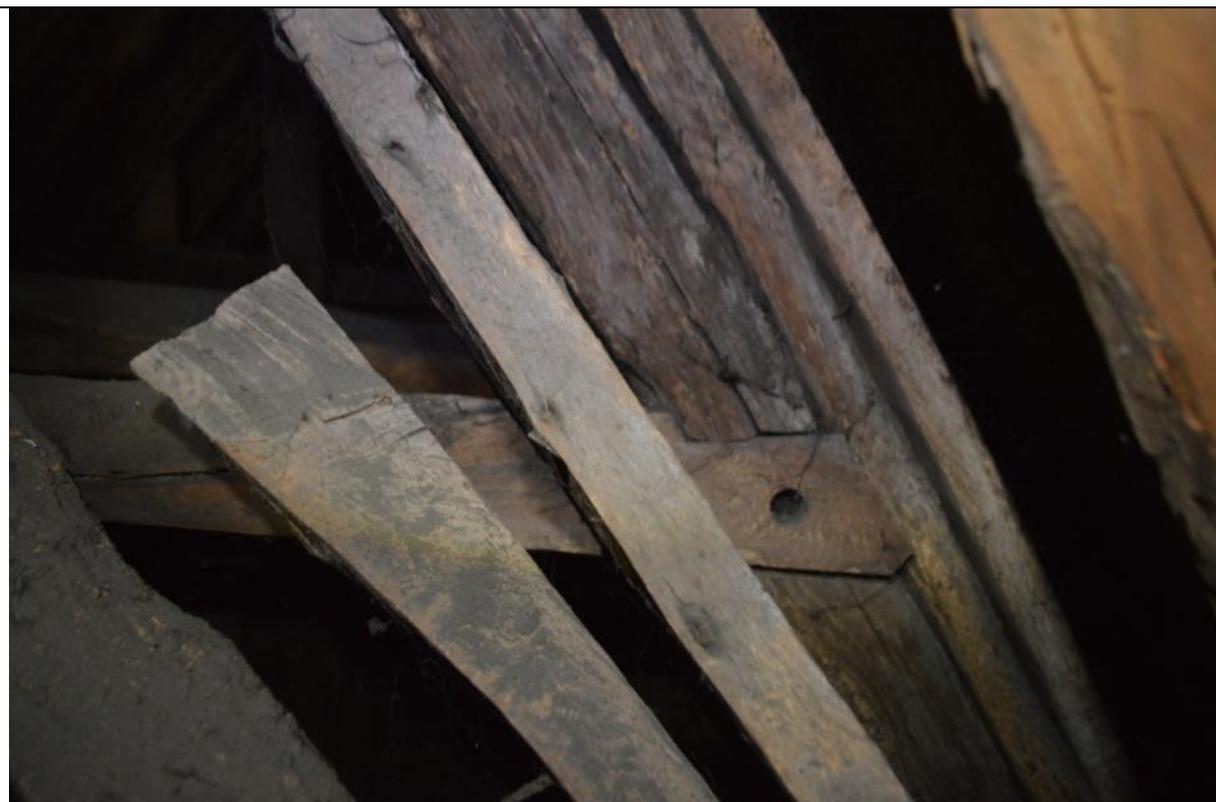
Plate 9: The in situ collar below the redundant jointing for the high set collar on the same rafter (east side of roof)

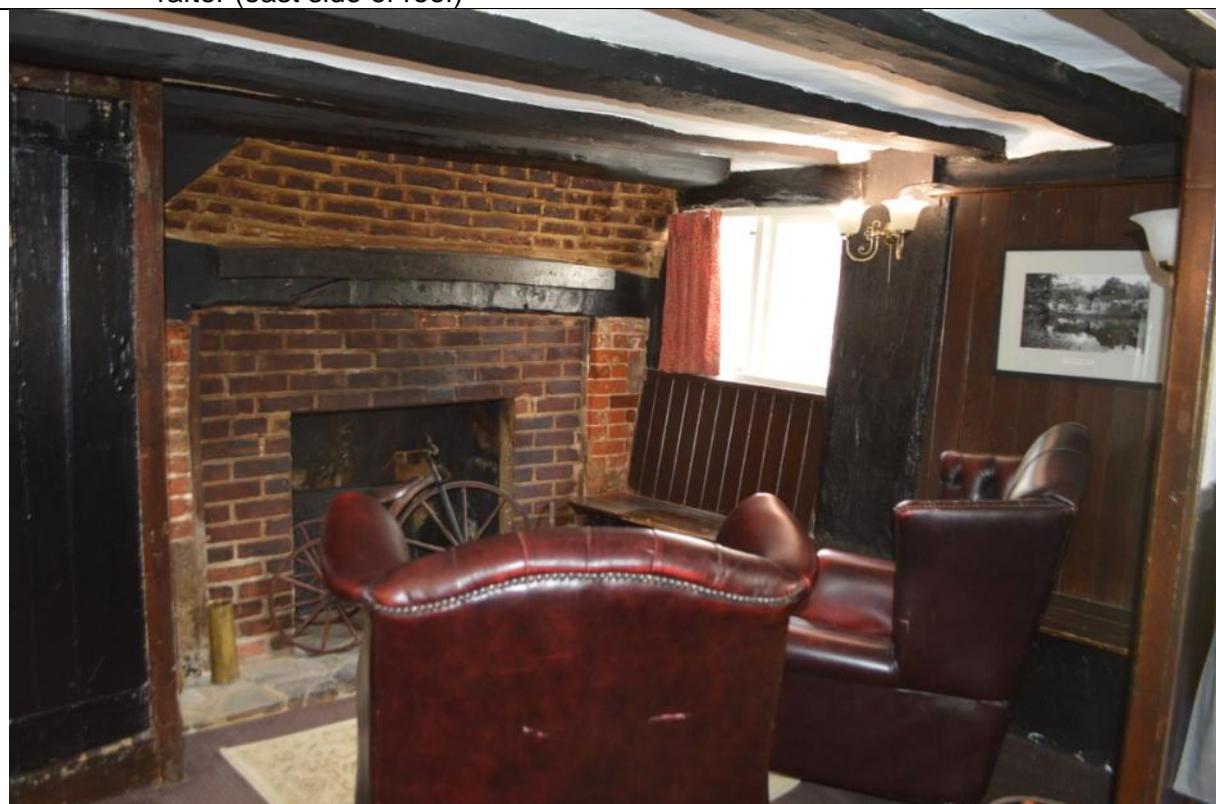
Plate 10: The 18<sup>th</sup> century fireplace with its 20<sup>th</sup> century brick in-fill within the multi-flue chimney stack inserted into the phase 1 northern end bay

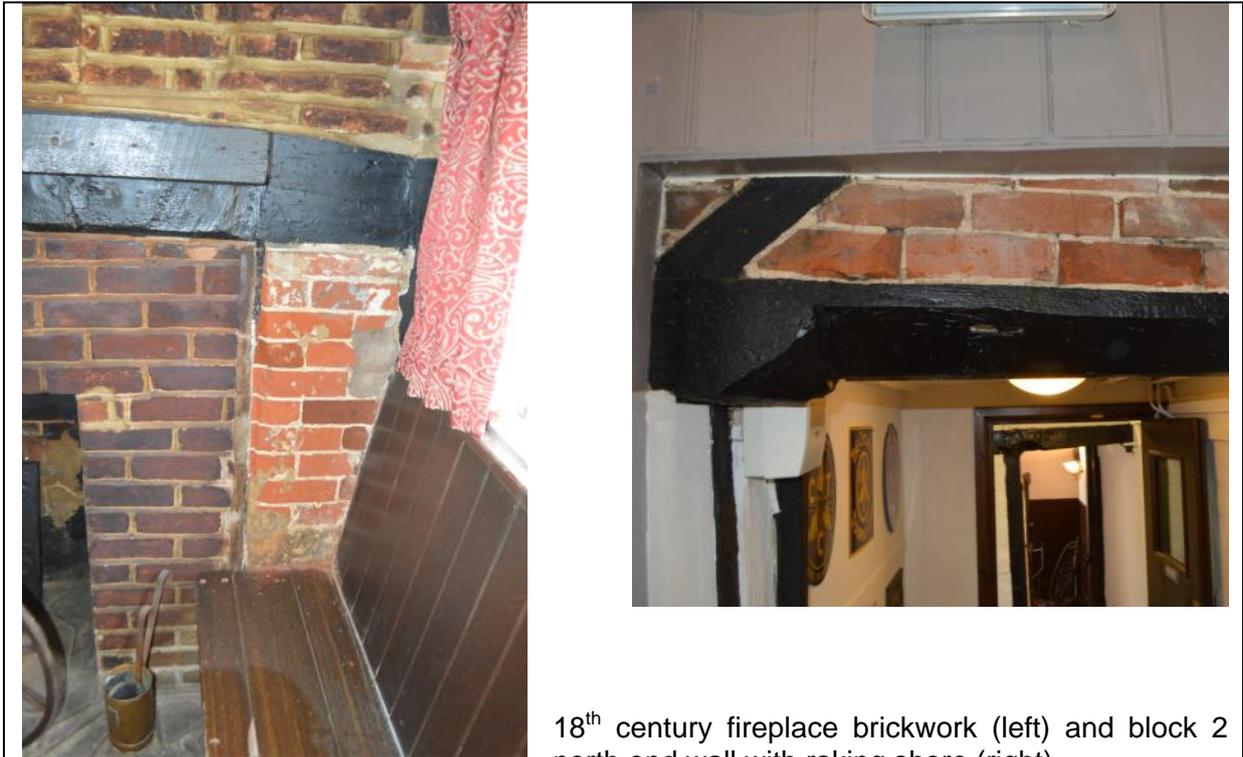
18<sup>th</sup> century fireplace brickwork (left) and block 2 north end wall with raking shore (right)

Plate 11: The characteristics of the 18<sup>th</sup> century brickwork

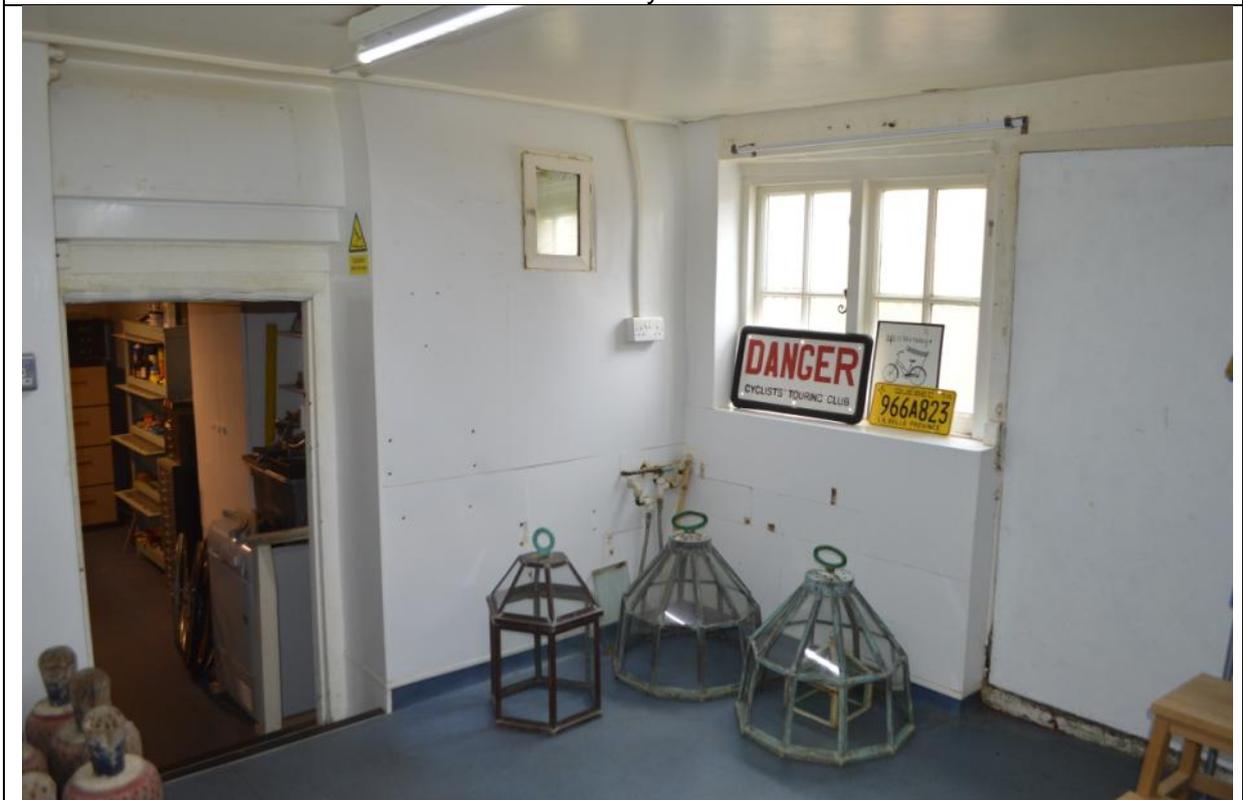
Plate 12: View from the interior of block 2's northeast room towards the lower floor of block 3

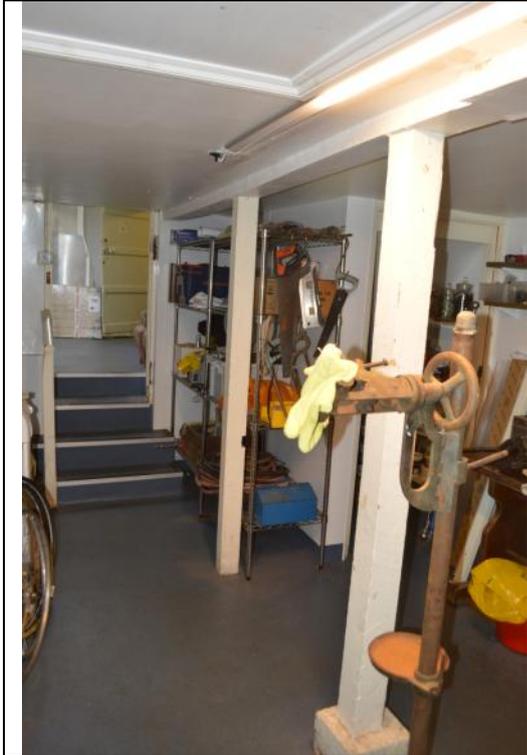
Plate 13: Interior of the lower floor of block 3 looking south to the raised floor within the northeast room of block 2

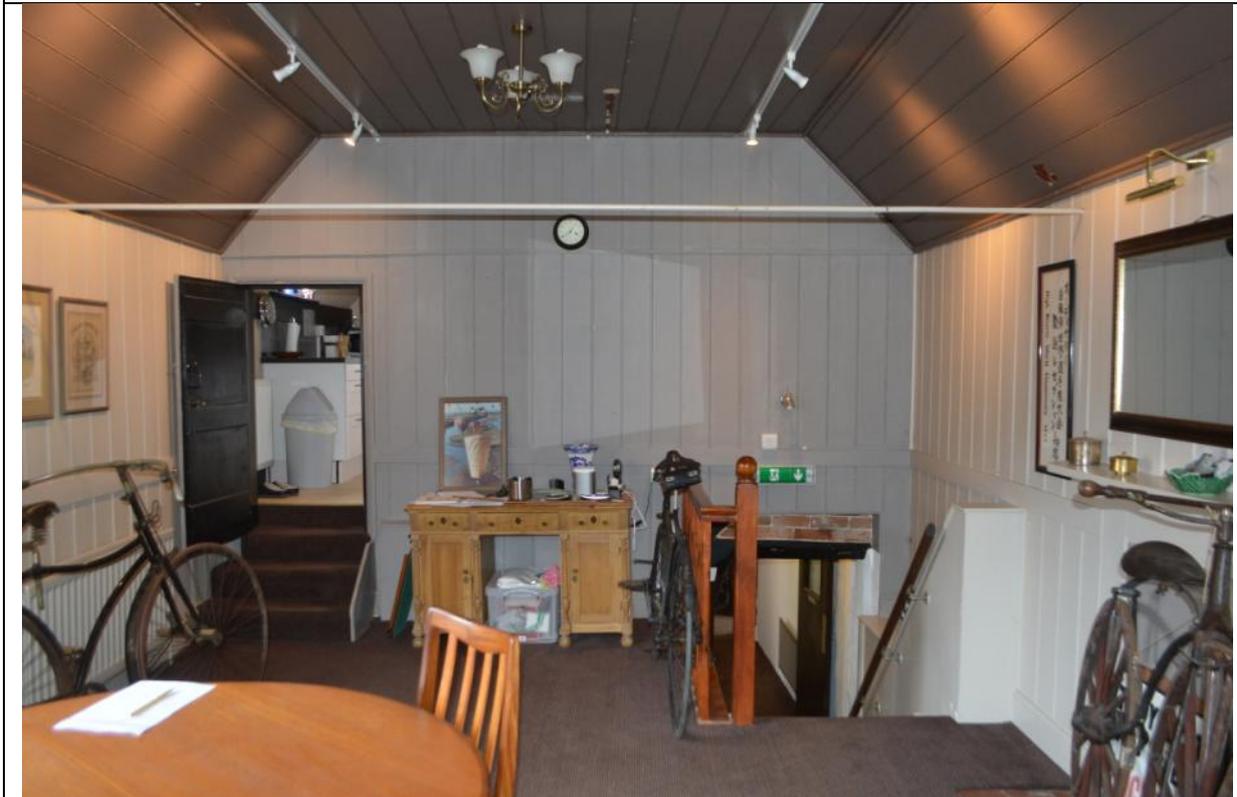
Plate 14: The modernised interior of block 3 showing the south end of the upper floor and the two staircases inserted to access the different floor levels of block 2

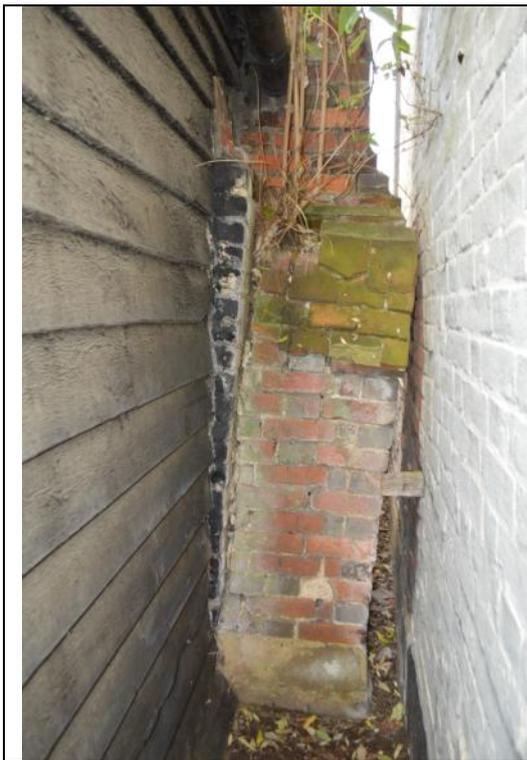
Plate 15: The northwest chimney stack, note the straight joint between it and the building

8.3.1 The northwest chimney stack, a single flue brick-built stack, awkwardly trapped between the west elevation of block 3 and the neighbouring dwelling was in a derelict state, parting with the building and creating damp issues to the inn and the neighbouring dwelling (Plate 15). The chimney stack was carefully dismantled to avoid further failure and any additional impacts that its continued failure or collapse may have on neighbouring fabric.

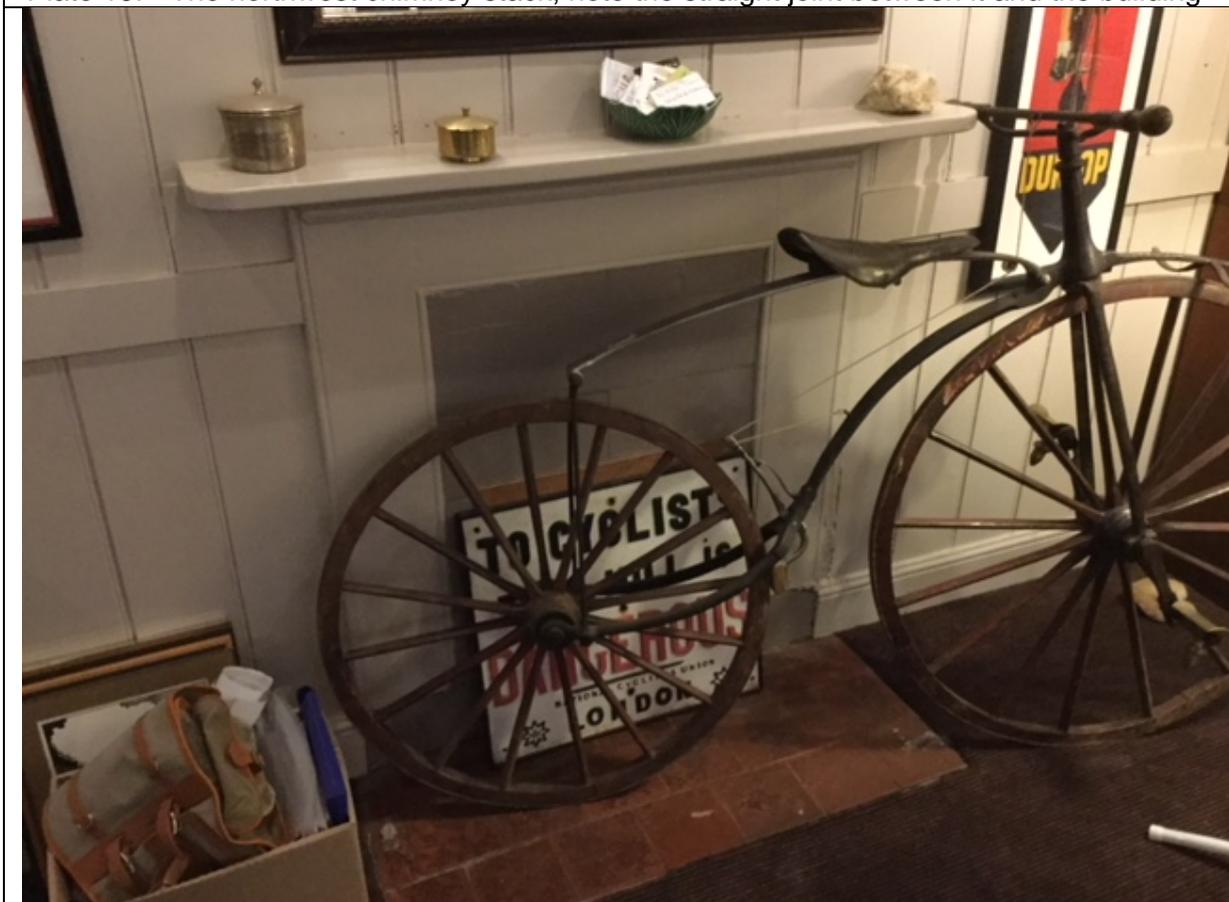
Plate 16: The interior finish and fireplace in the west elevation of the upper room of block 3

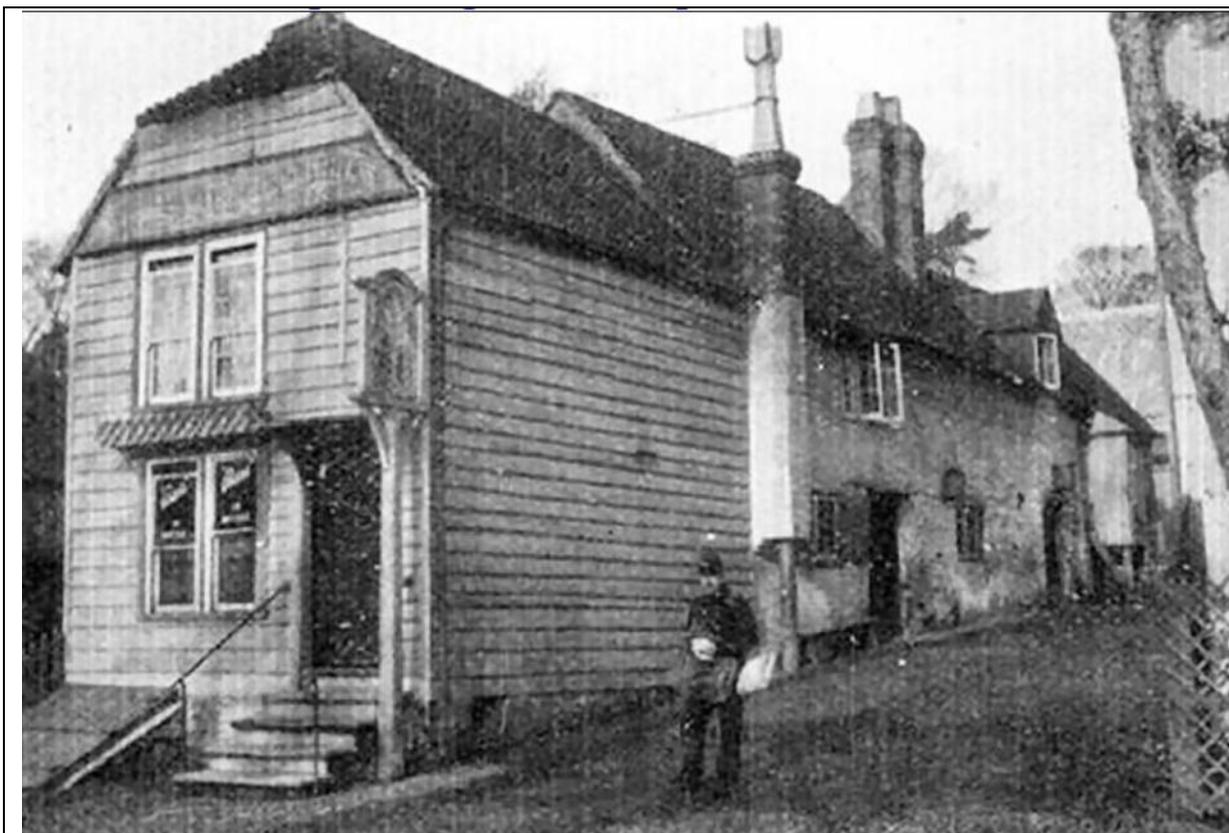
Plate 17: The General Wolfe Inn, south and east elevations complete with the end extensions (undated, c. late 19<sup>th</sup> or early 20<sup>th</sup> C)

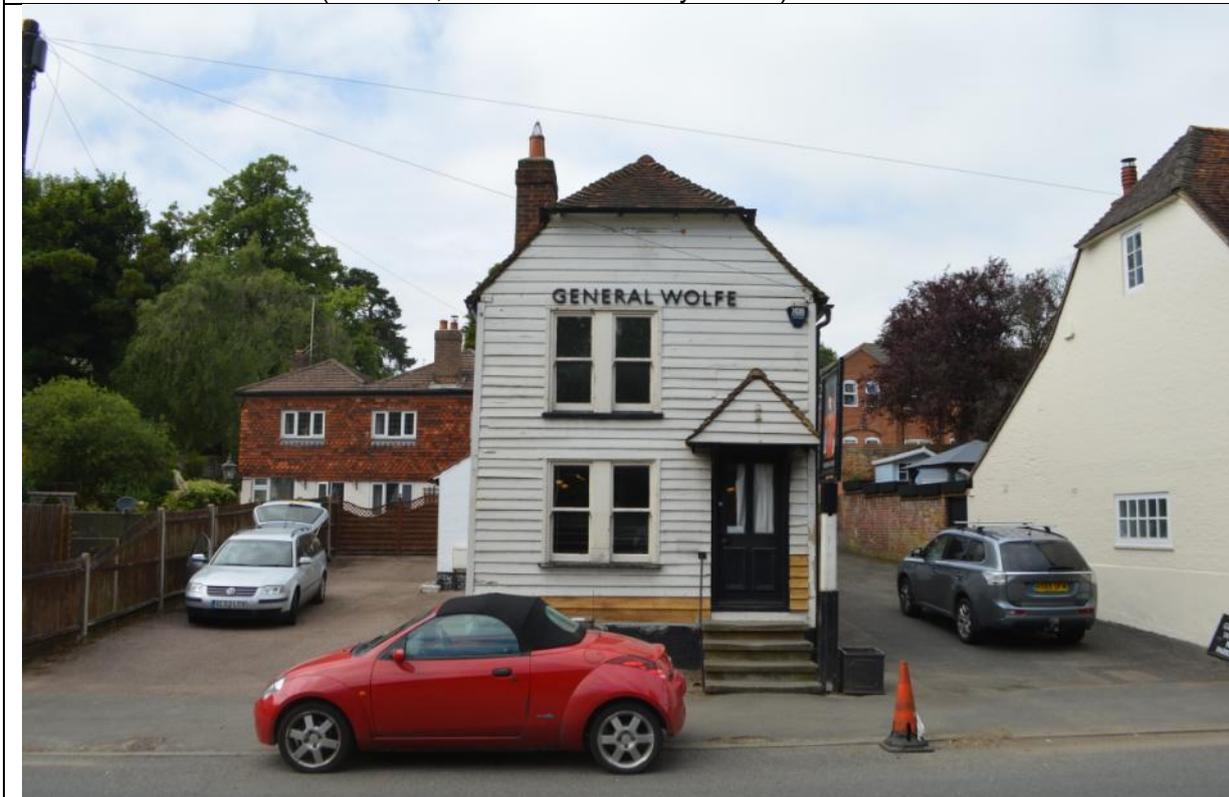
Plate 18: The south elevation of the former inn, 2018

- 6.4.16 Two sets of paired horned sash windows occupy the remainder of the elevation, lighting the rooms within: no further windows were originally included in this part of the building indicating the provision of two rooms, one on each floor, served by the windows in their south, principal elevation. The two rooms were heated from the outset as indicated by the inclusion of an internally projecting two-flue chimney stack on the western side of the block (Figure 9, Plate 18).

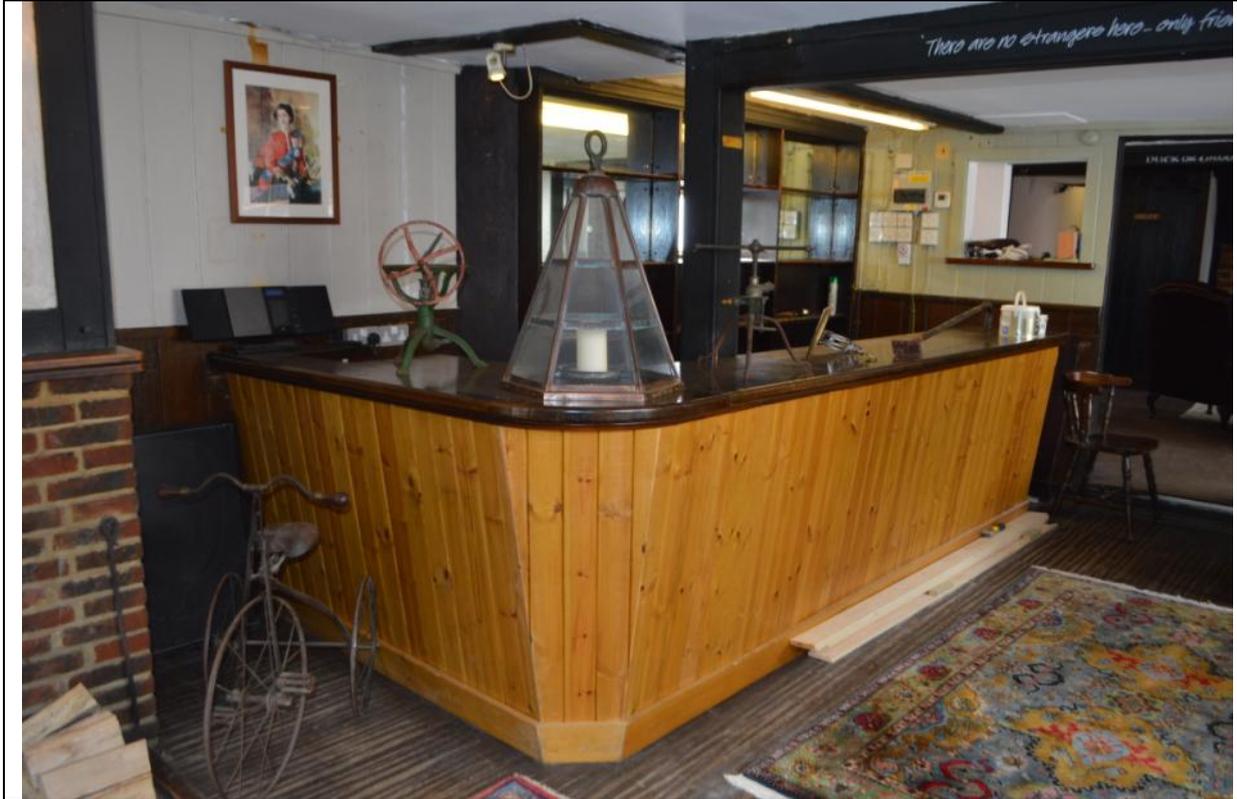
Plate 19: The existing bar in block 4, c. 1970

- 6.4.18 On ground floor room is the main part of the former public house, the bar. The existing bar, situated in the southwest corner of the room is of c. the third quarter of the 20<sup>th</sup> century in origin (Plate 19). At first floor level, the new room may have been part of the domestic accommodation for the publican or other workers employed at

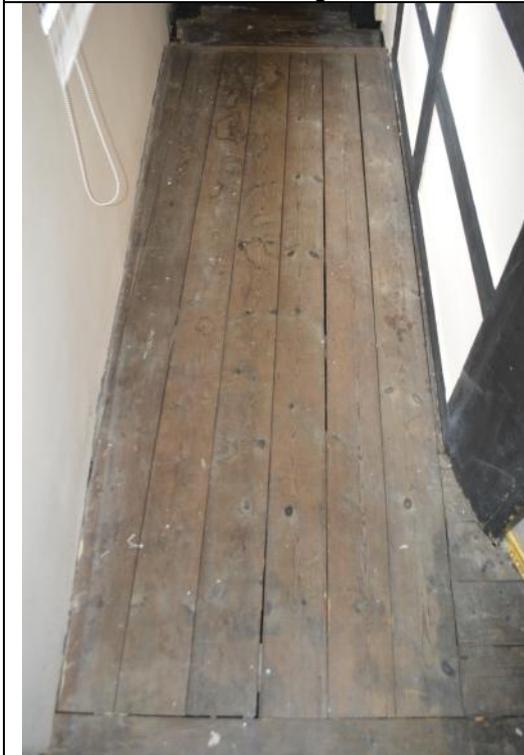
Plate 20: The corridor just north of the block 4 addition, its flooring indicative of the in-fill of a former staircase location

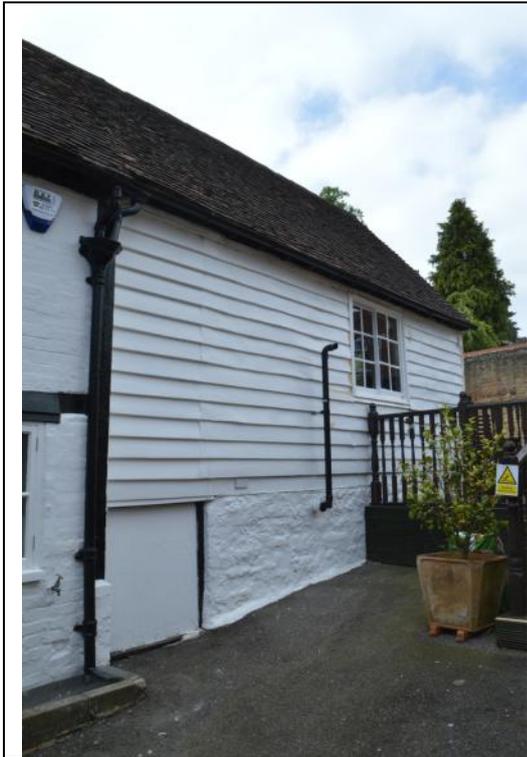
Plate 21: The east side of block 3, showing blocked opening to the lower floor

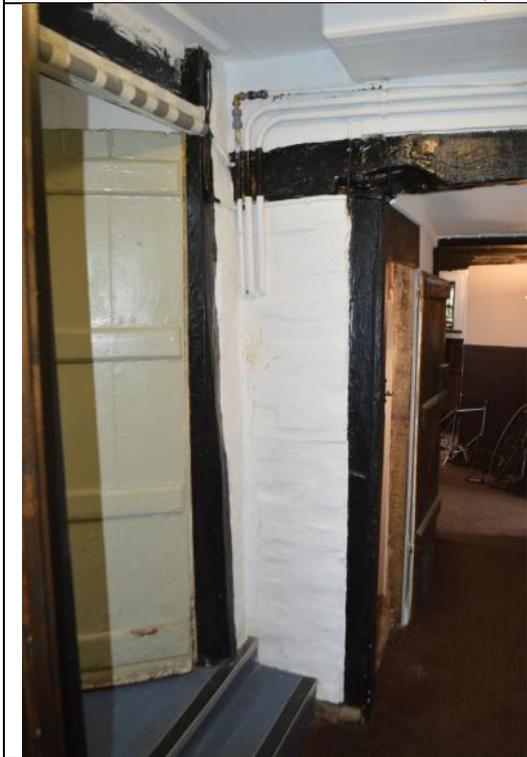
Plate 22: The steps leading to the raised floor in the northeast room of block 2 (looking south)

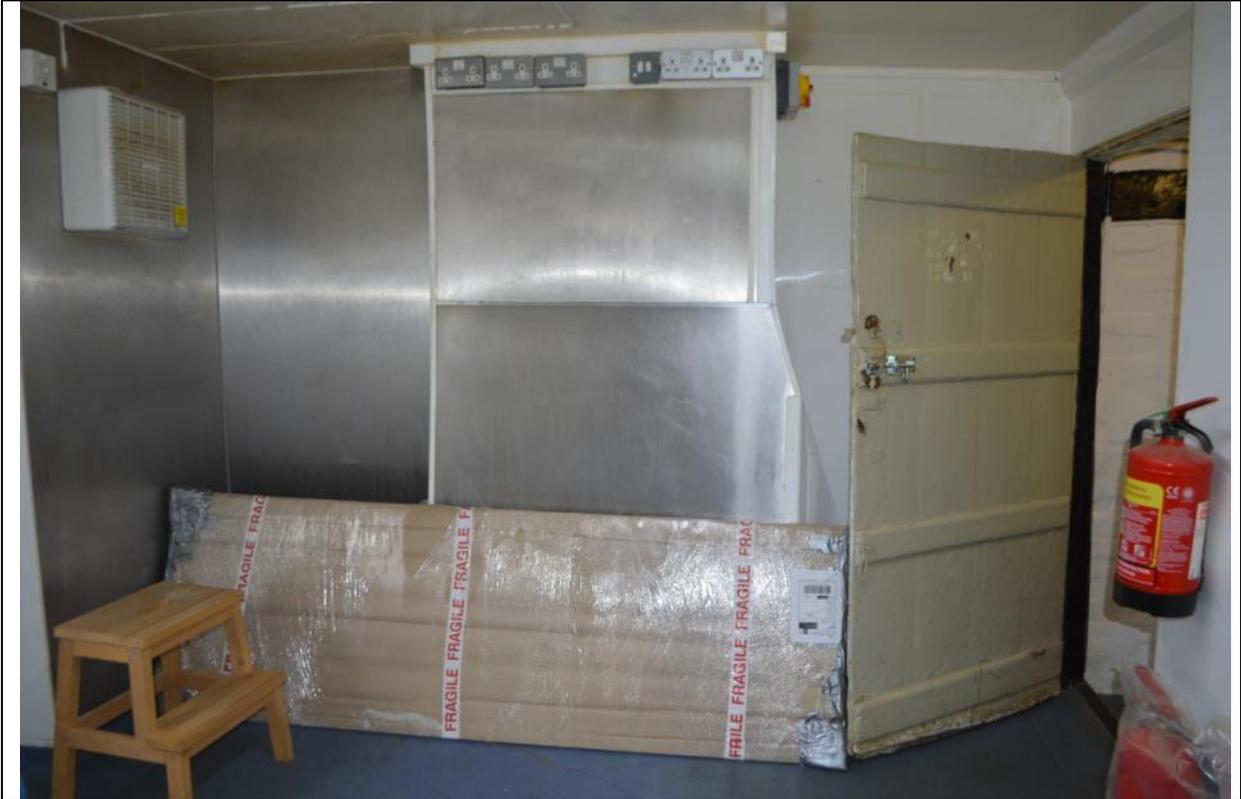
Plate 23: Applied wall finishes at the south end of block 2. Note the altered base of the boarded and ledged door to the west (right)

8.7.2 The planned removal of parts of the partition are intended to create more usable room proportions with better natural light provisions than those currently offered by the existing public house layout. The existing partition is of regular softwood stud construction with a plasterboard finish and a boarded and ledged door providing access to the former kitchen area (discussed above, Plates 22 and 23).

8.10.2 The proposed removal of the recent wall finishes (Plate 23) will enhance the appearance of the building, removing surfaces that are clearly detrimental to the character if not the structure of the listed building.

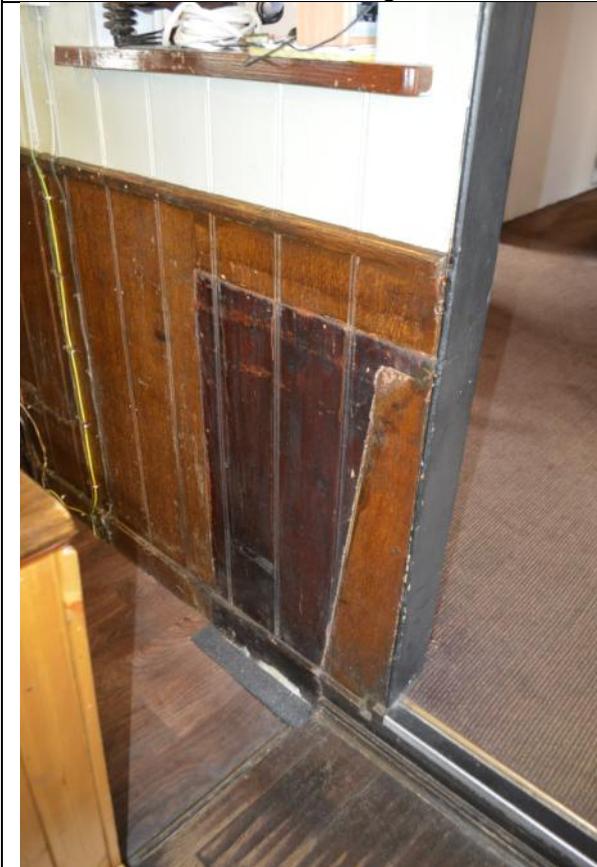
Plate 24: The pressure mark on the earlier matchboard wall finish at the northern end of block 4 indicating the shape and location of the c, 1970s bar

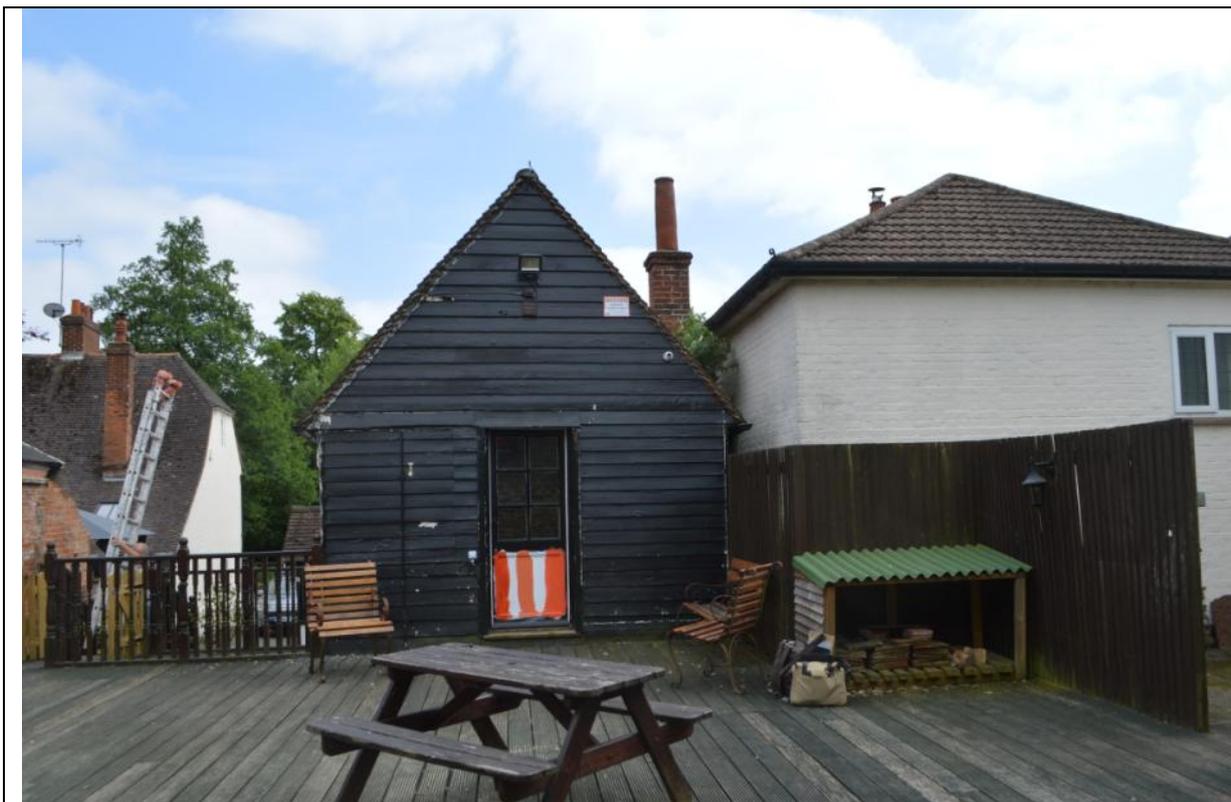
Plate 25: The north end elevation of block 3

8.13.1 The urban constraints of the plot of land occupied by the former inn, the long linear footprint of the building and the interior organisation specific to its use as a public house has had an impact on the amount of natural light within. As such, to increase natural light to the upper room of block 3 at the north end of the building, by replacing the existing doorway with a wider modern alternative that comprised a doorway and window arrangement (Plate 25, Dwg. No. 14).
