GENERAL WOLFE INN, WESTERHAM,  
KENT, TN16 1RQ

## HERITAGE STATEMENT AND IMPACT ASSESSMENT

Report No. 2018356  
October 2018, Revised July 2021

Prepared by Maggie Henderson

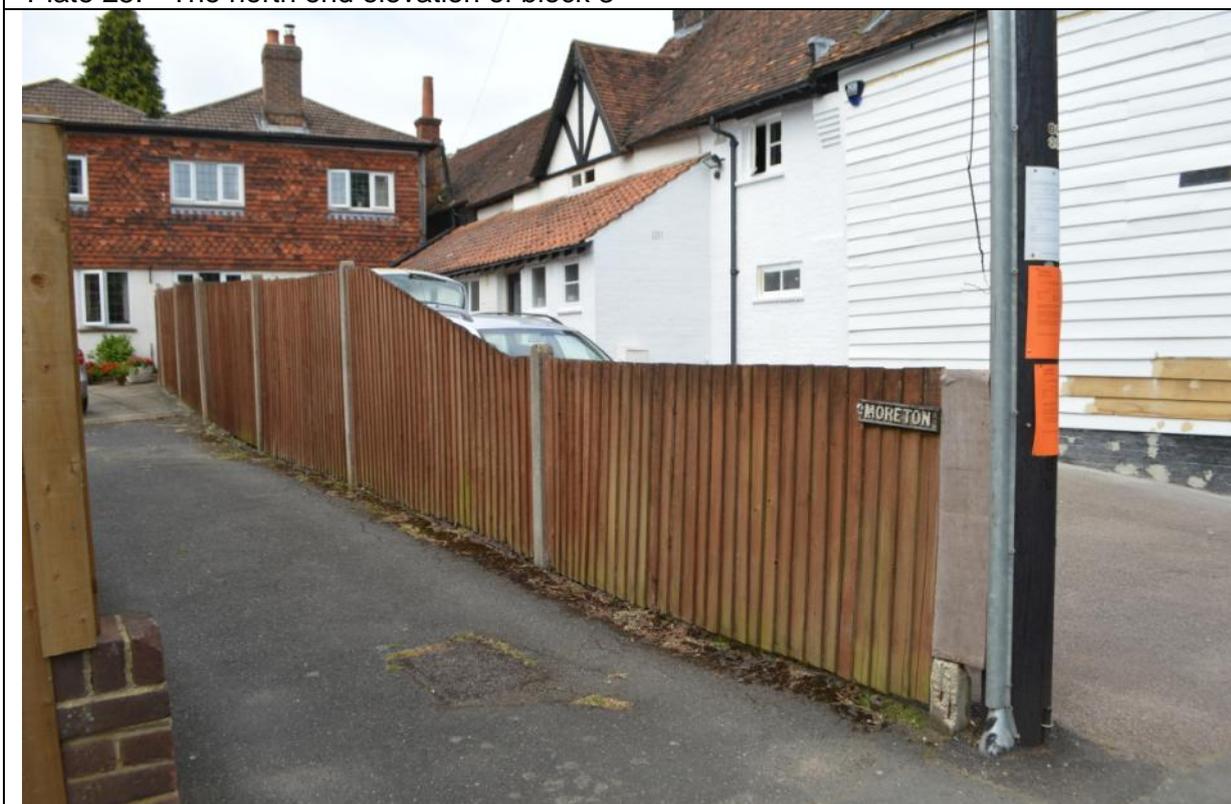
Plate 26: The fencing on the west side of the property, proposed for replacement

8.14.1 The existing modern fencing to the west of the property (Plate 26) is proposed for replacement with cast iron estate fencing at the southern end in conjunction with a low hedge (no higher than 1.25 metres). The replacement of the existing fencing, particularly when considered in conjunction with the other exterior improvements (points 12 and 13 below) could be considered to be a substantial visual enhancement. The enhancements to the exterior will have a positive impact on the listed building, the long pond opposite and the conservation area as a whole.

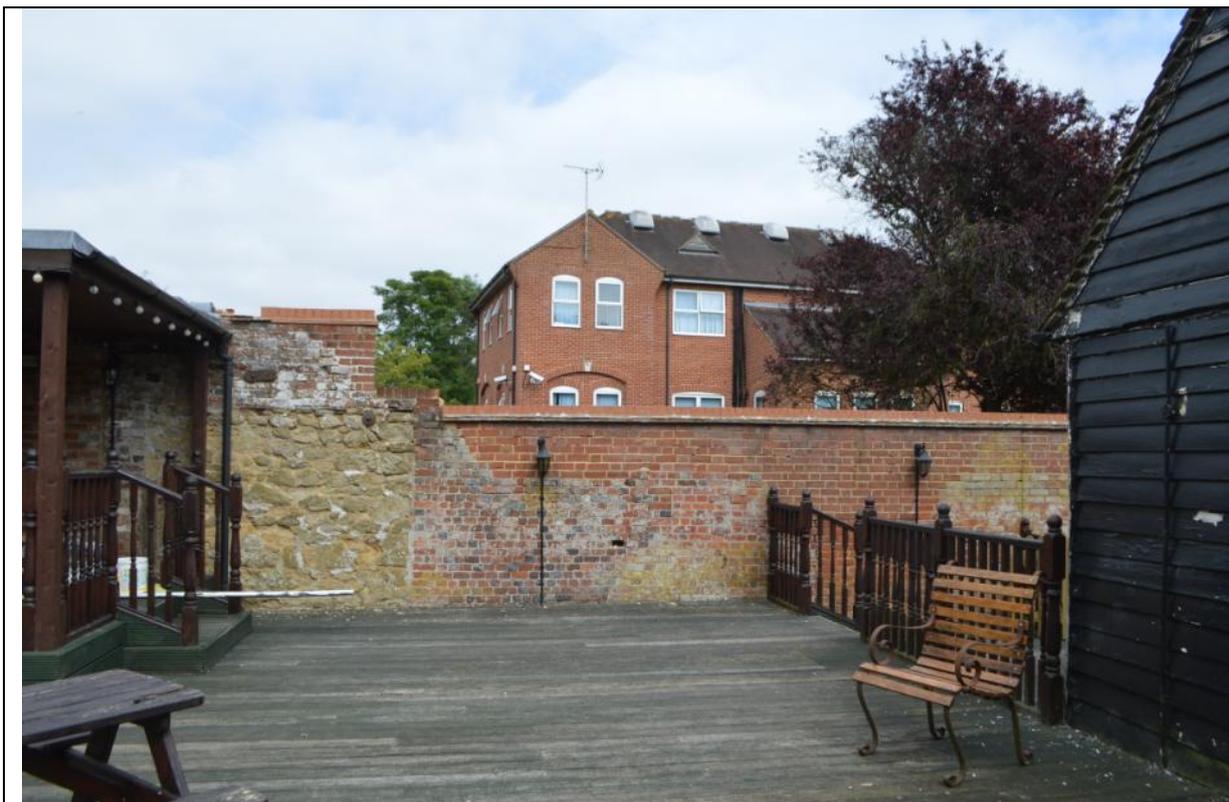
Plate 27: The east side of the courtyard at the north end of the property: an opportunity for enhancement

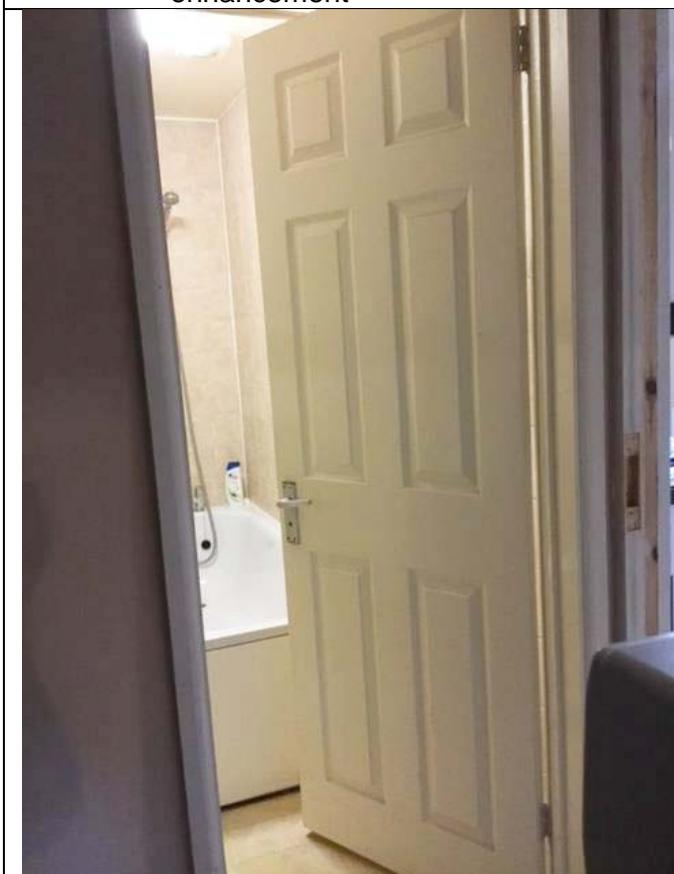
Plate 28: Modern generic faux Georgian six-panel door to first floor bathroom

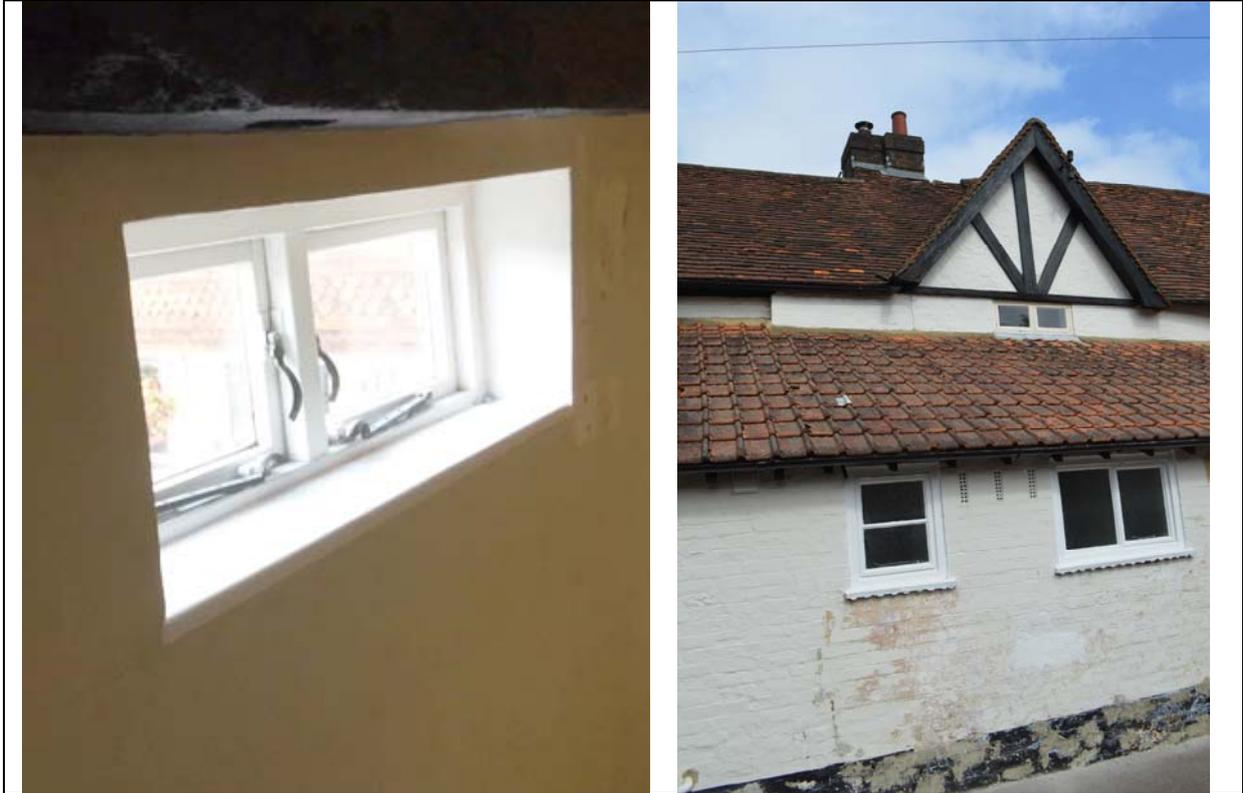
Plate 29: The window in the west wall, first floor, at the north end of block 1

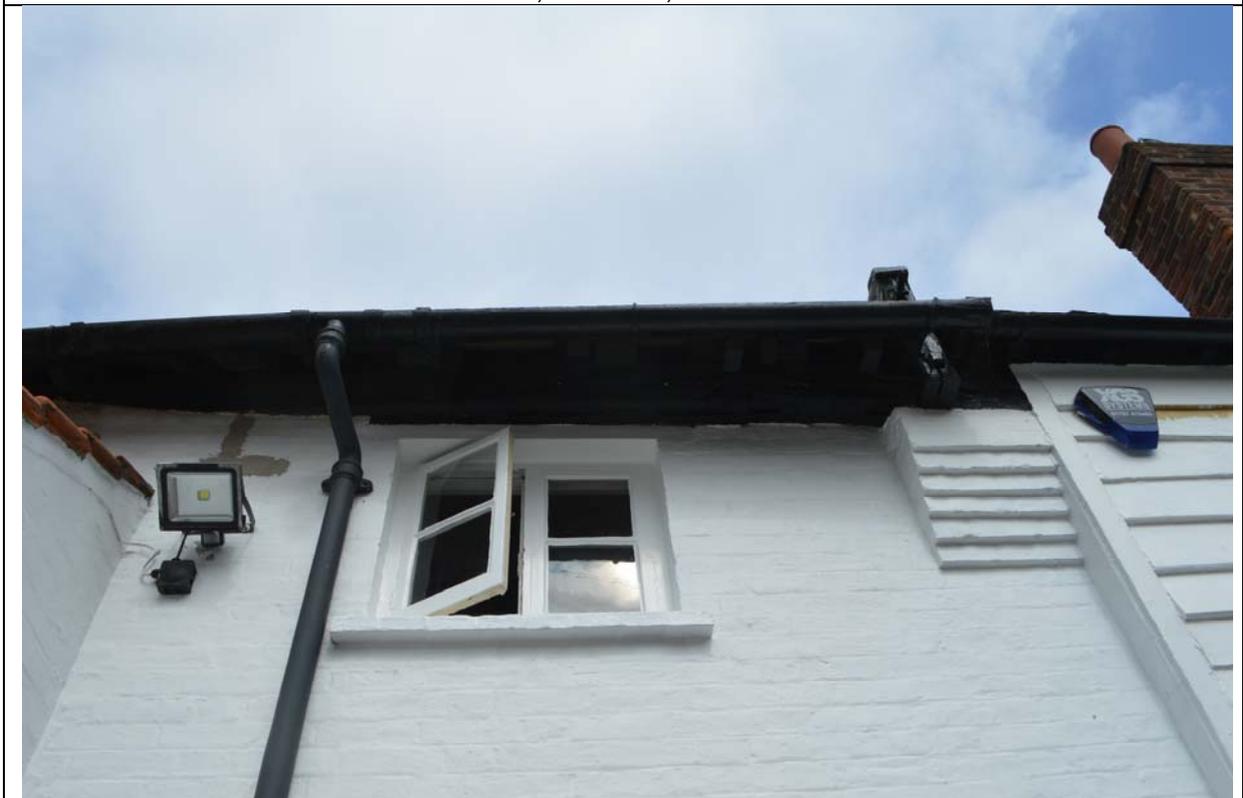
Plate 30: Two-light side-hung casement in west wall, first floor to the south of that proposed for replacement shown in Plate 28

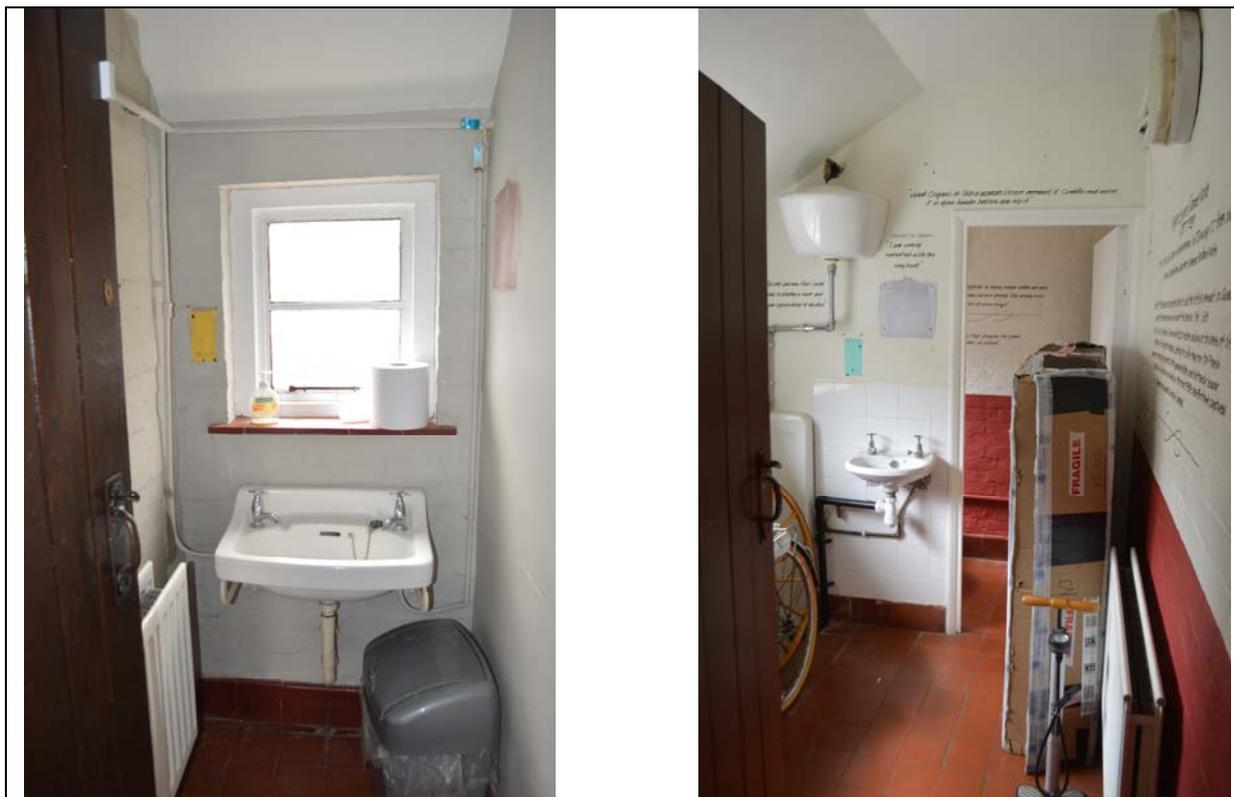
Plate 31: Modern fittings within the toilet block built against the west side of the main range

8.20.1 To bring the building back into use as a domestic dwelling it will be necessary to remove the redundant fittings within the toilet block (Plate 31). The single-storey lean-

8.20.2 The interior fittings have been subject to modernisation and replacement over the years as one would expect for such facilities within a functioning public house (Plate 31). As such, no historic fittings of note survive and their removal will not alter the significance or special character of this important building.
