**09 - PROPOSED LAYOUT** SCALE 1/25  
**GEN WOLFE WORKSHOP TO WORKSHOP/UTILITY USE**  
**PROPOSED : REINSTATEMENT AND ALTERATIONS**  
**AT : GENERAL WOLFE. WESTERHAM. TN16 1RQ.**  
**FOR : MR PHILIP SAUNDERS**

**PROPOSED : REINSTATEMENT AND ALTERATIONS**  
**AT : GENERAL WOLFE. WESTERHAM. TN16 1RQ.**  
**FOR : MR PHILIP SAUNDERS**

**PROPOSED : REMOVAL/REPLACEMENT OF FAILED CHIMNEY**

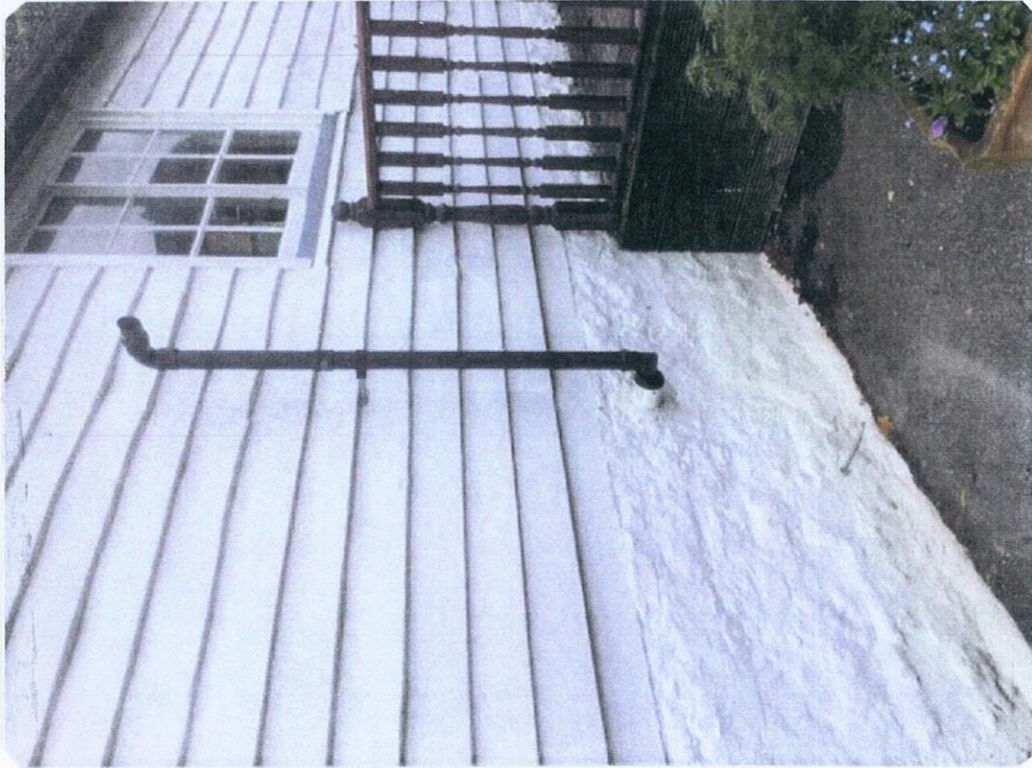
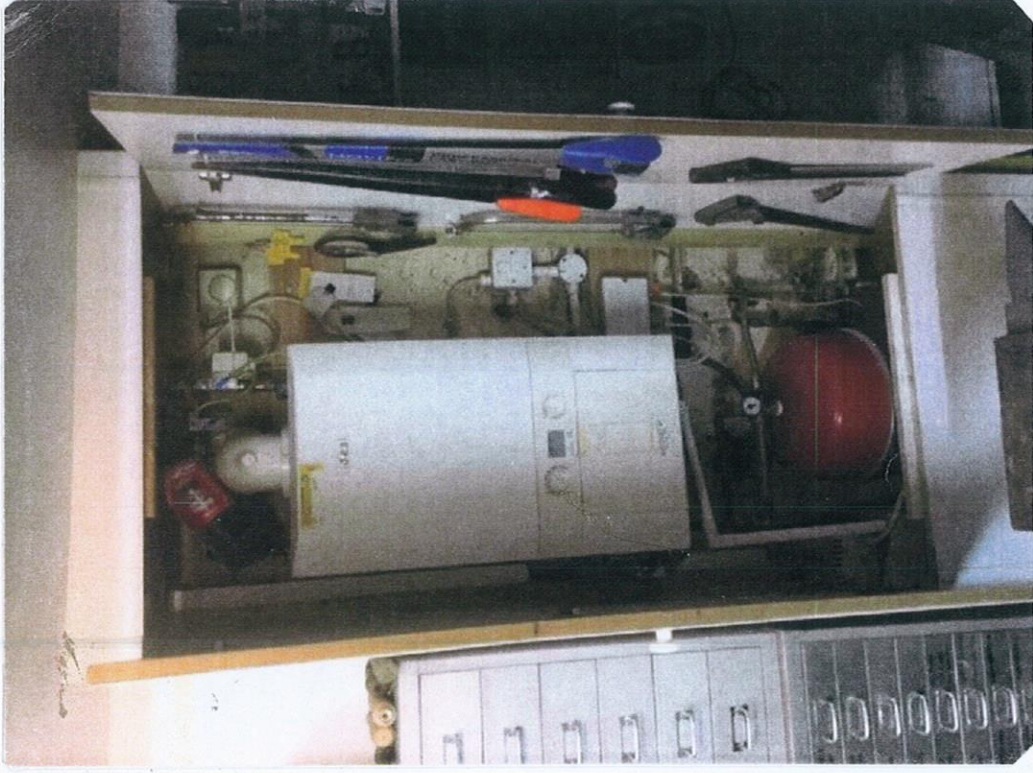
**PHOTOGRAPHS TO BE READ IN CONJUNCTION WITH DRAWING 09**

**ORIGINAL FAILED GAS FIRED BOILER**  
PREVIOUS FAILED BOILER AND FLUE REPLACED WITH NEW  
BOILER AND FLUE LOCATED IN THE SAME LOCATION.

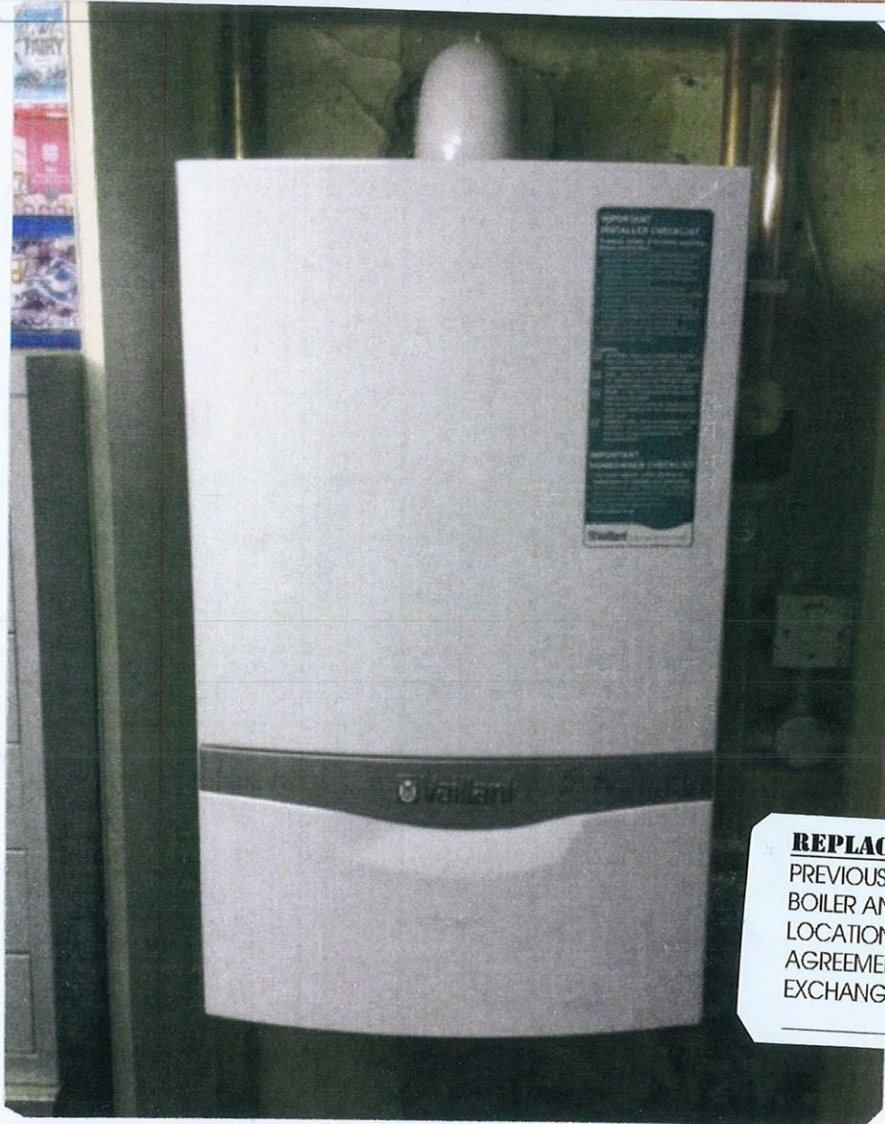
**PHOTOGRAPHS TO BE READ IN CONJUNCTION WITH DRAWING 09**

**REPLACEMENT GAS FIRED BOILER**  
PREVIOUS FAILED BOILER REPLACED WITH NEW BOILER AND EXTERNAL FLUE FITTED IN THE SAME LOCATION WITHIN THE WORKSHOP BUILDING. AGREEMENT SUBJECT TO OPREVIOUS LIASON AND EXCHANGES WITH 'CONSERVATION OFFICE'.

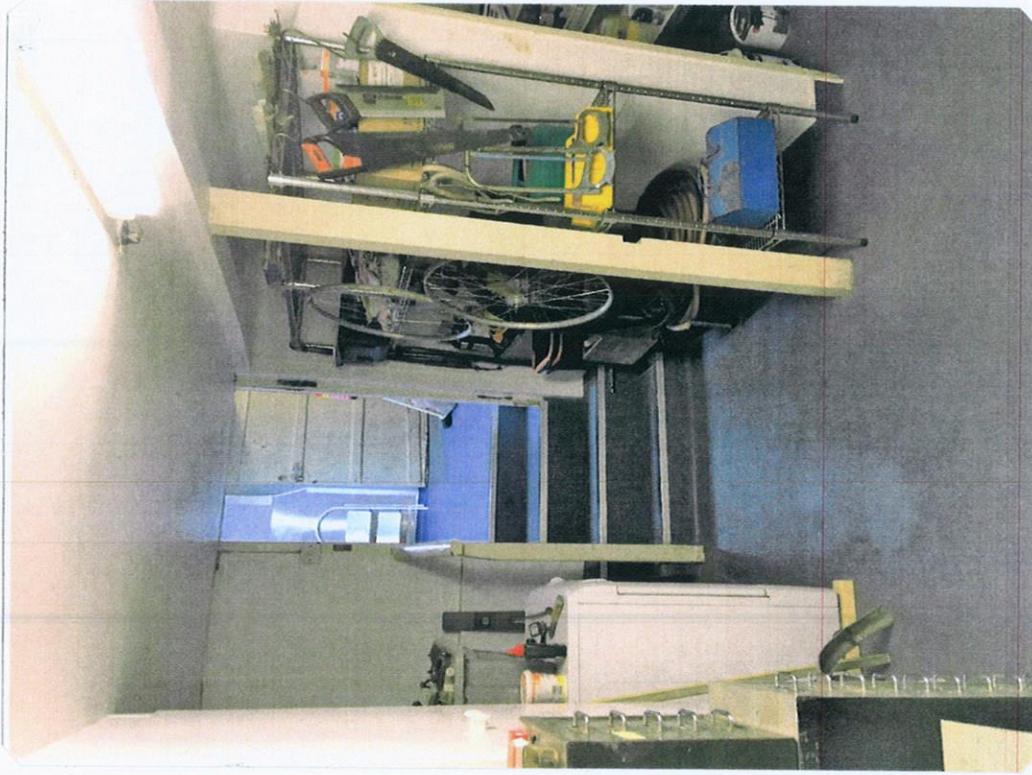
**GENERAL WORKSHOP UTILITY VIEWS**  
VIEW THROUGH TO STUDIO AT UPPER LEVEL.  
SEE LAYOUT DRAWING NUMBER 08

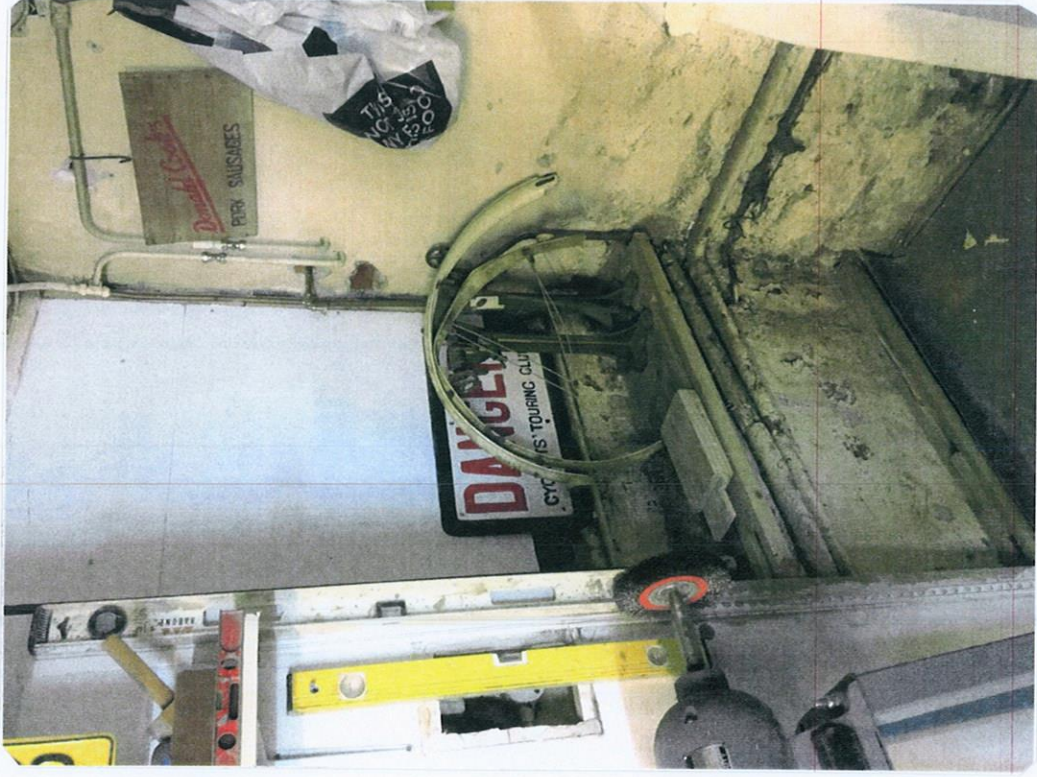
**EXISTING BLOCKED WINDOW OPENING**  
PREVIOUS BLOCKED WINDOW OPENING AT EAST SIDE  
TO BE EXPOSED AND NEW HW PAINTED WINDOW TO  
BE FITTED WITH FLUSH FRONT  
TO MATCH SURROUNDING WINDOWS.

**EXISTING SOLID BLOCKING TO OPENING**  
THE ORIGINAL ACCESS DOOR SERVING BREWERY CELLAR  
(I.E WORKSHOP) HAS BEEN PREVIOUSLY BLOCKED WITH SOLID PLY  
THE EXISTING BLOCKING IS TO BE REMOVED AND THE OPENING  
INFILLED WITH PAINTED TIMBER CASEMENT WINDOW.  
SINGLE REBATED/FLUSH FRONT (SEE DRG NO 15/02).

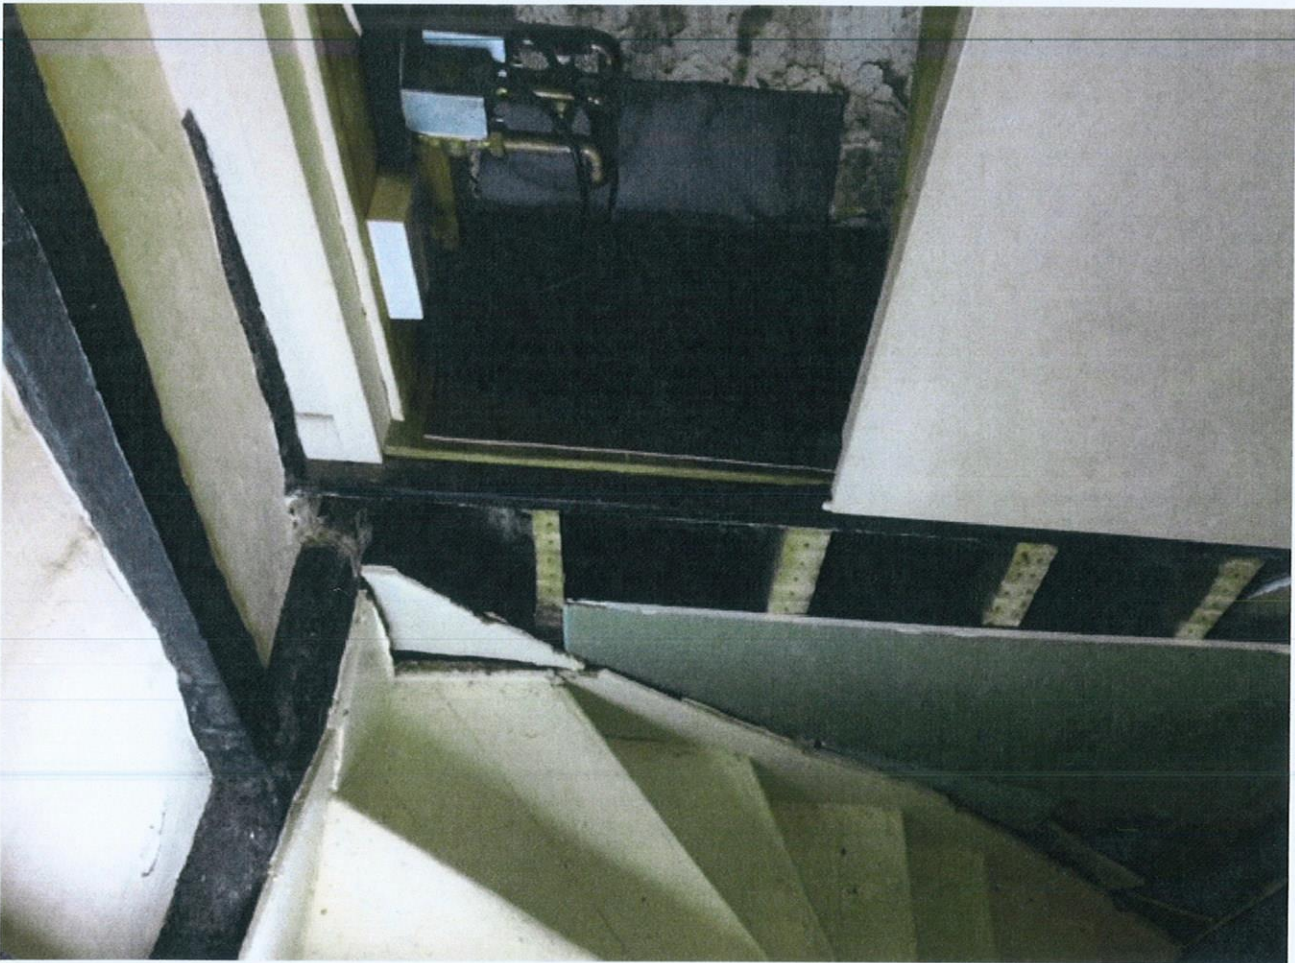
#### **HISTORIC CHIMNEY**

THE STAIR ENCLOSURE IS FORMED WITH SOFTWOOD STUDWORK FACED WITH SINGLE SKIN PLASTERBOARD AND BOARDING.

THE LINING CONCEALS THE ORIGINAL 'PHASE 1' MASONRY FIRE BREAST AND STACK AND IS PROPOSED TO BE REMOVED TO EXPOSE THE HISTORIC BRICK FLANK OF THE ORIGINAL STACK.

AT FIRST FLOOR LEVEL, THE CASING COMPRISES HARDBOARD ON SOFTWOOD FRAME TO FORM LINEN AND TANK CUPBOARD PROPOSED TO BE REMOVED TO EXPOSE THE ORIGINAL STACK.

SCRIBE AND FIT A PAINTED TOP TO STAIR STRING TO SEAL THE GAP BETWEEN STRING AND THE STACK AND CLOSE STRING TO THE FLOOR.

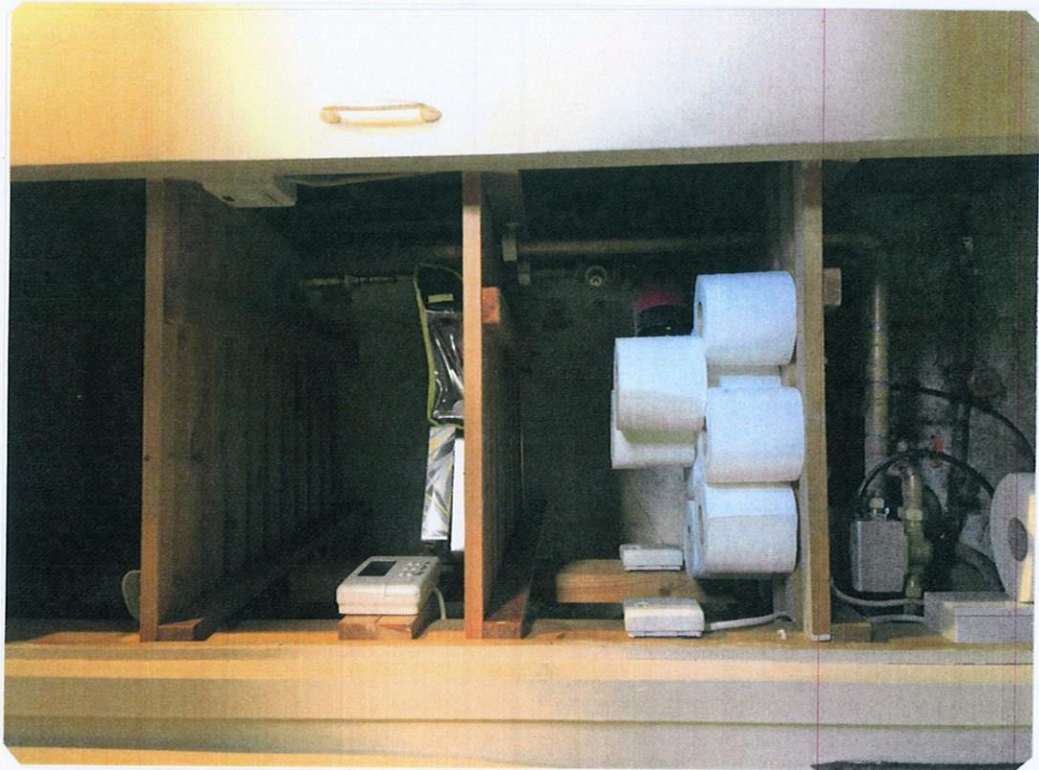
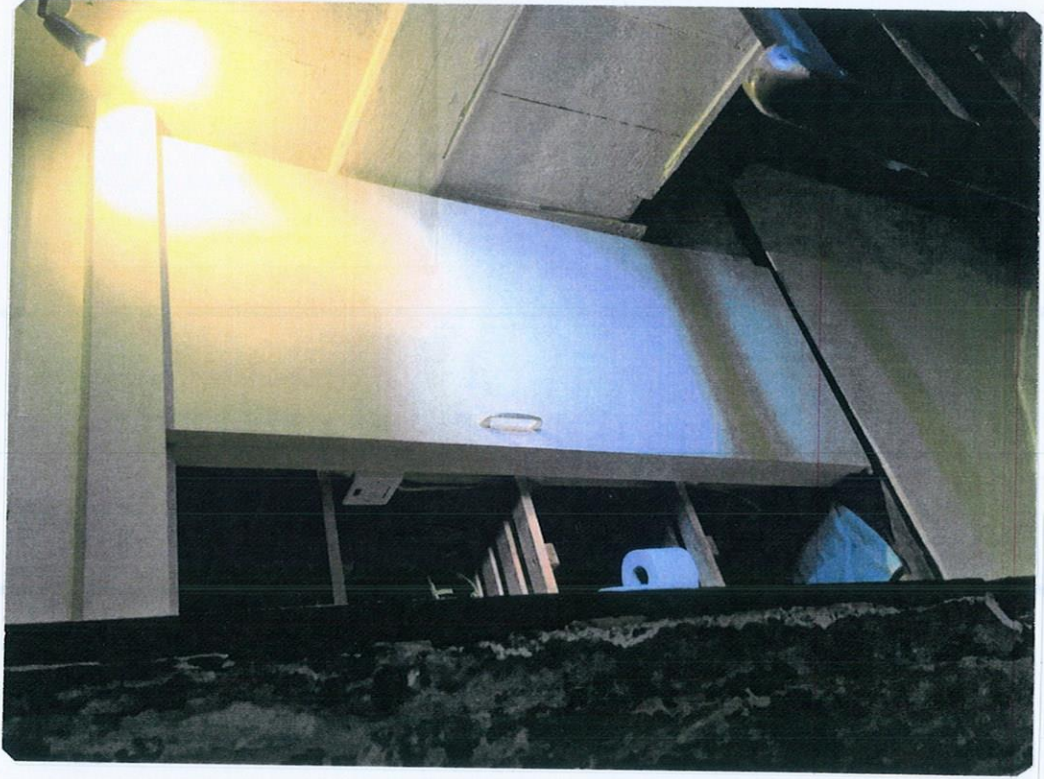
**PHOTOGRAPHS TO BE READ IN CONJUNCTION WITH DRAWING 10**

**EXPOSE HISTORIC STACK**  
LINEN ENCLOSURE, FLUSH DOOR, FITTINGS AND SHELVING AT  
HEAD OF STAIR TO BE REMOVED TO EXPOSE THE ORIGINAL STACK.  
STACK TO BE REPAIRED IF DISTURBED WITH MATERIALS TO MATCH  
SURROUNDING FABRIC.

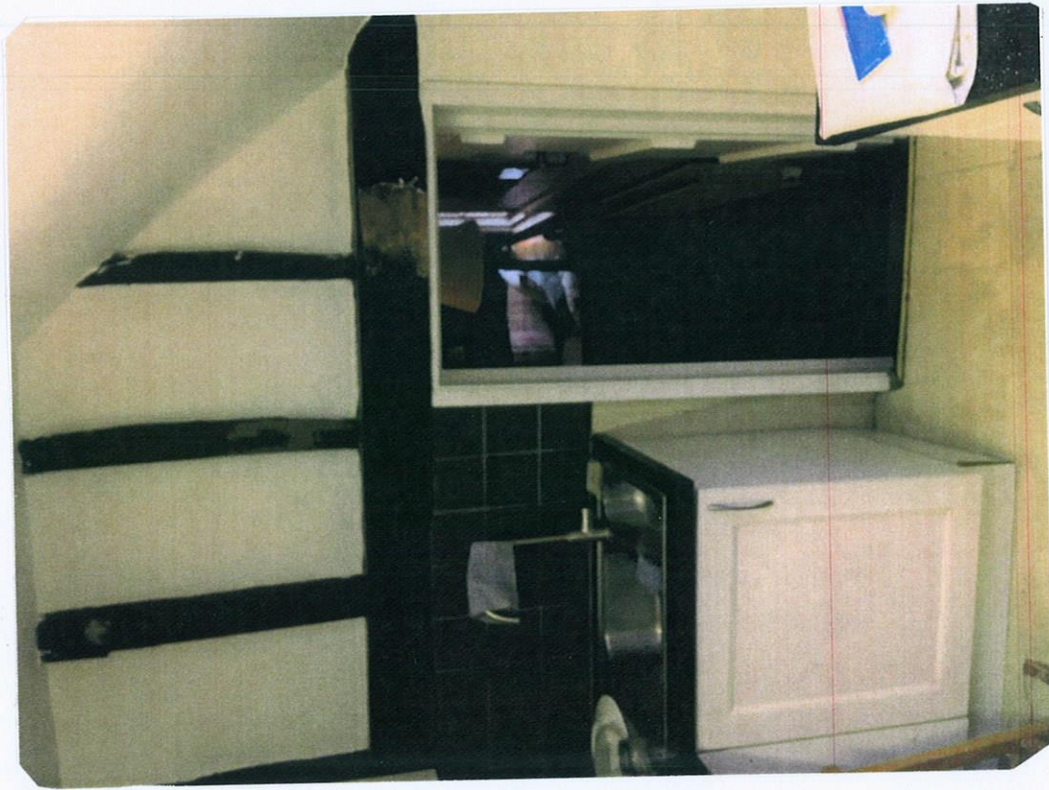
**PHOTOGRAPHS TO BE READ IN CONJUNCTION WITH DRAWING 10**

**EXISTING PUB FLAT KITCHEN.**  
VIEW THROUGH TO STEPS LEADING TO LOUNGE  
AT LOWER LEVEL.  
SEE LAYOUT DRAWING NUMBER 10

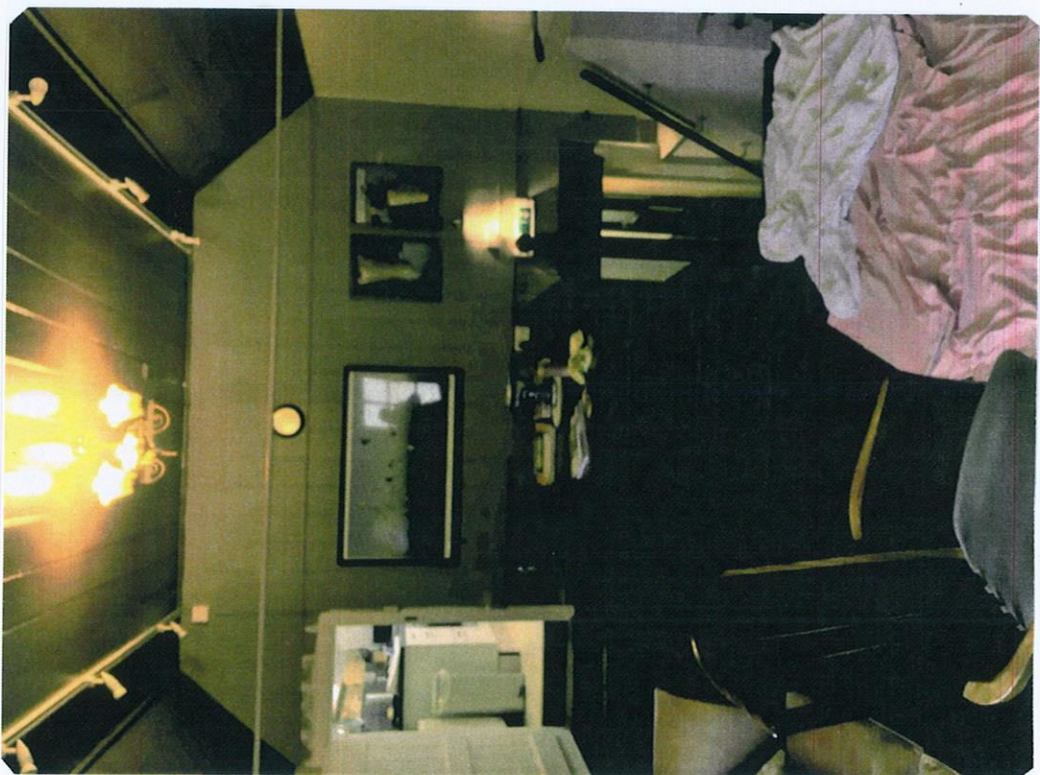
**PHOTOGRAPHS TO BE READ IN CONJUNCTION WITH DRAWING 11**

**VIEW TO STAIRS.**  
STAIR UP TO ORIGINAL  
FLAT KITCHEN.  
STAIR DOWN TO CORRIDOR

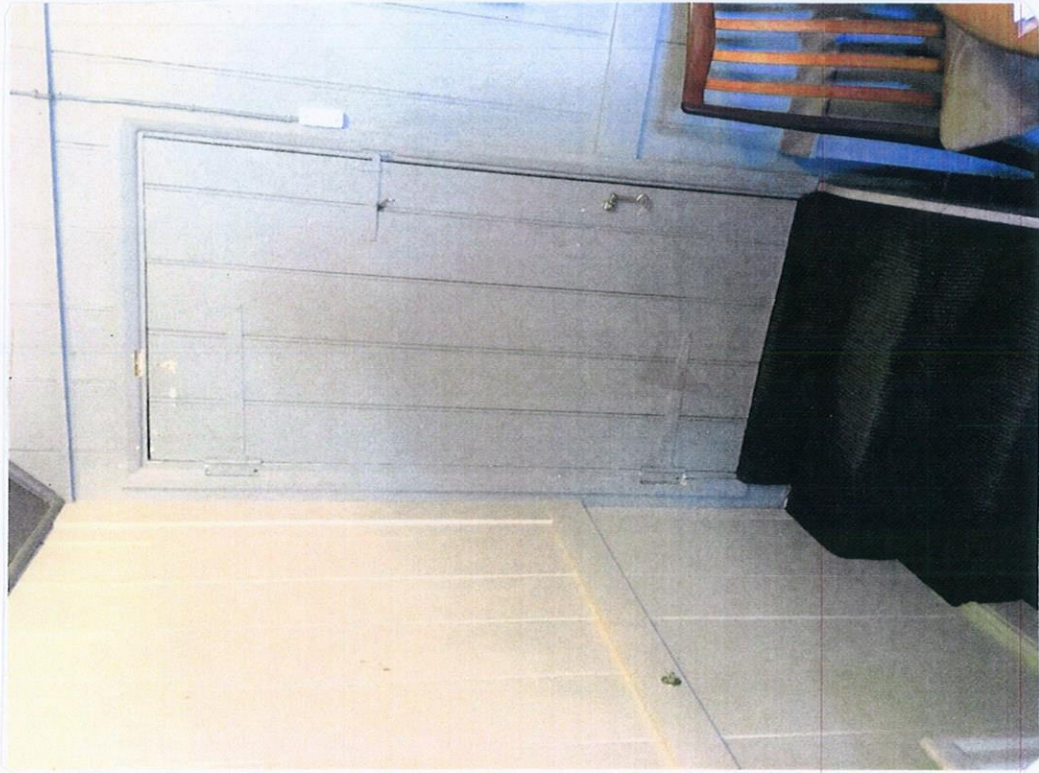
**PHOTOGRAPHS TO BE READ IN CONJUNCTION WITH DRAWING 11**

**STEPS UP TO 'KITCHEN'**  
STAIR UP TO PUB FLAT (KITCHEN).  
BOARDED DOOR AND WALLS.  
CARPETTED STEPS.

**STEPS UP TO KITCHEN.**  
 RETAIN STEPS UP TO KITCHEN  
 WITH BOARDED DOOR.

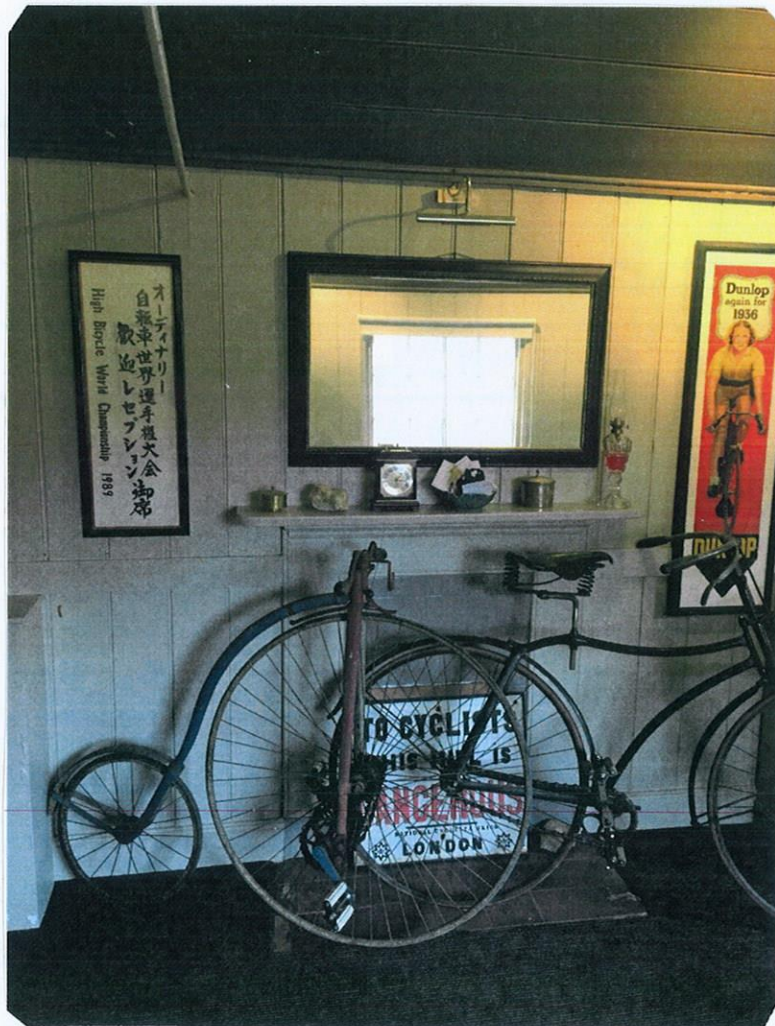
**PHOTOGRAPHS TO BE READ IN CONJUNCTION WITH DRAWING 11**

**FIREPLACE**

REDUNDANT FIREPLACE SURROUND RETAINED WITH PAINTED BOARDED WALL PANELLING.

**FIREPLACE**  
 REDUNDANT FIREPLACE SURROUND RETAINED  
 WITH PAINTED BOARDED WALL PANELLING.

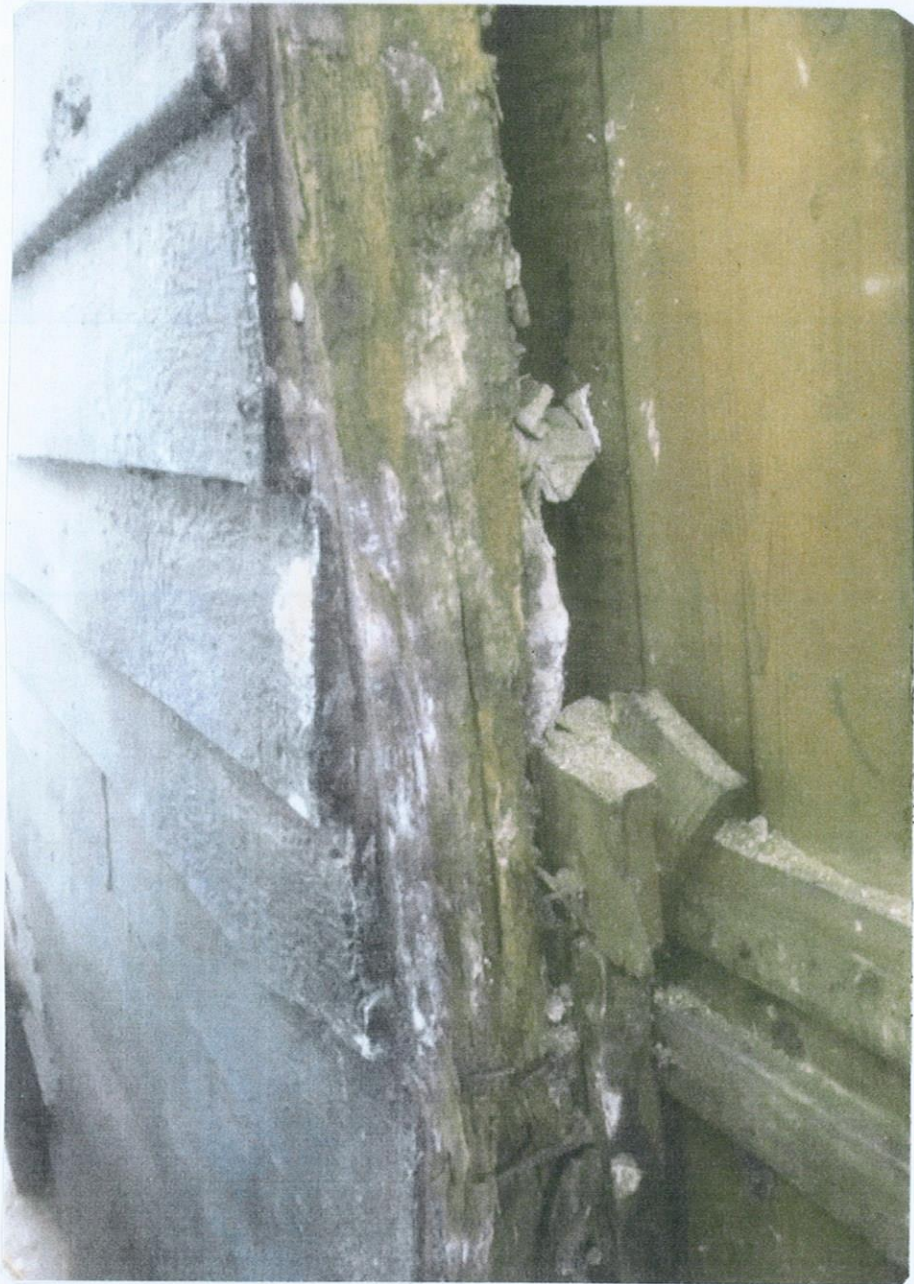
**PHOTOGRAPH TO BE READ IN CONJUNCTION WITH DRAWING 11**

**REPLACEMENT EVIDENCE FOR DEFECTIVE STACK.**

REMOVE CLIENT'S TEMP' PROTECTION TO EXPOSE EXISTING TIMBER FRAMED WALLING.  
RETAIN EXISTING SOUND STUDS AND FIT OAK INFILL STUDS.  
INFILL VOID WITH INSULATION, MEMBRANE AND WBP SHEATHING.  
CONSTRUCT SALVAGED BRICK/LIME MORTAR FACING TIED TO STABILISED FRAME.  
ALL TO PROVIDE HISTORICAL EVIDENCE OF DEFECTIVE STACK NOW REMOVED  
SEE DRAWING NUMBER 11/01

**REPLACEMENT EVIDENCE FOR DEFECTIVE STACK.**  
 REMOVE CLIENT'S TEMP' PROTECTION TO EXPOSE EXISTING  
 TIMBER FRAMED WALLING.  
 RETAIN EXISTING SOUND STUDS AND FIT OAK INFILL STUDS.  
 INFILL VOID WITH INSULATION, MEMBRANE AND WBP SHEATHING.  
 WITH BRICK FACING TIED TO STABILISED FRAME.  
 SEE DRAWING NUMBER 11/01
